EVALUATION OF SELECTED TREES AT

DAWSON SHORT PLAT
10827 NE 108TH STREET
KIRKLAND, WA 98033

January 18, 2006

AMENDED August 16, 2006

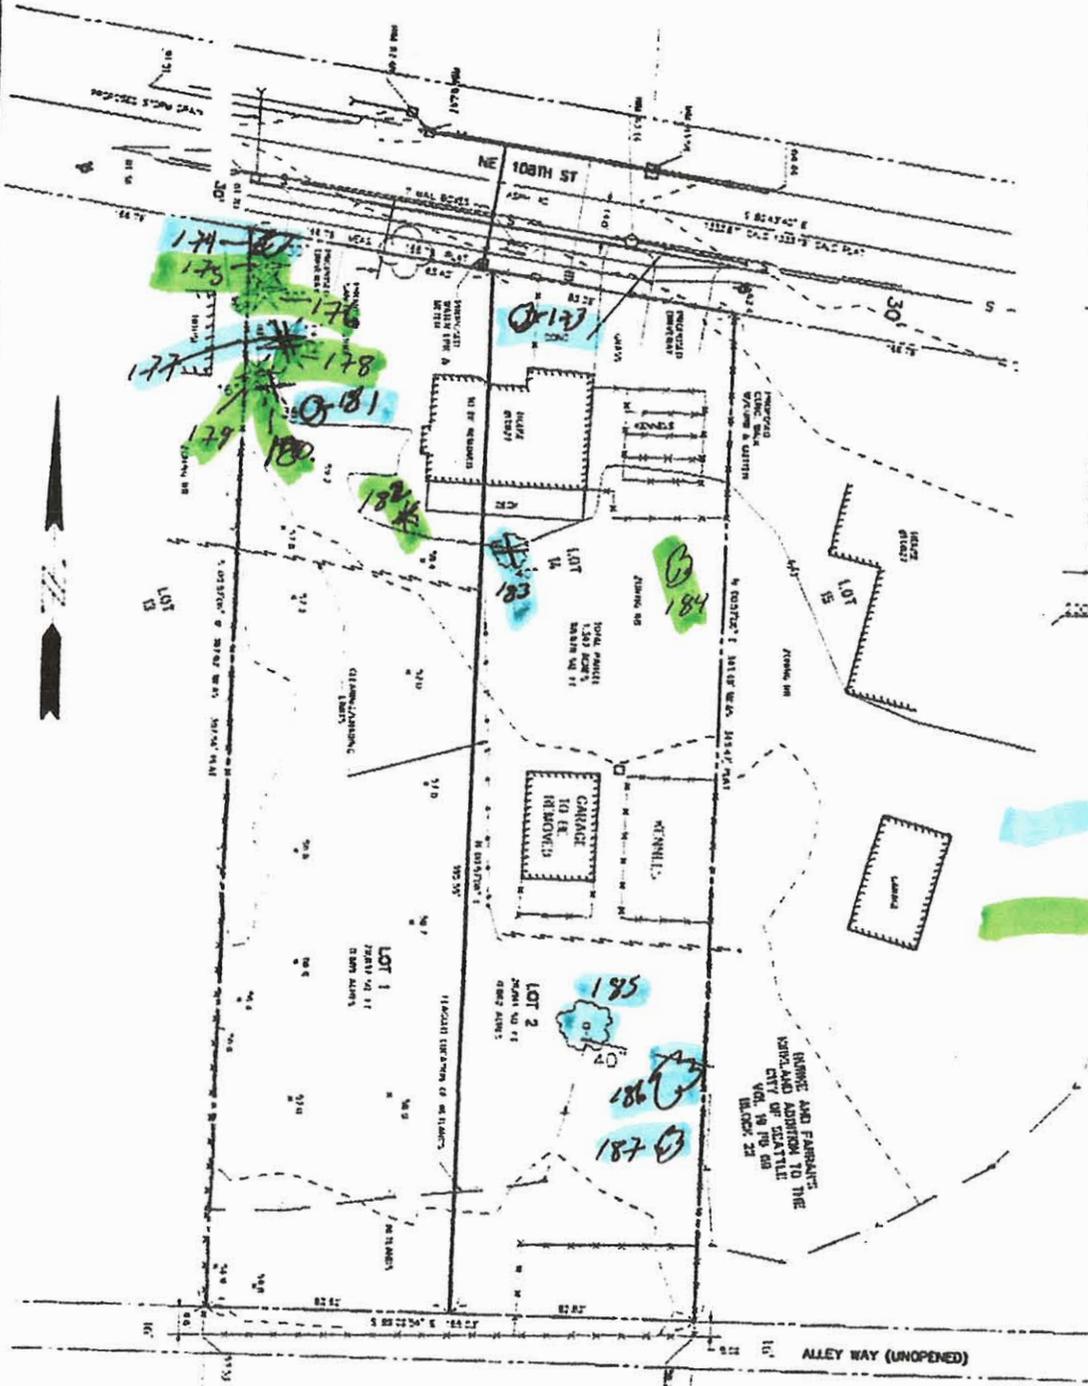
ATTACHMENT 1 - SITE PLAN

- Non-Viable Trees

- Viable Trees

TREE RETENTION

EXISTING SIGNIFICANT TREES 9

TREES TO BE RETAINED 4

TREES FOR REMOVAL 5

* Please note that if trees 175, 176, 179, and 180 are retained the limits of disturbance can be managed as a unit. However, trees 174, 177, and 181 will need to be carefully removed and their stumps ground out.
