Brian K. Gilles, Consulting Arborist
ISA Certified Arborist # PN-0260A
ASCA Registered Consulting Arborist # RCA-418
ISA TRAQ Qualified
ISA TRAQ Certified Instructor

RE: Permit No. DRV15-01462
Parkplace Shopping Center

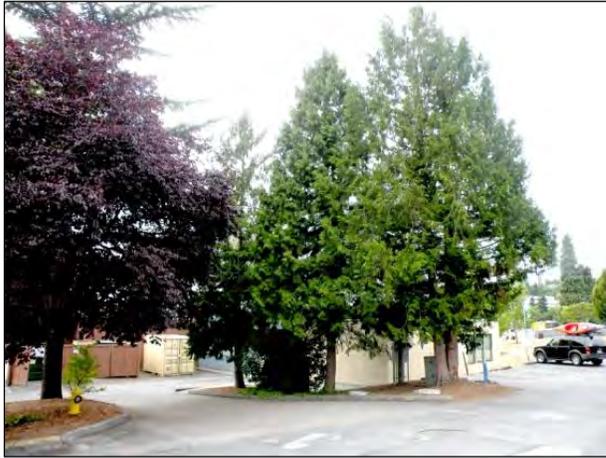
Photo # 2: West property line extension to Kirkland Way showing trees # 126—131 in August 2010.

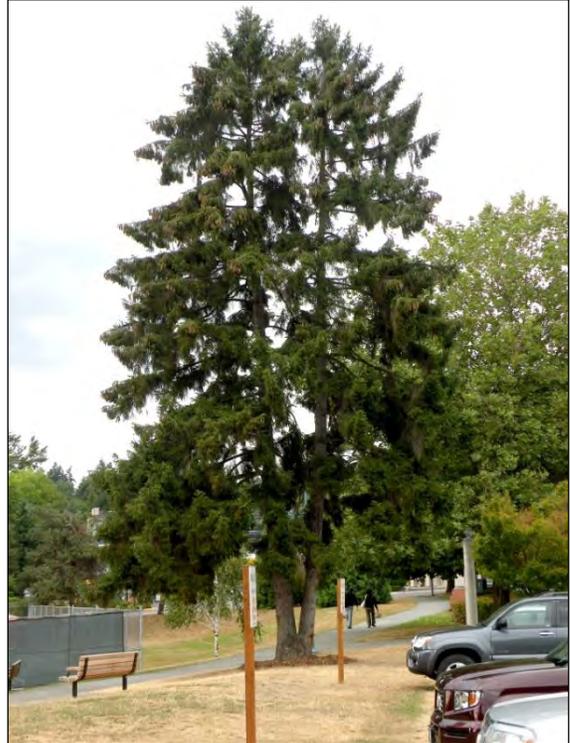
Photo # 3: Tree # 183 west of the west property line in Peter Kirk Park

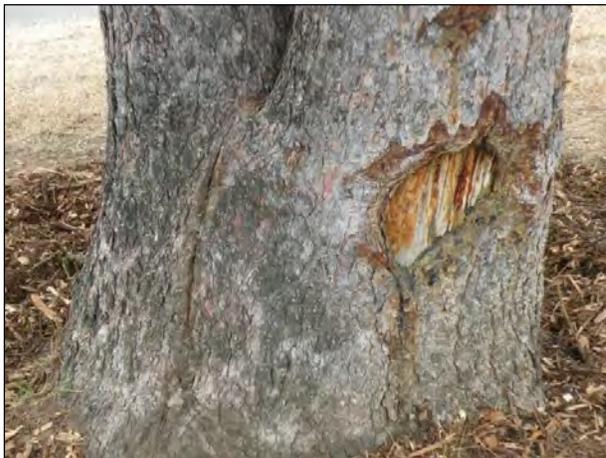
Photo # 4: The base of # 183 showing the open wound and the included bark—the wound appears to be well compartmentalized.

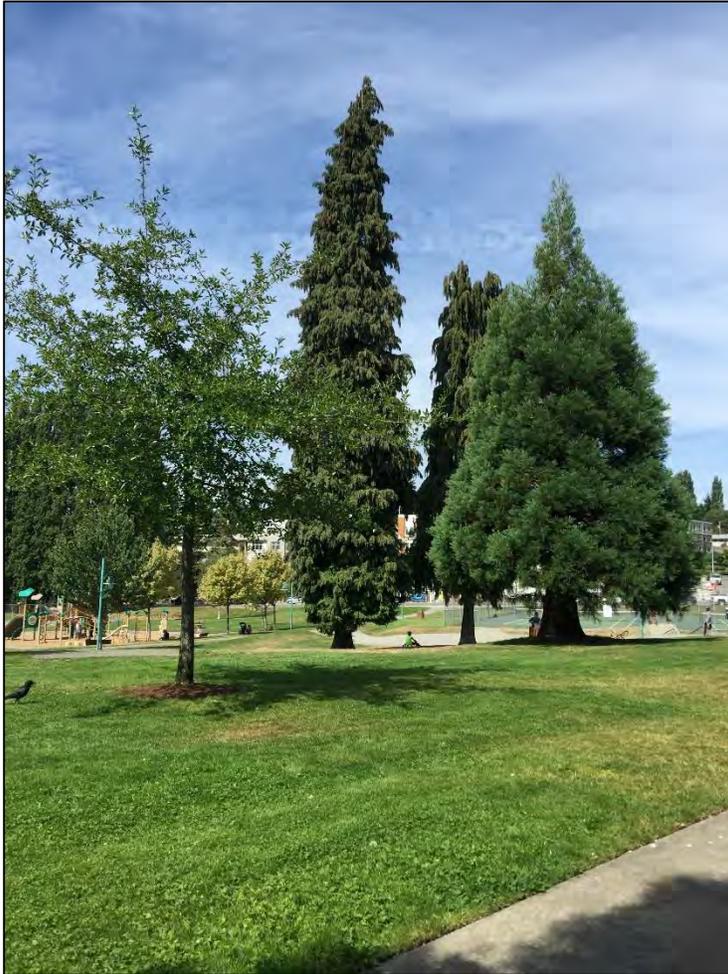
Photo # 5: looking from near the west side of the QFC building looking northwest at four park trees, the tennis courts, the skateboard park, and the play area.

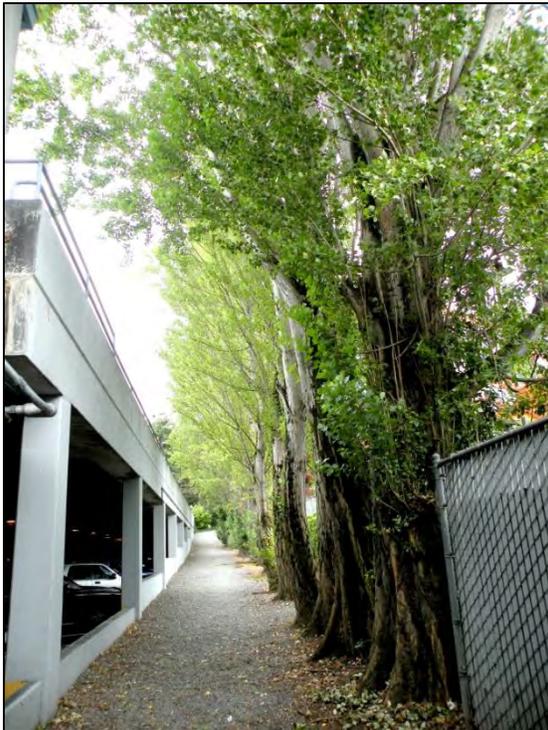
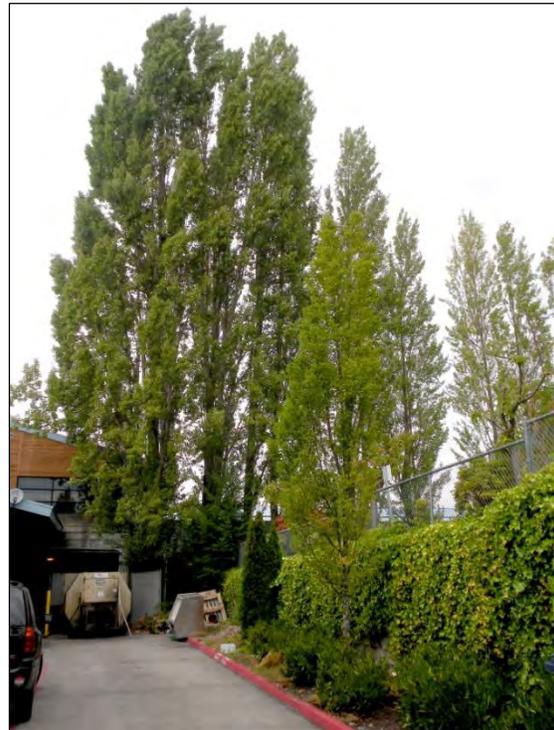
There are 37 trees along the southern property line that are in this category. Sixteen of the 37 trees, numbers 138 through 153, are a row of Lombardy Poplars, *Populus nigra 'Italica.'* They are growing in a row between the parking garage structure and the block retaining wall that is holding up the parking lot on the adjacent property to the south. The majority are in declining condition. Given the drought of the last two years and the limited soil volume they have to exploit, it is not surprising that they have deteriorated in the last five years. They are now suffering from a canker disease that this cultivar is vulnerable to all across North America. While the row is not a problem today, they are in such a poor state that I judge that they will not likely tolerate the stress of demolition and

reconstruction of the site unless all construction activity can be kept to existing limits. And, only if the trees are treated with fungicide, fertilizer, beneficial microbes, and proper irrigation. Even with these treatments I do not believe that this row of majestic trees can be retained.

Photos # 5 & 6: showing the row of Lombardy Poplars from various views as they were in August of 2010. In the last five years they have deteriorated considerably.

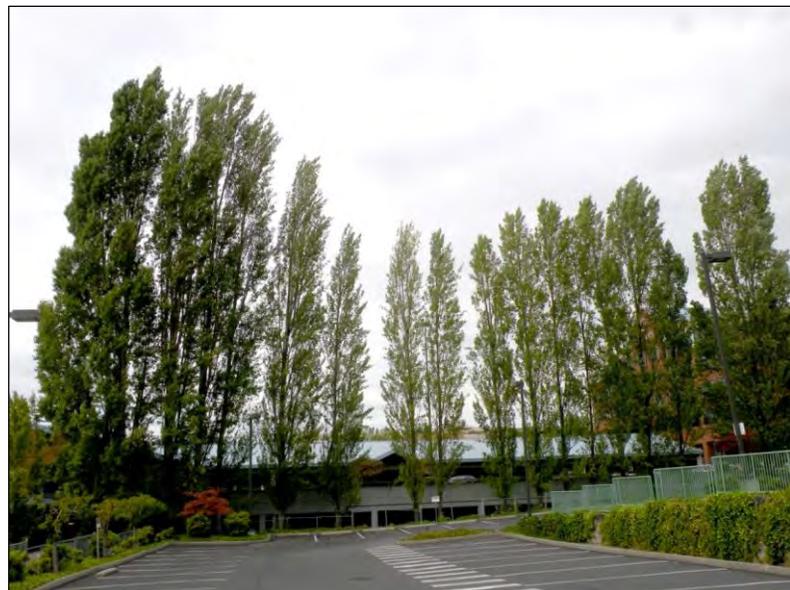
Photo # 7: Looking south at the row of Lombardy Poplar trees from the parking area in August 2010.

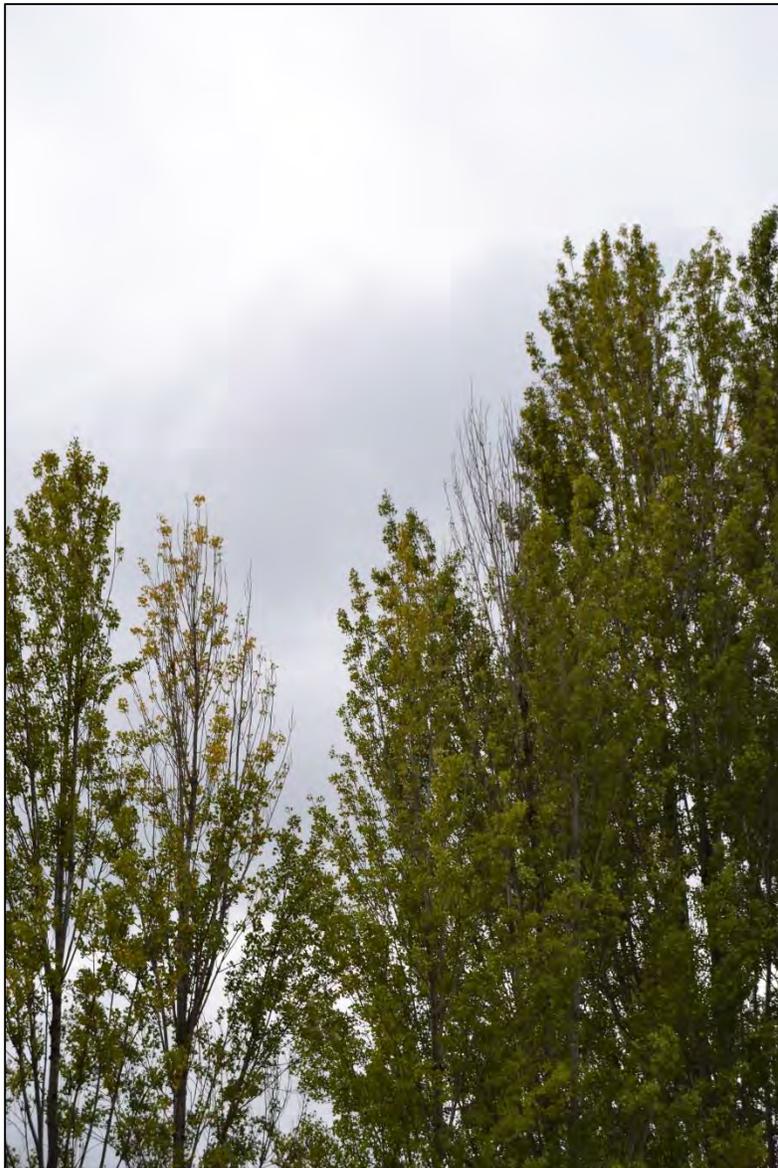
Photo # 8: Showing the crowns of the Poplars today, 9/14/15, and their declining condition. Instead of having dense healthy canopies and crowns, the top 15% of the canopy, the foliage is thin, pale in color, and has a lot of dieback associated with the Poplar Canker.

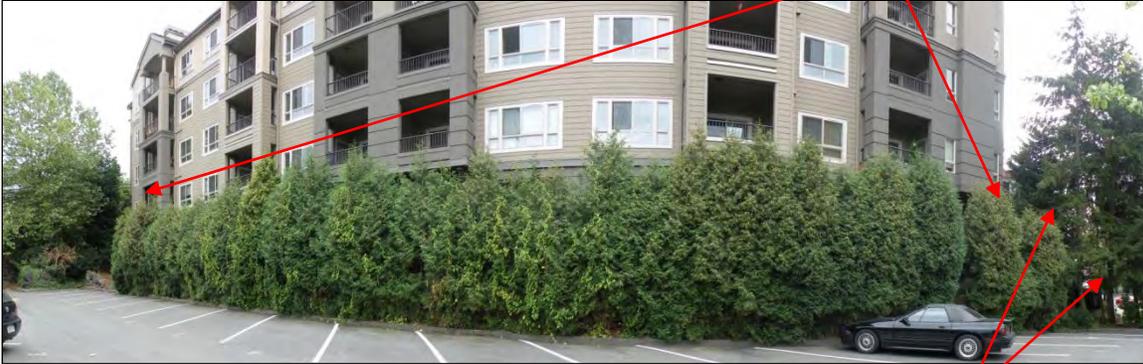
Trees 159 – 167

Photo # 8: Panoramic view of the Pyramidalis Hedge of 37 plants listed as # 165

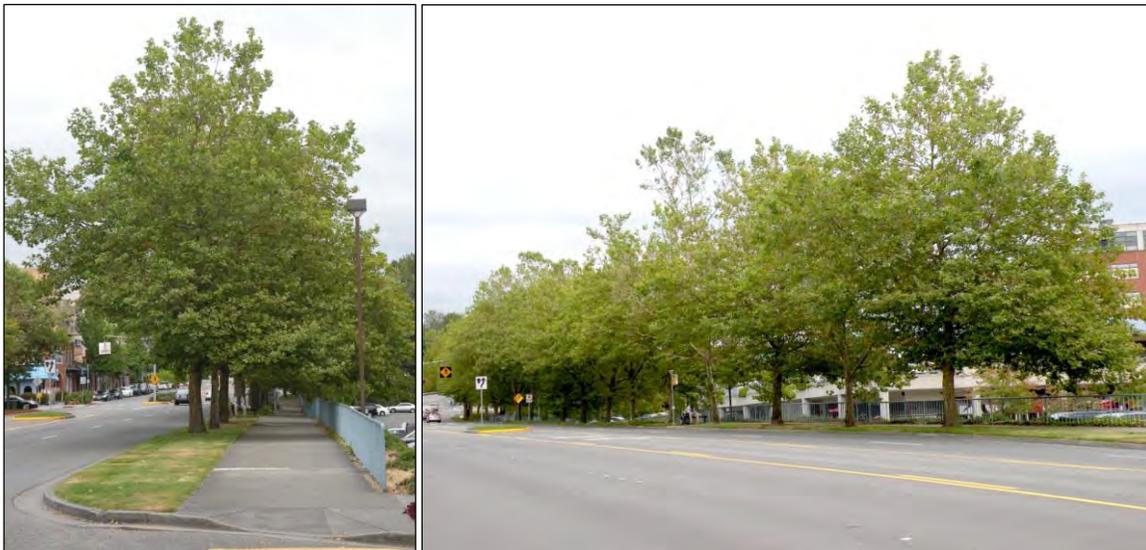
Photos # 9 & 10: Looking east on Central Way at trees # 188 – 207

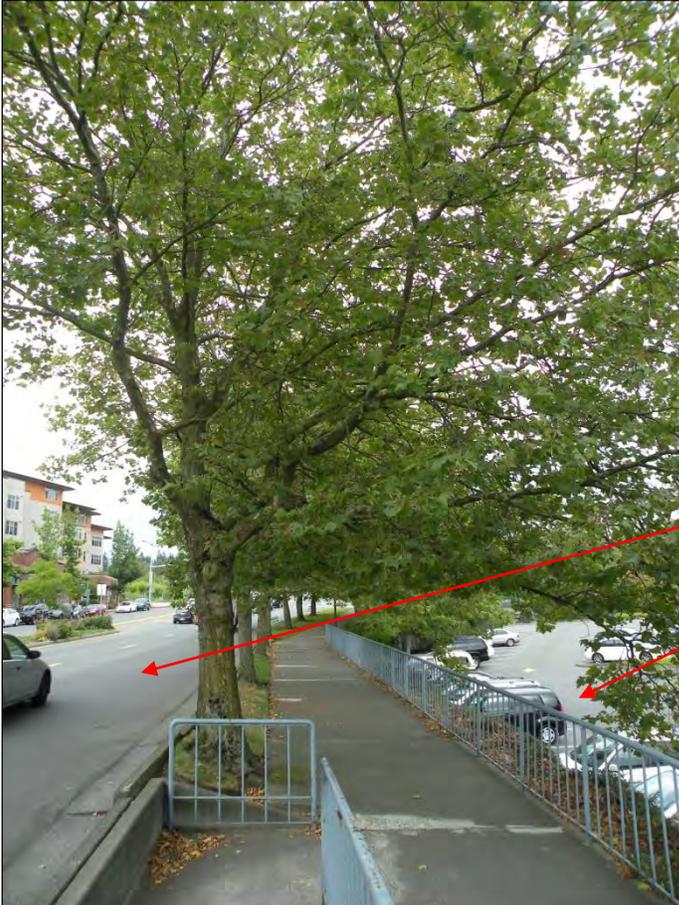
Photo #11: Looking west along Central way

Note the Elevation difference between the street and the parking lot

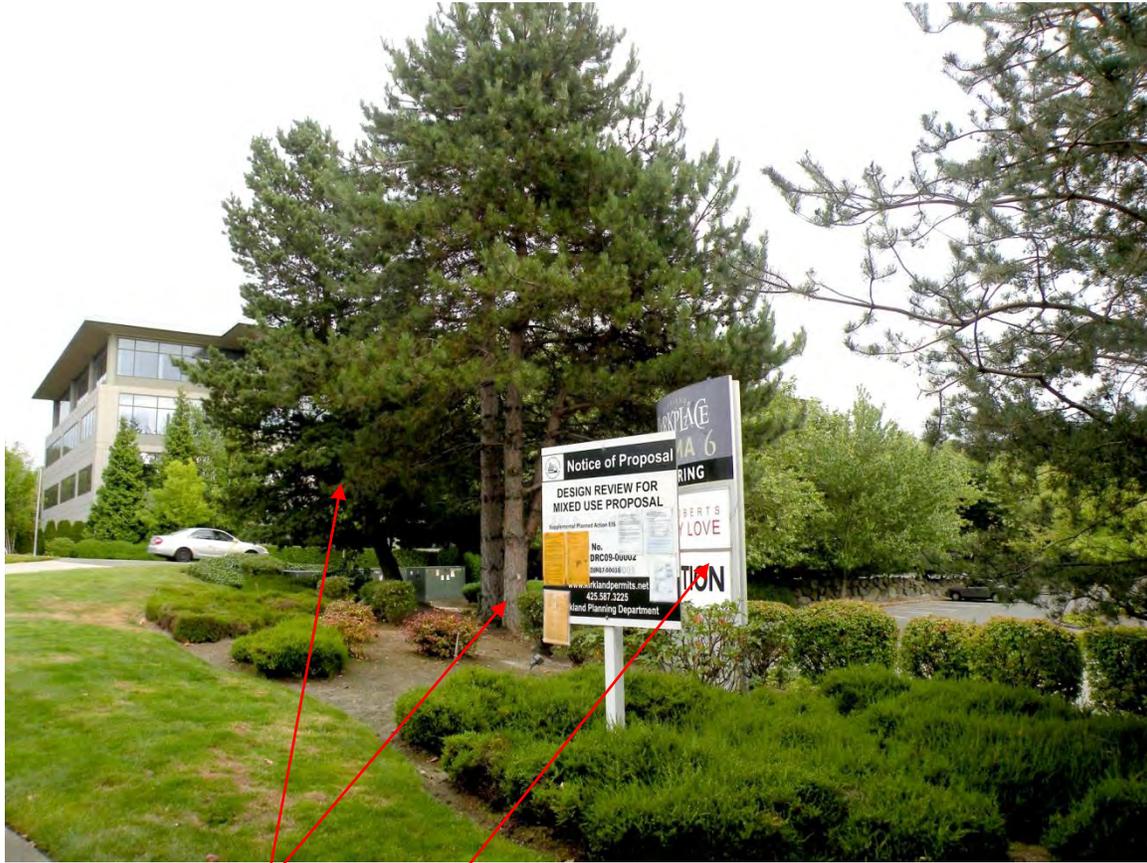
Photo # 12: trees # 208 – 210 and the sign in the northeast corner of the property

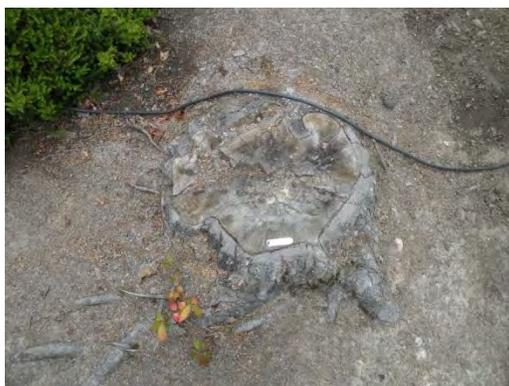
The site plan shows a tree symbol that was given the number 211. The tree was a pine but, judging from the oxidation of the stump that remains, it was cut down years ago. It is included in the inventory to account for the symbol on the site plan.

Photo # 13: the stump of # 211
