**ARBORIST REPORT**  
for  
**Astronomics North Building Expansion Project**  
**Kirkland, WA**

**April 8<sup>th</sup>, 2015**

Date of Field Examination: April 1<sup>st</sup>, 2015

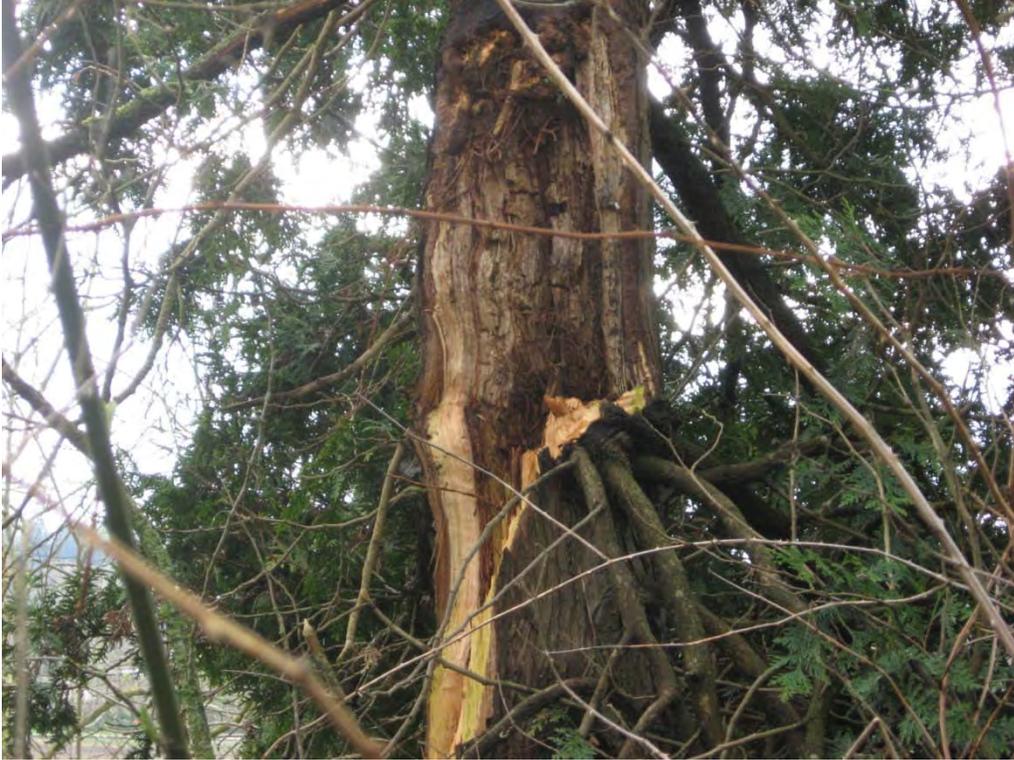
The Lawson cypress is mature. They have developed typical structure with multiple forked tops. Tree #3 recently failed, see picture below. The Leyland cypress is also mature to over-mature. One tree recently failed, falling downhill toward the railroad tracks. The root crown of this tree had extensive decay.

Tree #3, recent major failure, structure compromised

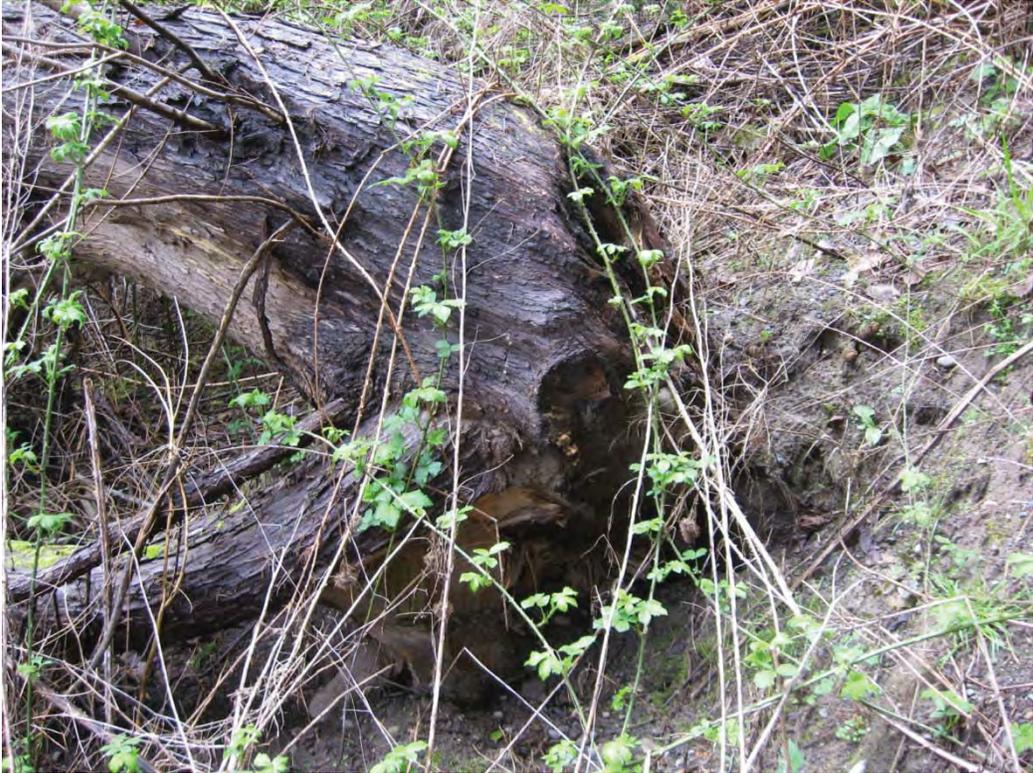
Recent Leyland cypress failure – whole tree failure (root disease)

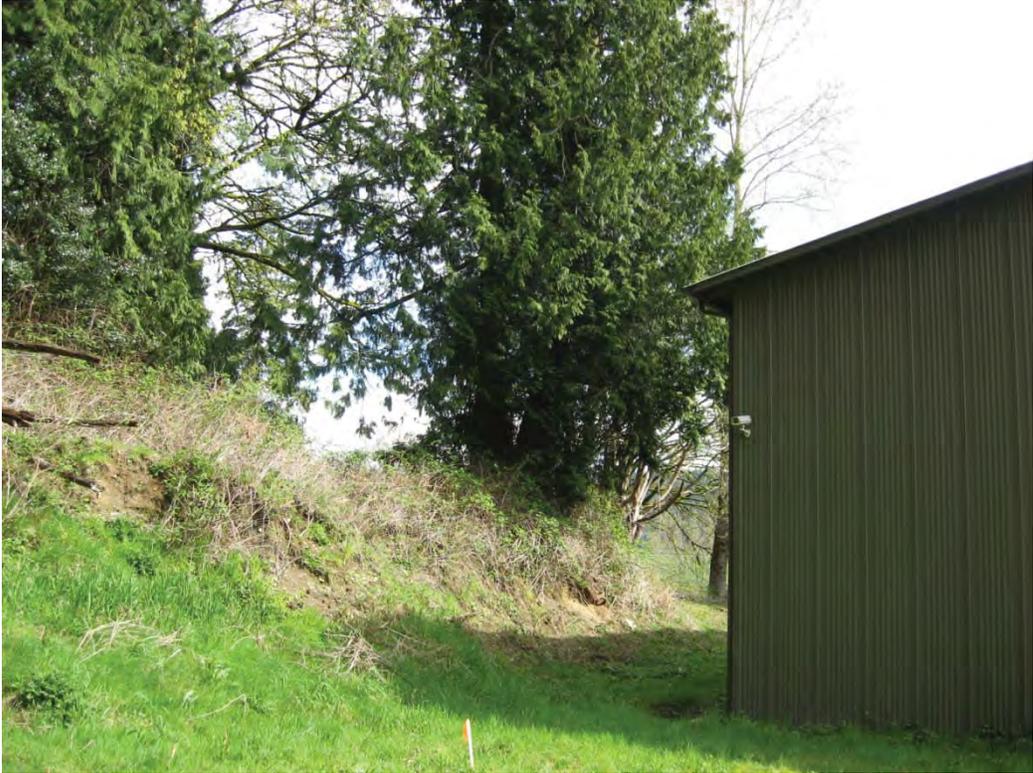
Neighboring Tree #48

Tree #48 is a mature western red cedar situated on the property line. The grade was cut previously south of the tree, see picture below, exposing large surface roots. The main trunk forks at roughly 3' above ground into two large co-dominant stems. The build-up of included or embedded bark between the stems is considerable. The forked attachment is inherently weak. The south stem is positioned to fall towards the proposal should a failure occur. Risk of failure is considered high.

On the north perimeter, Tree #48 is problematic. The major structural defect is concerning. The south stem or trunk is positioned to fall directly toward the proposal should it split off. The considerable buildup of included or embedded bark between the forked stems indicates a weak attachment and high probability of failure. Removal of this tree is recommended to abate the potentially hazardous condition.

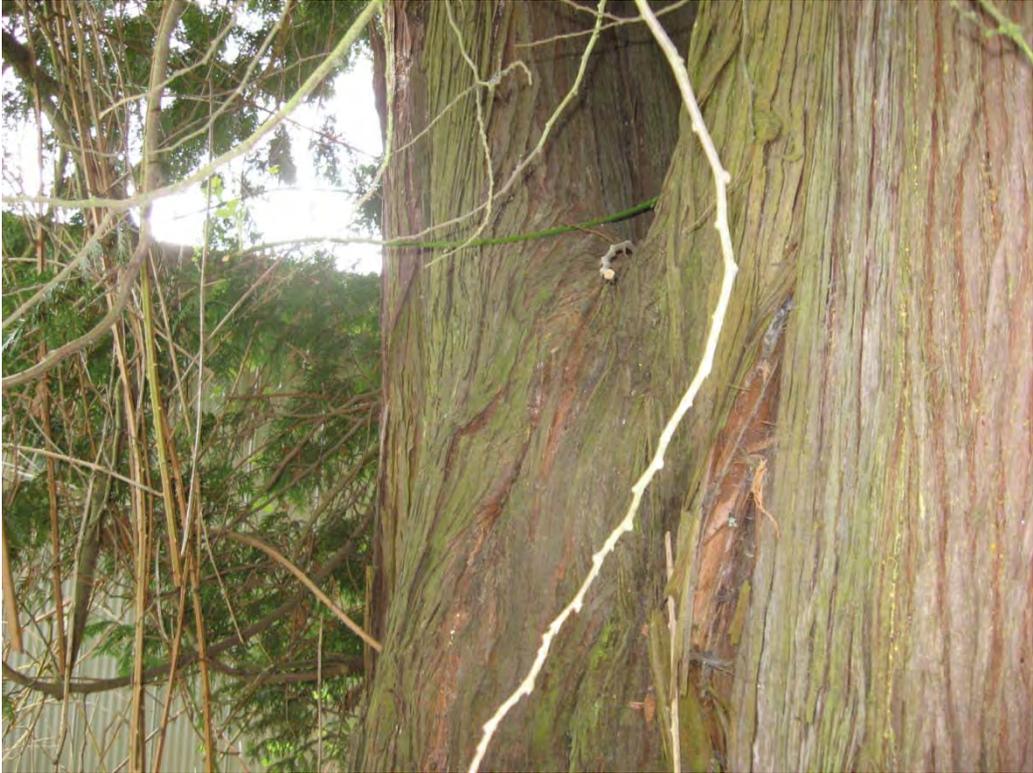
Tree #48, major fork, codominant stems – moderate to high risk

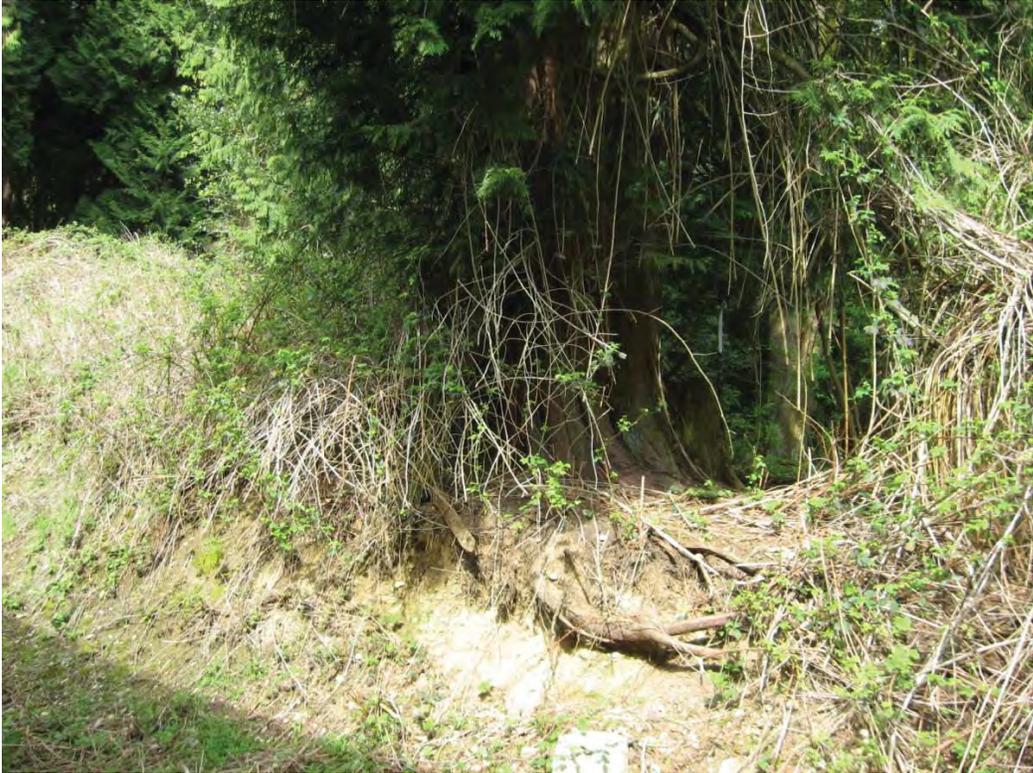
#48, grade previously cut – exposed roots

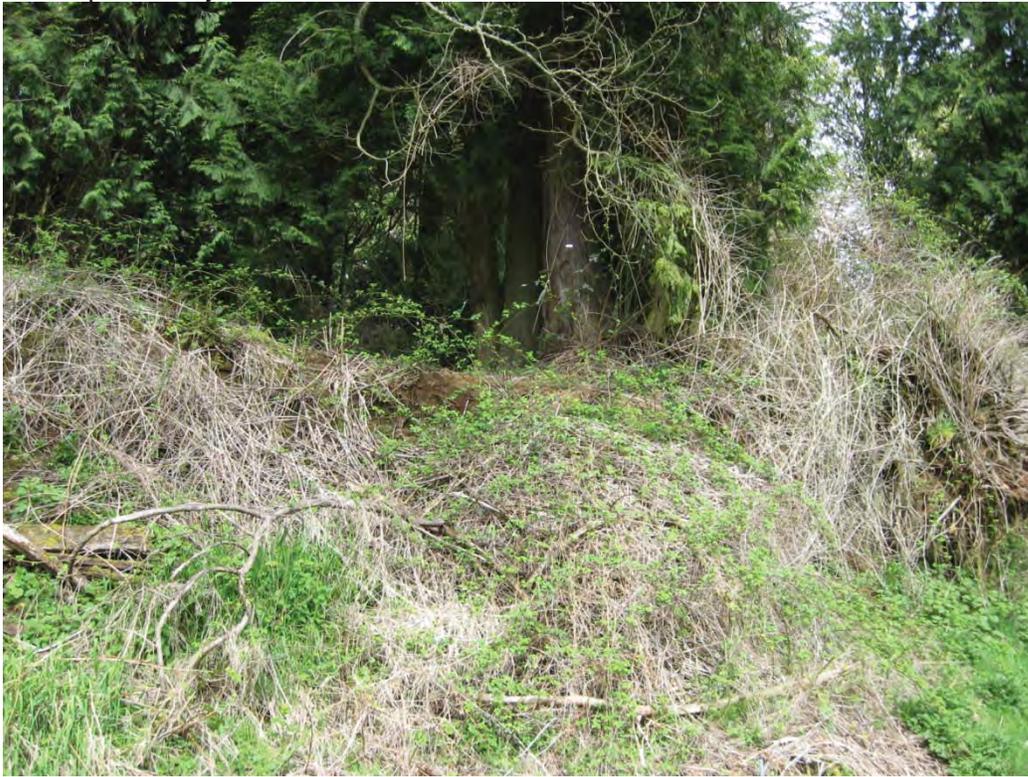
Trees #49 and #50 are mature western red cedars. The grade was also cut in the past south of the trees, roughly 8' from the closest trunk face. Both have developed good form. Foliage color and density are normal. Both are considered to be in fair to good condition.

Grade previously cut south of Trees #49 and #50

Trees #49 and #50 can be retained. Past excavations and grading directly to the south have not had an adverse impact on health or stability. It would appear from the site plan that no further encroachment will be necessary for future site improvements.

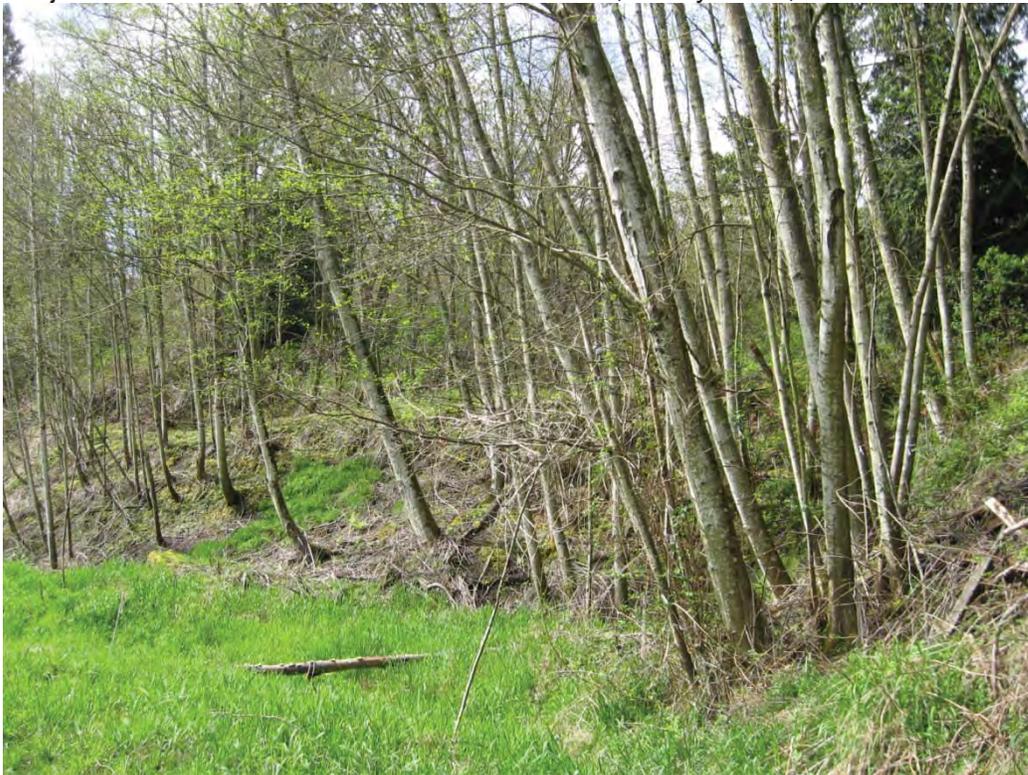
The majority of red alder in the northwest portion is recommended for removal. Trees have developed poor form with heavy downhill leans. Many are showing signs of premature decline (top dieback), which is typical for alder that has regenerated on disturbed sites. The vast majority is considered 'borderline' viable and non-viable.

Subject Trees #51 > #100 red alder on cut bank, heavy leans, decline

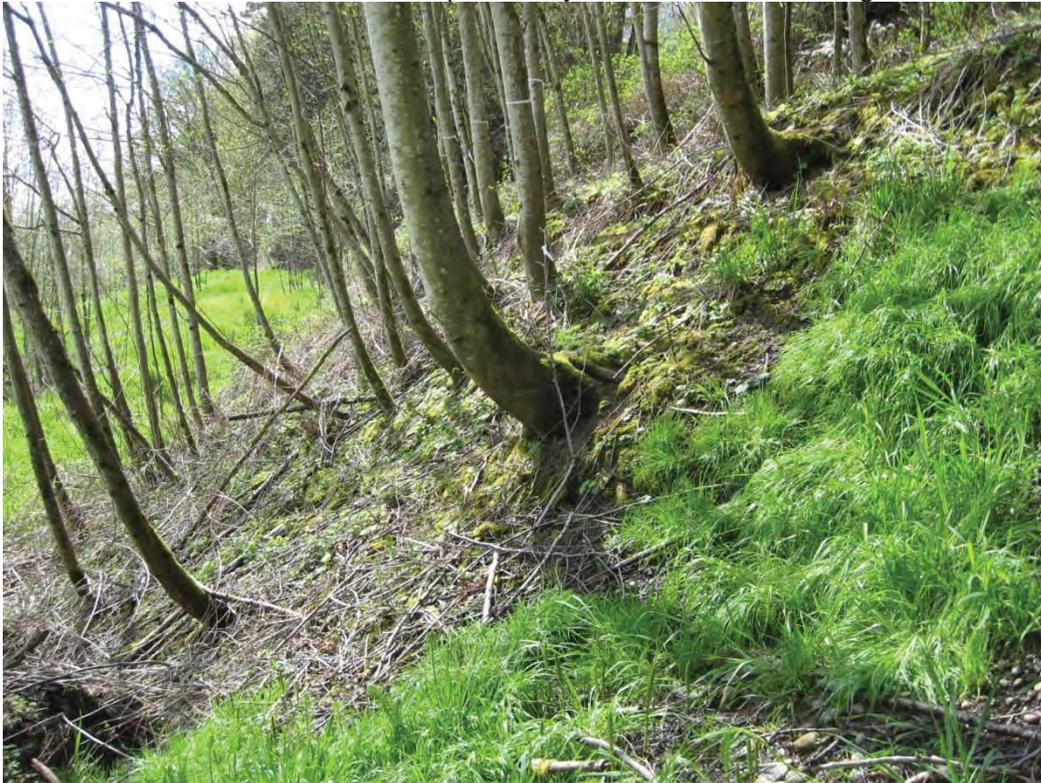
Prolific red alder establishment has occurred on the previously disturbed area in the northwest portion of the site, see pictures below. Trees are estimated at 8 to 10 years of age. Many are growing on a steep cut bank. Several have developed heavy leans toward the proposal. Trees have developed poor trunk taper and structure from intense competition for sunlight. Many are in premature decline.

Prolific red alder establishment on previously disturbed area-looking south

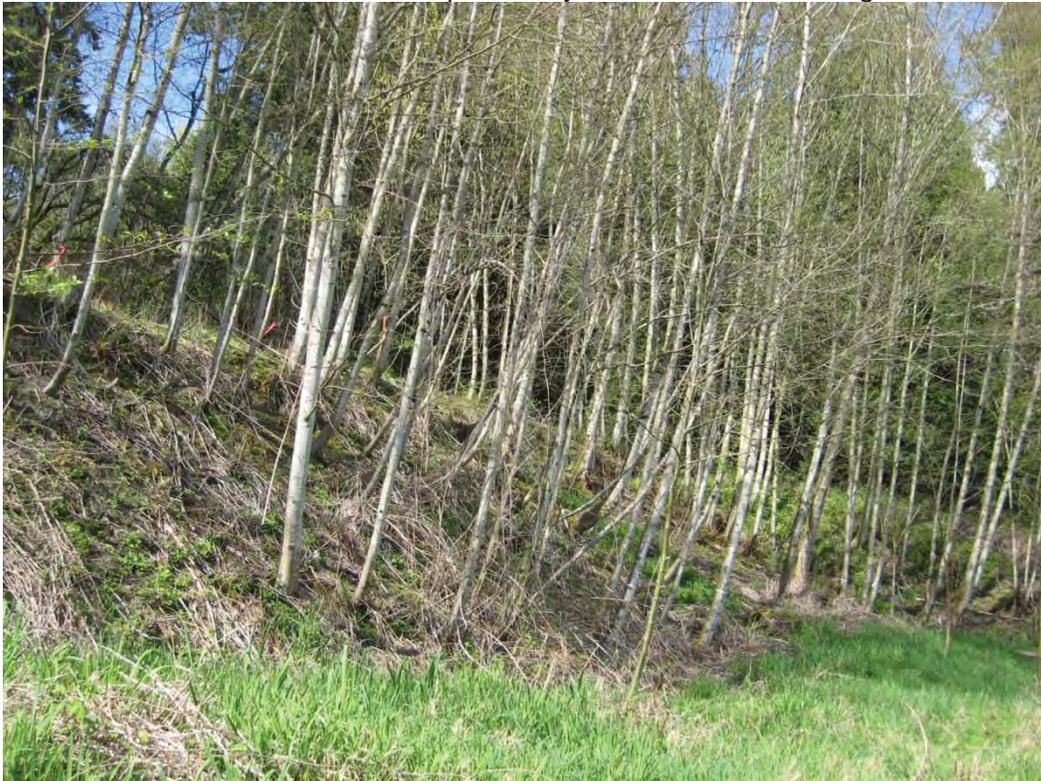
Prolific red alder establishment on previously disturbed area-looking north

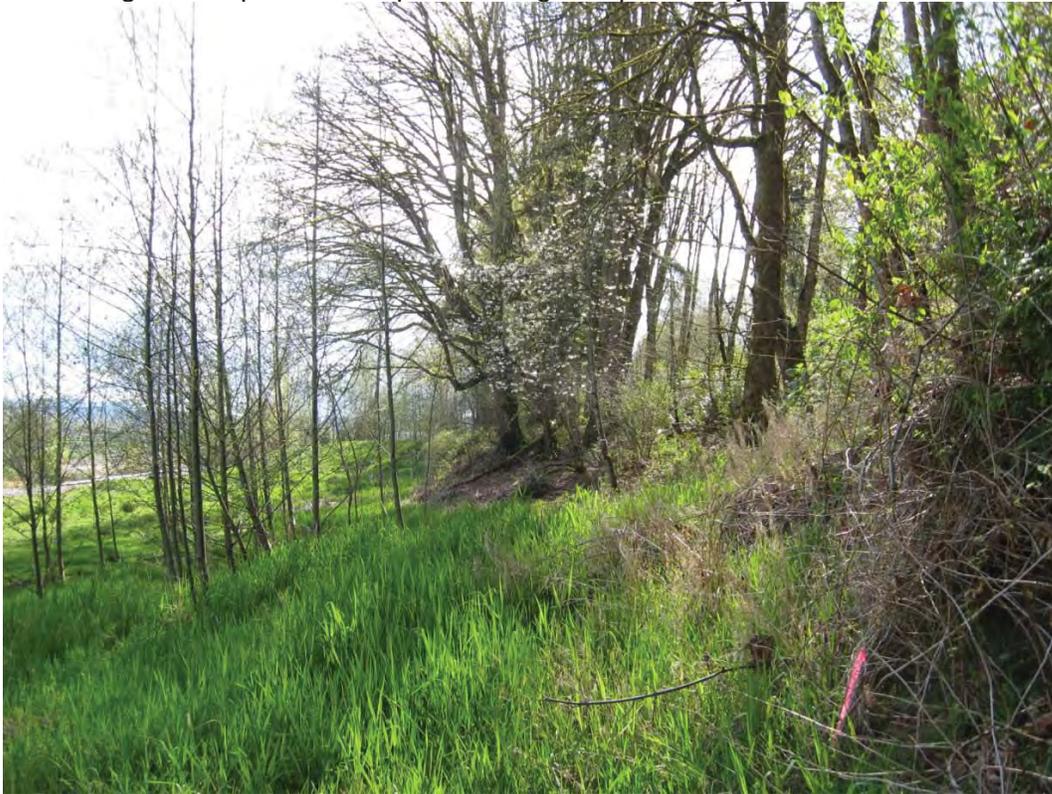
Mature big leaf maple on west perimeter, grade previously cut east of trees

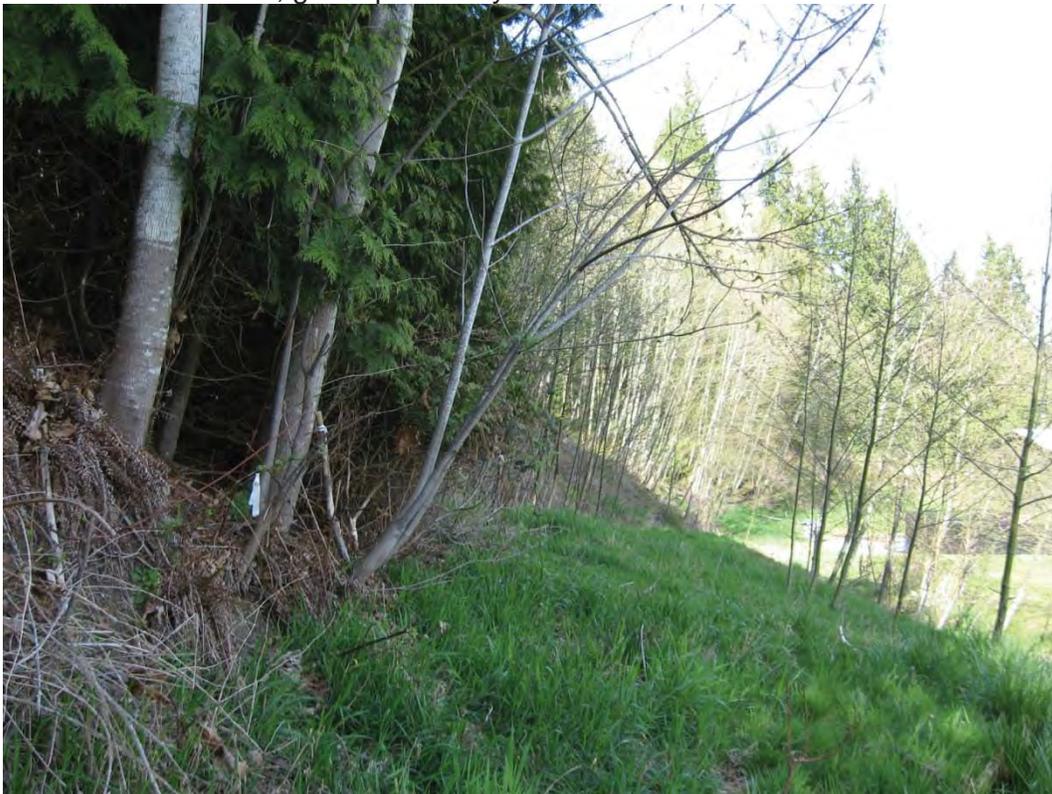
Trees #113 and #114, grade previously cut east of trees

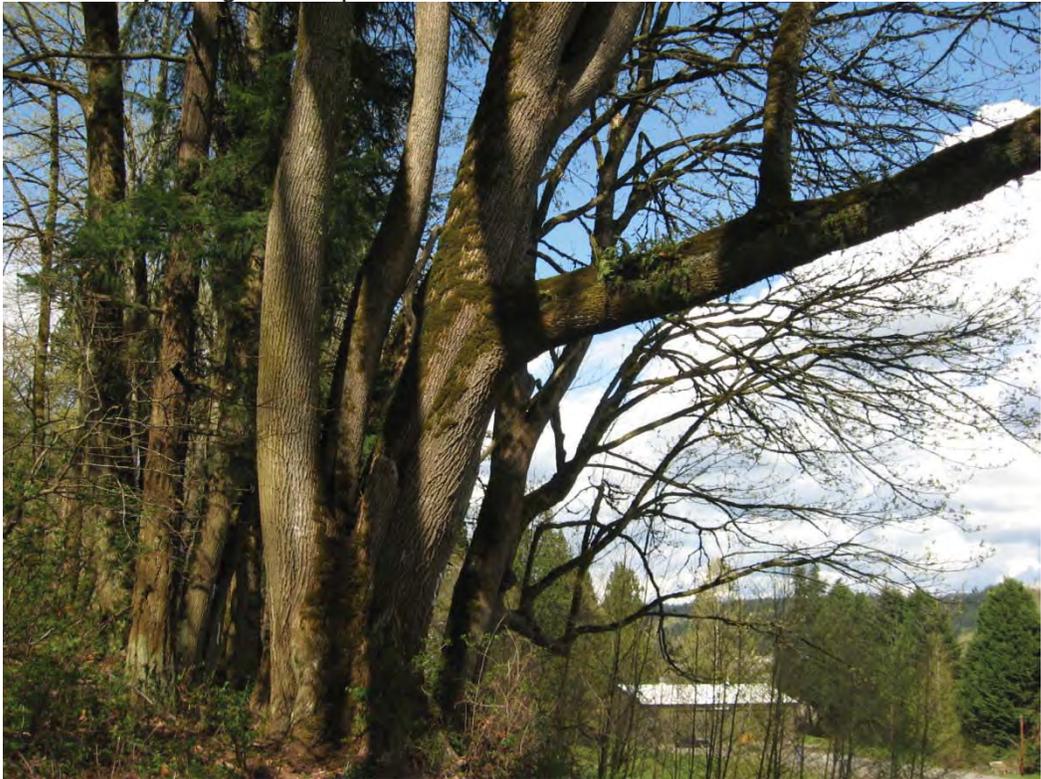
Mature subject big leaf maple on west perimeter

The majority of the mature big leaf maples along the south end of the west perimeter is in fair condition and can be feasibly retained. Tree #116 has a large dead stem that should be removed to reduce hazard risk. Tree #117 is in decline and considered 'borderline' viable. It has a significant soft rot infection which has already caused one stem to fail. Removal is recommended to abate hazard potential. On the remaining mature maples, crown clean pruning is recommended to remove deadwood and any weakly attached branches prior to the completion of construction. Some end-weight reduction may be necessary to reduce the potential of future branch failures onto the new parking lot.

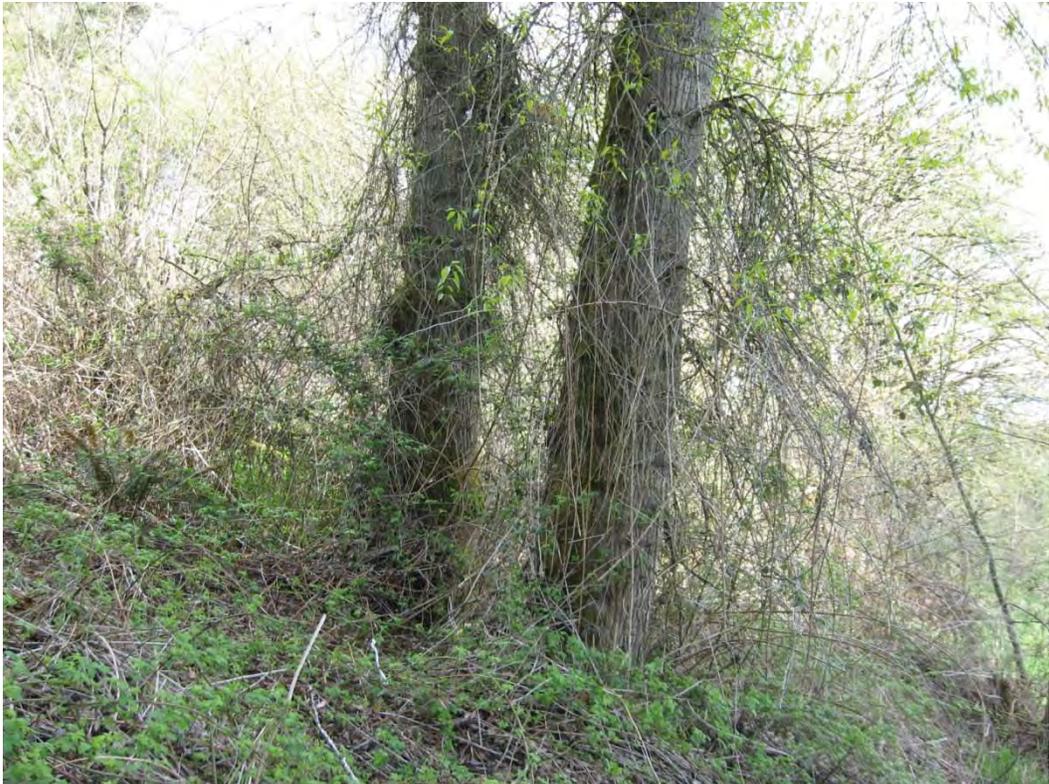
There are two mature to over-mature black cottonwoods (#118 and #119) situated at the south end of the west perimeter. These are problematic given their proximity to the proposed improvements.

Mature cottonwood trees #118 and #119 – removal recommended

The over-mature black cottonwood trees, #118, #119 and #120 are recommended for removal. These will be problematic in the future as they begin to naturally decline. This is a relatively short-lived pioneer species.
