**CEDARBROOK
TREE PLAN**

**9900 – 124TH AVE NE
KIRKLAND, WA**

February 28th, 2013

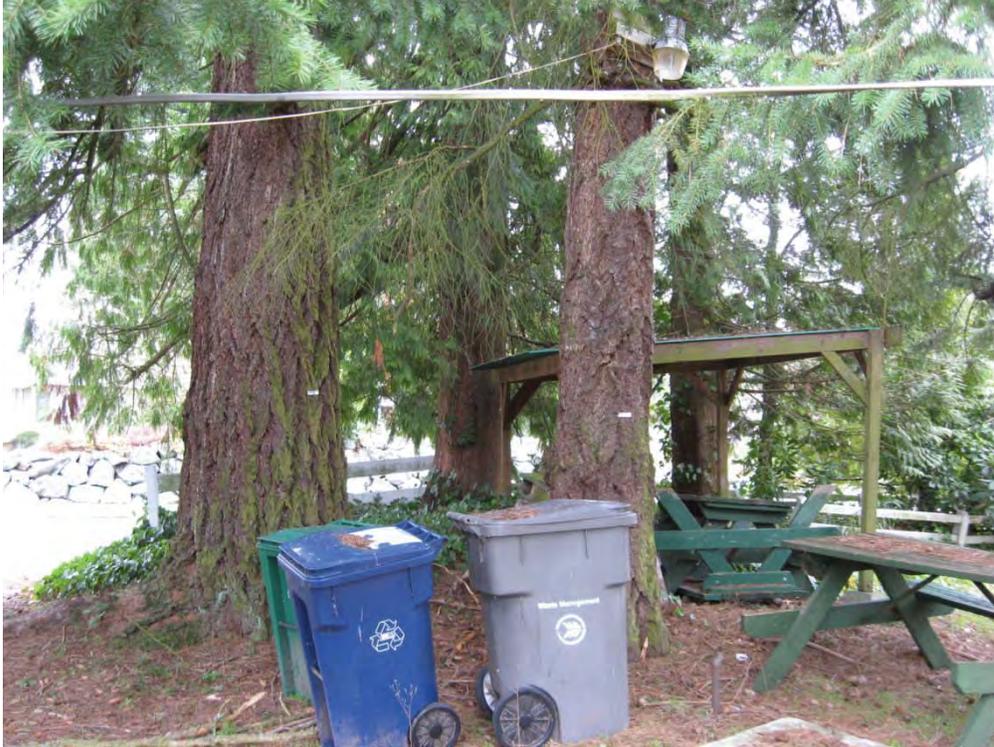
Trees #107 and #108

The grouping of evergreen trees to be retained at the front of the site is also in fairly good condition. These include two mature western red cedars in the right-of-way and two mature Douglas-fir on the subject property. The Douglas-fir trees are exhibiting healthy foliage of normal color and density. The tops of both have broken out in the past. Perhaps the top of Tree #108 was cut in the very distant past. The re-grown top appears to be soundly attached to the trunk, see picture in the photos section at the end of this report. No outward indicators of internal decay were observed on either Douglas-fir. Both are considered low to moderate risk and retention is feasible. The two western red cedars in the right-of-way also appear to be in good health, displaying good color and foliage density. No concerning defects were observed. Tree #106 has developed a large lateral scaffold branch that extends to the northwest. The main trunk of #106 also forks at approximately 10' above ground. The forked attachment appears sound. No outward signs of internal decay or pre-mature failure were observed.

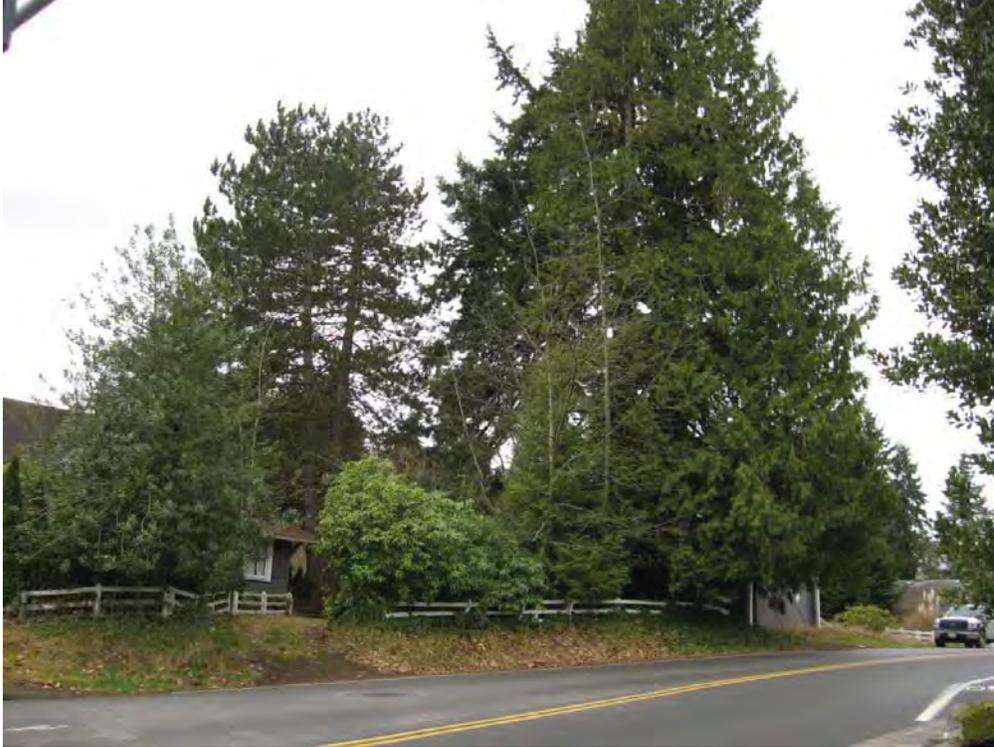
View of right-of-way red cedars (#105 & #106) in front of property trees #107 and #108
Tree #101 on far left (holly) and Austrian pines #109 and #110 next to existing house
Trees #103 and #104 are visible in front, poorly tapered, tall and skinny oak trees.

The sidewalk construction in the right-of-way adjacent to Trees #105 and #106 shall be performed diligently. The sidewalk shall be constructed at or above existing grade. Only the removal of the sod layer, the top two to four inches shall be allowed.

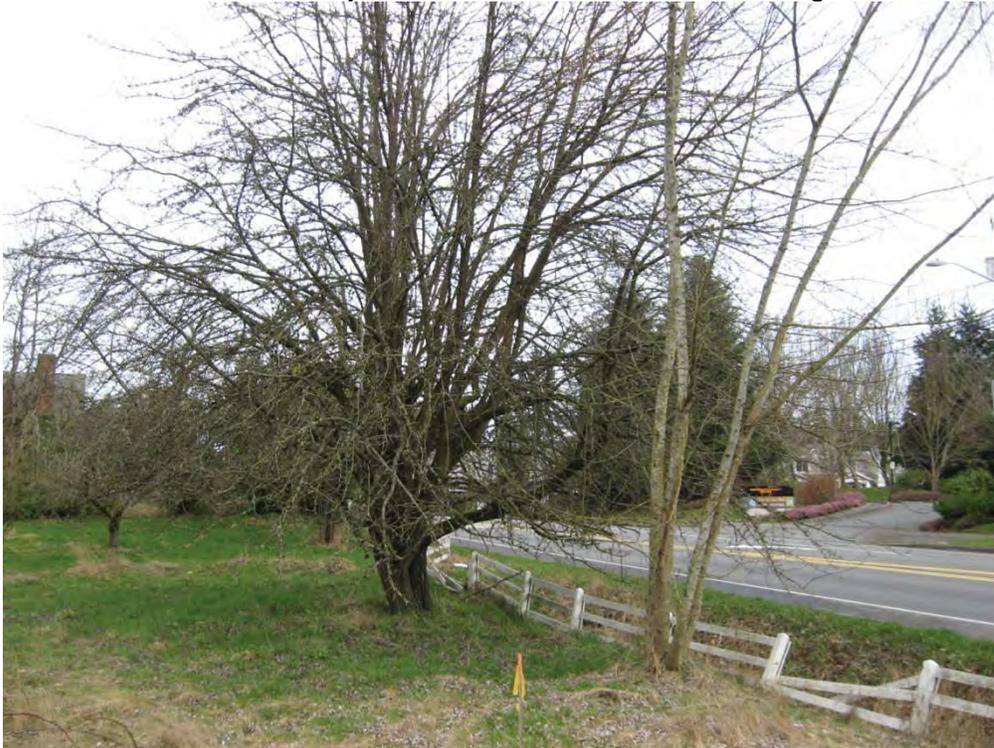
Tree #7114 is a young 4-stem clump of silver maple. Three of the stems measure 6" DBH and one is 4" DBH, with total heights of 46'. Stems are very poorly tapered and highly susceptible to breakage, due to the height to diameter ratios, leans and weak wood structure.

Trees #7113 and #7114 adjacent to 124th AVE NE. #7114 on right is considered non-viable

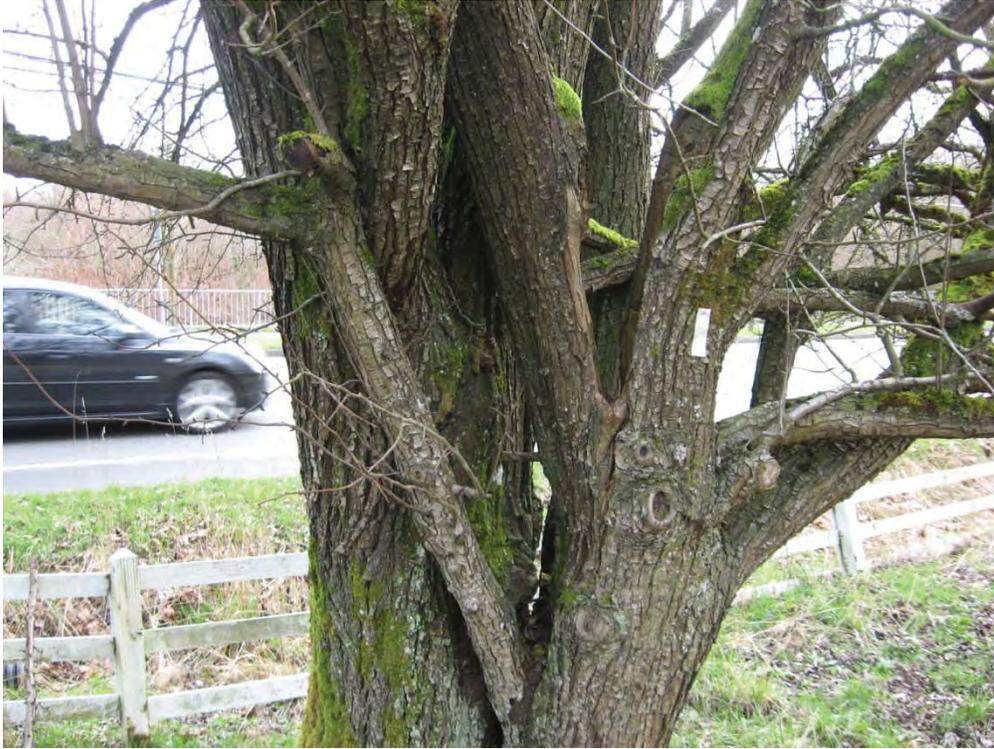
Codominant stem failure on Tree #7113

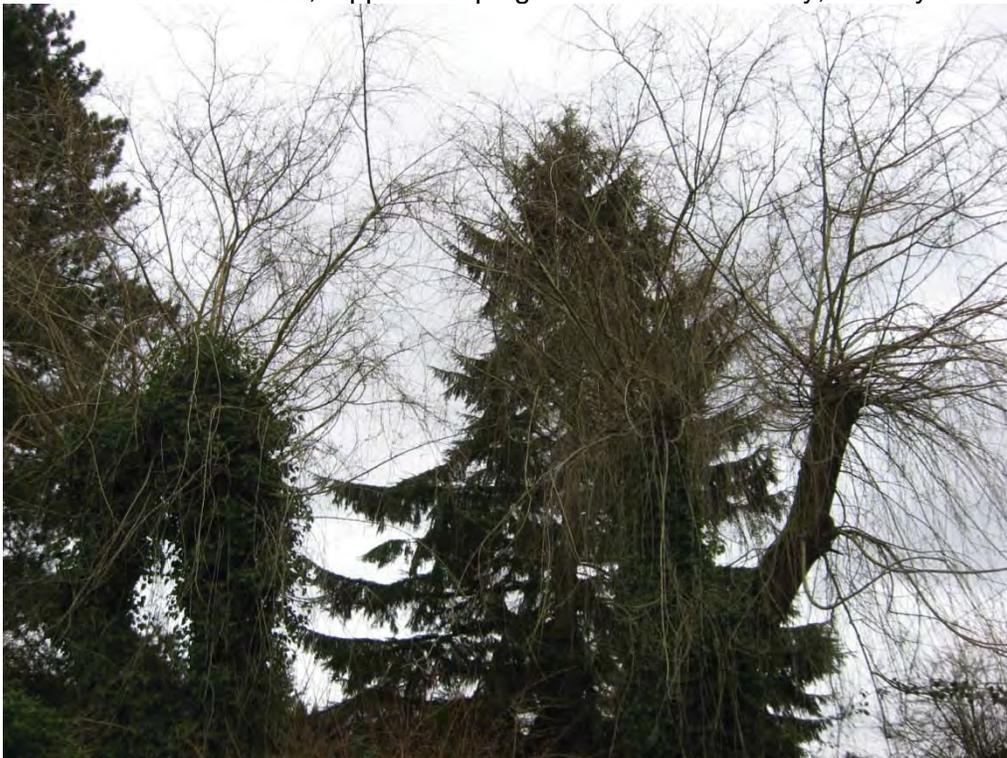
Trees #2868 and #2867 are mature weeping willows that were topped a few years ago at approximately 16' to 20' above ground, see picture below. #2868 has three main trunks that were topped and #2867 has two. The bases of both trees are covered in English ivy, inhibiting a thorough trunk and root crown inspection. Vigorous sprouts from topping cuts are poorly attached and highly susceptible to breakage.

Trees #2867 and #2868, topped weeping willows covered in ivy, viability borderline

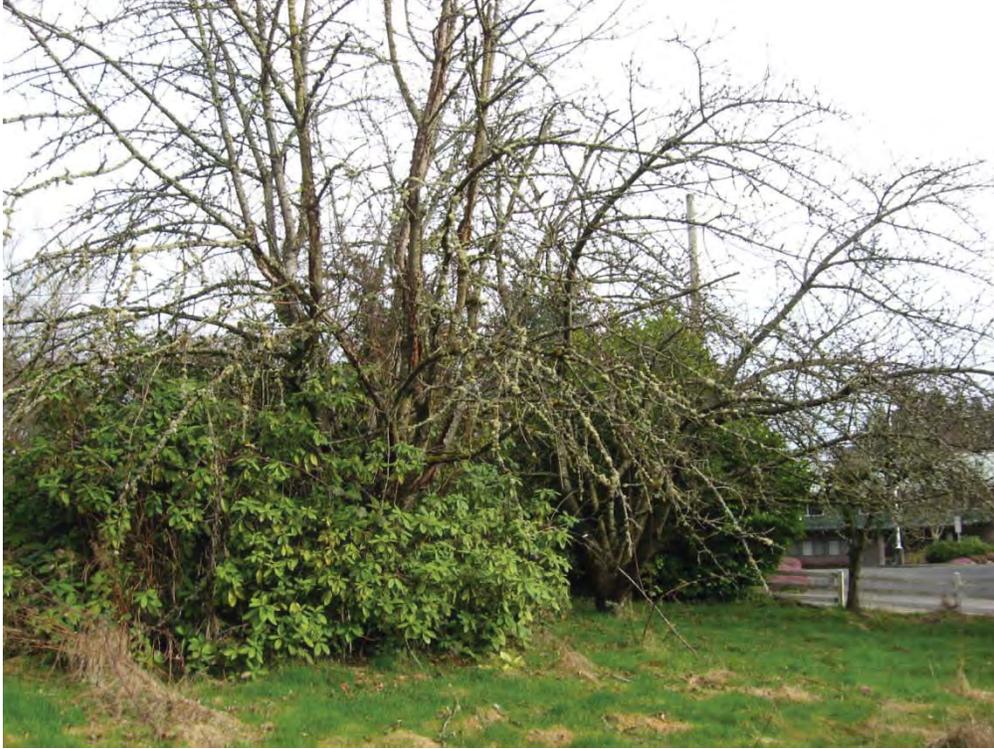
Tree #116, a mature fruit cherry is in vast decline. The south half of the crown is completely dead. Several branches in the north half have a canker disease and are also in decline.

Tree #116, south half of crown is dead, remaining live section is heavily diseased

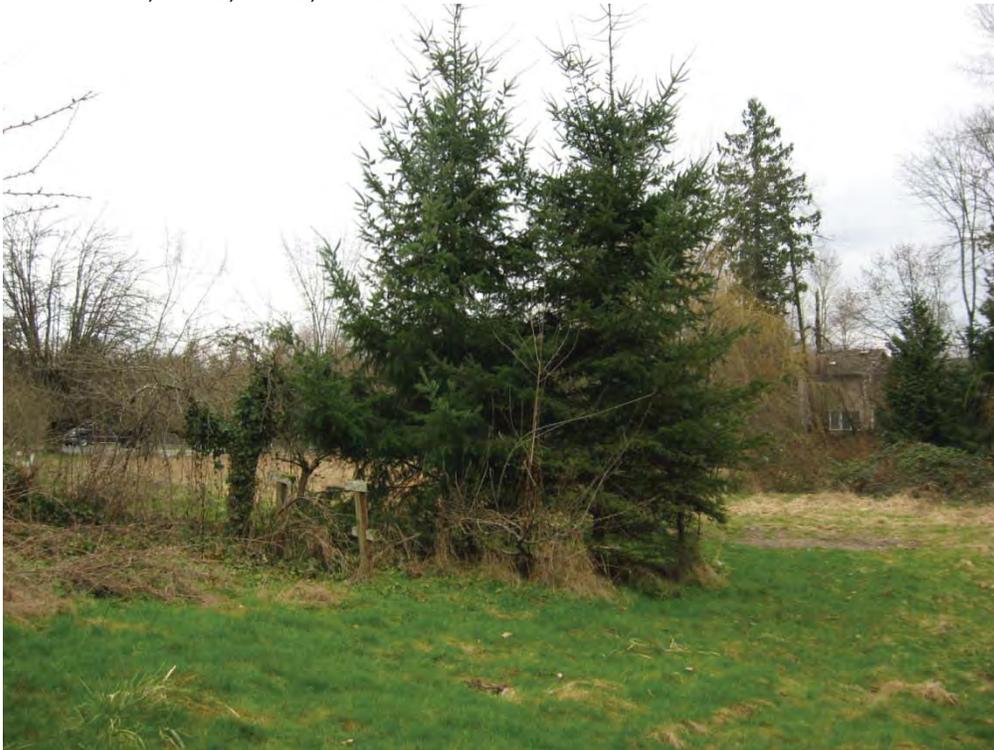
Trees #117, #118, #119, #120 and #121

Tree #117 is a mature pear variety. The lower trunk and main scaffold branches have considerable internal decay. The subject has had several recent branch failures. It is falling apart.

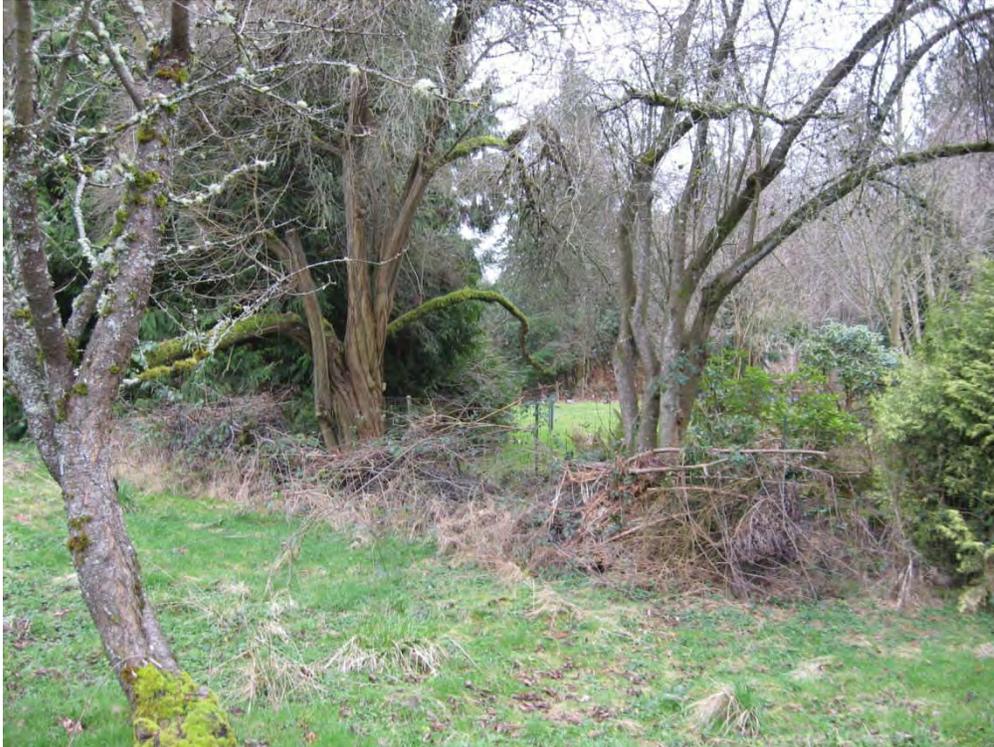
Tree #155 is a mature locust situated near the west property line. A large stem that extended to the east that apparently failed was removed some time ago, as well as a smaller stem. The subject is not considered high risk given the total height of only 30'. It is considered over-mature with a limited useful lifespan.

Tree #155 on west property line and #156 on right. #2863 on far left of photo.
