Exploration Logs Laboratory Testing Results

Radke Short Plat King County, WA

Project No. KE140565A

RADKE SUBDIVISION SUB15-00615

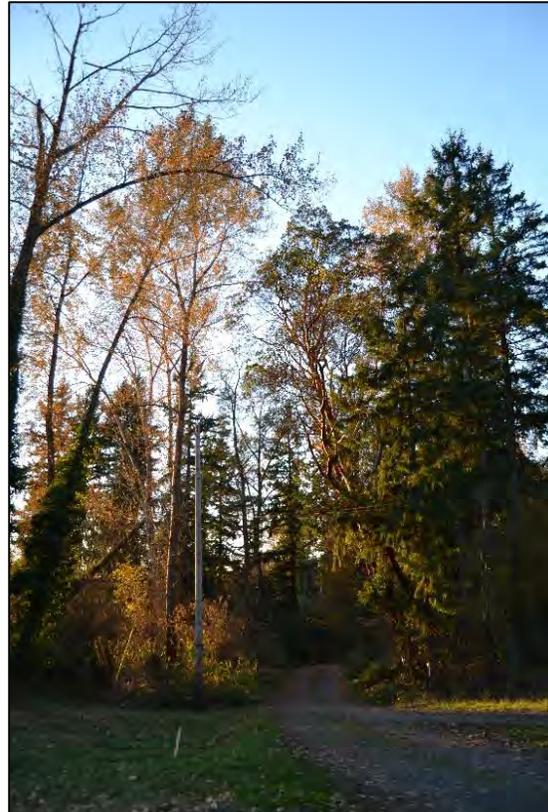
Photo # 2: Looking west toward Juanita Drive from the central parking area.

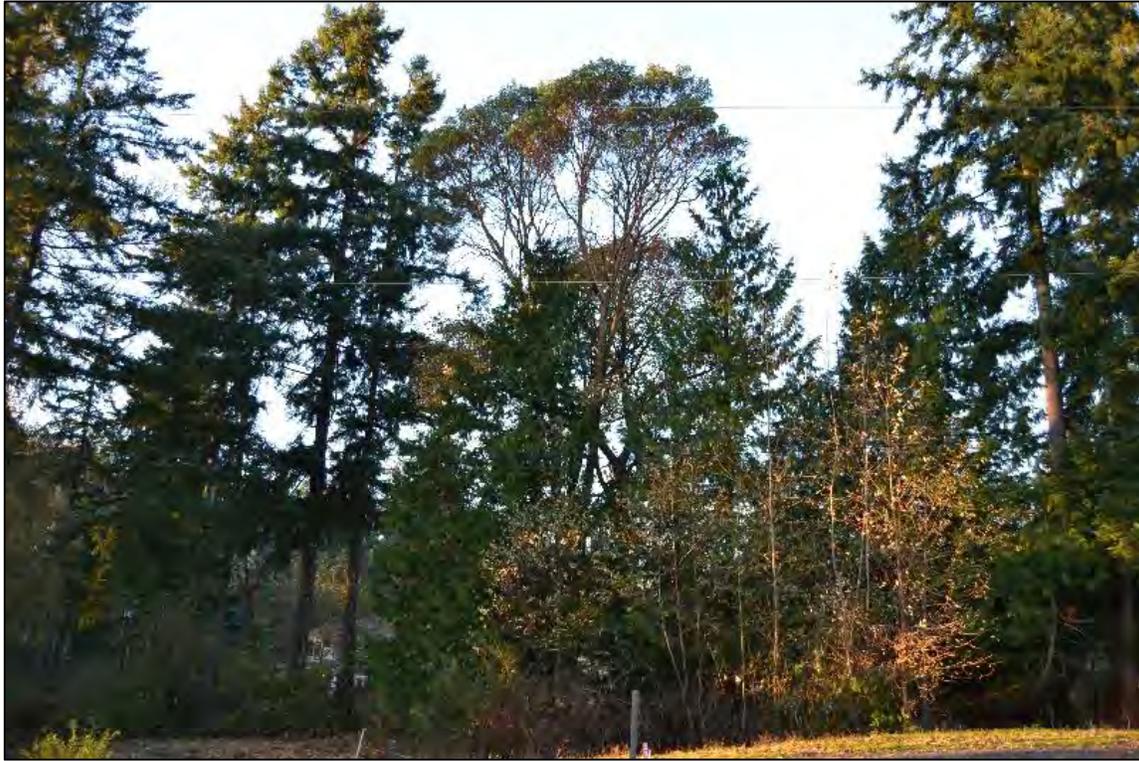
Photo # 3: Looking west from the central parking area. The driveway and houses can be seen in the lower portion of the photo.

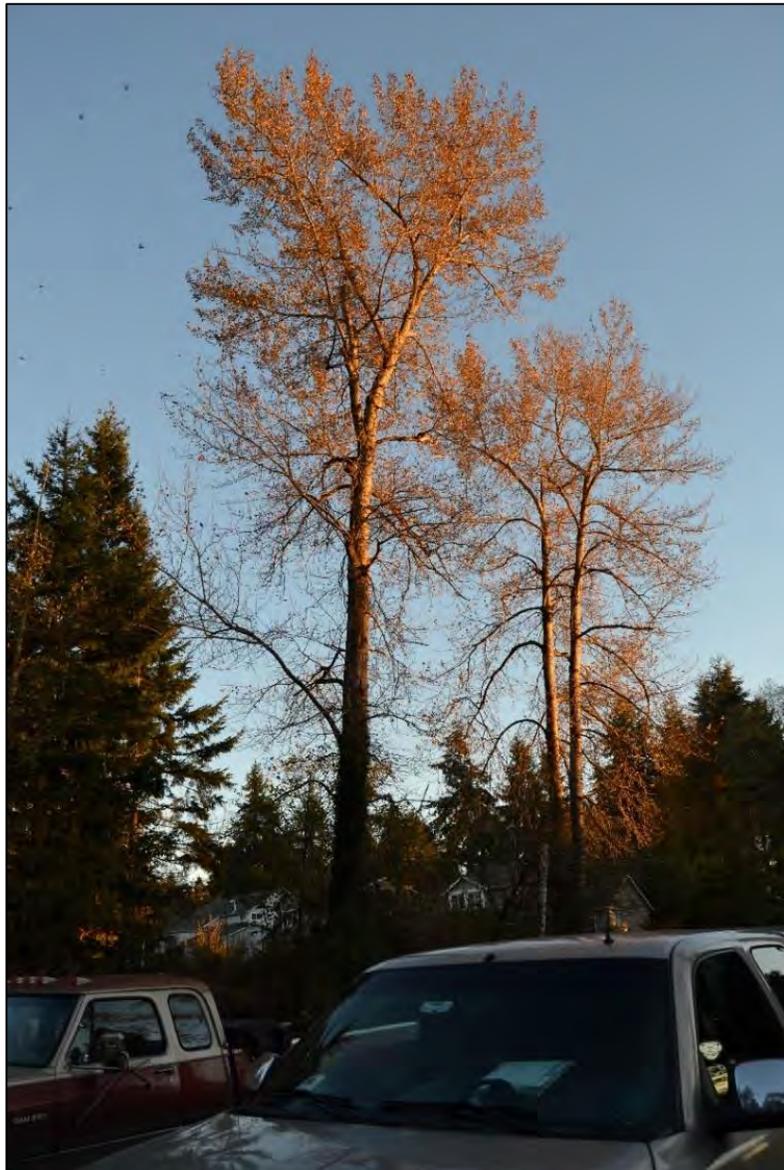
Photo # 3:
Looking SE at
Black
Cottonwood
trees #'s 5711,
5377, and
5376. Close
observation
reveals that
they have
already begun
to shed large
limbs.

There are 26 Black Cottonwood trees on the subject property. They are all *Significant* as defined by Kirkland Code. One Cottonwood is Dead. One is Dying. Nine are in Poor Condition. The remaining 15 trees are all in Fair or Good condition. However, I am recommending that all 26 be removed for safety. They are too large, too brittle, too susceptible to loss of large limbs, and too unpredictable to be retained. They should all be removed for safety.
