**TREE PLAN III
AT**

**RUNNING SHORT PLAT
7004 132ND AVE NE
KIRKLAND, WA 98033**

June 11, 2007

ATTACHMENT 5

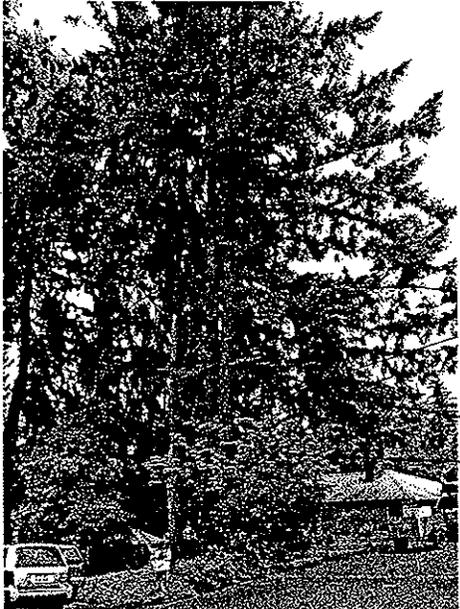
View of northern property line and driveway
Tree # 782
Tree # 781

Trees # 781 and 782, located just north of the north property line, can be adequately protected with a tree protection fence along the north side of the existing driveway. The southern limbs of # 781 may need to be trimmed to allow for the safe entry and exit of the site. It is recommended that the neighbor be contacted and that the neighbor be made aware of the need and allowed to make the necessary pruning cuts themselves.

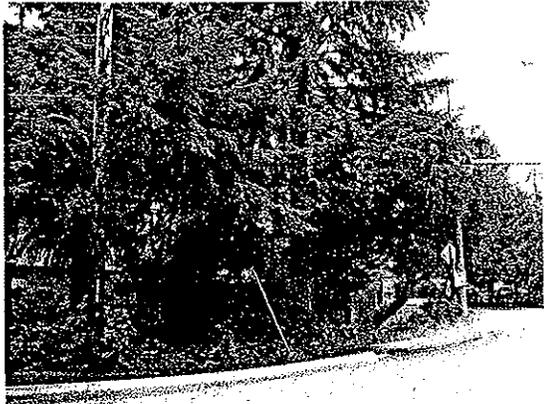
View of the southwest property corner at the intersection of NE 70th Street and 122nd Avenue NE
