**ADDENDUM TO THE
ARBORICULTURAL REPORT
RE-EVALUATION OF TREES
AT**

**THE TOTEM LAKE APARTMENTS SITE
At NE 115th Street & 124th Avenue NE
KIRKLAND, WA 98033**

April 7, 2011 Addendum

GILLES CONSULTING
Brian K. Gilles, Consulting Arborist
ISA Certified Arborist # PN-0260
ASCA Registered Consulting Arborist # RCA-418A

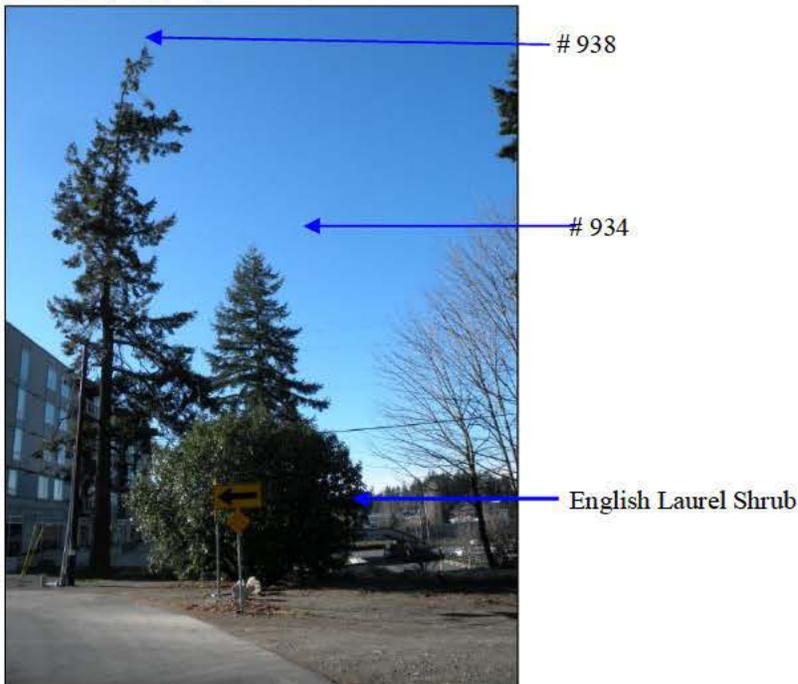
Photo # 1: Looking west from NE 115th

- Given the topography it is unlikely that this row of trees will be impacted. As noted in the February 10, 2011 report, the Tree Protection Fence and the Temporary
