**ARBORICULTURAL REPORT  
RE-EVALUATION OF TREES  
AT**

**THE TOTEM LAKE APARTMENTS SITE  
At NE 115<sup>th</sup> Street & 124<sup>th</sup> Avenue NE  
KIRKLAND, WA 98033**

**February 10, 2011**

**PREPARED BY:**  
**GILLES CONSULTING**  
Brian K. Gilles, Consulting Arborist  
*ISA Certified Arborist # PN-0260*  
*ASCA Registered Consulting Arborist # RCA-418A*

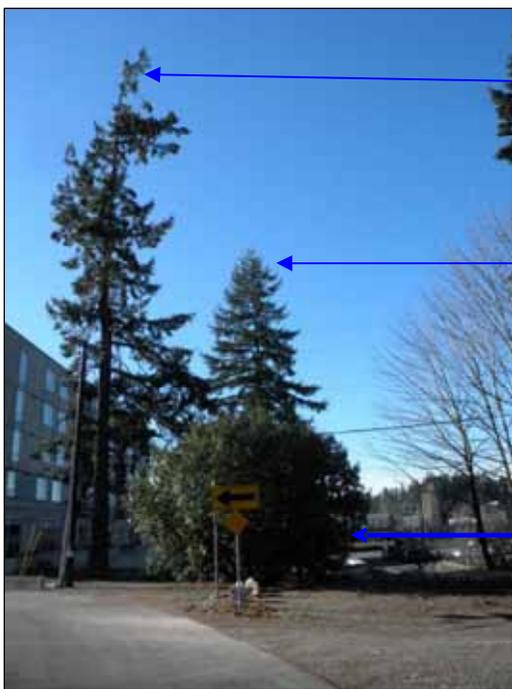
Photo # 1: Looking west from NE 115<sup>th</sup>

The tree is in Fair condition now but is in rapid decline. The tree was growing for decades in a harsh roadside environment. The construction of the new office building just south of the tree and demolition of the old 2-story house has stressed the tree. The outward symptoms of the lower trunk indicate that the tree could be suffering from root rot and base rot. Before any effort is made to retain this tree I recommend that the tree be tested with a Resistograph to determine the extent of internal decay.

- Right-of-Way Trees:
  - # 938 is the only right-of-way tree.
  - It is in rapid decline. It has symptoms that may indicate center rot, base rot, and root rot.

- Before any effort is made to retain this tree I strongly recommend it be tested with a Resistograph to determine if internal decay exists; and if it does, to what extent it exists. If the decay is in an advanced stage it will change the health rating of the tree from Fair to Poor and the recommendation will change from retention to removal.

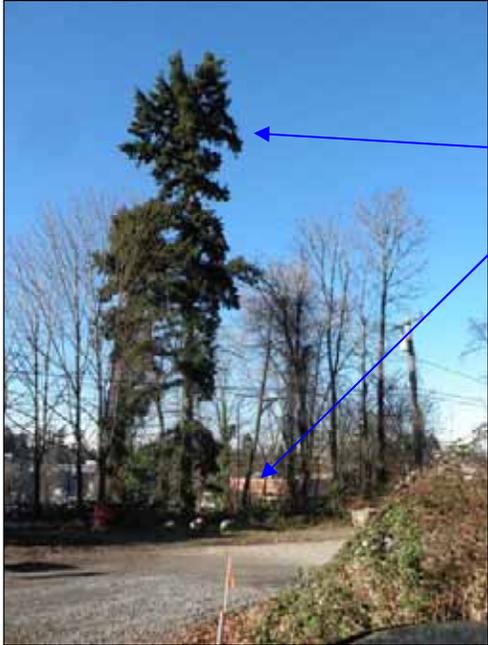
# 947

Photo # 2: Looking northwest from NE 115<sup>th</sup> Street onto the Vacated Slater Road

The 76 gas station and store

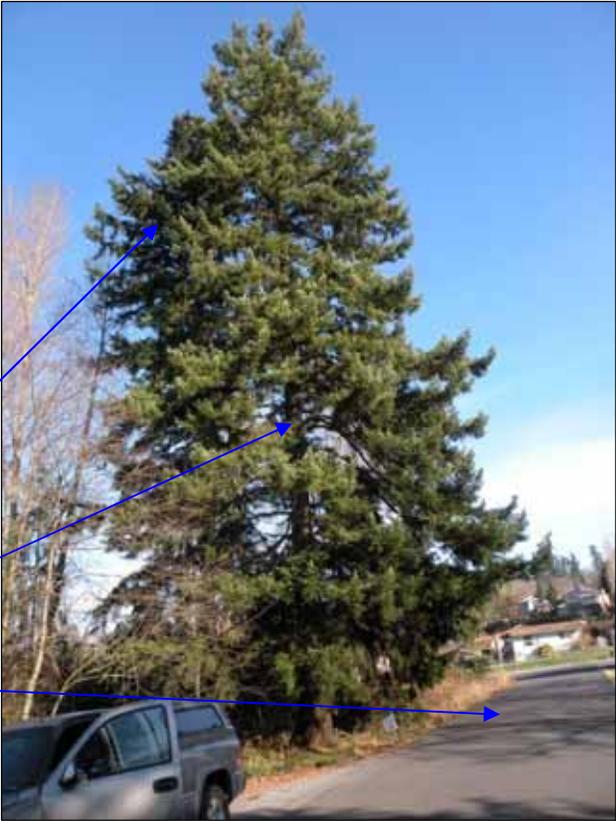
Photo # 3: #'s 822 & 821

Vacated Slater Road
