# ORCAS MOON COTTAGES

RE: Tree Inventory at Forbes Creek, TPN 3890100050 & 3890100055.

Robert Londo, Orcas Moon, LLC  
 RE: Tree Inventory at Forbes Creek, TPN 3890100050 & 3890100055.  
 November 20, 2017  
 Page 20 of 21  
 Attachment No. 4 - Preliminary Tree Retention Plan

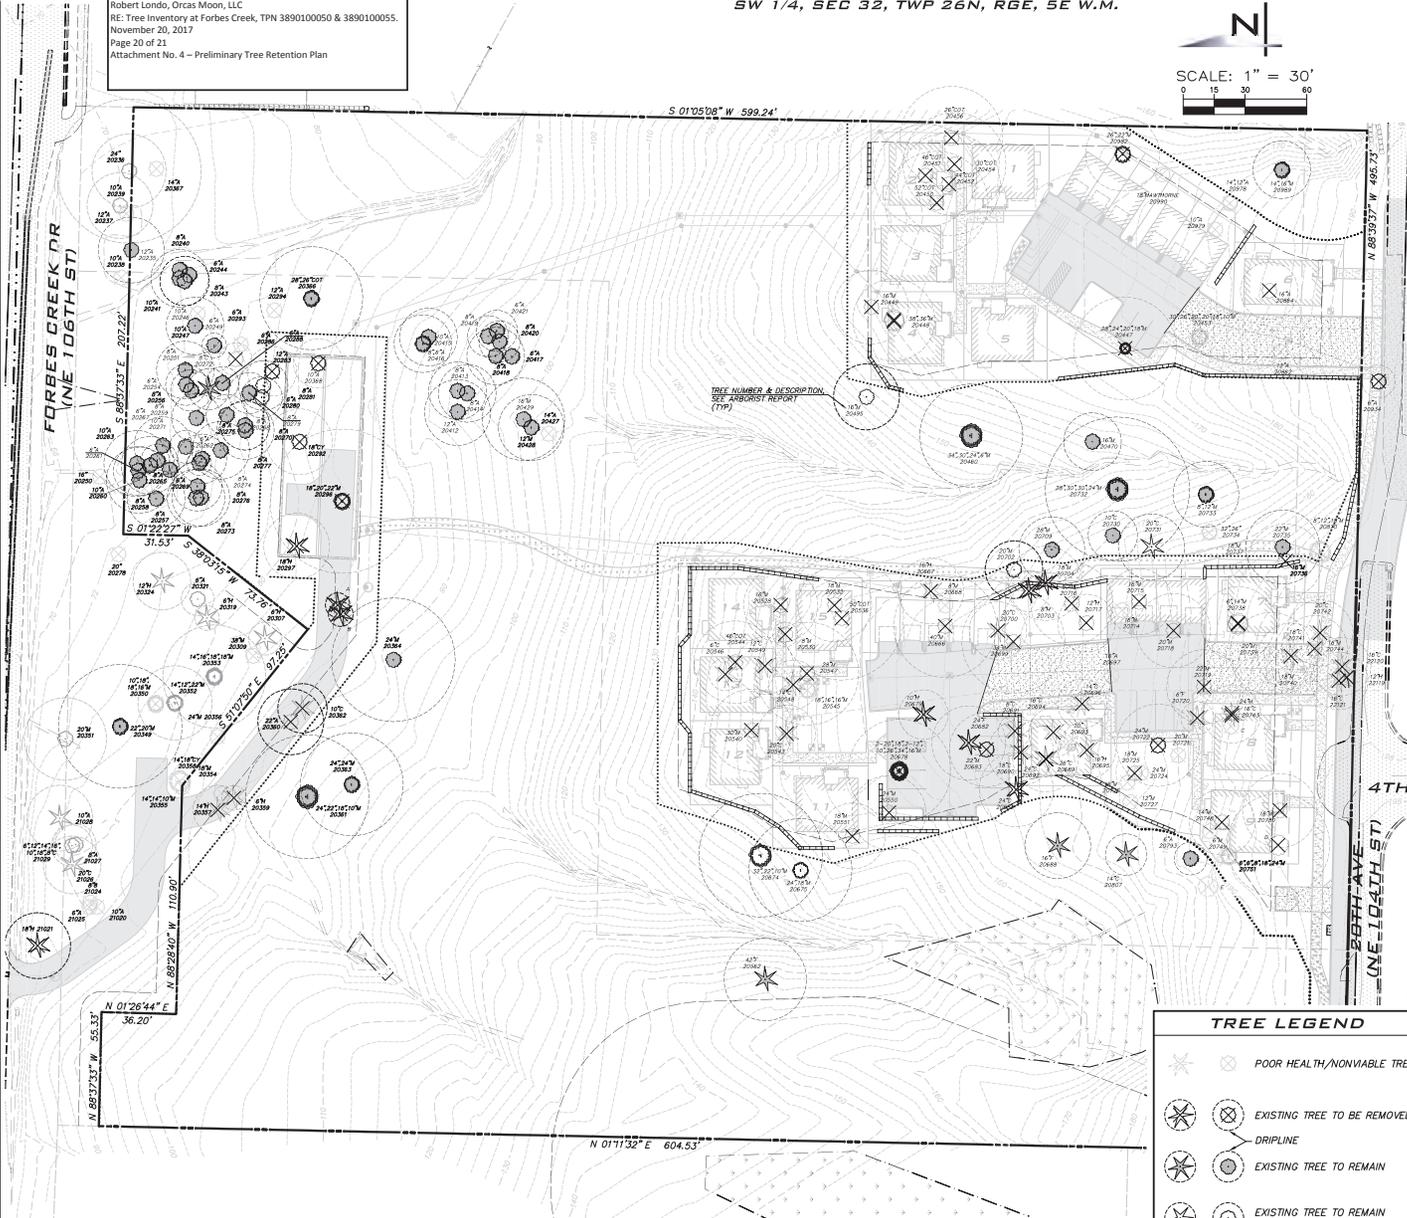
Parcel	Proposed Action	Density Credits	Retained TDC	TREE NO.	DBH	Species	Dripline	Health	Structure	Visible Defects	Viable Tree?
B	SAVE	2	2	20235	12	Red alder	16	1	2	Decline	
A	OFFSITE	0	0	20236	36	Weeping willow	35	2	2	Diseased, ivy	
A	NON-VIABLE	0	0	20237	12	Red alder	18	1	3	Upper trunk decay	NO
A	NON-VIABLE	0	0	20238	10	Red alder	12	1	3	Trunk failure	NO
A	OFFSITE	0	0	20239	10	Red alder	14	1	2	Asymmetric canopy	
B	SAVE	0	0	20240	8	Red alder	0	3	3	Covered in vines	NO
B	SAVE	1	1	20241	10	Red alder	14	1	2	Asymmetric, vines	
B	SAVE	1	1	20243	8	Red alder	12	1	2	Asymmetric	
B	SAVE	0	0	20244	6	Red alder	0	3	3	Covered in vines	NO
B	NON-VIABLE	0	0	20246	8	Red alder	6	1	3	Adjacent tree fell into it	NO
B	SAVE	1	1	20247	10	Red alder	14	1	2	Asymmetric	
B	SAVE	1	1	20249	6	Red alder	6	1	2	Suppressed	
A	NON-VIABLE	0	0	20250	16	Weeping willow	12	1	3	Previous trunk failure	NO
B	SAVE	1	1	20251	8	Red alder	14	1	2	Asymmetric

Parcel	Proposed Action	Density Credits	Retained TDC	TREE NO.	DBH	Species	Dripline	Health	Structure	Visible Defects	Viable Tree?
B	SAVE	1	1	20263	10	Red alder	16	1	2	Asymmetric	
B	SAVE	1	1	20264	8	Red alder	12	1	1		
B	SAVE	1	1	20265	8	Red alder	14	1	2	Asymmetric	
B	SAVE	1	1	20266	6	Red alder	6	1	2	Suppressed	
B	SAVE	1	1	20267	6	Red alder	8	1	2	Asymmetric	
B	SAVE	1	1	20268	8	Red alder	14	1	2	Lean	
B	SAVE	1	1	20269	6	Red alder	8	1	2	Suppressed	
B	SAVE	1	1	20270	8	Red alder	10	1	1		
B	SAVE	1	1	20271	10	Red alder	14	1	1		
B	SAVE	1	1.5	20272	8	Western red-cedar	10	1	1		
B	SAVE	1	1	20273	8	Red alder	14	1	2	Asymmetric	
B	SAVE	1	1	20274	8	Red alder	12	1	2	Asymmetric	
B	SAVE	1	1	20275	8	Red alder	12	1	2	Lean	
B	SAVE	1	1	20276	8	Red alder	14	1	2	Suppressed	
B	SAVE	1	1	20277	8	Red alder	14	1	2	Sweep	
A	NON-VIABLE	0	0	20278	28	Red alder	12	2	3	Decline, decay	NO
B	SAVE	1	1	20279	8	Red alder	10	1	1		
B	IMPACTED	0	0	20280	6	Red alder	10	1	2	Lean

Parcel	Proposed Action	Density Credits	Retained TDC	TREE NO.	DBH	Species	Dripline	Health	Structure	Visible Defects	Viable Tree?
B	REMOVE	0	0	20292	18	Bitter cherry	16	1	2	Asymmetric	
B	NON-VIABLE	0	0	20293	6	Red alder	8	1	3	Root failure	NO
B	NON-VIABLE	0	0	20294	12	Red alder	10	3	3	Decline, vine, dying-nearly dead	NO
B	REMOVE	0	0	20296	22,40	Bigleaf maple	35	1	2	Soil heave	
A	NON-VIABLE	0	0	20297	18	Douglas-fir	16	1	1		
A	OFFSITE	0	0	20307	6	Douglas-fir	8	1	2	Suppressed	
A	NON-VIABLE	0	0	20309	38	Bigleaf maple	30	1	3	Decay, Kretzschmaria	NO
A	OFFSITE	0	0	20319	6	Douglas-fir	6	1	2	Suppressed	
A	OFFSITE	0	0	20321	6	Red alder	8	1	1		
A	OFFSITE	0	0	20324	12	Douglas-fir	14	1	1		
B	SAVE	11	11	20349	22,20	Bigleaf maple	30	1	2	Double leader	
A	NON-VIABLE	0	0	20350	10",18", 18",16	Bigleaf maple	20	2	3	Decline, stump sprout, Kretzschmaria	NO
A	OFFSITE	0	0	20351	20	Bigleaf maple	20	1	1		
A	OFFSITE	0	0	20352	14,12,22	Bigleaf maple	18	1	2	Multiple leaders

A	OFFSITE	0	0	20353	14",16", 18",18	Bigleaf maple	25	2	2	Decay, multiple leaders, chain embedded in trunk	
B	NON-VIABLE	0	0	20354	18	Bigleaf maple	16	2	3	Decline, trunk decay, Kretzschmaria	NO
B	NON-VIABLE	0	0	20355	10,14,14"	Bigleaf maple	16	2	3	Decline, trunk decay, Kretzschmaria	NO
B	NON-VIABLE	0	0	20356	24	Bigleaf maple	18	2	3	Decline, Kretzschmaria	NO
B	REMOVE	0	0	20357	14	Douglas-fir	12	1	2	Ivy

Parcel	Proposed Action	Density Credits	Retained TDC	TREE NO.	DBH	Species	Dripline	Health	Structure	Visible Defects	Viable Tree?
B	NON-VIABLE	0	0	20358	18	Bitter cherry	12	2	3	Decline, stem failure	NO
B	REMOVE	0	0	20359	6	Douglas-fir	6	1	2	Suppressed	
A	REMOVE	0	0	20360	22	Red alder	16	2	2	Decline, double leader	
B	SAVE	15	15	20361	24",22", 18",10	Bigleaf maple	30	1	2	Multiple leaders	
A	REMOVE	0	0	20362	10,14,14"	Western red-cedar	12	1	1		
B	SAVE	13	13	20363	24,24	Bigleaf maple	25	1	2	Double leader	
B	SAVE	8	8	20364	24	Bigleaf maple	30	1	1		
B	SAVE	21	21	20366	38,40	Black cottonwood	25	1	2	Double leader	
B	NON-VIABLE	0	0	20367	14	Red alder	10	1	3	Lean, ivy	NO
B	REMOVE	0	0	20368	10	Red alder	12	2	2	Decline, nearly dead	
B	SAVE	2	2	20412	12	Red alder	16	1	1		
B	SAVE	1	1	20413	8	Red alder	14	1	2	Asymmetric	
B	SAVE	1	1	20414	8	Red alder	14	1	2	asymmetric	
B	SAVE	1	1	20415	10	Red alder	14	1	1		
B	SAVE	1	1	20416	6,8	Red alder	14	1	2	Asymmetric, double leader, included bark

Parcel	Proposed Action	Density Credits	Retained TDC	TREE NO.	DBH	Species	Dripline	Health	Structure	Visible Defects	Viable Tree?
B	NON-VIABLE	0	0	20428	12	Bigleaf maple	16	1	2	Asymmetric	
B	SAVE	5	5	20429	18	Bigleaf maple	20	2	1	Stunted upper foliage	
B	REMOVE	0	0	20447	18,20,24,28	Bigleaf maple	25	1	2	Multiple leaders	
B	REMOVE	0	0	20448	36,38	Bigleaf maple	20	1	2	Double leader	
B	REMOVE	0	0	20449	16	Bigleaf maple	18	1	1		
B	REMOVE	0	0	20450	52	Black cottonwood	25	1	2	Asymmetric, sweep	
B	REMOVE	0	0	20451	65	Black cottonwood	25	1	2	Asymmetric, sweep	
B	REMOVE	0	0	20452	44	Black cottonwood	25	1	2	Asymmetric, sweep	
B	NON-VIABLE	0	0	20453	10,18,20,20,26,30	Bigleaf maple	30	1	3	Previous failure, multiple leaders, stump sprout	NO
B	REMOVE	0	0	20454	30	Black cottonwood	25	1	2	Asymmetric, sweet	
B	REMOVE	0	0	20456	26	Black cottonwood	25	1	2	Asymmetric, sweet	
B	SAVE	21	21	20460	6,24,30,34	Bigleaf maple	25	1	2	Multiple leaders

B	SAVE	4	4	20470	16	Bigleaf maple	14	1	2	Trunk wound, deadwood	
B	IMPACTED	0	0	20495	16	Bigleaf maple	16	1	1		
B	REMOVE	0	0	20528	16	Bigleaf maple	18	1	2	Asymmetric	
B	REMOVE	0	0	20530	8	Douglas-fir	6	1	2	Suppressed	
B	REMOVE	0	0	20532	18	Bigleaf maple	18	1	2	Deadwood, asymmetric	
B	REMOVE	0	0	20536	50	Black cottonwood	30	1	1		
B	REMOVE	0	0	20540	30	Bigleaf maple	20	1	2	Asymmetric	
B	REMOVE	0	0	20543	20	Western red-cedar	14	1	1		
B	REMOVE	0	0	20544	54	Black cottonwood	20	1	2	Sweep in trunk	
B	NON-VIABLE	0	0	20545	18,16,16	Bigleaf maple	20	2	3	Stunted, trunk failure,	NO

Parcel	Proposed Action	Density Credits	Retained TDC	TREE NO.	DBH	Species	Dripline	Health	Structure	Visible Defects	Viable Tree?
										stumpsprout	
B	REMOVE	0	0	20546	6	Western red-cedar	8	1	2	Suppressed	
B	REMOVE	0	0	20547	28	Bigleaf maple	25	1	2	Branch failure, asymmetric	
B	REMOVE	0	0	20548	14	Western red-cedar	12	1	2	Suppressed	
B	REMOVE	0	0	20549	12	Western red-cedar	14	1	2	Suppressed	
B	REMOVE	0	0	20550	24	Bigleaf maple	18	1	2	Asymmetric	
B	REMOVE	0	0	20551	18	Bigleaf maple	16	1	2	Seam in trunk	
B	SAVE	17	25.5	20562	42	Douglas-fir	20	1	1		
B	REMOVE	0	0	20666	40	Bigleaf maple	25	1	2	Spiral cracks in trunk	
B	REMOVE	0	0	20667	16	Western hemlock	16	1	1		
B	NON-VIABLE	0	0	20668	8	Bigleaf maple	14	1	3	Asymmetric, suppressed	NO
B	IMPACTED	0	0	20674	32,22,10	Bigleaf maple	30	1	2	Multiple leaders	
B	IMPACTED	0	0	20675	24,18	Bigleaf maple	25	2	2	Stunted foliage, stump sprout	
B	REMOVE	0	0	20678	2-20",18", 2-12",10", 26",34",16	Bigleaf maple	25	2	2	Stunted foliage, multiple leader, deadwood

Parcel	Proposed Action	Density Credits	Retained TDC	TREE NO.	DBH	Species	Dripline	Health	Structure	Visible Defects	Viable Tree?
B	REMOVE	0	0	20690	18	Western red-cedar	16	1	1		
B	REMOVE	0	0	20691	8	Western red-cedar	8	1	2	Asymmetric	
B	NON-VIABLE	0	0	20693	10	Red alder	14	1	3	Lean	NO
B	REMOVE	0	0	20694	18	Western red-cedar	12	1	2	Sweep in trunk	
B	REMOVE	0	0	20695	16	Western hemlock	14	1	1		
B	REMOVE	0	0	20696	14	Western red-cedar	12	1	1		
B	NON-VIABLE	0	0	20697	16	Red alder	12	1	3	Top of tree is dead	NO
B	REMOVE	0	0	20699	34	Bigleaf maple	25	1	2	Asymmetric	
B	REMOVE	0	0	20700	20	Western red-cedar	14	1	1		
B	IMPACTED	0	0	20702	16	Bigleaf maple	14	1	1		
B	REMOVE	0	0	20703	8	Western hemlock	10	1	2	Suppressed	
B	REMOVE	0	0	20704	18	Bigleaf maple	18	1	2	Deadwood	
B	SAVE	8	8	20709	24	Bigleaf maple	16	1	1		
B	NON-VIABLE	0	0	20714	14	Bigleaf maple	16	1	3	Asymmetric, trunk decay	NO
B	REMOVE	0	0	20715	16	Bigleaf maple	16	1	2	Asymmetric

B	REMOVE	0	0	20716	28	Bigleaf maple	20	1	1		
B	REMOVE	0	0	20717	12	Western hemlock	14	1	2	Suppressed	
B	REMOVE	0	0	20718	20	Bigleaf maple	18	1	1		
B	REMOVE	0	0	20719	22	Bigleaf maple	18	1	2	Asymmetric	
B	REMOVE	0	0	20720	6	Douglas-fir	8	1	2	Suppressed	
B	NON-VIABLE	0	0	20721	20	Bigleaf maple	18	1	3	Trunk decay	NO
B	REMOVE	0	0	20722	24	Bigleaf maple	20	1	2	Asymmetric

Parcel	Proposed Action	Density Credits	Retained TDC	TREE NO.	DBH	Species	Dripline	Health	Structure	Visible Defects	Viable Tree?
B	REMOVE	0	0	20724	18,24	Bigleaf maple	20	1	3	Stumpsprout	NO
B	NON-VIABLE	0	0	20726	16	Bigleaf maple	18	1	3	Dog leg, stumpsprout	NO
B	NON-VIABLE	0	0	20727	12	Bigleaf maple	16	1	3	Asymmetric, lean	NO
B	SAVE	1	1.5	20730	10	Western red-cedar	12	1	1		
B	IMPACTED	0	0	20731	20	Western red-cedar	16	1	1		
B	SAVE	21	21	20732	28,30,30,24	Bigleaf maple	35	1	2	Deadwood, failure, stumpsprout	
B	SAVE	3	3	20733	8,12	Bigleaf maple	16	1	2	Asymmetric, stumpsprout	
B	NON-VIABLE	0	0	20734	32,26	Bigleaf maple	25	1	3	Trunk decay, stumpsprout, Kretschmaria	NO
B	SAVE	7	7	20735	22	Bigleaf maple	18	1	2	Deadwood, asymmetric	
B	REMOVE	0	0	20736	16	Bigleaf maple	18	1	2	Asymmetric, stumpsprout	
B	NON-VIABLE	0	0	20737	16	Bigleaf maple	16	1	3	Leaning in adjacent tree	NO
B	REMOVE	0	0	20738	6,14	Bigleaf maple	18	1	2	Stump sprout

B	NON-VIABLE	0	0	20739	20	Bigleaf maple	20	1	3	Stump sprout	NO
B	NON-VIABLE	0	0	20740	18	Bigleaf maple	16	1	3	Dog leg, branch failure, stumpsprout	NO
B	REMOVE	0	0	20741	18	Western red-cedar	16	1	1		
B	REMOVE	0	0	20742	22	Western red-cedar	16	1	1		
B	REMOVE	0	0	20743	16	Western red-cedar	14	1	2	Growing against maple	
B	REMOVE	0	0	20744	16	Bigleaf maple	16	1	2	Previous branch failure, sweep in trunk	
B	REMOVE	0	0	20748	14	Bigleaf maple	16	1	2	Asymmetric

Parcel	Proposed Action	Density Credits	Retained TDC	TREE NO.	DBH	Species	Dripline	Health	Structure	Visible Defects	Viable Tree?
B	NON-VIABLE	0	0	20749	6	Bigleaf maple	12	1	3	Dog leg, trunk injury, stumpsprout	NO
B	NON-VIABLE	0	0	20751	6,6,8,18,24	Bigleaf maple	25	2	3	Decline, decay, stumpsprout	NO
B	REMOVE	0	0	20780	16	Bigleaf maple	18	1	2	Dog leg in trunk	
B	SAVE	1	1	20793	6	Pacific dogwood	8	1	2	deadwood	
B	SAVE	3	4.5	20807	14	Western red-cedar	10	1	2	Sweep in trunk	
B	NON-VIABLE	0	0	20862	12	Red alder	8	2	3	Decline	NO
B	REMOVE	0	0	20864	16	Red alder	14	1	1		
B	NON-VIABLE	0	0	20870	8,12,18	Bigleaf maple	18	1	3	Asymmetric, stumpsprout	NO
B	REMOVE	0	0	20934	6	Red alder	8	1	1		
B	NON-VIABLE	0	0	20978	12,14	Red alder	12	2	3	Top failure	NO
B	NON-VIABLE	0	0	20979	10	Red alder	8	2	3	Top of tree is dead	NO
B	REMOVE	0	0	20982	22,26	Bigleaf maple	18	1	2	Trunk decay	
B	SAVE	6	6	20989	14,16	Bigleaf maple	14	1	2	dogleg, asymmetric

B	NON-VIABLE	0	0	20990	18	Scouler's willow	14	1	3	leaning trunk	NO
A	NON-VIABLE	0	0	21020	10	Red alder	14	1	3	Trunk wound/decay	NO
A	OFFSITE	0	0	21021	18	Douglas-fir	16	1	2	Topped for power lines	
B	REMOVE	0	0	21022	16	Douglas-fir	16	1	2	Topped for power lines	
A	NON-VIABLE	0	0	21024	7	Red alder	8	2	3	Decline, decay	NO
A	NON-VIABLE	0	0	21025	7	Red alder	8	2	3	Decline, decay	NO
A	OFFSITE	0	0	21026	20	Western red-cedar	14	1	1		
A	OFFSITE	0	0	21027	7	Red alder	10	2	2	Decline, decay

Parcel	Proposed Action	Density Credits	Retained TDC	TREE NO.	DBH	Species	Dripline	Health	Structure	Visible Defects	Viable Tree?
A	OFFSITE	0	0	21028	10	Red alder	10	1	1		
A	OFFSITE	0	0	21029	6",12",14",16", 10",18",8"	Western red-cedar	16	1	2	Stump sprout	
B	NON-VIABLE	0	0	22119	14	Western hemlock	10	1	3	Branch decline, spiral cracks in trunk	NO
B	REMOVE	0	0	22120	18	Western red-cedar	14	1	2	Asymmetric	
B	REMOVE	0	0	22121	18	Western red-cedar	14	1	2	Asymmetric	
B	REMOVE	0	0	A	8	Douglas-fir	6	1	1		
B	REMOVE	0	0	B	8	Western red-cedar	6	1	2	Sweep	
B	NON-VIABLE	0	0	C	24	Bigleaf maple	16	1	3	Trunk decay	NO
B	REMOVE	0	0	D	48	Black cottonwood	25	1	1		
B	NON-VIABLE	0	0	E	16	Bigleaf maple	18	1	3	Asymmetric, stumpsprout	NO
<b>Tree Credits</b>		210	222.5	Retained TDC of 222.5 includes 1.5x for retained native conifers. DBH – trunk diameter in inches 4.5' from grade. Dripline as radius in feet from the trunk.

**TREE PROTECTION MEASURES**

- TREE PROTECTION FENCES WILL NEED TO BE PLACED AROUND EACH TREE OR GROUP OF TREES TO BE RETAINED.
  - TREE PROTECTION FENCES ARE TO BE PLACED ACCORDING TO CITY STANDARD PLAN NO. 06-2-49 AND AS NOTED IN THE TREE INVENTORY/CONDITIONS SPREADSHEET, COLUMN 6 - LIMITS OF DISTURBANCE (SEE ARBORIST REPORT DATED 6/14/17).
  - TREE PROTECTION FENCES MUST BE INSPECTED PRIOR TO THE BEGINNING OF ANY CONSTRUCTION WORK/ACTIVITIES.
  - NOTHING MUST BE PARKED OR STORED WITHIN THE TREE PROTECTION FENCES—NO EQUIPMENT, VEHICLES, SOIL, DEBRIS, OR CONSTRUCTION SUPPLIES OF ANY SORTS.
- CEMENT TRUCKS MUST NOT BE ALLOWED TO DEPOSIT WASTE OR WASH OUT MATERIALS FROM THEIR TRUCKS WITHIN THE TREE PROTECTION FENCES.
- TREE PROTECTION FENCES NEED TO BE CLEARLY MARKED WITH THE FOLLOWING OR SIMILAR TEXT IN FOUR INCH OR LARGER LETTERS:
