Culvert Assessment Memorandum

Preliminary Assessments: Fish Passage at City of Kirkland Road and Trail Stream Culverts

August 2014

The Watershed Company Reference Number:
120612

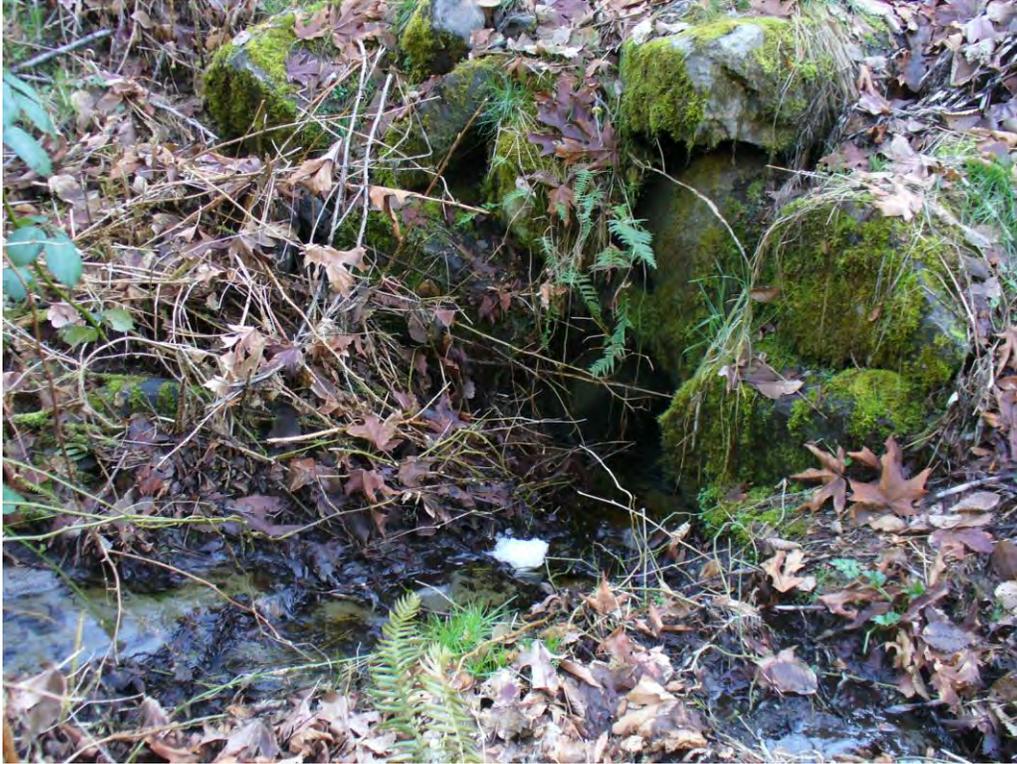
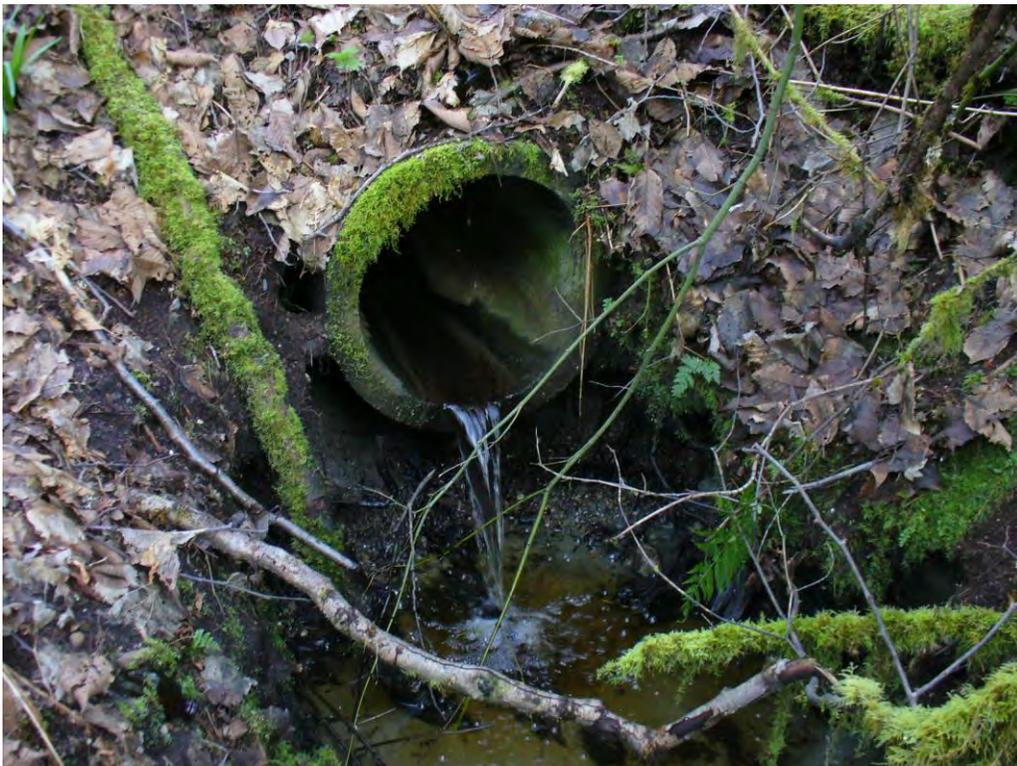
Figure 5. Culvert HP-3 Inlet at Holmes Point Drive, 3-8-13

Figure 6. Culvert HP-3 Outlet at Holmes Point Drive, 3-8-13

HP-3 (4)	Holmes Pt.	18 in, 71 ft., RCP	Holmes Pt. Drive	4 - Full Barrier due to plunge and velocity due to steepness	Also note that pipe crossing Holmes Pt Drive and pipe on SE side of Holmes Pt Drive are a barrier to stream near 13808 Homes Pt Drive	Steep, very near headwaters, type N per DNR mapping, fish use or habitat near culvert doubtful. Two full barriers are present downstream. Little or no habitat present upstream. Replacement not justifiable based on fish use or habitat.	4	0.0
Denny Creek								
DE-1 (5)	Denny Creek	10-foot-wide by 4 ½ foot high concrete box culvert, 55 ft.	Holmes Pt. Drive	1 - Fully Passable.	Denny Creek report may have already evaluated this culvert.	N/A - culvert is already fully passable.	4	0.0
DE-2 (6)	Denny Creek	24 in, 138 ft., Concrete	Juanita Drive	4 - Presumed full barrier due to long length and high slope with correspondingly high velocities.	Neighborhood wants pedestrian underpass combined with fish passage improvements at this location.	This culvert is on a significant, fish-bearing stream with no downstream barriers. A moderate amount of habitat would be made accessible to migratory, anadromous fish upstream. High priority within the City for replacement. Moderately high cost. Has a high degree of community support; costs would increase if a requested pedestrian underpass were included.	1	9.2

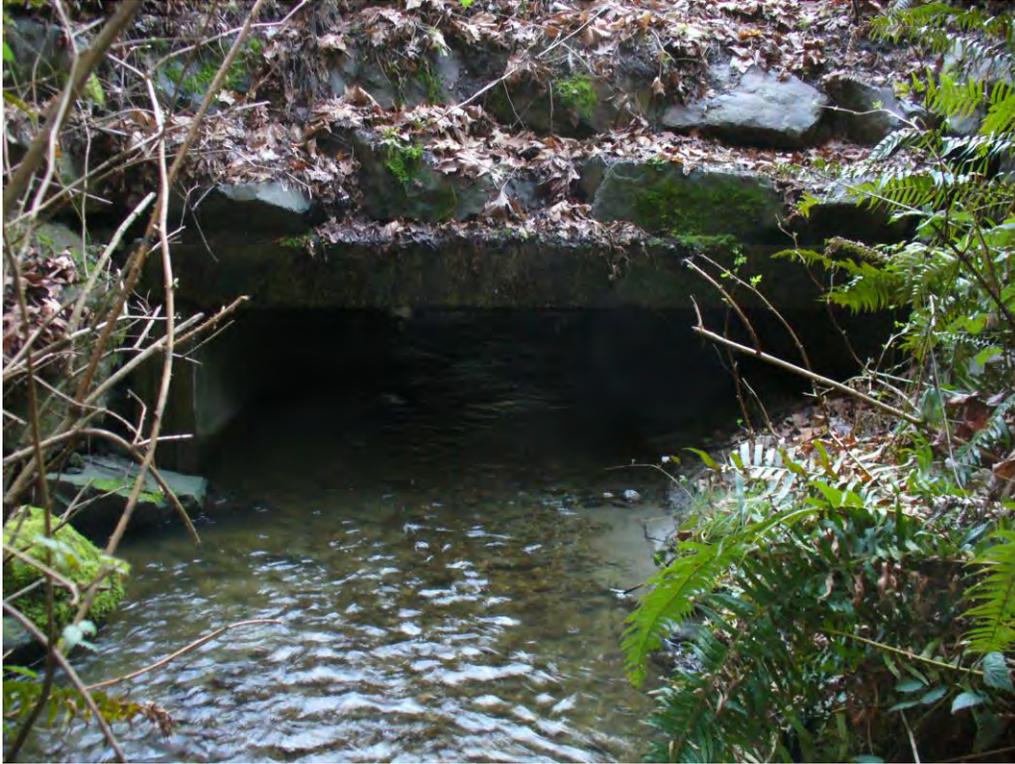
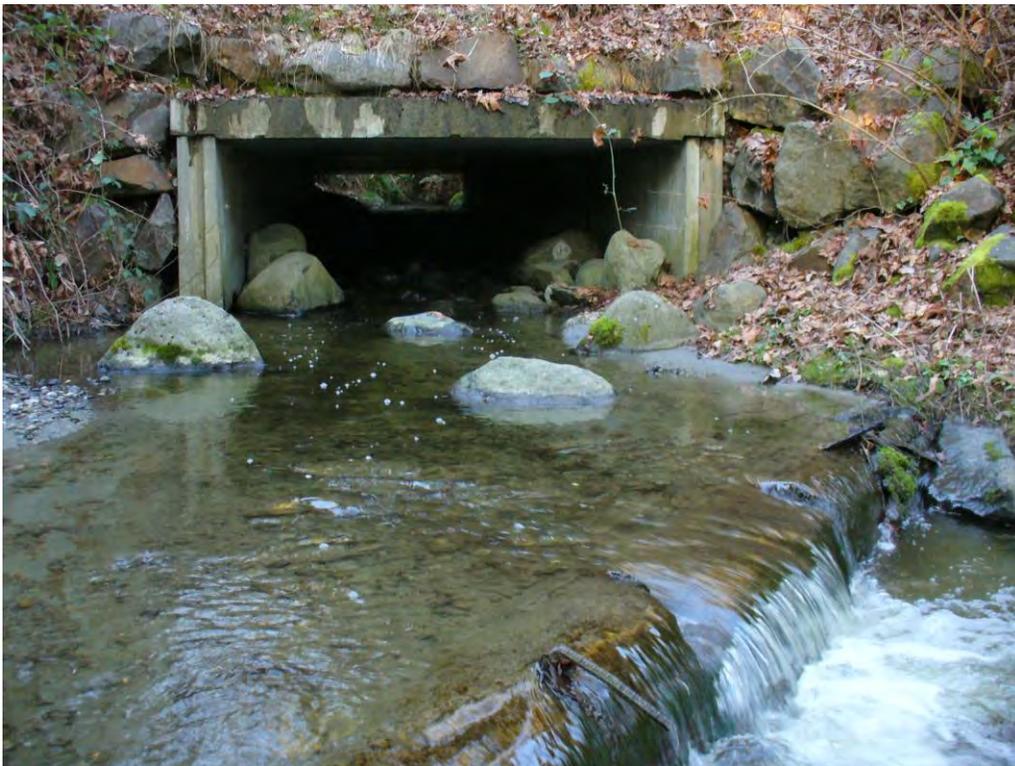
Figure 7. Culvert DE-1 Inlet at Holmes Point Drive, 3-8-13

Notes: This culvert is fully passable in its present condition as of 3/13. Look at whether Denny Creek report has already evaluated this culvert.

Figure 8. Culvert DE-1 Outlet at Holmes Point Drive, 3-8-13

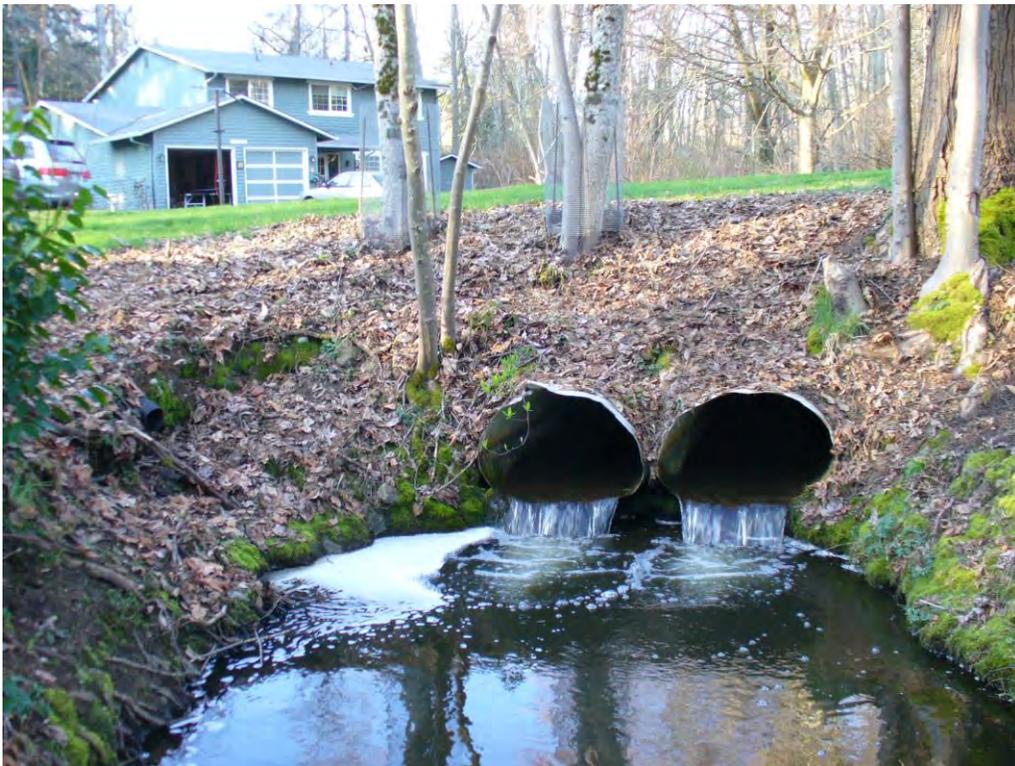
Figure 12. Culvert DE-3 Outlet at 78th Place NE, 3-8-13

DE-3 (A)	Denny Creek	76 ft. twin corrugated pipes 24" high by 36" wide	13433 78th PI NE	2 - Hindrance. Moderate-sized trout could jump into and swim through these culverts.	In open space area in front of home	No fish found in 1998 study, but habitat appears suitable, type F per DNR mapping. Culvert downstream at Juanita Drive is a barrier and would need to be upgraded to allow anadromous access. Some habitat available upstream in low-gradient tributaries and beaver pond habitat. Though relatively low cost, there would be limited benefits to replacing this culvert because it is already largely passable, a downstream barrier is present, and quantity of potential habitat farther upstream is limited.	3	2.3
Champagne Creek								
CH-1 (7)	Champagne Creek	18 in., 226 ft., concrete	Juanita Drive	4 - Full barrier due to plunge at outfall and velocity due to slope and smooth pipe.	Little potential habitat available upstream.	Fish use not expected this far upstream, but cutthroat use documented farther downstream. Downstream incised channel likely includes barriers. There is not significant habitat available upstream so this is not a high priority.	4	2.6

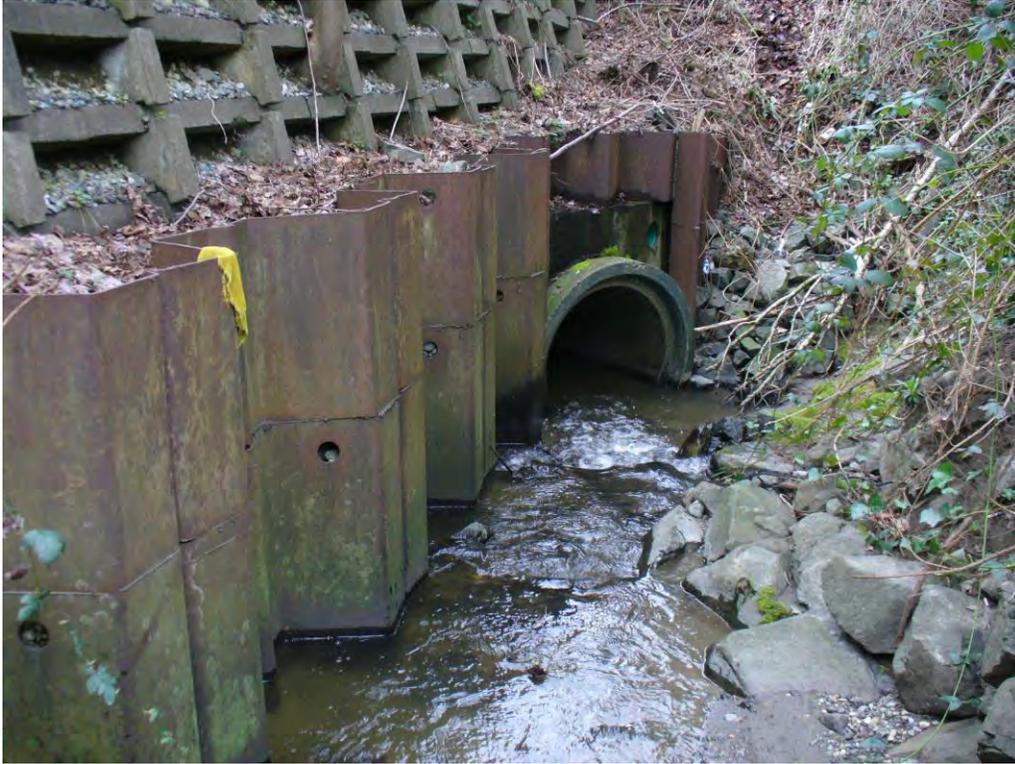
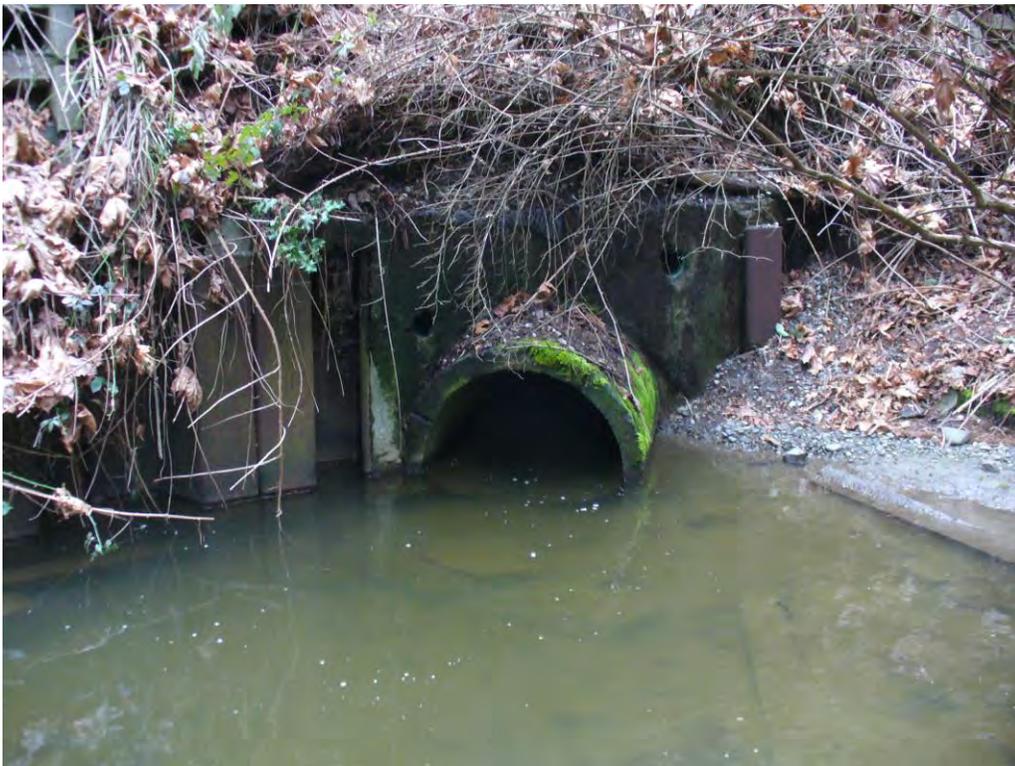
Figure 18. Culvert JC-10 Inlet at Juanita Woodinville Way, 3-11-13

Figure 19. Culvert JC-10 Outlet at Juanita Woodinville Way, 3-11-13

JC-10 (17)	Juanita Creek- NW/east trib	36 in, 108 ft., concrete	Juanita Woodinville Way	3 - Partial Barrier. Fish can swim easily through the lower part of the pipe at most flows, then need to pass through a short, low-depth, high-velocity section at the upper end.	King County may have data on this pipe.	This culvert is on a significant, fish-bearing stream with no full barriers downstream. A moderate amount of habitat would be made more accessible to migratory, anadromous fish upstream. Relatively high priority within the City for replacement. Moderately high cost.	1	8.8
JC-11 (18)	Juanita Creek- NW/east trib	48 in, 78 ft., concrete	NE 140th Place	1 - Fully passable. Culvert is countersunk with a near-zero gradient.	King County may have data on this pipe.	N/A - culvert is already fully passable.	4	0.0
JC-12 (19)	Juanita Creek- NW/east trib	3-foot by 4-foot CMP, 73 ft.,	102nd Ave NE	3 - Partial barrier. No plunge at outfall, but flows are shallow, swift, and moderately steep.	King County may have data on this pipe.	This culvert is on a significant, fish-bearing stream with no full barriers downstream. A moderate amount of habitat would be made more accessible to migratory, anadromous fish upstream. Relatively high priority within the City for replacement.	1	6.7

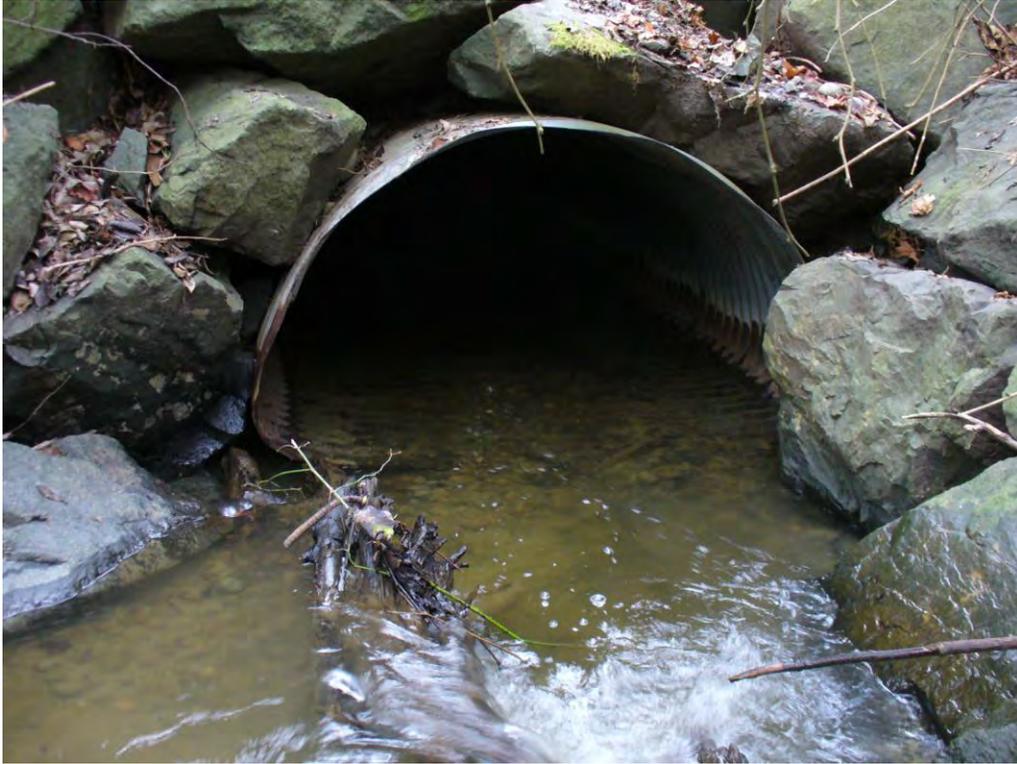
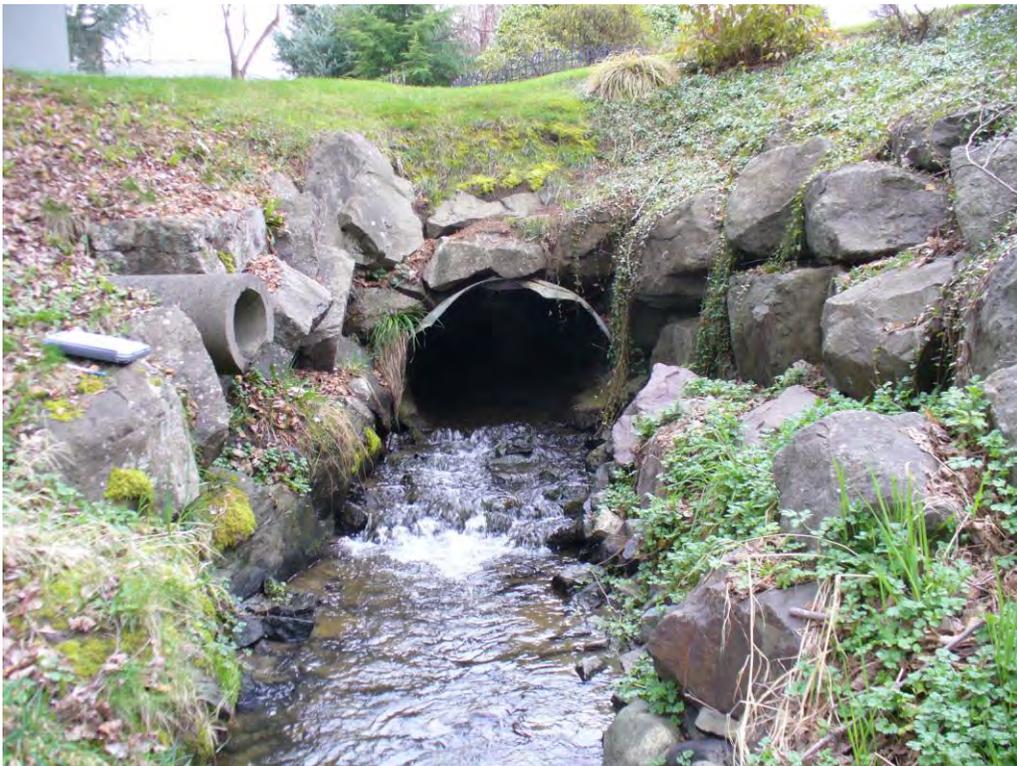
Figure 22. Culvert JC-12 Inlet at 102nd Avenue NE, 3-11-13

Meets WDFW Culvert Design Manual Criteria? No. Fails depth, slope, and substrate requirements. (1.25 OHW width for no slope, 1.2 OHW width +2 for stream simulation. Hydraulic Option not amenable to field assessment).

Figure 23. Culvert JC-12 Outlet at 102nd Avenue NE, 3-11-13

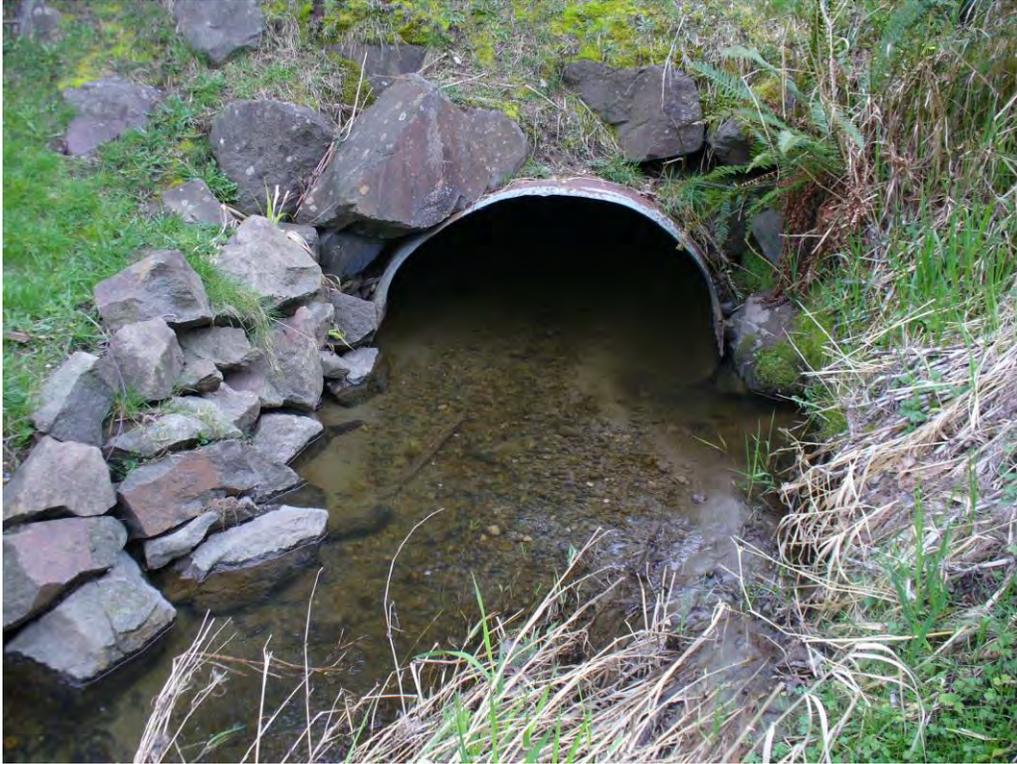
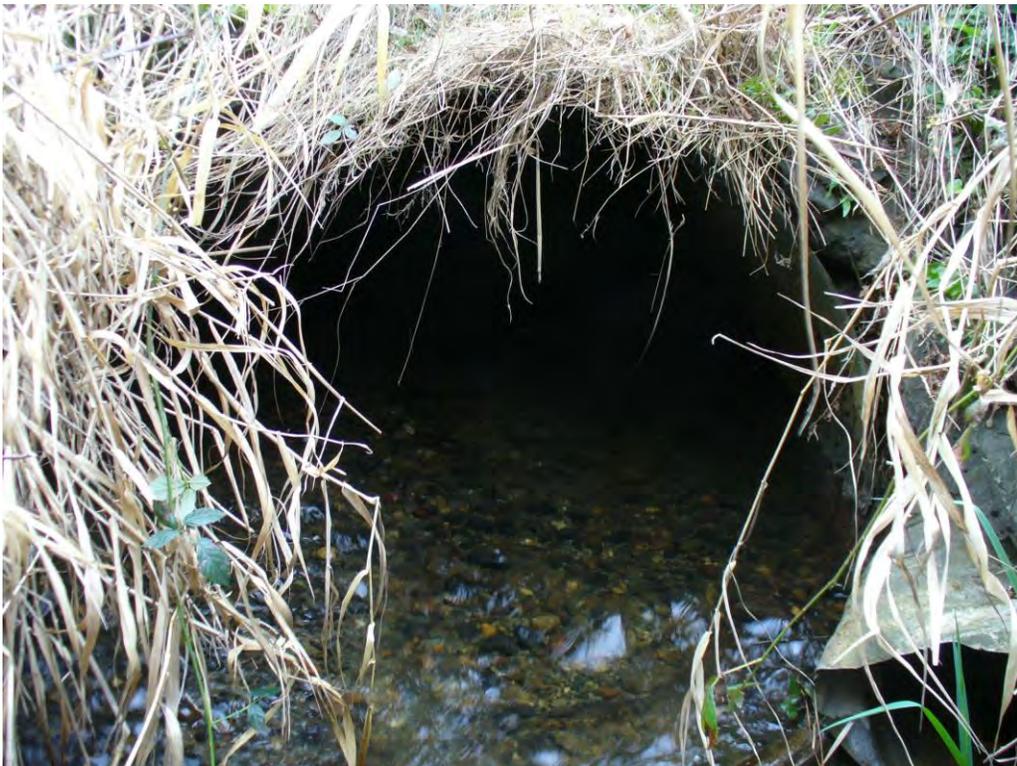
Figure 24. Culvert JC-13 Inlet at 101st Place NE, 3-11-13

Figure 25. Culvert JC-13 Outlet at 101st Place NE, 3-11-13

JC-13 (20)	Juanita Creek- NW/east trib	4-foot wide by 3-foot high CMP	101st Place NE	2 - Migration hindrance; mostly passable. Long length, width does not meet design standards.		This culvert is on a significant, fish-bearing stream with no full barriers downstream. A moderate amount of habitat would be made more accessible to migratory, anadromous fish upstream. However, since this culvert is already mostly passable, it is of lower priority for replacement than some of the other crossings of the Juanita Creek- NW/east trib .	3	4.8
JC-14 (21)	Juanita Creek- NW/east trib	42 in, 125ft, concrete	100th Ave NE	4 - Full barrier due to inlet plunge onto steep, smooth concrete for approx. 40 feet. Also due to 2 ½ foot plunge at outfall.	King County may have data on this pipe.	This culvert is on a significant, fish-bearing stream with no full barriers downstream. A moderate amount of habitat would be made accessible to migratory, anadromous fish upstream. Relatively high priority within the City for replacement. However, high expense and design complicated considerably by the presence of an in-stream detention facility extending upstream.	2 (note: previously rated high priority, but lowered to p2 due to high cost, location high in the watershed.)	8.8

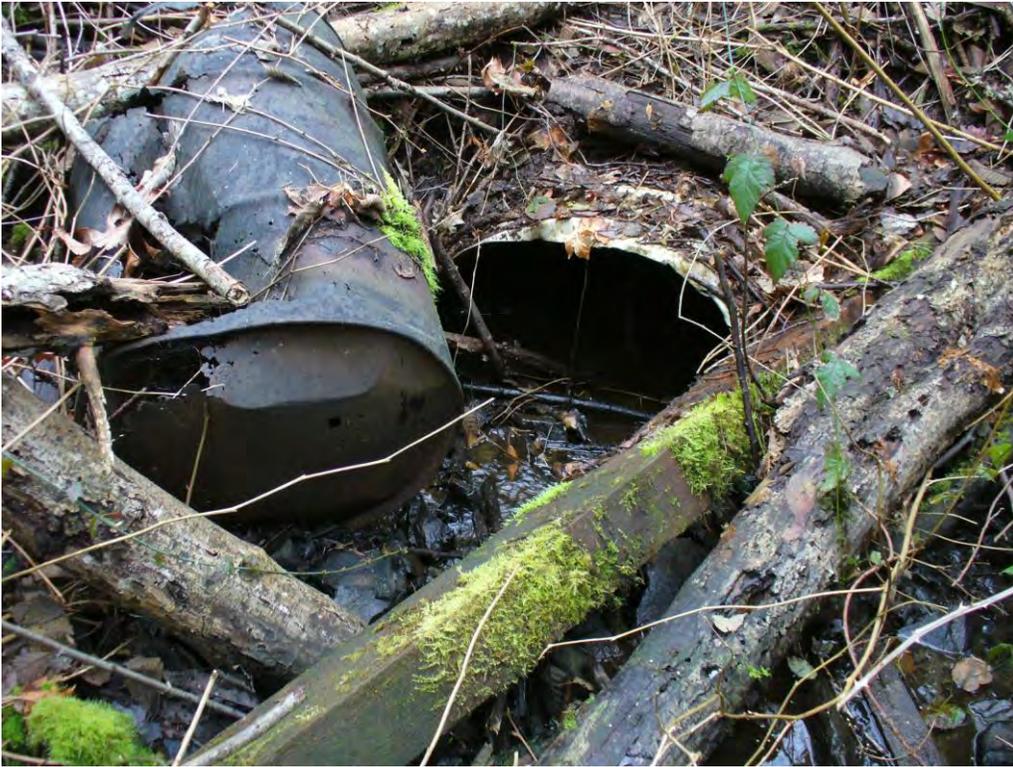
Figure 30. Culvert JC-16 Inlet at 88th Avenue NE, 3-12-13

Substrate/roughness w/in culvert? Quarry spalls in pipe at inlet. Little/none at outlet

Notes: Quarry spall heaven! Huge amounts of quarry spalls – fairly old – were placed at this culvert outlet. Also quarry spalls and a lot of accumulated debris at the inlet. Check whether King County has any data on this pipe?

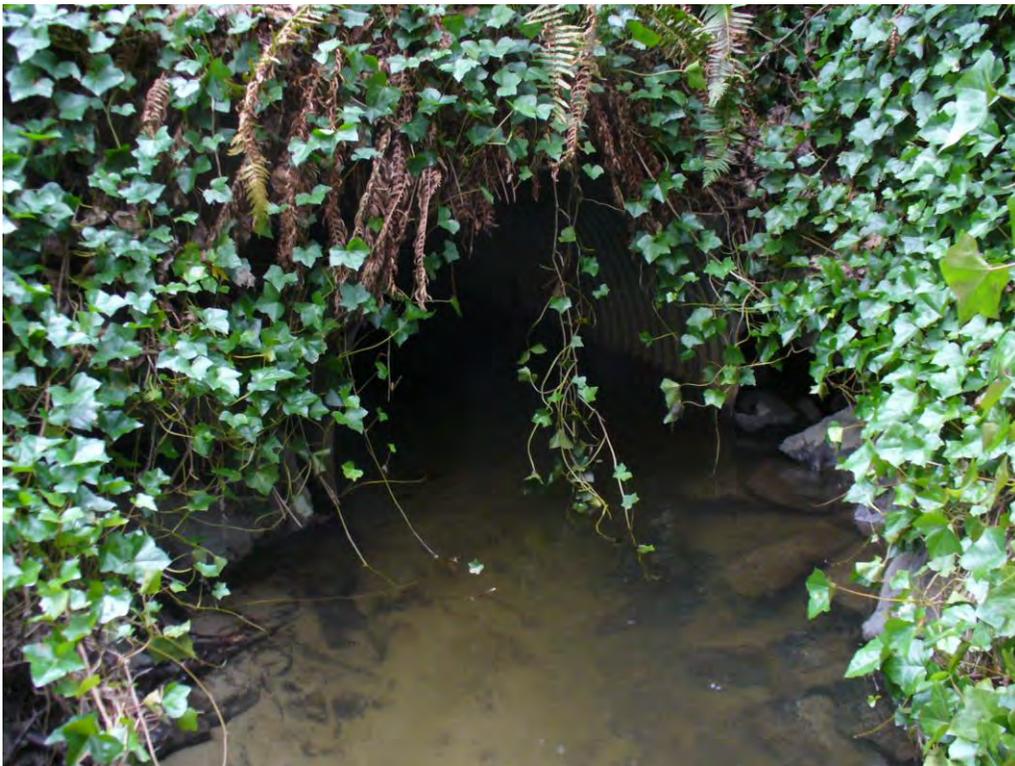
Figure 39. Culvert JC-20 Outlet at 111th Avenue NE, 3-12-13

Passage Assessment – Passable, Full/Partial Barrier: Not a barrier – passage conditions are fairly good.

JC-20 (24)	Juanita Creek-NE/east trib	60-inch CMP, 77 ft.	111th Ave NE	1 - Not a barrier - passage conditions are fairly good.	CIP to fix headwall on this culvert underway	N/A - culvert is already fully passable.	4	0.0
JC-21 (26)	Juanita Creek-NE/east trib	48-inch CMP with tar	I-405	4 - Full barrier due to high plunge onto rock at the outlet. Also very long and steep, likely resulting in a velocity barrier.	I-405 probably evaluated this as part of Nickel Project.	This culvert is on Juanita Creek, a significant, fish-bearing stream in the City with partial barriers downstream. The crossing is high in the basin, near the headwaters, and a moderate amount of habitat would be made more accessible to migratory, anadromous fish upstream. Priority for replacement is moderately high, but would be a WSDOT project along I-405. Likely very high cost.	2 (Limited habitat upstream, expensive)	7.8
JC-22 (g)	Juanita Creek (east trib)	Concrete, 1 @24", 1 @ 18"	108th Avenue NE	4 - full barrier due to slope and velocity, plunges at outfalls	Below I-405.	This culvert is a full barrier near the mouth of the Juanita east trib. There are no full barriers downstream but a number of full barriers occur upstream, limiting the amount of habitat that would be made accessible if this culvert were to be upgraded. It could rate fairly high for replacement if the upstream pond outlet at 109th Ave. NE could be replaced as well, possibly with additional improvements extending farther upstream. Moderate costs.	2	7.0

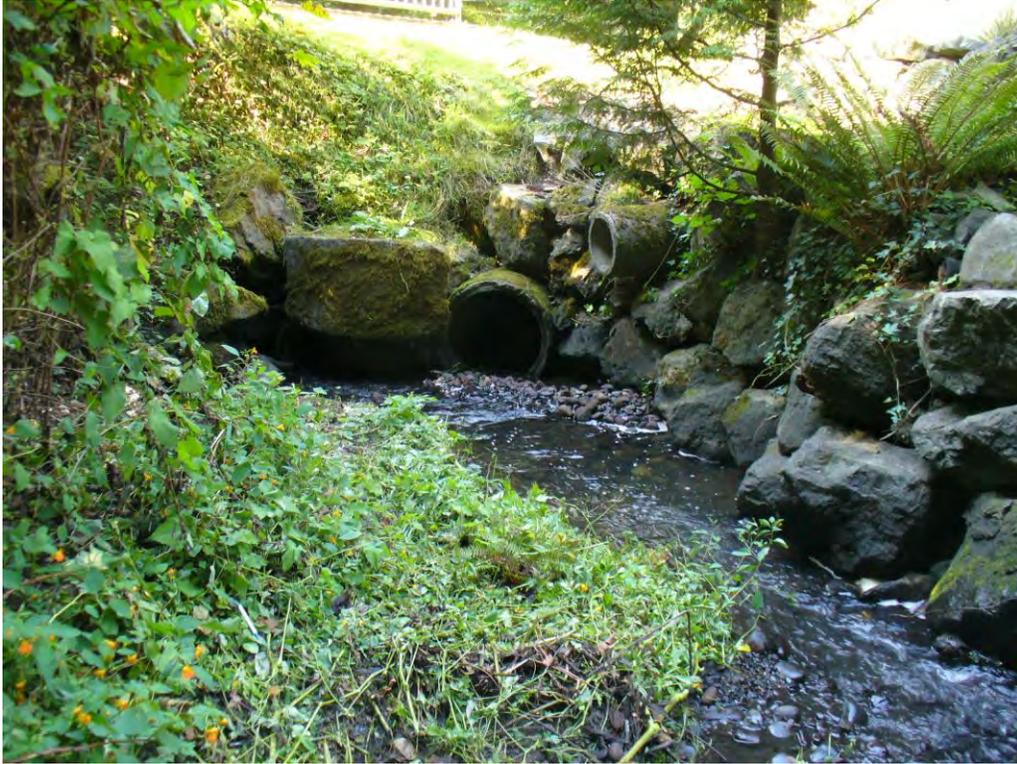
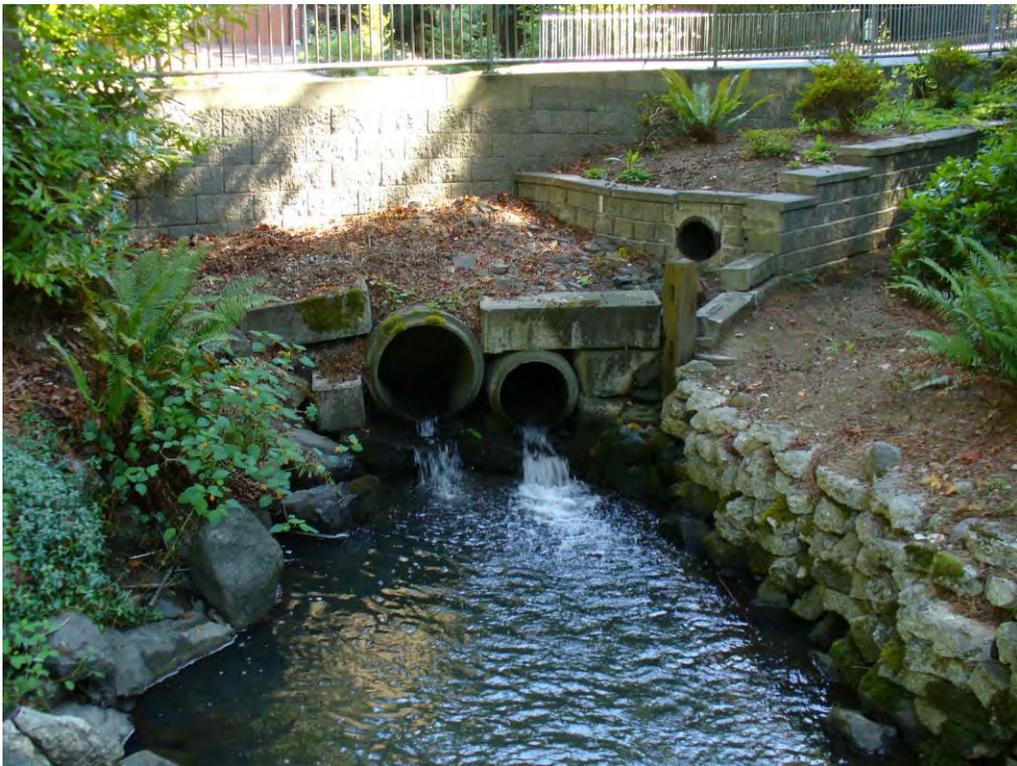
Figure 42. Culvert JC-22 Inlet at 108th Avenue NE, 9-12-13

Notes: Could rate fairly high for replacement if the upstream pond outlet at 109th Ave. NE could be replaced as well.

Figure 43. Culvert JC-22 Outlet at 108th Avenue NE, 9-12-13

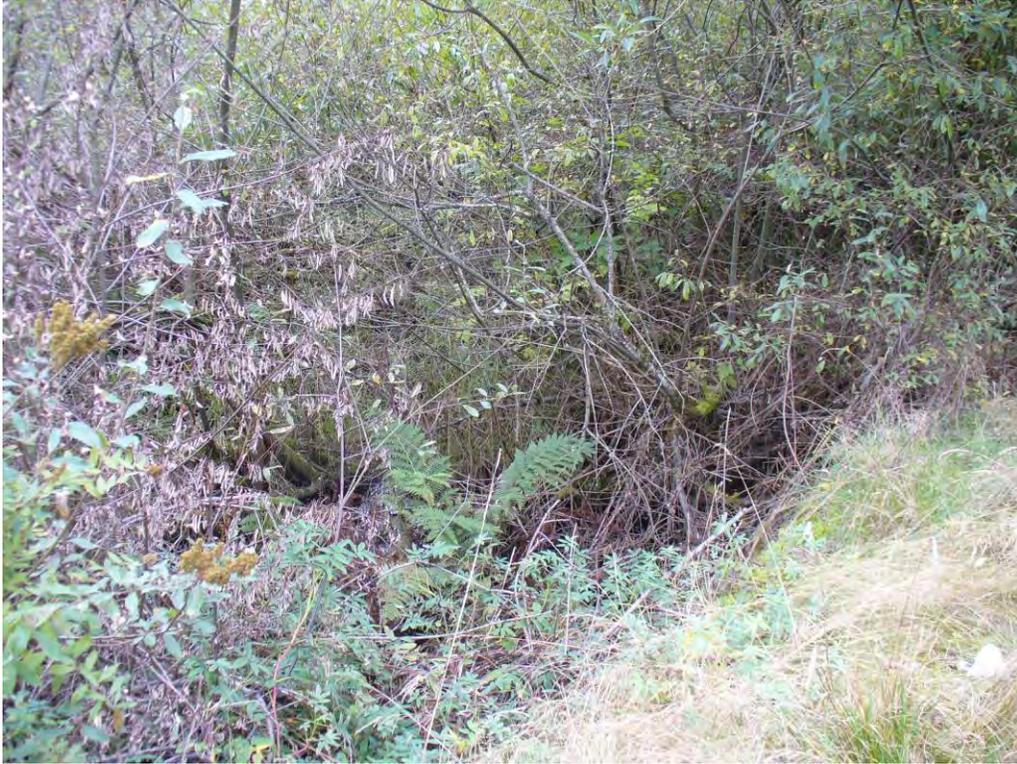
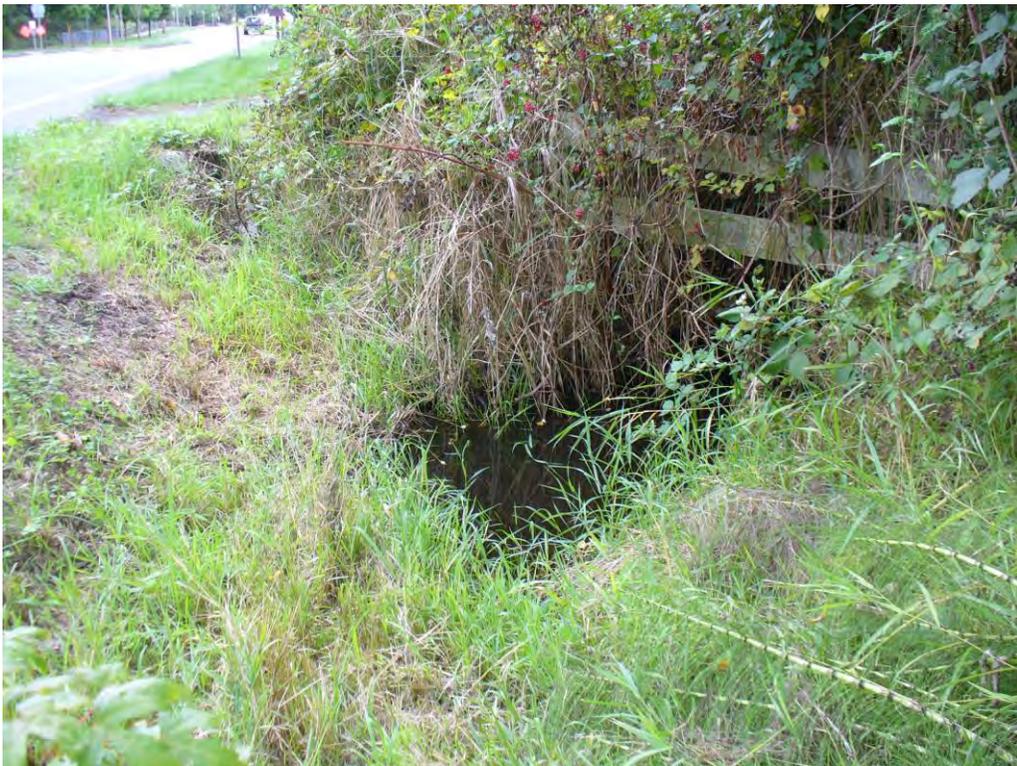
Figure 64. Culvert FO-10 Inlet at 124th Avenue NE, 9-17-13

Fish use of Stream Segment: Cutthroat found just downstream in 1998
Y/N/Unk./Presumed

Figure 65. Culvert FO-10 Outlet at 124th Avenue NE, 9-17-13

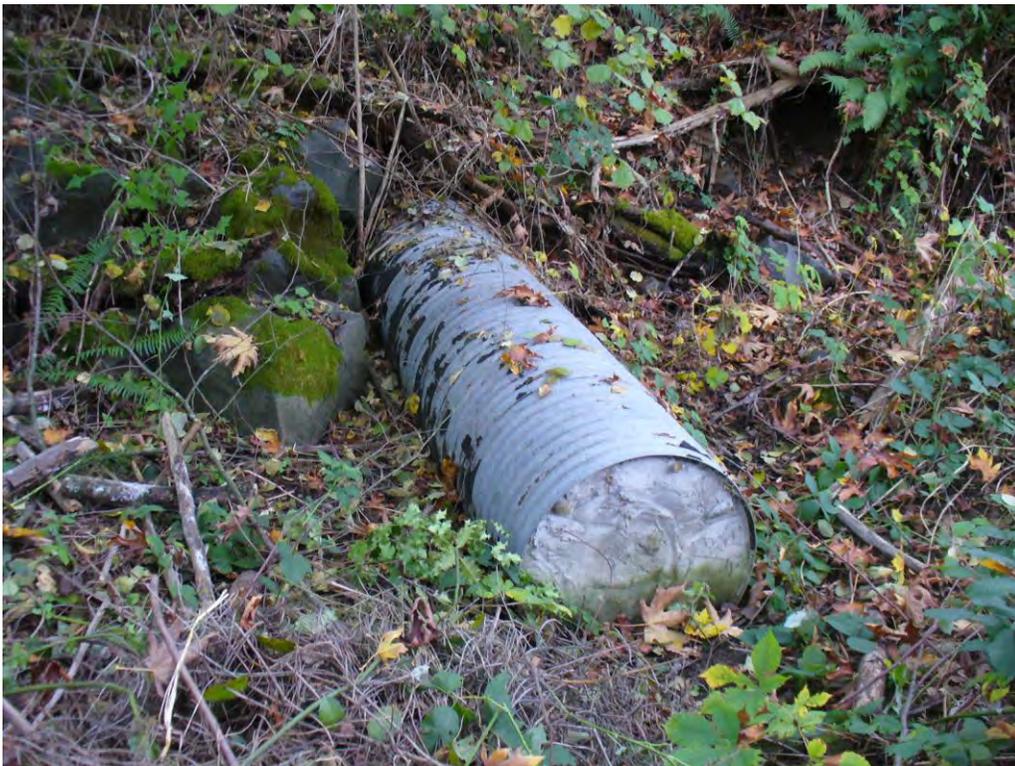
Figure 73. Culvert MB-4 Outlet near Kirkland Way, 10-25-13

Notes: Found 24-inch concrete inlet as the ditch/swale along Kirkland Way. Then “DRAIN” manhole along CKC. Found 30-inch CMP “outfall” on west side of CKC fully filled with concrete!

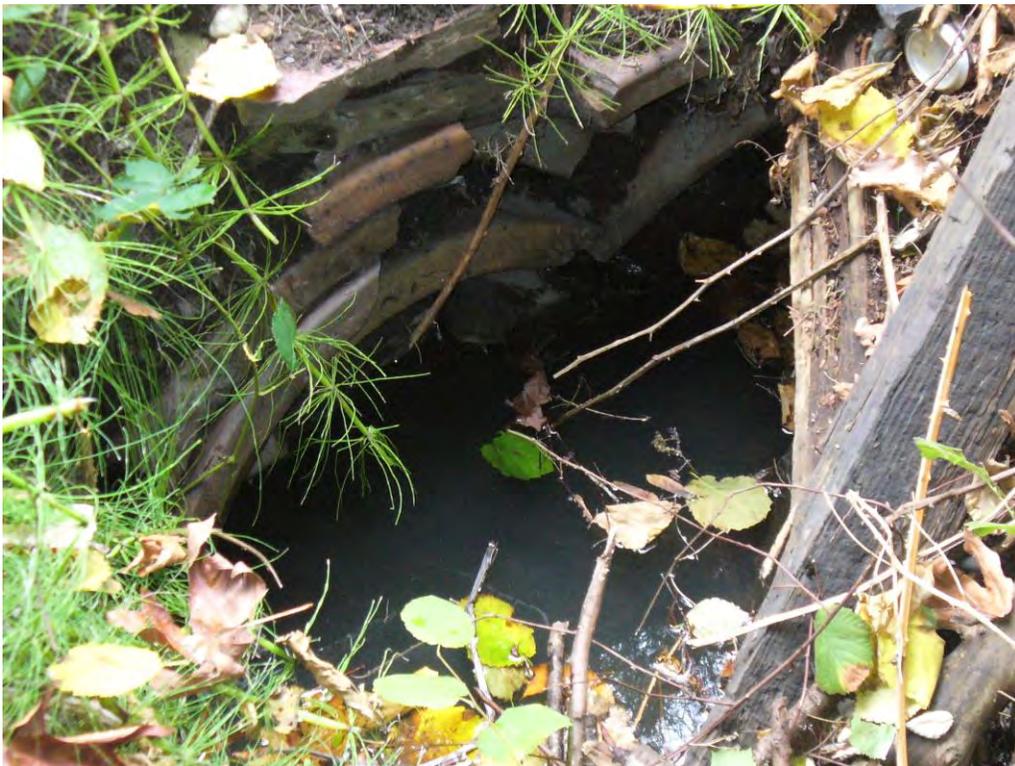
Figure 75. Culvert MB-5 Outlet at Kirkland Way, 10-25-13

Passage Assessment – Passable, Full/Partial Barrier: 3 - Not a full barrier due to outfall conditions, but upstream unknown.

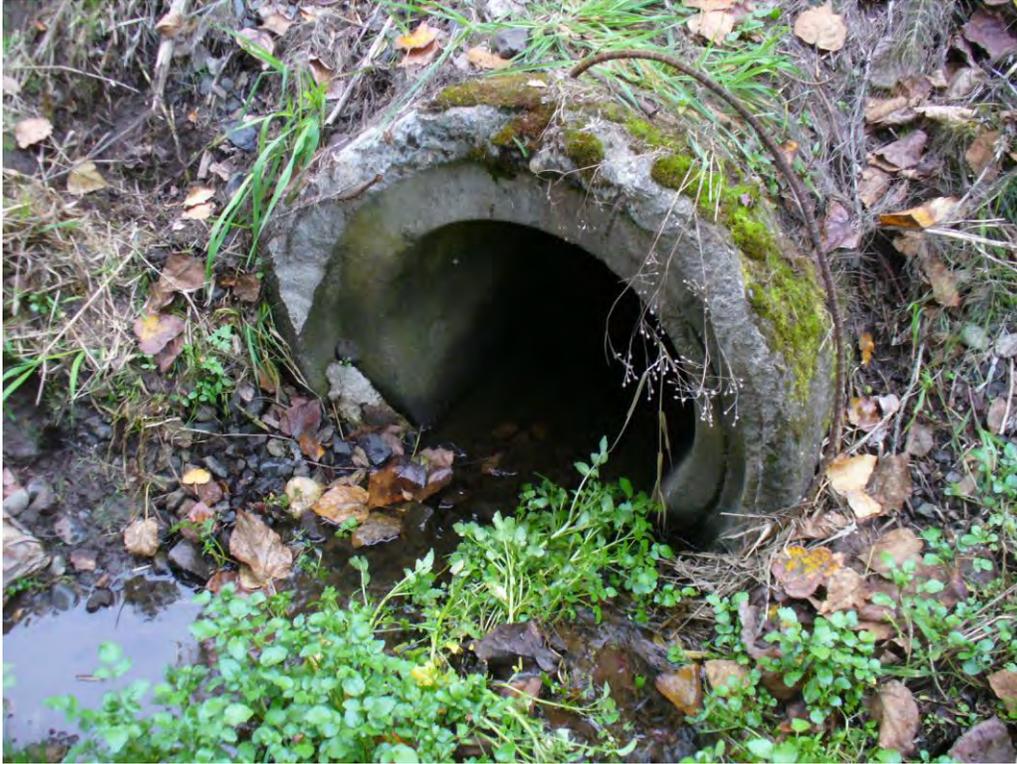
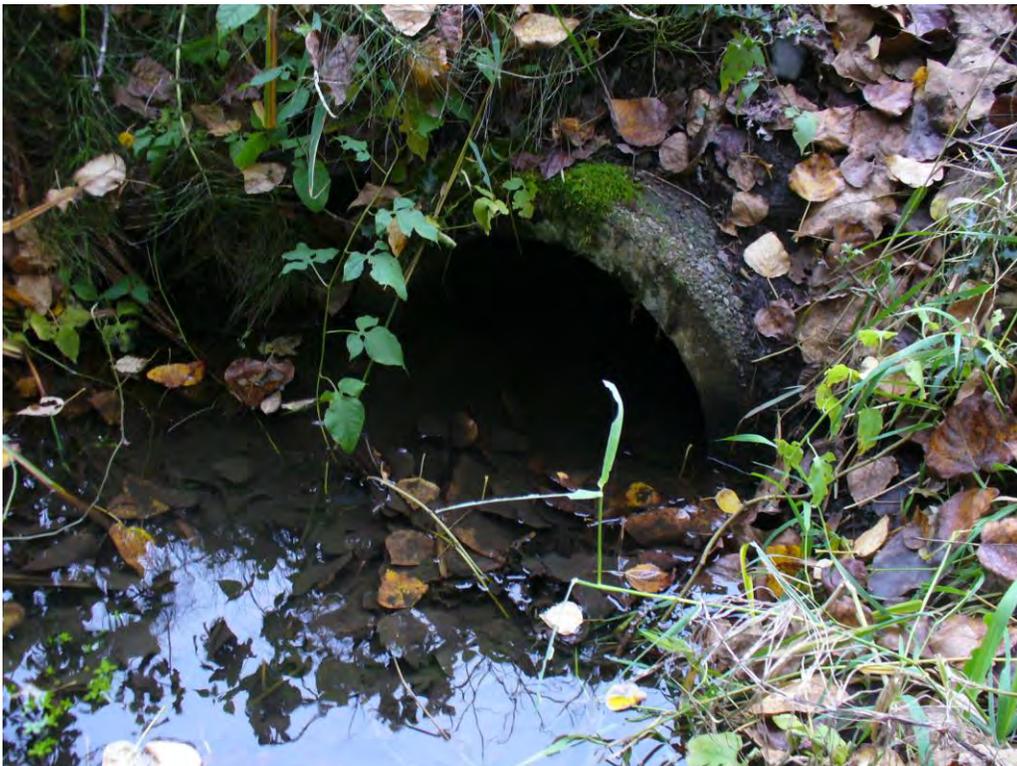
Figure 81. Culvert MB-9 Inlet at NE 96th Street, 10-22-13

Figure 82. Culvert MB-9 Outlet at NE 96th Street, 10-22-13

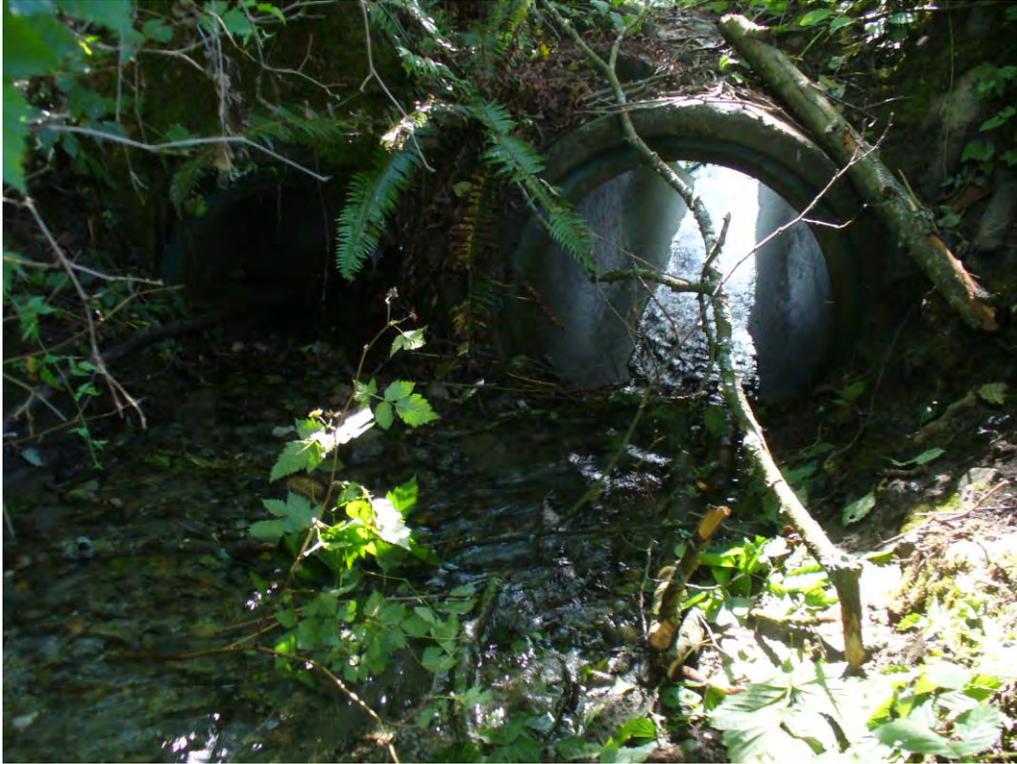
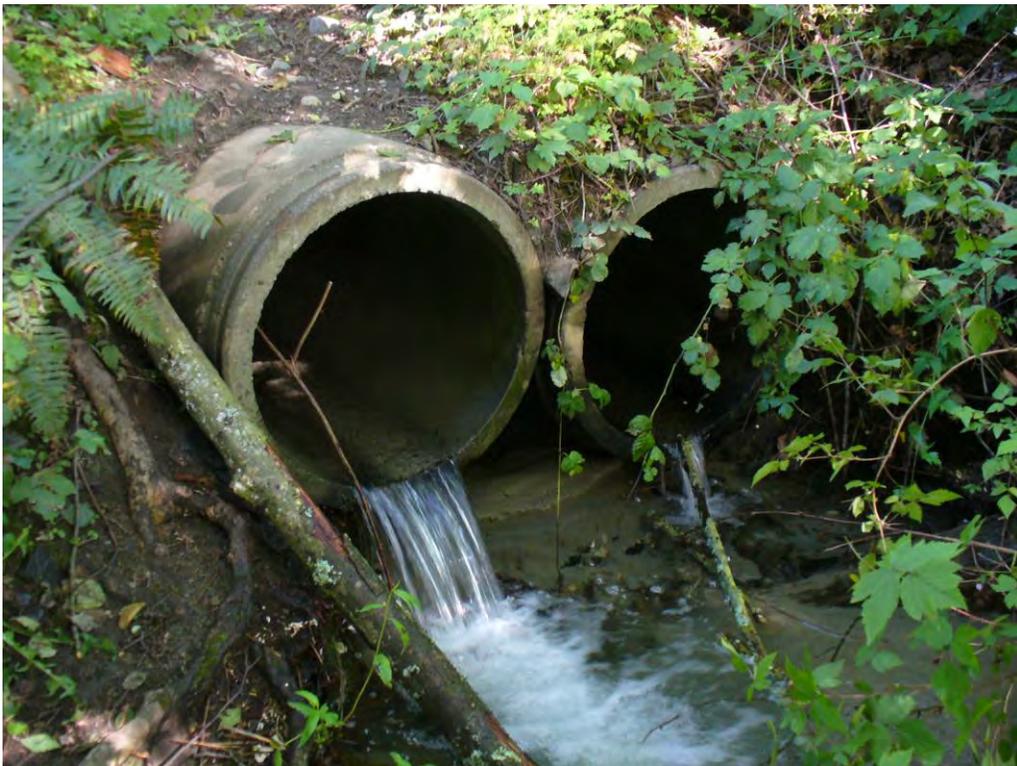
Figure 85. Culvert EC-2 Inlet at dead end of 10th Street S, 6-28-13

Figure 86. Culvert EC-2 Outlet at dead end of 10th Street S, 6-28-13

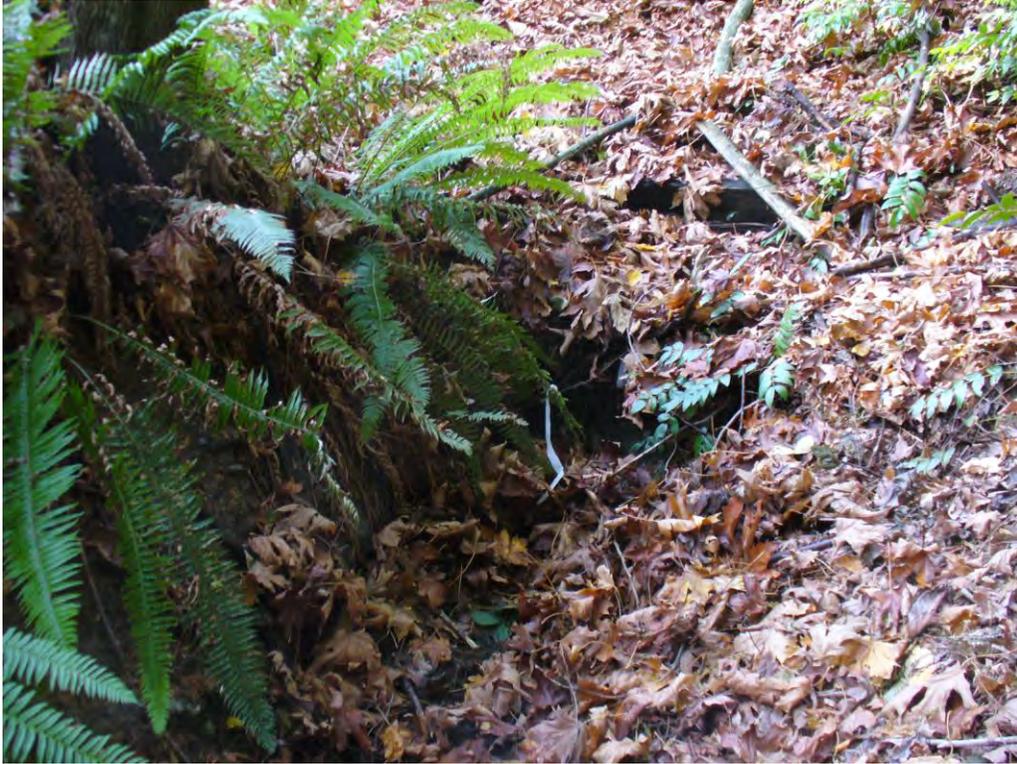
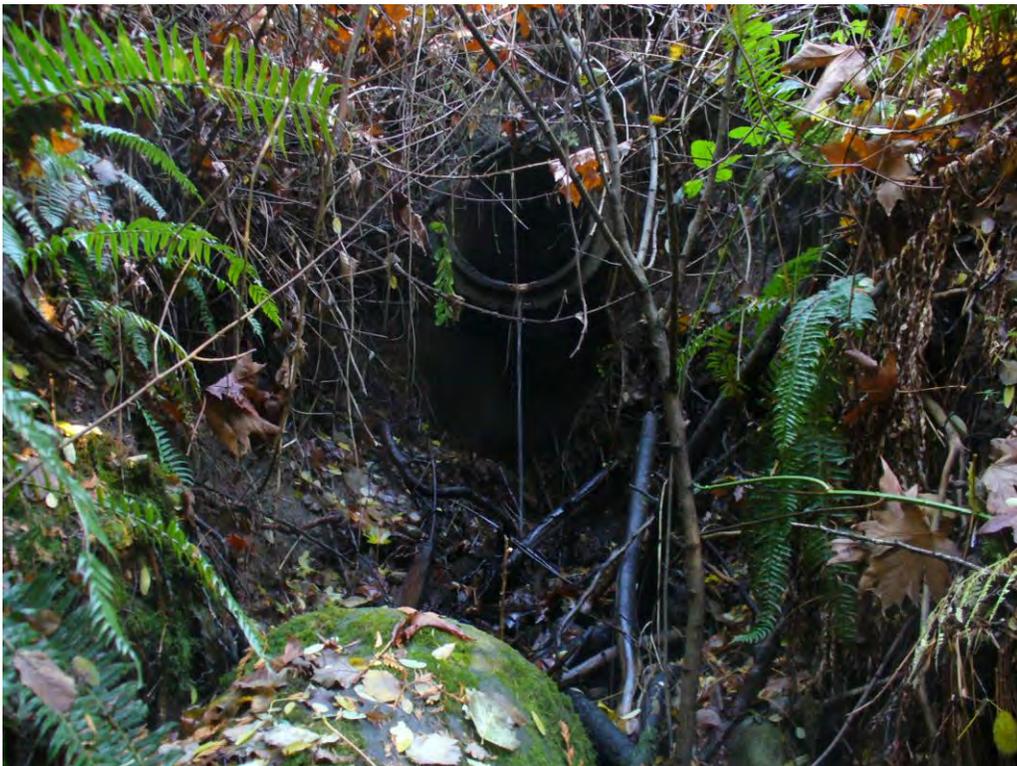
Figure 93. Culvert HSB-1 Inlet at NE 43rd Street 11-8-13,

Figure 94. Culvert HSP-1 Outlet at NE 43rd Street, 11-8-13
