Culvert Assessment Memorandum

Preliminary Assessments: Fish Passage at City of Kirkland Road and Trail Stream Culverts

August 2014

The Watershed Company Reference Number:
120612

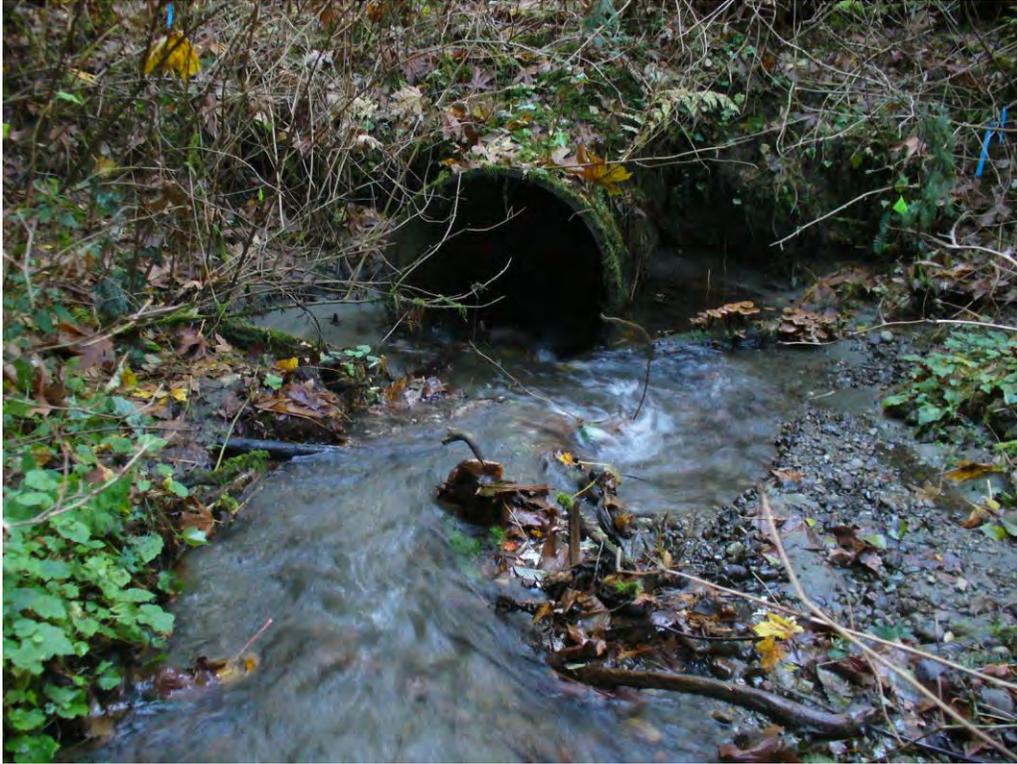
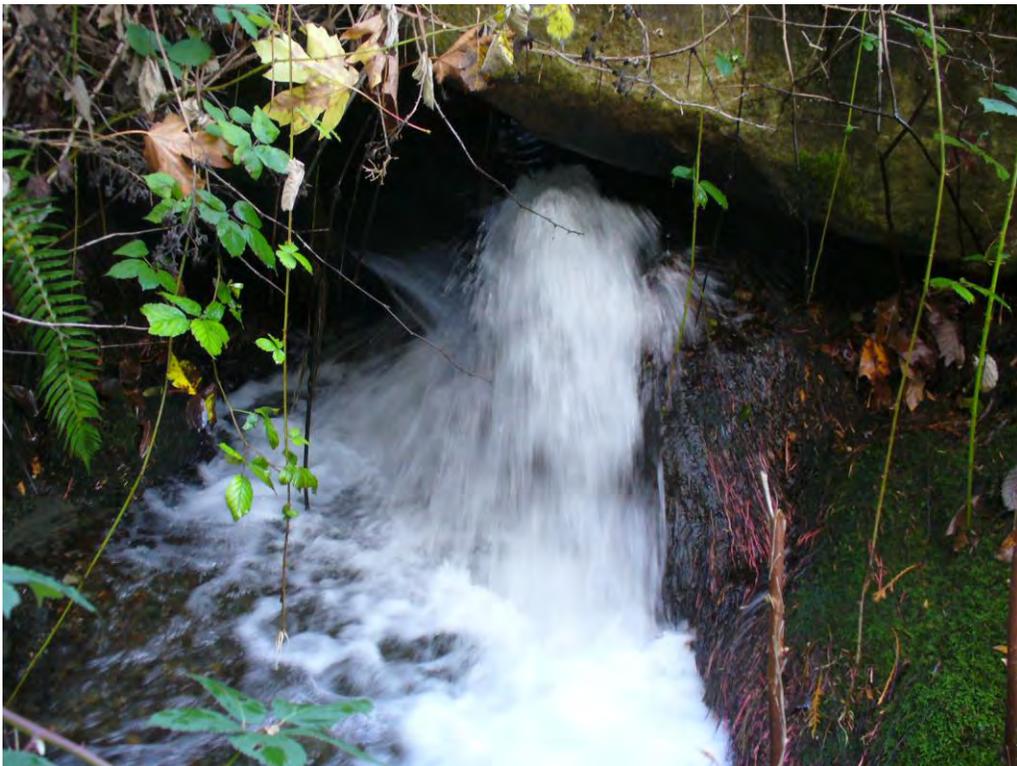
Figure 97. Culvert CO-3 Inlet at NE 38th Place, 11-8-13

Notes: Flow perhaps 2 cfs on 11/8/13. The CKC prism above the culvert is high and massive. Expensive to replace, however the flows are here to support fish. High cutthroat usage documented downstream to Lake Washington.

Figure 98. Culvert CO-3 Outlet at NE 38th Place, 11-8-13
