## **FIRE STATION 21**

9816 Forbes Creek Dr  
Built 1997

**RE**                    *Kirkland Fire Stations – District Study*

### Mechanical Systems Survey

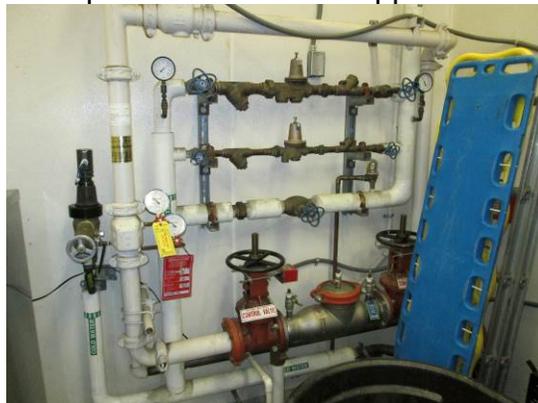
- A. **Utilities:**
1. Domestic Water and Fire – are served by connections off the south side of the building.
  2. Waste – is served by a 4” connection off the East side of the building.
  3. Gas – Natural gas is served by a meter on the Southeast corner of the building.
- B. **Fire Sprinklers:** The building has a sprinkler system. Water is supplied by a 4” connection to the sprinkler riser in the apparatus bay.

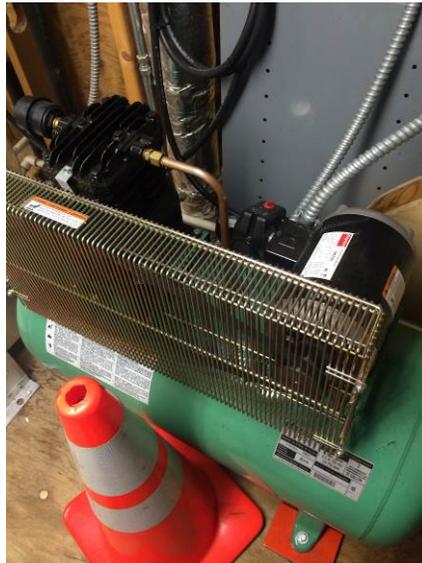
7. Compressed Air: A 35 gallon horizontal tank with mounted compressor rated at 125 PSIG is located in the mezzanine. In good condition.

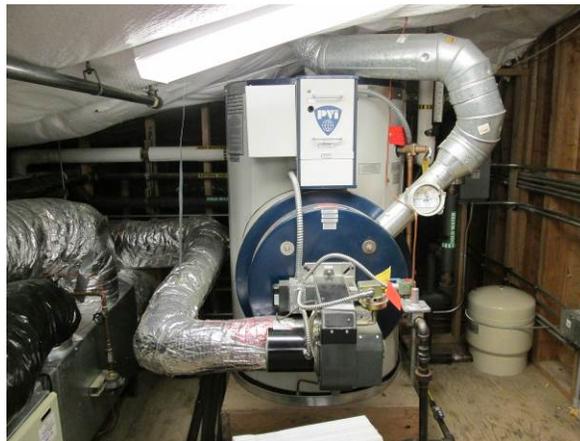
8. Piping: The domestic water service pipe that was visible is copper. Piping is in good condition.
9. Domestic hot water: The plumbing fixtures are served by a 125 gallon natural gas fired commercial water heater. The water heater was manufactured in 1997 but appears to be in fair condition.

1. The mechanical systems are of a 1997 vintage and approaching the end of useful life. Replacement or upgrade should be anticipated in the next 3 years.

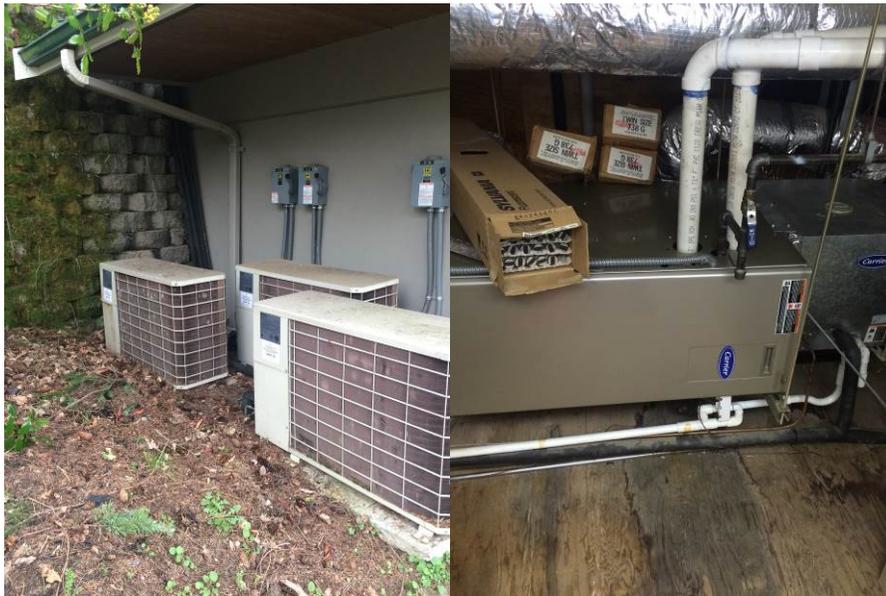
1. HVAC Systems: The building has three gas furnaces with split DX cooling. One system serves the dorms and main corridor. A second system serves the office spaces and the building entry. The third system serves the kitchen and day room. The DX cooling outdoor condensing units are located outside at the northeast corner of the building. The furnaces and the condensing units are in poor condition.

2. The condensing units which use R-22 refrigerant cannot be directly replaced due to the phase out of that refrigerant. When considering replacement of refrigerant equipment, it will need to be a newer refrigerant like R-410a. This will necessitate replacing not only the exterior condensing unit but also the indoor coil and refrigerant piping all at the same time.

3. The exterior refrigerant pipe insulation is in poor condition and should be replaced and provided with aluminum jacket or galvanized sheet metal cover for protection.

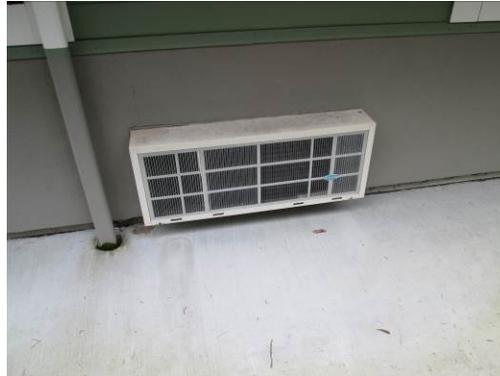
2. Refrigerant: All systems use R-22 refrigerant.
3. Ventilation: All three furnaces have outdoor air intake capabilities.
4. Radiant Heating: The apparatus bay is heated by overhead radiant vacuum tube system, in fair condition.
5. Heat Pumps: Three through wall heat pumps provide heating and cooling for the fitness area, the lower level storage space, and the meeting room. The heat pumps are in poor condition.
