FIRE STATION 26

9930 124th AVE NE

RE *Kirkland Fire Stations – District Study*

Mechanical Systems Survey

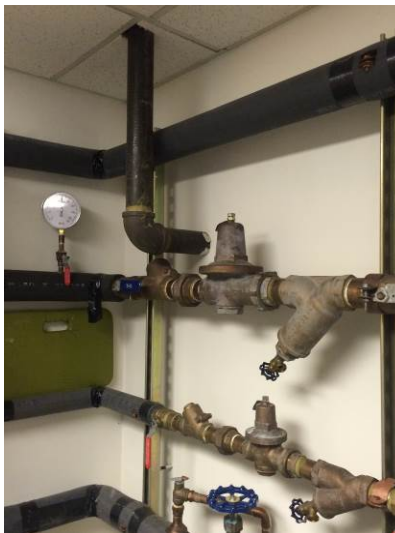
1. Domestic Water and Fire – are served by connections off the Northwest corner of the building. The domestic water PRV is located in the storage room on the 1st floor.

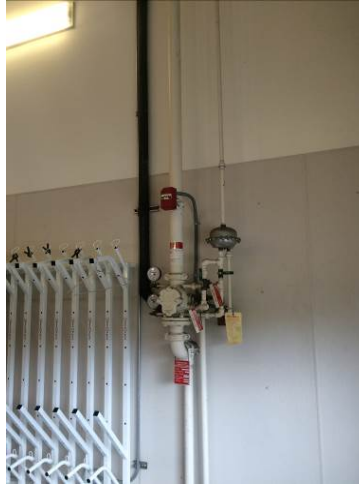
- B. **Fire Sprinklers:** The building has a sprinkler system. Water is supplied by a 4" connection to the sprinkler riser in the apparatus bay.

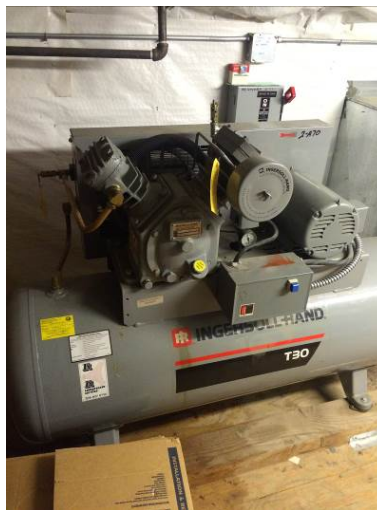
- b. An under-counter dishwasher is located next to the sink.
5. Apparatus bay:
- a. Drains: A trench drain is located on each side of the bay and is connected to an oil/sand interceptor outside the building on the south side of the apparatus bay.
6. Laundry Room:
- a. Laundry Sink: Fiberglass sink dual handle faucet, in good condition.
 - b. Washer: Residential clothes washer with laundry box.
7. Washdown Room
- a. Shower: Wall mounted, hand spray head in fair condition.
 - b. Service Sink: Stainless steel, double bowl, dual handle faucet in fair condition.
8. Emergency Fixtures:
- a. Emergency eyewash wall mounted in apparatus bay, in good condition.
 - b. No emergency shower.
9. Compressed Air: A 60 gallon horizontal tank with mounted 1 HP compressor rated at 100 PSIG is located in the mezzanine. Air compressor is in good condition.

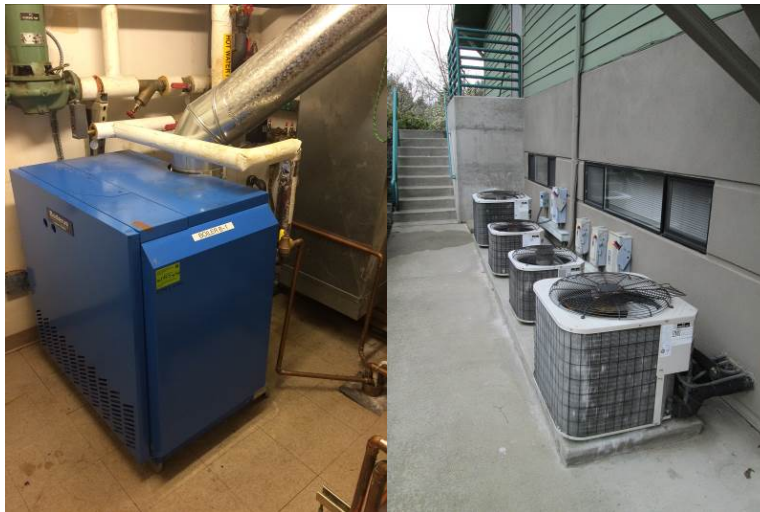
1. HVAC Systems: The building has a natural gas fired boiler serving five fan coils. The boiler was manufactured in 2004 and appears to be in good condition. The fan coils have cooling from five condensing units located outside the south end of the building. The fan coils serve the classroom, kitchen/dining, offices/lobby, dormitory, and the storage rooms. These units are in poor condition.

2. Refrigerant: All systems use R-22 refrigerant.

1. The mechanical systems are of a 1994 vintage and approaching the end of useful life. Replacement or upgrade should be anticipated in the next 3 years.
2. The condensing units which use R-22 refrigerant cannot be directly replaced due to the phase out of that refrigerant. When considering replacement of refrigerant equipment, it will need to be a newer refrigerant like R-410a. This will necessitate replacing not only the exterior

condensing unit but also the indoor fan coil and refrigerant piping all at the same time.

3. The exterior refrigerant pipe insulation is in poor condition and should be replaced and provided with aluminum jacket or galvanized sheet metal cover for protection.
4. While individual restroom exhaust fans can be replaced as necessary, we would recommend common in-line or roof mounted exhaust fan(s) with ceiling grilles in each restroom. This arrangement would provide better ventilation control and a longer equipment life expectancy than residential style exhaust fans.

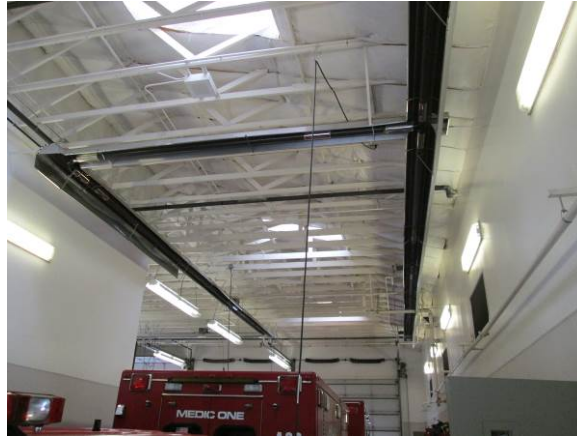
4. Radiant Heating: The apparatus bay is heated by overhead vacuum radiant heating tubes in poor condition.

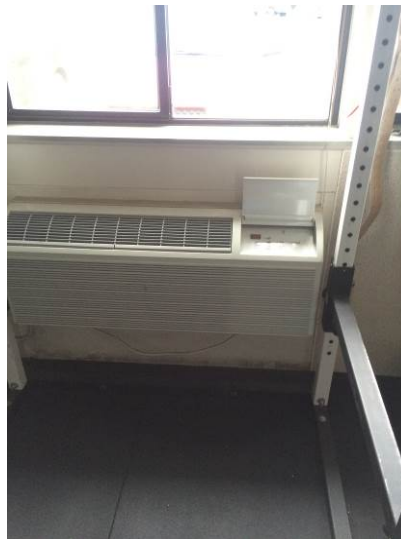
5. Heat Pumps: A through wall heat pump provides heating and cooling for the fitness area. This unit is in poor condition.
