Culvert Assessment Memorandum

Preliminary Assessments: Fish Passage at City of Kirkland Road and Trail Stream Culverts

Fish Passage at City of Kirkland Road and Trail Stream Culverts

August 2014

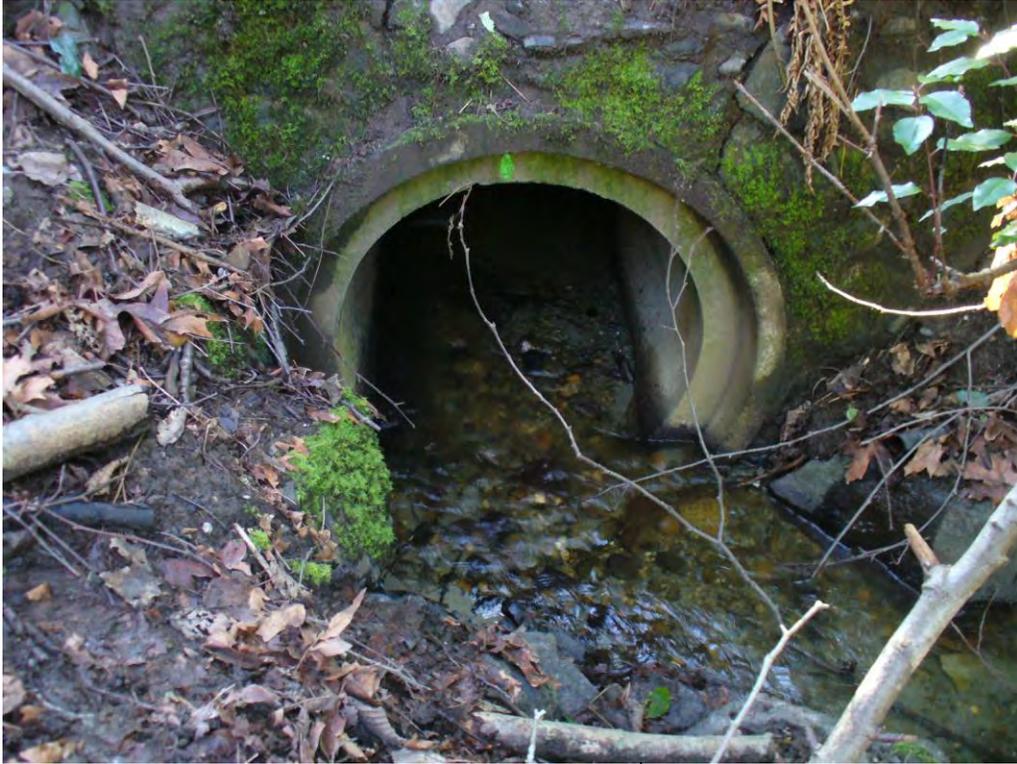
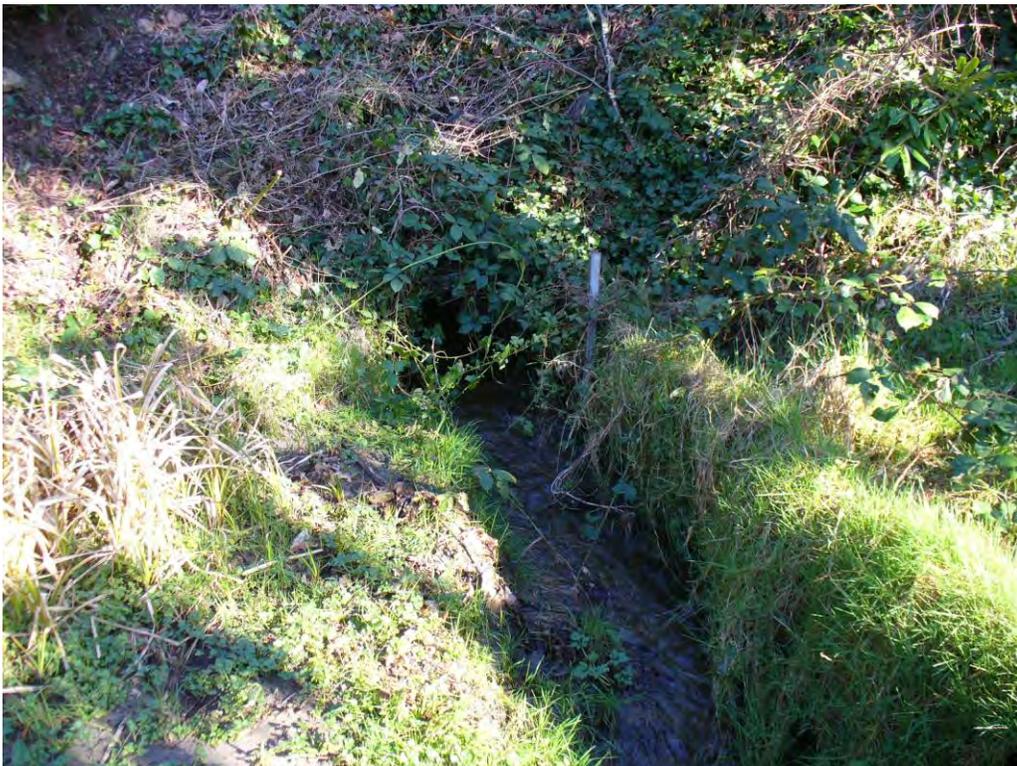
Figure 1. Culvert HP-1 Inlet at 62nd Ave, 3-8-13

Figure 2. Culvert HP-1 Outlet at 62nd Ave, 3-8-13

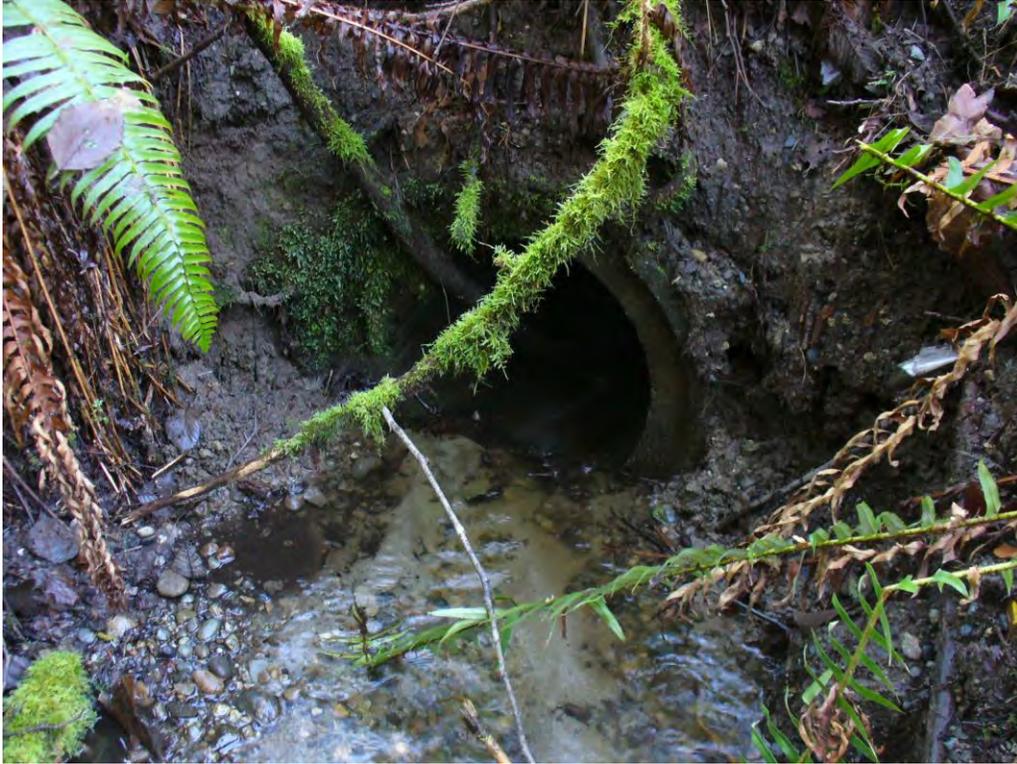
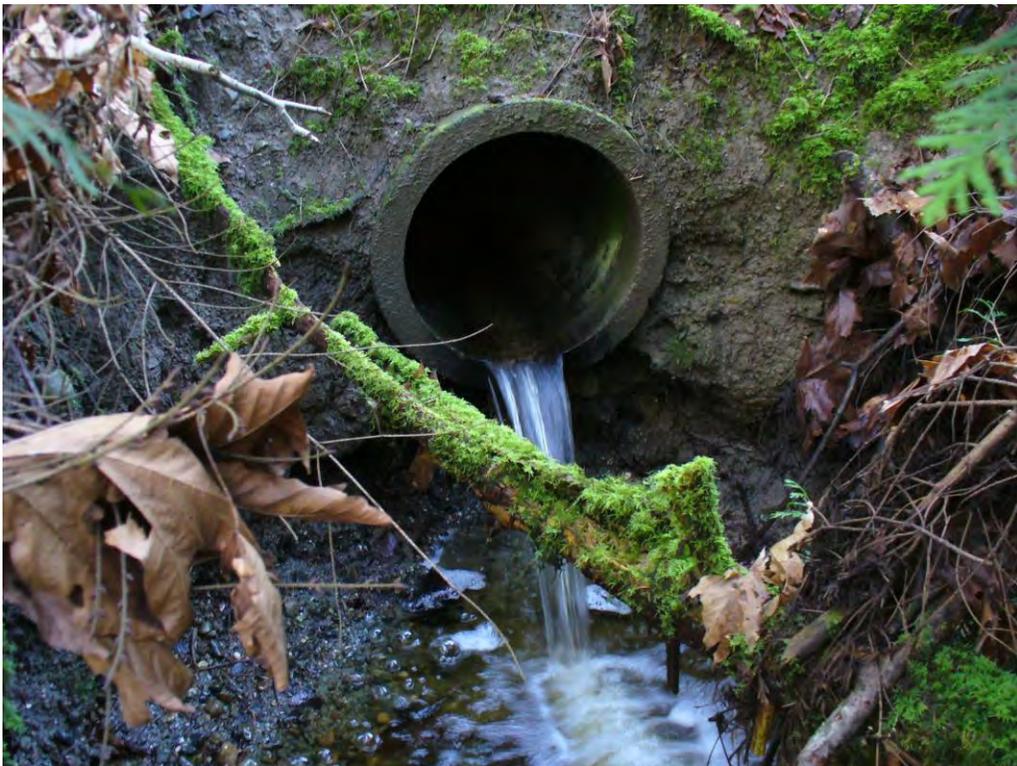
Figure 3. Culvert HP-2 Inlet at Holmes Point Drive, 3-8-13

Figure 4. Culvert HP-2 Outlet at Holmes Point Drive, 3-8-13

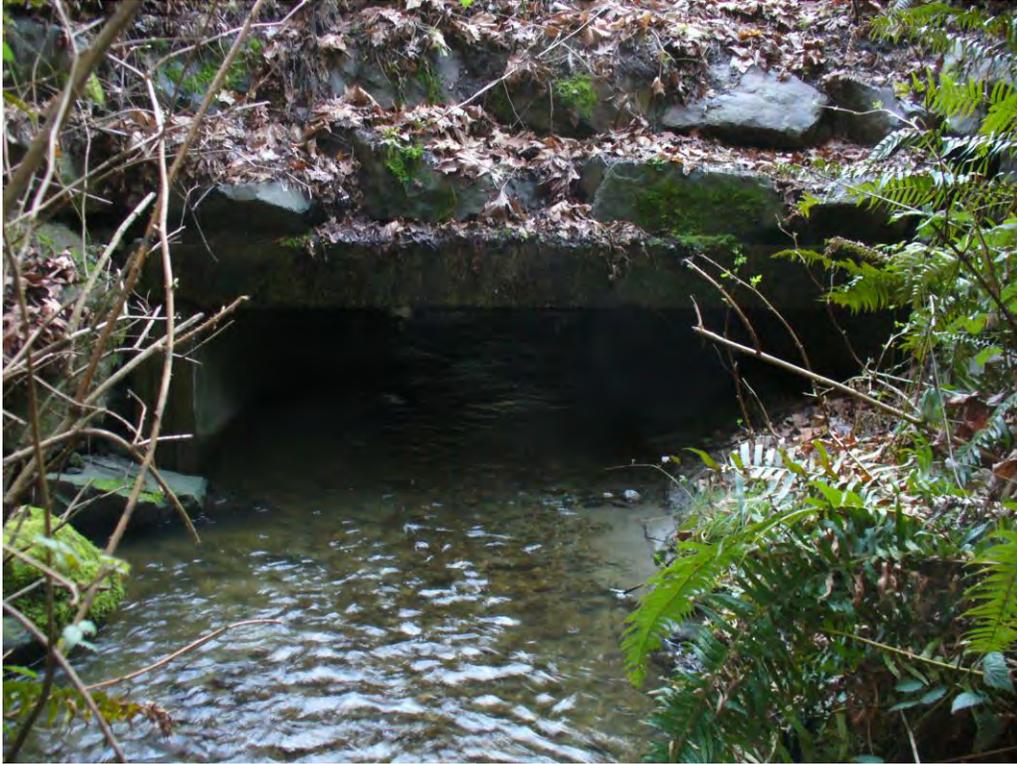
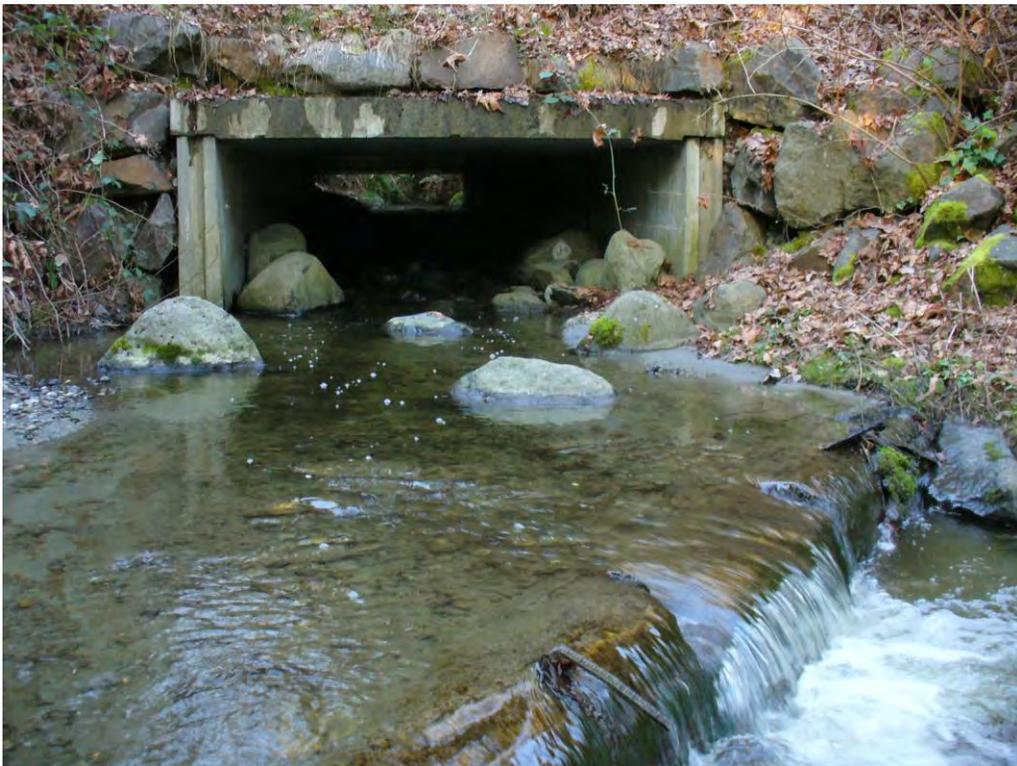
Notes: This culvert is fully passable in its present condition as of 3/13. Look at whether Denny Creek report has already evaluated this culvert.

Figure 7. Culvert DE-1 Inlet at Holmes Point Drive, 3-8-13

Figure 8. Culvert DE-1 Outlet at Holmes Point Drive, 3-8-13

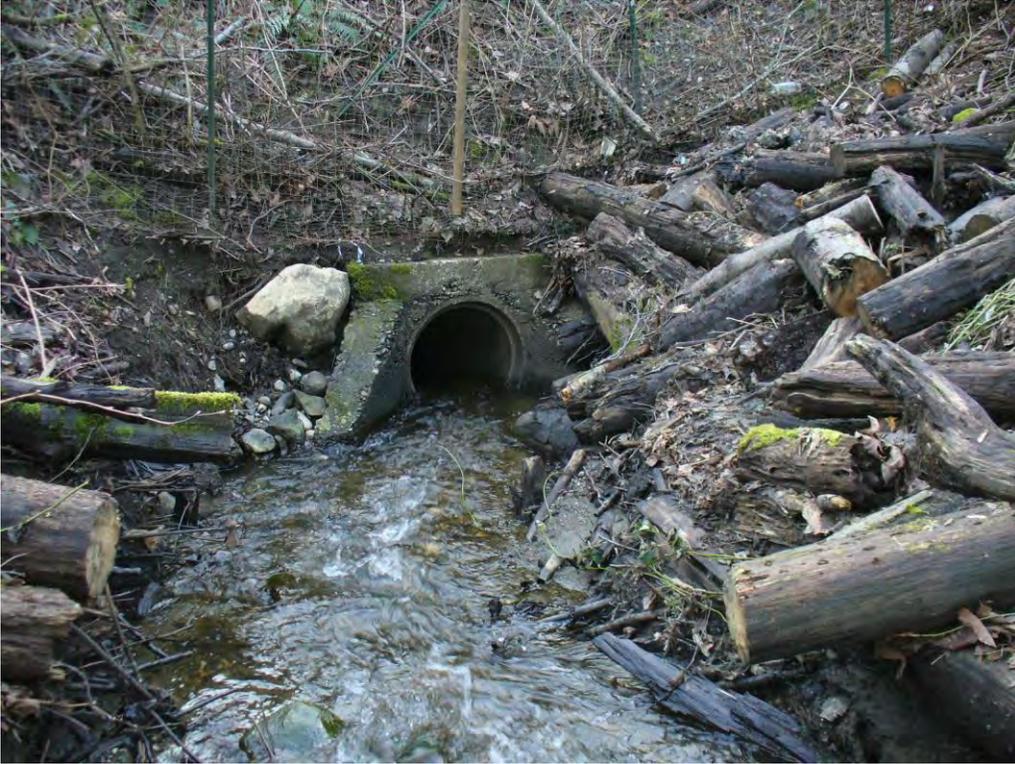
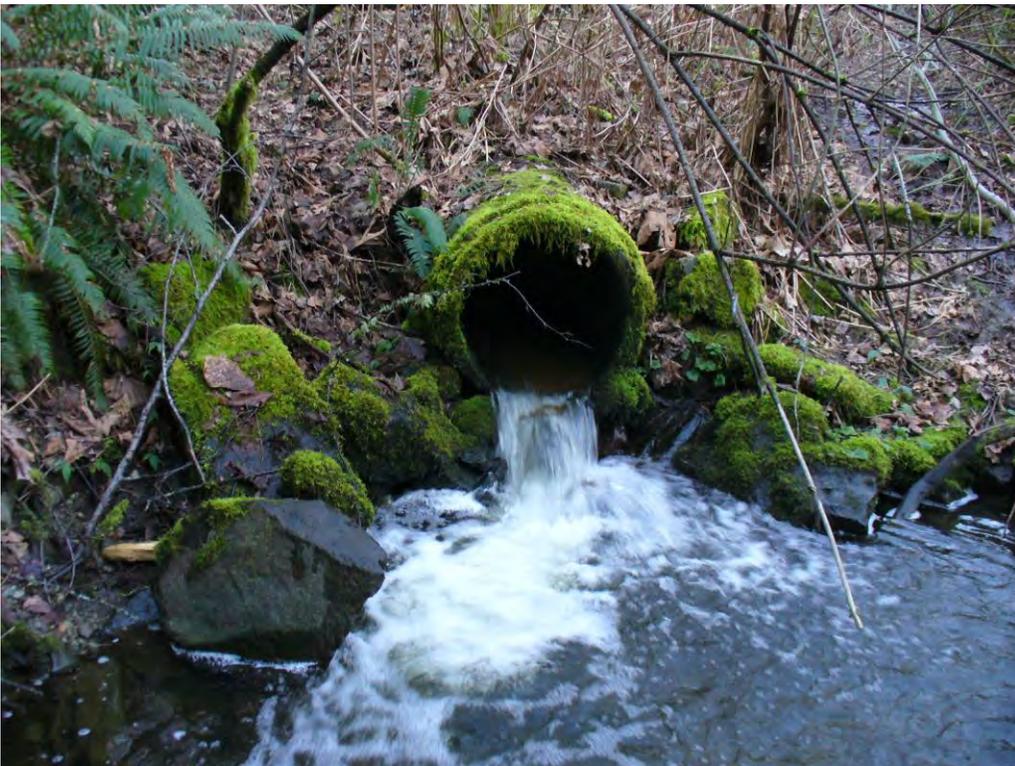
Figure 9. Culvert DE-2 Inlet at Juanita Drive, 3-8-13

Figure 10. Culvert DE-2 Outlet at Juanita Drive, 3-8-13

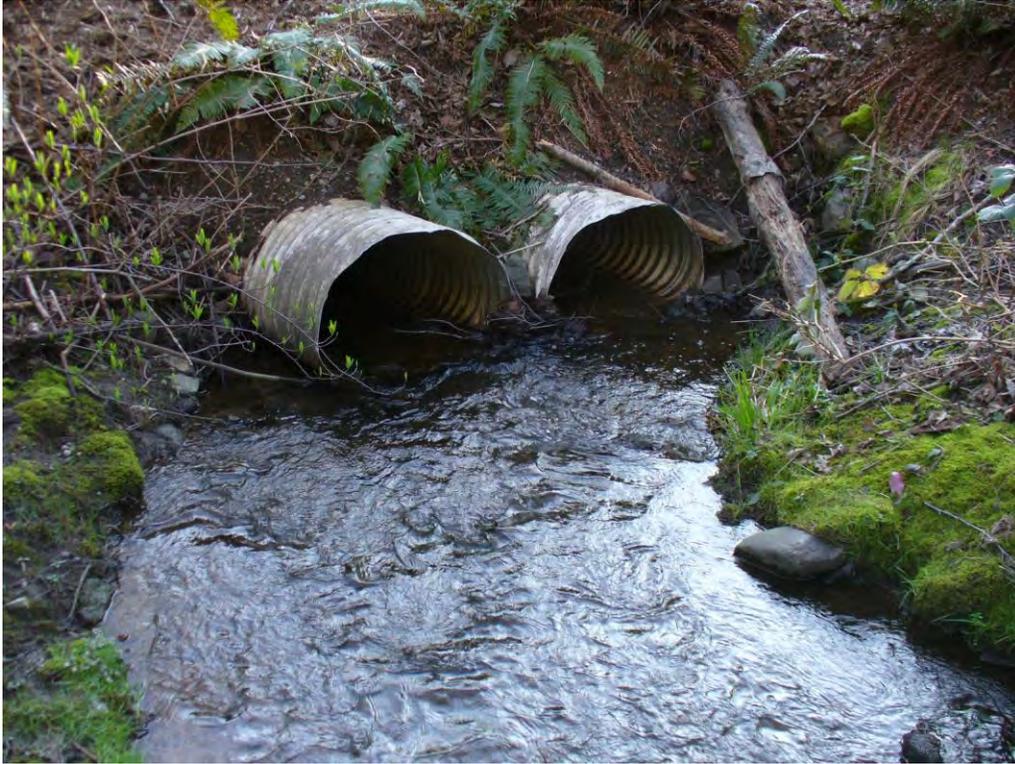
Figure 11. Culvert DE-3 Inlet at 78th Place NE, 3-8-13

Figure 12. Culvert DE-3 Outlet at 78th Place NE, 3-8-13

DE-3 (A)	Denny Creek	76 ft. twin corrugated pipes 24" high by 36" wide	13433 78th PI NE	2 - Hindrance. Moderate-sized trout could jump into and swim through these culverts.	In open space area in front of home	No fish found in 1998 study, but habitat appears suitable, type F per DNR mapping. Culvert downstream at Juanita Drive is a barrier and would need to be upgraded to allow anadromous access. Some habitat available upstream in low-gradient tributaries and beaver pond habitat. Though relatively low cost, there would be limited benefits to replacing this culvert because it is already largely passable, a downstream barrier is present, and quantity of potential habitat farther upstream is limited.	3	2.3
Champagne Creek								
CH-1 (7)	Champagne Creek	18 in., 226 ft., concrete	Juanita Drive	4 - Full barrier due to plunge at outfall and velocity due to slope and smooth pipe.	Little potential habitat available upstream.	Fish use not expected this far upstream, but cutthroat use documented farther downstream. Downstream incised channel likely includes barriers. There is not significant habitat available upstream so this is not a high priority.	4	2.6

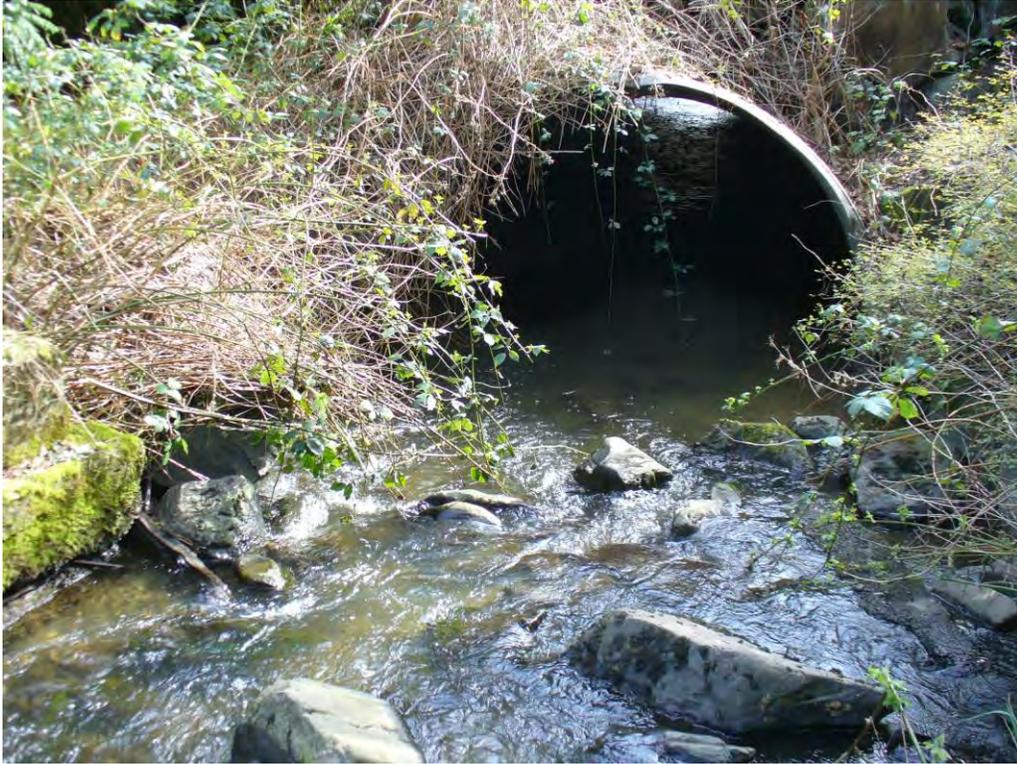
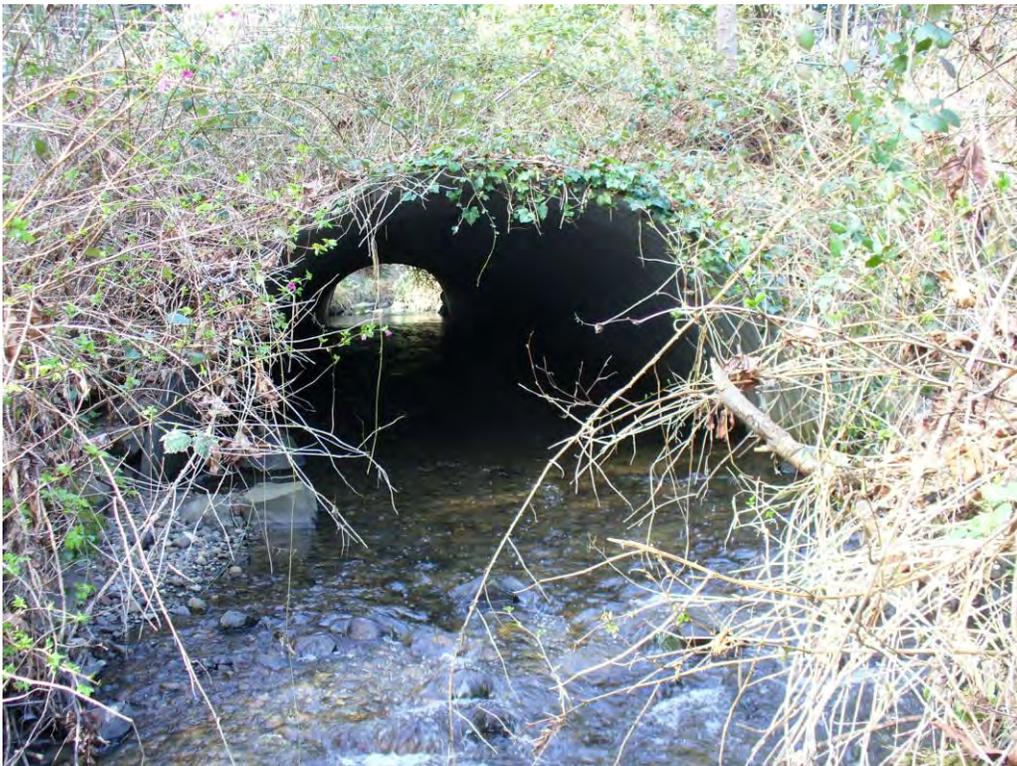
Figure 15. Culvert JC-8 Inlet, 3-26-13

Figure 16. Culvert JC-8 Outlet, 3-26-13

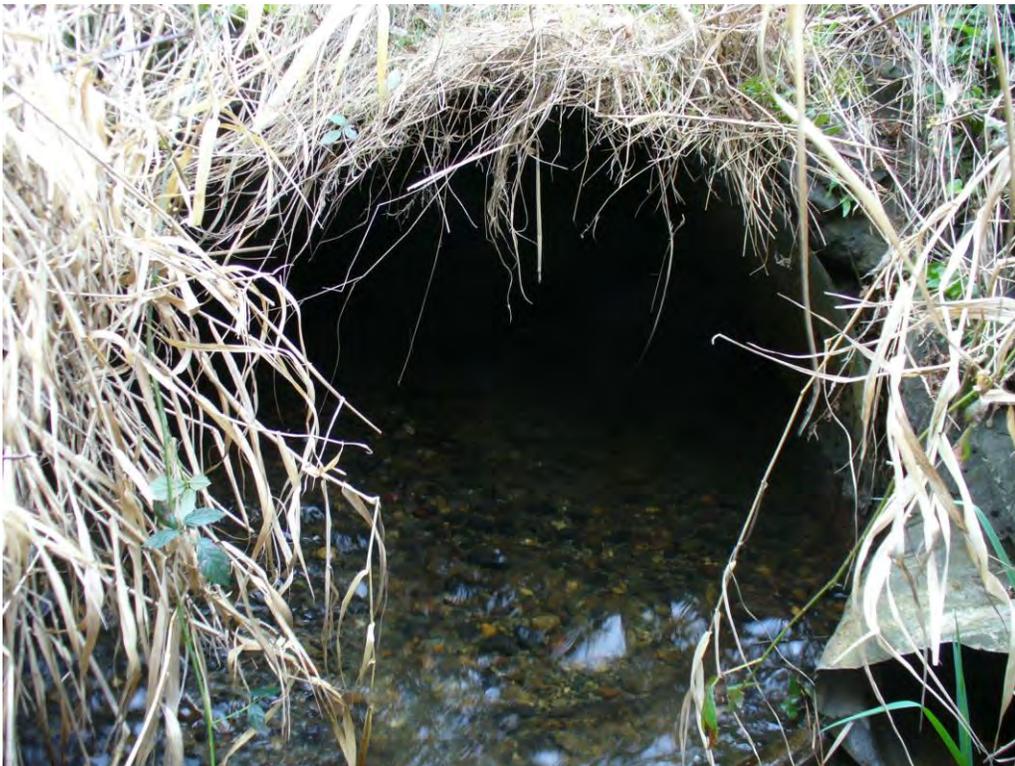
Figure 25. Culvert JC-13 Outlet at 101st Place NE, 3-11-13

JC-13 (20)	Juanita Creek- NW/east trib	4-foot wide by 3-foot high CMP	101st Place NE	2 - Migration hindrance; mostly passable. Long length, width does not meet design standards.		This culvert is on a significant, fish-bearing stream with no full barriers downstream. A moderate amount of habitat would be made more accessible to migratory, anadromous fish upstream. However, since this culvert is already mostly passable, it is of lower priority for replacement than some of the other crossings of the Juanita Creek- NW/east trib .	3	4.8
JC-14 (21)	Juanita Creek- NW/east trib	42 in, 125ft, concrete	100th Ave NE	4 - Full barrier due to inlet plunge onto steep, smooth concrete for approx. 40 feet. Also due to 2 ½ foot plunge at outfall.	King County may have data on this pipe.	This culvert is on a significant, fish-bearing stream with no full barriers downstream. A moderate amount of habitat would be made accessible to migratory, anadromous fish upstream. Relatively high priority within the City for replacement. However, high expense and design complicated considerably by the presence of an in-stream detention facility extending upstream.	2 (note: previously rated high priority, but lowered to p2 due to high cost, location high in the watershed.)	8.8

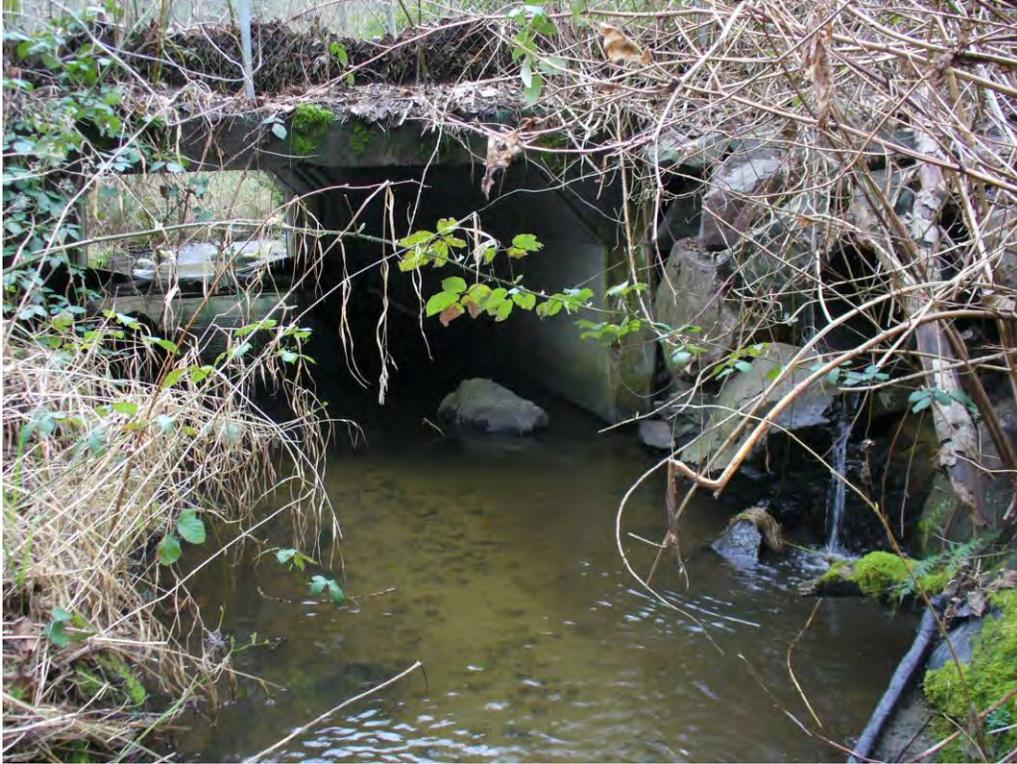
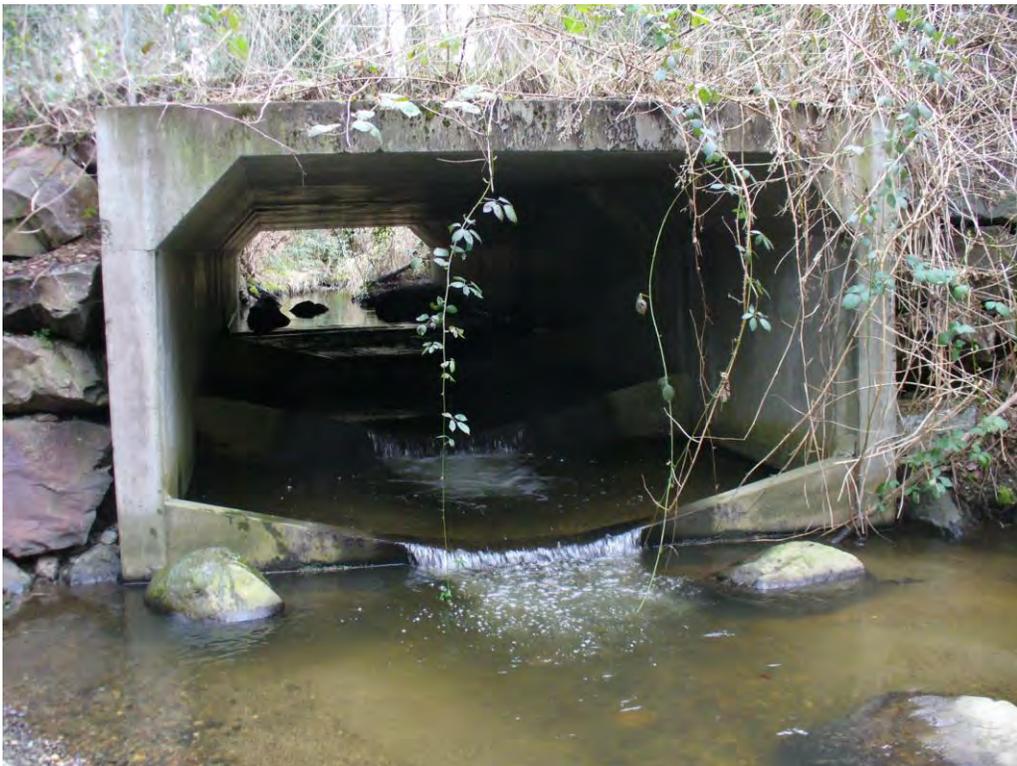
Figure 34. Culvert JC-18 Inlet at NE 140th Street, 3-12-13

Figure 35. Culvert JC-18 Outlet at NE 140th Street, 3-12-13

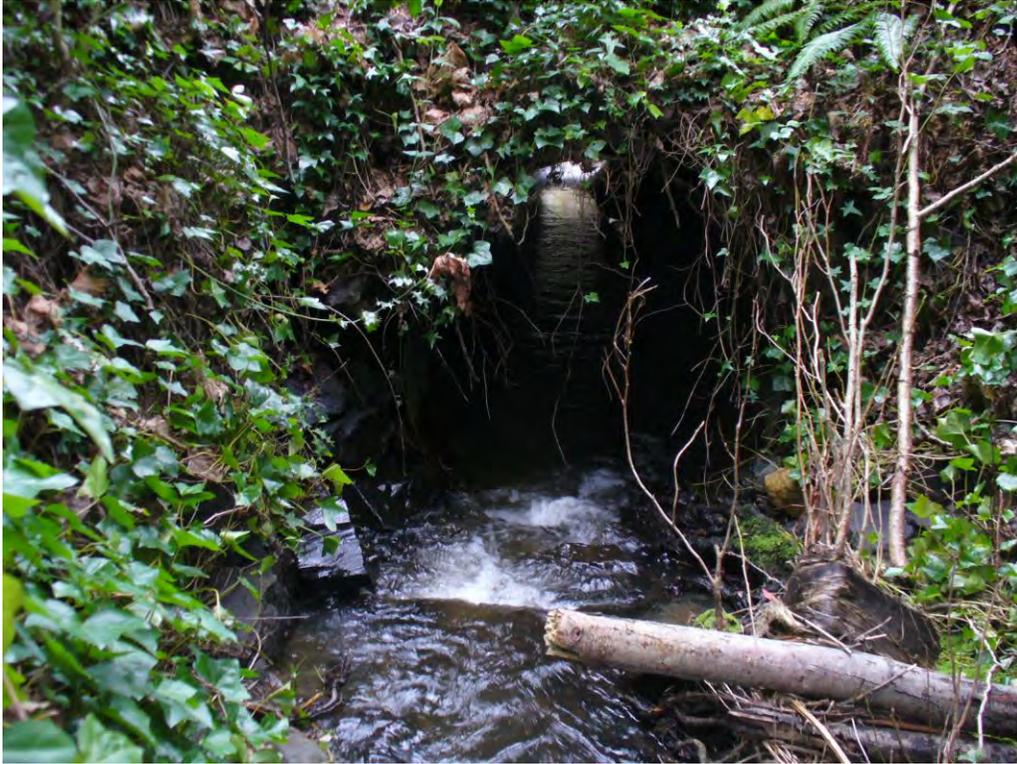
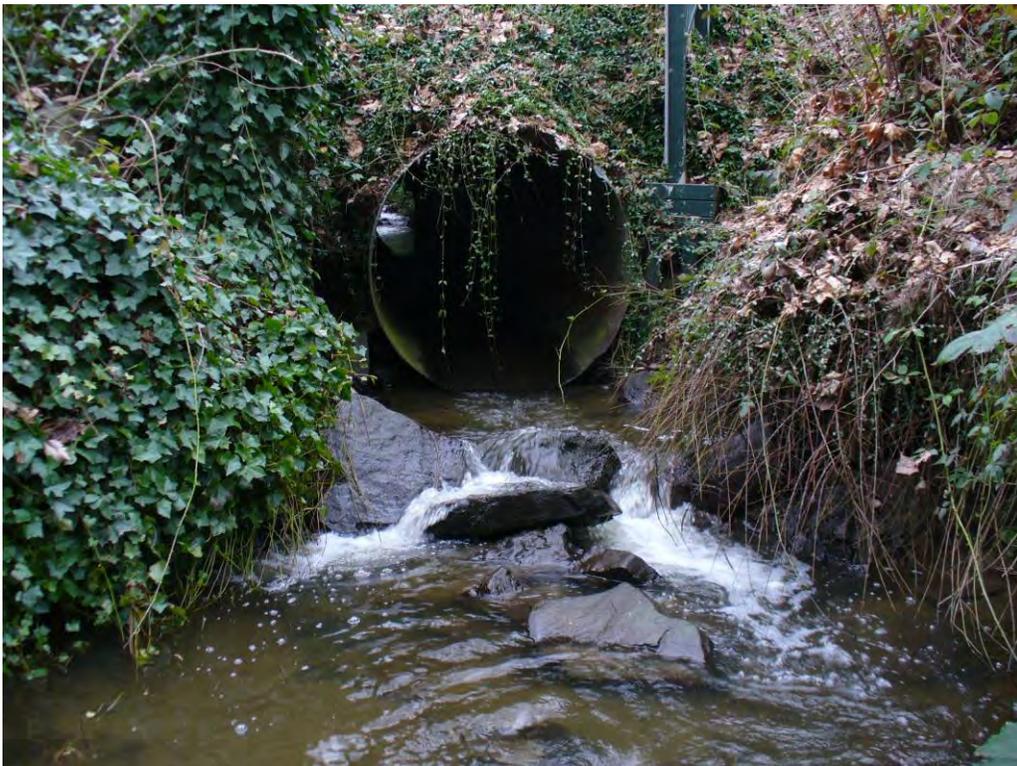
Figure 36. Culvert JC-19 Inlet at NE141st Street, 3-12-13

Figure 37. Culvert JC-19 Outlet NE 141st Street, 3-12-13

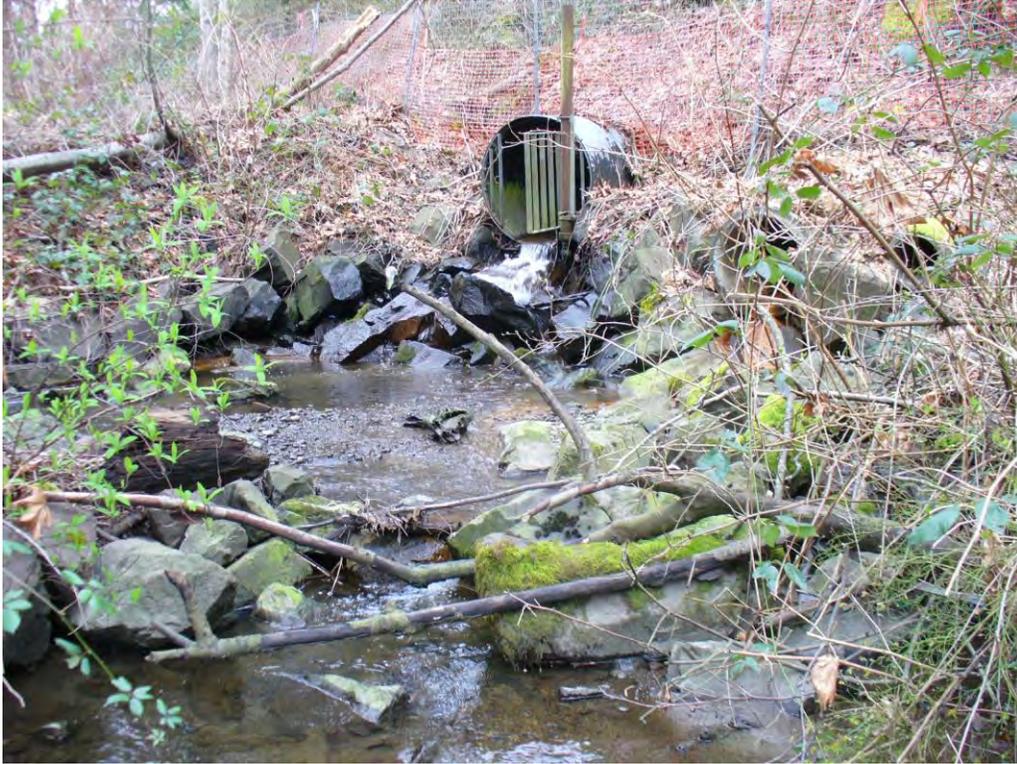
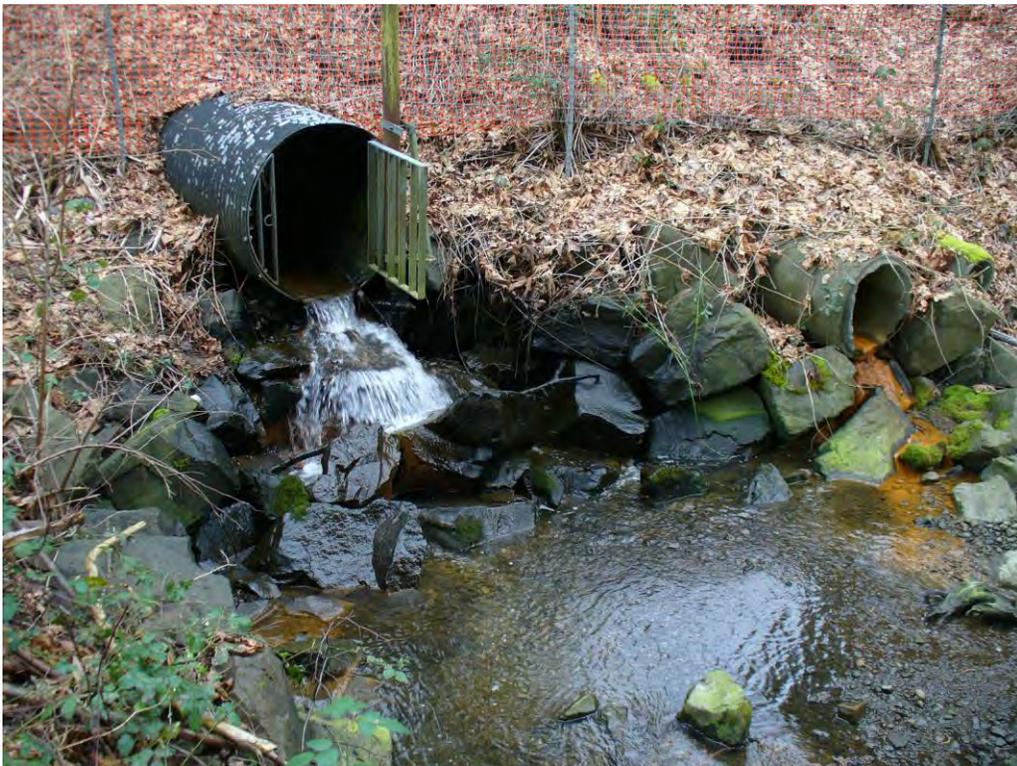
Figure 40. Culvert JC-21 Outlet at I-405, 3-12-13

Figure 41. Culvert JC-21 Outlet at I-405, 3-12-13

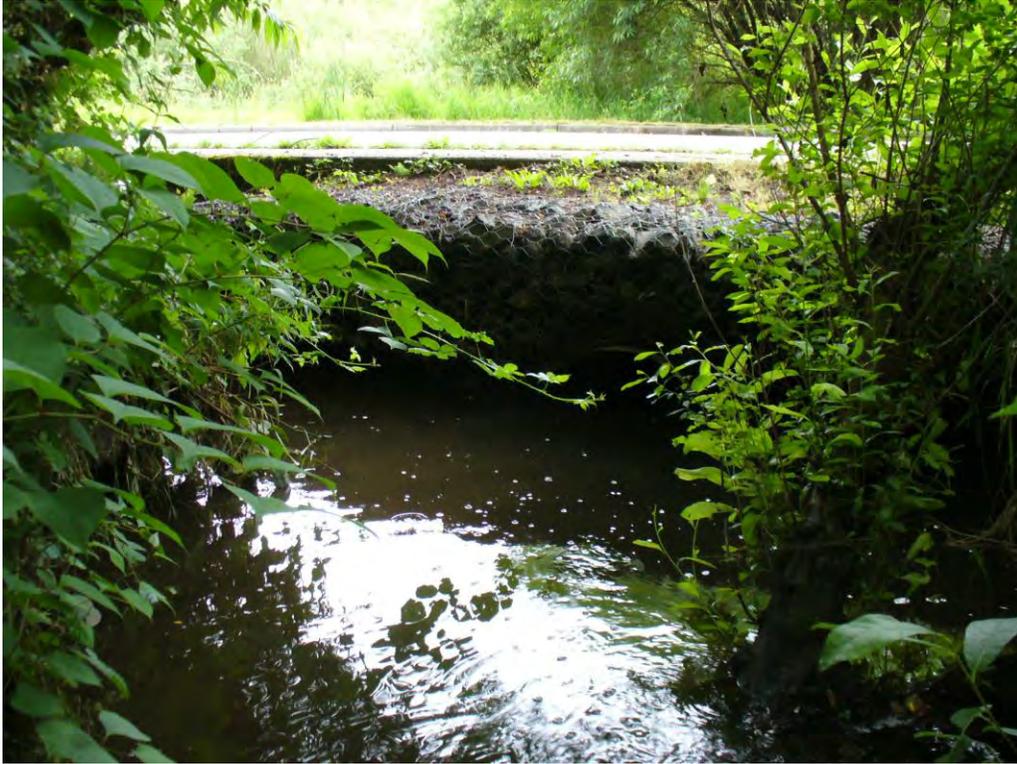
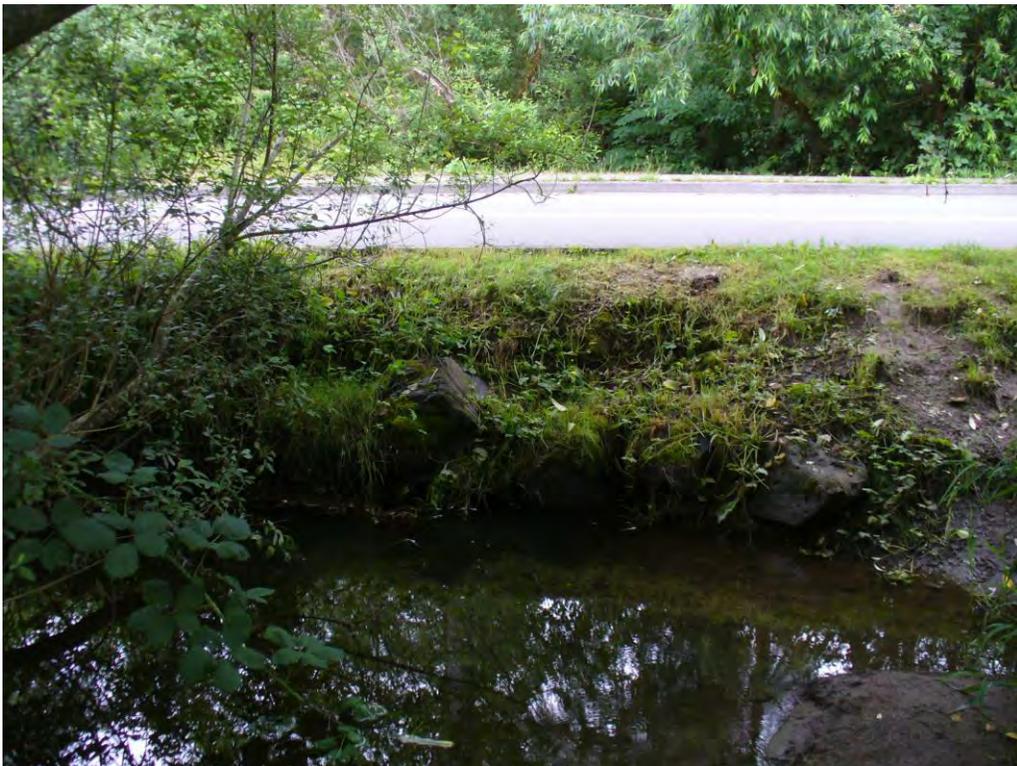
Figure 48. Culvert FO-1 Inlet at 108th Avenue NE, 6-27-13

Figure 49. Culvert FO-1 Outlet at 108th Avenue NE, 6-27-13

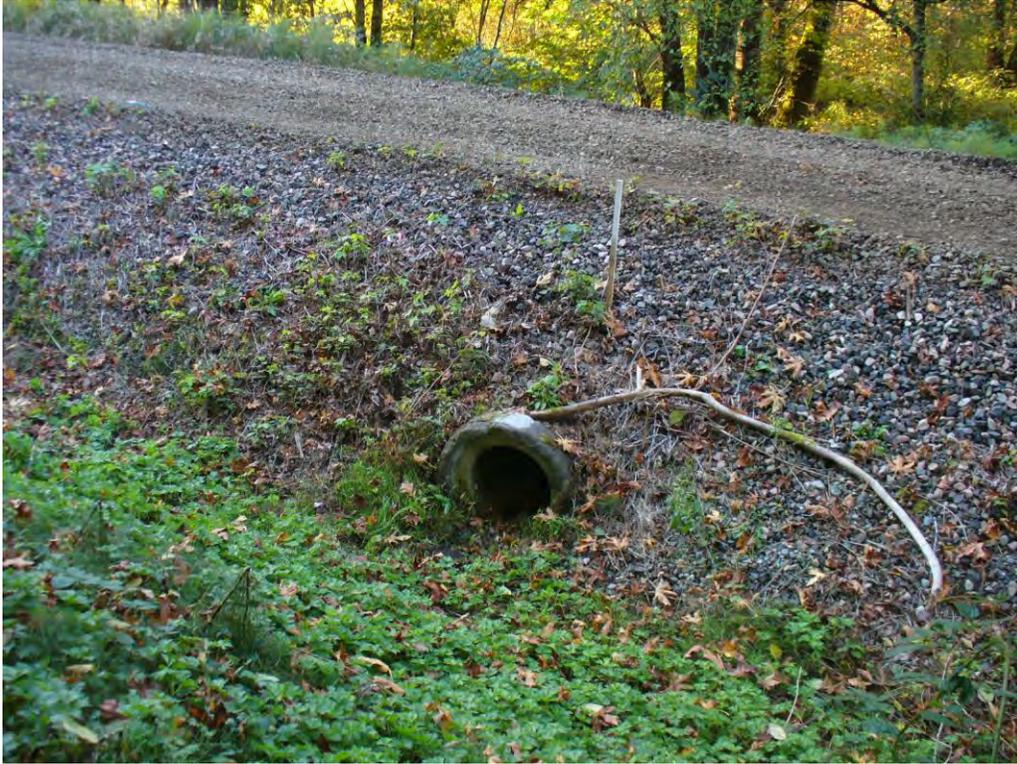
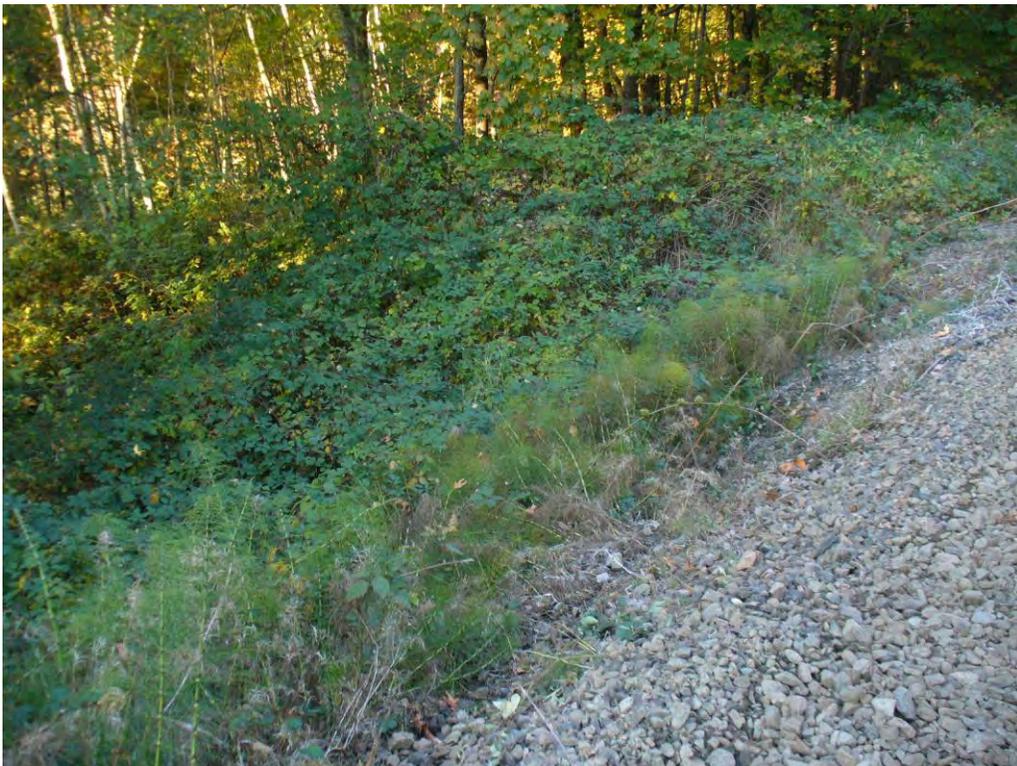
Figure 54. Culvert FO-4 Inlet near dead end of 111th Avenue NE (CKC), 10-18-13

Figure 55. Culvert FO-4 Outlet near dead end of 111th Avenue NE (CKC), 10-18-13

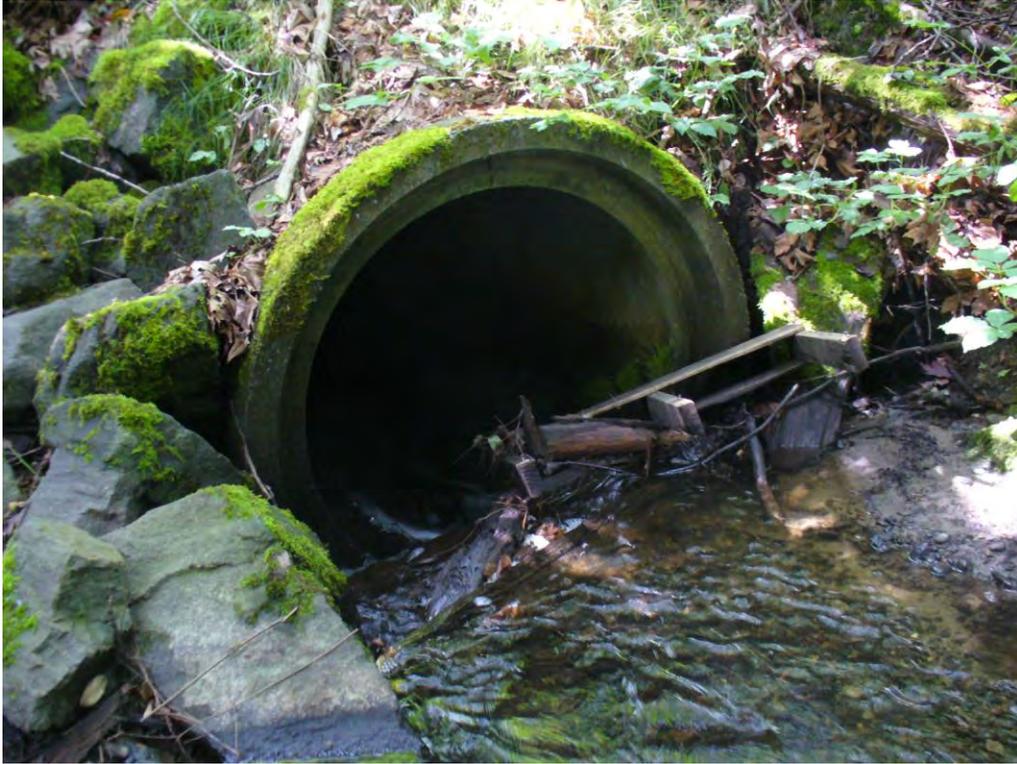
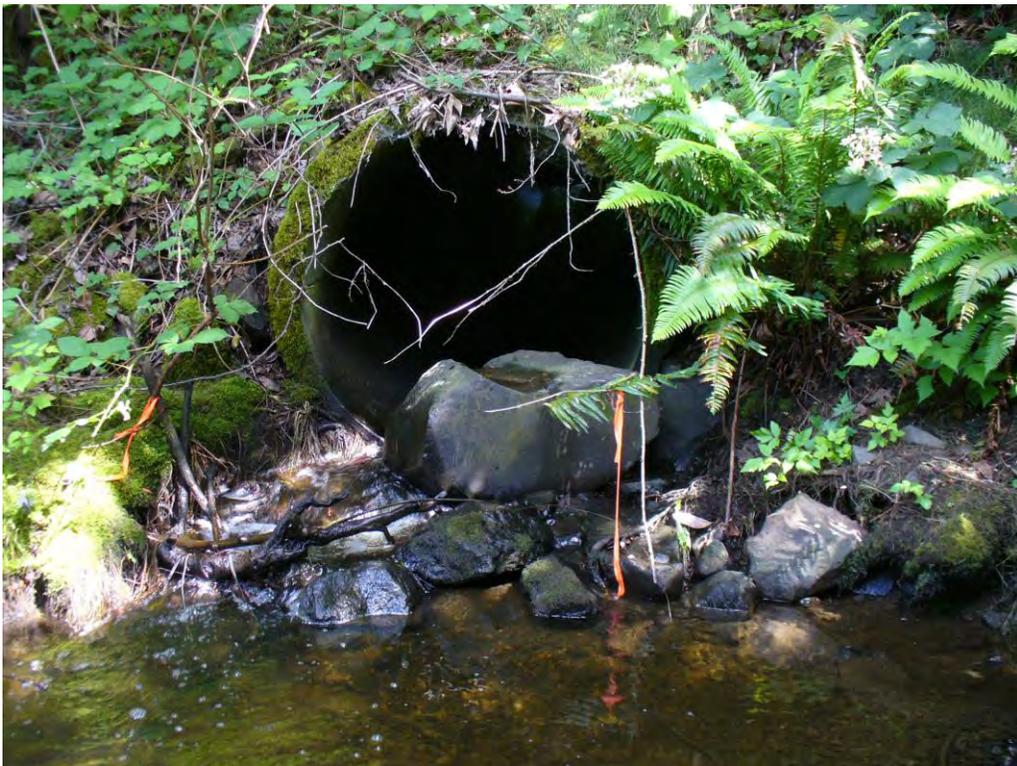
Figure 60. Culvert FO-7 Inlet at 117th Place NE and 116th Avenue NE, 6-28-13

Figure 61. Culvert FO-7 Outlet at 117th Place NE and 116th Avenue NE, 6-28-13

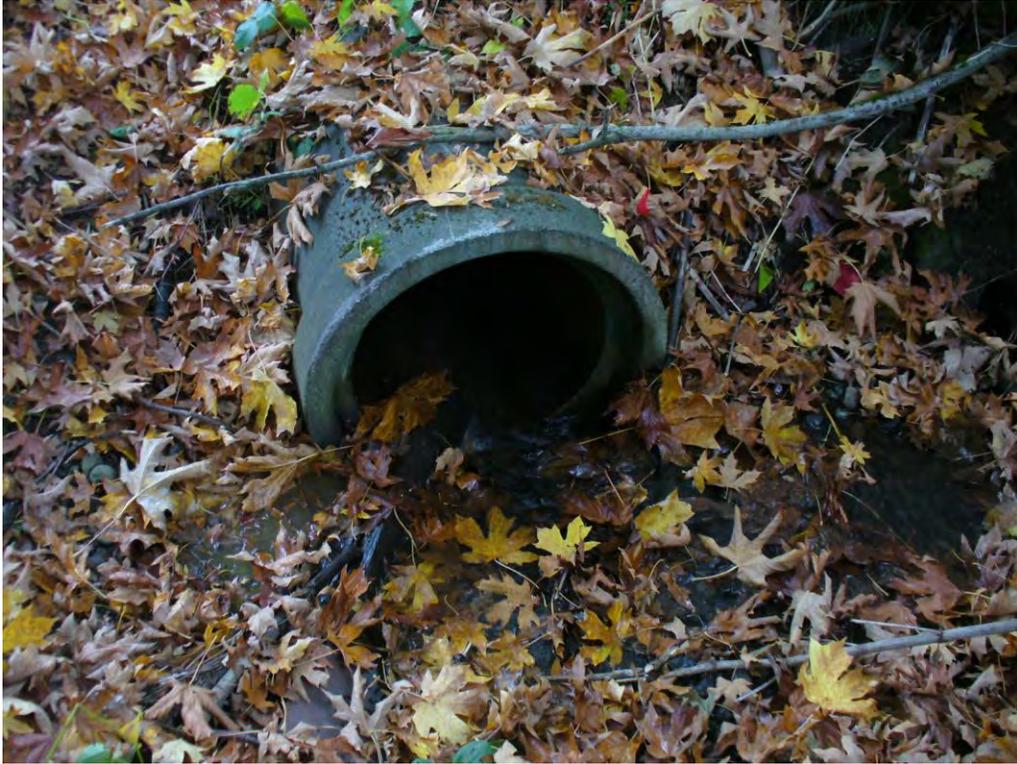
Figure 68. Culvert MB-1 Inlet in CKC, 10-25-13

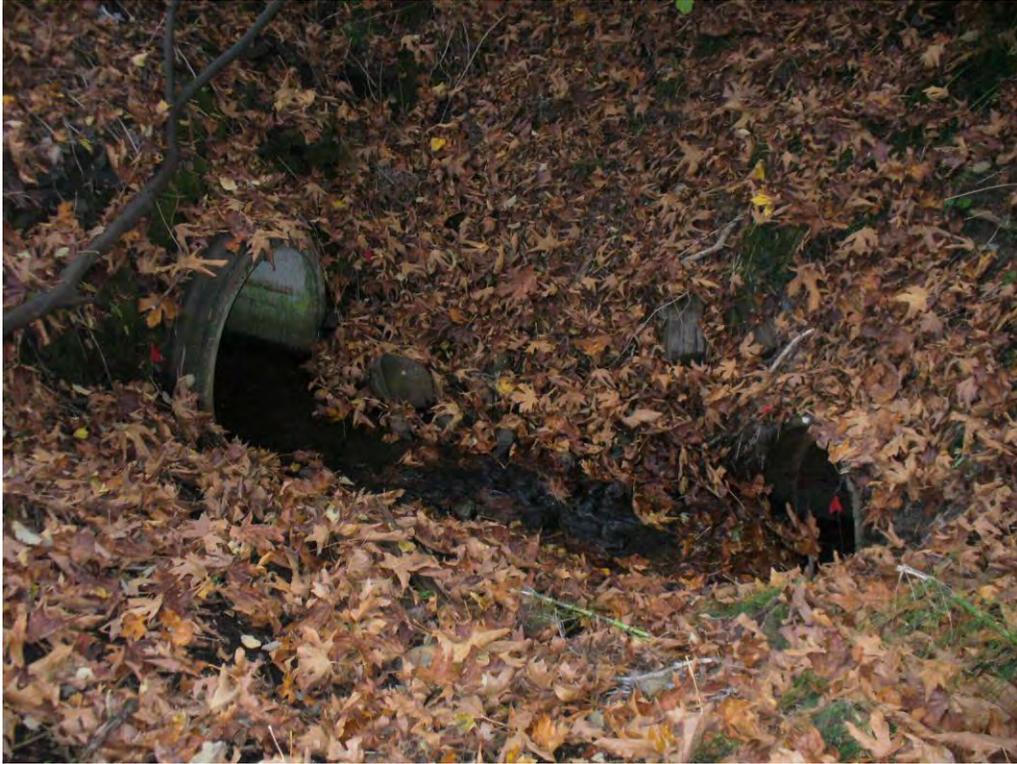
Figure 71. Culvert MB-3 Outlet at Cross Kirkland Corridor, 10-25-13

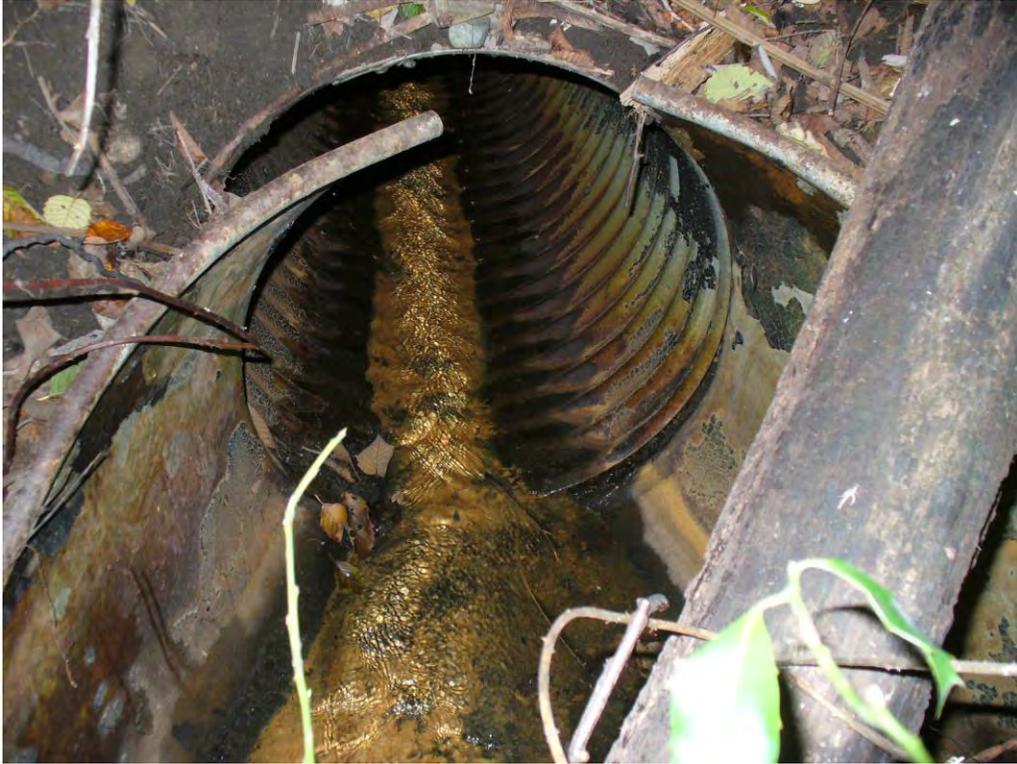
Pipes enter from both north and south along the CKC, but a stream/drainage culvert inlet was also found beyond the blackberries upstream. A 24-inch CMP with a trickle of flow on 10/23/13

Figure 78. Culvert MB-7 Inlet north of 85th (CKC), 10-23-13

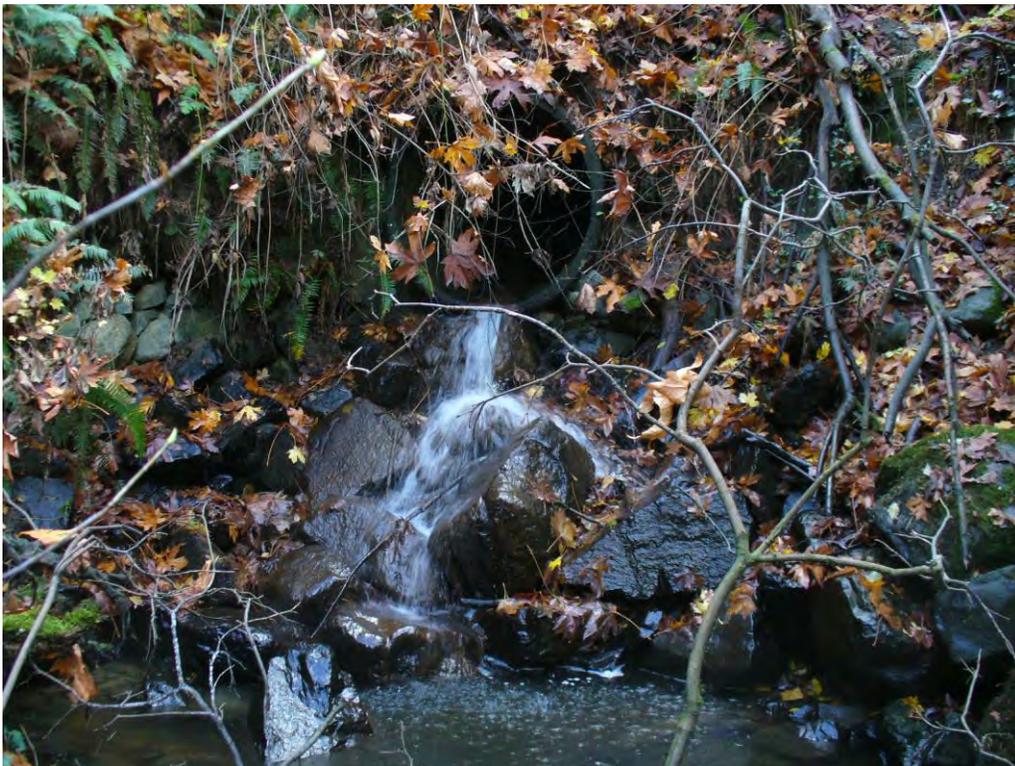
Notes: Good flow on 11/8/13. Bank instability on right side. Lots of boulder armoring. Wood in pool below culvert. Fish use unknown, but possible habitat for isolated trout. Culvert inlet(s) not found – mapped as piped for some distance upstream

Figure 88. Culvert HSA-1 Outlet between 62nd and 64th Streets, 11-8-13
