Culvert Assessment Memorandum

Preliminary Assessments: Fish Passage at City of Kirkland Road and Trail Stream Culverts

Fish Passage at City of Kirkland Road and Trail Stream Culverts

August 2014

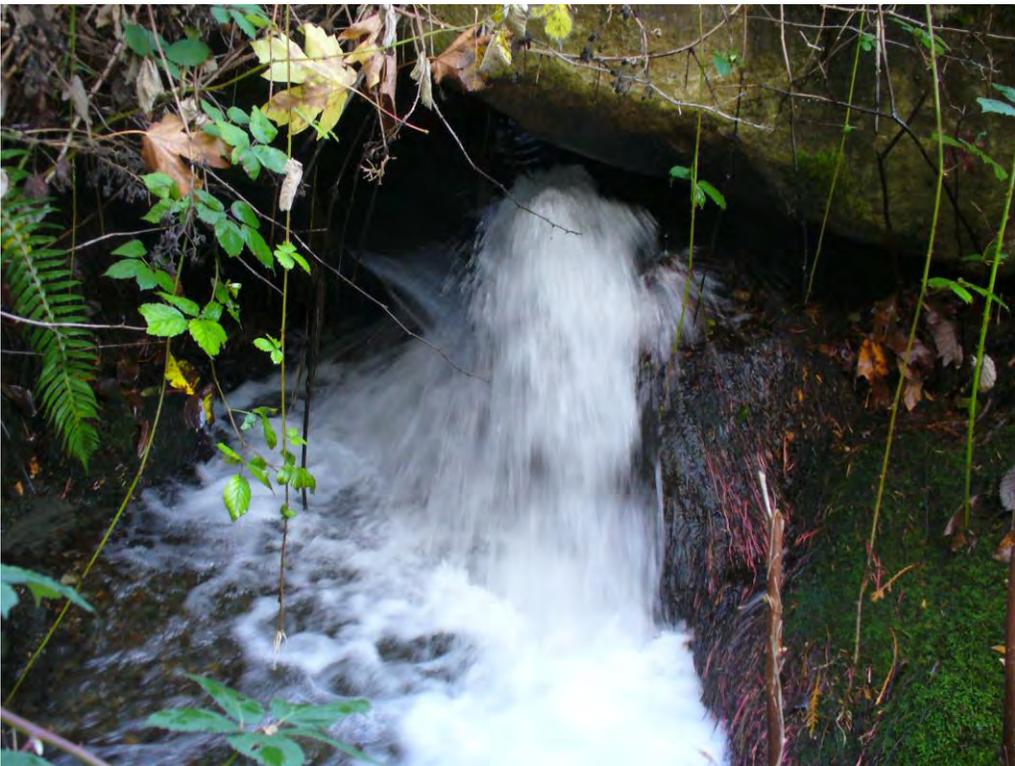
Notes: Flow perhaps 2 cfs on 11/8/13. The CKC prism above the culvert is high and massive.
Expensive to replace, however the flows are here to support fish. High cutthroat usage
documented downstream to Lake Washington.

Figure 98. Culvert CO-3 Outlet at NE 38th Place, 11-8-13
