Appendix G

Summary of Annexation Area Stream Survey

Stream Walk Photo Logs

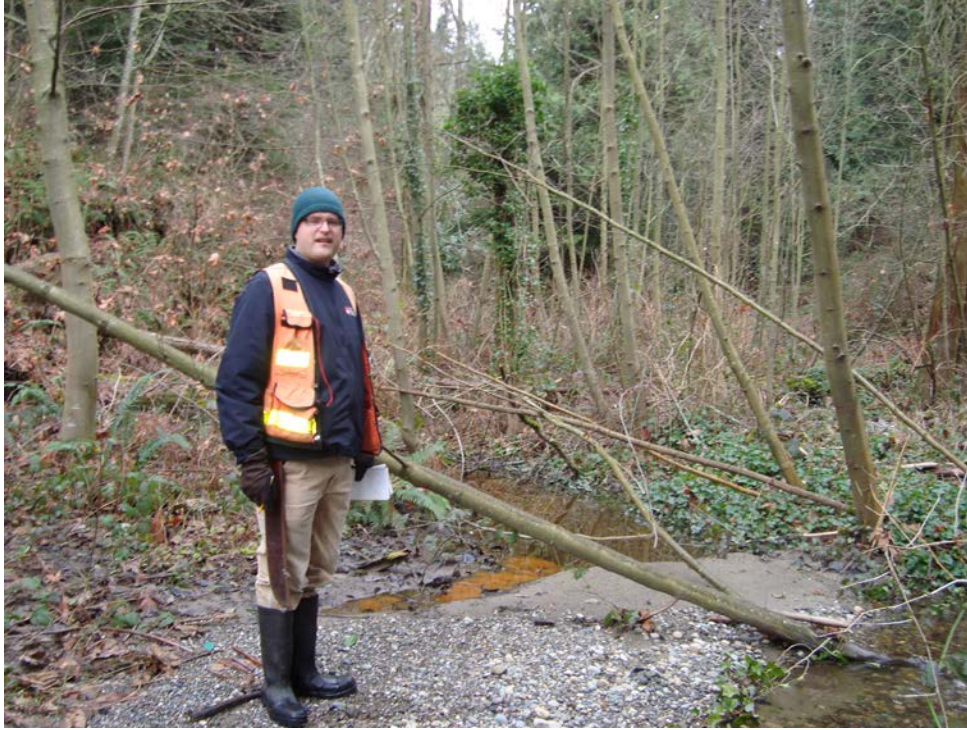
Photo #1. Lower Champagne Creek deposition

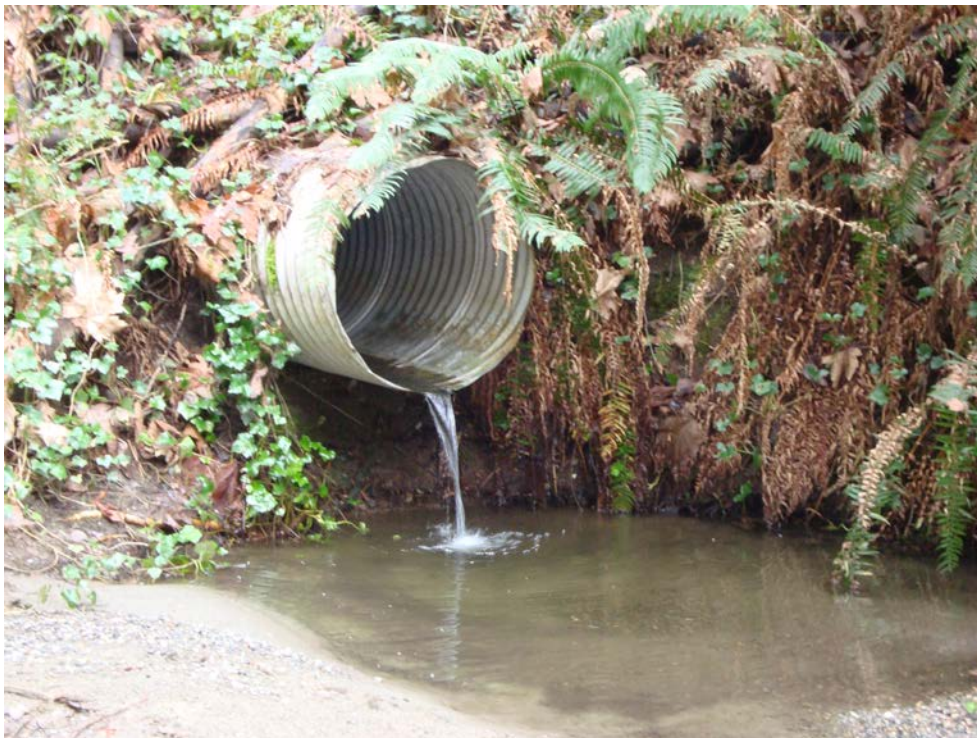
Photo #2. Left bank outfall from NE 112th Street

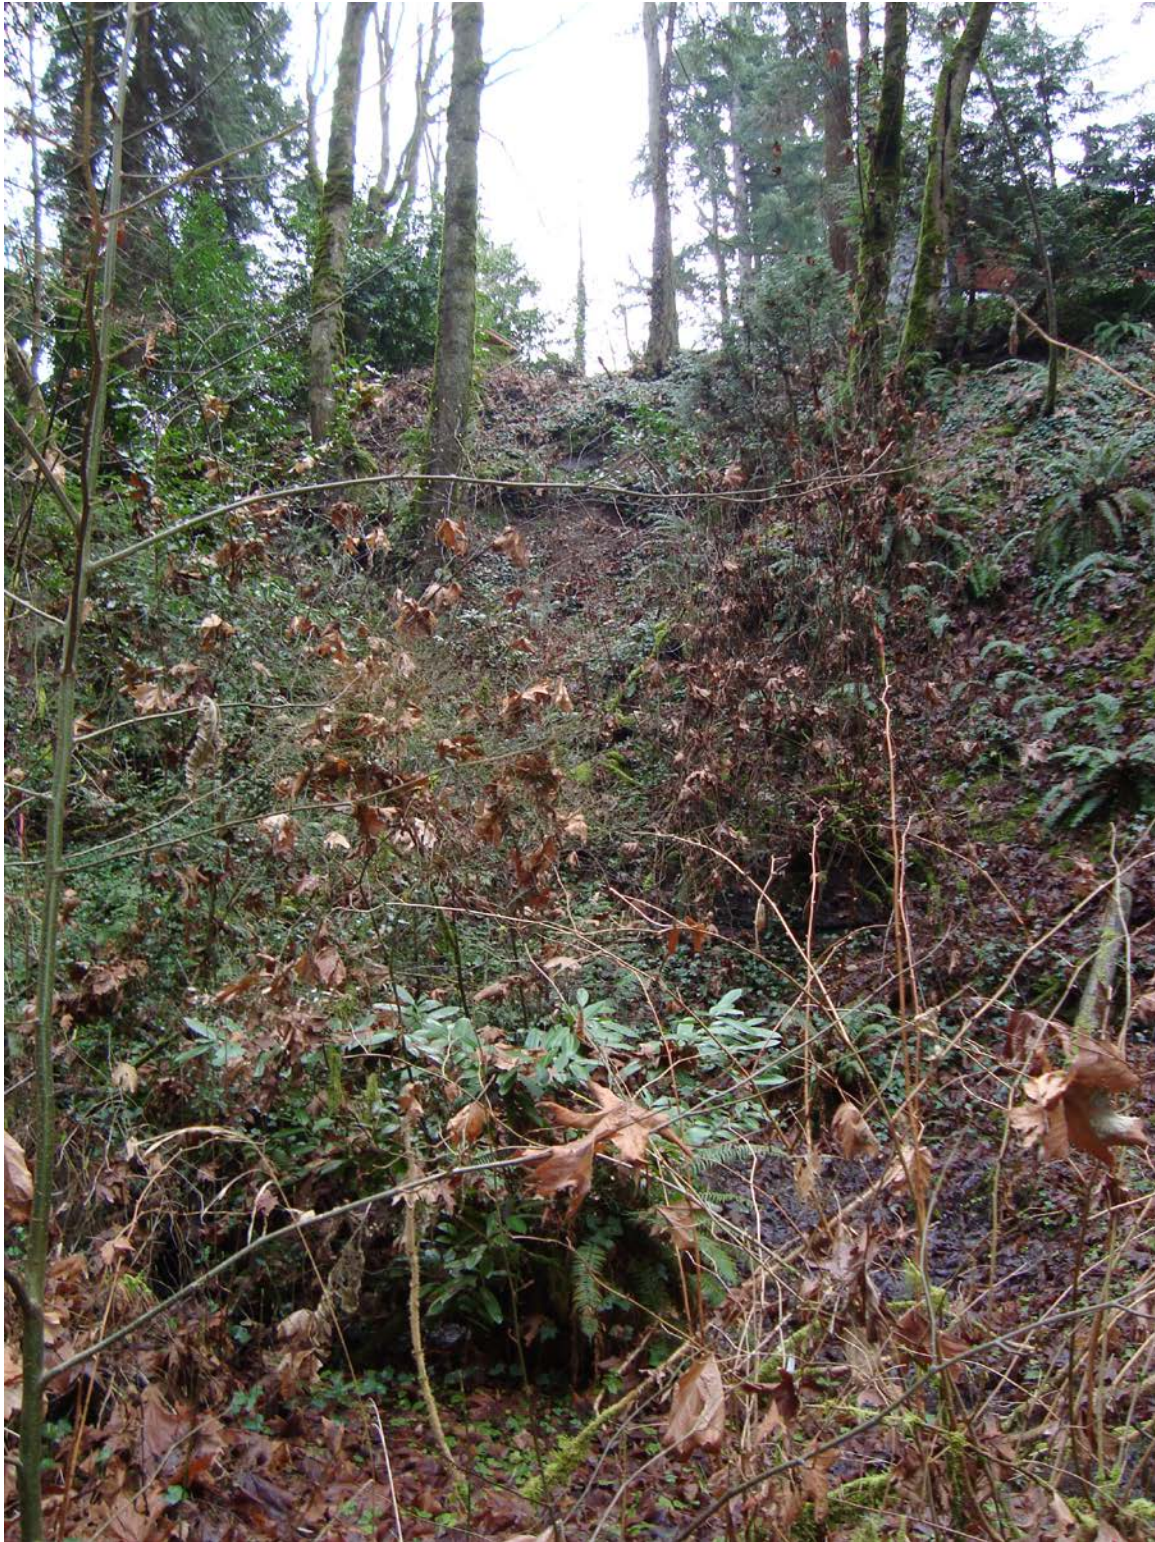
Photo #3. Left bank slope. Lots of seepage, leaning fir trees, and generally unstable conditions approximately 800 feet upstream from mouth

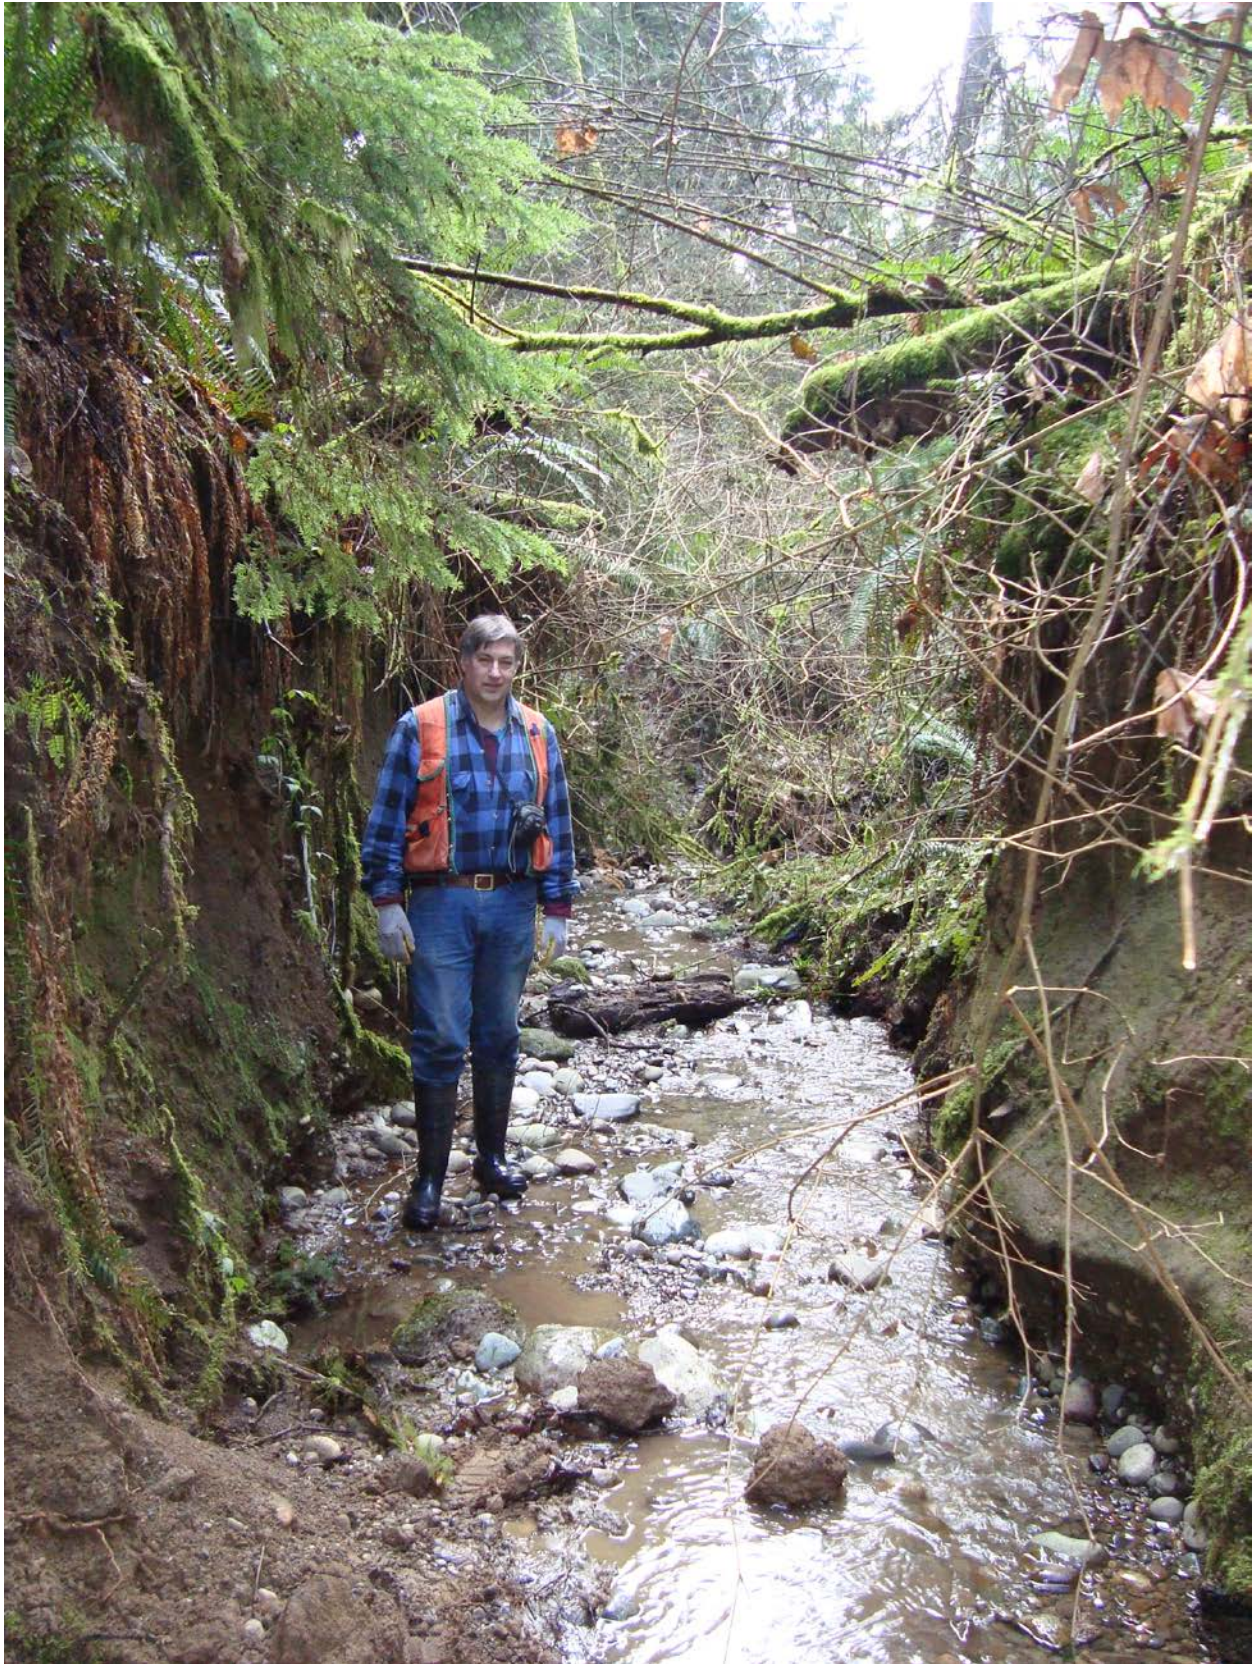
Photo #4. Channel incision in Champagne Creek

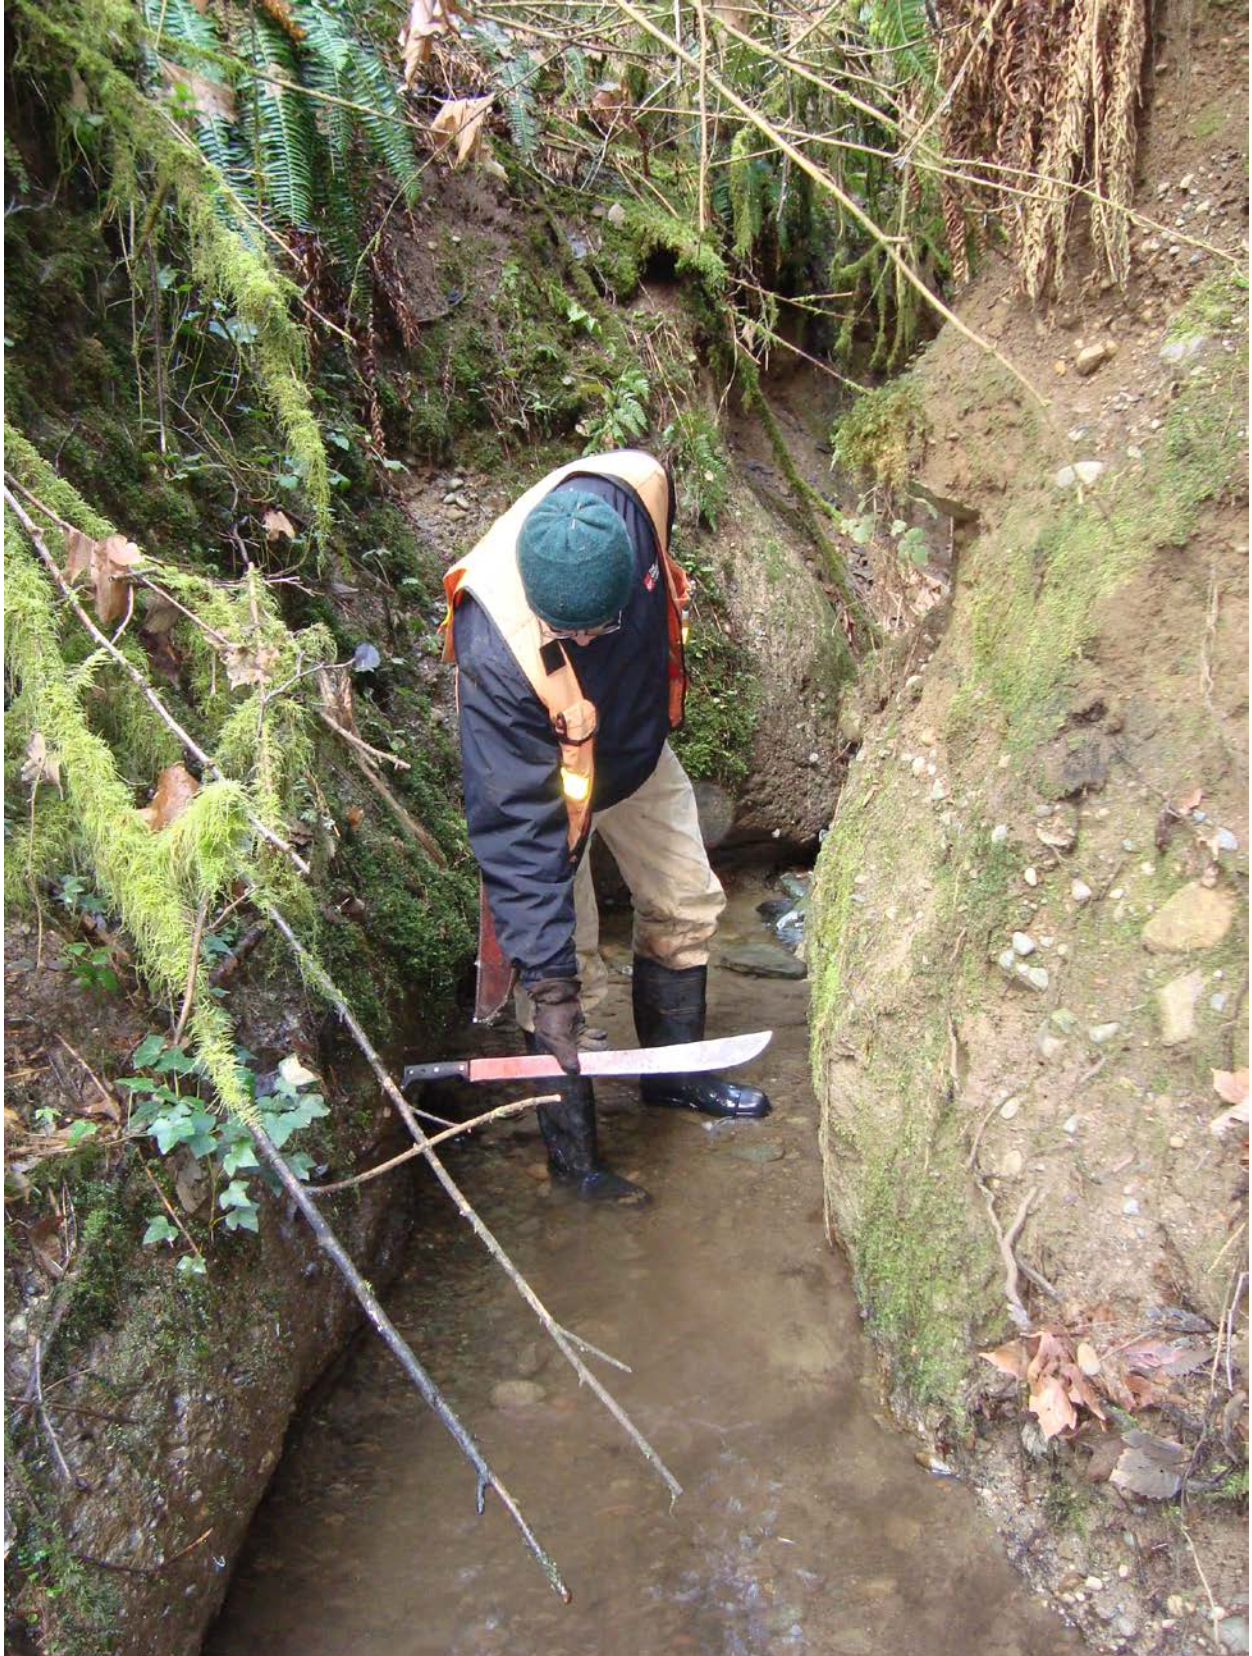
Photo #5. More channel incision upstream of Photo #4—channel narrows in this location

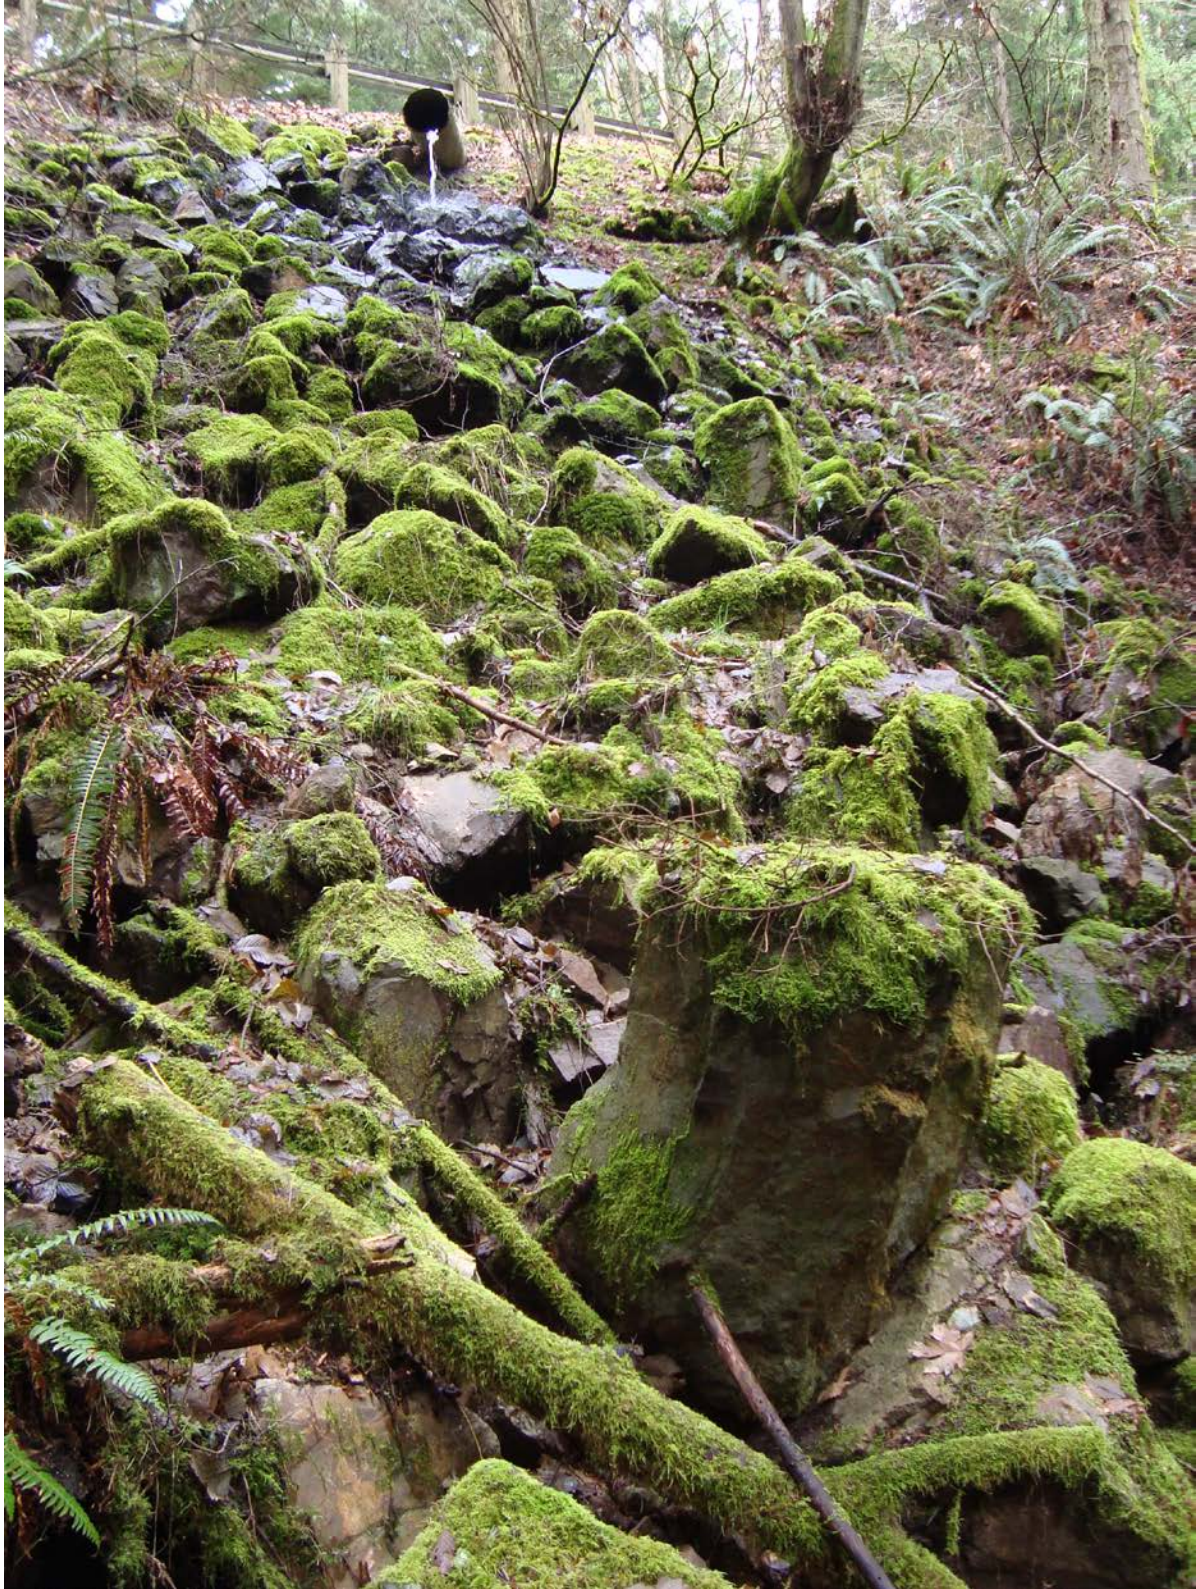
Photo #6. Road runoff from Juanita Drive on left bank

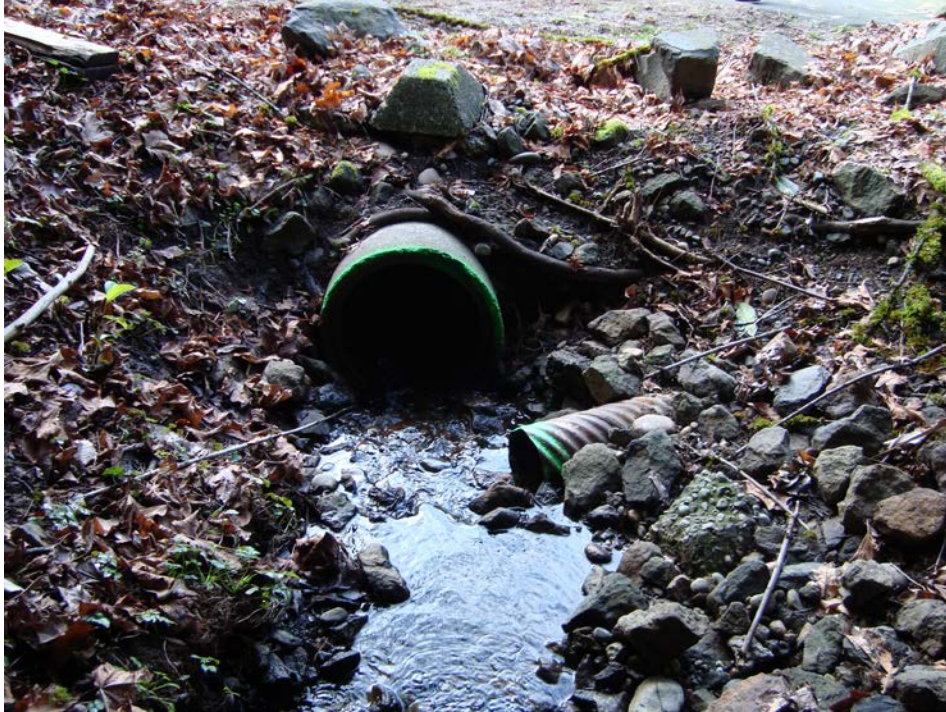
Photo #8. Upstream end of culvert under Juanita Drive

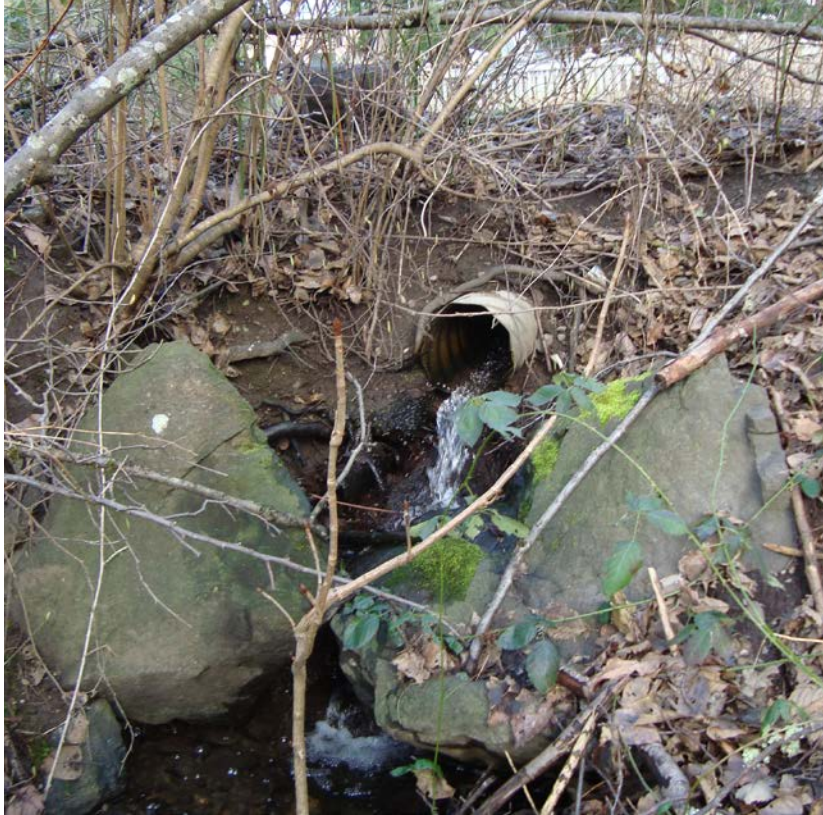
Photo #10. Driveway culvert as Champagne Creek crosses through residential yards

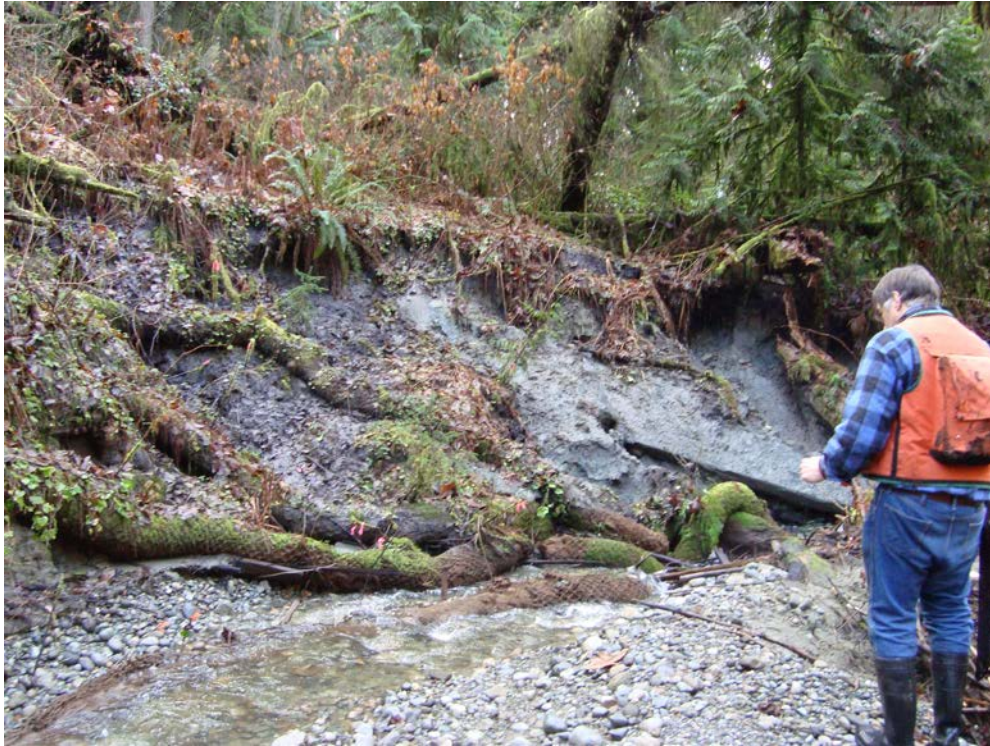
Photo #6. Left bank seepage, and bank failure in clay deposits

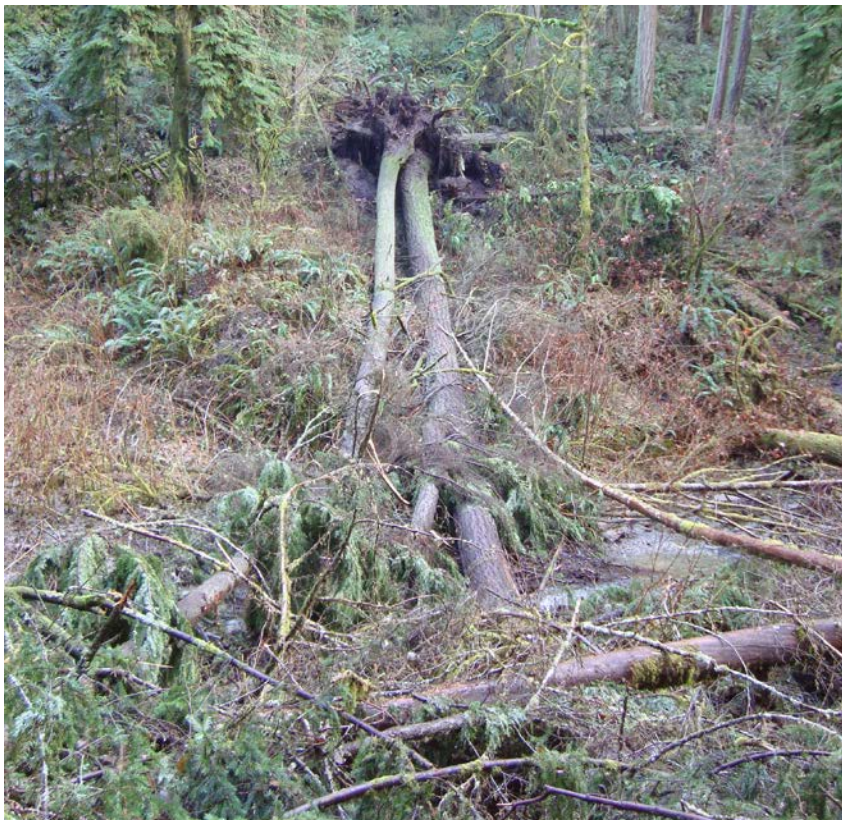
Photo #7. Left bank slope instability and downed trees

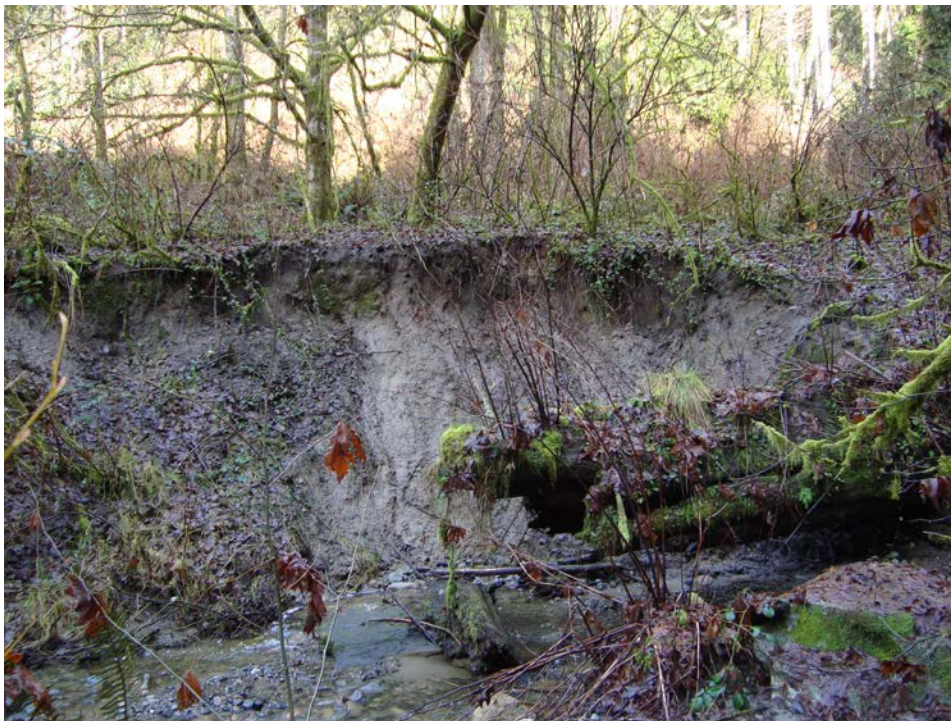
Photo #9. Right bank hillslope failure downstream of Stone Bridge

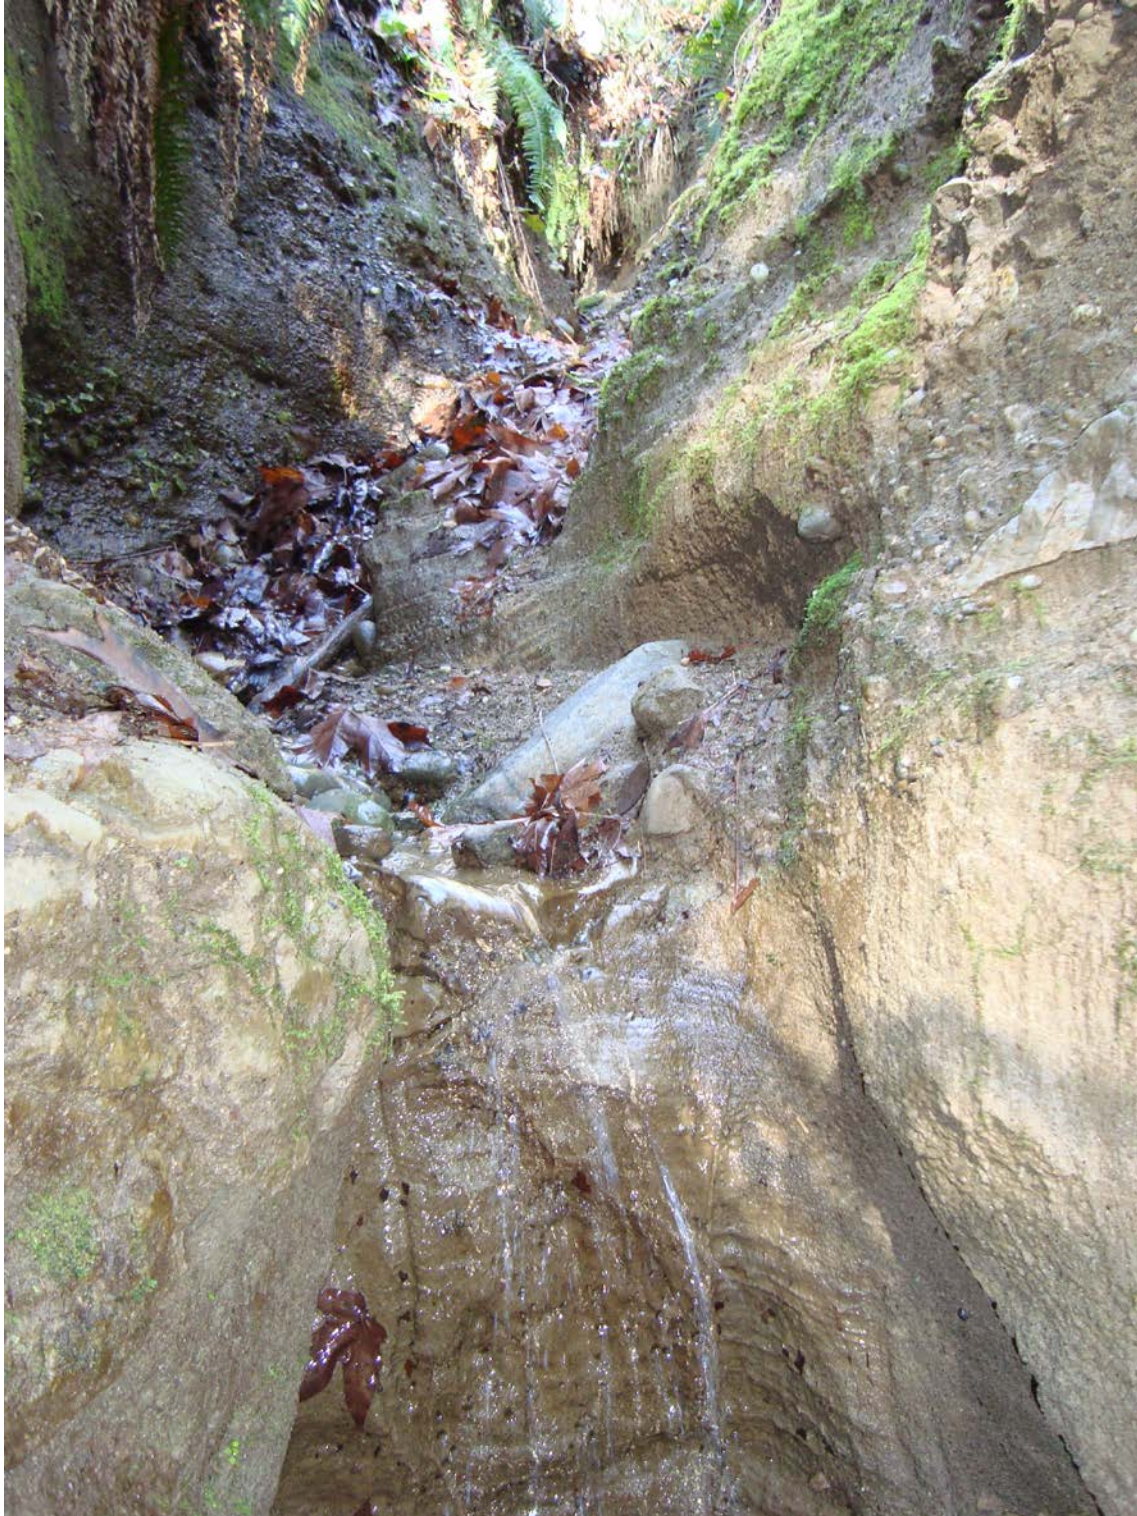
Photo #12. Eroded gully on right bank, extends upslope to plateau in vicinity of 72nd Ave NE

Deep eroded gully on right bank from stormwater runoff on top of slope. Stormwater has since been tightlined to stream via large diameter HDPE pipe

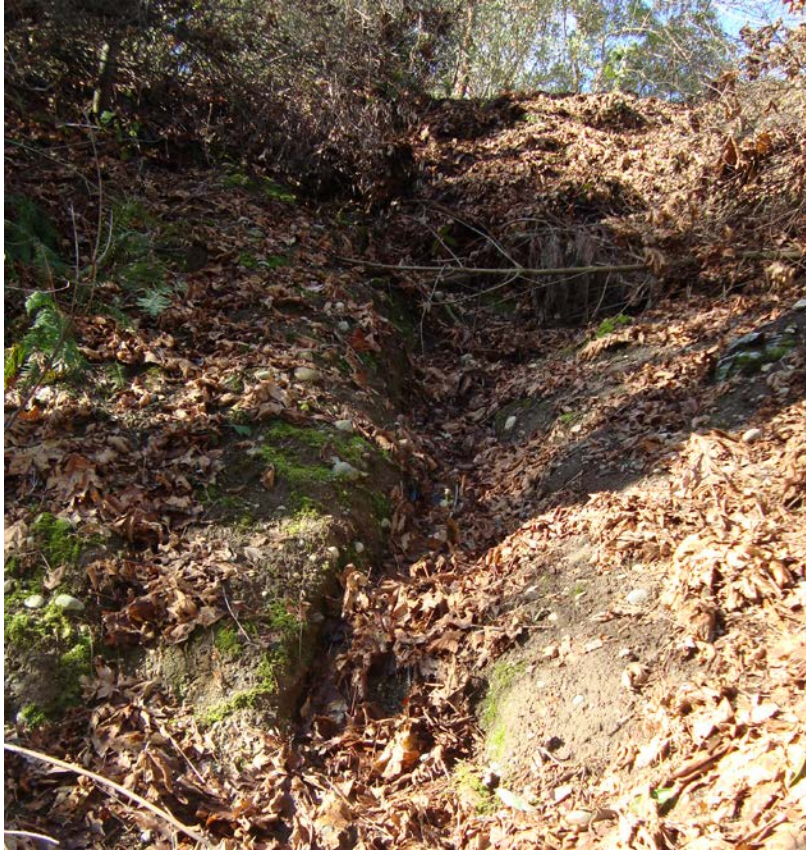
Photo #13. Near top of eroded gully

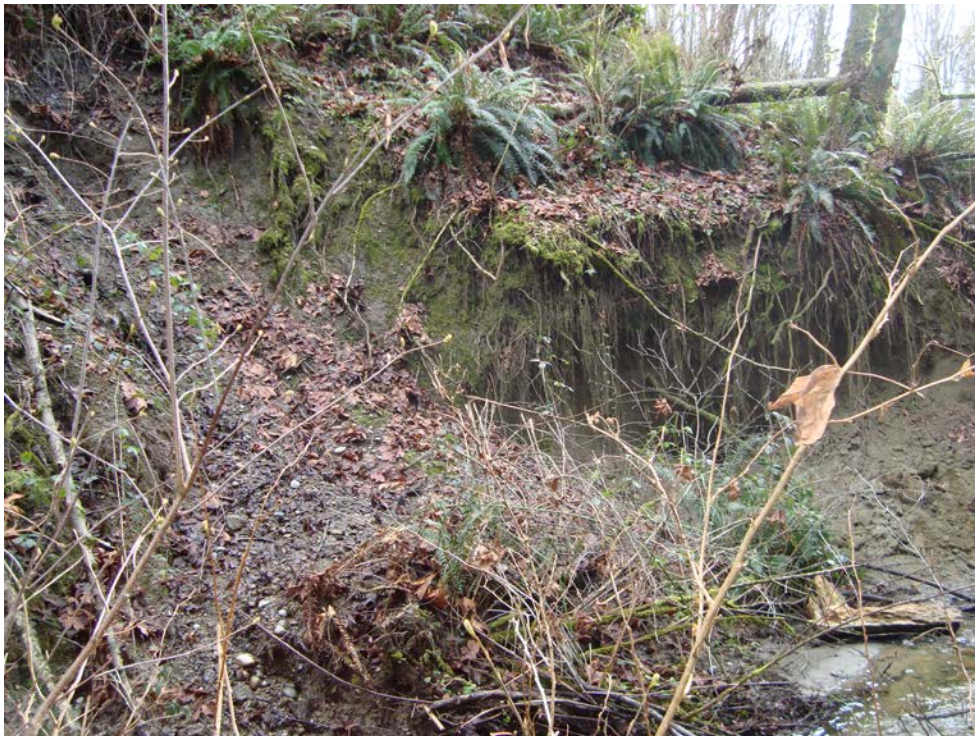
Photo #16. Right bank hillslope failure

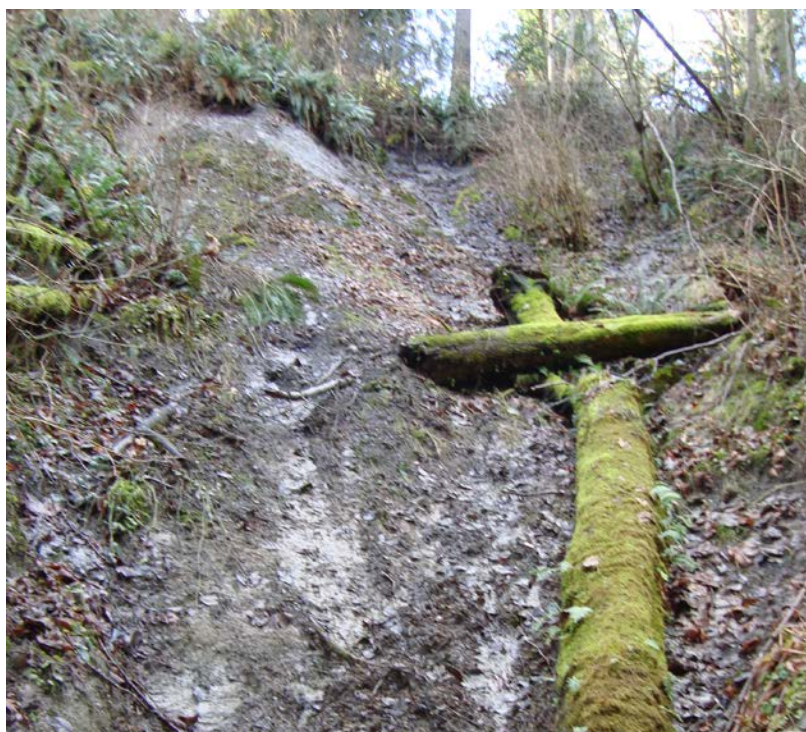
Photo #18. Example of landslides in upper ravine reach

Many landslides in advance outwash.

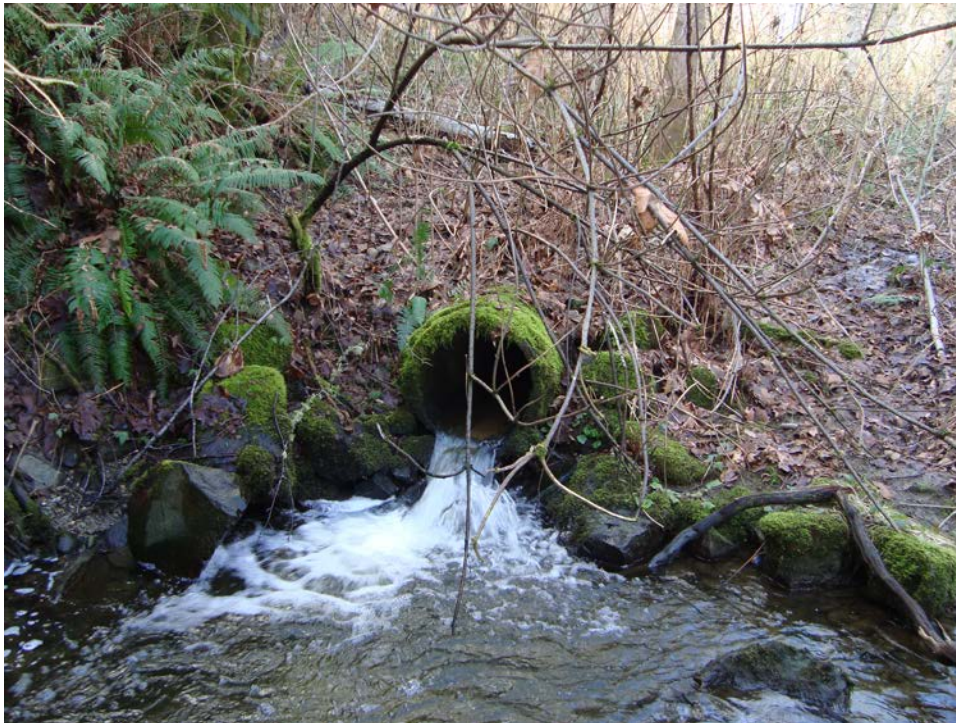
The Juanita Drive stream crossing is through a 24-inch diameter concrete culvert. The culvert appears to be a complete fish passage barrier. The channel immediately upstream of Juanita Drive was not walked because private property access was not obtained. In Big Finn Hill Park, there are multiple channels through a wetland complex that also has significant beaver activity that alters flow patterns. This area is near the top of the basin and is very low gradient.

Photo #20. Juanita Drive culvert crossing, looking upstream.

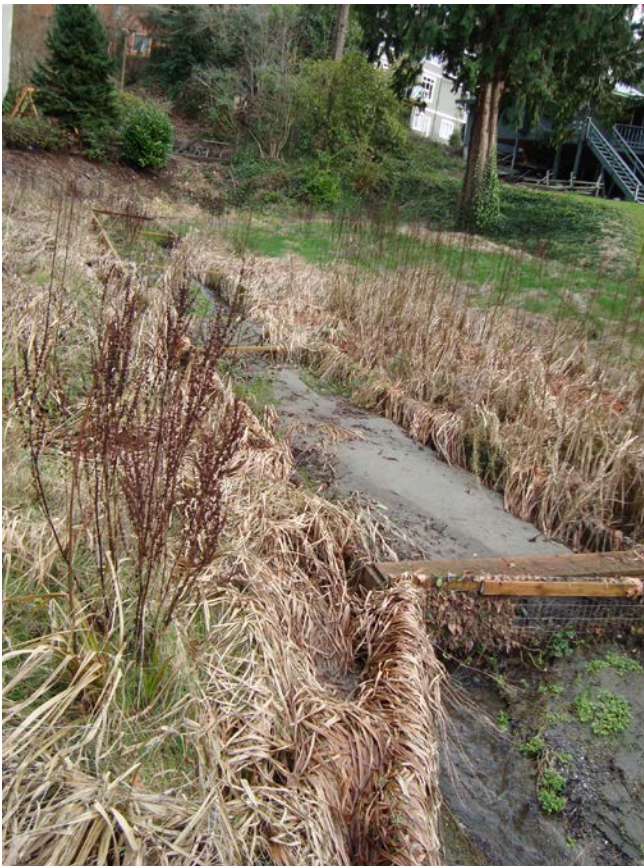
Photo #4 Channel upstream of dam filled with sediment and reed canary grass

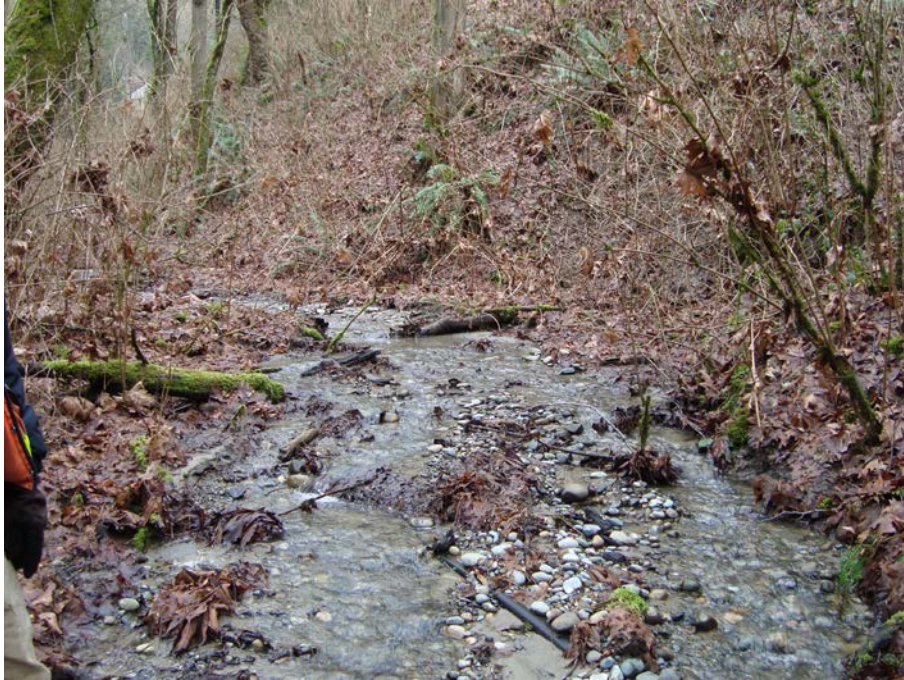
Photo #6. Upstream of 62nd Ave NE looking upstream. Black pipe in stream channel was present throughout this reach. Right side of photo is Holmes Point Drive road embankment.

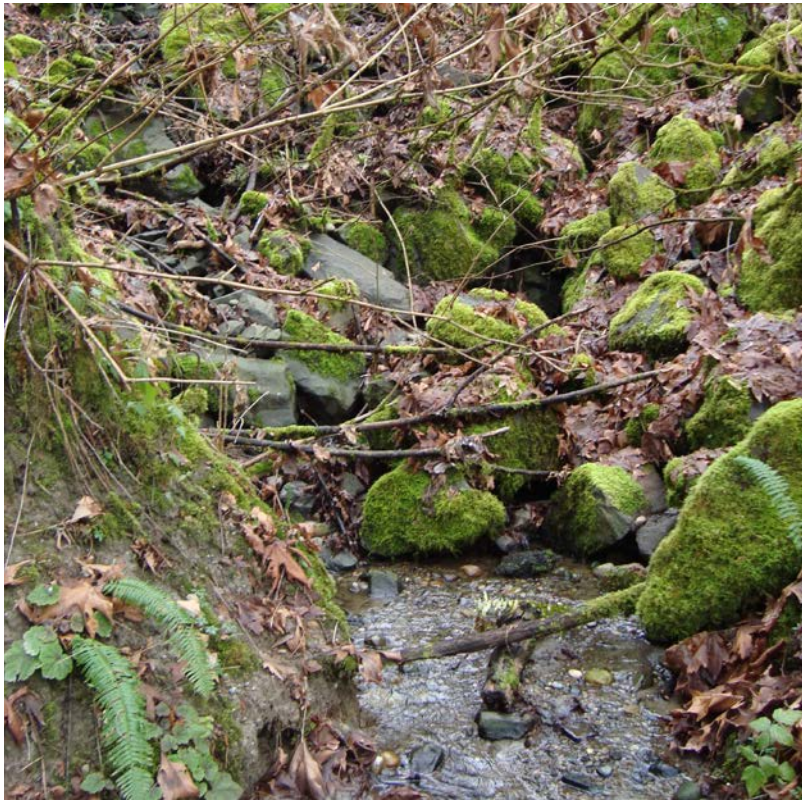
Photo #7. Rip rap in channel from road embankment

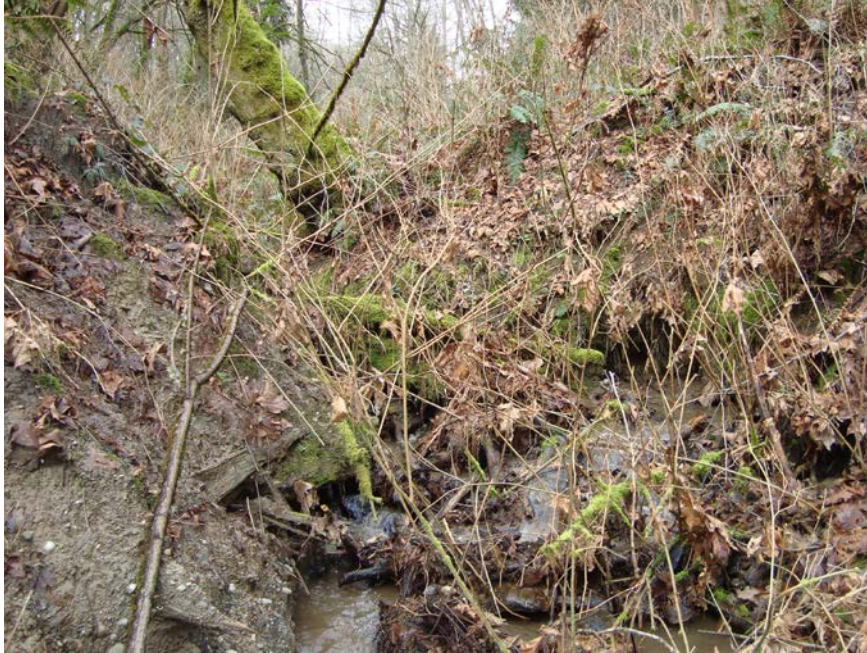
Photo #9. Slope failures adjacent to channel

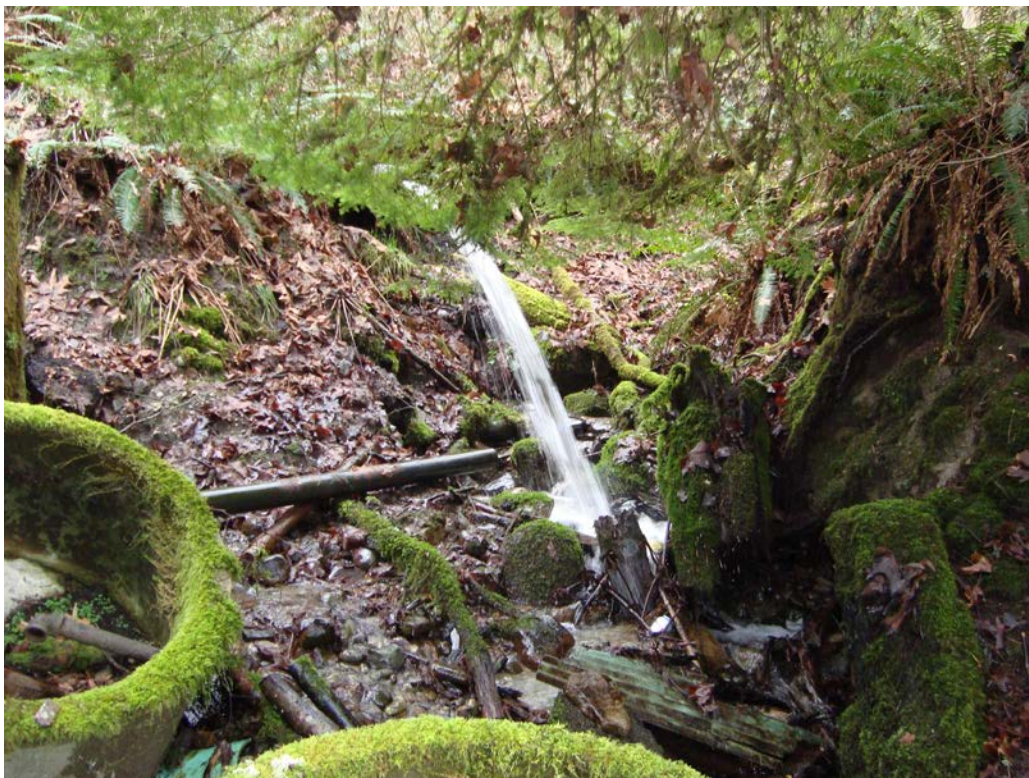
Photo #10. Downstream end of pump house. Concrete debris in channel.

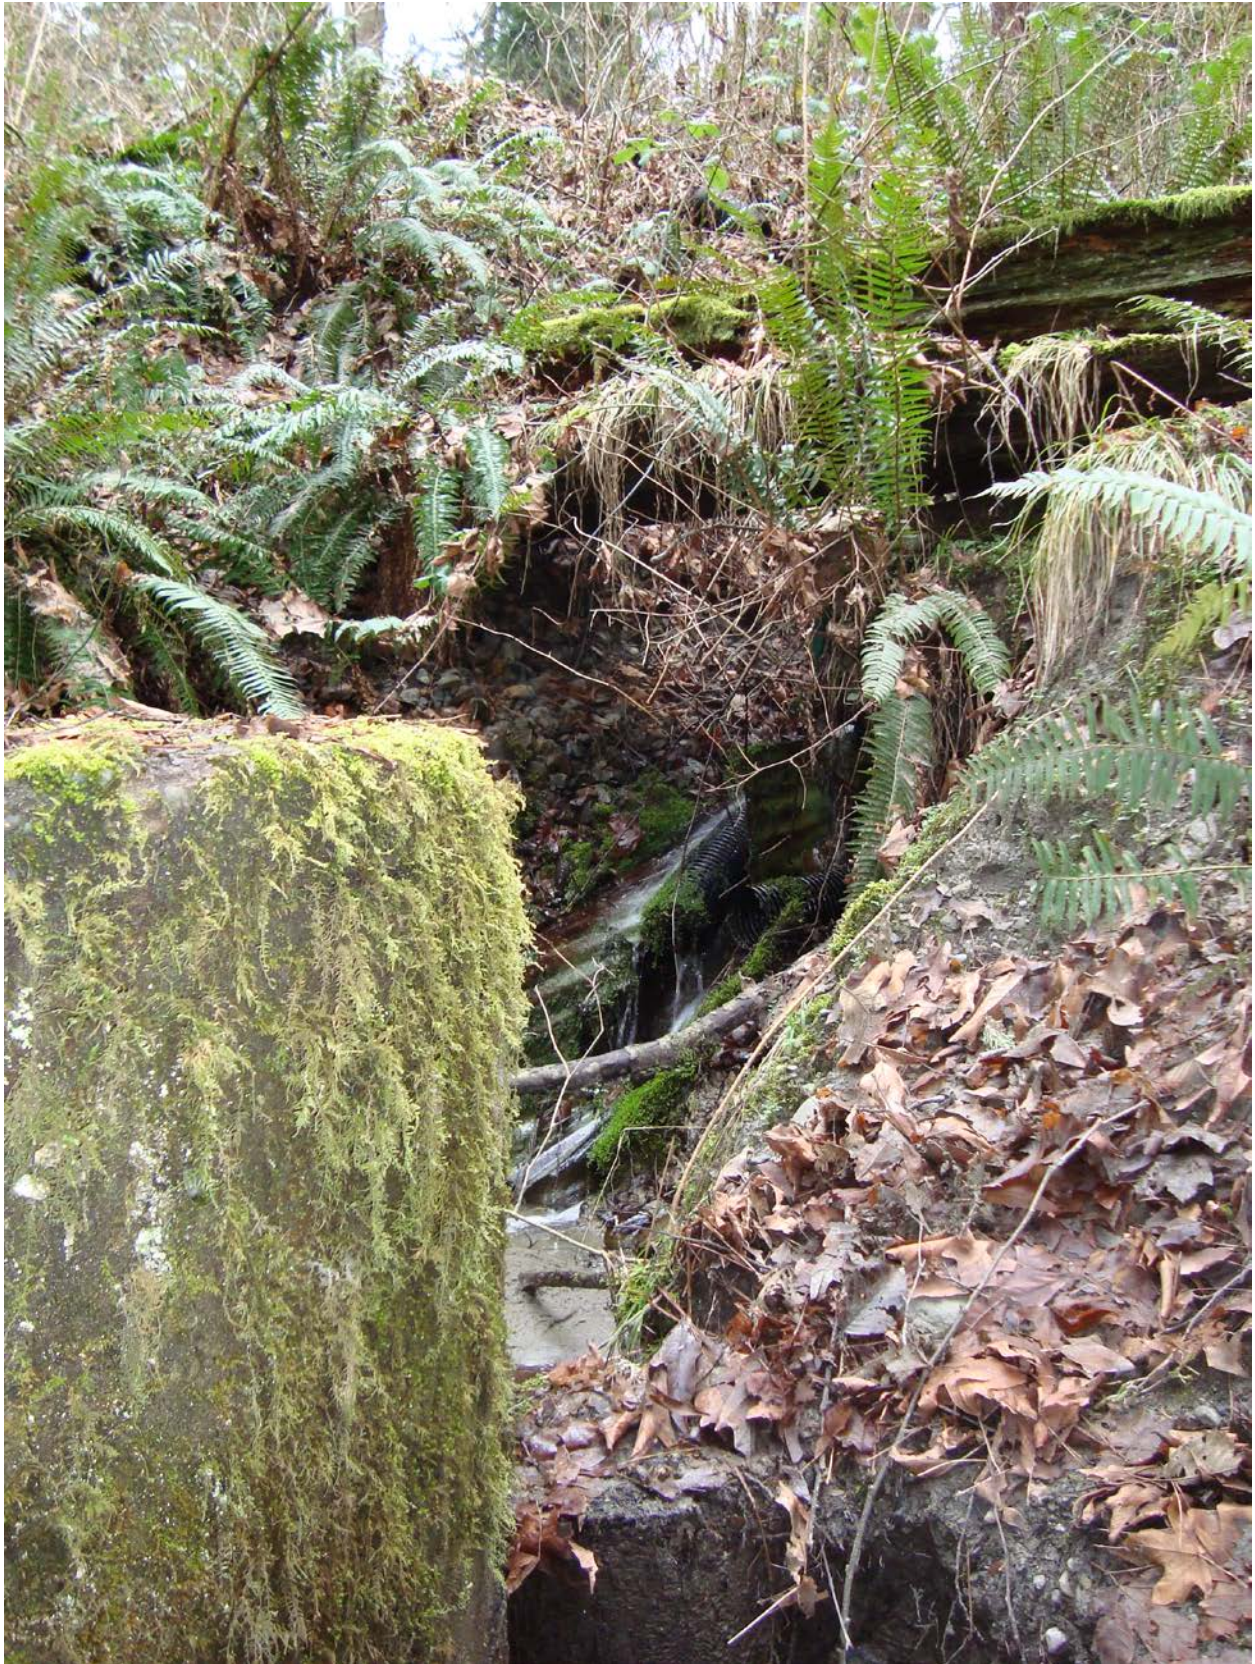
Photo #11. Concrete debris in channel downstream of pump house
