Appendix G

Summary of Annexation Area Stream Survey

Stream Walk Photo Logs

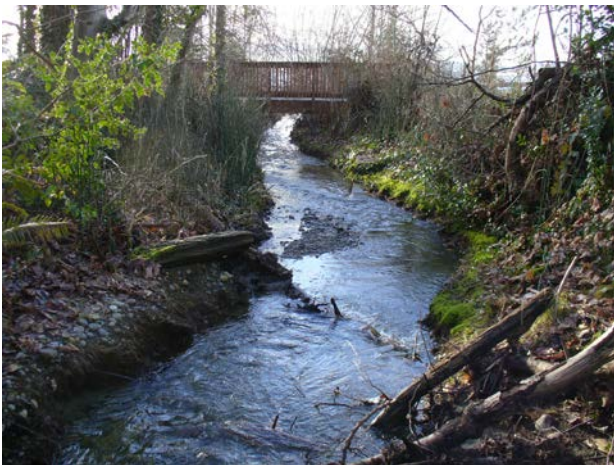
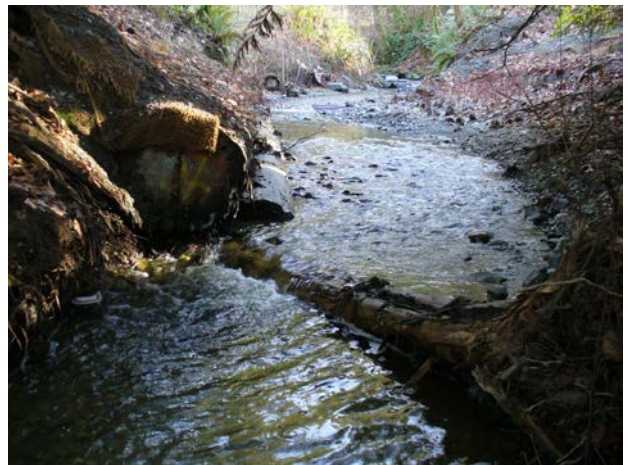
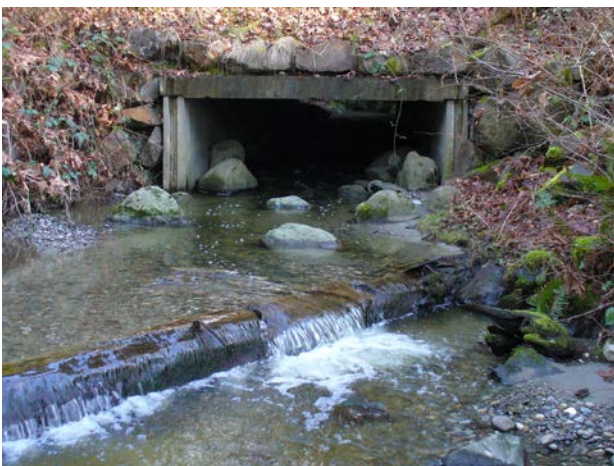
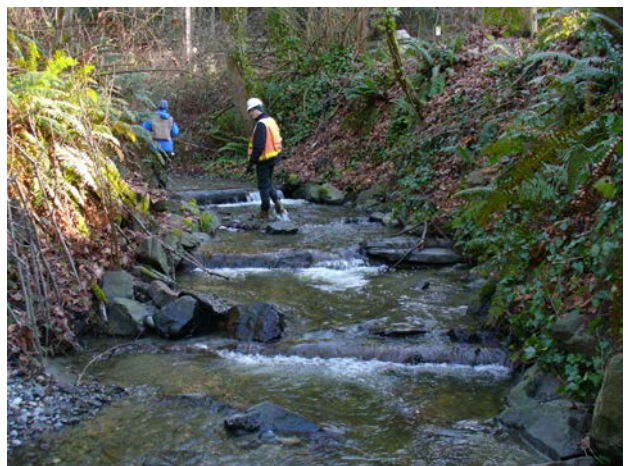
Description and Comments: Vegetation noted – Cottonwood, fir, cedar, holly, ivy. Potential for a project to remove ivy and other non-natives. New log structures installed as part of or mitigation for late 2011/early 2012 sewer line crossing project. Older series of log weirs leads up to concrete box culvert under Holmes Point Dr. NE which is 10 feet wide with about 3 feet of clearance. No fish passage issues. Banks fairly stable, w/ added logs. Good bank vegetation, but the buffer is narrow. Gravel generally a good size gradation for salmonid fish spawning, but sandier than ideal. Pools are of moderate depth and definition. See Photos below:

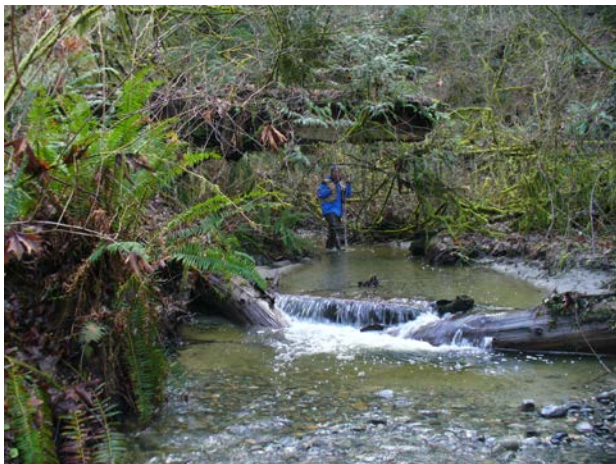
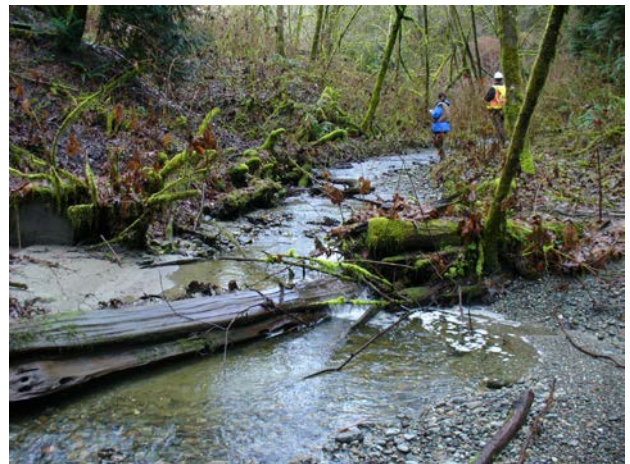
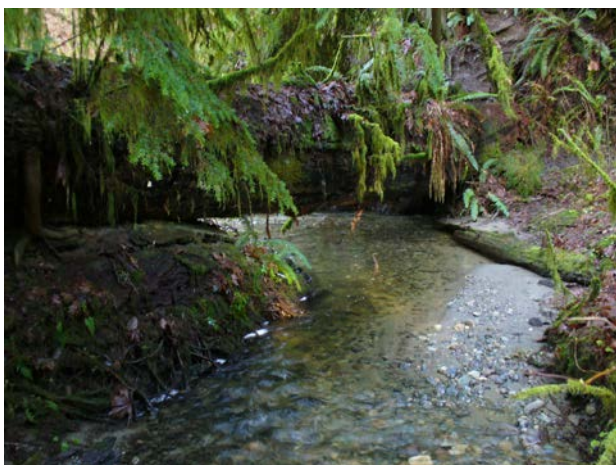
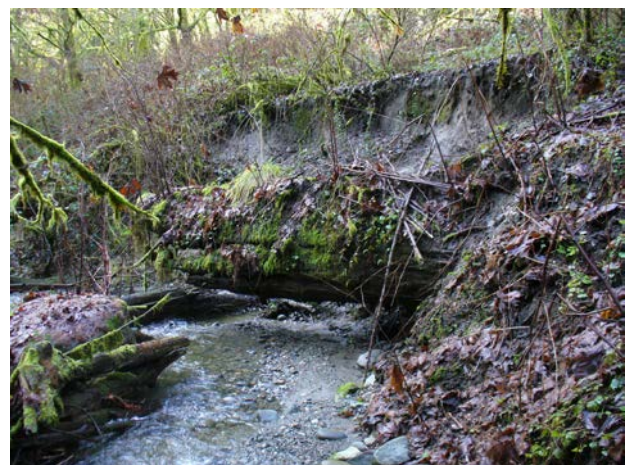
Description and Comments: A stream gage is present at the upstream end of box culvert. Streambanks near-vertical in places, up to 3-4 feet high. Gravel variable being very coarse but still sandy in places and mostly sand in others. Stream flows through wooded ravine with wide buffers. Vegetation includes alder, bigleaf maple, cottonwood, cedar, hemlock, salmonberry, sword fern and vine maple. One stand of non-native Japanese knotweed noted. Good amounts of moderately-sized large wood in the stream, resulting in good pool/riffle definition, but pools on the shallow side possibly due to high sand loading. Some areas of moderate bank instability recruiting silt and sand to the creek. See Photos below:

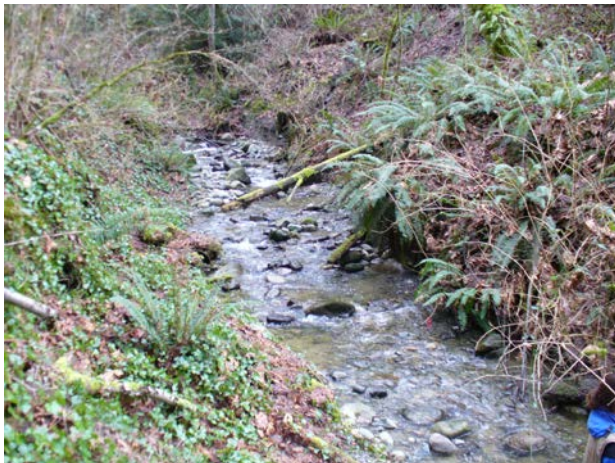
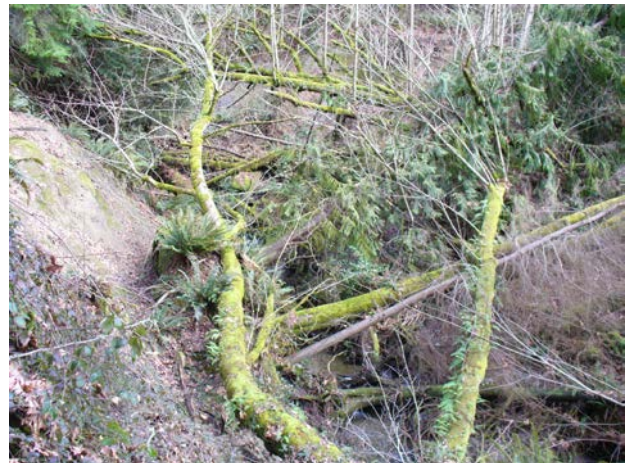
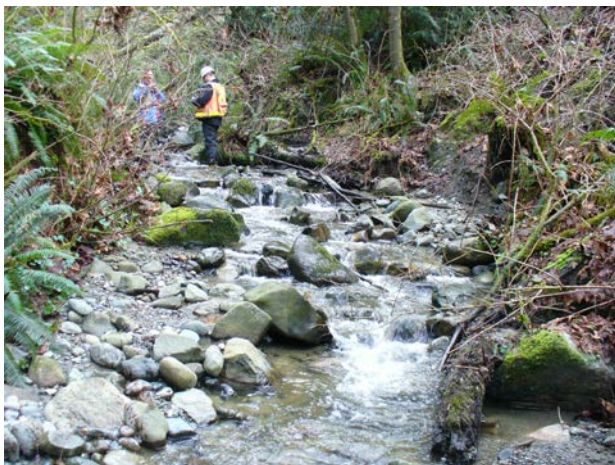
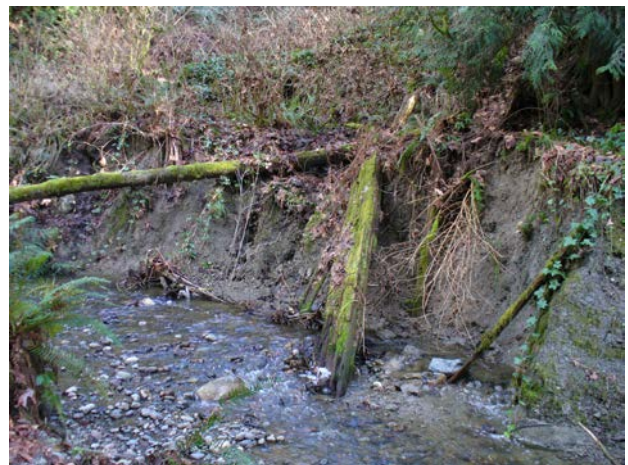
Description and Comments: Noteworthy characteristics of the upper ravine include a prevalence of boulders along much of the streambed length. Also, sections of ravine sideslope and streambank instability are common, resulting in large amounts of wood, as well as substrate materials, being supplied to the stream channel as trees fall and slide into the creek. A natural log weir barrier to fish passage was noted, though this is likely not a permanent feature and should correct itself on its own with time. A short distance farther upstream is the outfall of the culvert under Juanita Drive NE, a 2-foot-diameter concrete pipe which is likely a complete or near-complete fish passage barrier due to high velocities and a plunge at the outfall. See Photos below:

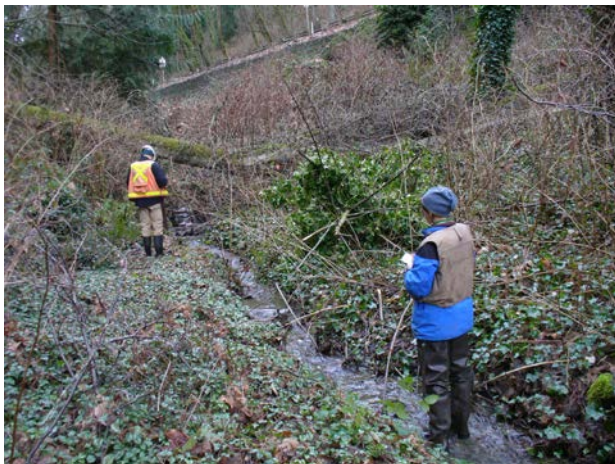
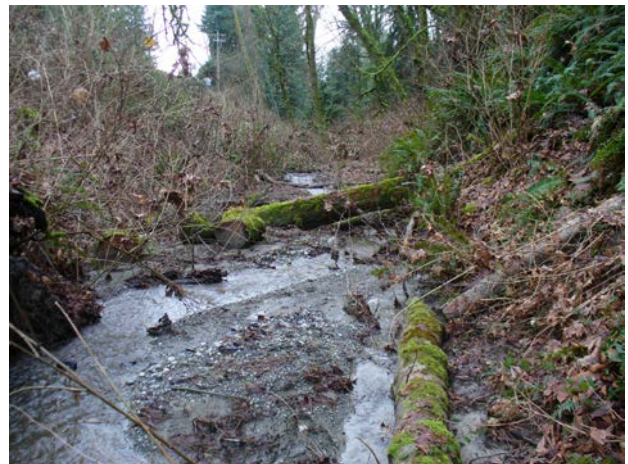
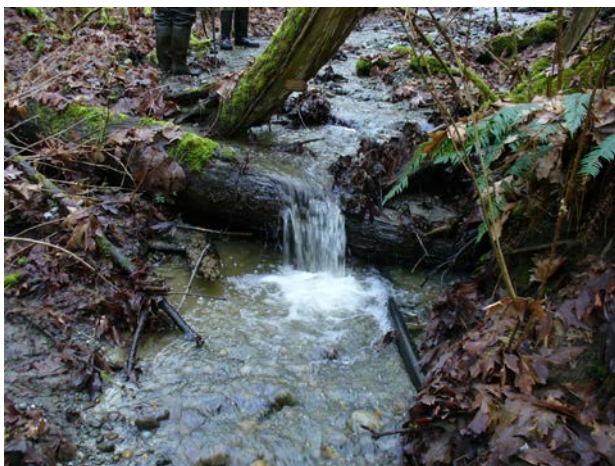
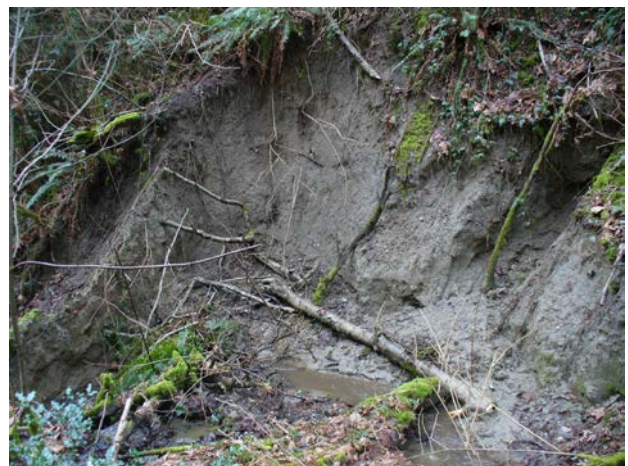
Description and Comments: Vegetation noted – Alder, Maple, cedar, salmonberry, sword fern, ivy. Strong potential for a project to remove ivy and other non-natives. The channel substrate is mostly silty, very sandy small gravel with some larger gravel. Braided sections, the filled-up reservoir in the lower section, and alluvial fan deposits at the mouth plus bank instability indicate that the stream carries a high sediment loading. Some wood is present, but pools formed tend to be shallow due to the sediment load. See Photos below:

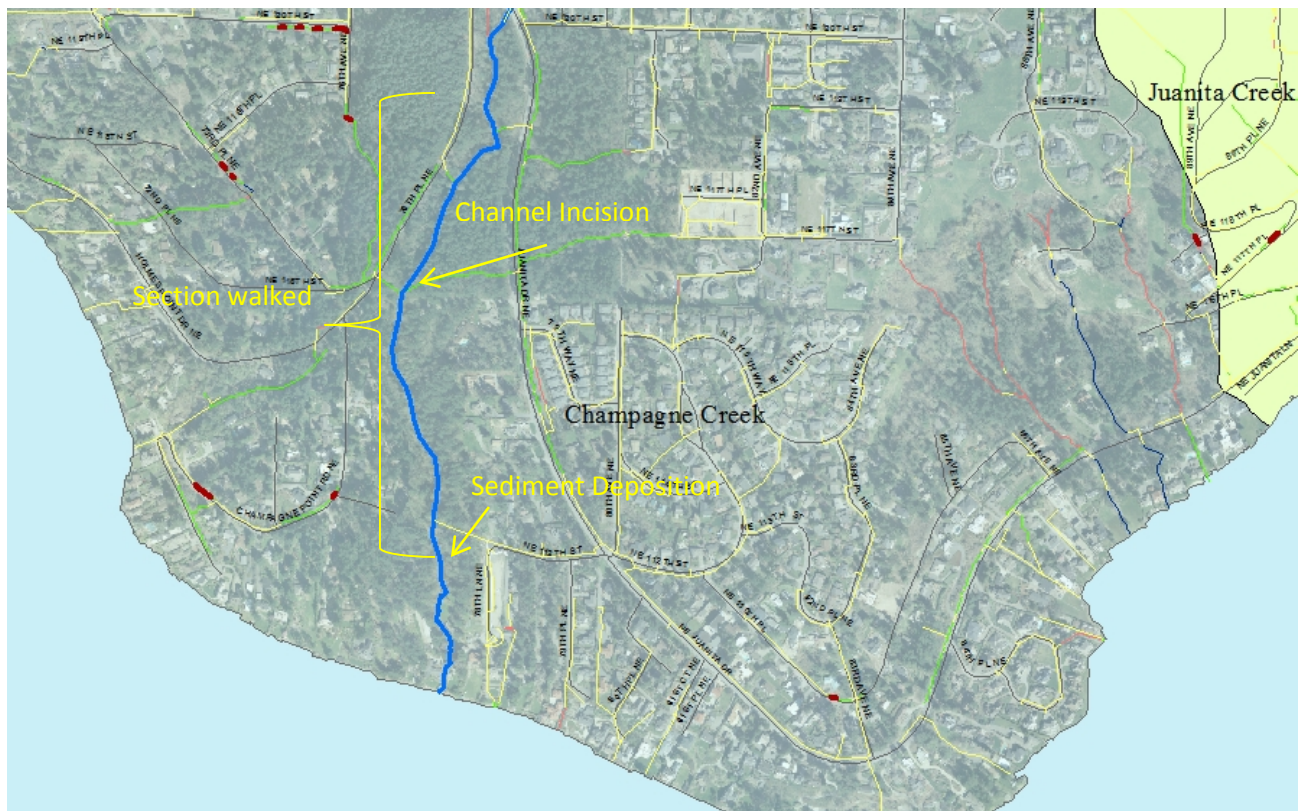
Example of extreme channel incision in Champagne Creek.

Issues:

Deposition in lowest reaches, and extreme incision through Juanita Woodlands.

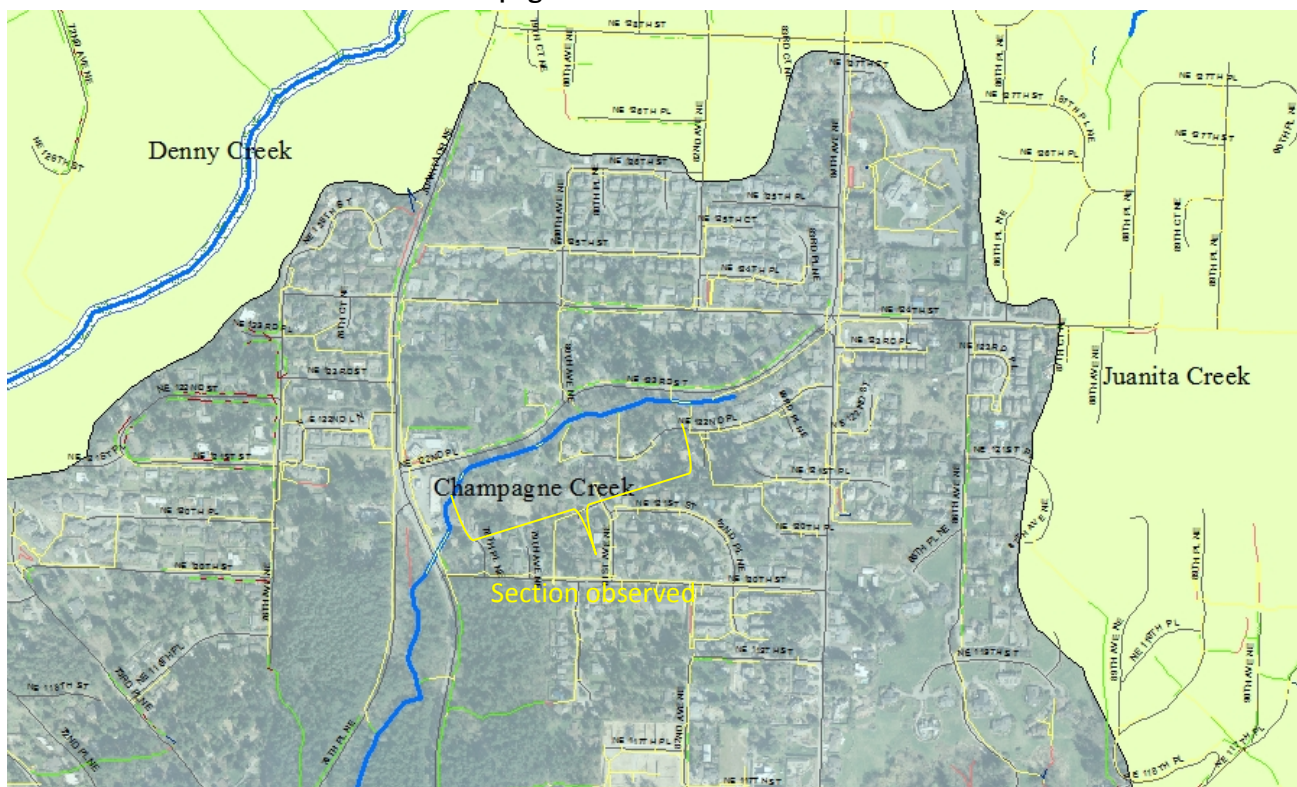
Typical stream section above Juanita Drive

Issues:
 Very little bank vegetation, confined channel, narrow riparian area
