**Tree Summary Table**

For: Benjamin Franklin Elementary School

**American Forest Management, Inc.**

Date: 1/15/2020

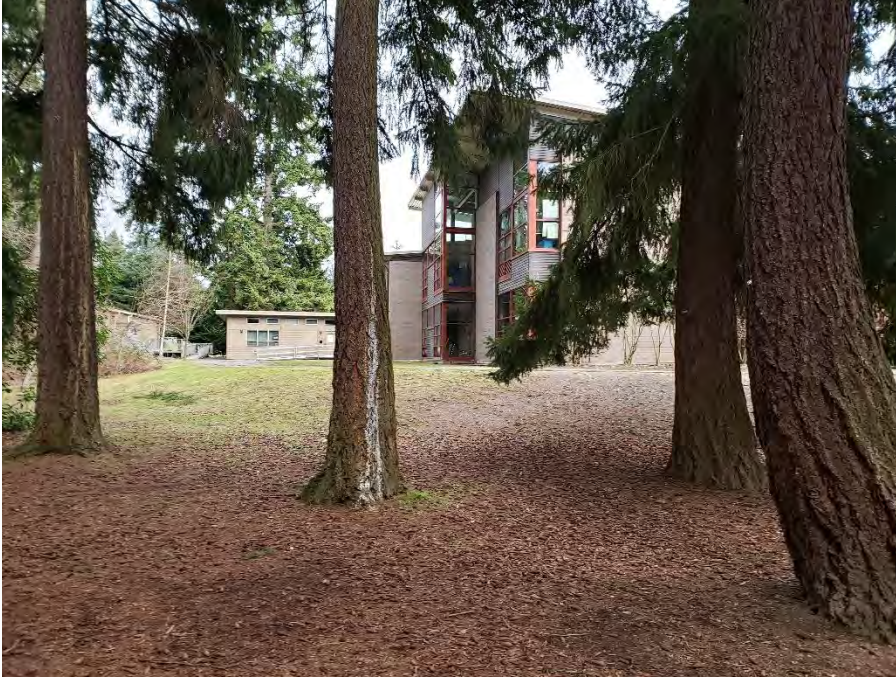
Photo 11. Facing west looking at trees 97 through 100. These are Douglas-fir trees that will likely be impacted by the proposed classroom addition on the west side of the existing school building.

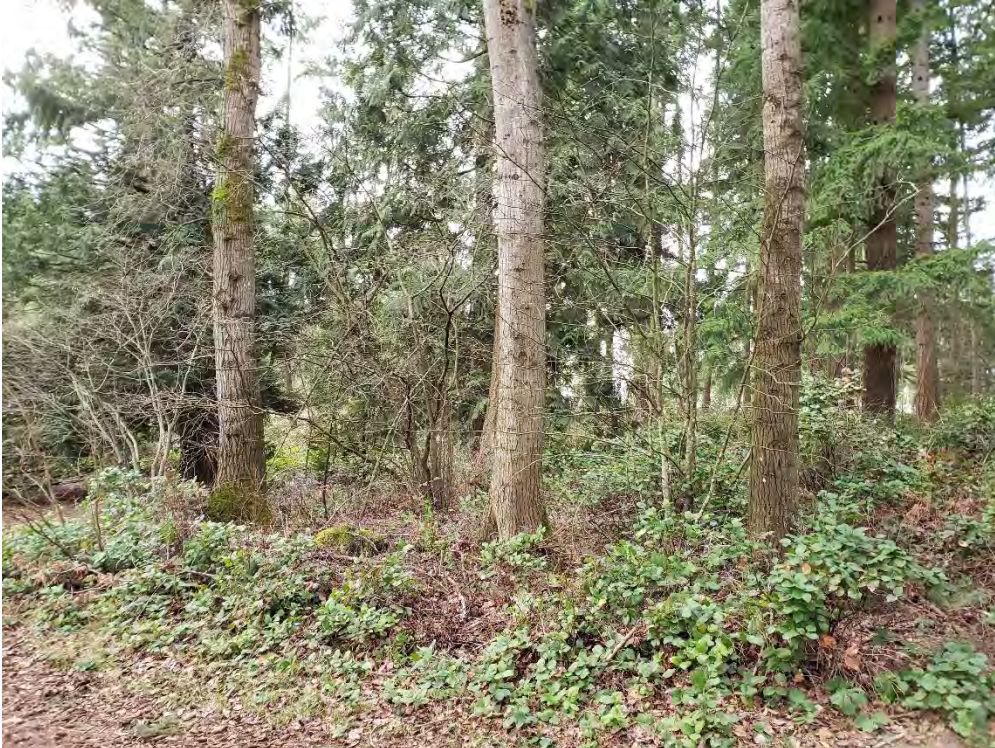
Photo 12. Trees number 101, 102, and 103 from left to right. These black cottonwood trees should not be isolated and if retained should be reassessed by a qualified arborist following development activity.

100	Douglas fir	<i>Pseudotsuga menziesii</i>	29.6	11	98	18	21	27	10	Good	Yes	Old shear crack on the east. 57' to school.
101	Black cottonwood	<i>Populus trichocarpa</i>	27.3	10	95	15	16	10	15	Fair	Yes	Old branch blowouts, suppressed by neighboring conifers. Reassess following development activity. Do not isolate.
102	Black cottonwood	<i>Populus trichocarpa</i>	21.5	7	95	15	27	20	10	Fair	Yes	Strong sweep to north. Reassess following development activity. Do not isolate.
103	Black cottonwood	<i>Populus trichocarpa</i>	16.1	5	80	16	16	18	12	Fair	Yes	Suppressed by neighboring conifers. Reassess following development activity. Do not isolate.
104	Douglas fir	<i>Pseudotsuga menziesii</i>	34.5	14	127	25	10	12	27	Good	Yes	Normal vigor. Normal LCR.
105	Western hemlock	<i>Tsuga heterophylla</i>	15.2	4	50	12	12	12	3	Poor	No	Nearly dead. Remove or snag.
106	Douglas fir	<i>Pseudotsuga menziesii</i>	14.4	4	47	13	13	13	13	Good	Yes	Slight sweep to south.

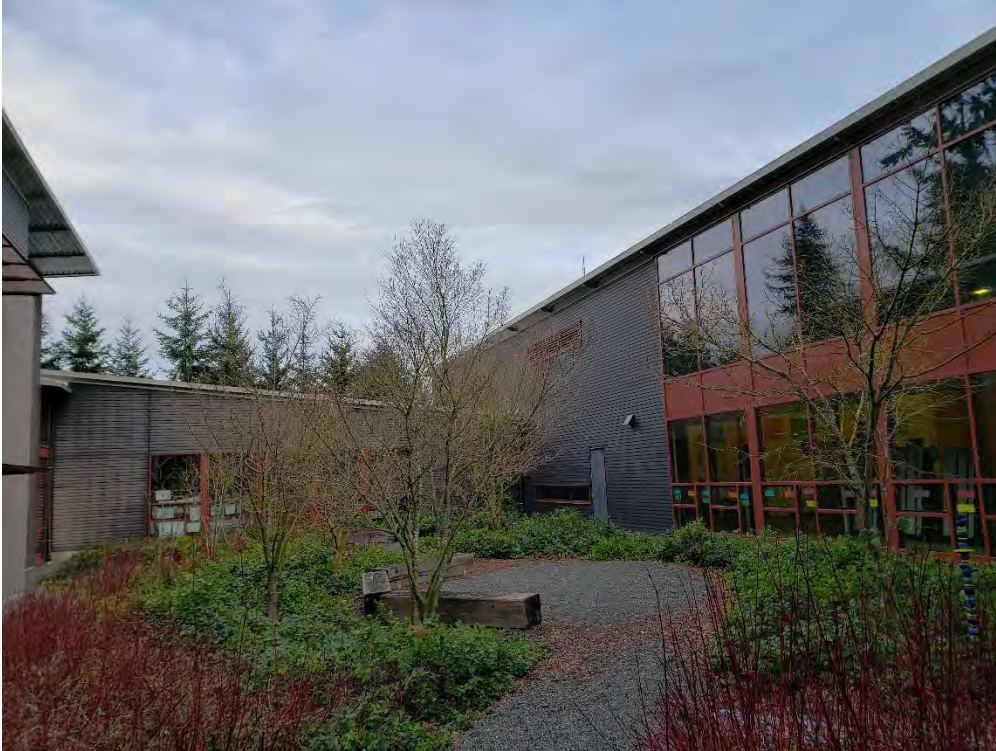
Photo 13. Showing trees 109 through 113 located in the courtyard. Trees 111, 112, and 113 are under 6 inches DBH and are not considered significant trees. These trees are unlikely to be impacted by the proposed development activity.
