## Section 3 Offsite Analysis

### 3.1 LEVEL I DOWNSTREAM ANALYSIS

DOWNSTREAM DRAINAGE EXHIBIT

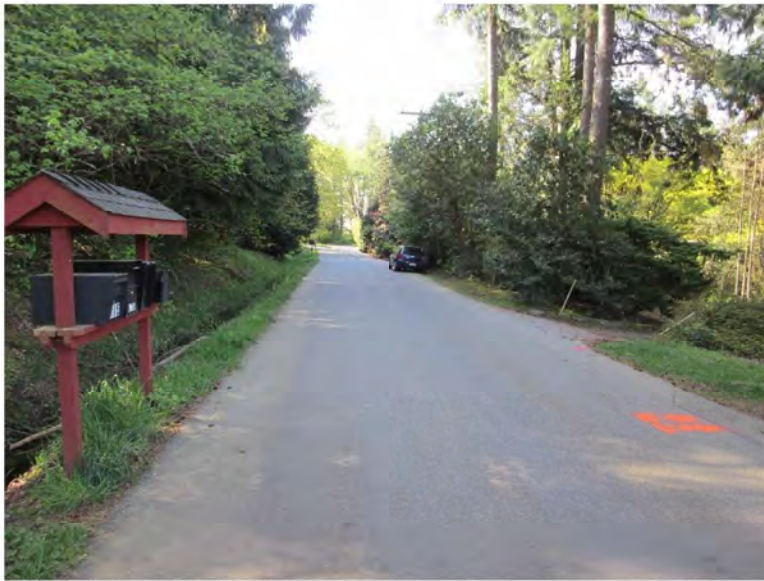
*Photo 1A: Site frontage where flows in the developed condition will be conveyed to the drainage swale along the east side of 112<sup>th</sup> Ave. – looking south.*

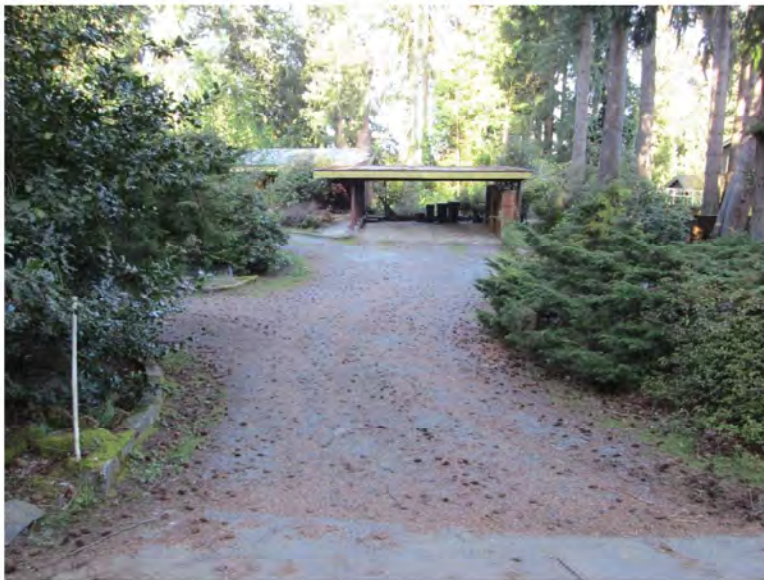
*Photo 2A: Site runoff sheet flows west across property's gravel driveway*

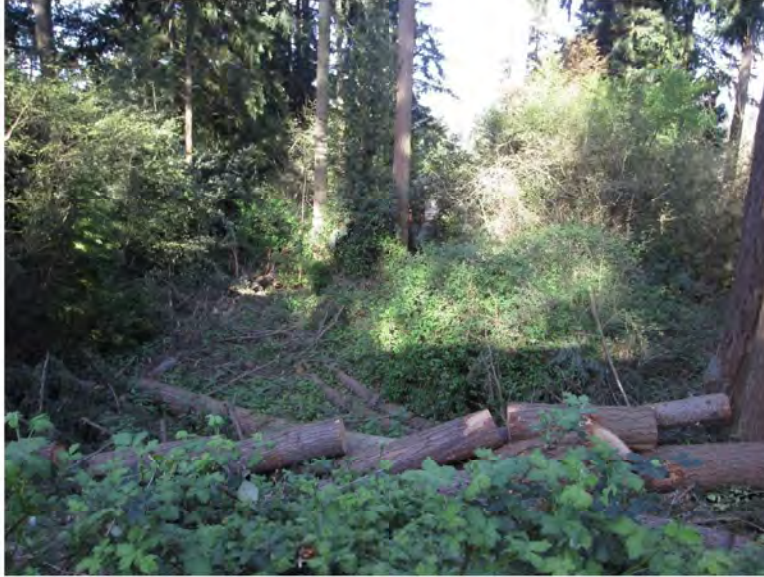
*Photo 3A: Site runoff continues to sheet flow west across steep slopes on the western portion of property. – looking west.*

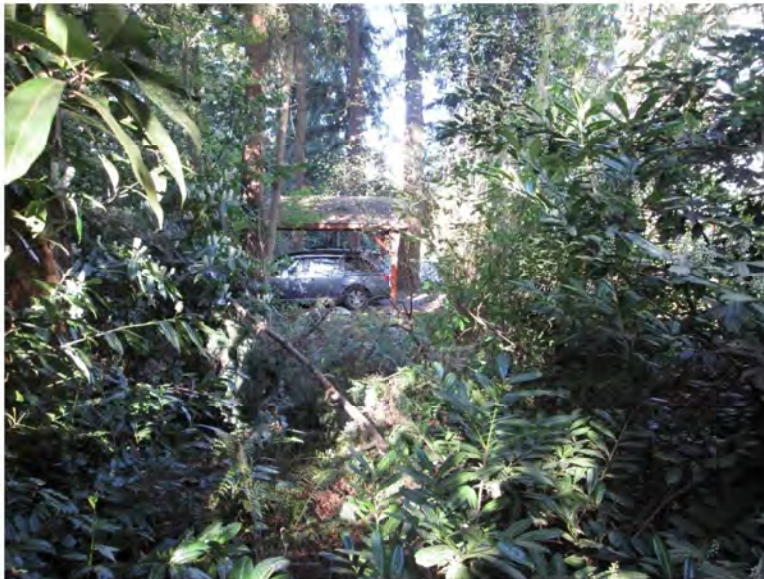
*Photo 4A: Site runoff sheet flows west onto adjacent property. – looking west.*

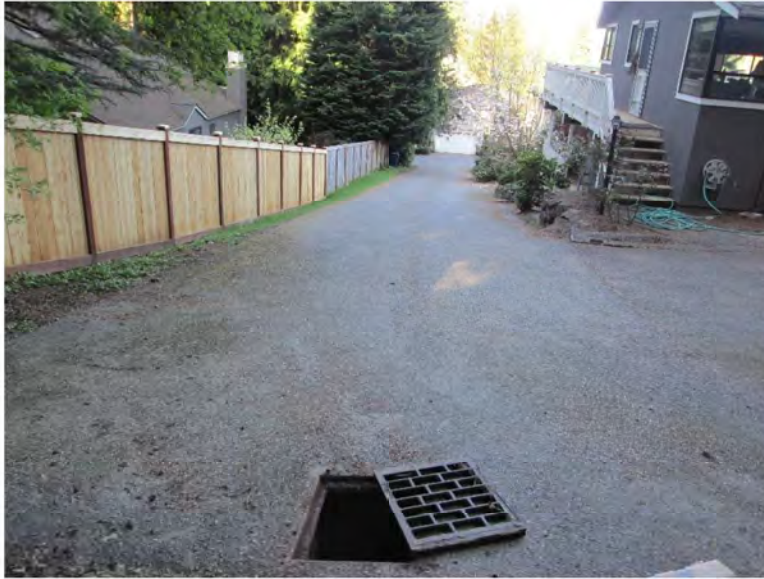
*Photo 5A: Flows enter a Type-I catch basin and continue west. – looking west.*

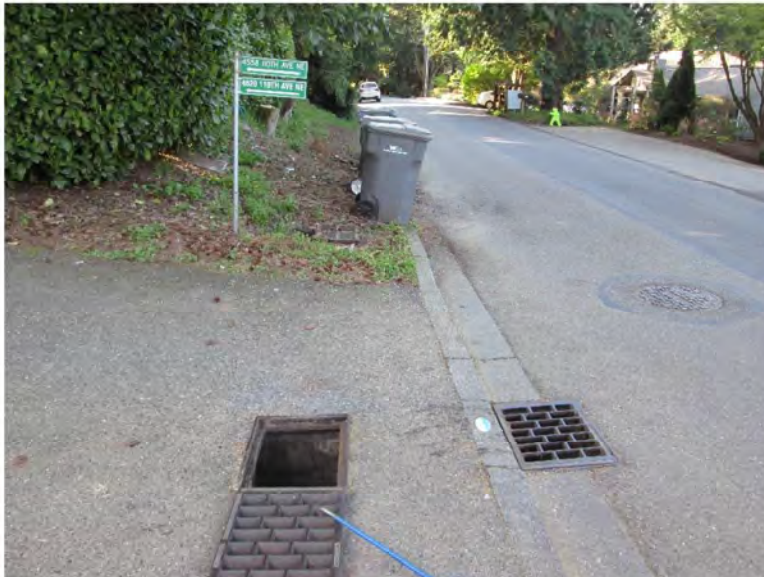
*Photo 6A: Flows enter a Type-I catch basin in the east side of 110<sup>th</sup> Ave NE and continue south. – looking south.*

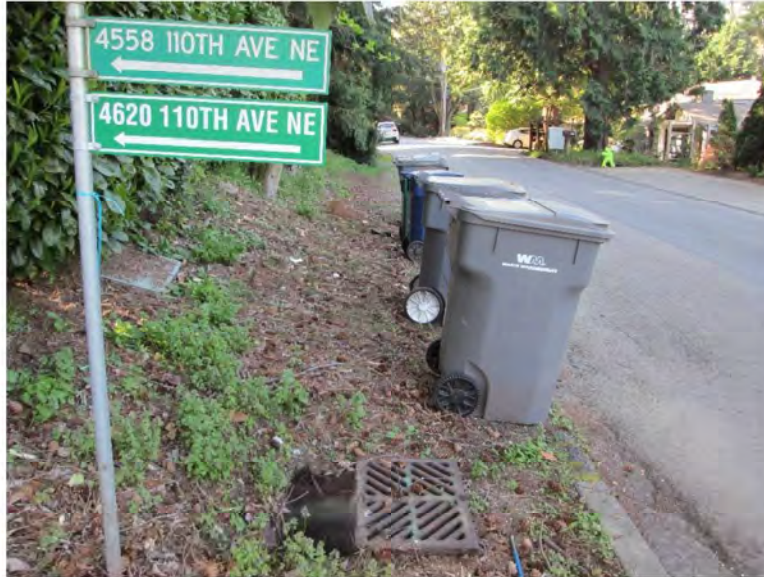
*Photo 7A: Flows enter a Type-I catch basin in the east side of 110<sup>th</sup> Ave NE and continue south. – looking south.*

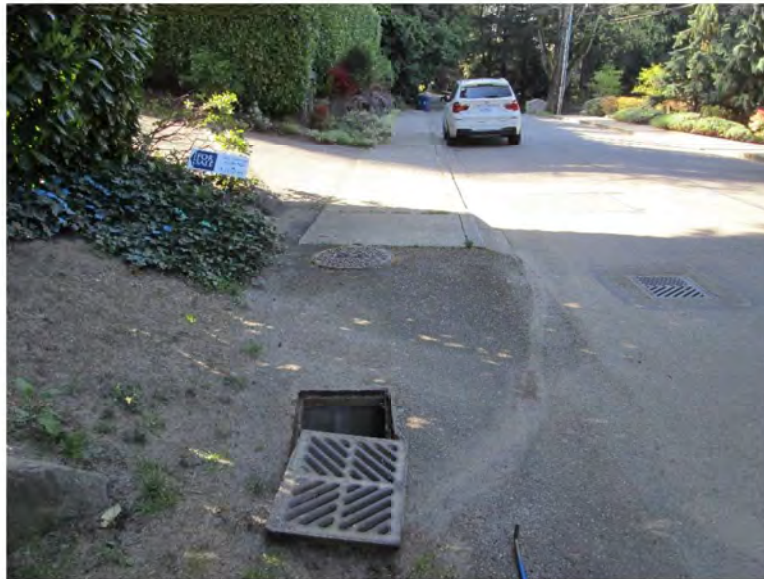
*Photo 8A: Flows enter a Type-I catch basin in the east side of 110<sup>th</sup> Ave NE and continue southwest to the Type-I catch basin in Photo 9. – looking south.*

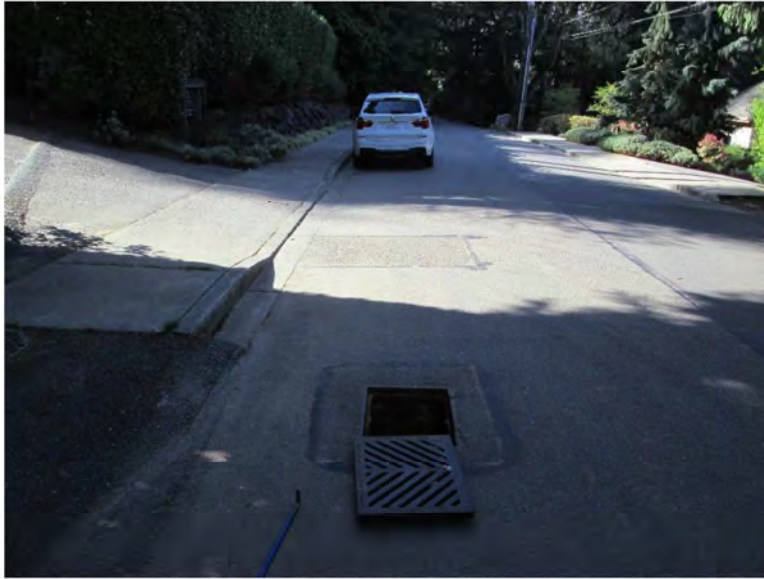
*Photo 9A: Flows enter a Type-I catch basin in the east side of 110<sup>th</sup> Ave NE and continue south. – looking south.*

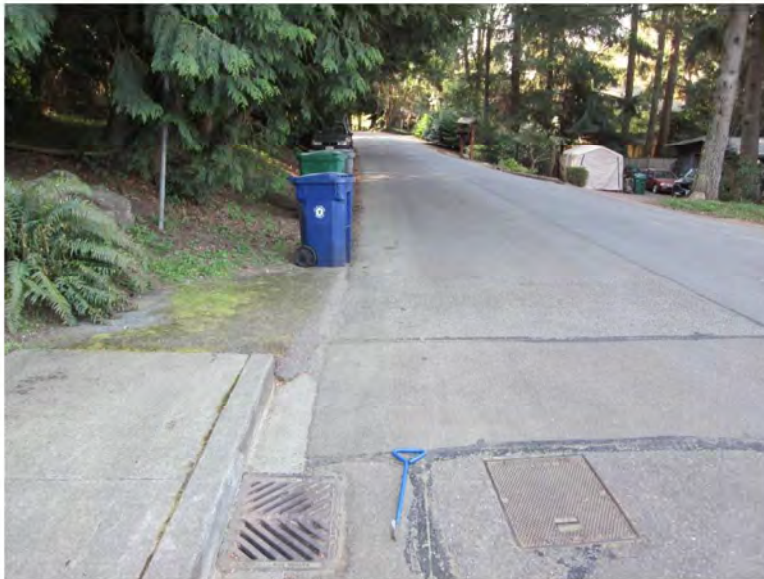
*Photo 10A: Flows enter a Type-I catch basin in the east side of 110<sup>th</sup> Ave NE and continue south. – looking south.*

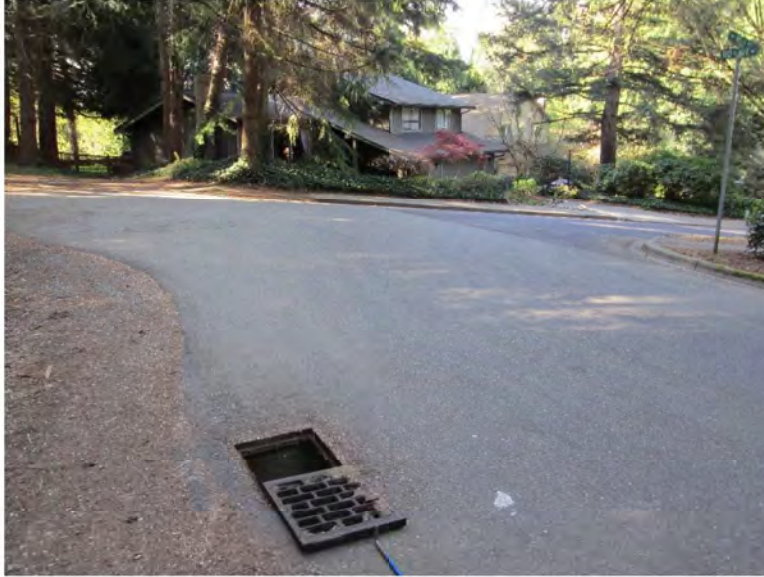
*Photo 11A: Flows enter a Type-I catch basin in the east side of 110<sup>th</sup> Ave NE and continue southwest. – looking southwest.*

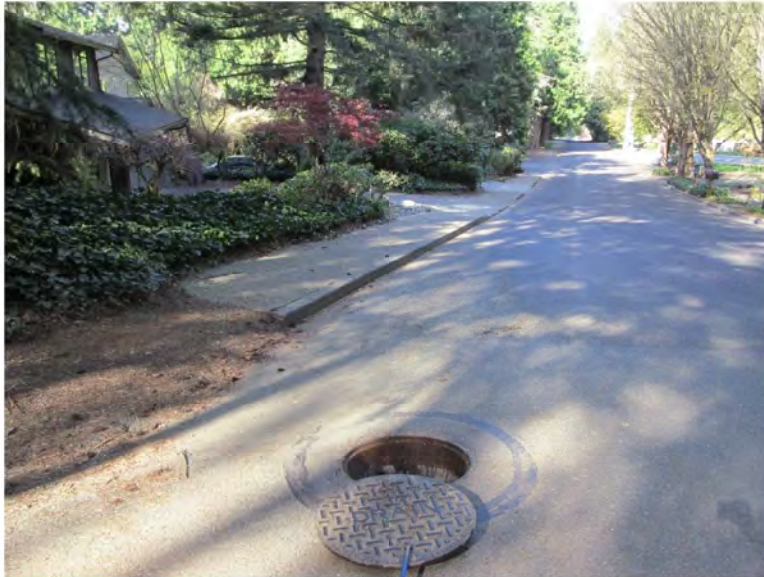
*Photo 12A: Flows enter a control structure in intersection 110th Ave NE and NE 45th St and continue west. – looking west.*

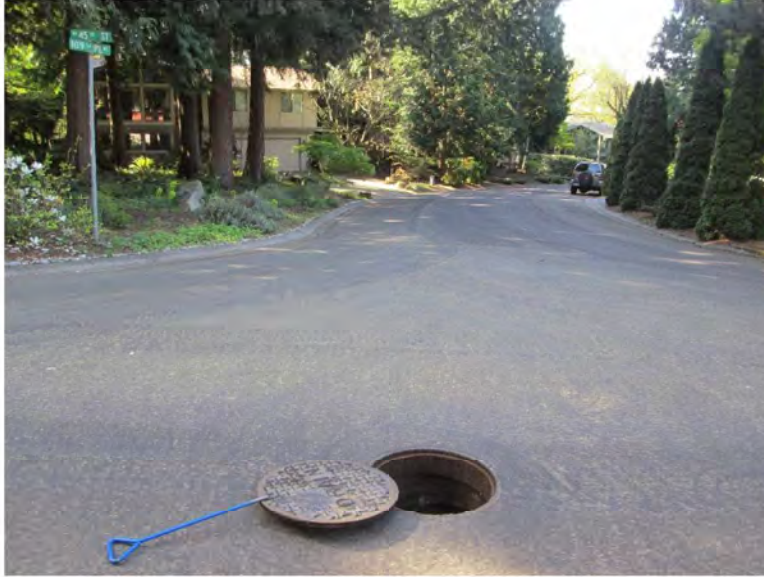
*Photo 13A: Flows enter a control structure in intersection NE 45<sup>th</sup> St and 109<sup>th</sup> PL NE and continue south. – looking south.*

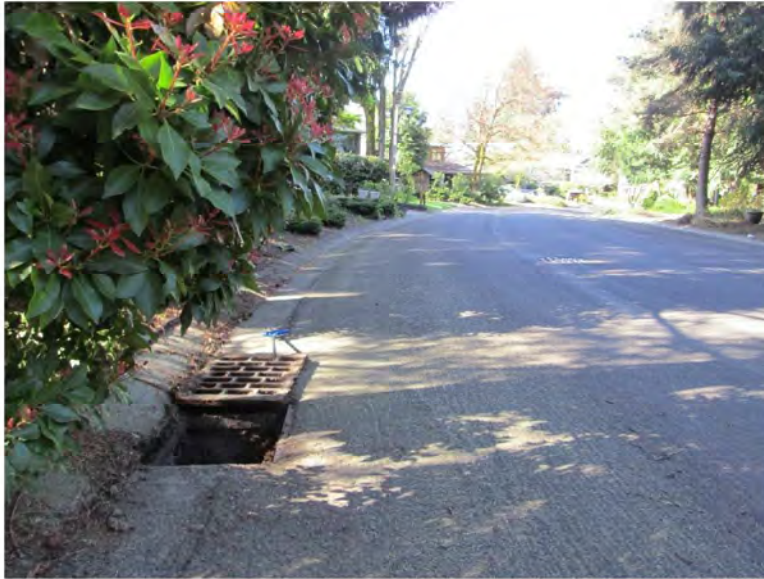
*Photo 14A: Flows enter a Type-I catch basin in the east side of 109<sup>th</sup> PL NE and continue south. – looking south.*

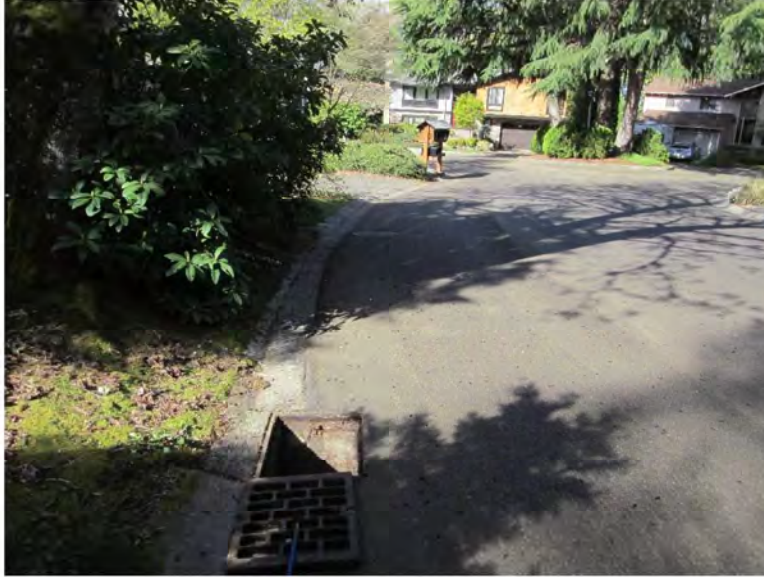
*Photo 15A: Flows enter a Type-I catch basin in the east side of 109<sup>th</sup> PL NE and continue southwest. This is past the quarter-mile downstream point. – looking southwest.*

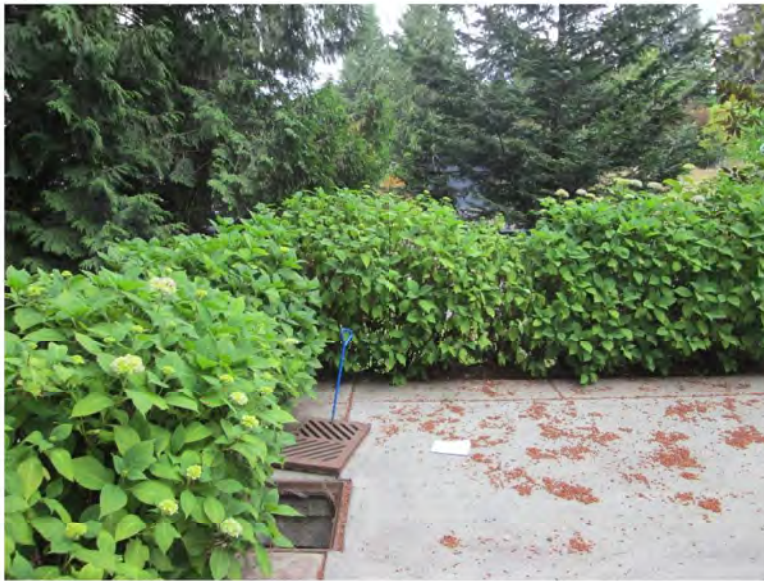
*Photo 1B: Onsite flows will be conveyed via pipe to the Type-II CB in the northeastern portion of parcel #954420-0262 and will continue north. – looking north.*

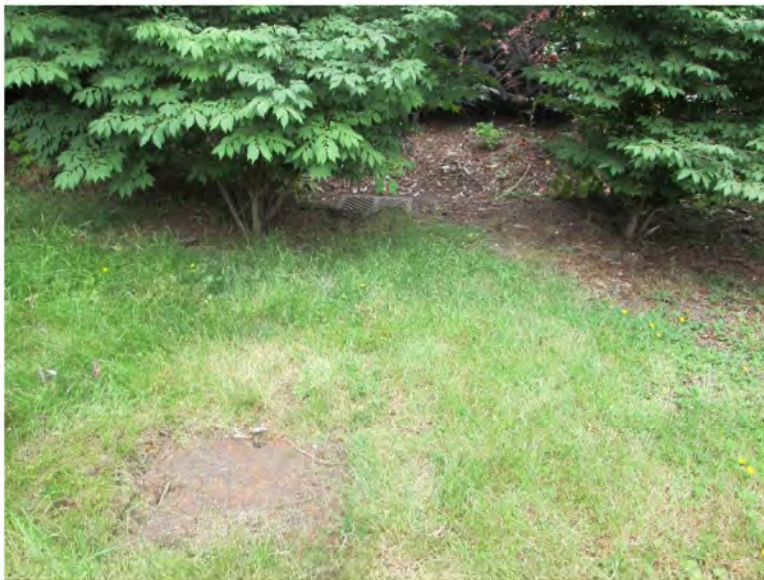
*Photo 2B: Flows enter a Type-I catch basin in the southeastern portion of parcel #941360 -0160 and continue west. – looking west.*

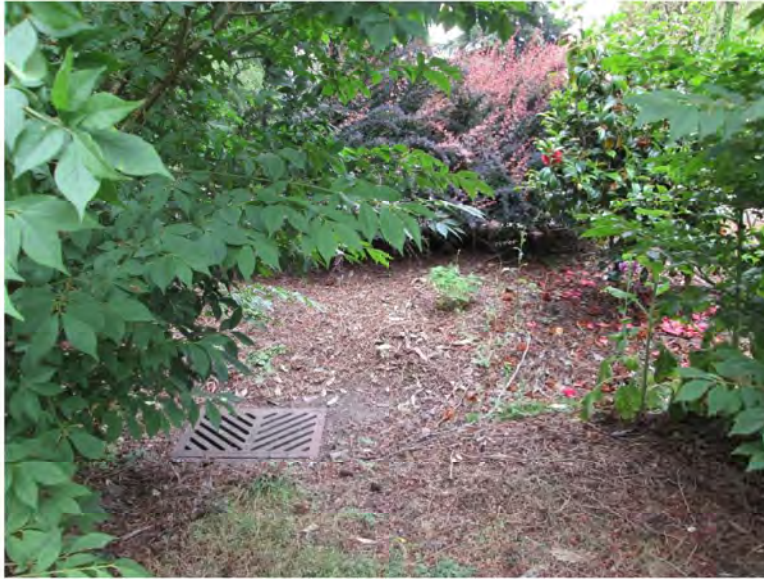
*Photo 3B: Flows enter a Type-I catch basin and continue west. – looking west.*

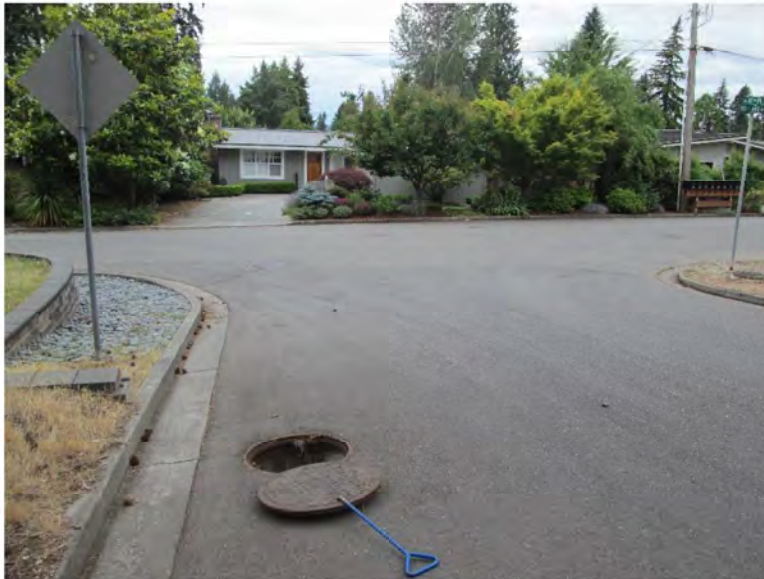
*Photo 4B: Flows enter a Type-I catch basin in the south side of NE 47<sup>th</sup> PL and continue west. – looking west.*

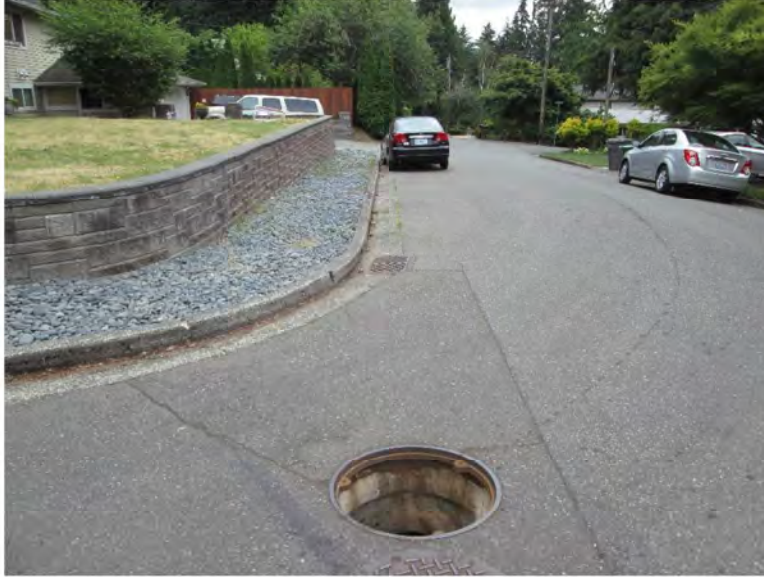
*Photo 5B: Flows enter a Type-I catch basin within intersection NE 47<sup>th</sup> PL and 110<sup>th</sup> Ave NE and continue south. – looking south.*

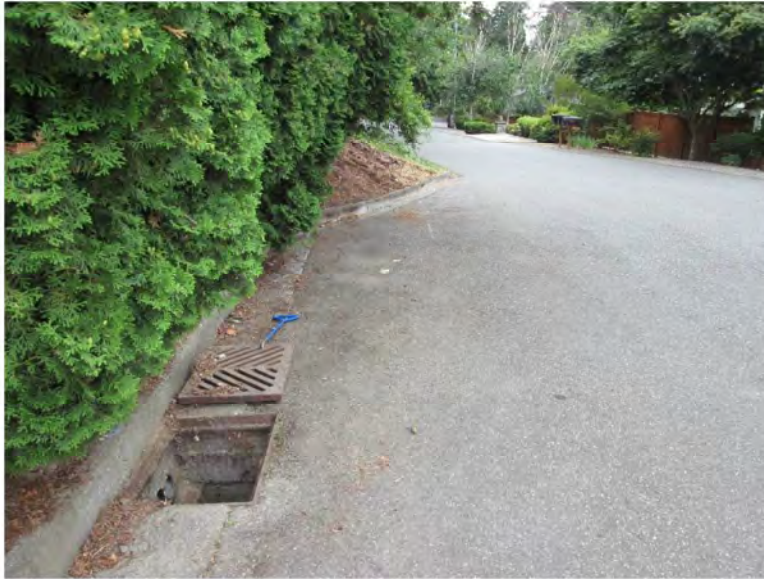
*Photo 6B: Flows enter a Type-I catch basin in the east side of 110<sup>th</sup> Ave NE and continue west. – looking west.*

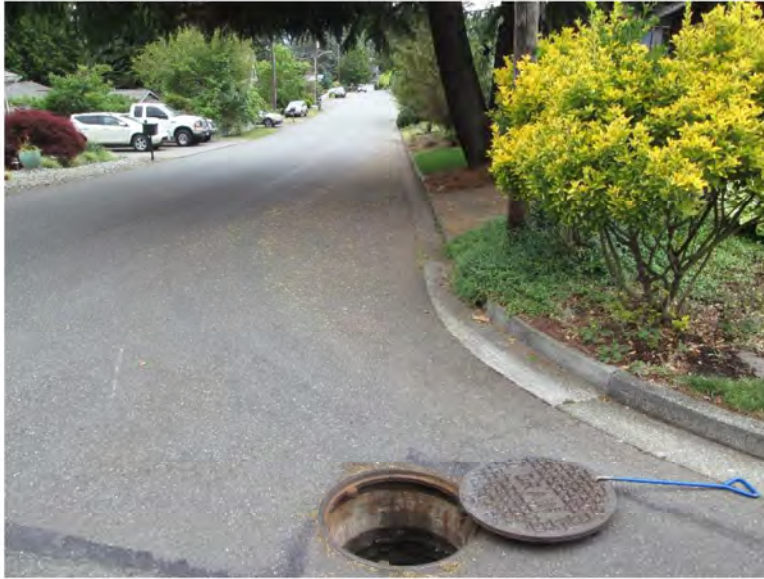
*Photo 7B: Flows enter a Type-II catch basin in the northwestern corner of intersection 110<sup>th</sup> Ave NE and NE 47<sup>th</sup> St and continue west. – looking west.*

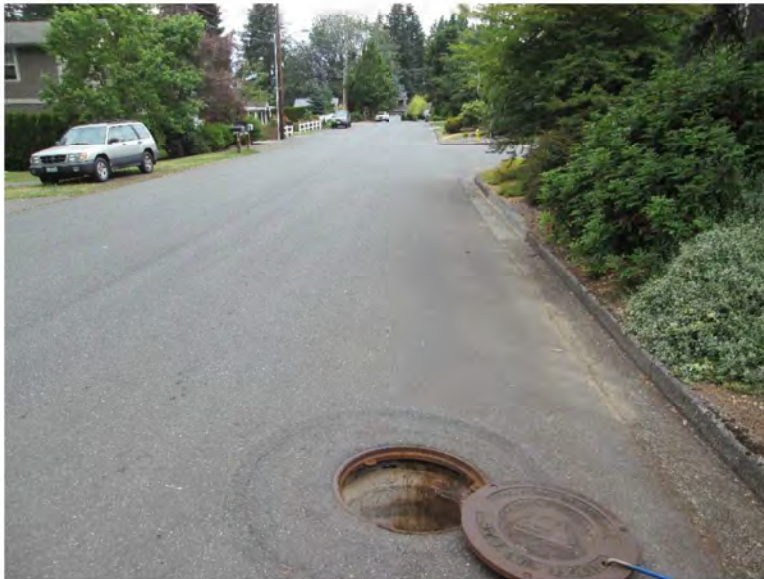
*Photo 8B: Flows enter a Type-II catch basin in the north side of NE 47<sup>th</sup> St and continue west. – looking west.*

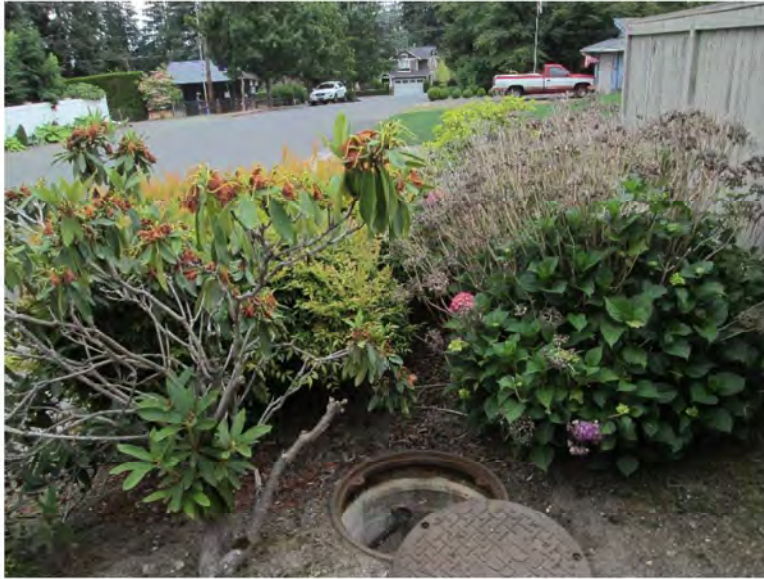
*Photo 9B: Flows enter a Type-II catch basin in the south portion of parcel #941360-0570 and continue west. – looking west.*

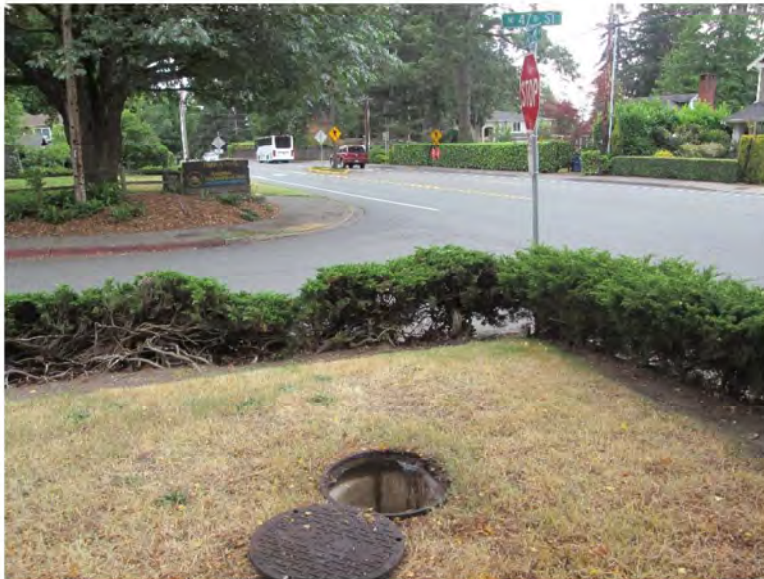
*Photo 10B: Flows enter a Type-II catch basin in the southwest portion of parcel #41360-0540 and continue south. – looking southwest.*

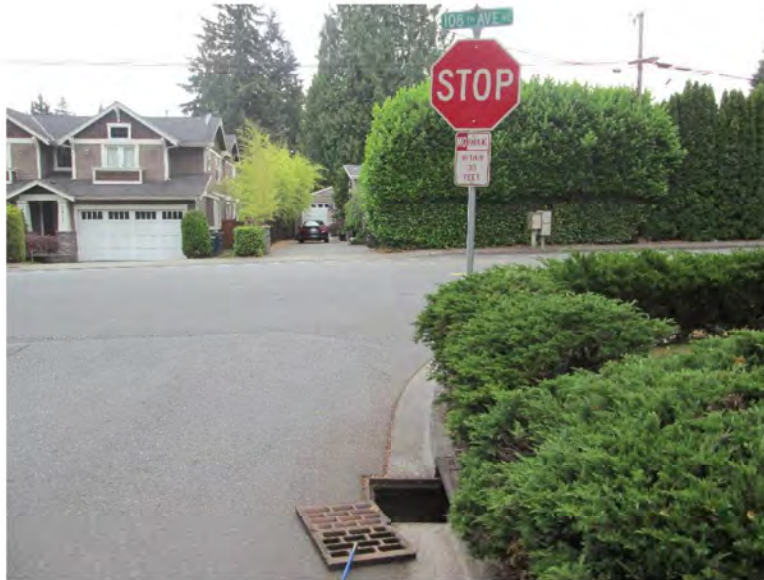
*Photo 11B: Flows enter a Type-I catch basin in the north side of NE 47<sup>th</sup> St and continue south. – looking west.*

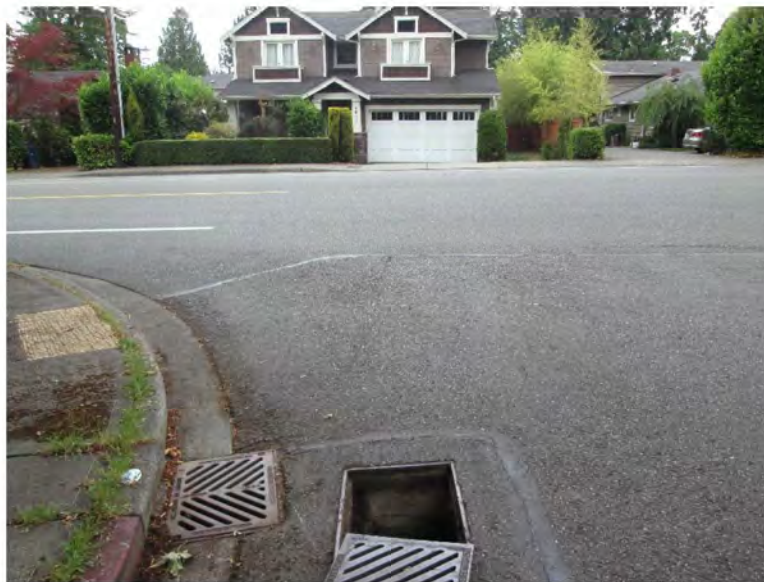
*Photo 12B: Flows enter a Type-I catch basin in the south side of NE 47<sup>th</sup> St and continue south. – looking west.*

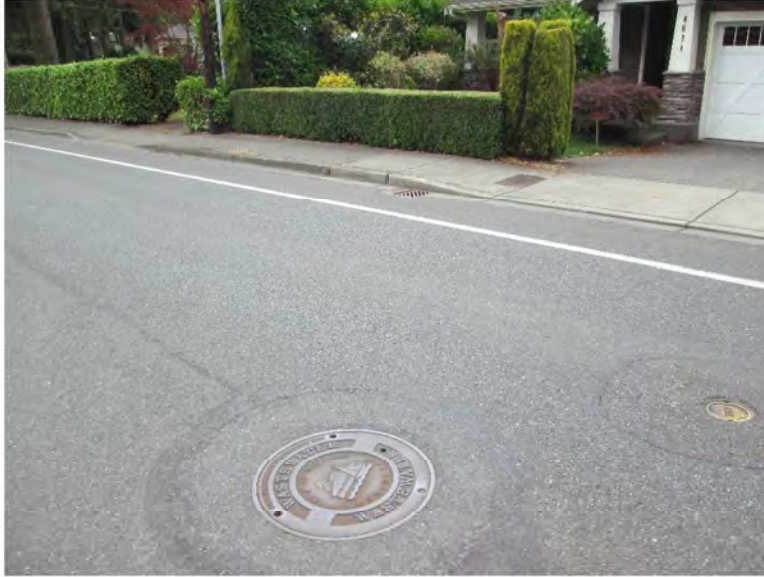
*Photo 13B: Flows enter a control structure in intersection NE 47<sup>th</sup> St and 108<sup>th</sup> Ave NE and continue southwest. – looking southwest.*

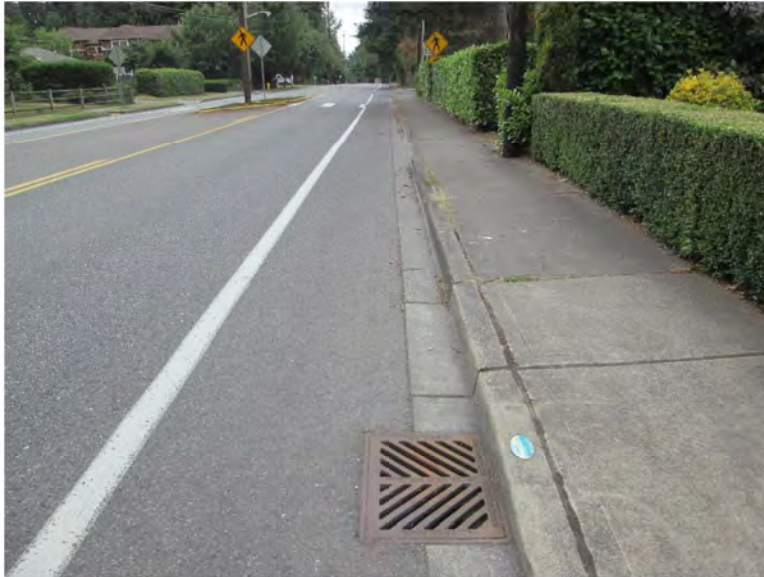
*Photo 14B: Flows enter a Type-I catch basin on the west side of 108<sup>th</sup> Ave NE and continue south. This is the quarter-mile downstream point. – looking south.*

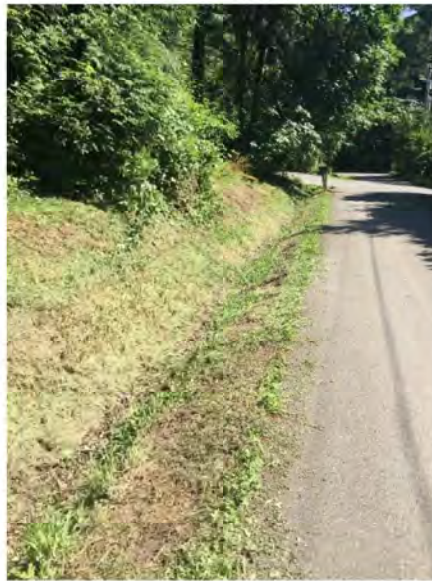
*Photo 1C: Flows continue south along the open channel V-ditch – looking south.*

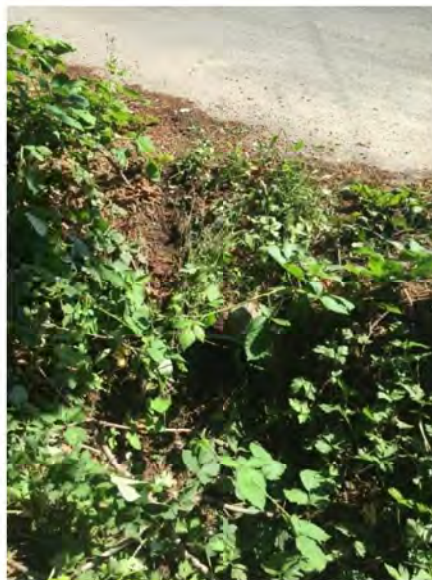
*Photo 2C: Flows continue south along the open channel V-ditch and are conveyed through a 12" pvc driveway culvert. Flows continue south – looking south.*

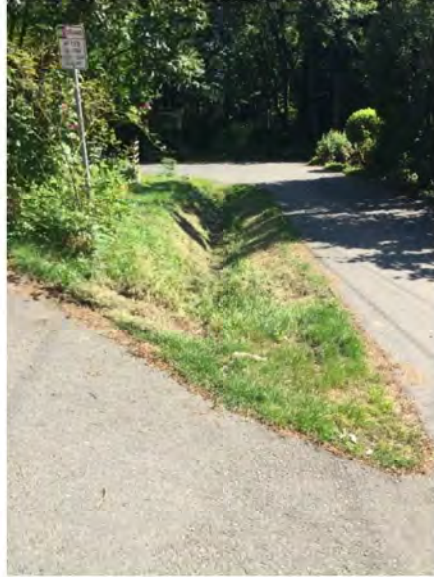
*Photo 3C: Flows are conveyed through the 12" pvc driveway culvert and outlet into an open channel V-ditch – looking south.*

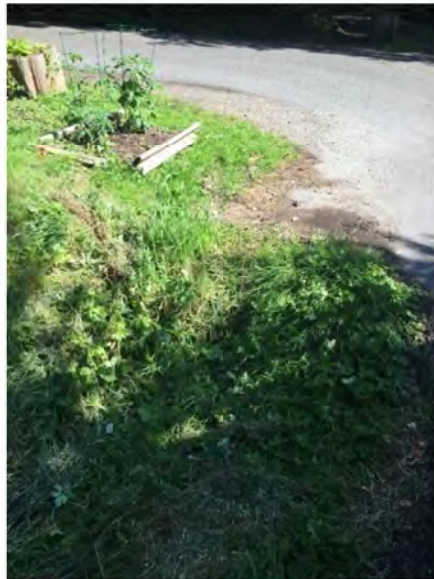
*Photo 4C: Flows continue south along V-ditch into a 12" ADS pipe which conveys the stormwater underneath 112<sup>th</sup> Ave NE toward Watershed Park – looking south.*

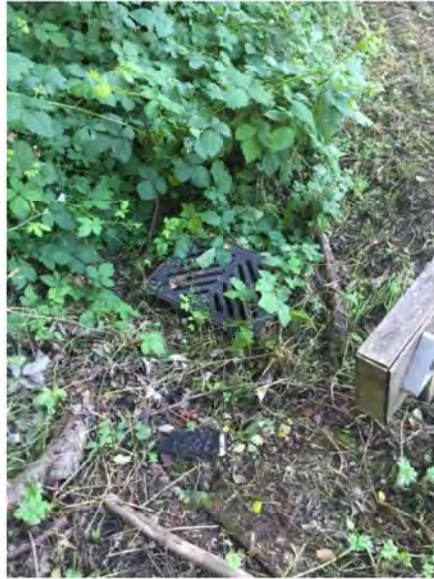
*Photo 5C: Flows are conveyed south under 112<sup>th</sup> Ave NE to an existing CB Type-1 located along the north perimeter of Watershed Park. Flows continue west. – looking southeast.*

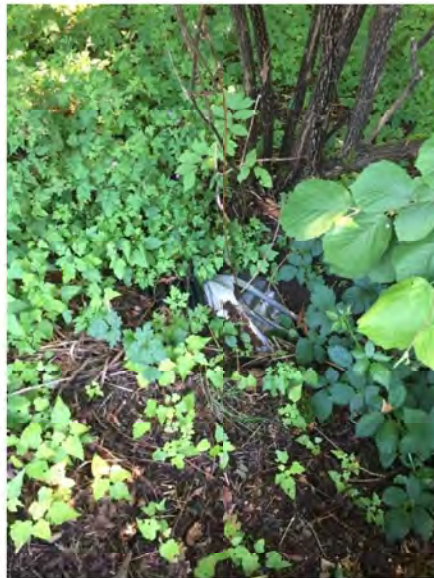
*Photo 6C: Stormwater flows west along the north perimeter of Watershed Park approximately 100' before out-letting via the 12" ADS pipe with debris cage into Watershed Park. – Looking south.*
