LAKE WASHINGTON SCHOOL DISTRICT  
KIRKLAND MS ADDITION  
439 18th Ave.  
Kirkland, WA 98003

TREE PROTECTION PLAN  
TP1.00

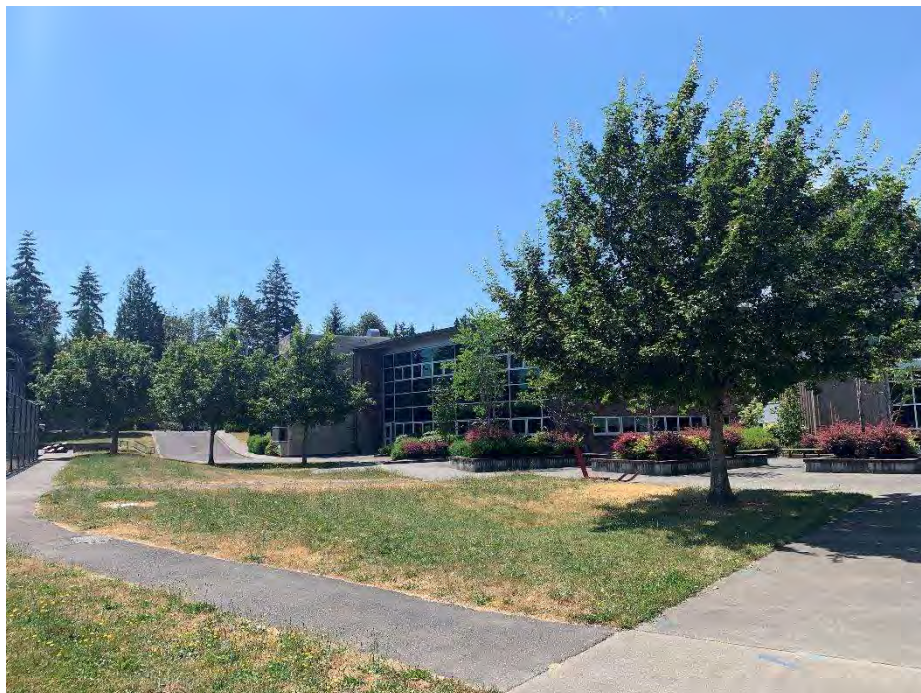
All trees were found to be in *Excellent* condition; there were no structural defects, and the foliage was healthy.

Tree #1 is a Norway maple (*Acer platanoides*) with a diameter of 12.8 inches. This tree was found to be in *Excellent* Health and have *Excellent* Structure. This tree is of Moderate Retention Value due to its condition. The CRZ is 12.8 (rounded to 13) feet from the trunk. This tree will be removed for a new covered walkway to the campus and the new classroom addition.

Tree #2 is another Norway maple (*Acer platanoides*) with a diameter of 8.9 inches. This tree was found to be in *Excellent* Health and have *Excellent* Structure. This tree is of Moderate Retention Value due to its condition. The CRZ is 8.9 (rounded to 9) feet from the trunk. This tree is not planned to be impacted by development. Tree Protection Fencing should be placed around the TPZ, which is at a minimum, four-and-a-half (4.5) feet from the trunk.

Tree #3 is another Norway maple (*Acer platanoides*) with a diameter of 8.4 inches. This tree was found to be in *Excellent* Health and have *Excellent* Structure. This tree is of Moderate Retention Value due to its condition. The CRZ is 8.4 (rounded to 9) feet from the trunk. This tree is not planned to be impacted by development. Tree Protection Fencing should be placed around the TPZ, which is at a minimum, four-and-a-half (4.5) feet from the trunk.

Tree #4 is another Norway maple (*Acer platanoides*) with a diameter of 11.5 inches. This tree was found to be in *Excellent* Health and have *Excellent* Structure. This tree is of Moderate Retention Value due to its condition. The CRZ is 11.5 (rounded to 12) feet from the trunk. This tree will be removed for a new covered walkway to the campus and the new classroom addition.

Figure 2. All inventoried Trees #1 – #4 from left to right.

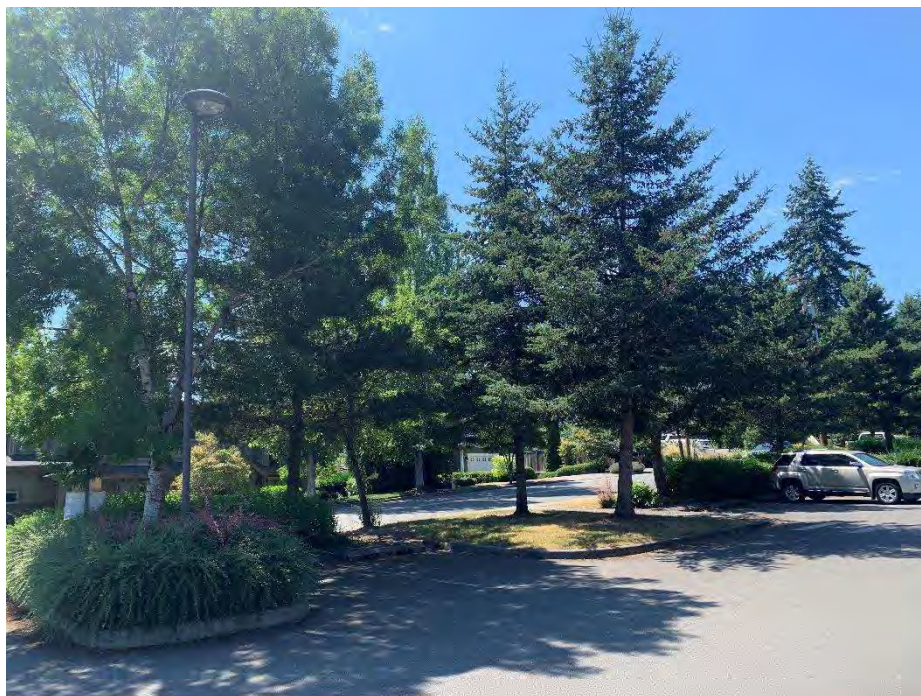
Figure 3. Trees border the subject parcel and are within the parking lot in landscape beds.

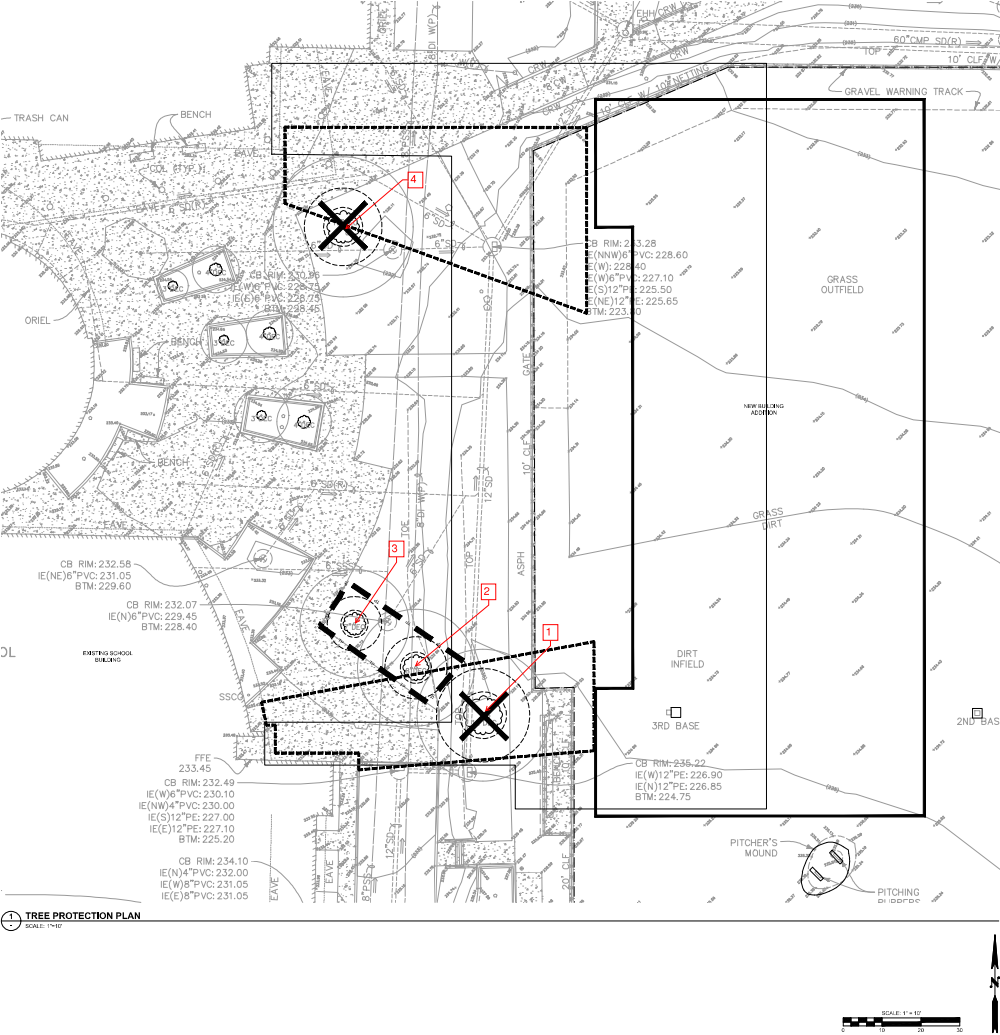
The Watershed Company arborist visited the site on July 28, 2022 to inventory and assess the trees identified on this survey.
