**Subject:** Kirkland Cannery Pre-Design Study

# THE HISTORIC KIRKLAND CANNERY PROJECT

**Kirkland Cannery Building – Study for Adaptive Re-Use**  
City of Kirkland

## **Architectural Deficiency Report**

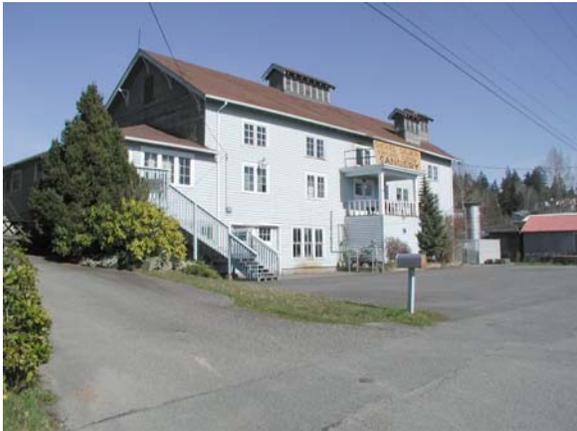
Figure 1: Exterior view of south façade

Corrections: The wood siding is in need of repair and will require replacement. The vinyl siding should be replaced to return the exterior to its historic condition. Structurally, the exterior walls will need to be tied to the foundation, and new plywood added in some areas as shear walls to resist lateral earthquake forces. The preliminary structural walk-through and review, by Degenkolb Engineers has not included a structural analysis of the building's ability to withstand lateral seismic forces (see structural review following).

The South façade of the building presents a vinyl siding that replaced the original horizontal wood board siding, which is still present on the north, east and west sides of the structure.
