## CHAPTER 54 – NRH BUSINESS DISTRICT (NRHBD) ZONES

ATTACHMENT 1, SITE PLAN  
 Totem Lake Apartments Site  
 NE 115 & 116 Streets, at 124th Ave NE  
 & Slater Road, Kirkland, WA  
 February 2, 2011  
 Gilles Consulting  
 Page 13 of 31

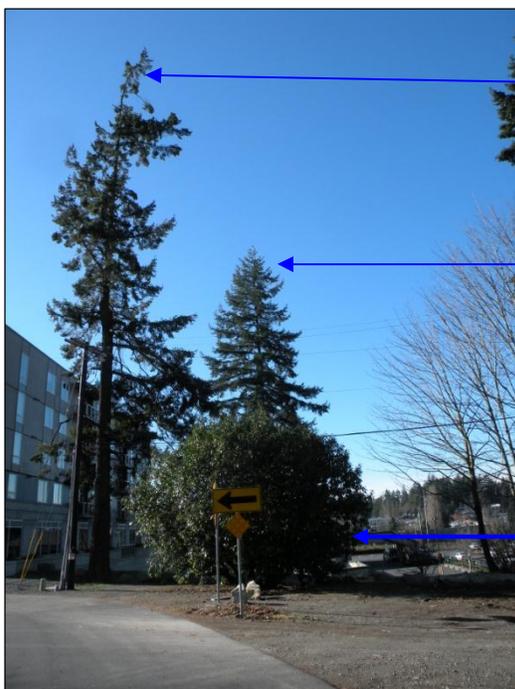
Photo # 1: Looking west from NE 115<sup>th</sup>

- Right-of-Way Trees:
  - # 938 is the only right-of-way tree.
  - It is in rapid decline. It has symptoms that may indicate center rot, base rot, and root rot.

- Before any effort is made to retain this tree I strongly recommend it be tested with a Resistograph to determine if internal decay exists; and if it does, to what extent it exists. If the decay is in an advanced stage it will change the health rating of the tree from Fair to Poor and the recommendation will change from retention to removal.

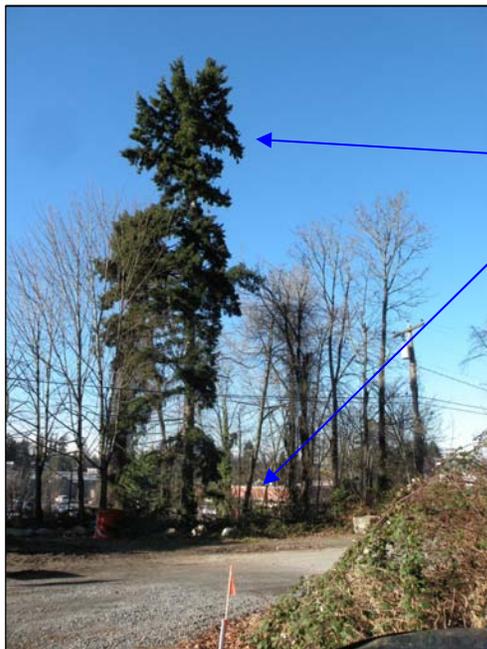
# 947

Photo # 2: Looking northwest from NE 115<sup>th</sup> Street onto the Vacated Slater Road

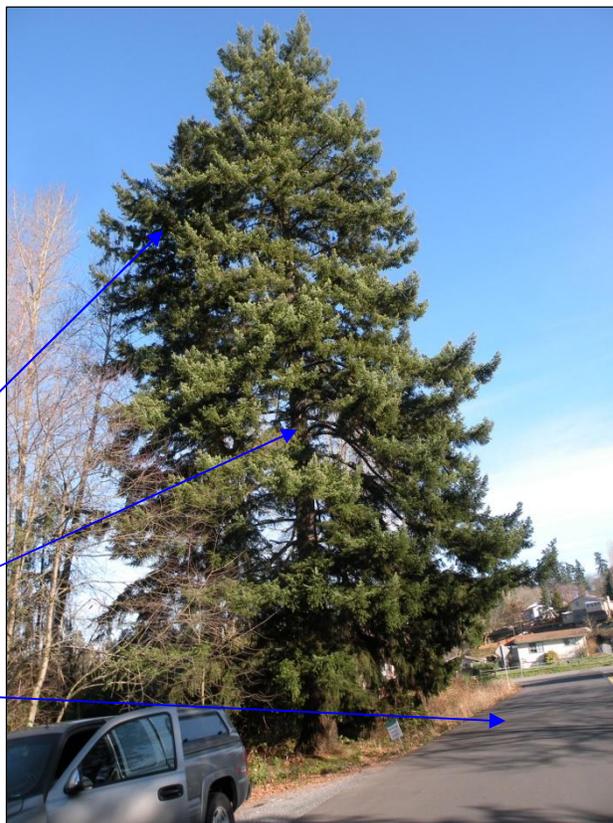
Photo # 3: #s 822 & 821

Vacated Slater Road
