Exhibit G--Grove with buildable area  
Appeal of two short plats:  
Avalon East : SUB14-01032  
Avalon West: SUB14-01033

# AVALON EAST - EAST

TO: Josh Lysen, Vice President Merit Homes  
JOB SITE: Avalon East & West - 10633 128<sup>th</sup> Ave NE, Kirkland, WA 98033  
SUBJECT: Tree Inventory & Assessment  
DATE: March 3, 2014; Revised May 27, 2014  
PREPARED BY: Sean Dugan,  
Registered Consulting Arborist #457  
ISA Certified Board Certified Master Arborist PN-5459B  
ISA Qualified Tree Risk Assessor

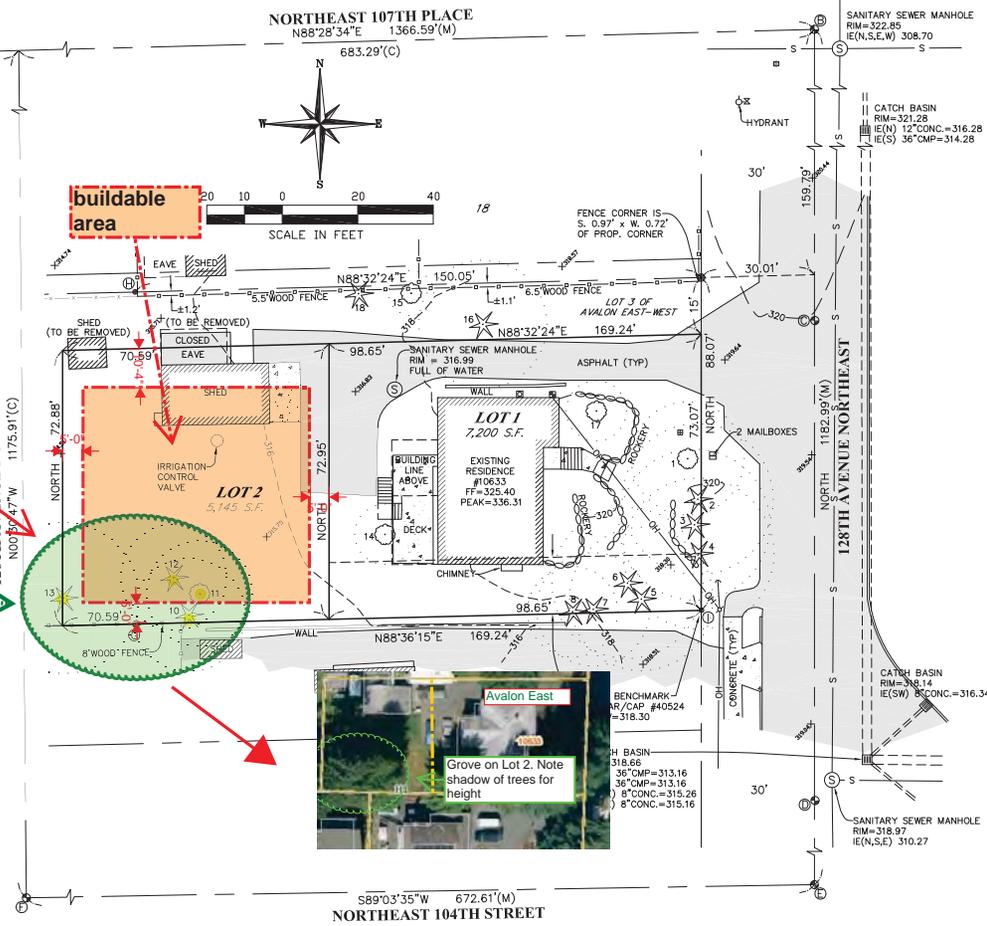
Trees 10-13

approximate  
diplines of the  
grove. The diplines  
per the arborist  
report is the limit of  
disturbance.

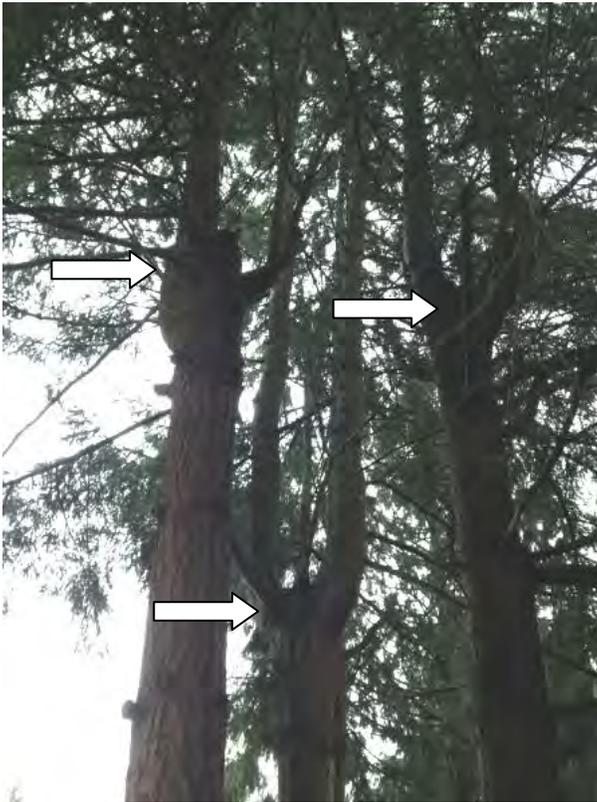
All of these trees have been topped in the past and the reiterative leads are approximately 40 to 60 feet tall. Several of the leads are poorly structured and are showing symptoms that indicate decay possibly exists at the point of the topping. (See Figure 1)

Figure 1. View looking southwest at trees 5, 6 and 7; white arrows point to the past topping cuts.

Each of the Douglas-fir trees in the stand currently present a moderate level of risk to the surrounding targets due to the potential for failure of the new leads. The likelihood of these failing will increase over time and so will the risk potential. Long-term management will be required to prevent a failure from contacting the future structure. Options for management are limited.

If any of the trees are removed I believe that it will have a negative impact on the adjacent trees. During my assessment, I was able to evaluate how the trees react in moderate wind gusts. Each tree relies on the adjacent trees for support during the bending moment of the leads. If a tree is removed, the support will go with it and there will be a greater likelihood of the remaining trees to fail.

5	Douglas-fir/ <i>Pseudotsuga menziesii</i>	22.5		Good**	Fair-	Drip Line	No	Moderate/ High	Remove - Structure	0	topped, 3 leads- 1 dead, tallest 50 feet tall, decayed stump, slight resin stream, stub cut, kink on top main lead
6	Douglas-fir/ <i>Pseudotsuga menziesii</i>	17		Good**	Poor	Drip Line	No	Moderate/ High	Remove - Structure	0	topped, new 40 foot lead- major stress riser
7	Douglas-fir/ <i>Pseudotsuga menziesii</i>	22.3		Good**	Fair	Drip Line	No	Moderate/ High	Remove - Structure	0	topped, growth 60 feet tall, ridge between new leads, U-shaped
8	Douglas-fir/ <i>Pseudotsuga menziesii</i>	17.2		Good**	Fair-	Drip Line	No	Moderate/ High	Remove - Structure	0	topped, 2 new leads 50 feet tall, fiber buckling on compression side of main new lead
9	Cherry/ <i>Prunus</i> spp.	7		Poor	Poor	Drip Line	No	Low	Remove - Health	0	over mature & in decline, diseased
10	Western hemlock/ <i>Tsuga heterophylla</i>	20		Good	Fair	Drip Line	Yes	Low		6	multiple tops-narrow angle of attachment
