RE: RESTORATION PLAN FOR THE TO JUANITA HIGH SCHOOL TEMPORARY PARKING AREAS, JUANITA HIGH SCHOOL PROJECT, KIRKLAND, WASHINGTON

**ARBORIST REPORT
FOR
JUANITA HIGH SCHOOL
KIRKLAND, WA**

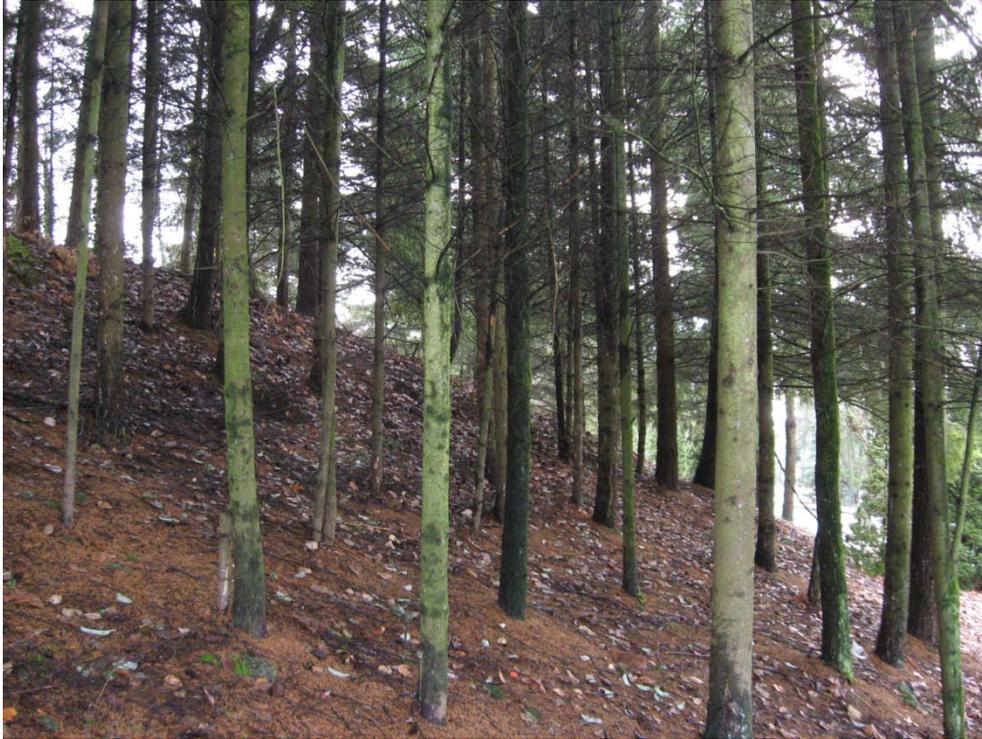
East perimeter (entrance), dense Douglas-fir

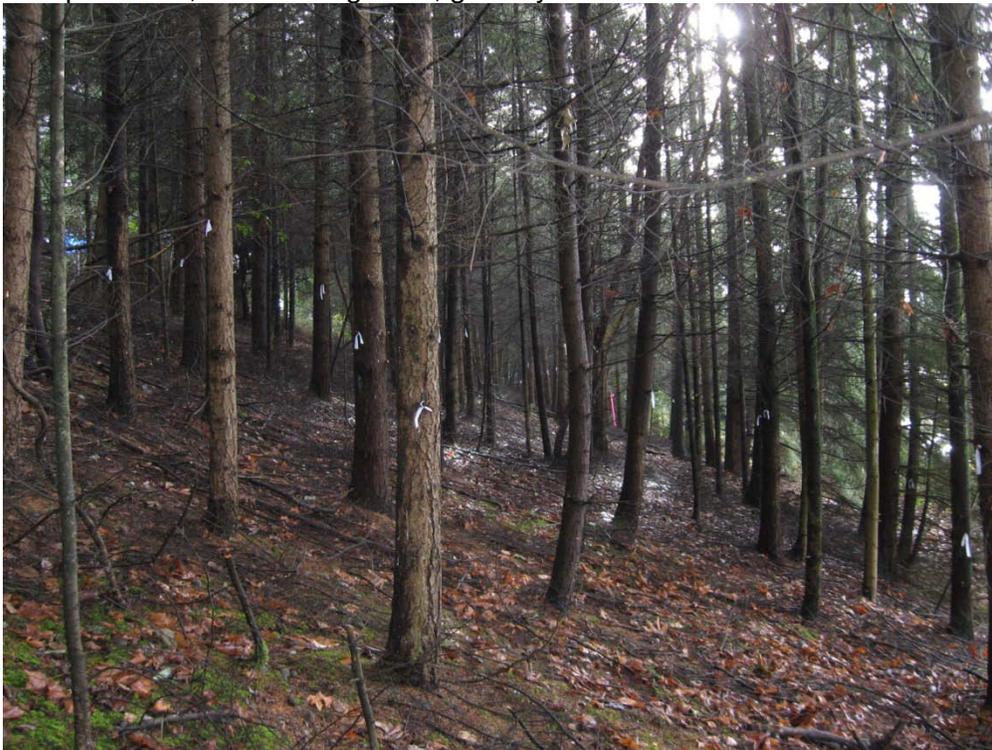
East perimeter, dense Douglas-fir, gravelly soils

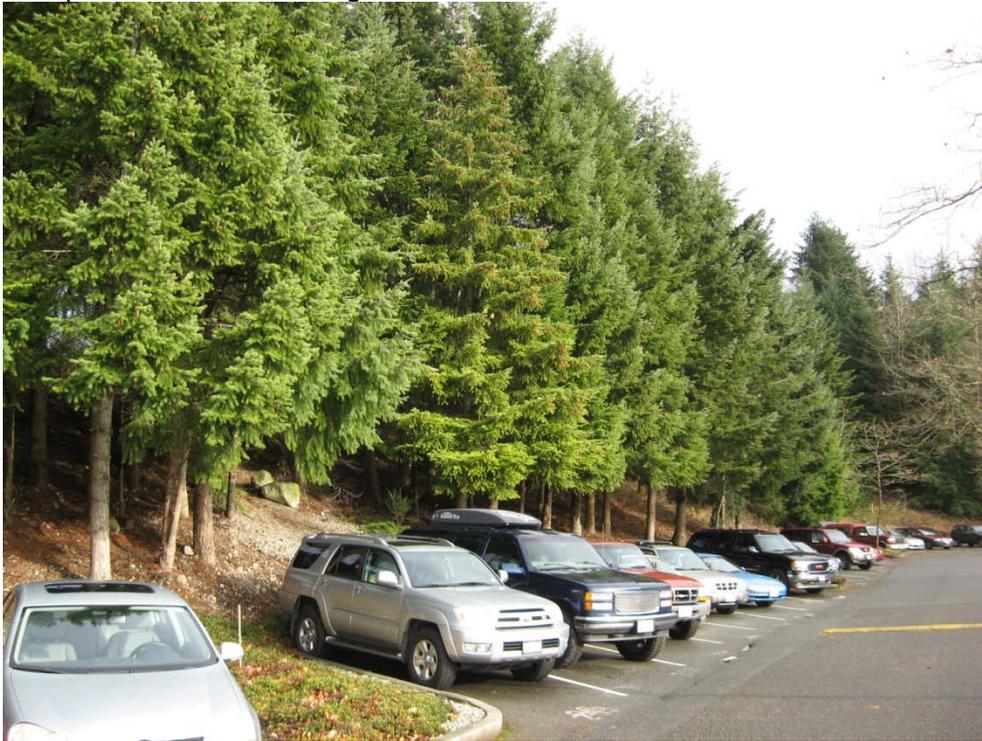
East perimeter, dense Douglas-fir

On the east perimeter, the Douglas-fir is too dense. Trees are under heavy competition for sunlight and nutrients. To improve the health and structural stability of the more dominant trees, thinning out the smaller suppressed trees is recommended. In these dense stands of Douglas-fir, consider removing all trees 6" in

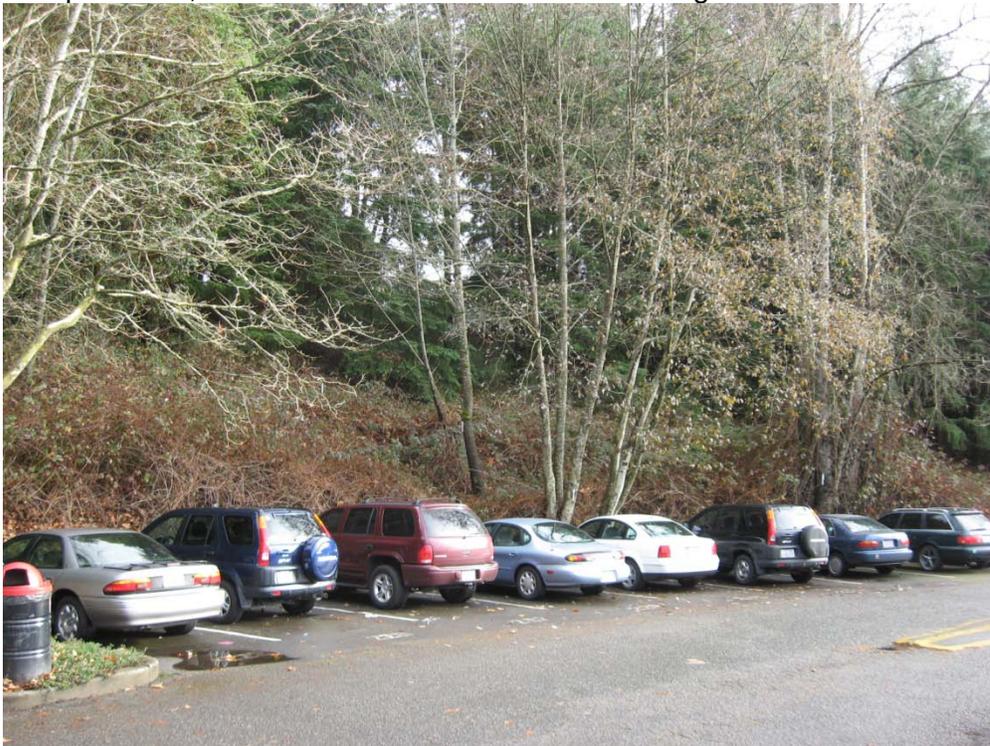
East perimeter, volunteer cottonwood and alder on edge

It is also assumed that the parking lot will be reconstructed or re-designed, given its current condition. Volunteer species of red alder, black cottonwood, bitter cherry and big leaf maple that have developed near the parking lot edge should be removed. Most have developed poor form and structure, with natural leans out over the parking lot. The majority of these are non-significant saplings. The removal of all trees with a condition rating of "poor" is recommended to reduce associated risks.

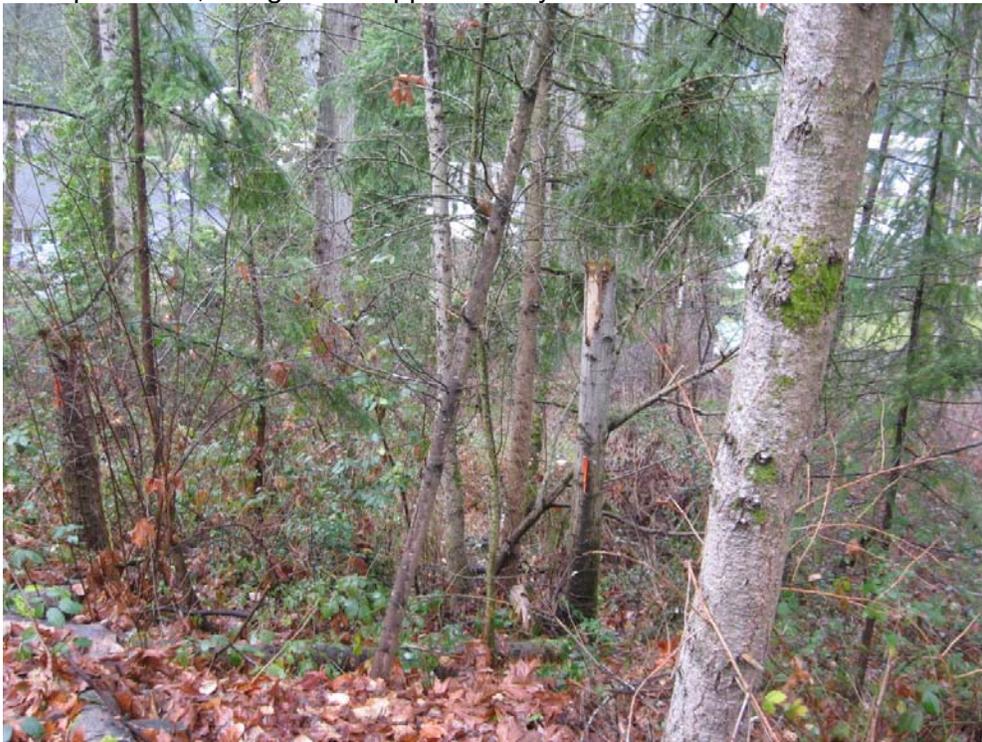
West perimeter, Douglas-fir suppressed by cottonwood

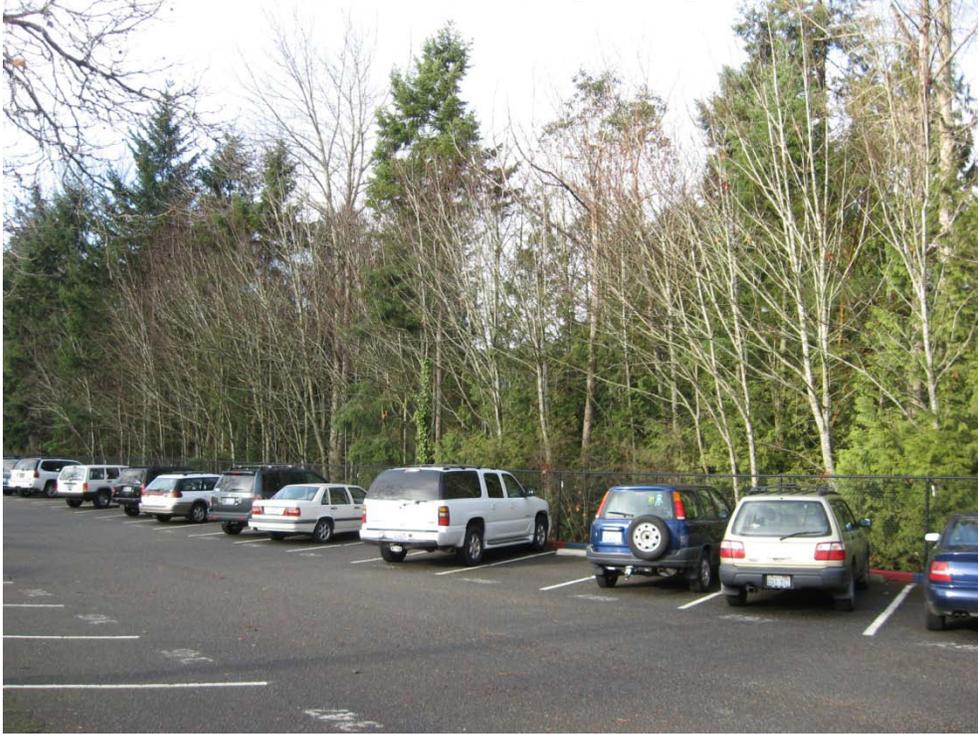
Northwest perimeter, volunteer maple saplings on edge

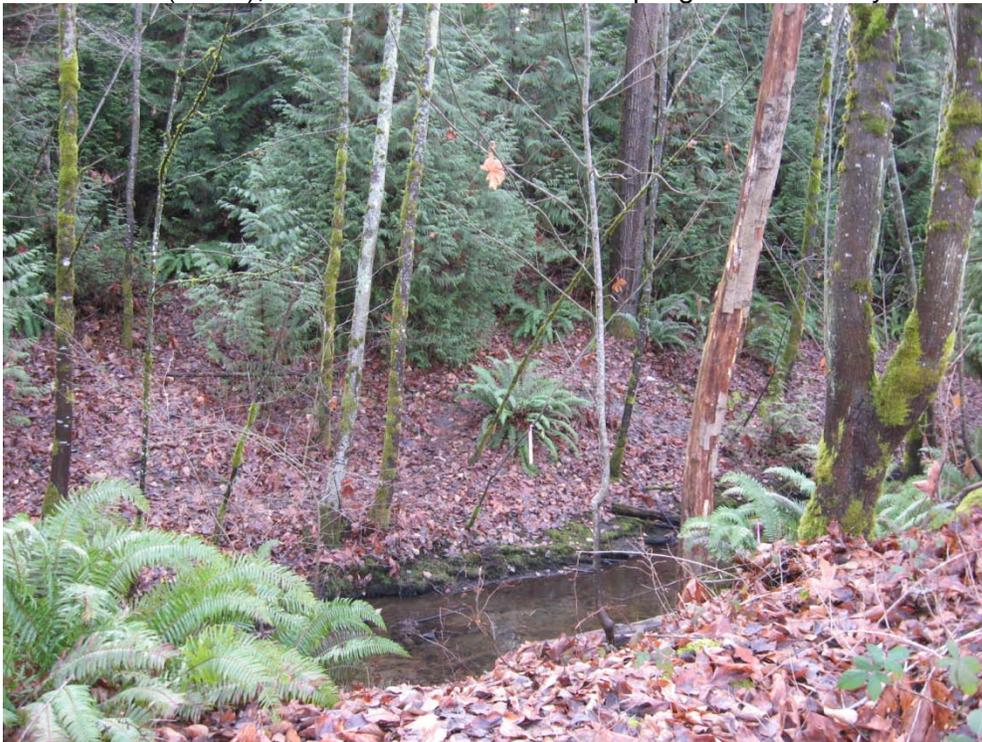
South buffer (creek), dense western red cedar saplings in understory

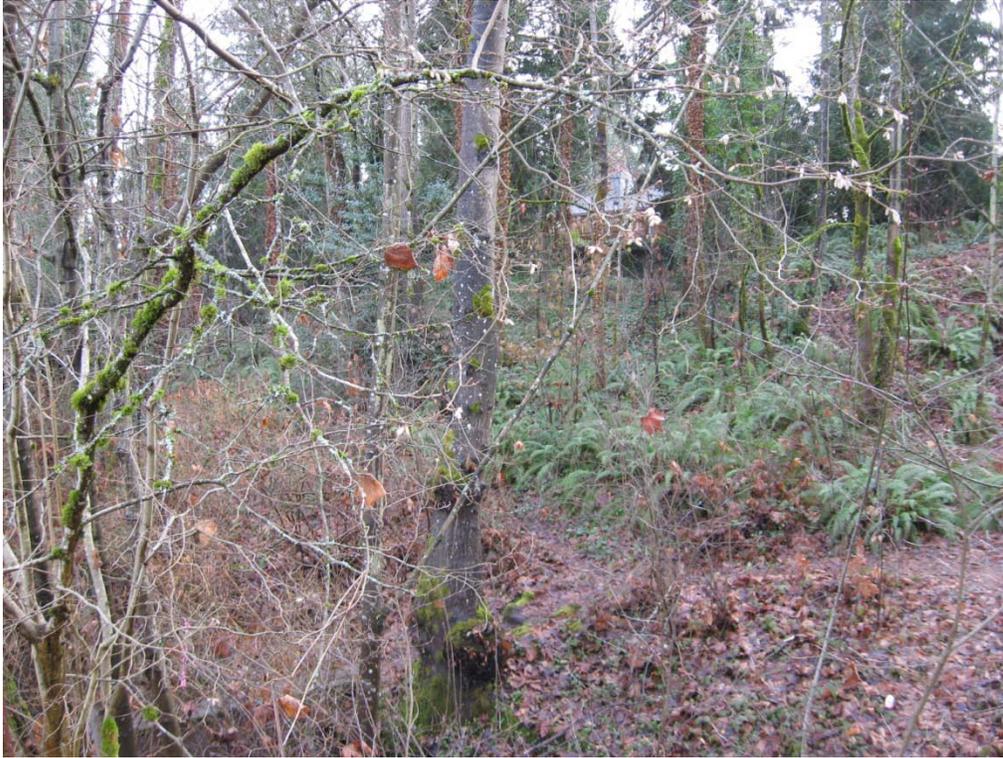
South buffer, primarily a cottonwood overstory

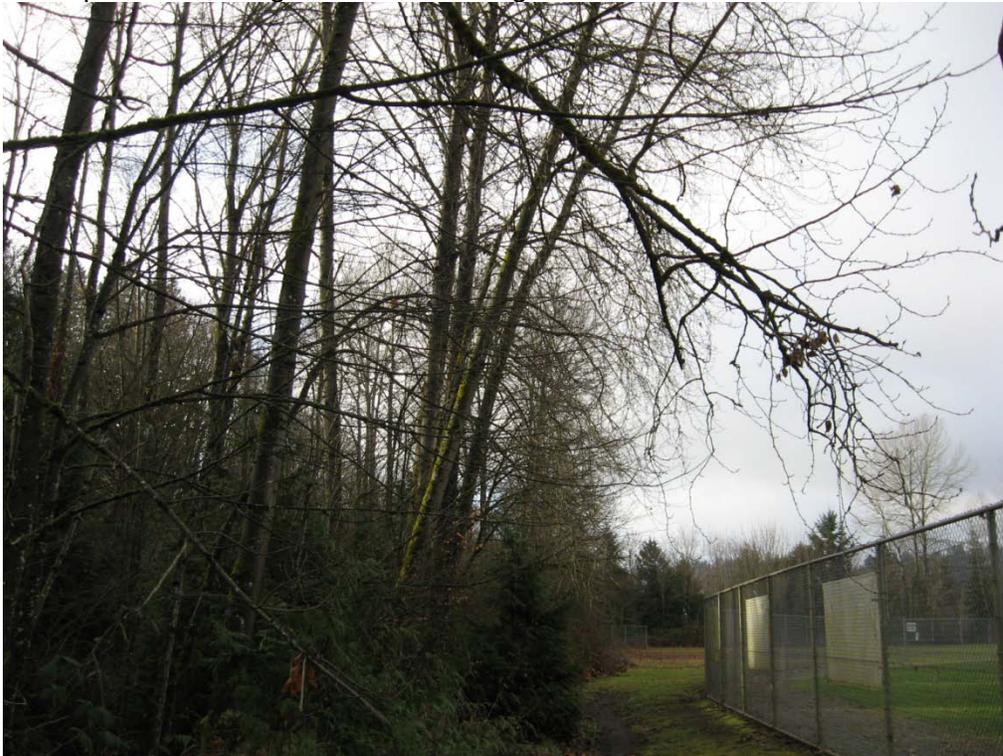
The southwest and south perimeter tree buffers are in fairly good condition. There is a good component of western red cedar in the understory to eventually take the place of the pioneer cottonwood trees. Only three high-risk trees were identified on the north edge. These include trees #1369, #1370 and #1371 behind the baseball field. Removal is recommended to abate the hazard. Trees along the south edge of this critical area buffer adjacent to neighboring properties were not assessed as part of this assignment.

South perimeter, 3 high-risk trees on edge

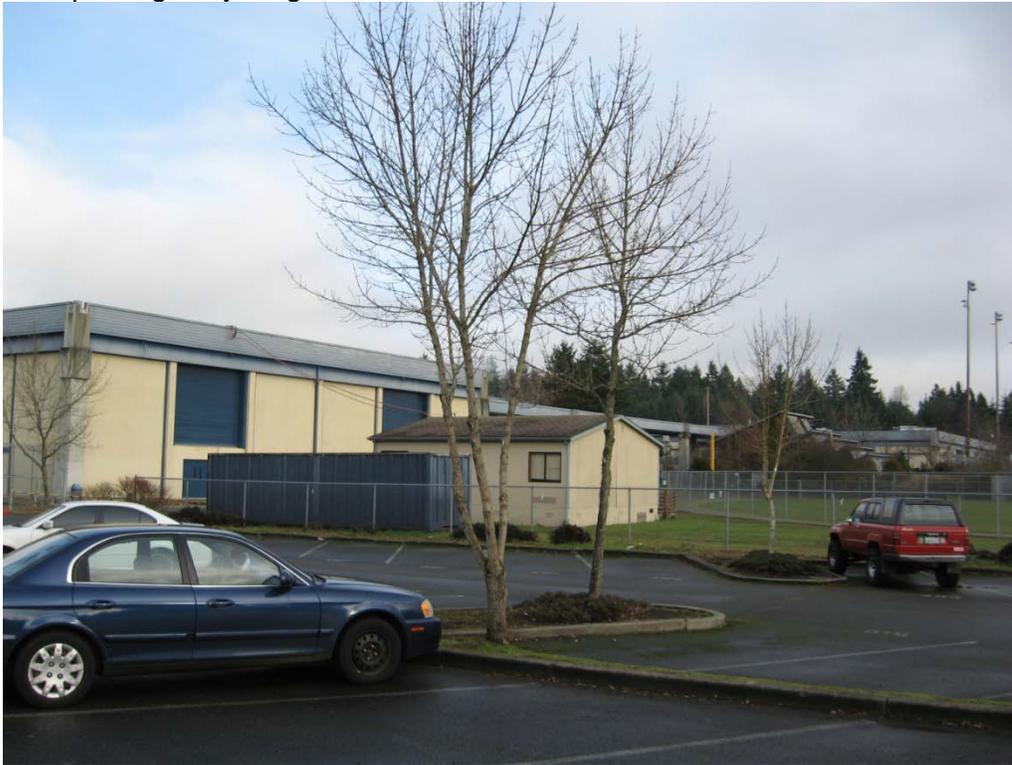
Back parking lot, young ash

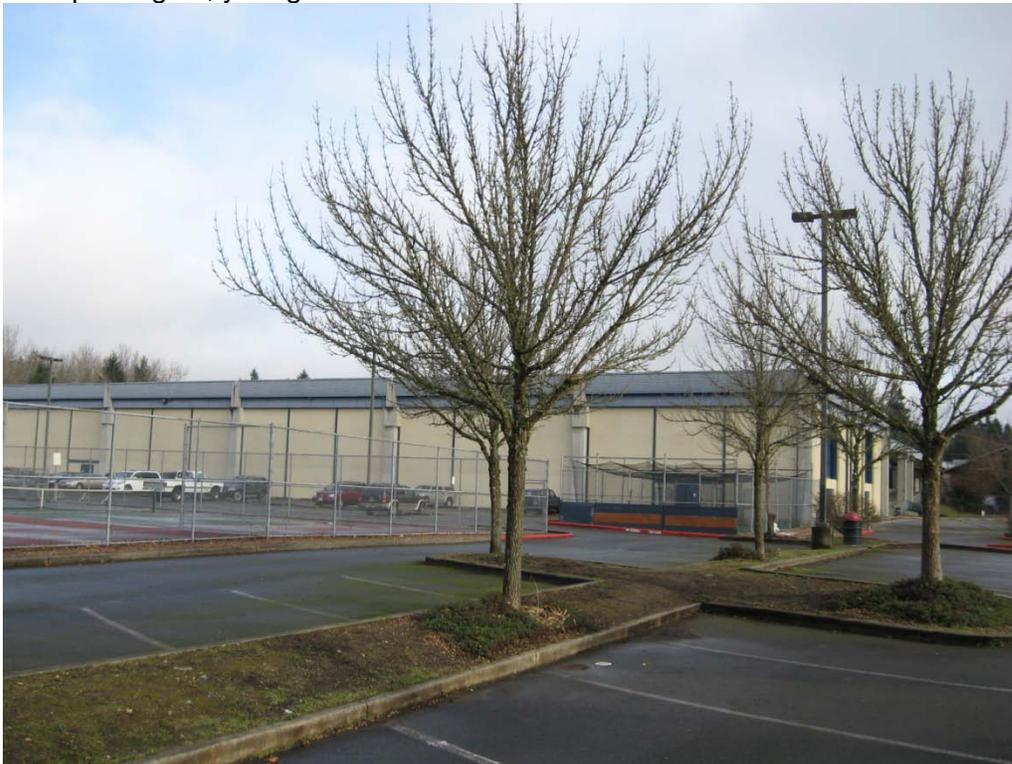
Back parking lot trees are comprised of a variety of ash. These are younger specimens, estimated at 10 to 20 years of age. Most are in good condition with well-shaped uniform canopies. A couple of the younger ash trees have developed compromising structural defects.

Back parking lot, young to semi-mature ash

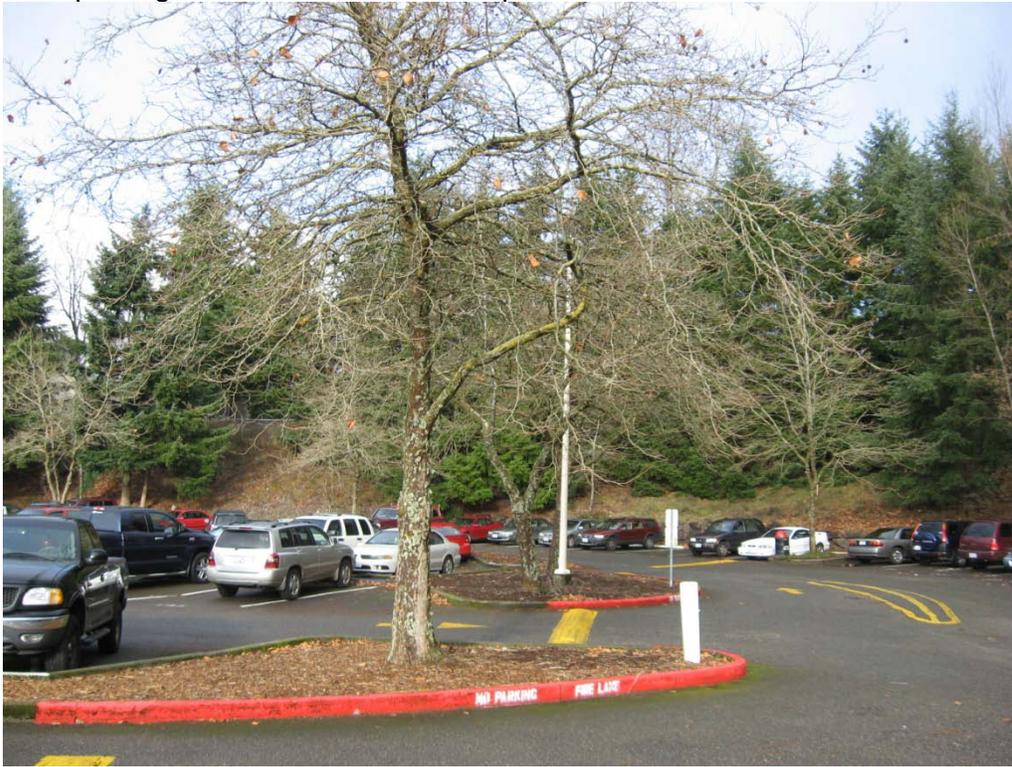
Front parking lot trees are comprised of semi-mature London plane, estimated at roughly 40 years of age. All are in good condition. No indicators of decline were observed. Trees have developed good architecture/form with soundly attached scaffolds. Many could use a light crown cleaning to remove natural deadwood and thin out denser portions of their canopies.

Front parking lot, semi-mature London plane
