Geotechnical Report and Geologically Hazardous Areas Evaluation
Proposed SFRs and DADUs: 8230 NE 117th Street, Kirkland, Washington
December 16, 2021

ARBORIST REPORT

8230 NE 117th Street
Kirkland, WA

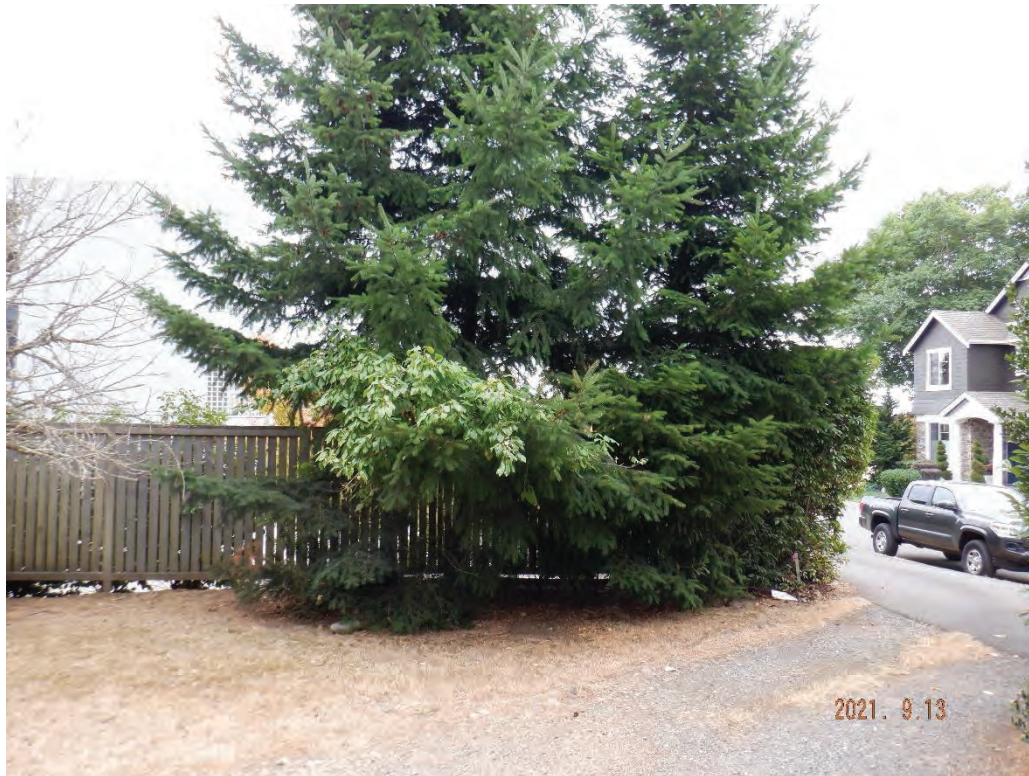
Trees #1, #2 and #3 are small, young Douglas fir trees near the southwest corner of the property. Vigor is good. No concerns were observed. Condition is 'good'.

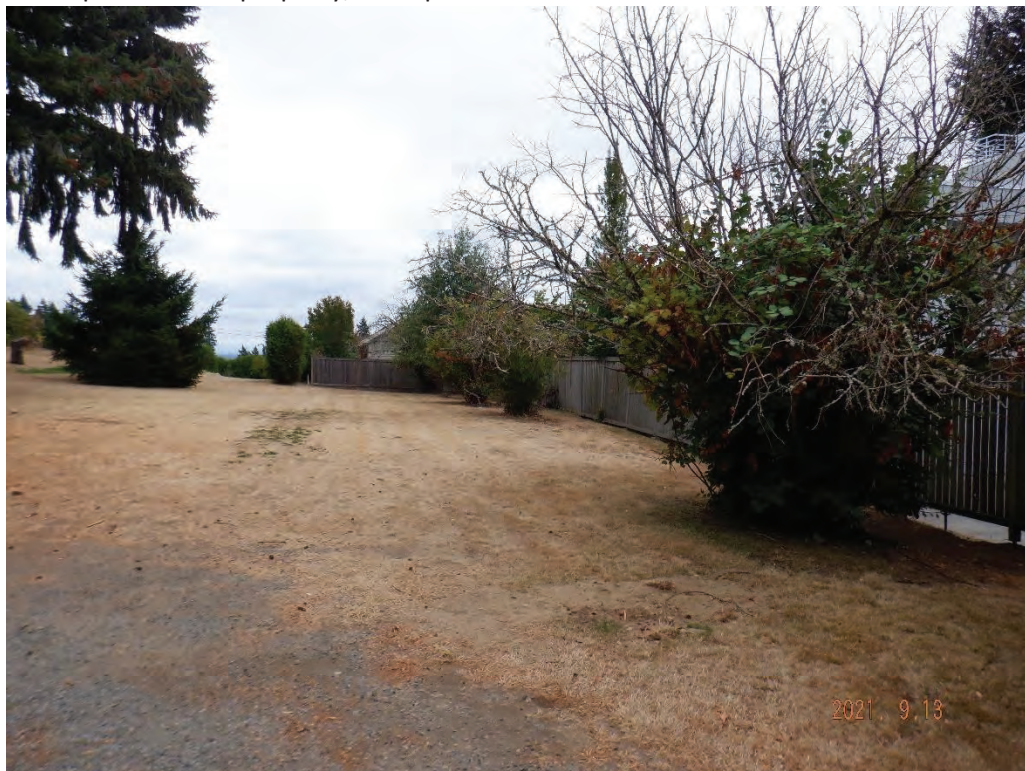
Tree #4 is a young to semi-mature apple tree on the south perimeter of the property. There are also three dead fruit trees on the south perimeter. It has developed typical form for the species. Overall condition is rated as 'fair'.

South perimeter of property, dead plum trees

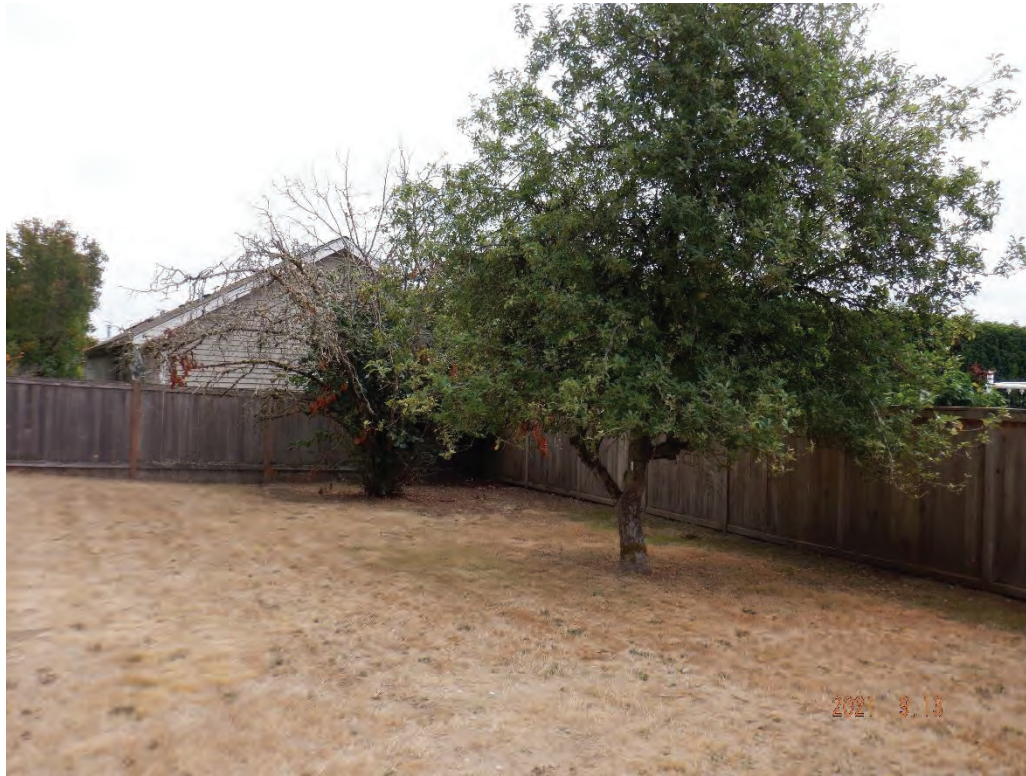
Southeast corner of site, Tree #4 in foreground, dead fruit tree in background

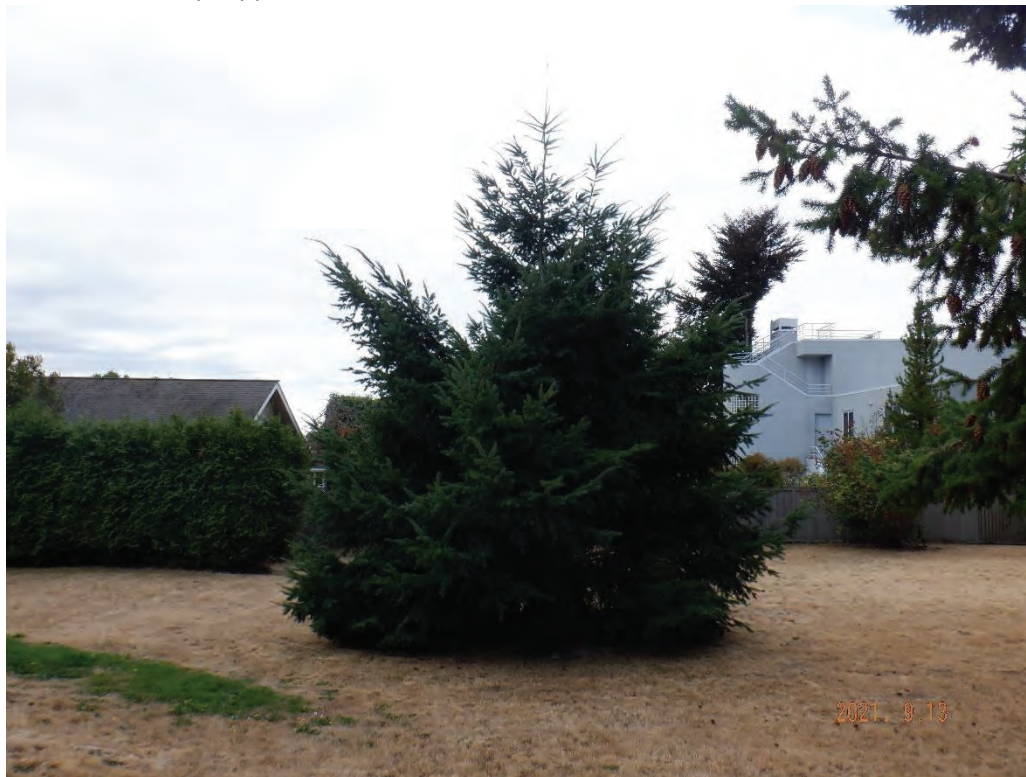
Tree #5 is another young Douglas fir tree on the east perimeter of the property. It has been recently topped at roughly 12-feet above ground. The tree was likely topped because it was interfering with somebody's view of Lake Washington. It is of good vigor. Overall condition is rated as 'fair'.

Tree #5, recently topped

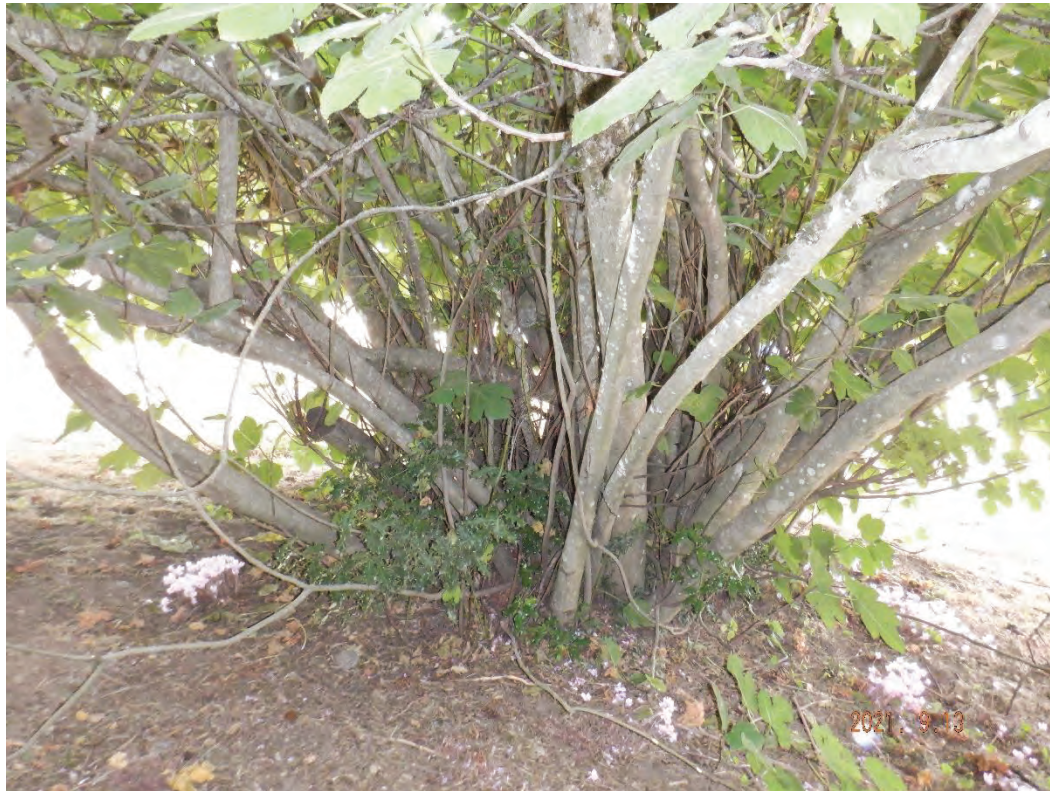
Tree #6 is a large cluster of figs, comprised of multiple small diameter stems. It has a large-spreading canopy and is of good vigor. Condition is 'good'.

Tree #6, fig, large cluster of small stems

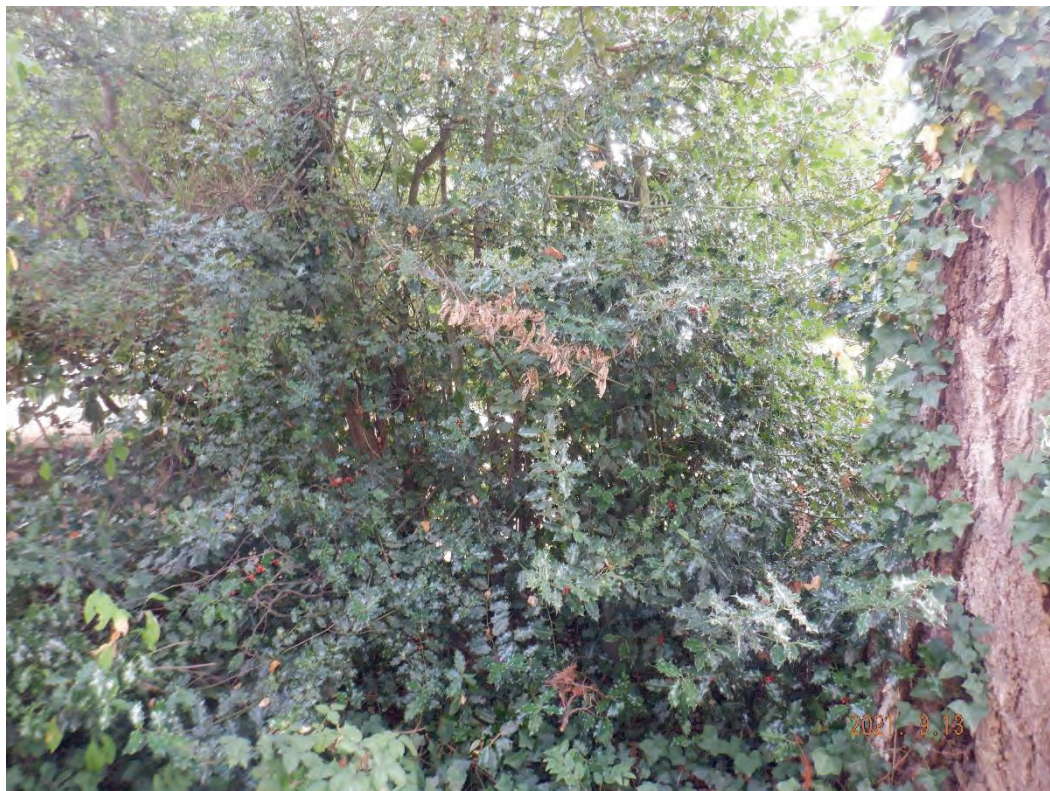
Trees #7 and #8

Trees #7 is a young to semi-mature English hawthorn. This is likely a volunteer and was not planted. The lower trunk forks into multiple tops. It has an asymmetric crown or canopy to the north. It is in 'fair' condition.

Tree #8 is a young English holly. This is likely a volunteer and was not planted. It has developed typical form for the species. Condition is 'fair'.

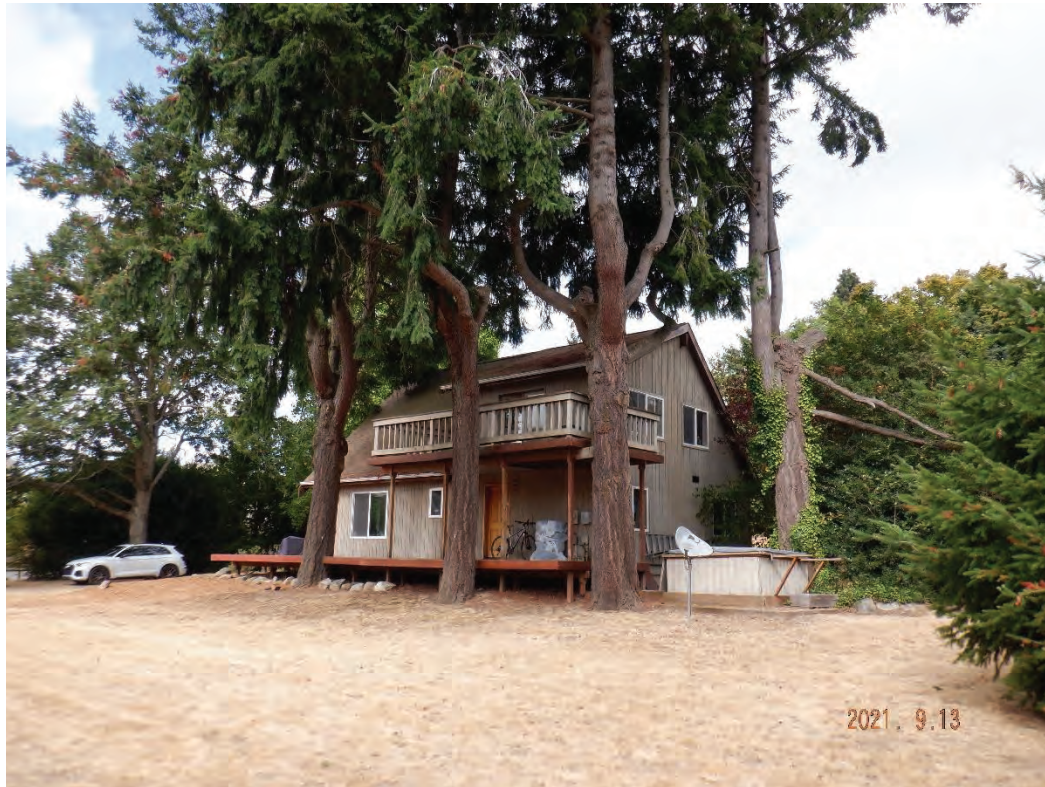
Trees #9 > #12

Trees #9, #10, #11 and #12 are semi-mature Douglas fir located close to the existing house, on the south side. All of these were topped many, many years ago at roughly 16-feet above ground. See pictures below. They have developed two or more new tops or upright stems from the old topping cuts. Forked attachments appear sound. Vigor is fairly good. Foliage is of normal color and density. The lower trunks appear sound with no outward indicators of any significant internal decay issues. Overall condition is rated as 'fair'.

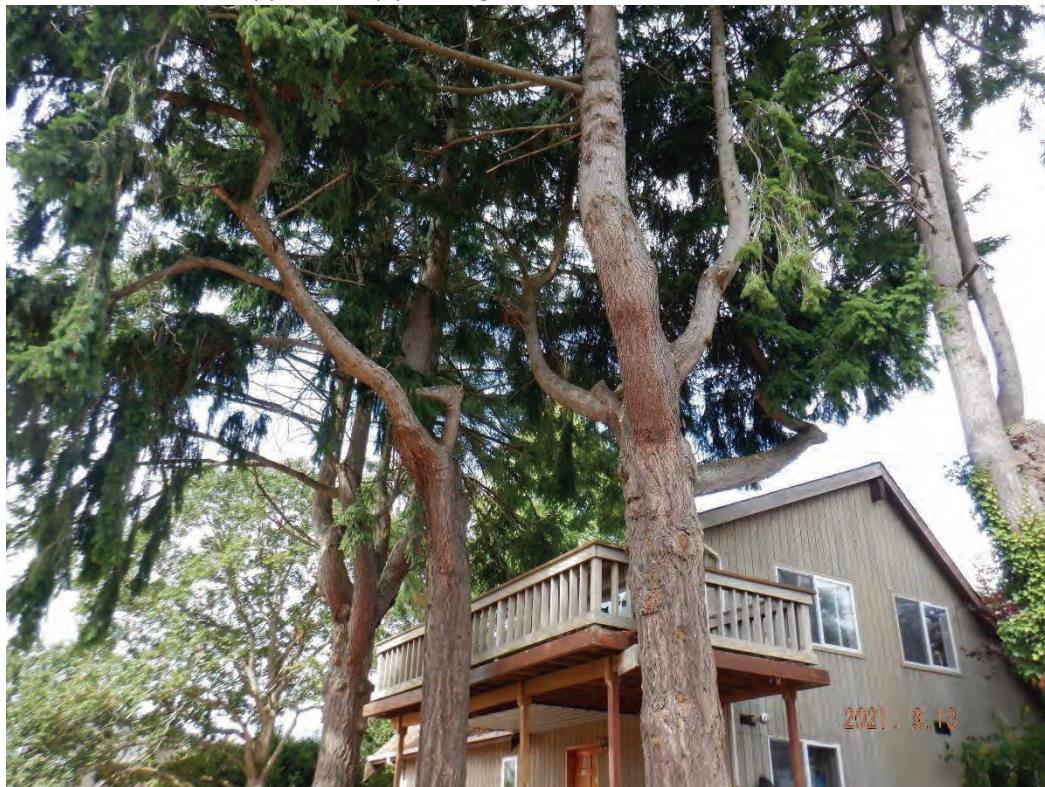
Trees #9 > #12, all topped many years ago

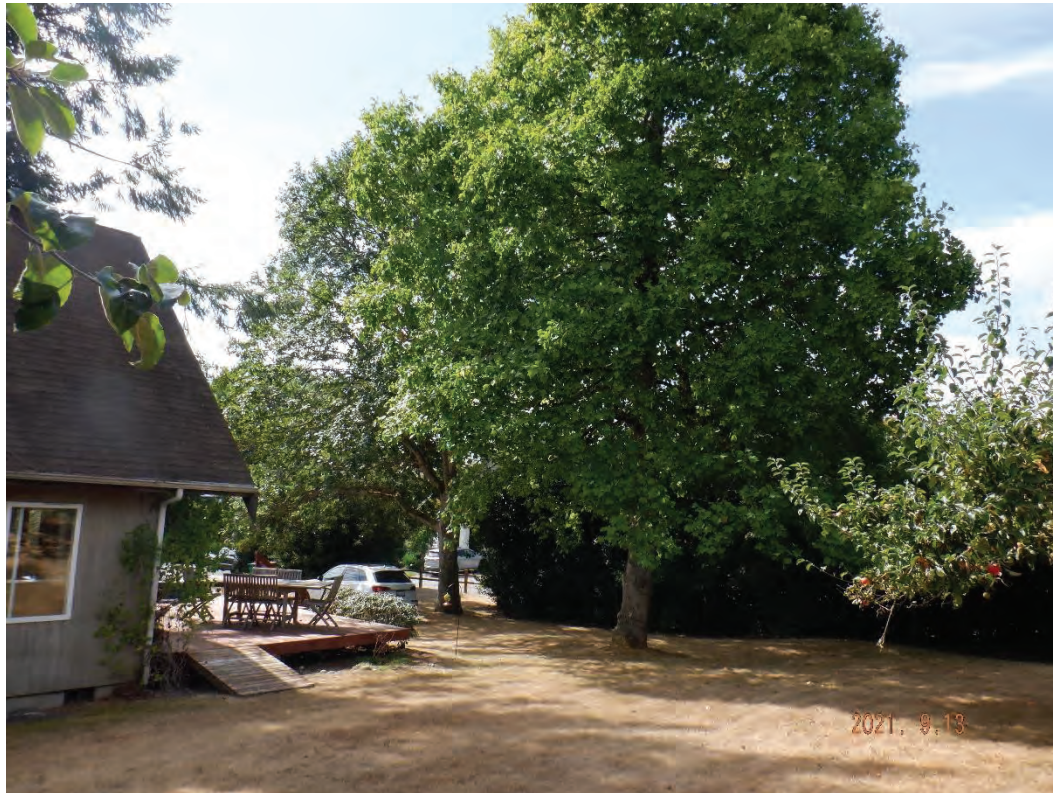
Tree #13 is a semi-mature white oak. It has developed good structural form. Vigor is good. Condition is 'good'.

Front of property, Tree #17 – center, #13 in background on left

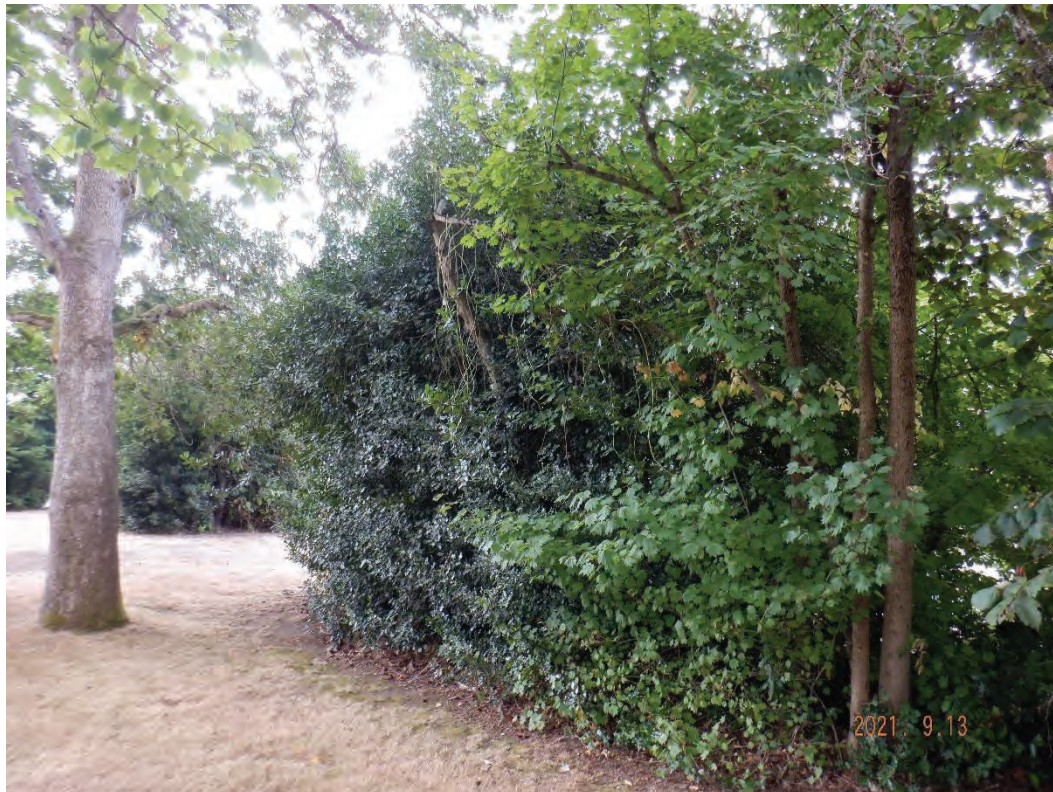
Trees #14, #15 and #18 > #24 are young to semi-mature English holly, planted in a row across the front of the property. These have developed typical form for the species and are of fairly good vigor. Condition is 'fair'.

Tree #16 is a young Siberian elm. This is likely a volunteer and was not planted. It has developed typical form for the species. Condition is 'fair'.

Tree #13 on left, #14 > #16 on right

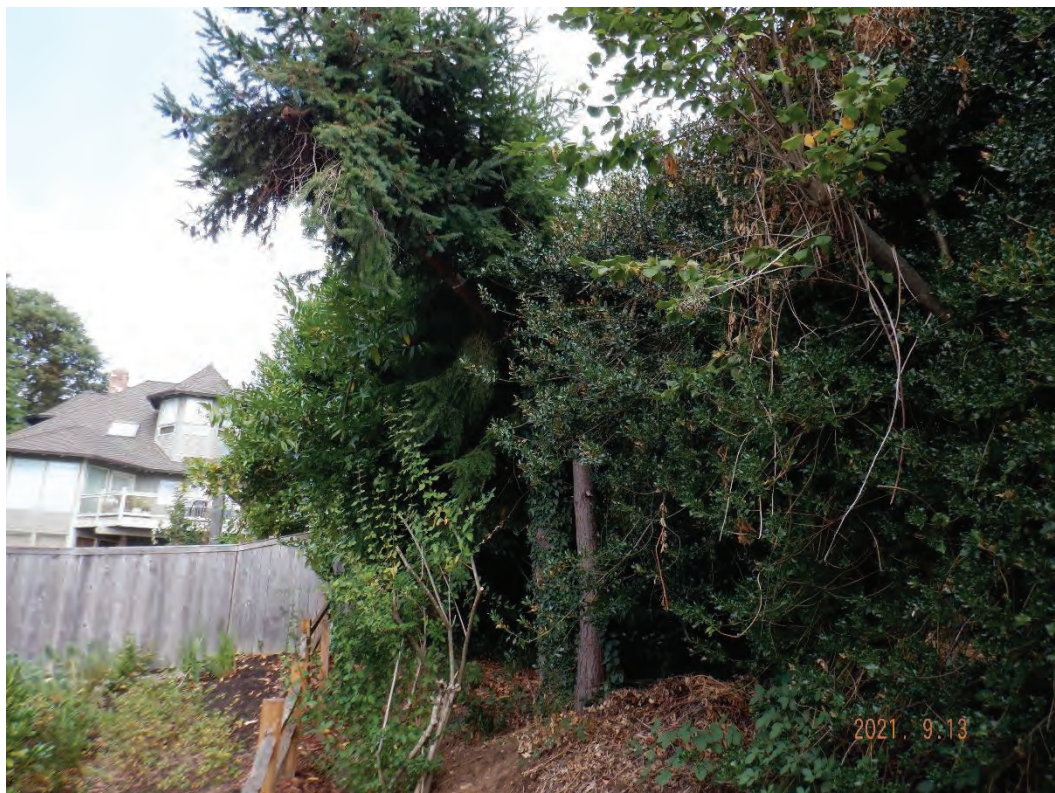
Trees #25 and #26 are a young to semi-mature Douglas fir and Western hemlock located in the northwest corner of the property. Both have been topped at roughly 12-feet above ground. Both have very few live branches. Structural form has been compromised by the topping. These are in 'poor' condition.

Trees #25 and #26 in northwest corner of site
