Subject: TEMPORARY LICENSE AGREEMENT FOR USE OF PETER KIRK PARK BY KPP DEVELOPMENT LLC (URBAN KIRKLAND DEVELOPMENT)

Appraisal Report

Peter Kirk Park Easement Site
South Side of Central Way
Kirkland, WA

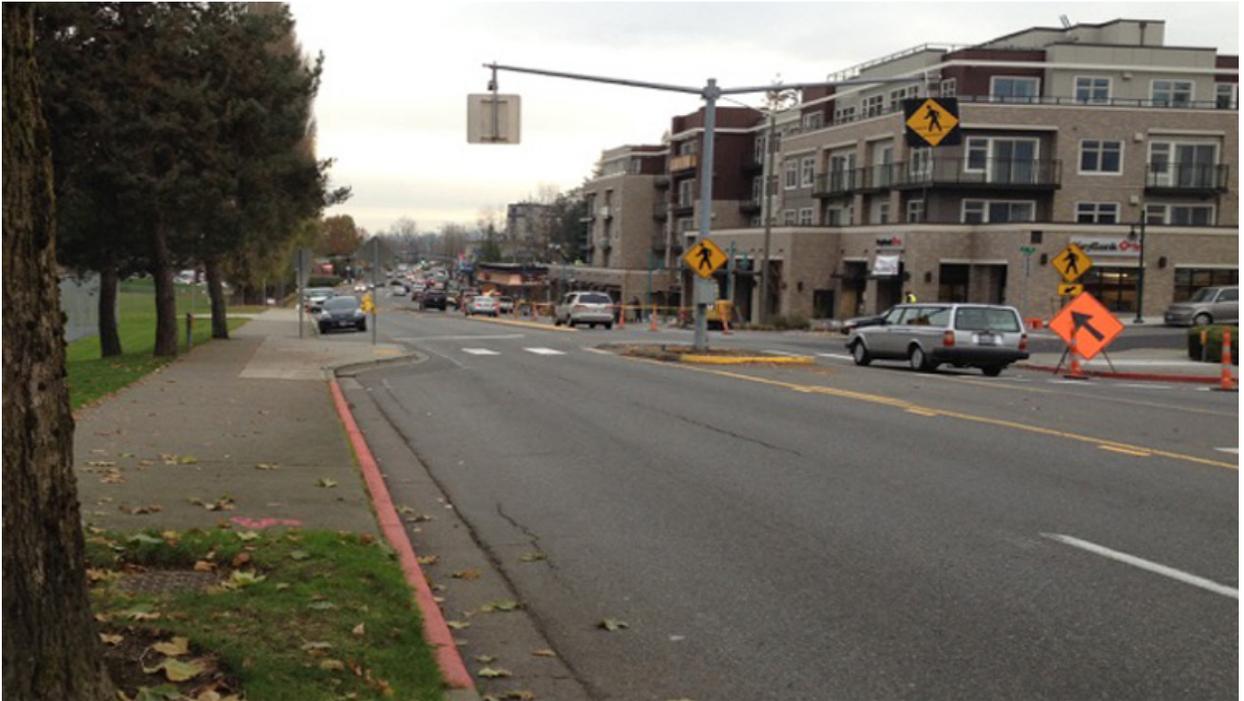
Northeast corner of subject, looking west along Central Way

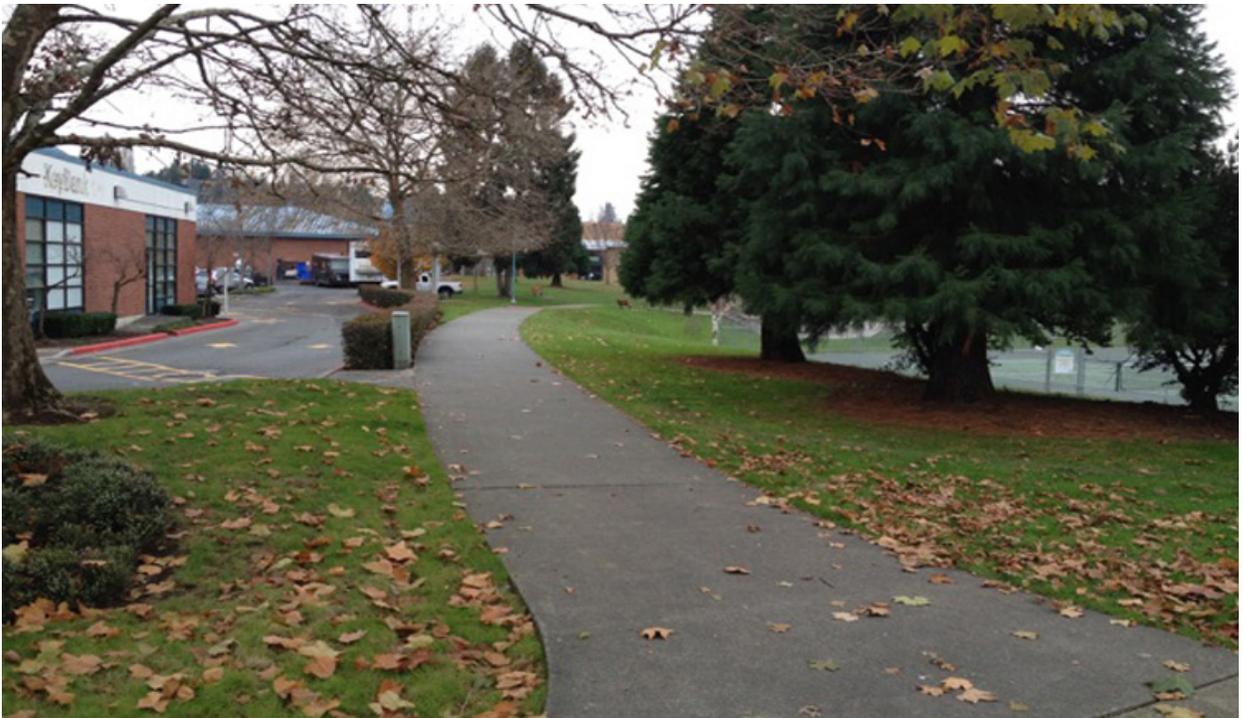
At the northeast corner, looking south along proposed easement area

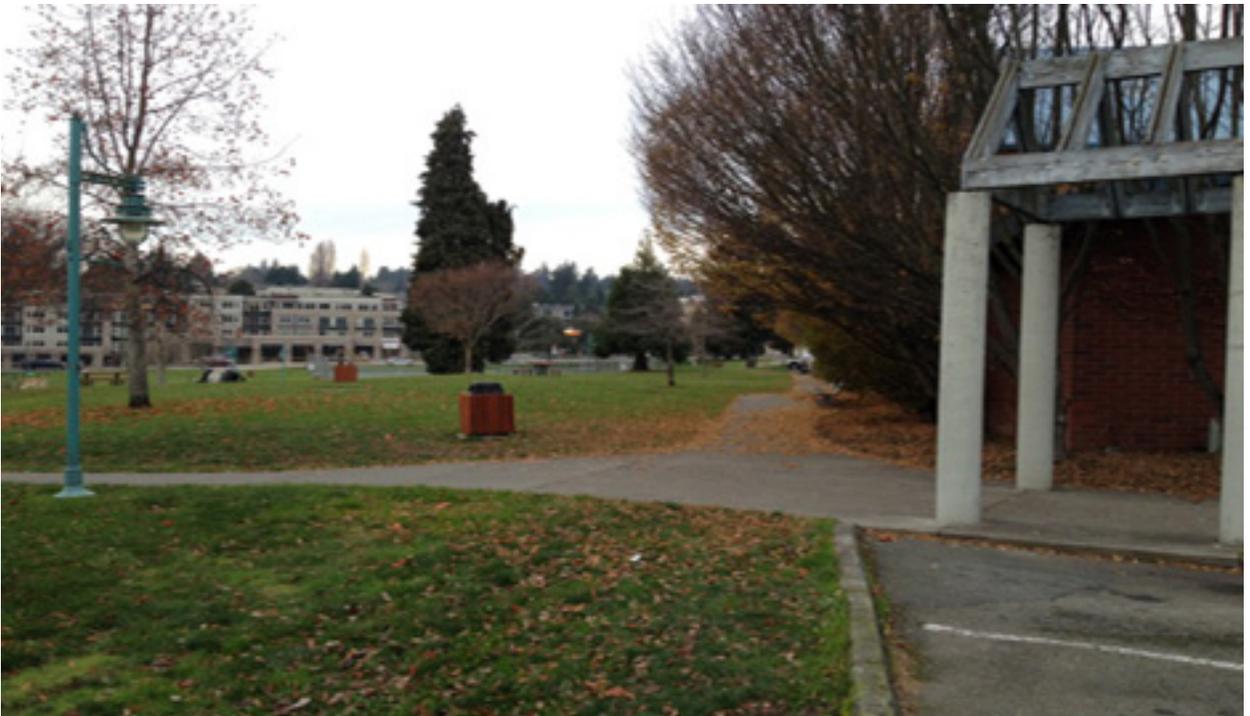
East side of subject, looking north along proposed easement area near QFC

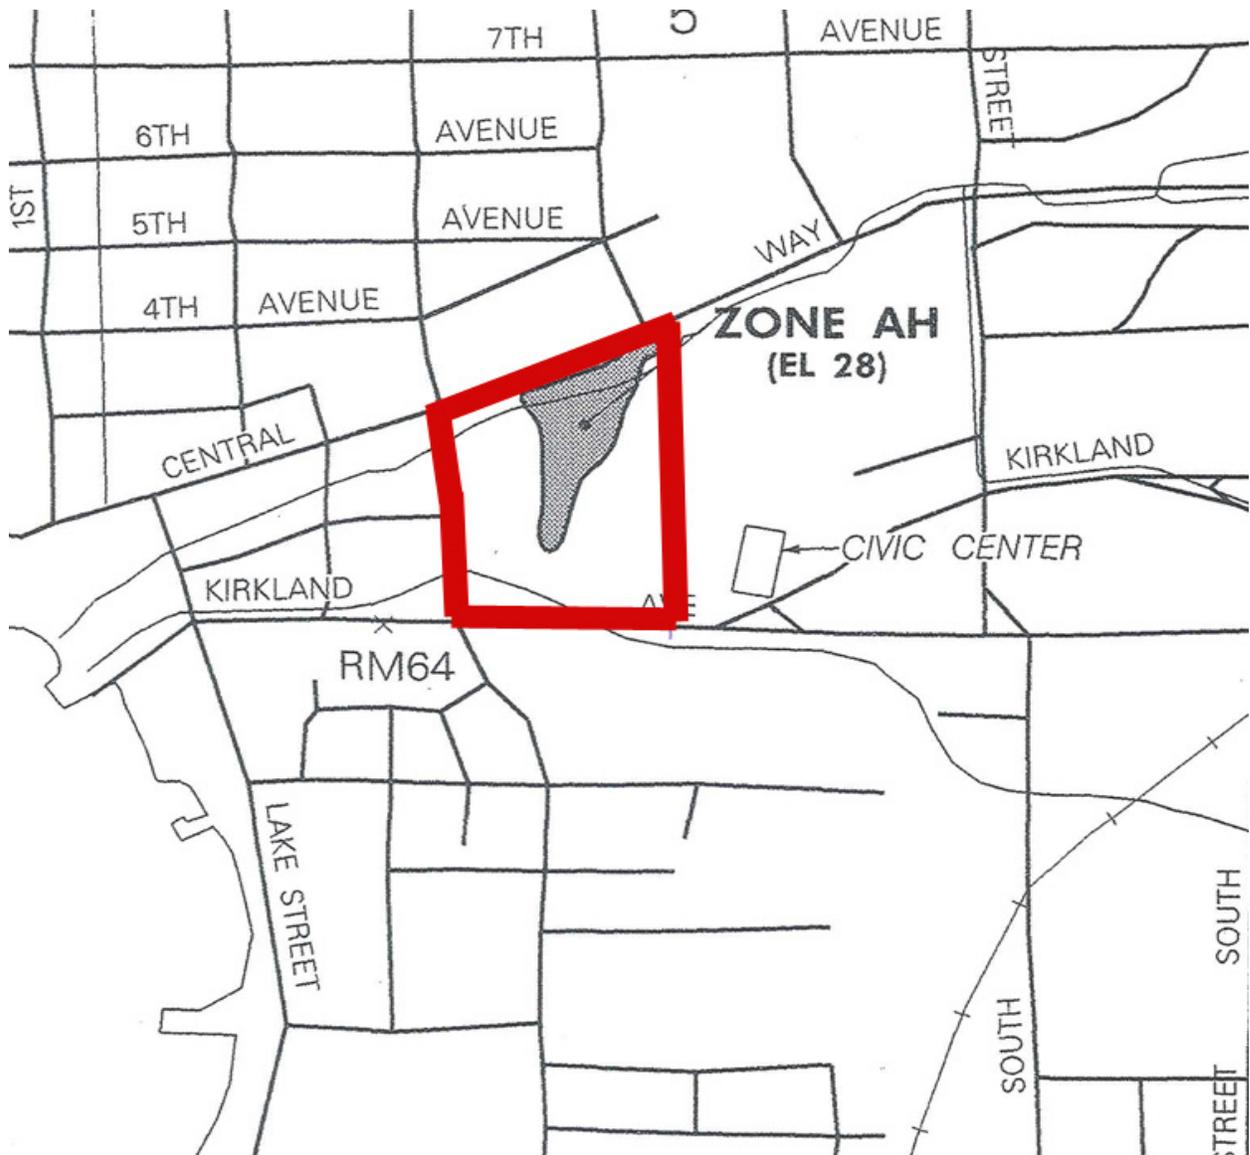
FEMA Map

According to FEMA mapping (FIRM -0356), a portion the subject is encumbered by the 100-year flood hazard area. The site is classified as Zone AH, an area which can have flood depths of 1 to 3 feet, usually in a ponding fashion. It appears to be primarily in the northeastern portion of the site, thinning as it moves south, and lies relative to the existing ballfields and play areas. We refer the reader to the enclosed mapping.

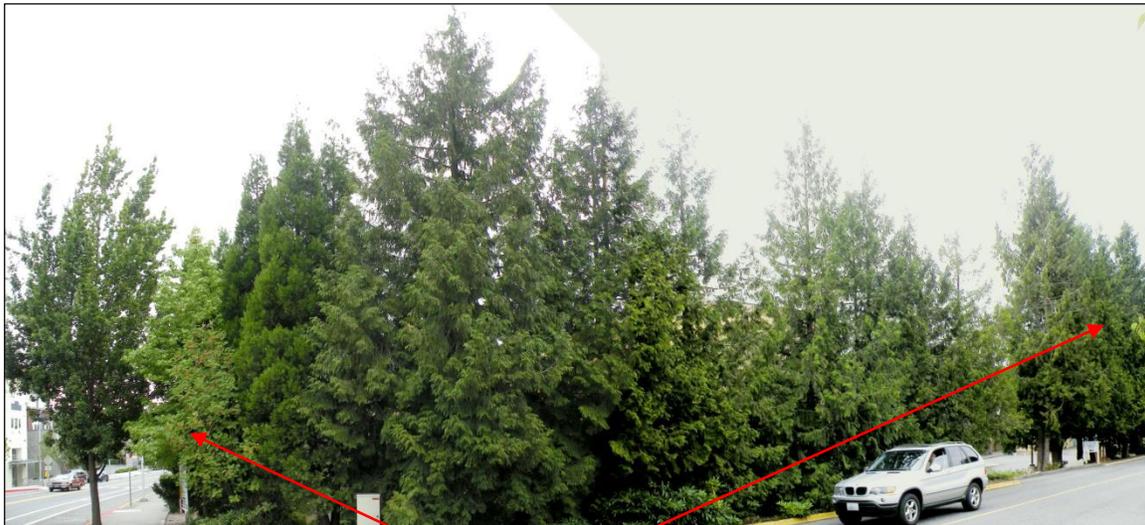
Trees 102 -- 124

Photo # 1: Panoramic photo of the trees along the west property line extension with vehicular access to Kirkland Way showing trees # 101 – 124 as they looked in August of 2010.

Tree # 101 is in the Kirkland Avenue sidewalk and will need to be protected during construction

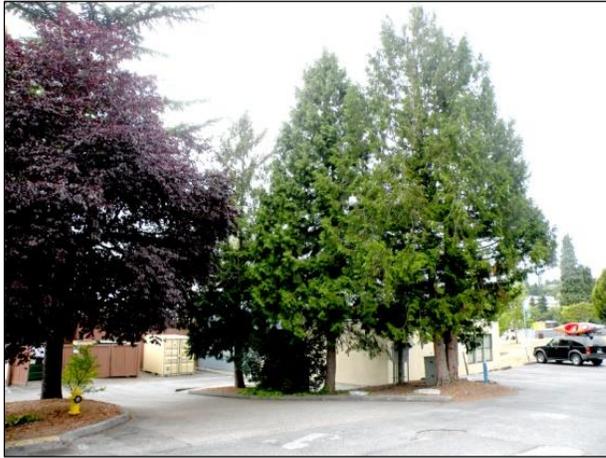
Photo # 2: West property line extension to Kirkland Way showing trees # 126—131 in August 2010.

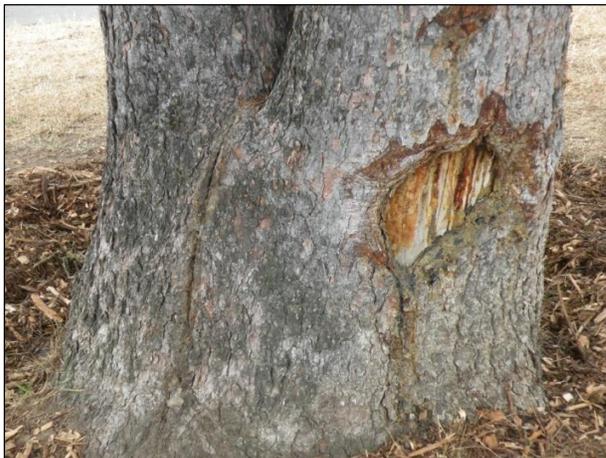
Photo # 4: The base of # 183 showing the open wound and the included bark—the wound appears to be well compartmentalized.

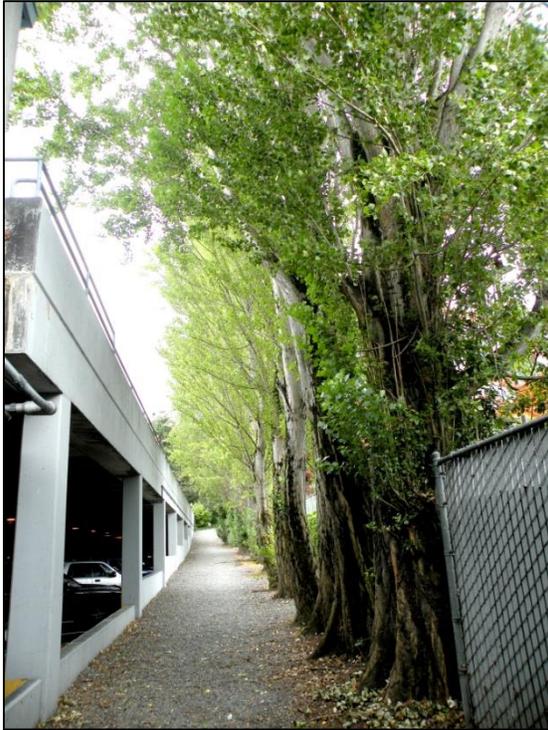
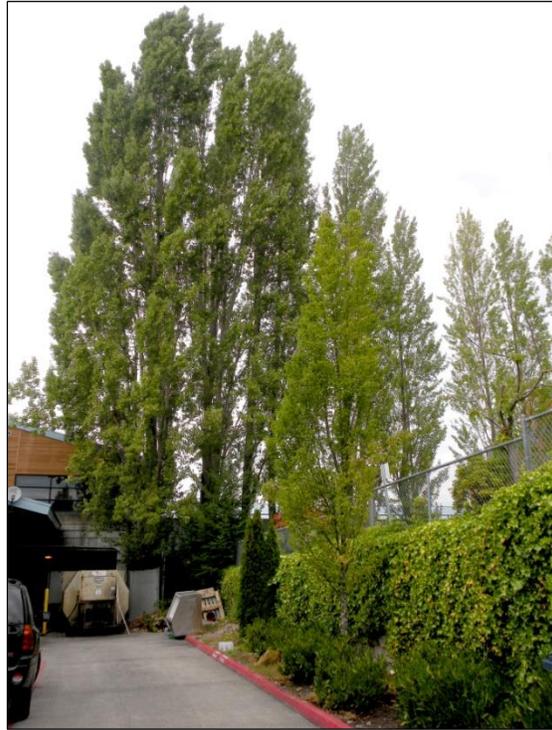
There are 37 trees along the southern property line that are in this category. Sixteen of the 37 trees, numbers 138 through 153, are a row of Lombardy Poplars, *Populus nigra 'Italica.'* They are growing in a row between the parking garage structure and the block retaining wall that is holding up the parking lot on the adjacent property to the south. The majority are in declining condition. Given the drought of the last two years and the limited soil volume they have to exploit, it is not surprising that they have deteriorated in the last five years. They are now suffering from a canker disease that this cultivar is vulnerable to all across North America. While the row is not a problem today, they are in such a poor state that I judge that they will not likely tolerate the stress of demolition and

Photos # 5 & 6: showing the row of Lombardy Poplars from various views as they were in August of 2010. In the last five years they have deteriorated considerably.

reconstruction of the site unless all construction activity can be kept to existing limits. And, only if the trees are treated with fungicide, fertilizer, beneficial microbes, and proper irrigation. Even with these treatments I do not believe that this row of majestic trees can be retained.

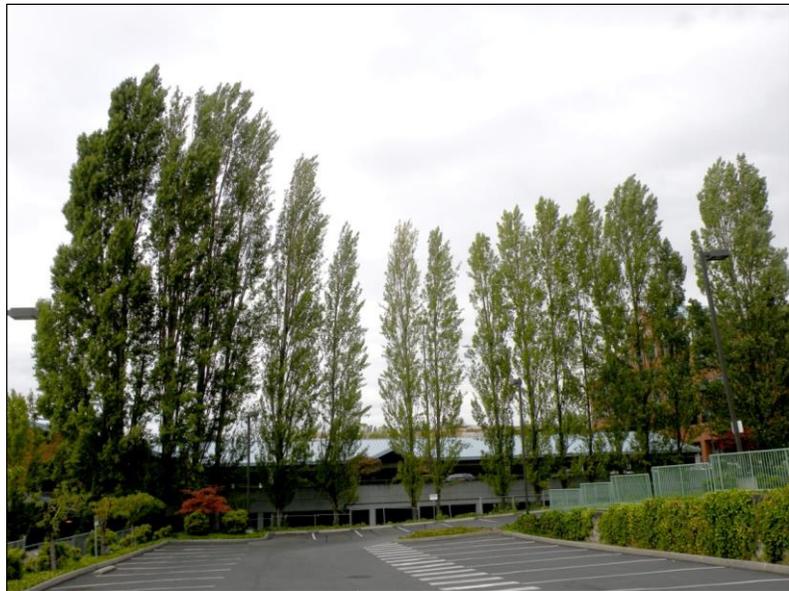
Photo # 7: Looking south at the row of Lombardy Poplar trees from the parking area in August 2010.

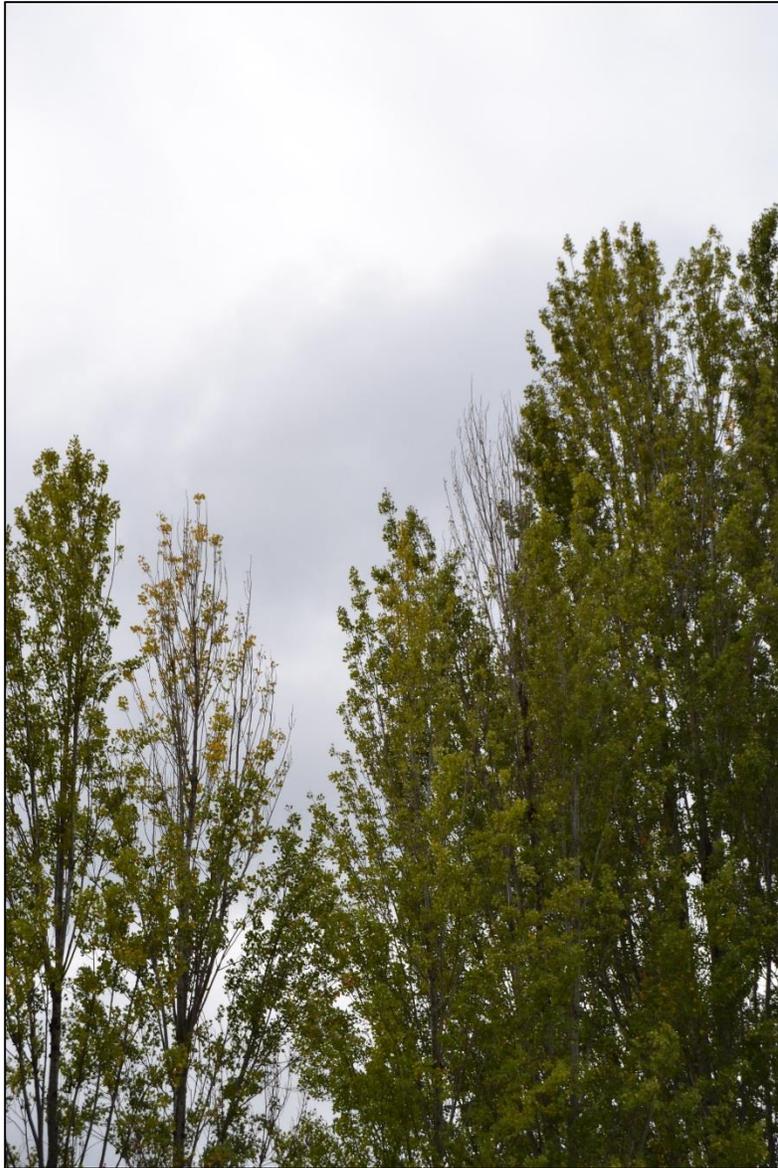
Photo # 8: Showing the crowns of the Poplars today, 9/14/15, and their declining condition. Instead of having dense healthy canopies and crowns, the top 15% of the canopy, the foliage is thin, pale in color, and has a lot of dieback associated with the Poplar Canker.

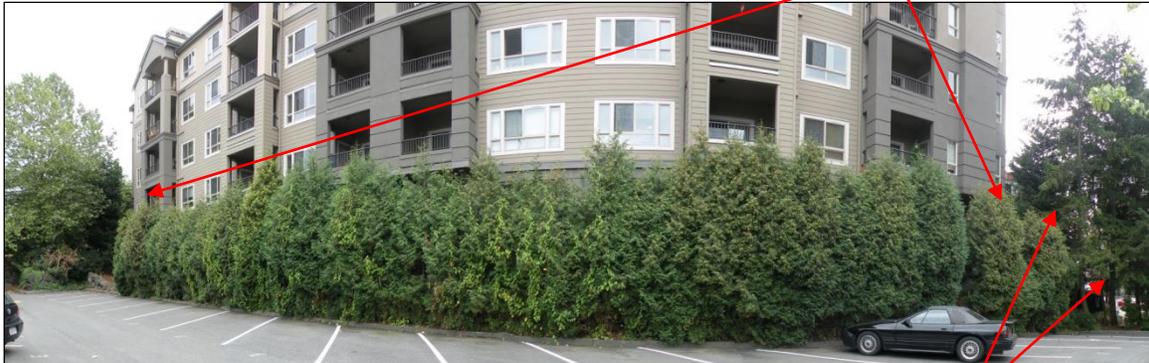
Trees 159 – 167

Trees # 154 – 167 are along the eastern and southern boundaries as one moves from the parking garage towards 6th Street. There is a *Pyramidalis* hedge along the southern property line between the parking lot and the apartments to the south. They have been given the number 165 for the entire hedge which consists of 37 trees.

Photo # 8: Panoramic view of the *Pyramidalis* Hedge of 37 plants listed as # 165

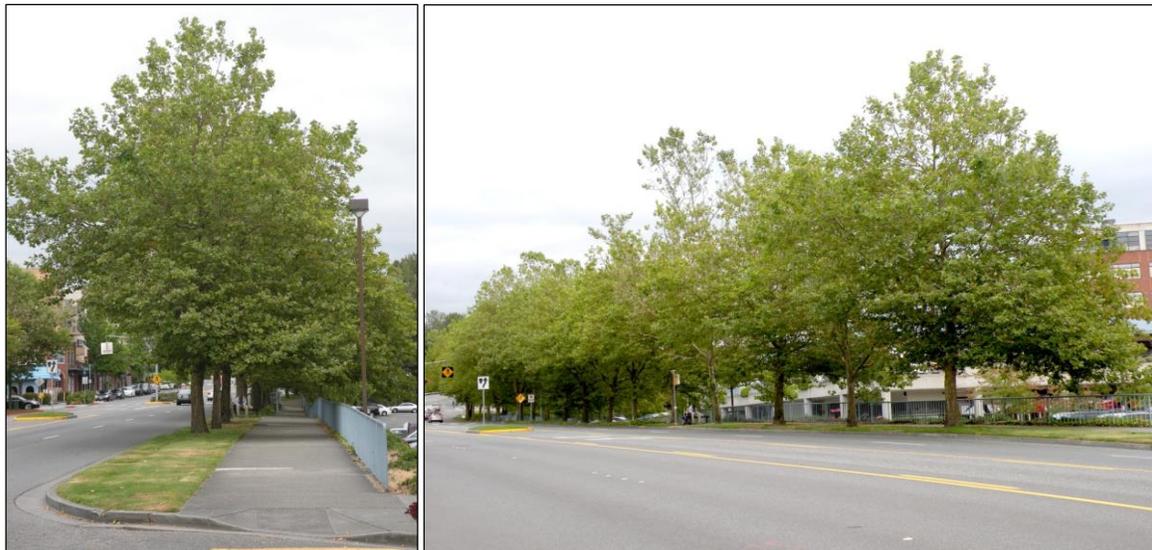
Photos # 9 & 10: Looking east on Central Way at trees # 188 – 207

There are 31 trees on the Central Way right-of-way. There is a row of 21 London Plane trees in a grass covered planter strip between the curb and the sidewalk. South of the sidewalk is a flower bed with 10 additional trees, shrubs, and a large sign.

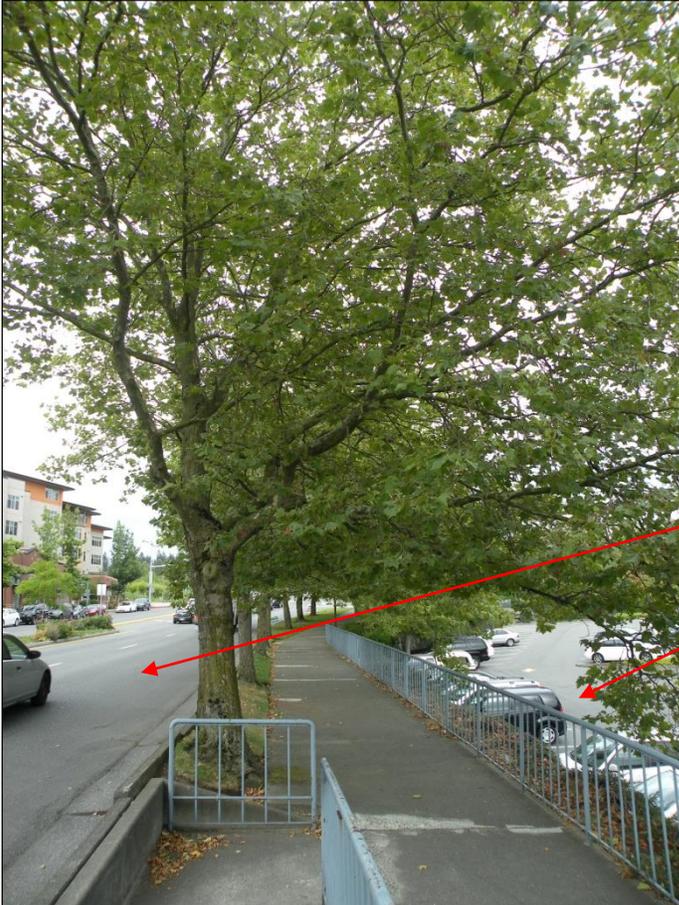
Photo #11: Looking west along Central way

Note the Elevation difference between the street and the parking lot

In the planter bed south of the sidewalk that parallels Central Way are trees # 208 to 217. They are growing in an area between the sidewalk and the retaining wall at the edge of the parking lot. There are some utilities and the Park Place sign is located there.

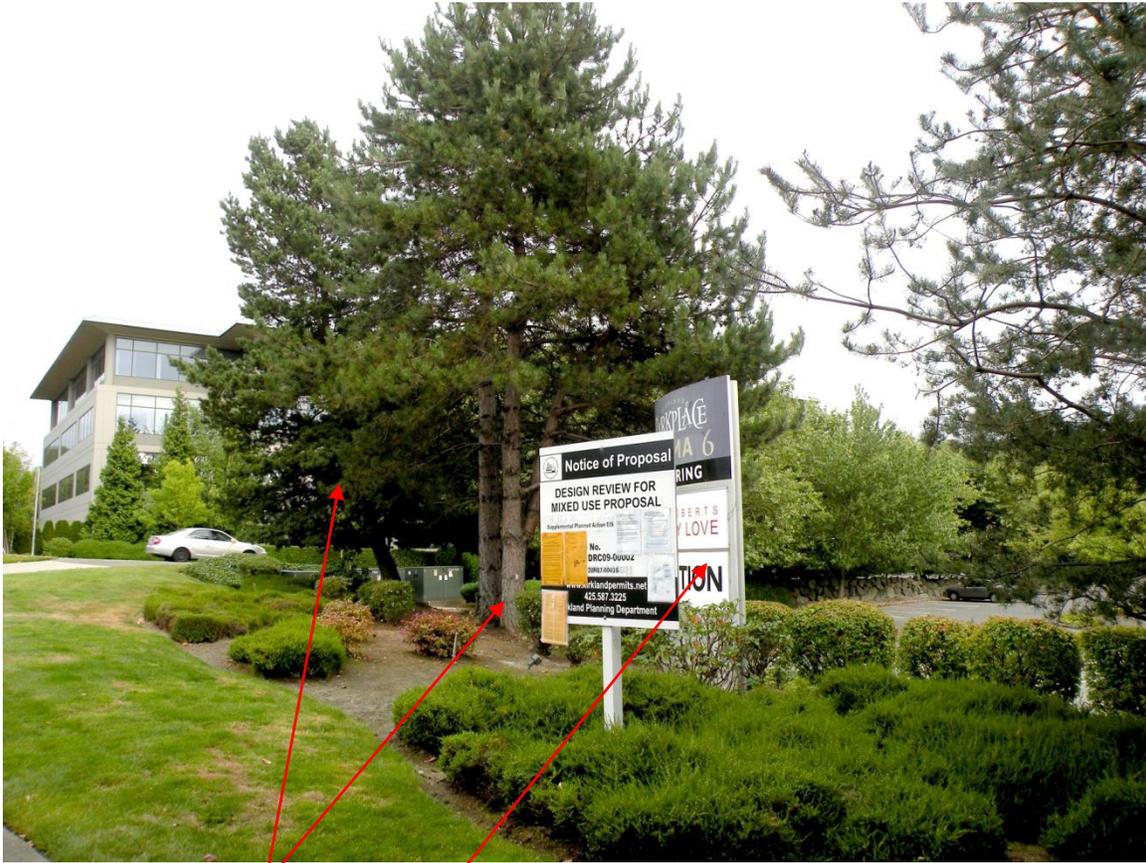
Photo # 12: trees # 208 – 210 and the sign in the northeast corner of the property

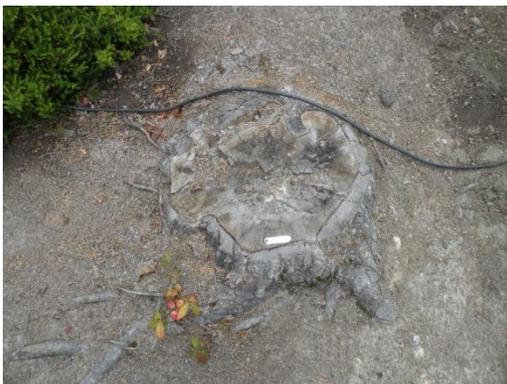
The site plan shows a tree symbol that was given the number 211. The tree was a pine but, judging from the oxidation of the stump that remains, it was cut down years ago. It is included in the inventory to account for the symbol on the site plan.

Photo # 13: the stump of # 211

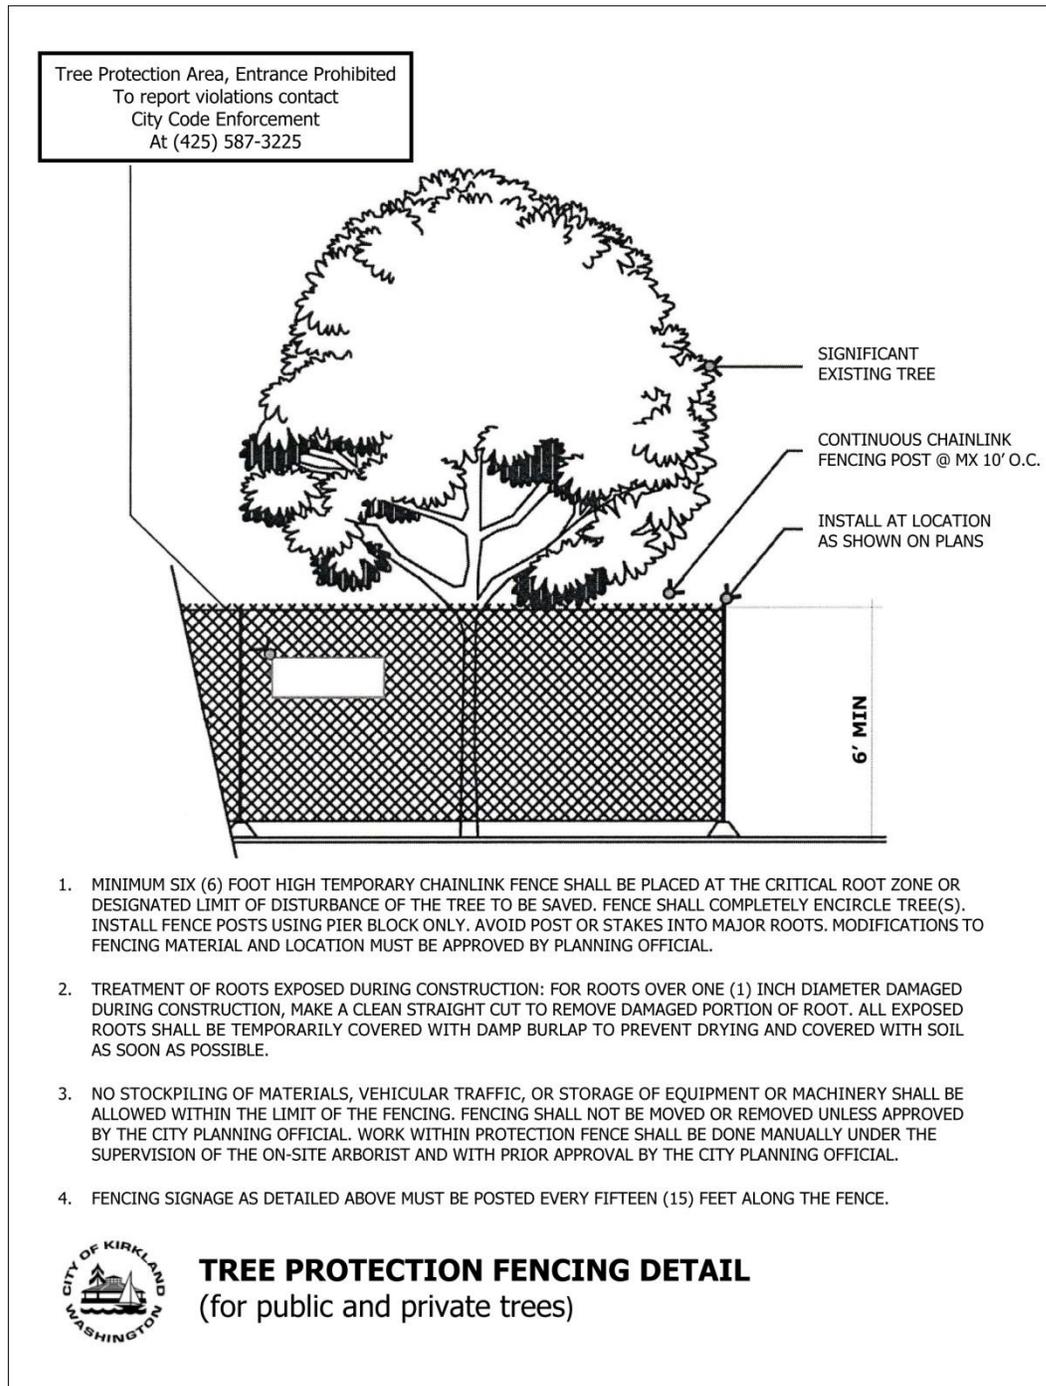
TREE PROTECTION AREA

Entrance Prohibited
