CITY OF KIRKLAND

Department of Public Works

MEMORANDUM

Subject: JUANITA CREEK CHANNEL ENHANCEMENTS AT JUANITA BEACH PARK
ACCEPT WORK AND ESTABLISH LIEN PERIOD

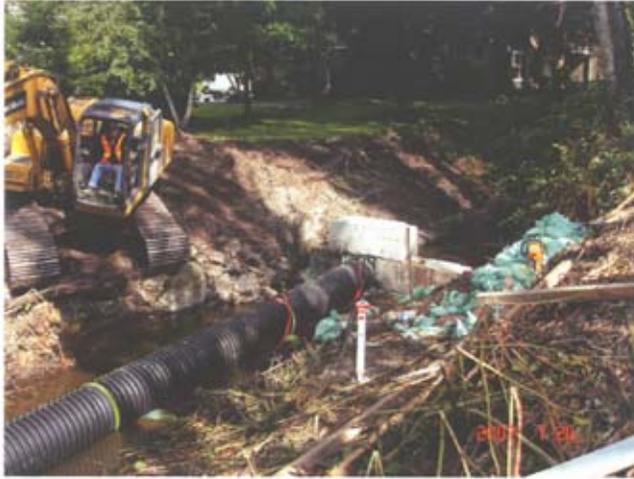
Photo Sequence 1 – Storm Damaged Upper Limits of Project, Looking West

Early construction photo of the contractor installing the temporary stream bypass.

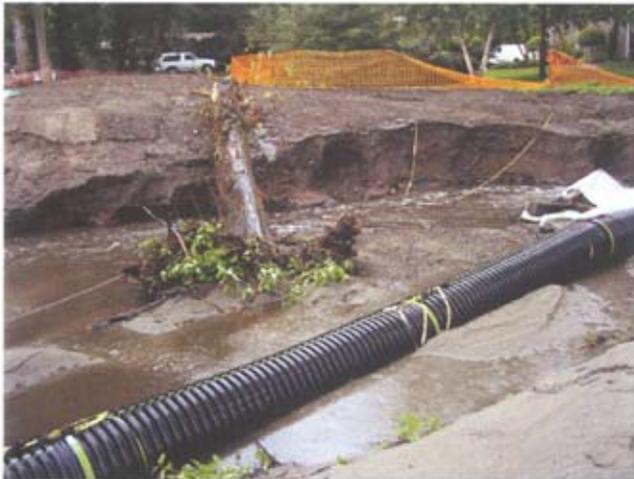
One day after the August 19th storm. The excessive erosion at this location was caused by high flows forced around the temporary stream bypass. No bank protection work was originally planned for this section. Repair of this area amounts to a major portion of the additional work associated with the August 19th storm damage.

The two month delay for completion is directly attributed to additional work that was required to repair damage to the site caused by an unseasonably large storm event that occurred on August 19, 2007. The storm event raised the water level in Juanita Creek to the top of its banks, destroying the Contractor's temporary stream bypass system, and causing substantial bank erosion to the work zone. The effects of this storm were reported to Council by reading file on September 24, 2007.

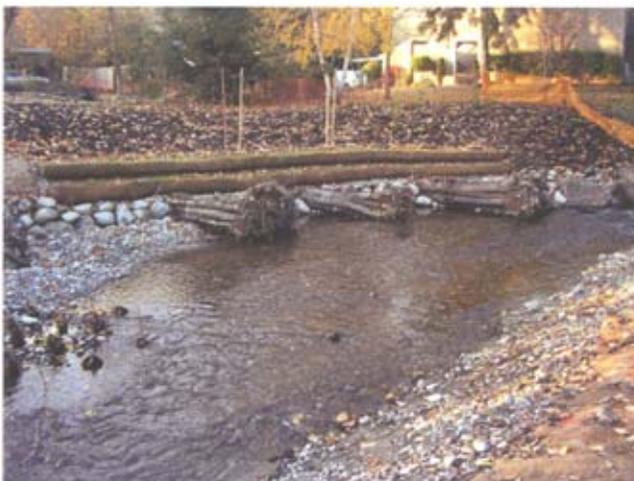
Completed section of additional bank protection work. The log structures provide fish habitat and direct flow away from the bank. Above the log structures are soil layers planted with willow stakes and wrapped in erosion control fabric that will decompose over time.

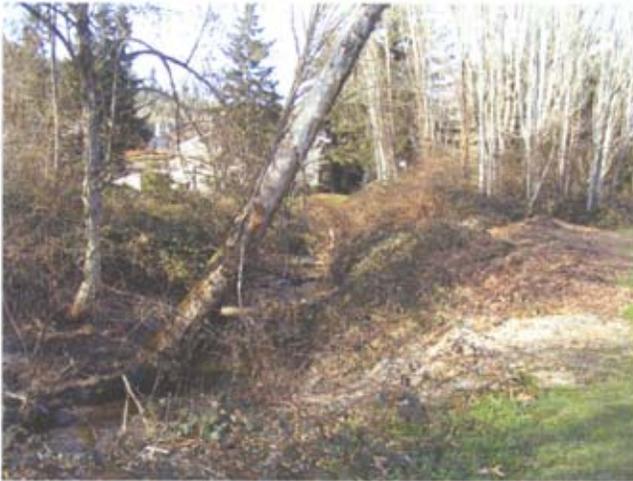
Photo Sequence 2 – Mid Project Bank Protection Section, Looking North

Pre-construction photo of planned bank protection section showing previously existing invasive plants

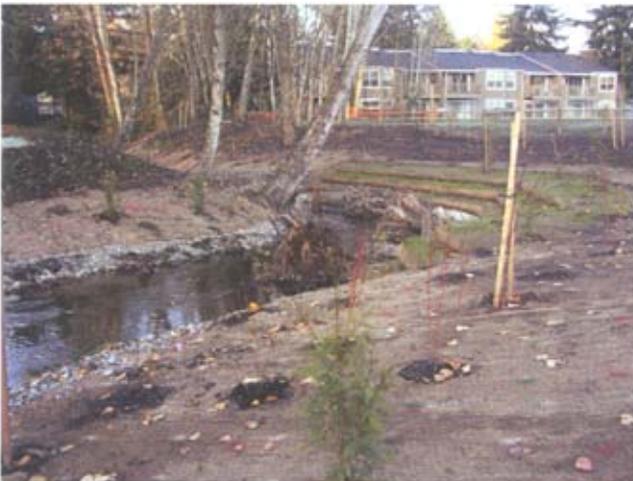
Completed bank protection section showing log structures and soil wrapped bank protection.

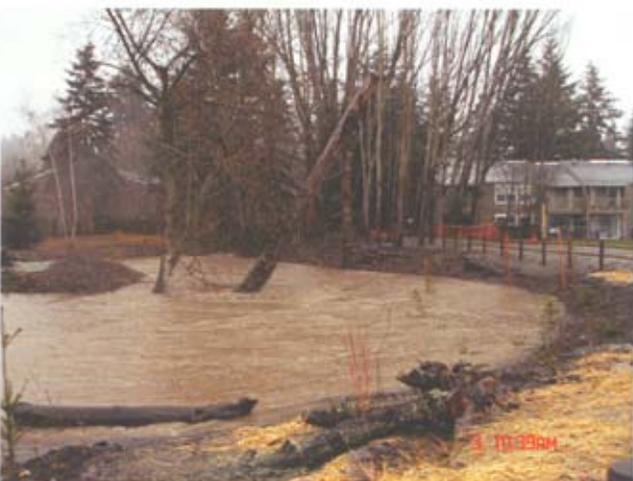
December 3rd storm event showing the high flows at the recently constructed bank protection section.

On December 3, 2007, after the Contractor's August storm restoration and original scope of work were completed, a second large storm event passed through the Kirkland area and again raised the water level in Juanita Creek. This second storm proved to be an excellent, albeit untimely, test for the recently completed project. After the water level normalized, it was apparent that the Project had successfully handled the high flows with only minor stream bank damage. The original intent of the Project's bank stabilization design was to reduce stream velocity and to protect the easily erosive banks by widening the narrow channel and installing log structures to redirect flow

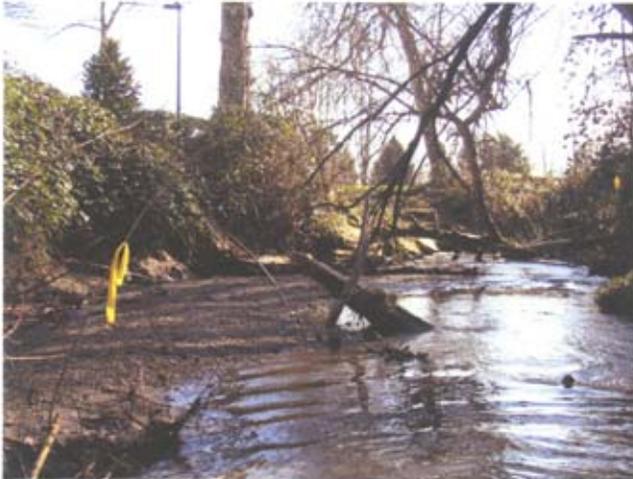
Photo Sequence 3 – Downstream Bank Protection Section, Looking South

Pre-construction photo showing eroded bank lined with broken up concrete slabs.

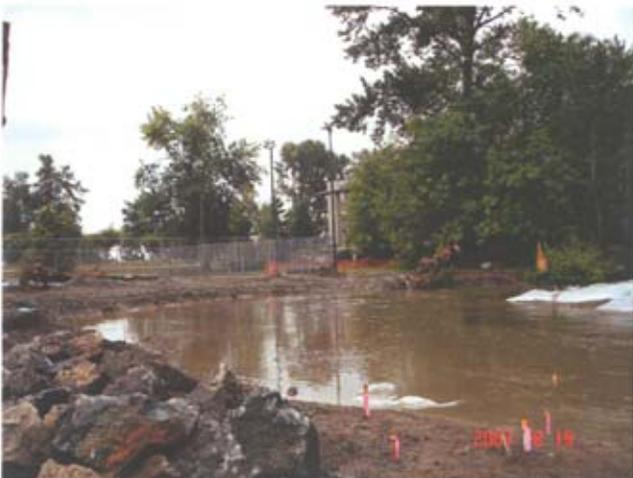
High flows during the August 19th storm. No significant damage occurred in this section. The channel had been re-graded at this time which provided a wider channel with lower velocity flows.

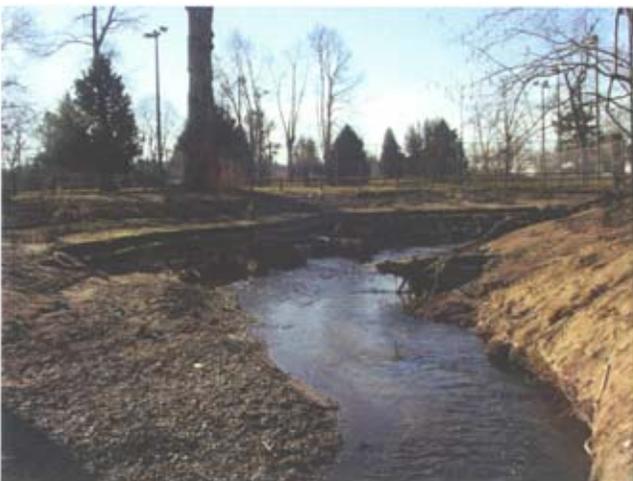
Completed bank protection section showing log structures and soil wrapped bank protection.

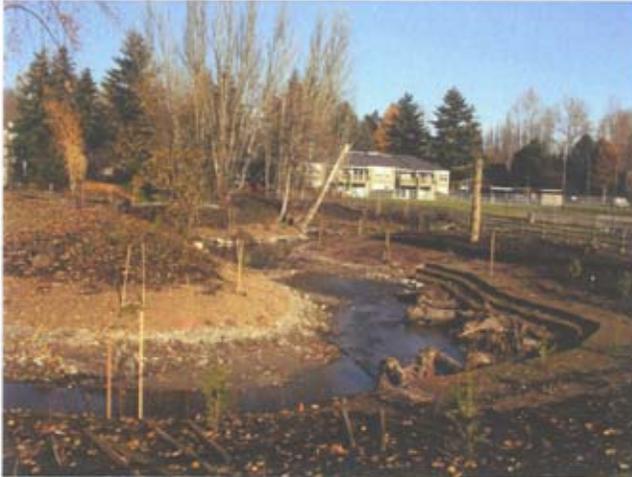
Photo Sequence 4 – Downstream End of Project After Completion Looking North

*Completed project prior to the
December 3rd storm*

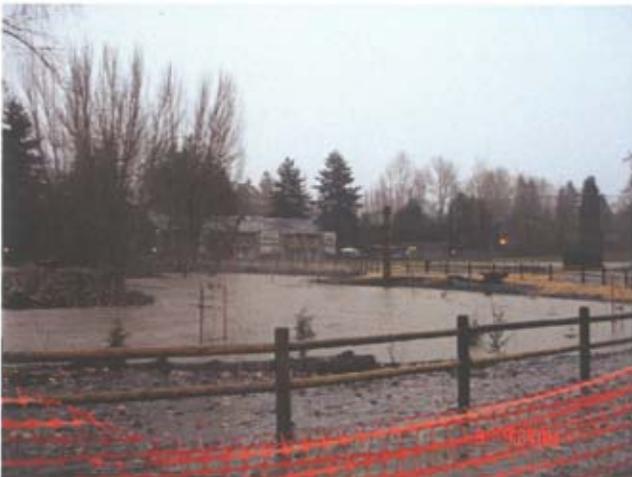
*Completed project during the
December 3rd storm*

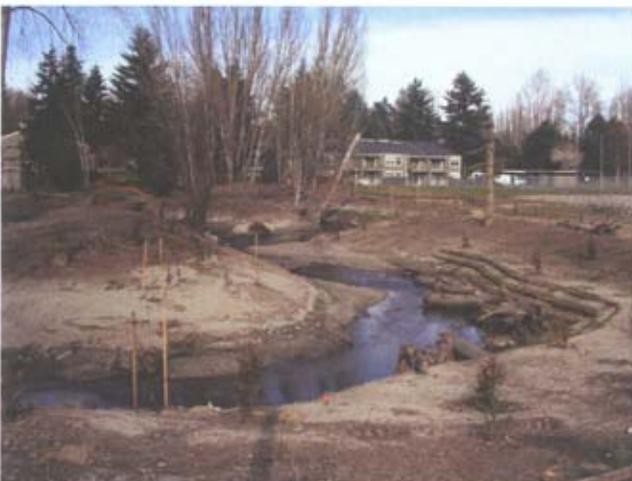
*Completed project after the December
3rd storm showing lost plants and
sediment deposited along stream bank.*

away from the banks at bends in the channel (Attachment C). The storm showed that objective was accomplished; however the storm did leave its mark on the Project in other ways. Plantings for the Project had just been finished a week prior, and approximately five hundred of the two thousand plants installed were carried downstream due to the high flows. Some costs to the Project, loss of plants totaling approximately \$2000 during the second storm, have been submitted to FEMA and are currently under consideration to be reimbursed.

Along with construction and inspection costs that went above those anticipated at the Contract award, costs associated with the monitoring and maintenance portion of the project have also come in higher than projected. The additional cost is again related to impacts from the December 3rd storm. Many of the (approximately 1500) plants that were not lost in the high flows were uprooted and submerged under water, and after the water level subsided, much of the re-vegetated banks were covered in sediment. Plant maintenance, and inventory were conducted after the storm to address immediate issues which prompted a less conservative approach on the estimation of plant survival (a lower survival rate was estimated), and the amount of additional labor required to ensure plant establishment have contributed to the increased cost. Due to the Project's visibility within the Juanita Beach Park and the potential impacts of poor restoration on future grant opportunities, \$57,000 of the requested additional funds will go towards the 5 years of plant monitoring and maintenance (Attachment D).
