**Subject:** Transit Center 60% Status update

# Peter Kirk Park Restroom Facility

Evaluation of existing condition

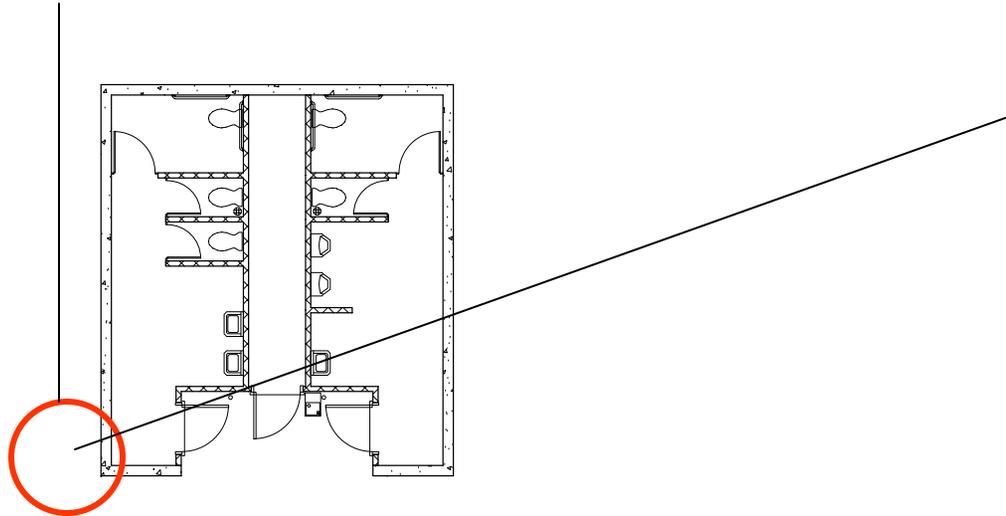
Wall movement along west

The precast concrete panel to the southeast of the restroom, which butts into the concrete face of the structure, is settling. This has caused it to rotate away from the restrooms and has allowed running water to penetrate along the western edge of the restrooms. This movement of water may have caused the deterioration of the waterproofing membrane along that corner of the restroom.

### 4 Retaining wall separation

Grind and reseal the joint. Apply waterproofing to wall  
And fill with chemical grout.

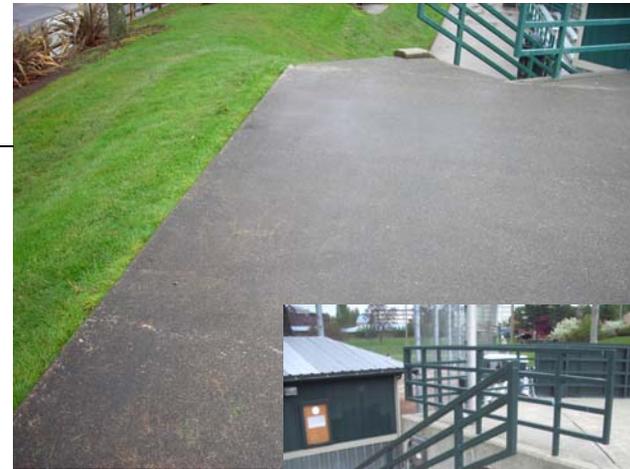
The northern edge of the roof deck butts against a slab that forms the lid for a small mechanical room. The caulk joint at the seam between the two slabs has deteriorated and may be aiding in the passing of moisture into the restroom. This is aiding in the passage of moisture into the void space between the restroom and the mechanical closet.

### 2 Joints

Grind and clean expansion joints. Reseal with chemical grout

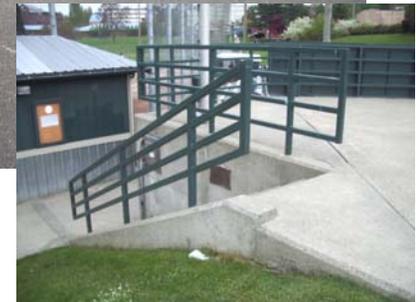
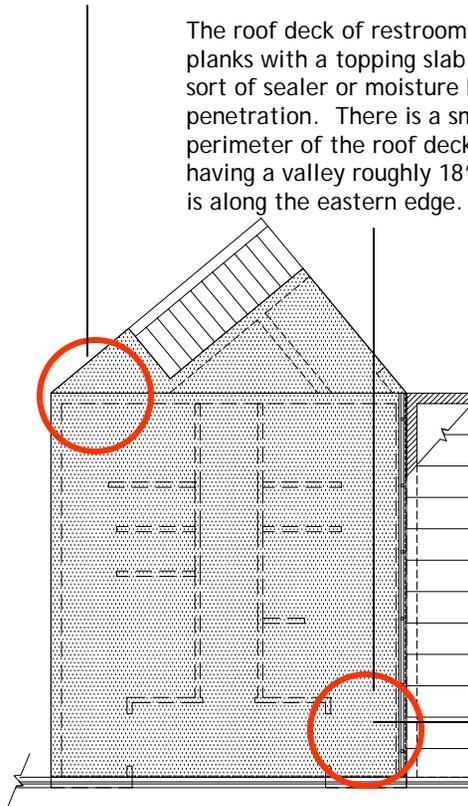
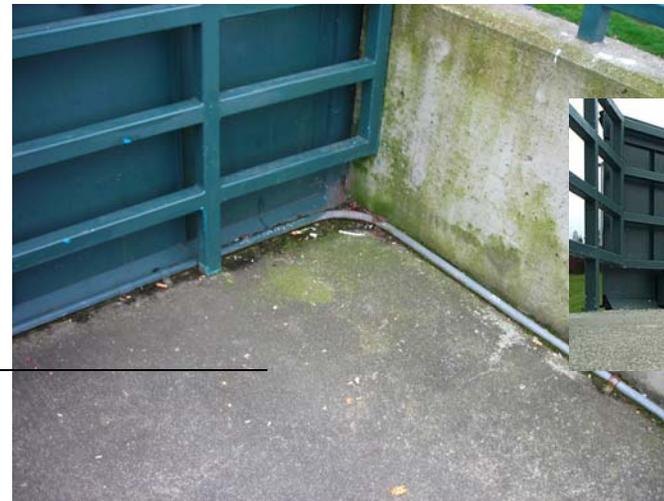
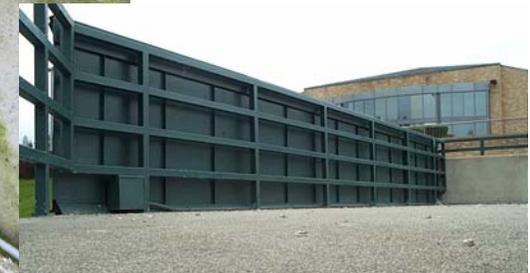
Drainage off roof and compromised joints.

The roof deck of restrooms is formed by 3 extruded concrete planks with a topping slab. The slab doesn't seem to have any sort of sealer or moisture barrier to slow or stop moisture penetration. There is a small amount of ponding around the perimeter of the roof deck. This is due to the slope of the deck having a valley roughly 18" from the edge. The worst condition is along the eastern edge.

### 1 Protect and seal roof slab

Sandblast exterior lid and apply Rainguard\* Micro-seal.

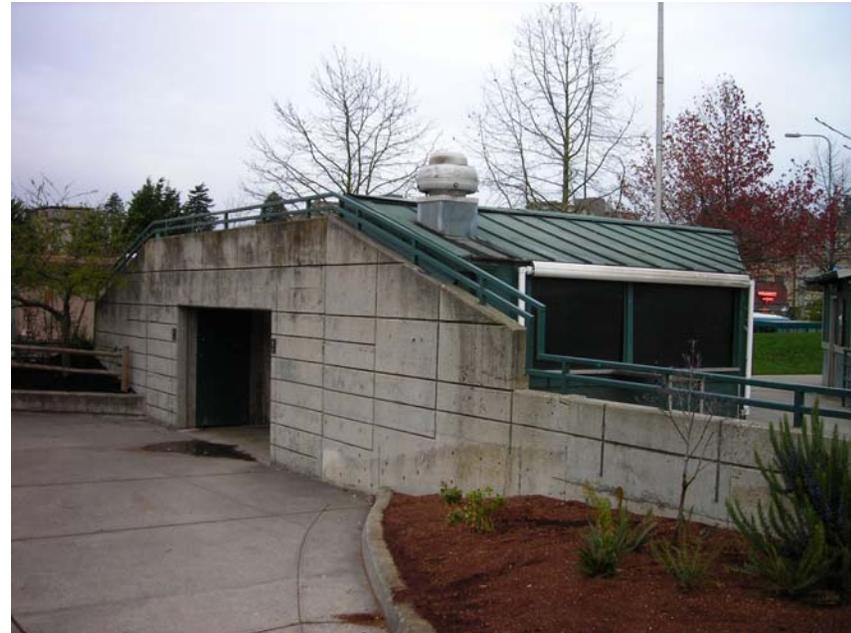
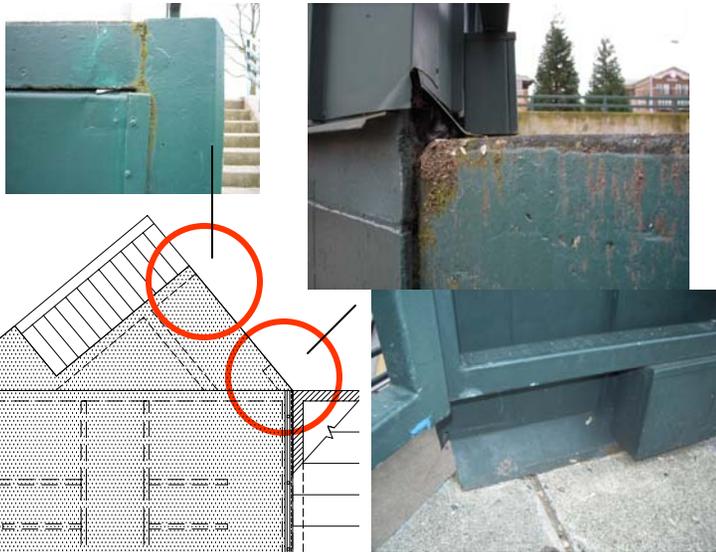
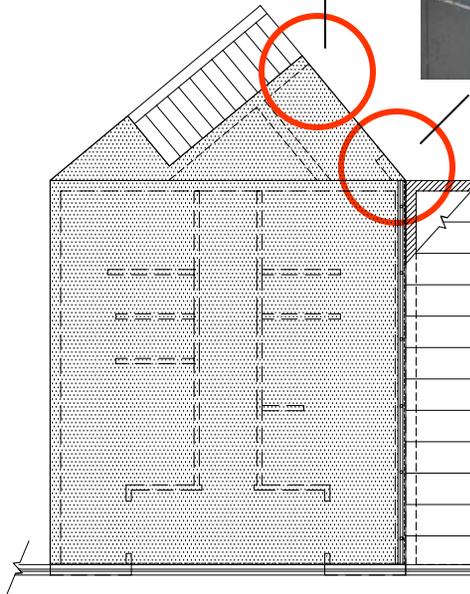
Drainage off roof and compromised joints.

A concession stand for the ball park was added along the eastern edge of the restrooms. This added structure now blocks runoff water which was originally designed to run directly off the edge. The concession stand causes water to pond along the edge of the slab. The flashing from the concession stand to the roof deck is not sloped to encourage the water to run in any direction. As a result, the water stands along that edge and passes through the slab into the restrooms below. The concession stand seems to be free from the adjacent moisture, however, the structure may eventually be affected.

### 3 Flashing

Apply sealant dam to underside of new wall flashing

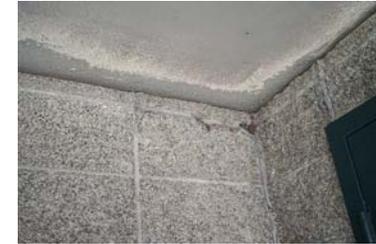
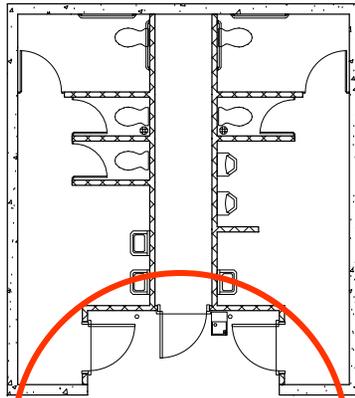
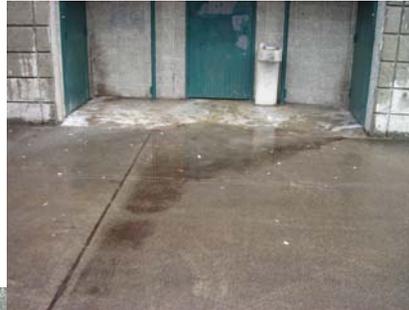
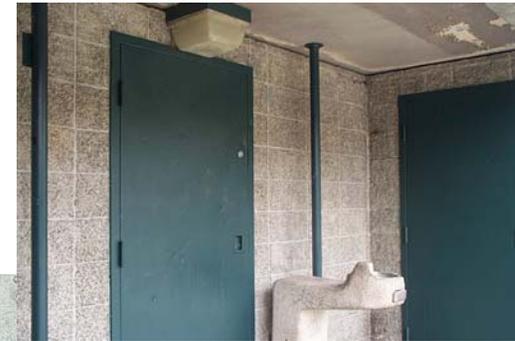
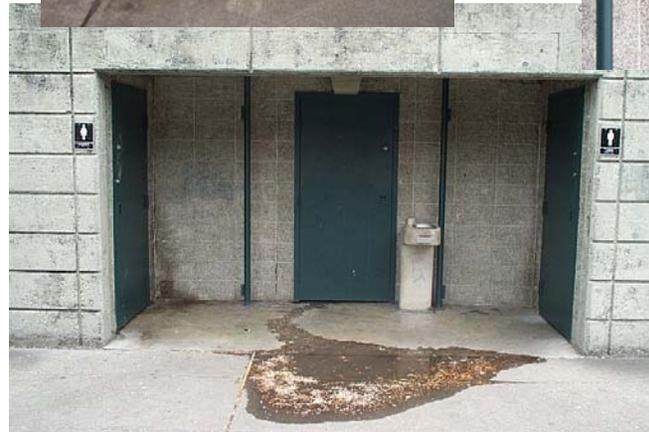
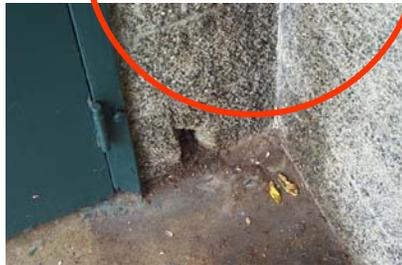
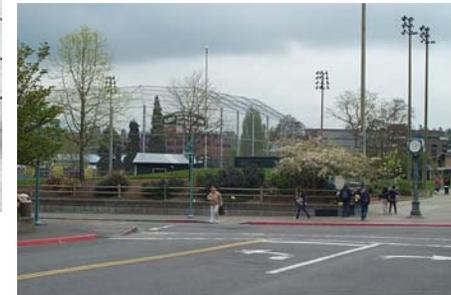
Controlling runoff from adjacent surfaces

The restrooms are accessed from a wide sidewalk along the south. This sidewalk slopes down towards the restroom doors. Water rolls down to pool in front of the restroom doors before flowing onward to a drain at the street beyond. Some of this runoff could be entering the restrooms directly under the doors. This was not directly observed but can be deduced by the water ring within the women's room and the mechanical space. This seems to be out of the scope of our work and may need to be addressed as part of the restroom façade improvement project associated with the street improvement project the City is undertaking.

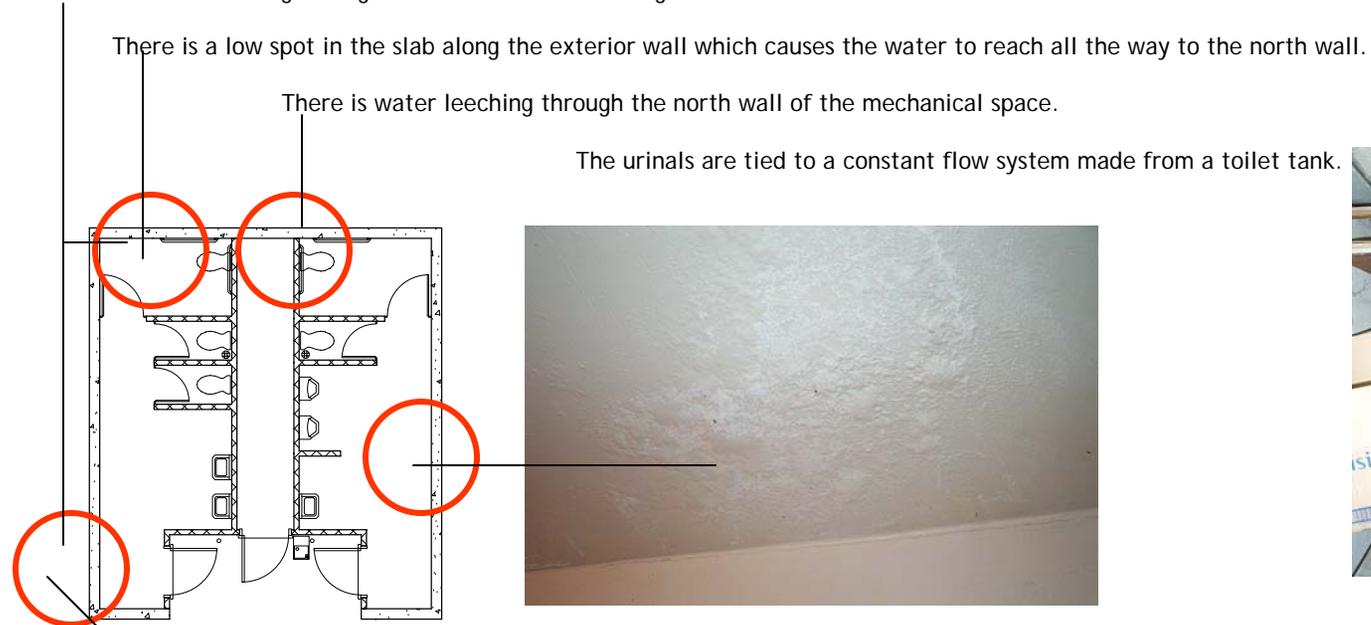
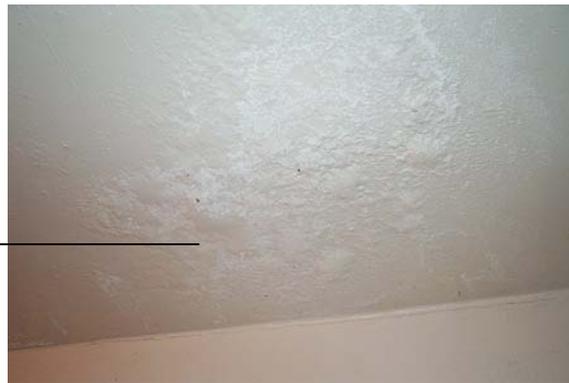
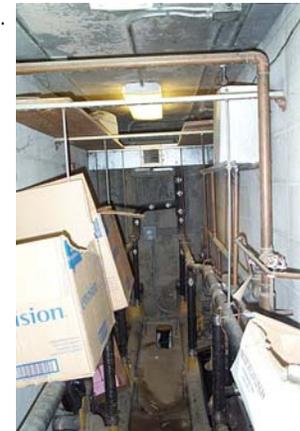
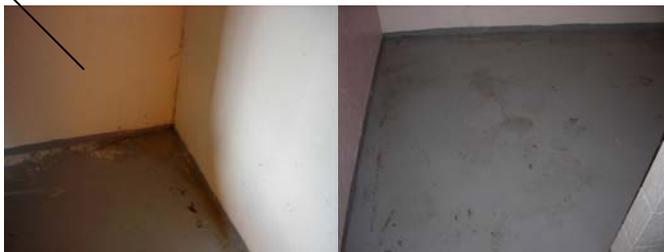
## Interior effects from leakages

There are signs of moisture penetration and efflorescent build up around the perimeter of the ceiling. This is all directly below the water ponding on the roof deck above. The worst seems to be along the eastern edge where the concession stand retains the runoff water.

There are signs of penetrating moisture and efflorescence was observed along the walls.

Standing water was found in the women's room along the southwest wall. It could be coming from two locations - a crack in the corner where moisture could be leeching through and/ or the water coming in under the door from the sidewalk runoff.

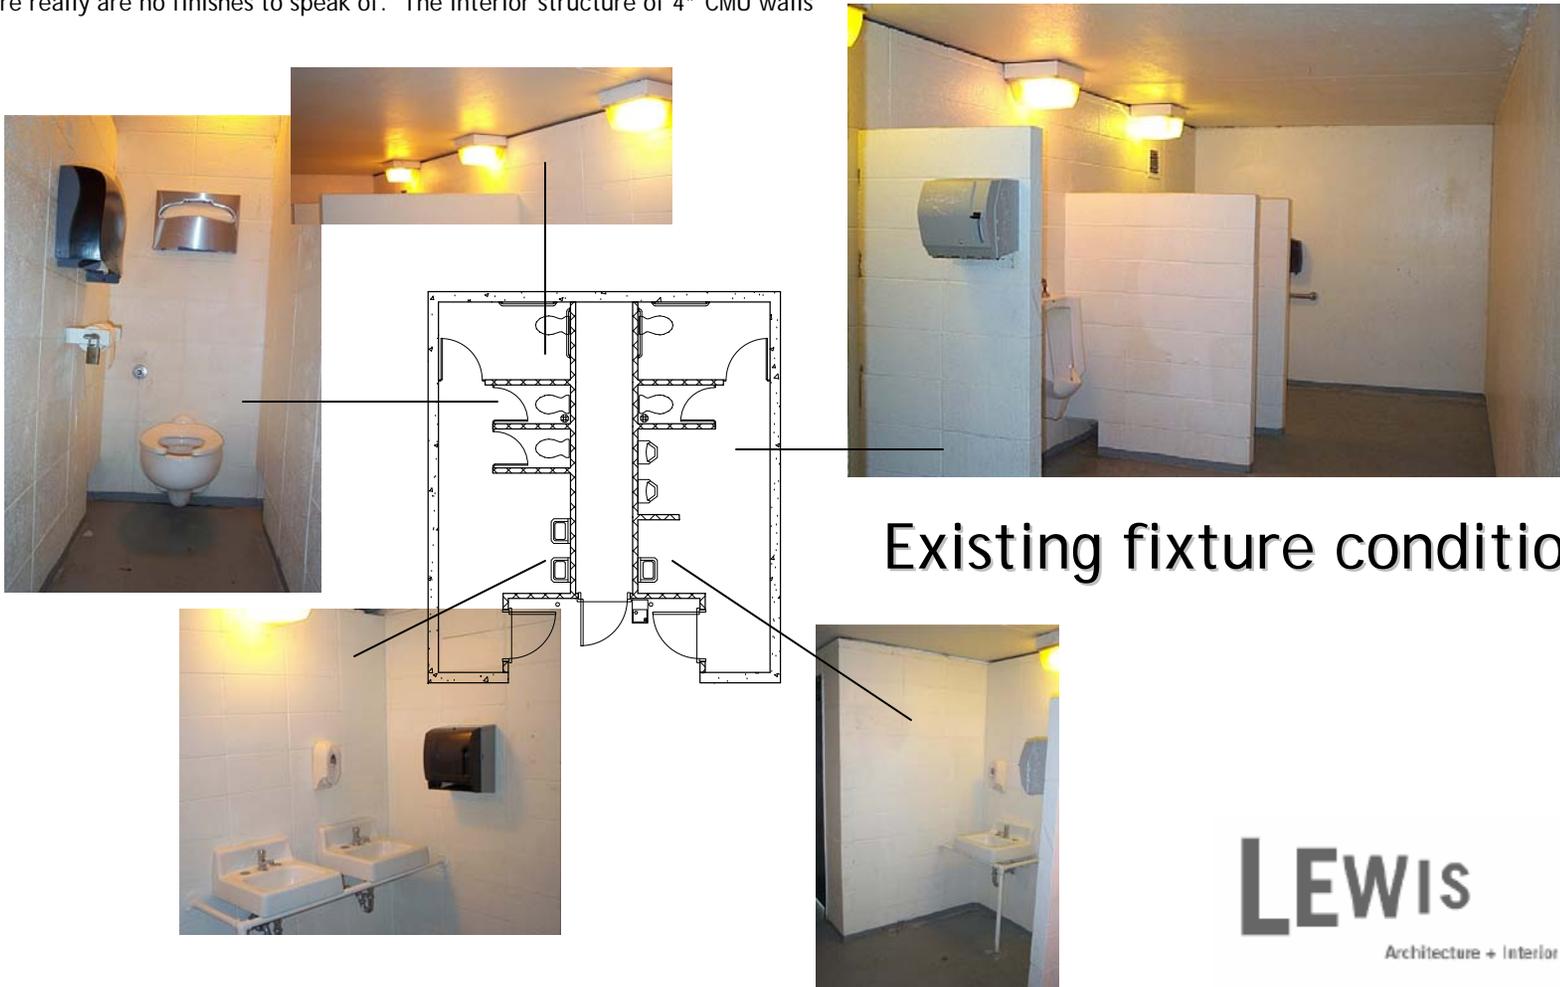
Existing fixture conditions

The lights in the ceiling are looking dated, and in need of repair.  
Due to the moisture issues the paint is in bad shape with layers of paint over other layers of paint without any sanding to smooth out the finish.  
Plumbing fixtures seem workable though they could use updating.

There really are no finishes to speak of. The interior structure of 4" CMU walls

Remove and replace all fixtures

Build up floor with epoxy grout Underlayment to drain. Apply Skid resistant epoxy finish.

Remove and install new Light fixtures surface mount on ceiling

Sandblast concrete and CMU Surfaces, wash and prep. Apply 3 coats of anti-graffitti coating - "Vandlguard"

Install partitions and doors to Toilet stalls.

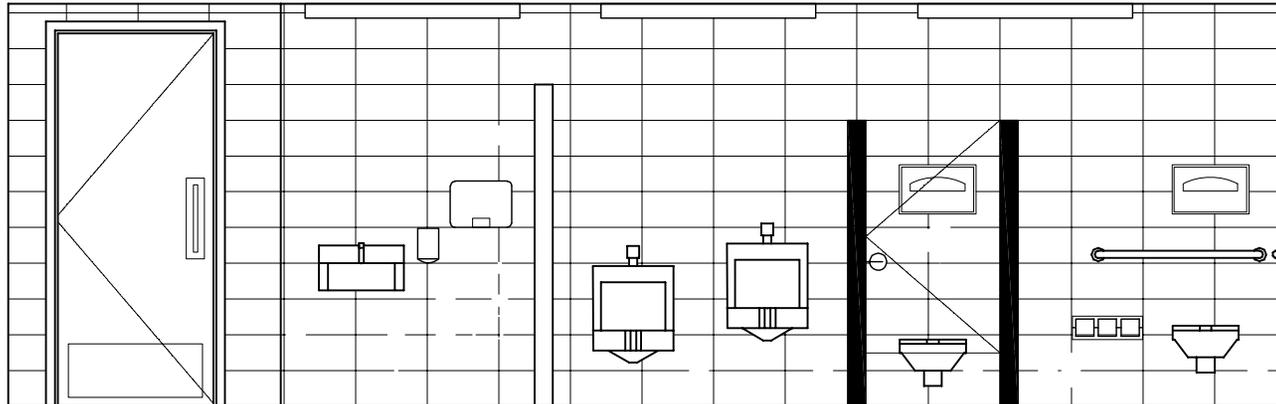
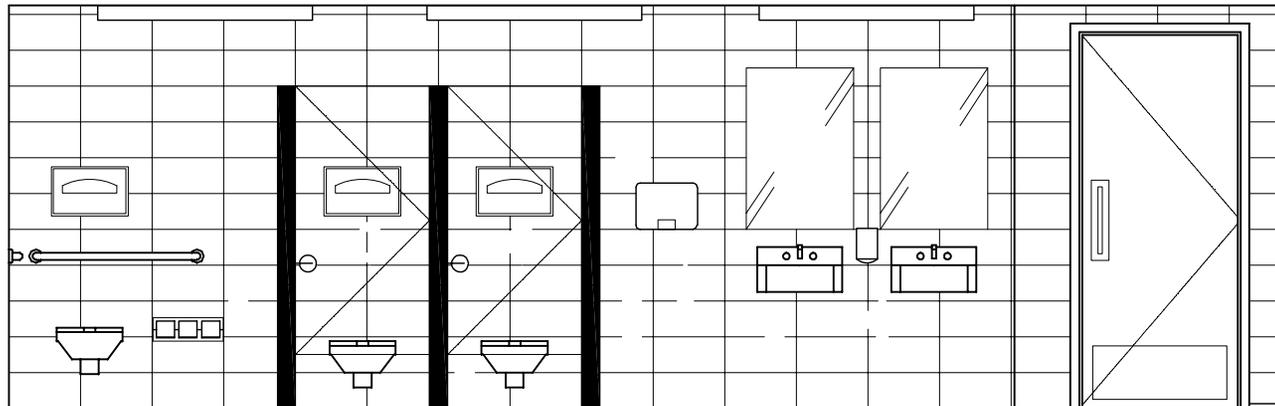
# Potential Upgrade

Tile on walls  
And partitions
