This Wetland Buffer Mitigation Plan has been prepared to identify proposed impacts to sensitive areas and describe compensatory mitigation requirements for construction of a single family home. The Tax ID of the subject property is (1238500670); it is also known as Lot 3 located on Forbes Lake on Slater Street NE in Kirkland, Washington (**Figure 1**). This report has been prepared for submittal to the City of Kirkland and has been prepared according to the City of Kirkland Zoning Code (KZC) Chapter 90.05.

<p>AQUATICA ENVIRONMENTAL CONSULTING, LLC 21214 RIMROCK ROAD MONROE, WA 98272 T (425) 802-8988 F (360) 805-9608</p>	<p>EXISTING CONDITIONS PLAN MAXINE KEESLING KIRKLAND, WASHINGTON</p>		<p>CHECKED BY KG</p>
	<p>SCALE AS NOTED 11.25.08</p>		<p>DATE 11.25.08</p>
<p>PROJECT NO. 07-102</p>		<p>FIGURE 2 OF 5</p>	<p>© COPYRIGHT - AQUATICA ENVIRONMENTAL CONSULTING</p>

TREE PLAN FOR MAXINE KEESLING LOT 3 Kirkland, WA

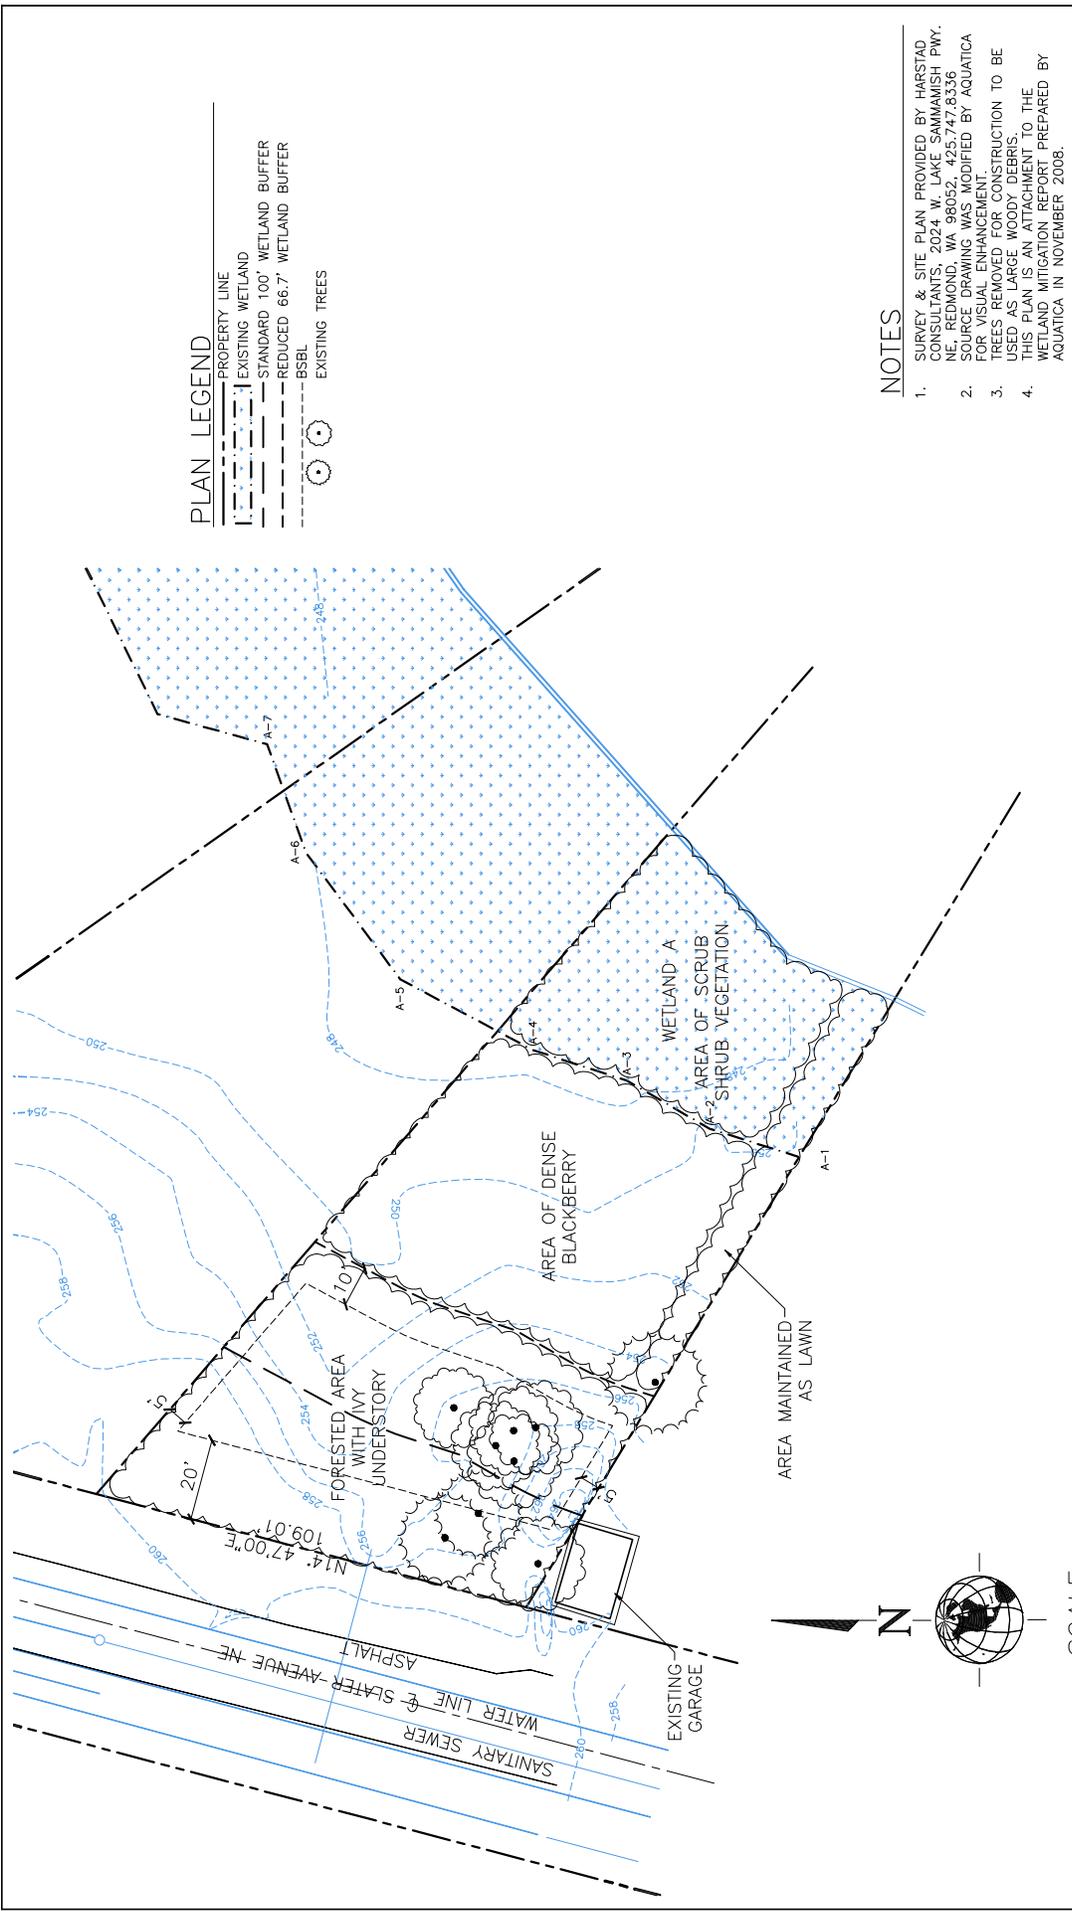
One wetland associated with Forbes Lake is present on the property (**Figure 2**). The wetland was delineated by Aquatica on January 6, 2008. The wetland, identified as "Wetland A" is a Type 1 wetland, located in a primary drainage basin and requires a 100-foot standard buffer (KZC 90.45(1)). The wetland delineation, category and buffer were reviewed and approved by the City's consultant, The Watershed Company, in January 2008. Additional information on the wetland was included in a wetland report prepared by The Watershed Company dated December 13, 2007. The wetland is located on the eastern third of the property and is contiguous with Forbes Lake. The 100-foot buffer extends through the majority of the lot, excluding the western edge near Slater Avenue NE.

The on-site wetland is dominated primarily by scrub shrub vegetation including Douglas' spiraea (*Spiraea douglasii*), Nootka rose (*Rosa nutkana*), and species of willow (*Salix lasiandra* and *S. sitchensis*). The majority of the buffer is dominated by Himalayan blackberry (*Rubus discolor*). The western edge of the lot and wetland buffer also includes several large trees (**Figure 2**).

An abundance of invasive weeds, primarily Himalayan blackberry and English Ivy are present on the property within the areas proposed for enhancement (**Figure 2**). Prior to planting, these species shall be cut down and their roots shall be grubbed out. Repeated site visits to grub these species will likely be necessary. As noted on **Figure 5**, weedy areas shall be sheet mulched with cardboard topped with a coarse mulch to suppress weeds and prevent herbaceous plant material from competing with planted species.

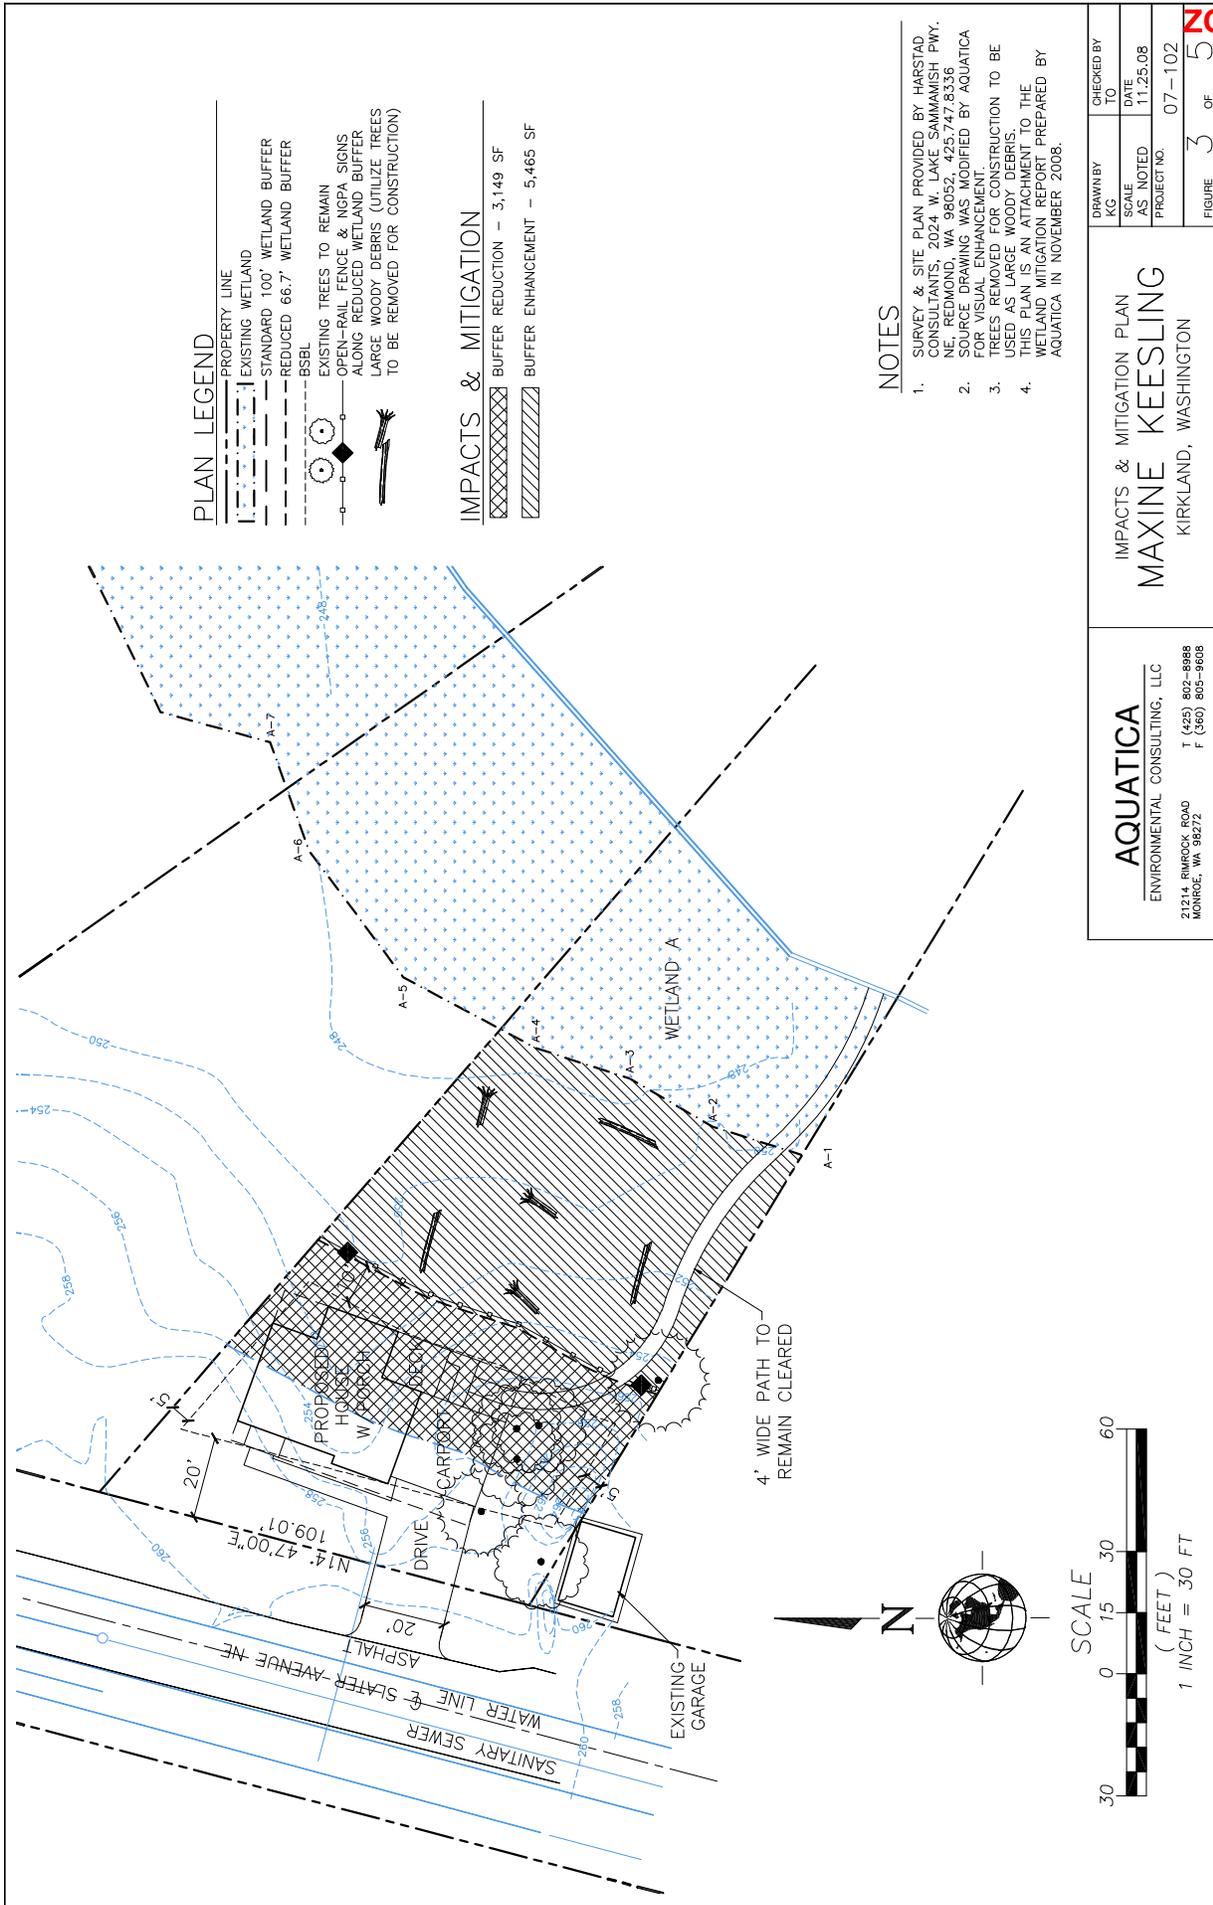
The proposed project includes the construction of a new home and carport on the western edge of the lot (**Figure 3**). Due to a 20-foot front yard setback and the extent of the wetland and 100-foot buffer, it was not possible to construct a house and avoid all sensitive areas. Excluding these areas left only a 15-foot strip of unencumbered property. For these reasons, the applicant is requesting a one-third reduction of the standard buffer to accommodate a house with a modest footprint of only approximately 1,000 sf and an associated parking area (carport).

The project proposes to reduce the wetland buffer by 3,149 sf, for the construction of a house and carport. The remaining wetland and buffer (5,465 sf) will be enhanced through invasive species removal and installation of native trees and shrubs (**Figure 3**).

Habitat features including either brush piles or large woody debris will be placed in the enhancement area (**Figure 3**). Larger logs or stumps will provide refuge for small mammals or amphibians while contributing to the soil as they decay. Brush piles provide cover for small mammals, as well as birds (such as juncos, wrens and sparrows), which are particularly attracted to them. Material for habitat features shall be obtained from trees that will need to be removed for construction.

Three large black cottonwood trees are shown as preserved off the southeast corner of the carport. These trees appear to be leaning towards or over the proposed house location and may pose a future hazard to the structure. These trees should be evaluated by a certified arborist and, if deemed hazardous, be “snagged” at a recommended height. Alternatively, complete removal with replacement trees may be acceptable per relevant Kirkland significant tree regulations.

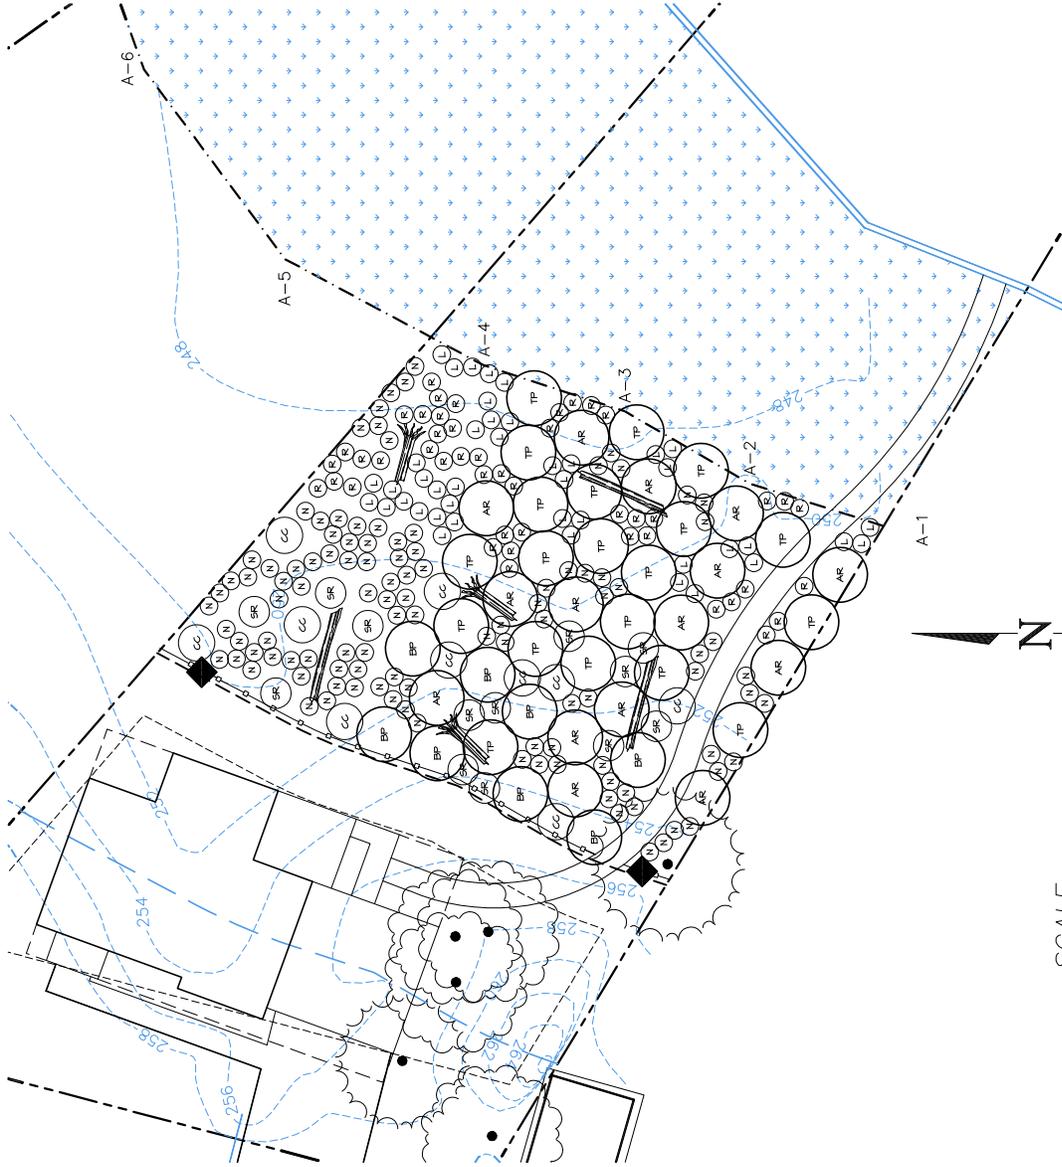
KEY	SCIENTIFIC NAME	COMMON NAME	SPACING	QTY	SIZE (MIN.)
CC	CORYLUS CORNUSTA	WESTERN HAZELNUT	6' O.C.	10	1 GAL.
L	LONGICERA INVOLUCRATA	BLACK TWIN-BERRY	6' O.C.	42	1 GAL.
N	ROSA NUTKANA	NOOTKA ROSE	6' O.C.	109	1 GAL.
R	RUBUS SPECTABILIS	SALMONBERRY	6' O.C.	46	1 GAL.
SR	SAMBUCUS RACEMOSA	RED ELDERBERRY	6' O.C.	13	1 GAL.

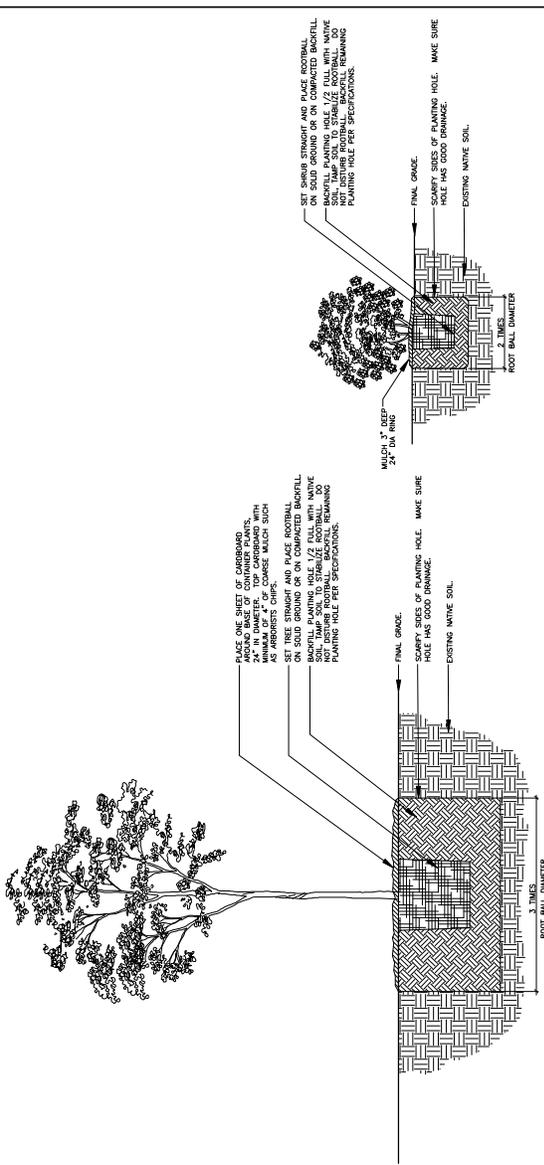
1 TREE PLANTING

2 SHRUB PLANTING

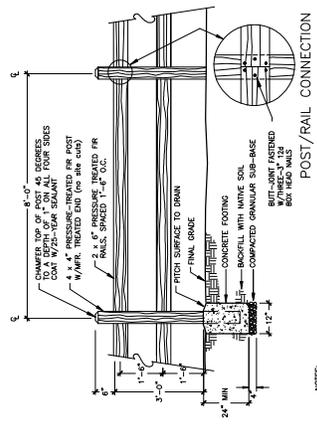
3 OPEN-RAIL FENCE

- NOTES:
- 1. FENCE TO BE GALV. WITH 1/4\"/>
- 2. TREAT WITH CLEAR PRESERVATIVE UPON COMPLETION OF INSTALLATION.
- 3. ALL FASTENERS TO BE GALVANIZED STEEL.

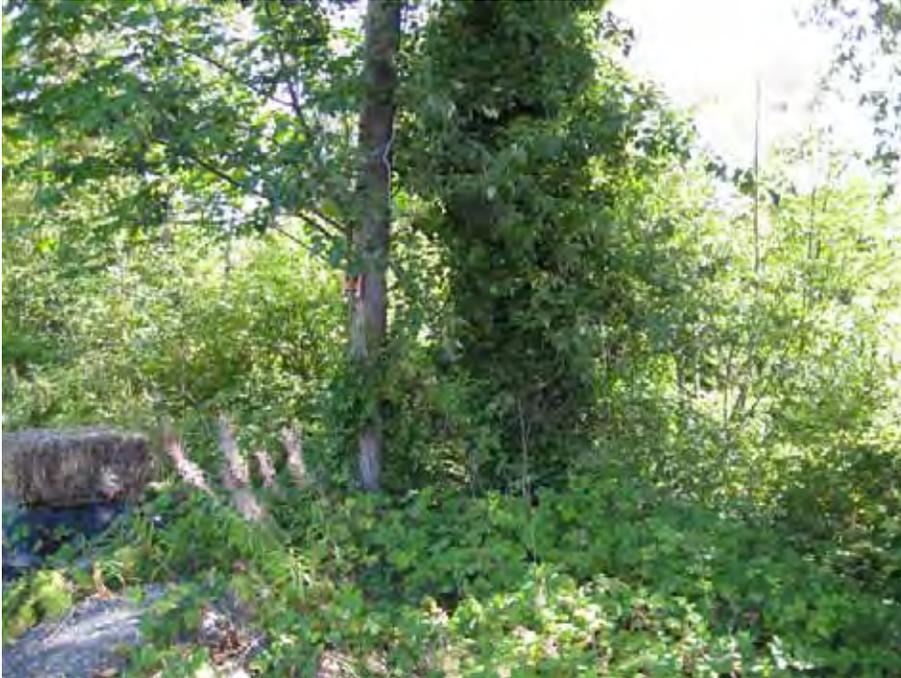
Trees #1 and #2

There are only 2 trees (#1 & #2) greater than 6” DBH on the portion of the lot to be developed. Both of these are black cottonwood. Tree #1 is in poor condition and considered non-viable. It has a recent broken top and is suppressed by tree #2. Tree #2 has forked top and is considered a moderate to high-risk tree.

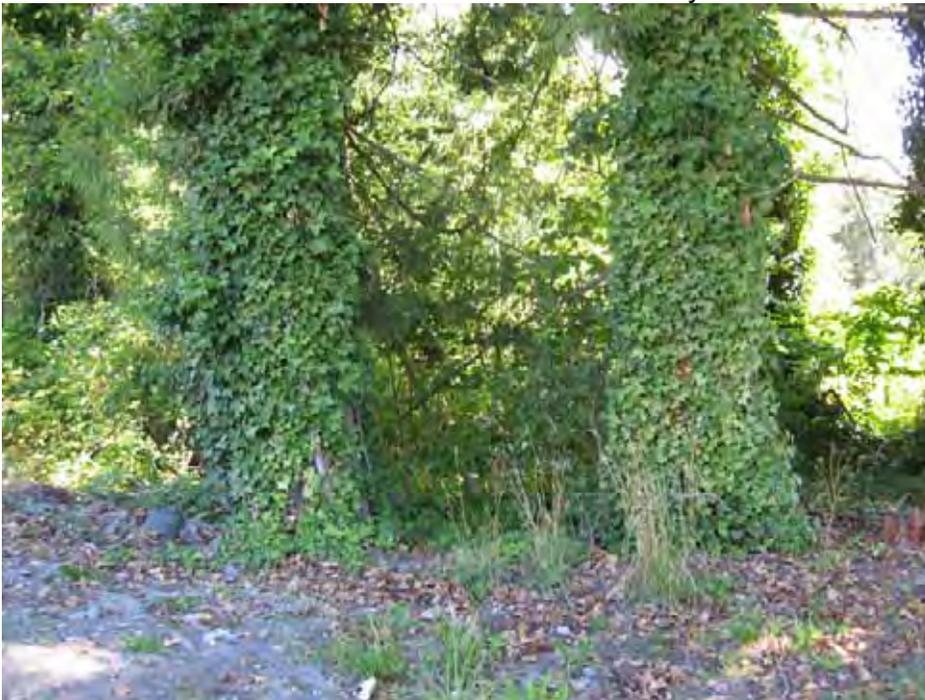
Trees #4 and #5 are mature western red cedars. Both are completely covered in ivy, which made an inspection of the lower trunk difficult. Decay was identified on the lower trunk of #5, and similar is expected for #4, which is typical for the species. Both trees are suppressed and overtopped by the cluster of cottonwood trees to the east. The top of tree #5 has recently died back. Vigor appears low. This tree should be monitored over the years. At this time, tree #4 is considered to be in fairly good condition and tree #5 only in fair condition. Both are low risk and feasible to retain.

Western red cedars – trees #4 and #5 – covered in ivy

The removal of ivy from all preserved trees is recommended.

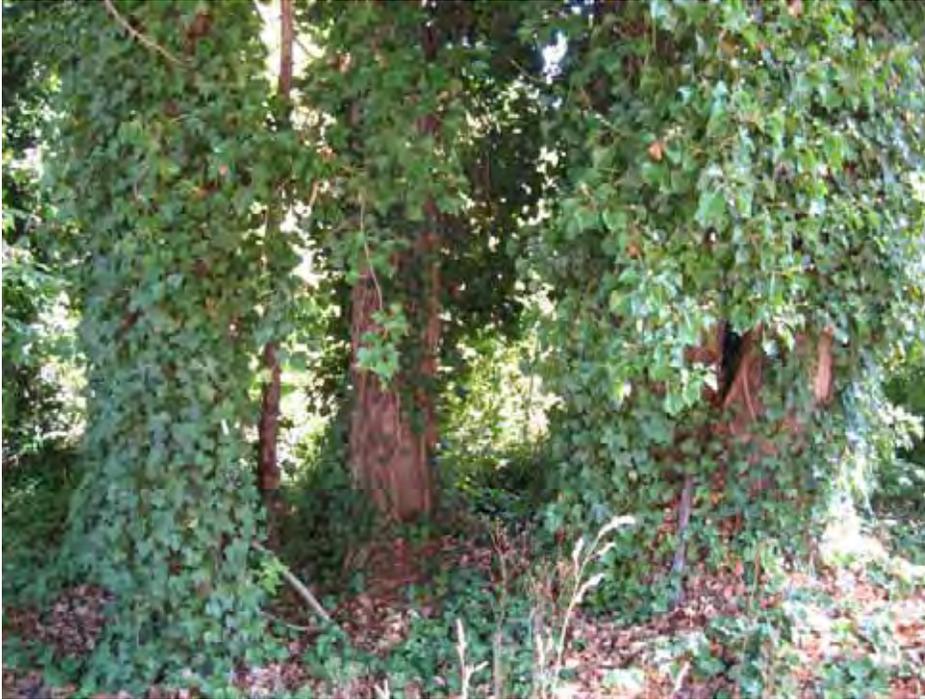
The majority of tree cover on this lot is resulting from a cluster of 7 closely spaced large cottonwood trees, identified on the plan. It is reasonable to retain this cluster, although you need to be aware that these trees will shed large branches from time to time. These trees appear healthy with minimal structural defects. The root systems are not subjected to saturated soils. Failure risk for the entire cluster is considered moderate, due to specie characteristics.

Cluster of mature cottonwood

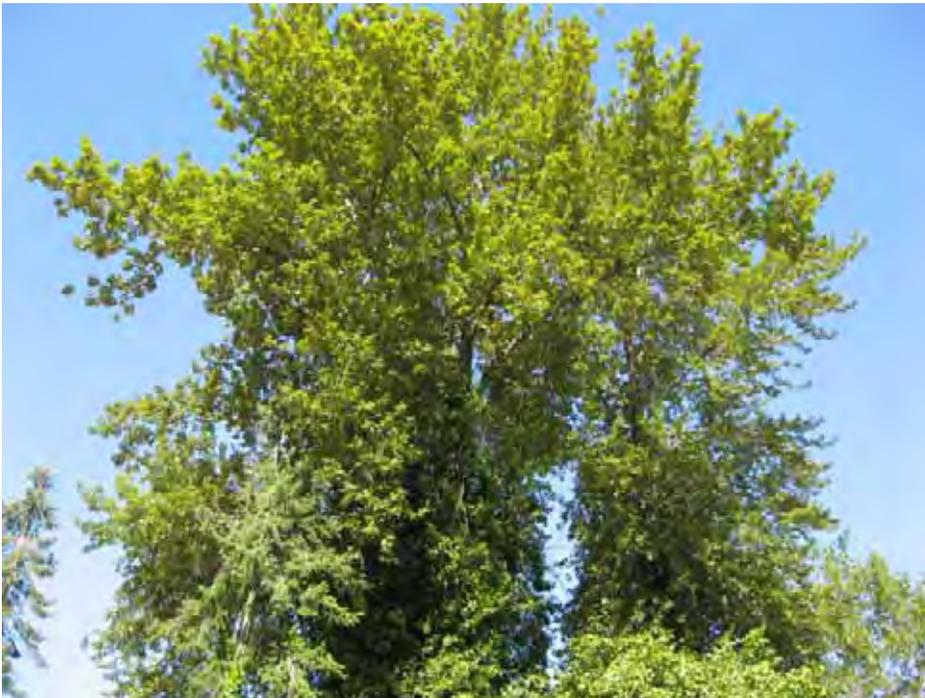
Crown of cottonwood cluster

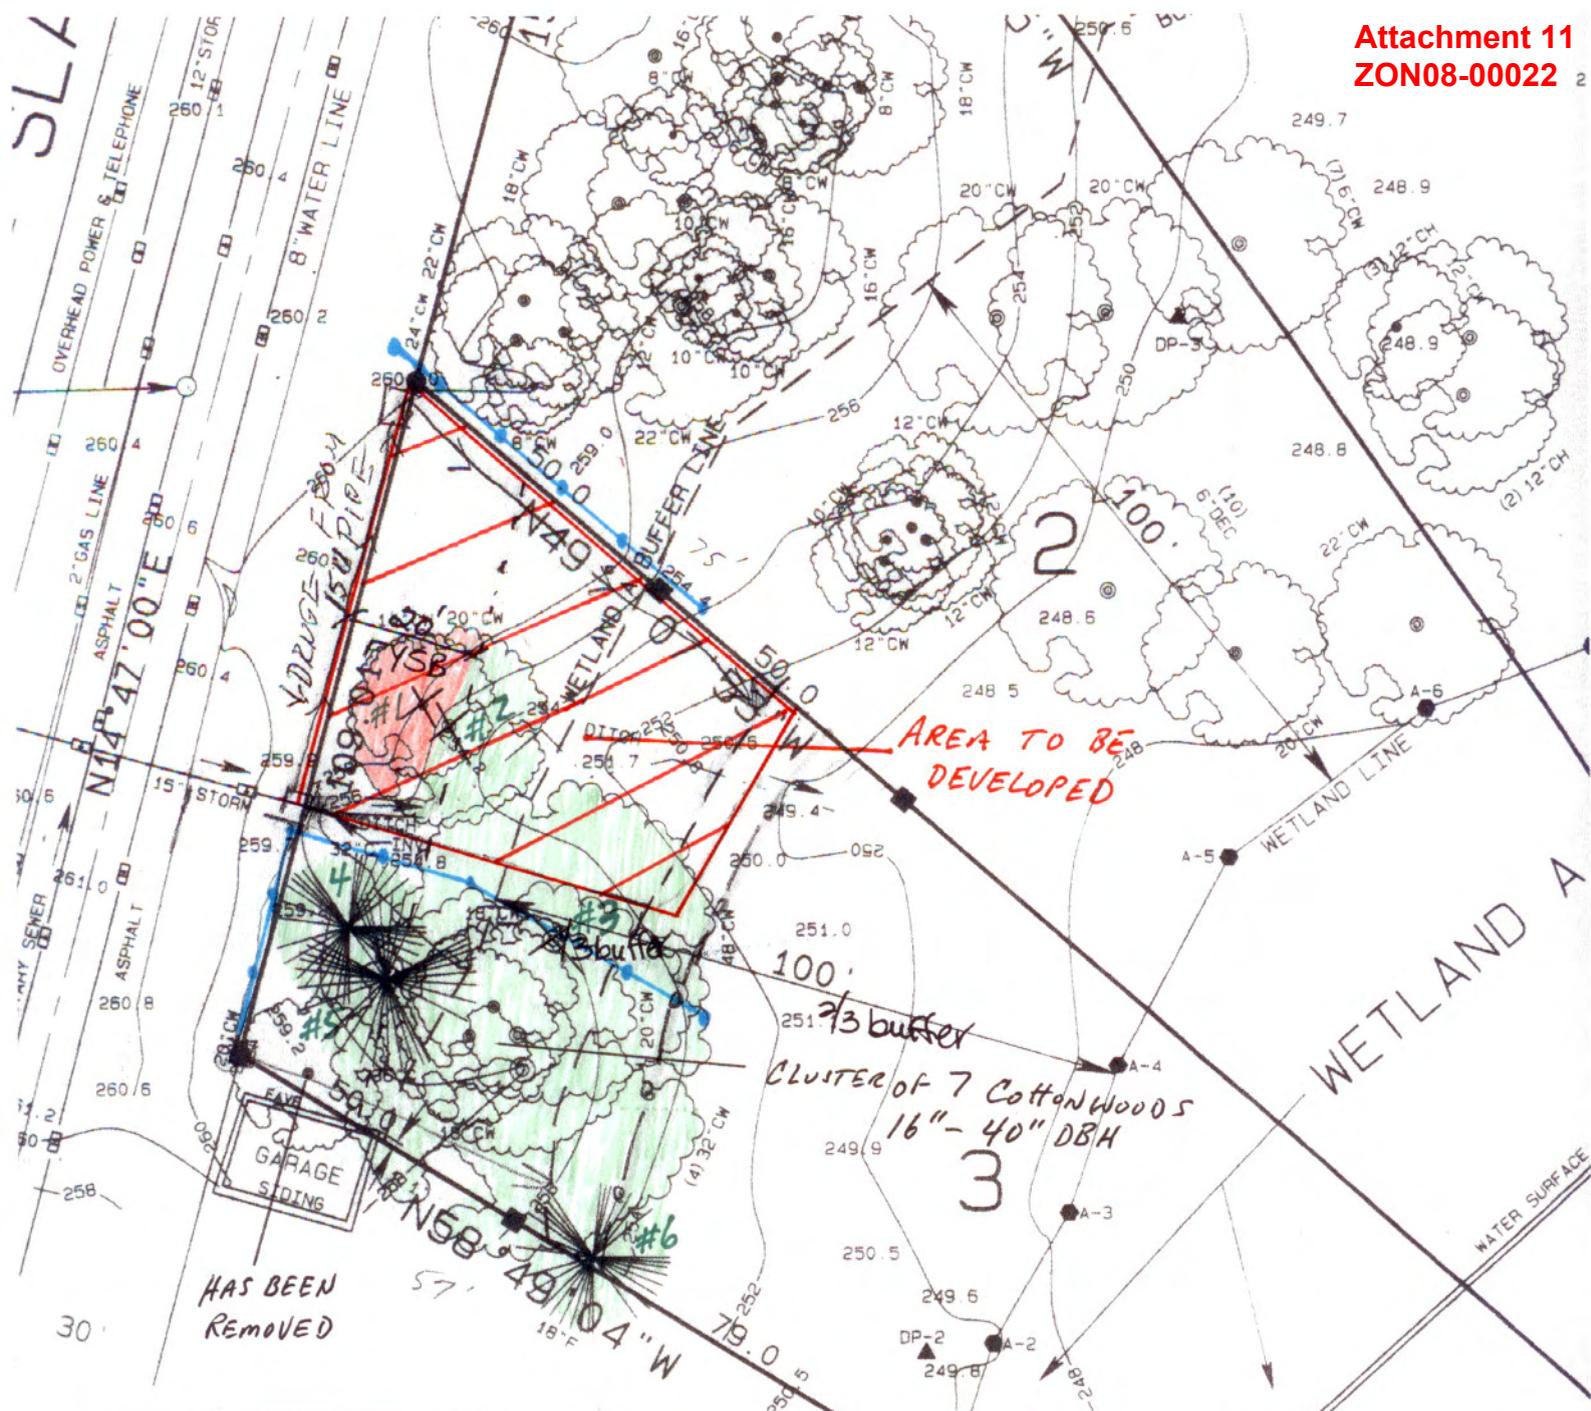
Scale 1" = 30'
Tree Legend

Limits of disturbance for the subject trees have been evaluated on the ground. The extent of driplines (farthest reaching branches) and recommended “Limits of Disturbance” can be found on the tree summary table at the back of this report. This information, as well as the recommended positioning of tree protection fencing has been plotted on a copy of the site plan, which is attached and part of this report.

Tag #	Species	DBH	Condition	Credits	Proposal
1	black cottonwood	15	fair-poor	na	Remove
2	black cottonwood	34	fair	na	Remove
3	black cottonwood	42	fair	na	Remove
4	western red cedar	29	fair	10.5	Retain
5	western red cedar	33	fair	12.5	Retain
6	Douglas-fir	12	fair	2.0	Retain
	Cluster of 7 large cottonwood	16-40	fair	42	Retain
