# Finn Hill Neighborhood Alliance Surface Water Plan

# **Surface Water Management and Drainage Concerns in the Finn Hill/Holmes Point Neighborhood**

**June 15, 2012**

**Prepared by Lou Berner  
Finn Hill Neighborhood Alliance**

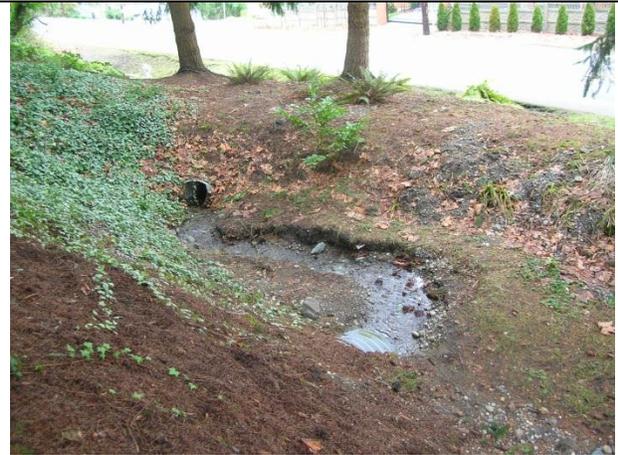
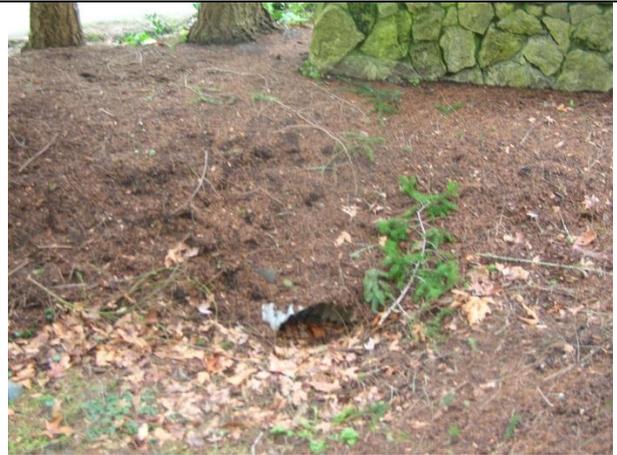
Storm water retention ponds throughout the neighborhood are in need of maintenance or repair. Across the Finn Hill neighborhood, there are 50 or more of these installations.

<p>Cut bank in retention pond indicates siltation.</p>	<p>The outflow pipe is almost silted over.</p>

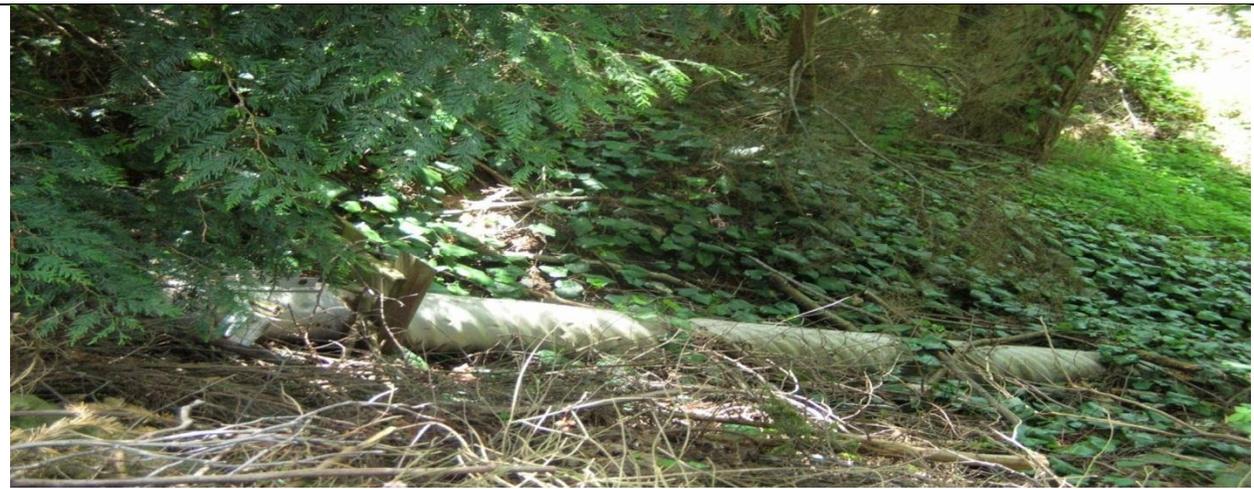
Homemade flumes and tight line configurations are prone to leaks and catastrophic failure.

<p>A homemade flume routes surface water runoff down a steep slope from the top of Finn Hill in Kirkland, Washington. There are many similar jerry-rigged pipes flowing off of the west side of Finn Hill, where rogue runoff and poorly managed systems lead to flooding of residences at the bottom of the hill.</p>

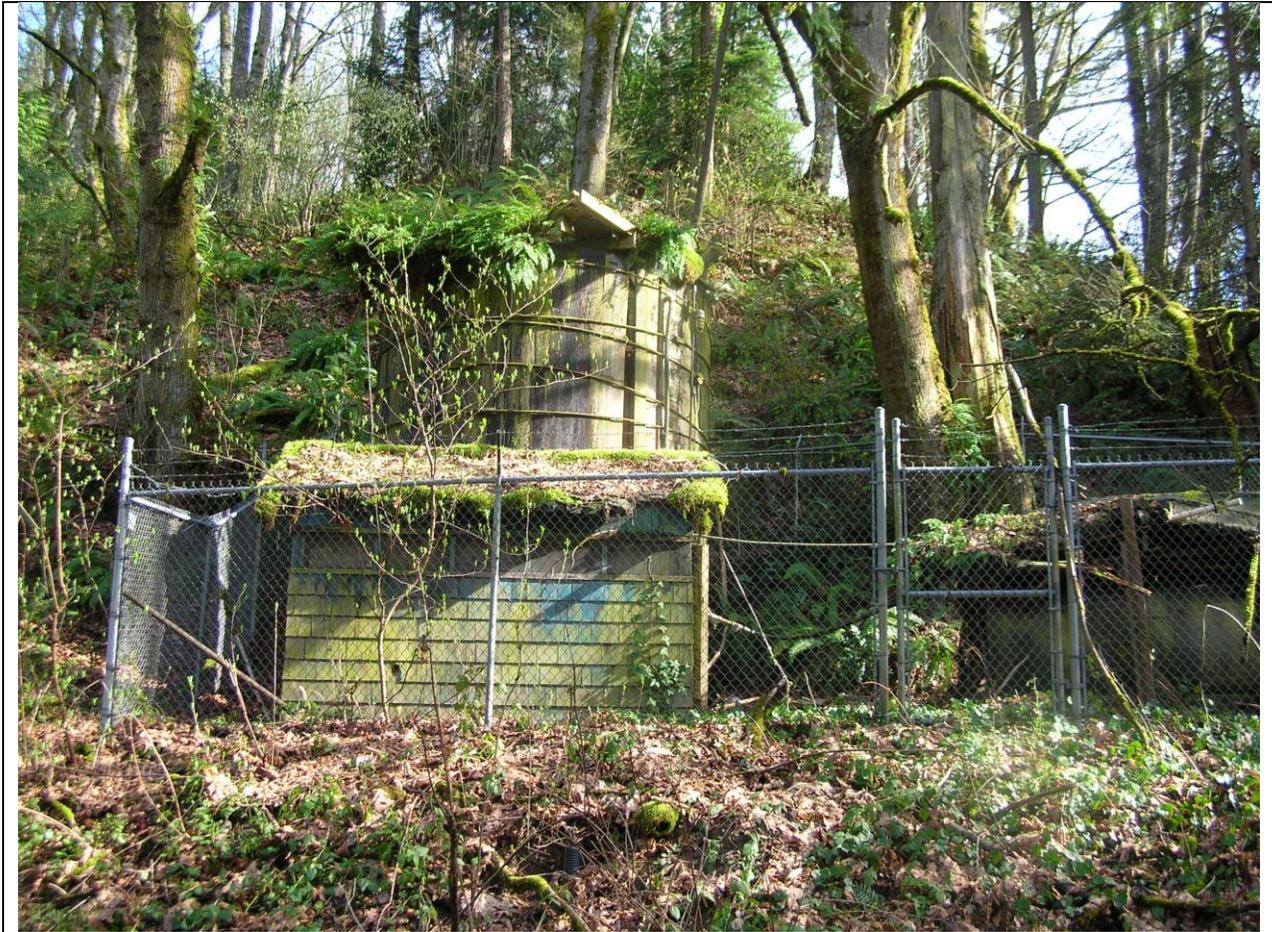
This old water tower over an abandoned well at the north end of Holmes Point Drive near 64<sup>th</sup> Terrace NE should be inspected and, if not in use, dismantled.

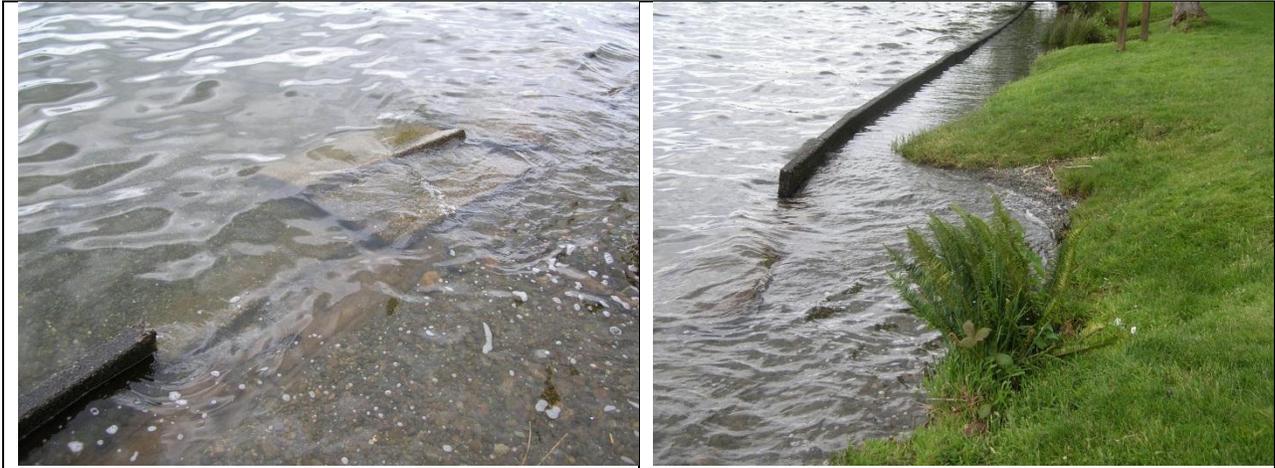
The crumbling, concrete bulkhead along the lake shore in O.O. Denny Park should be removed. King County has begun the permitting process for a project to remove it.

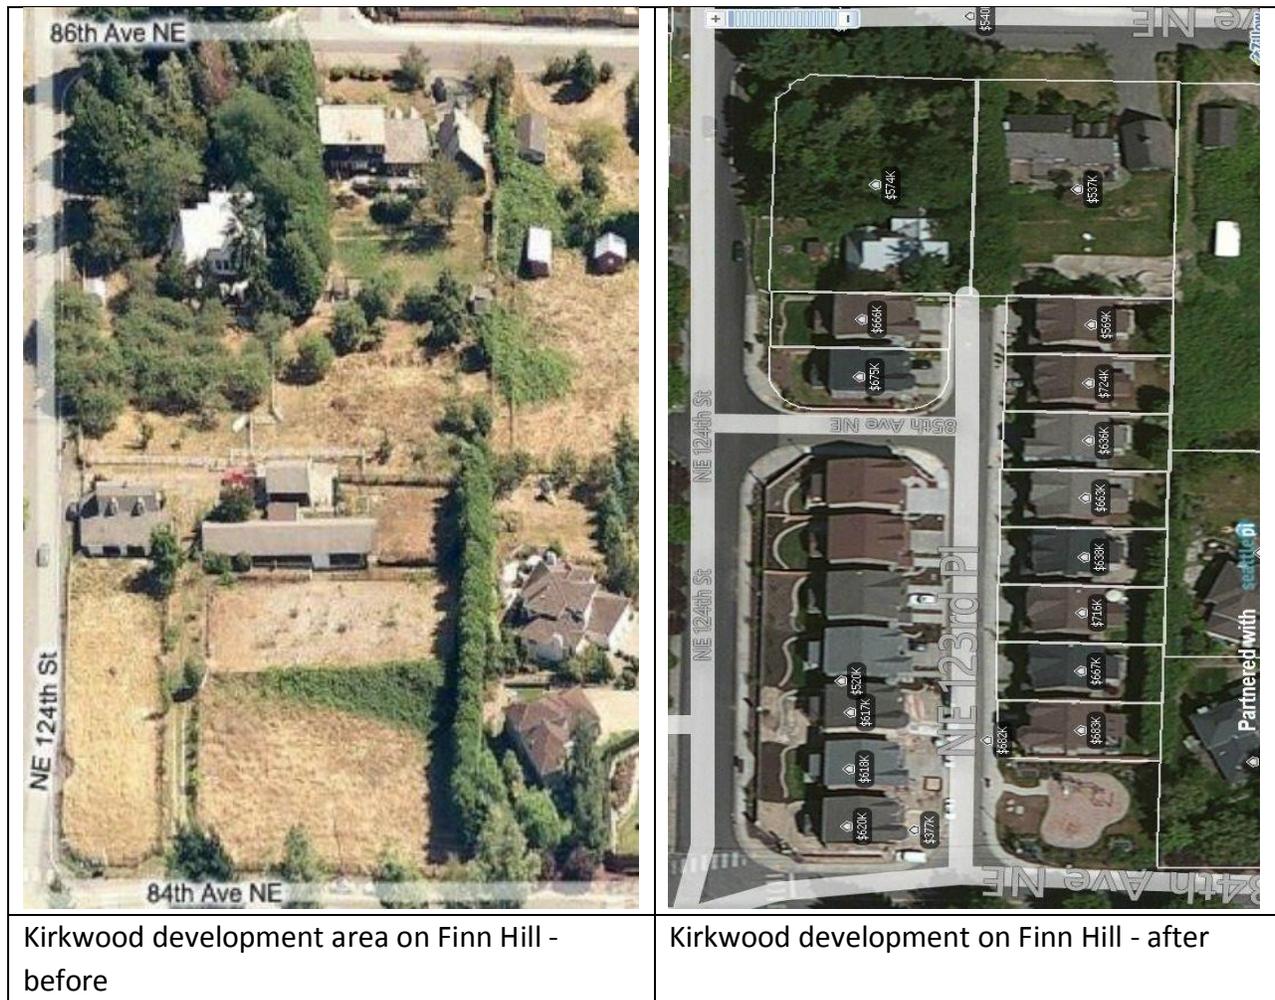
The example below illustrates poor implementation of surface water management in a new residential development. Specifically, building density is high and the percentage of impermeable surface is very high. All downspouts and surface water conveyance are routed to a single vault on the southwest corner of the development with little or no flow control.

Recommendations for low impact development:

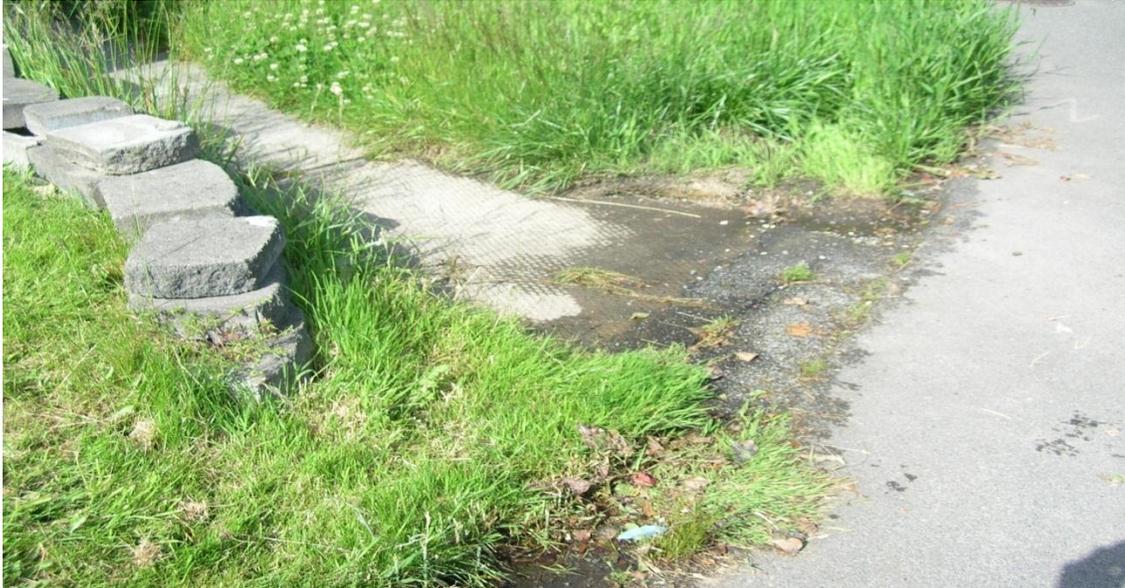
Owner – Anonymous	Contact: none
Address: NE 140 <sup>th</sup> Street and 100 <sup>th</sup> Ave NE	Survey response? No
Description – sidewalk low spot at 140 <sup>th</sup> street and 100 <sup>th</sup> avenue in Juanita pools to an extent that it blocks pedestrian crossing in wet weather.	
Solution – Needs gravel or improved drainage to prevent pooling.

<p>Mitigation plan:</p> <p>Owner – Kirkland Public Works          Action – Add gravel or improve drainage to prevent pooling over sidewalk.          Date complete -</p>

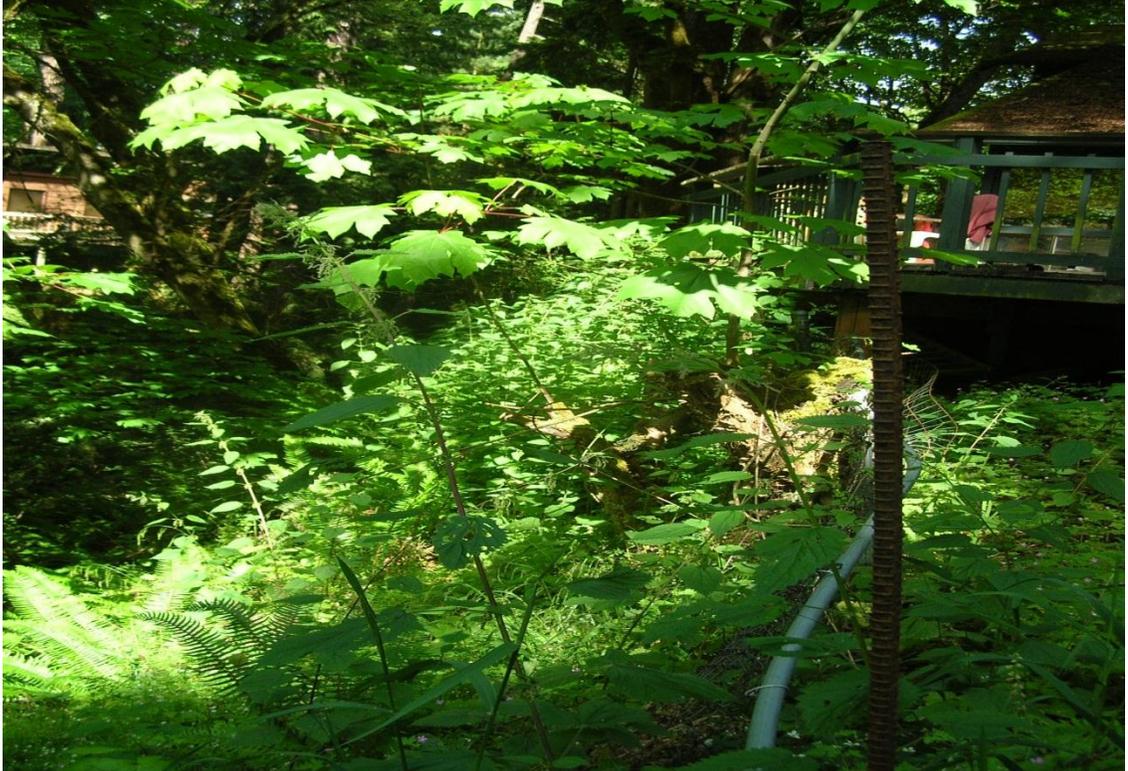
**Volchock**

<p>Owner – Tony Volchock</p>	<p>Contact: 425.821.8818, tmv8818@aol.com</p>
<p>Address: 12801 Juanita Drive NE 98034</p>	<p>Survey response? No</p>
<p>Description – House and deck are close to the edge of a steep, north-facing embankment, the tributary of Denny Creek that flows down NE 128<sup>th</sup> Street. Downspouts drain to soil, some are routed away from structures. Several shallow mudslides have eroded the hillside close to his deck.</p>	
<p>Solution – Ensure that all downspouts route runoff well away from the house, preferably to the bottom of the ravine, or at least well west of the deck. Plant native trees and shrubs to stabilize the hillside.</p>

<p>Mitigation plan:</p> <p>Owner – Kirkland Public Works: Site visit, education, mitigation plan.          Owner – FHNA: Education, plant native shrubs          Action – Education, plant native shrubs          Date complete -</p>

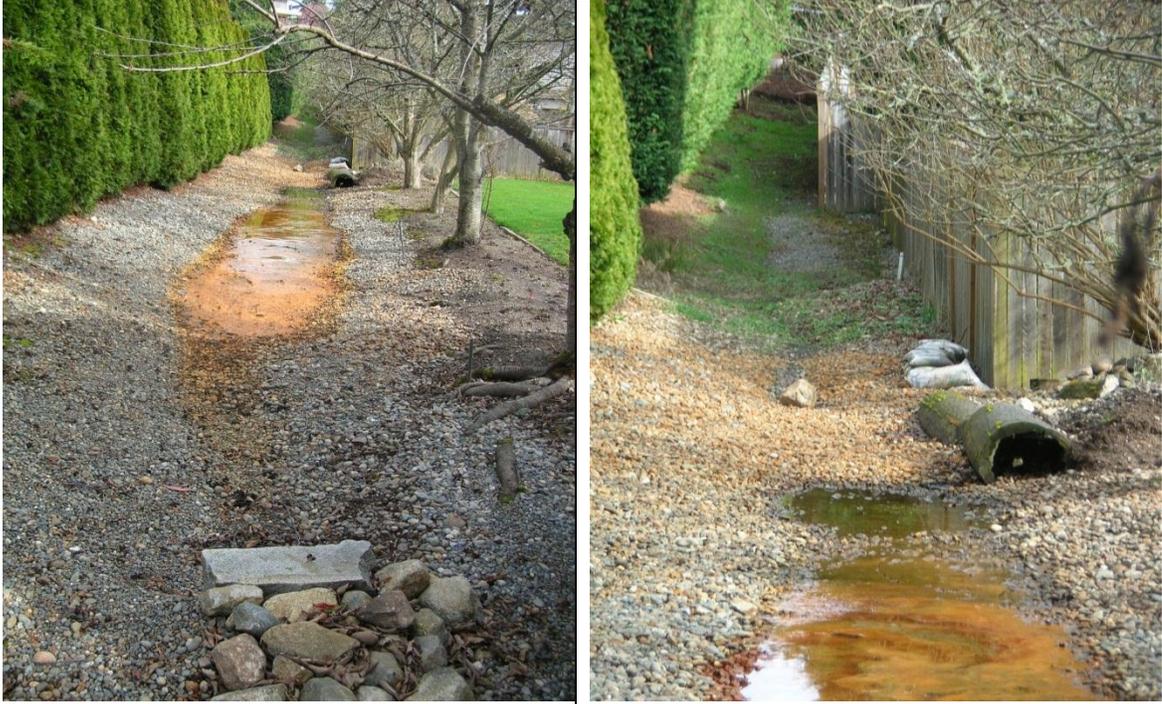
## Keyes

<p>Owner – Cami Keyes</p>	<p>Contact: 425.825.0404, keyescom@comcast.net</p>
<p>Address: 8126 NE 115th Court, 98034</p>	<p>Survey response? #2 Project map: yes</p>
<p>Description – Surface runoff from new construction uphill drains through her property. She has installed &gt;\$10k in French drains and a sump system, which works fairly well most of the time. Lack of proper drainage between homes and on street uphill. See attached materials from King County site inspection (Appendix D).</p>	
<p>Solution – Ensure that the existing perf drain and swale between residences has adequate slope and that the drain stays clear. This will take the pressure off of Ms. Keyes’ ad hoc solution.</p>

<p>Mitigation plan:</p> <p>Owner – Kirkland Public Works Action – Inspect perf drain, dredge swale, clear drain to improve drainage to the existing conveyance. Date complete –</p>

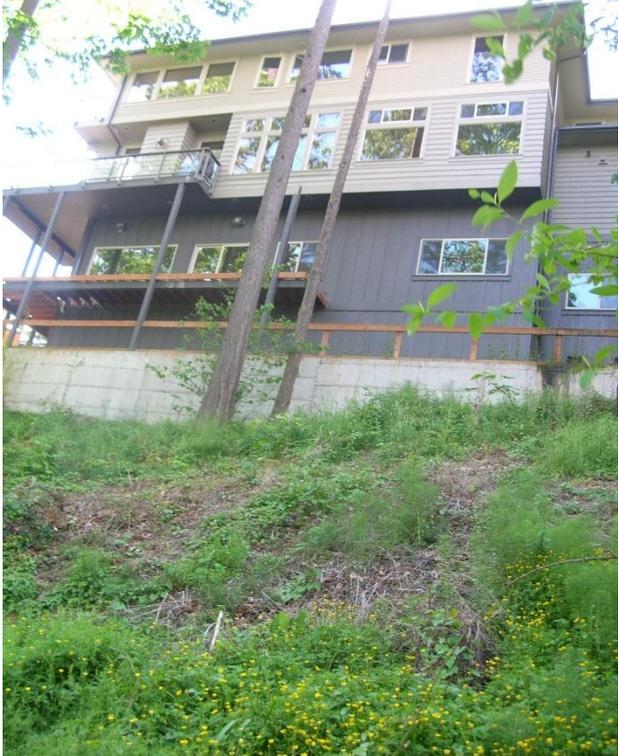
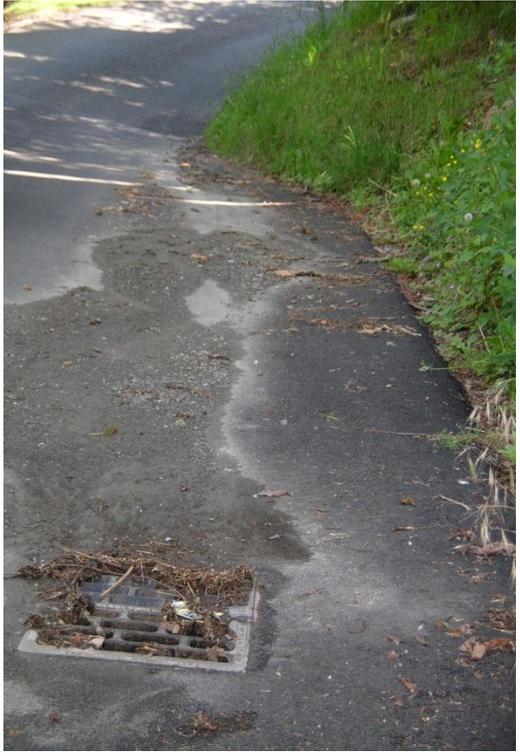
<p>Owner – Linda Leviton</p>	<p>Contact: becalmer@aol.com</p>
<p>Address: 11635 91st Place NE, unit 1B Goat Hill neighborhood</p>	<p>Survey response? #4</p>
<p>Description – Drainage is a historic problem and the new construction has exacerbated all the drainage issues of the street. The Manichuri construction is on wetlands that has historically been the run off location of Goat Hill. In spite of numerous county tries at mitigating the problem, there is a constant stream of run off.</p> <p>Significant volumes of soil and debris wash downslope into storm drains.</p>	
<p>Solution – Monitoring, education, LID, rain gardens and cisterns where feasible.</p>

<p>Mitigation plan:</p> <p>Owner – Kirkland Public Works Action – Monitoring, education, LID, rain gardens and cisterns where feasible. Date complete –</p>

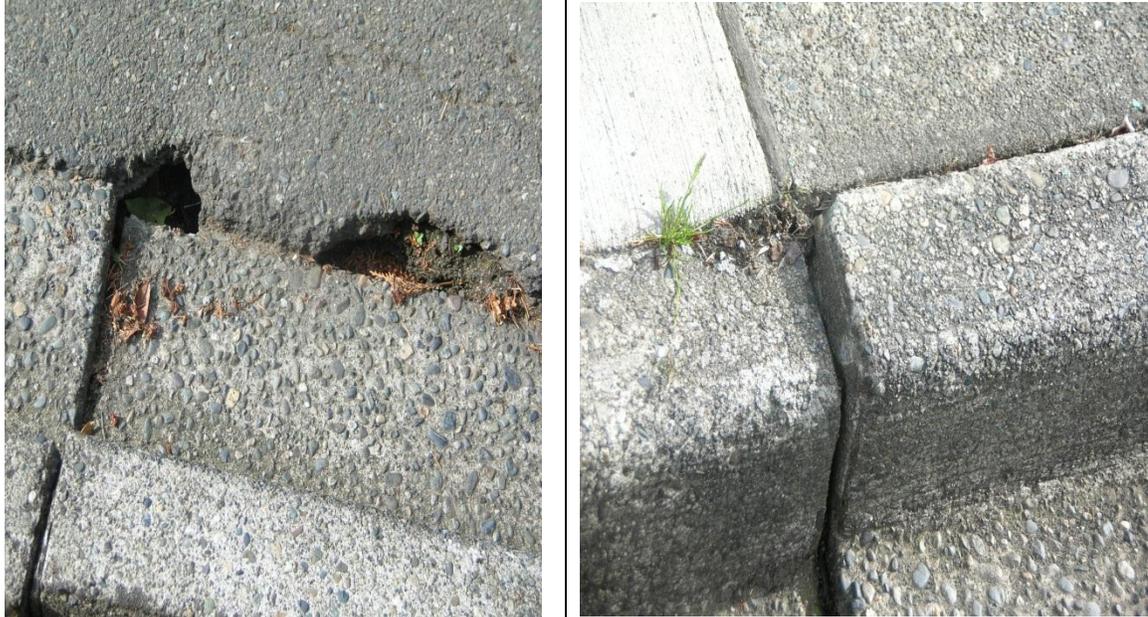
<p>Owner – Kristin Terpstra</p>	<p>Contact: klt@tecx.net</p>
<p>Address: 9601 NE 141<sup>st</sup> Place</p>	<p>Survey response? #5</p>
<p>Description – Water is flowing under the street, sidewalks, and driveways past 6-8 residences. It may be caused by a spring or a disconnected or damaged storm water conveyance. Water seeps through the pavement, sidewalks and curbs are buckling, and a sinkhole has formed. King County has patched individual areas without addressing the root cause.</p>	
<p>Solution – Inspection and repair of storm water conveyance.</p>

<p>Storm water is flowing under the street and sidewalk, undercutting the sub-surface material. Erosion under the sidewalk and street is causing driveway, sidewalk, and curb collapses, and has resulted in sinkhole formation.</p>	
<p>Mitigation plan:</p> <p>Owner – Kirkland Public Works          Action – Inspect and repair storm water conveyance          Complete –</p>

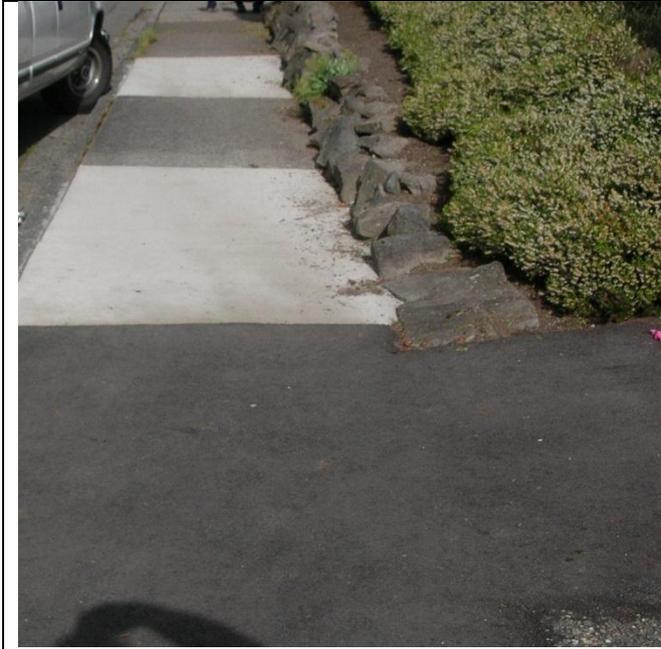
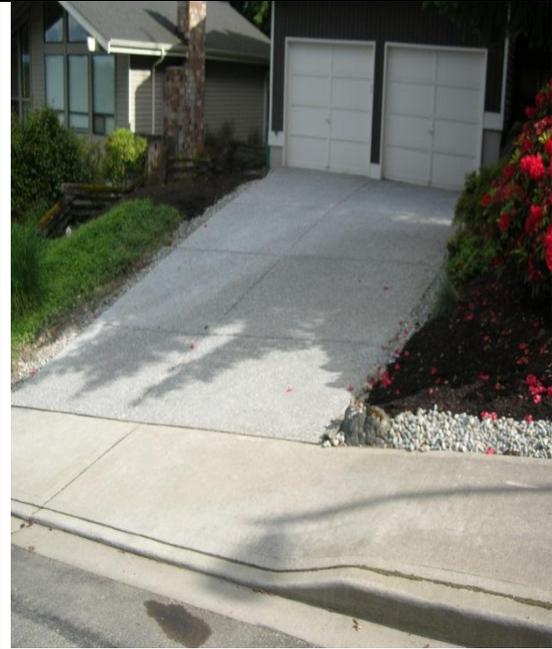
## Terpstra (continued)

King County has patched driveways and sidewalks without addressing the root cause: rogue runoff under the street and sidewalk. Several residents have replaced their driveways at their own expense.

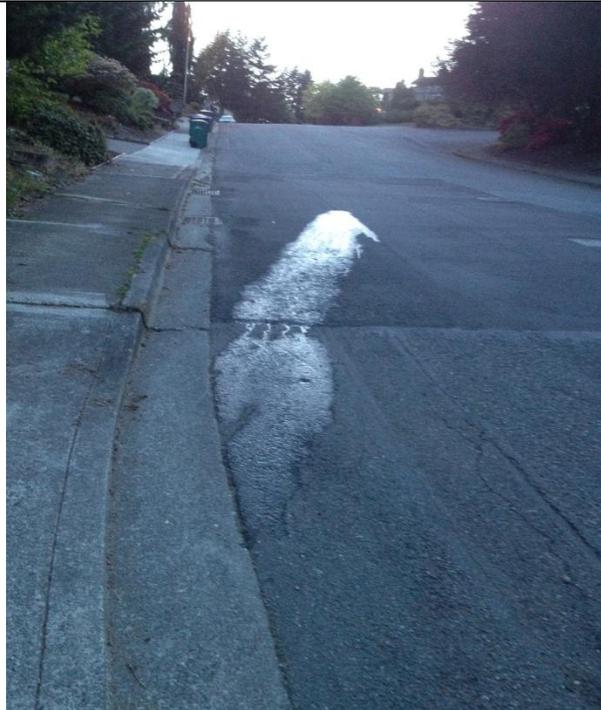
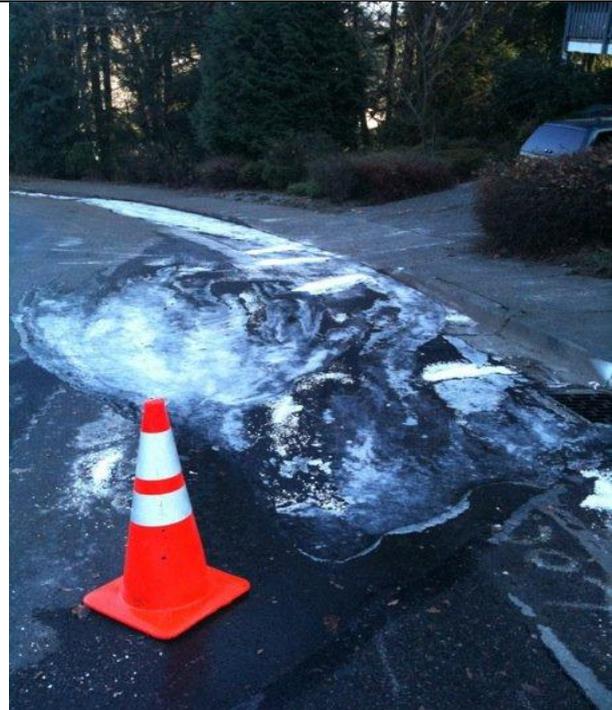
At left, water often seeps through the asphalt and runs down the street. At right, in winter, water seeps through the asphalt and creates a slick spot where water freezes on the street. Copious applications of salt and a traffic cone attempt to mitigate the hazard to traffic and pedestrians.

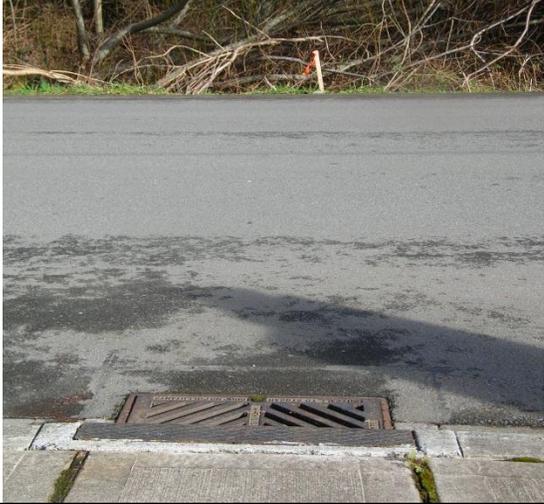
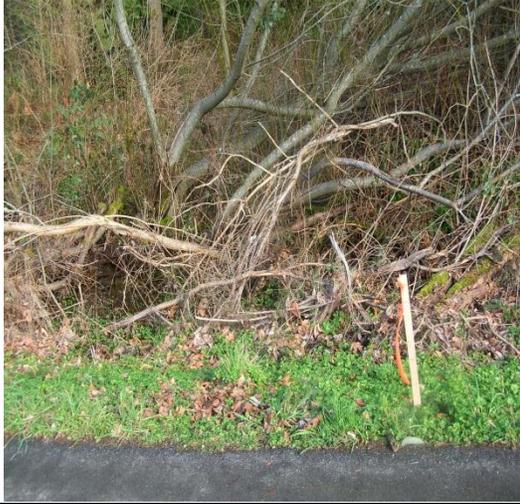
<p>Owner – Big Finn Hill Park</p>	<p>Contact: KC Parks? DOT? KPW?</p>
<p>Address: Near NE 133<sup>rd</sup> Street and 72<sup>nd</sup> NE.</p>	<p>Survey response? #9 Project map: yes</p>
<p>Description – Originally installed as part of a five lot residential development, about 2010.</p>	
<p>Solution – Install an updated culvert inlet to keep it clear of debris.</p>

<p>Looking east – upstream – along the culvert.</p>	<p>The inlet is in there somewhere...</p>

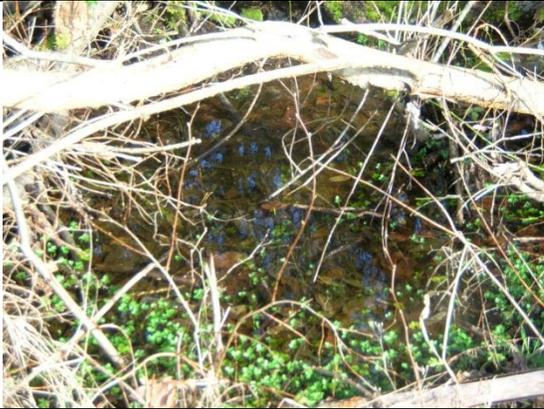
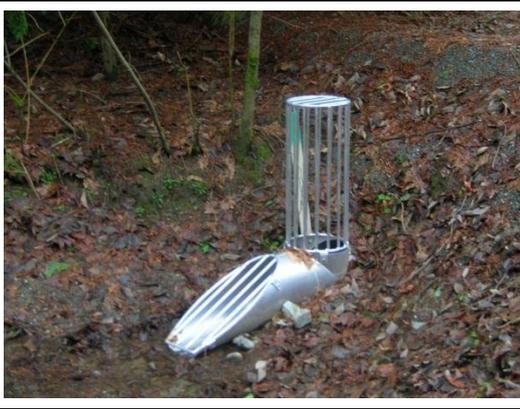
<p>Detailed view of the culvert inlet.</p>	<p>Proposed solution to keep the inlet clear.</p>
<p>Mitigation plan:</p> <p>Owner – Kirkland Public Works Action – Install cage over culvert inlet Complete –</p>

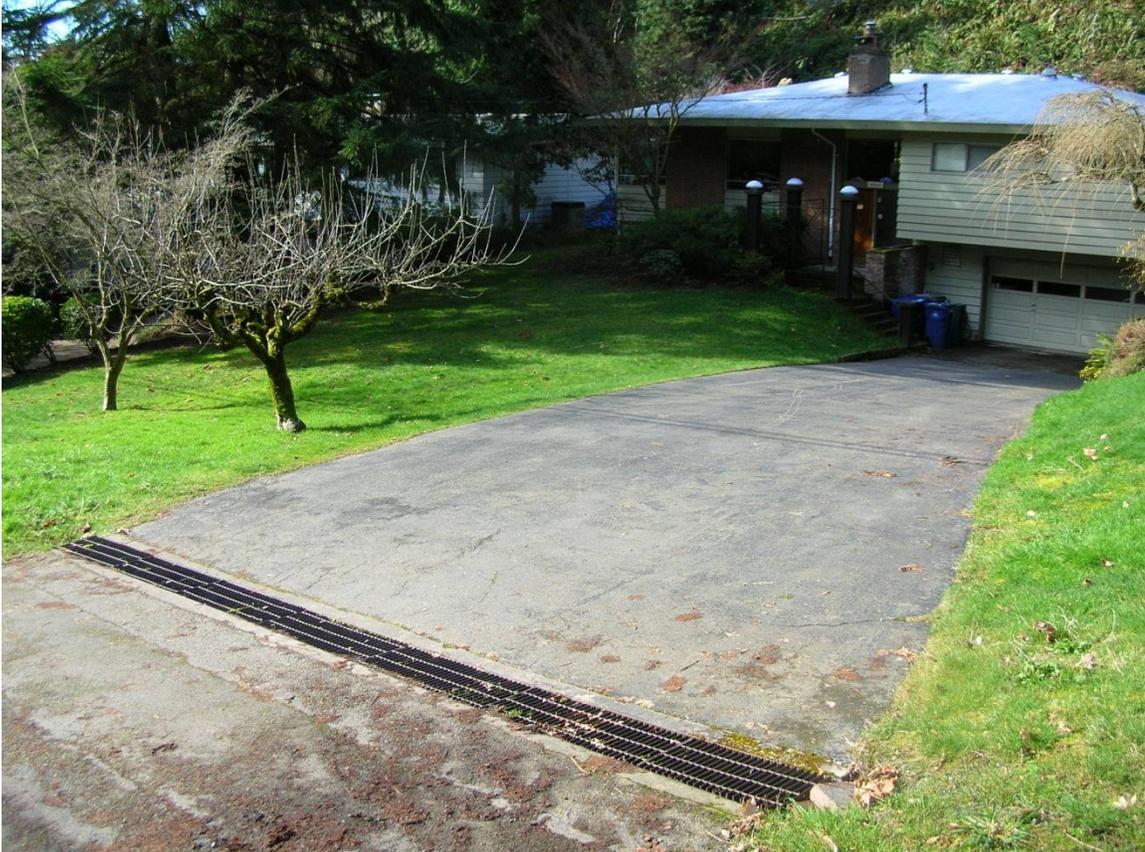
Owner – Dan Ayoub	Contact: 425 285 9682 <a href="mailto:dan.ayoub@gmail.com">dan.ayoub@gmail.com</a>
Address: 6628 NE 129 <sup>th</sup> St 98034	Survey response? #14
Description – Storm drain overflows and floods his yard. Driveway and yard slope toward house.	
Solution – Inspect drainage along road, recommend changes to improve conveyance of runoff.

Mitigation plan:  Owner – Kirkland Public Works Action – Site visit, education about self-mitigation. Complete –

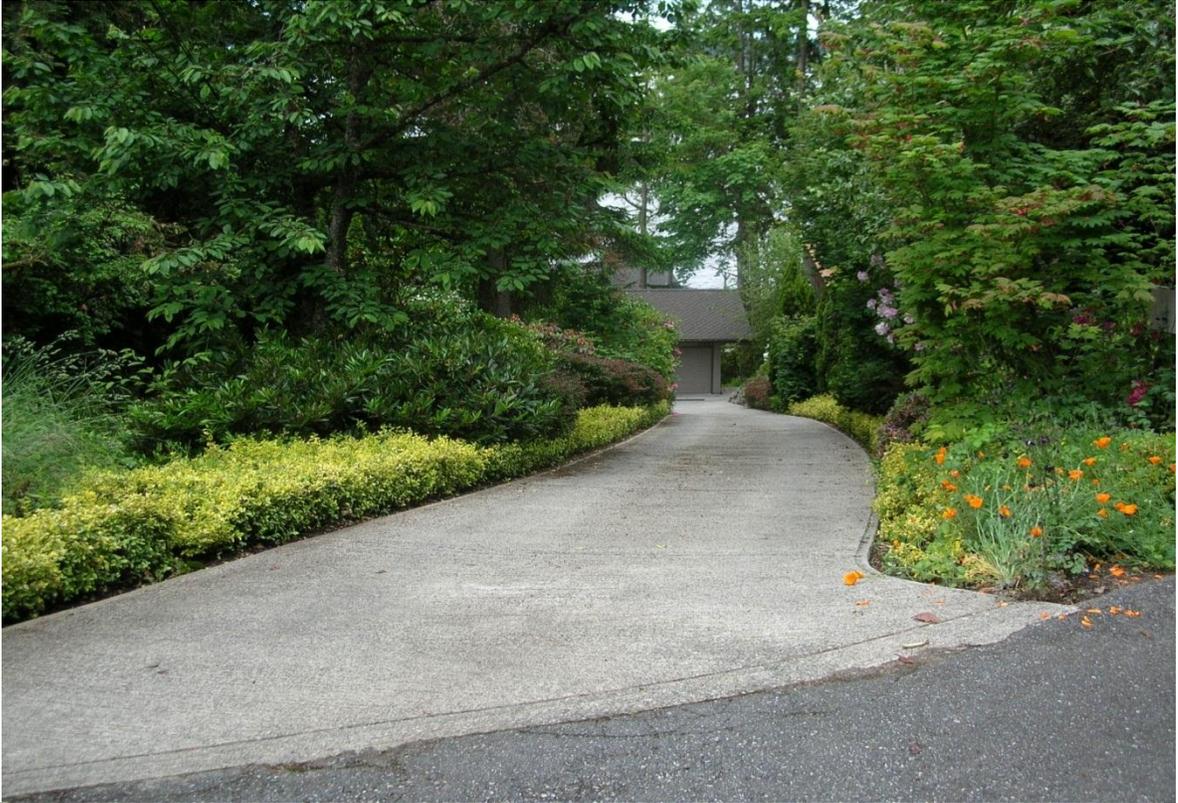
Description – Surface water flows across his property. An additional drain was added several years ago, but it is still a problem.	
Solution – Storm water catchment on the east side of Champagne Point Road should convey water down the east side of the road instead of directing it across the road here. There is a larger culvert about 200 feet north that should convey this water to the lake.	
Mitigation plan:  Owner – Unknown Action – Change conveyance to keep water moving down the east side of the street. Complete –

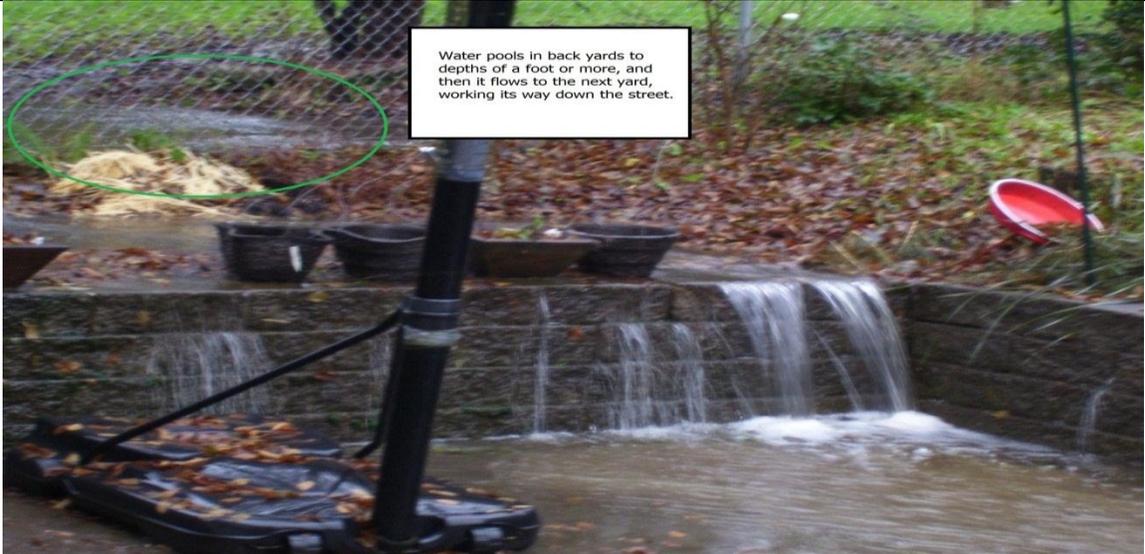
<p>Owner –Mark Smith, Mitch and Connie Winter</p>	<p>Contact: <a href="mailto:mjsmith01@hotmail.com">mjsmith01@hotmail.com</a> 425 821-1394 Mitch Winter <a href="mailto:ka7yer@comcast.net">ka7yer@comcast.net</a></p>
<p>Address: NE 143<sup>rd</sup> Street, west of 84<sup>th</sup> Avenue, 98034</p>	<p>Survey response? Smith #13, Winter #18</p>
<p>Description – During winter or whenever there are heavy rains, a creek forms in yards on the north side of NE 143<sup>rd</sup> Street. Some neighbors catch the water and, via their own piping or ad hoc solutions, move it to the next neighbor. Other people do not do anything and water builds up and it comes back up to street level during rain events.</p>	
<p>Solution – Site visit to look at ad hoc solutions, inspection of existing storm water conveyance, repair of conveyance damaged by recent utility work, education.</p>

<p>Residents along 143<sup>rd</sup> street have a long history of surface water problems. Utility work in the 1990's cut off access to storm water conveyance between the south-facing front yards and a major culvert next to the street. As a result, back yards – like the one pictured above – routinely flood during significant rainfall events.</p>

<p>Mitigation plan:</p> <p>Owner – Kirkland Public Works Action – Site visit to look at ad hoc solutions, inspection of existing storm water conveyance, repair or upgrade of conveyance damaged by recent utility work, education. Complete –</p>

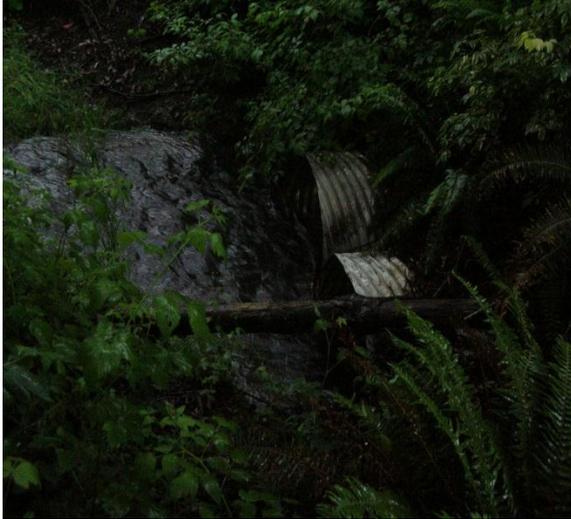
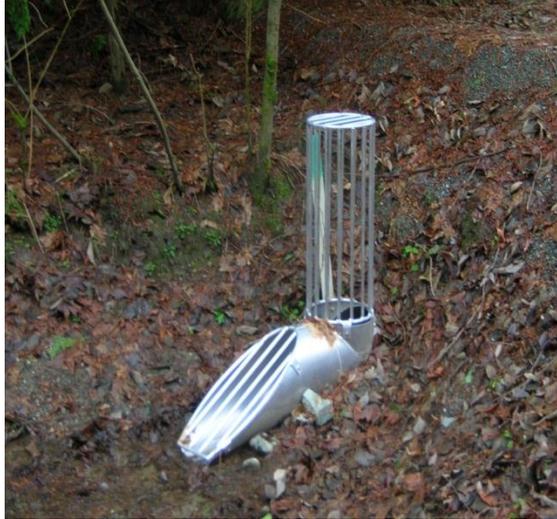
<p>Owner – Rainer and Linda Kirchner</p>	<p>Contact: lindarainer@yahoo.com</p>
<p>Address: 13433 78<sup>th</sup> Place NE 98034</p>	<p>Survey response? No. e-mail.</p>
<p>Description – Heavy rainfall events results in debris washing down Denny Creek, which clogs the culvert inlet under their driveway. The clogged culvert then floods the yard and results in standing water approaching the house. Note that the existing bioswale and retention pond for the BFH soccer field de-watered a tributary of Denny Creek, increasing pressure on the surface water conveyance past this residence. At times, the creek overflows the two culverts pictured below.</p>	
<p>Solution – Site inspection and discussion with home owners. Install a cage over culvert inlet.</p>

<p>The existing culvert inlet is open so it gets clogged with debris during storms.</p>	<p>A cage over the culvert inlet will prevent debris from causing flooding during high water.</p>

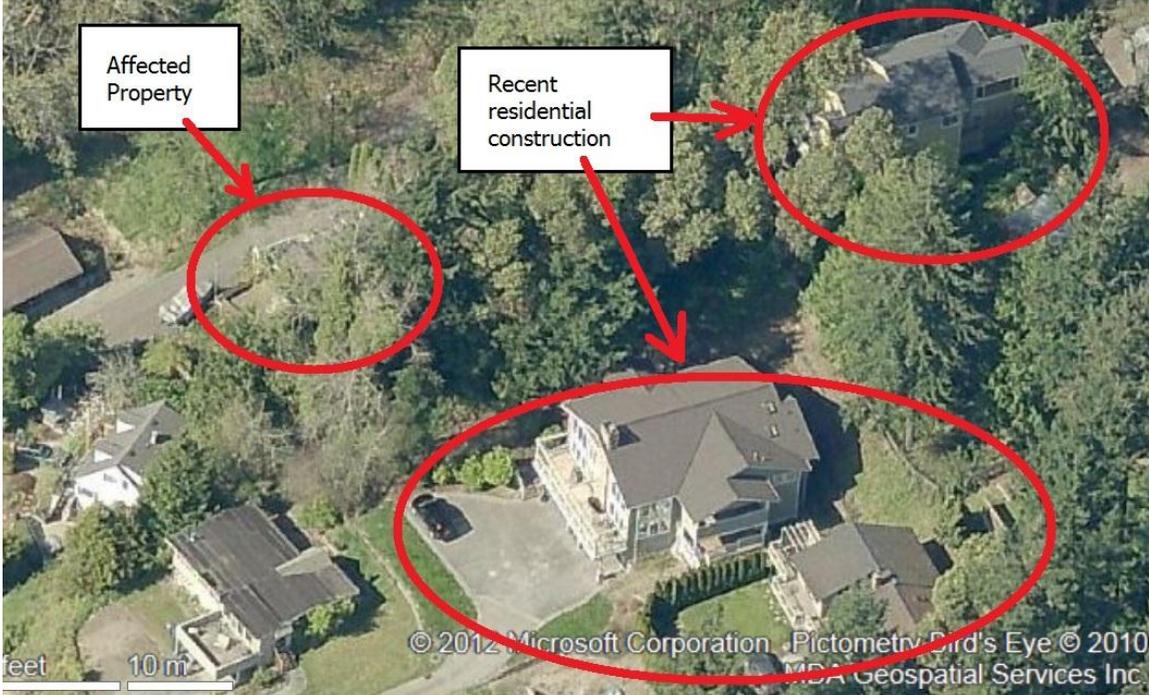
Owner – Rolf Lystad	Contact: rolfstad@aol.com
Address: 11109 Champagne Point Road NE 98034	Survey response? Personal contact.
<p>Description – New construction uphill from the residence has exacerbated an already stressed surface water situation. New homes run their downspouts to the edge of the property where, previously, runoff would have percolated into the ground.</p>	
<p>Solution – Negotiate with neighbors to re-think their runoff management strategy. Downspouts in their case should be routed into the storm water system, not to the downhill edge of the property.</p>

<p>Recent residential construction near Champagne Point has put additional stress on storm water conveyance structures put in place by existing residents.</p>	
<p>Mitigation plan:</p> <p>Owner – Kirkland Public Works          Action – Site inspection, education          Complete –</p>

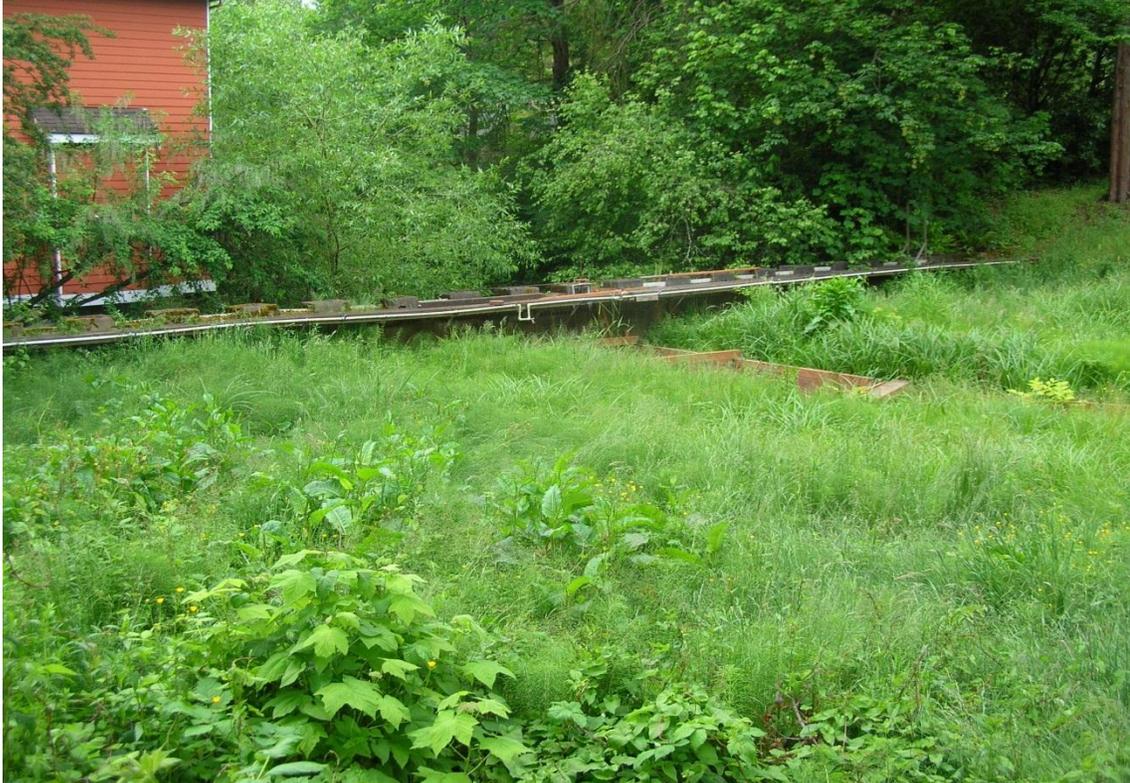
<p>Owner – Larry Johnson</p>	<p>Contact: None.</p>
<p>Address: 6060 NE 135<sup>th</sup> Street 98034</p>	<p>Survey response? No.</p>
<p>Description – Large pond and concrete dam on his property. Rogue runoff from the top of Finn Hill flows from residential developments through open space to ditches and culverts, eventually flowing across his property and then to the lake.</p>

<p>This 75-foot concrete dam has a control structure that allows formation of a pond. It has been used in the past as a trout pond and skating rink. A flow control upstream can be used to reduce water sent into this area.</p>	
<p>Solution – Use the control structure upstream to divert some of the runoff to the conveyance east of Holmes Point Drive, routing it south to a culvert and managed pipe into the lake.</p>	
<p>Mitigation plan:</p> <p>Owner – Kirkland Public Works          Action – Manage runoff at upstream control structure.          Complete –</p>

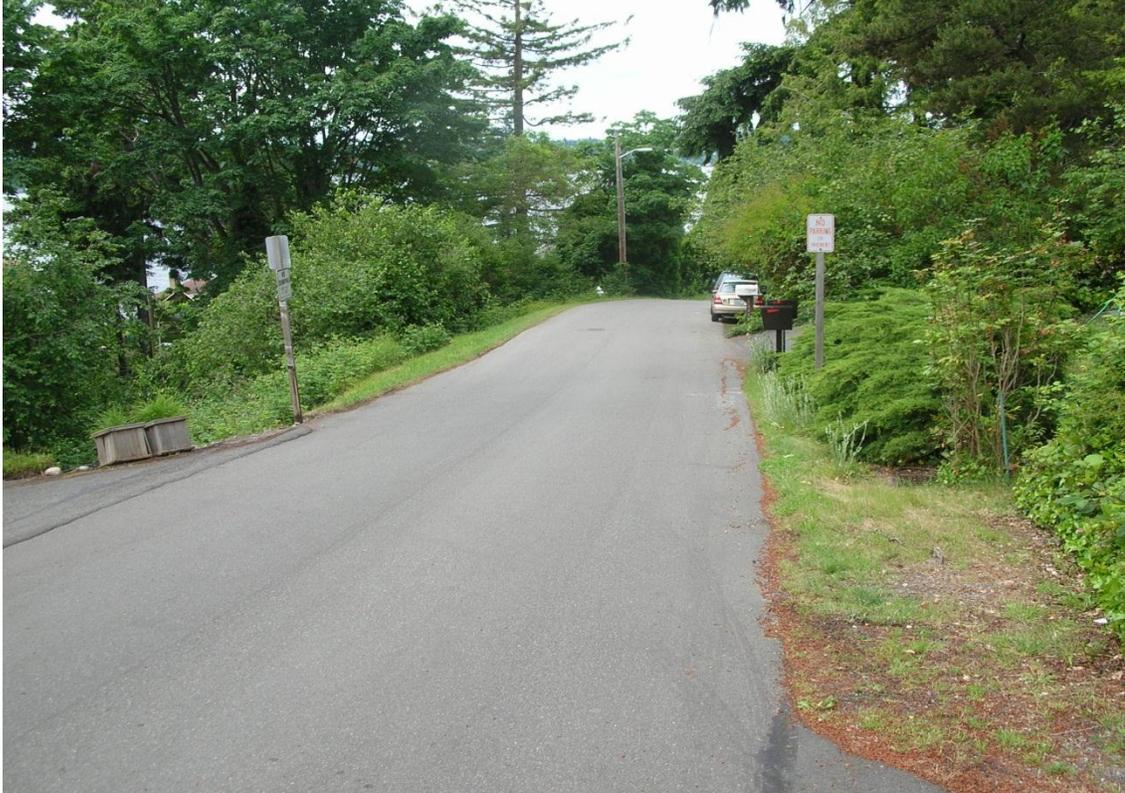
<p>Owner – Jacki vonAllmen</p>	<p>Contact: <a href="mailto:jvonallmen@overthelake.com">jvonallmen@overthelake.com</a></p>
<p>Address: 11144 Champagne Point Rd NE 98034</p>	<p>Survey response? Personal contact.</p>
<p>Description – Culvert routes drainage under the street near the parked car, and then down to the left over a steep embankment. Instead, conveyance should probably continue along the ditch on the right side of the street to a managed pipe that flows into the lake.</p>	
<p>Solution – Site inspection, change conveyance flow that currently directs flow under the street to, instead, continue down the east side of the street.</p>

<p>Mitigation plan:</p> <p>Owner – Kirkland Public Works          Action – Site inspection, change conveyance flow that currently directs flow under the street to, instead, continue down the east side of the street.          Complete -</p>

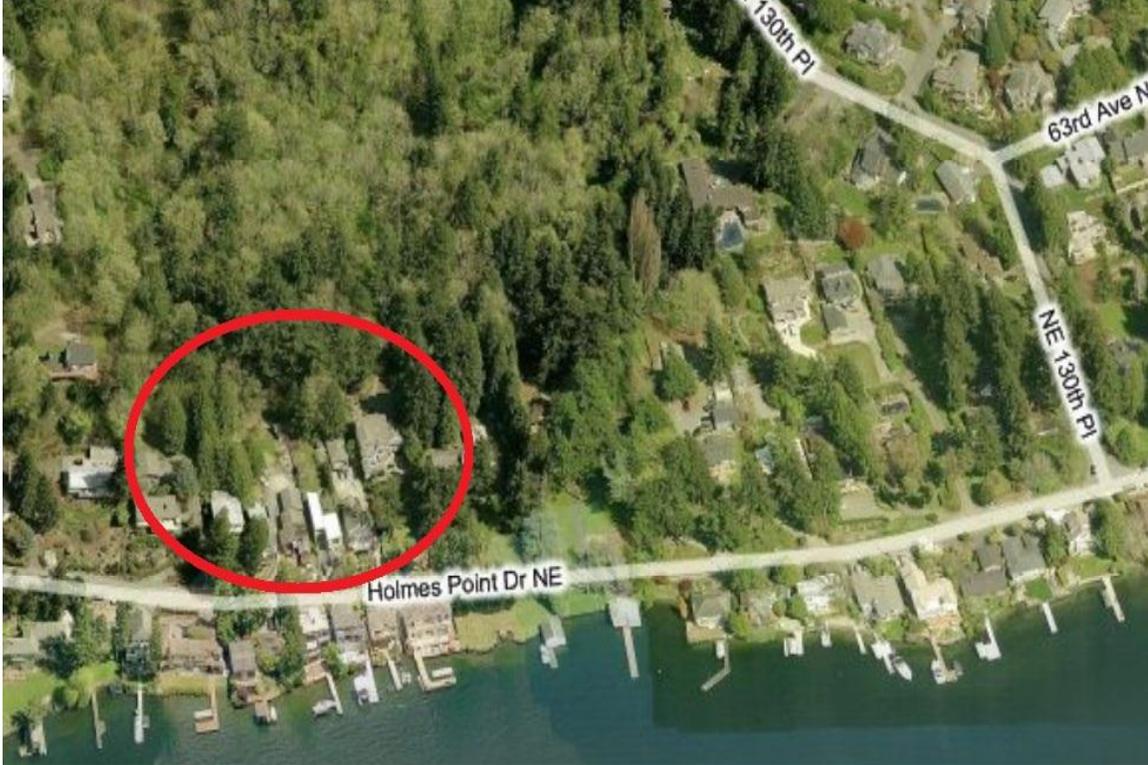
Owner – Natalie Danielson and others	Contact: <a href="mailto:natalieoutloud@gmail.com">natalieoutloud@gmail.com</a> 425.417.6173
Address: 13148 Holmes Point Drive	Survey response? Personal contact
Description – Several residences east of HPD regularly have problems with rogue runoff. Many residents have ad hoc plans in place: tarps, bricks, sump pumps, and sand bags.	
Solution – Need Kirkland assistance to develop mitigation plans, implement solutions.

The residences inside the red circle have been significantly impacted by runoff from the top of Finn Hill. In many cases, uphill residences simply route their surface water runoff to the edge of the hill, allowing it to flow downhill at the expense of neighbors to the west.	
<p>Mitigation plan:</p> <p>Owner – Kirkland Public Works          Action – Site inspections, interviews, mapping underground conveyance and retention structures, education, help with mitigation plans.          Complete -</p>

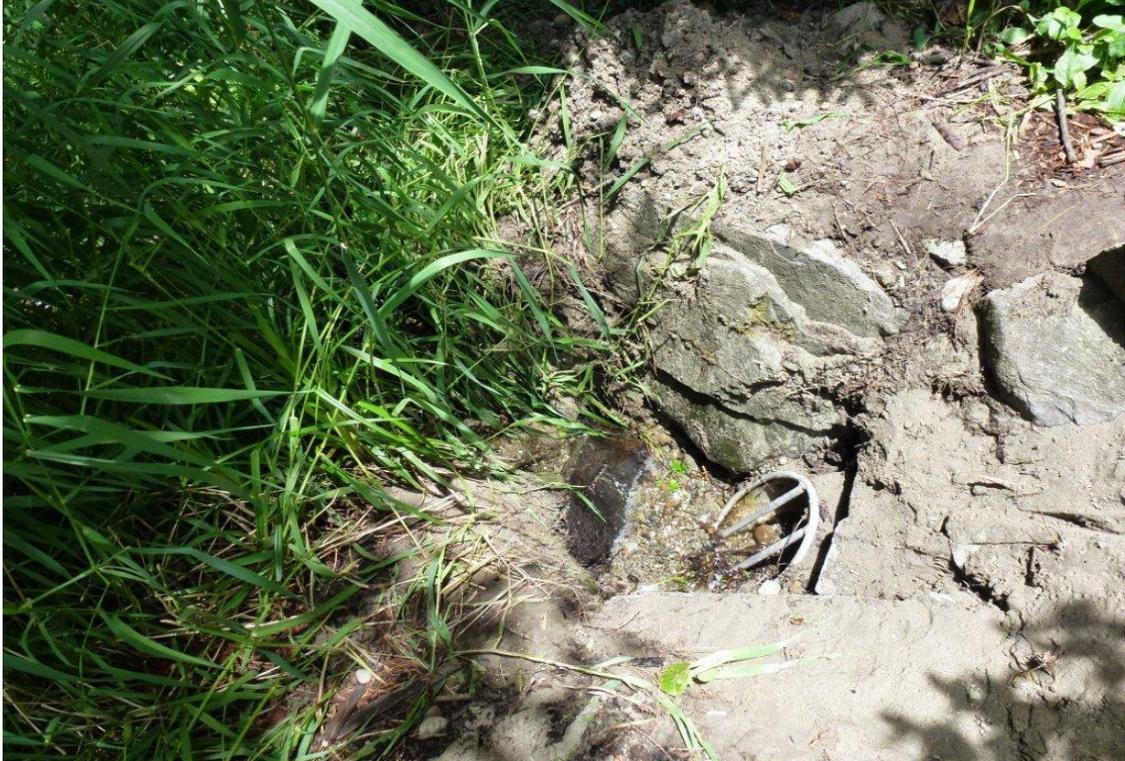
**Highlands Subdivision at Holmes Point (continued - 6481):**

<p>Owner – Mic Fite</p>	<p>Contact: Mic Fite <a href="mailto:micfite@comcast.net">micfite@comcast.net</a> 425-283-9506</p>
<p>Address: 6481 NE 135th Place 98034</p>	<p>Survey response? E-mail</p>
<p>Description – Runoff from uphill properties has caused severe mudslides and have damaged the house. Also, during heavy rain debris from uphill clogs the culvert inlet, water overflows, flooding the street and undermining the driveway.</p>

<p>Solution – Control surface run off from uphill properties and streets. Engineer the drainage system to handle current conditions. Install larger diameter culvert with grate under the driveway.</p>	
<p>Mitigation plan:</p> <p>Owner – Kirkland Public Works Action – Control surface run off from uphill properties and streets. Install larger diameter culvert with grate under the driveway. Complete –</p>
