# Finn Hill Neighborhood Alliance Surface Water Plan

# **Surface Water Management and Drainage Concerns in the Finn Hill/Holmes Point Neighborhood**

**June 15, 2012**

**Prepared by Lou Berner  
Finn Hill Neighborhood Alliance**

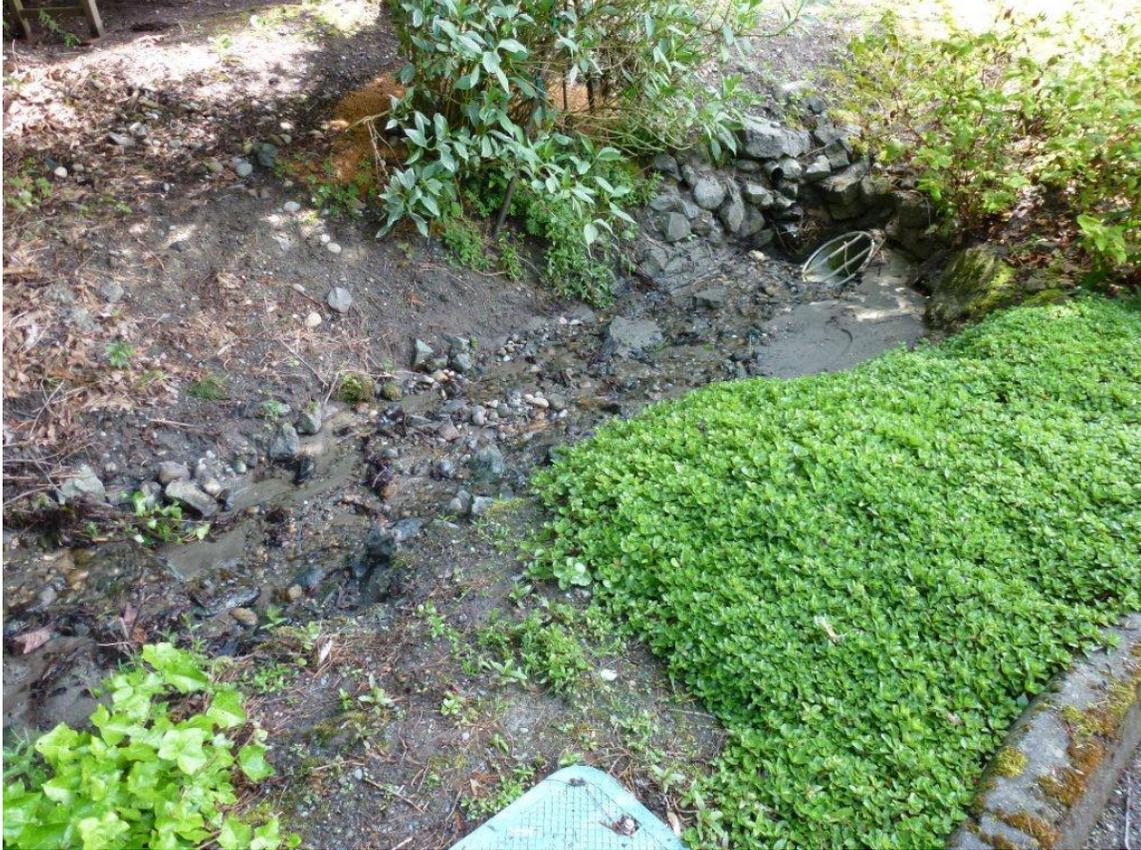
<p>Owner – Mic Fite</p>	<p>Contact: Mic Fite <a href="mailto:micfite@comcast.net">micfite@comcast.net</a> 425-283-9506</p>
<p>Address: 6475 NE 135th Place 98034</p>	<p>Survey response? E-mail</p>
<p>Description – The drainage ditch is silted up and overflows into the street during heavy rain.</p>

<p>Solution – vacuum out the silt</p>	
<p>Mitigation plan:</p> <p>Owner – Kirkland Public Works Action – vacuum out the silt Complete –</p>

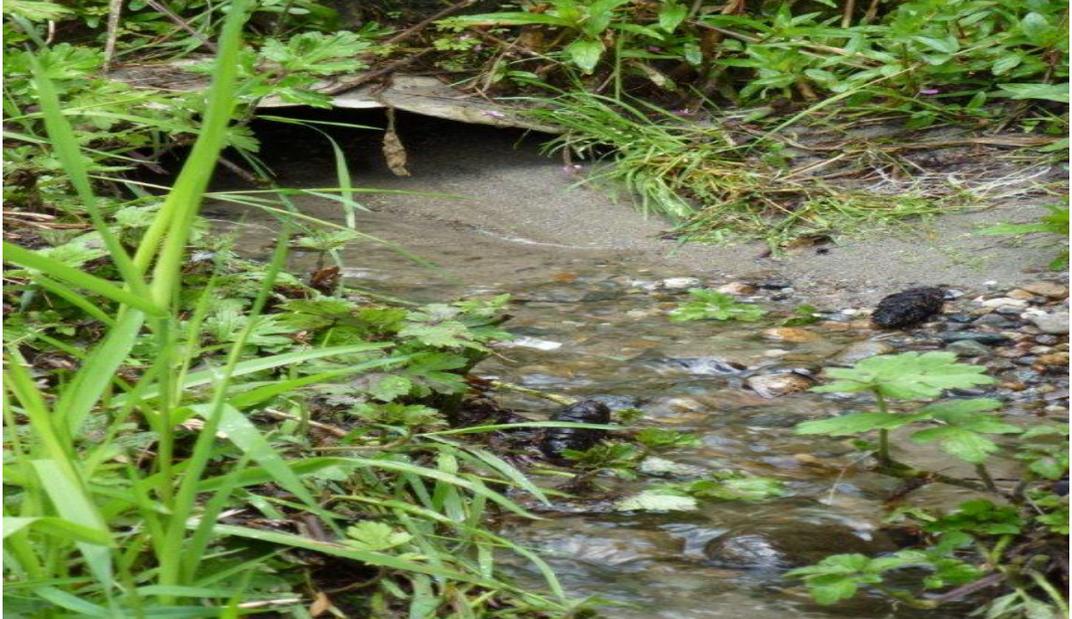
<p>Owner – Mic Fite</p>	<p>Contact: Mic Fite <a href="mailto:micfite@comcast.net">micfite@comcast.net</a> 425-283-9506</p>
<p>Address: 6439 NE 135th Place 98034</p>	<p>Survey response? E-mail</p>
<p>Description – <b>← TOP PRIORITY</b> The drain pipe is 90% blocked with silt. This severely limits the flow during rain and forces the excess water to overflow the inlets at #6475/#6481 and washes water and debris down the street.</p>

<p>Solution – Vacuum and flush out the silt</p>	
<p>Mitigation plan:</p> <p>Owner – Kirkland Public Works Action – Vacuum and flush out the silt Complete –</p>

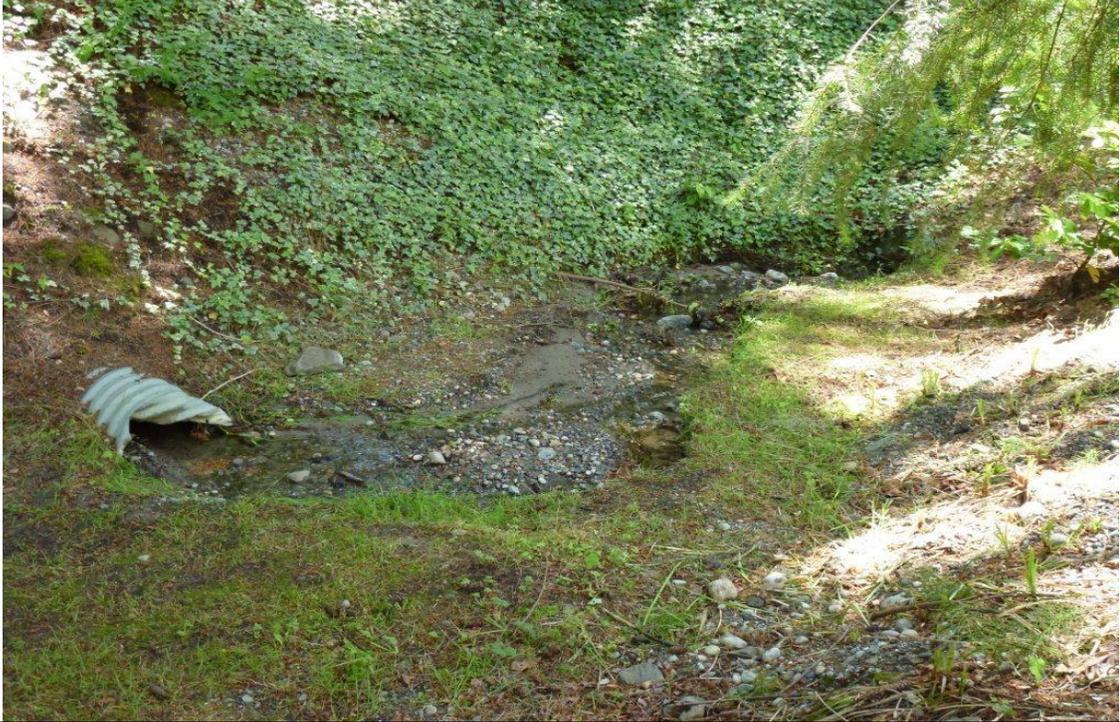
<p>Owner – Mic Fite</p>	<p>Contact: Mic Fite <a href="mailto:micfite@comcast.net">micfite@comcast.net</a> 425-283-9506</p>
<p>Address: Retention Pond at the entrance to The Highlands subdivision</p>	<p>Survey response? E-mail</p>
<p>Description – : The pond is severely silted up reducing its capacity; and the culvert that feeds into it is 2/3rds silted up; as well as the out flow culverts.</p>

<p>Solution – Dig out the retention pond to its original depth. Vacuum and flush out the silt that is blocking the pipes.</p>	
<p>Mitigation plan:</p> <p>Owner – Kirkland Public Works Action – Dig out the retention pond to its original depth. Vacuum and flush out the silt that is blocking the pipes. Complete –</p>

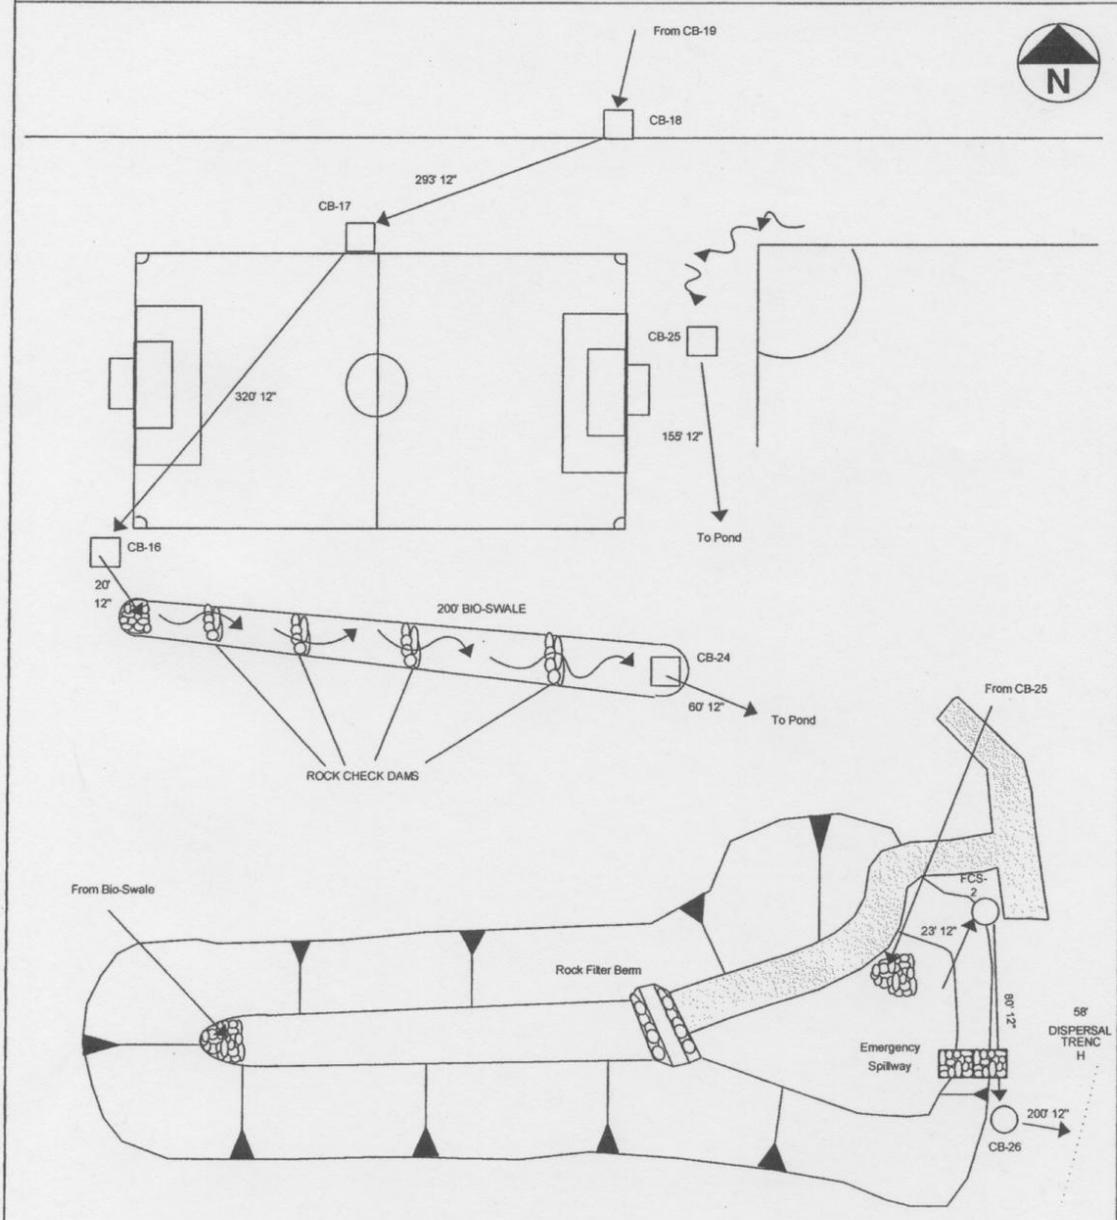
**FACILITY SKETCH SHEET**

On Tuesday, November 16, 2010 Drainage Investigator Mike Malnerich visited your drainage system and found some items needing maintenance. Enclosed for your convenience is a work list of those items and a sketch of your facility. **You will qualify for a Surface Water Management fee discount if these problems are corrected before January 13, 2011 and required pollution prevention best management practices (BMPs) are implemented.** Please complete the work, sign, and return the enclosed Maintenance Correction List to the King County Water and Land Resources Division at the above address, Attn: Tom Lew. If you need assistance or have questions, please call 206-296-1900.

Restore Pond - Remove trees from the pond's emergency overflow spillway. If tree is less than 4 inches in diameter, the root system may be left in place. Otherwise the roots should be removed and the berm restored. A licensed civil engineer should be consulted for proper berm/spillway restoration.	
Repair Control Structure - Locate and expose the following buried or paved over control structure catch basin: CS/CB-2	
Repair Conveyance CB/MH - Locate and expose the following buried or paved over catch basins: CB-17, CB-26	
Maintain Bioswale - Bioswale appears to have standing water in it. Possible solutions for this problem are as follows: 1. Remove any sediment or trash blocking swale. 2. Improve the grade from head to foot of swale. 3. Remove clogged check dams. 4. Add underdrains. 5. Convert to a wet biofiltration swale. First check dam at inlet end of Bio-swale is plugged. Remove material and replace check dam.

Maintain Bioswale - Bioswale vegetation is too sparse. Determine the cause of poor vegetative growth, such as too much shading. After correcting the cause, re-plant with plugs, seeds, or sod into loosened fertile soil.	
Water Quality Requirements - A water quality site consultation needs to be conducted. This consultation will identify potential sources of stormwater pollution and provide you with guidance on the required Best Management Practices (BMPs) in order to comply with King County's water quality code and to qualify for a fee reduction. You will be contacted by one of our water quality engineers to schedule a consultation or you may call (206) 296-1900 to request a consultation.

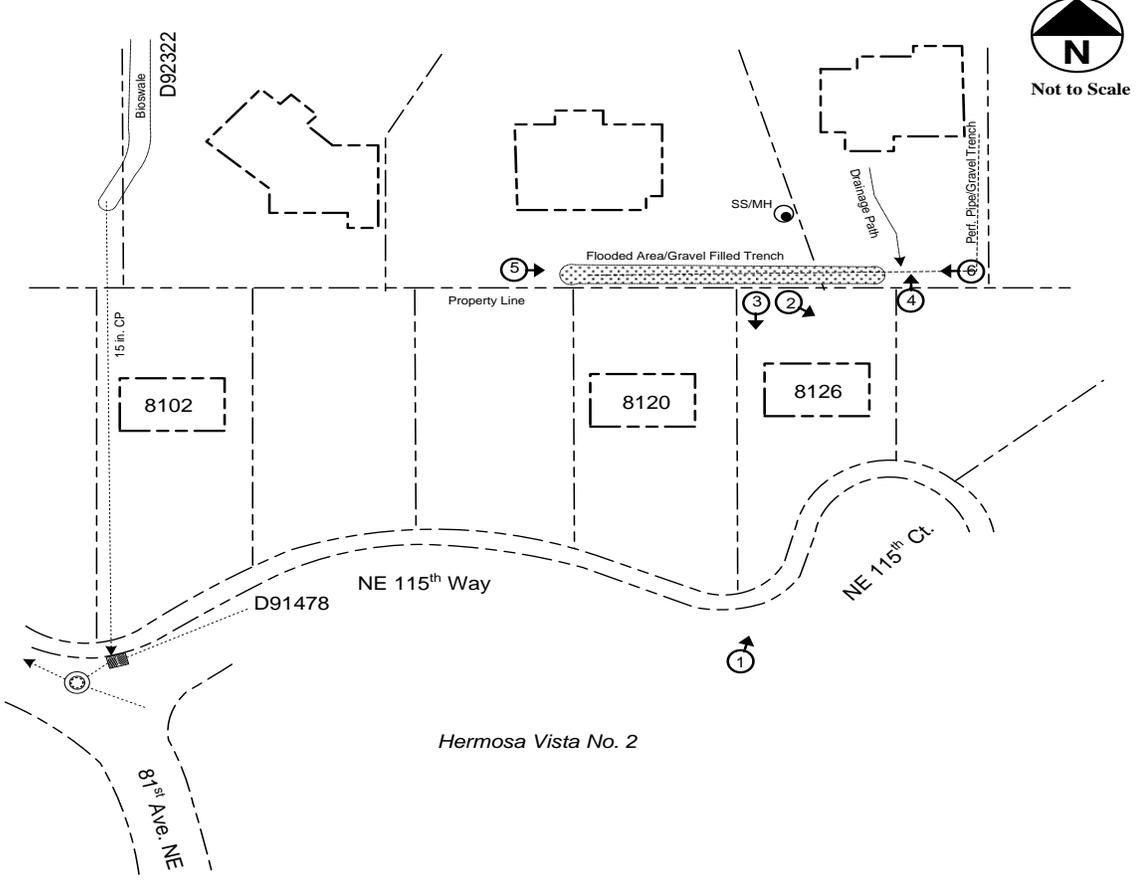
Conducted site investigation on 12/28/2010. The weather was clear and dry. This is the same problem identified in previous DIR 97-1252, 0662 and 98-0374. Ground water continues to pool along the north fence line of the residence and neighboring property to the west (8120). The previous investigations note that a perf.-pipe was installed in a pea gravel filled trench along the north line of both properties. The pipe and trench are on the neighboring properties to the north. Drainage was pooling above the trench and was flowing westerly to a point near the northwest corner of 8120 where the flow infiltrated. I could not determine just how far the perf.-pipe and trench extended to the west. However, approx. 280 ft. westerly from the northwest corner of 8120 there is a bioswale and 15 in. CP conveyance system that flows to a catch basin in front of 8102 NE 115<sup>th</sup> Way. It appears that the perf.-pipe and trench do not extend to this conveyance system.
