ADDENDUM TO THE ARBORICULTURAL REPORT RE-EVALUATION OF TREES AT

THE TOTEM LAKE APARTMENTS SITE At NE 115th Street & 124th Avenue NE KIRKLAND, WA 98033

April 7, 2011 Addendum

Addendum to the Arboricultural Report, Re-Evaluation of Trees
At the Totem Lake Apartments Site at the Intersection of
NE 115th St, 124th Ave NE, & Slater Ave, Kirkland, WA
Gilles Consulting
April 7, 2011
Page 2 of 23

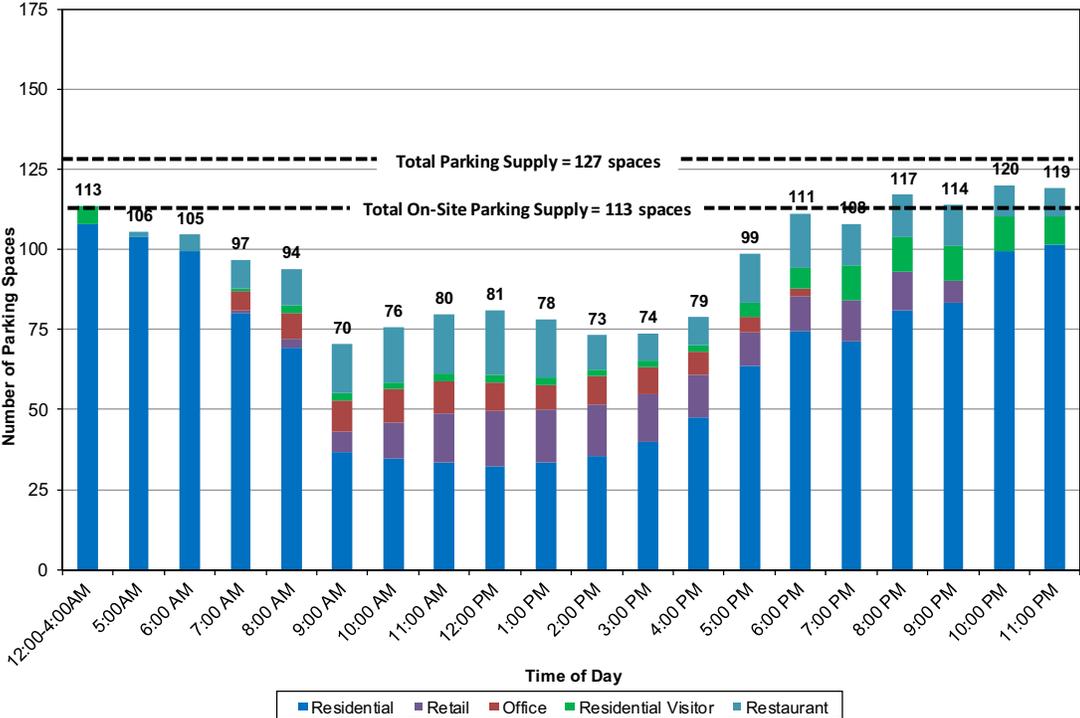
Weekday Shared Parking by Time of Day based on Parking Code Rates

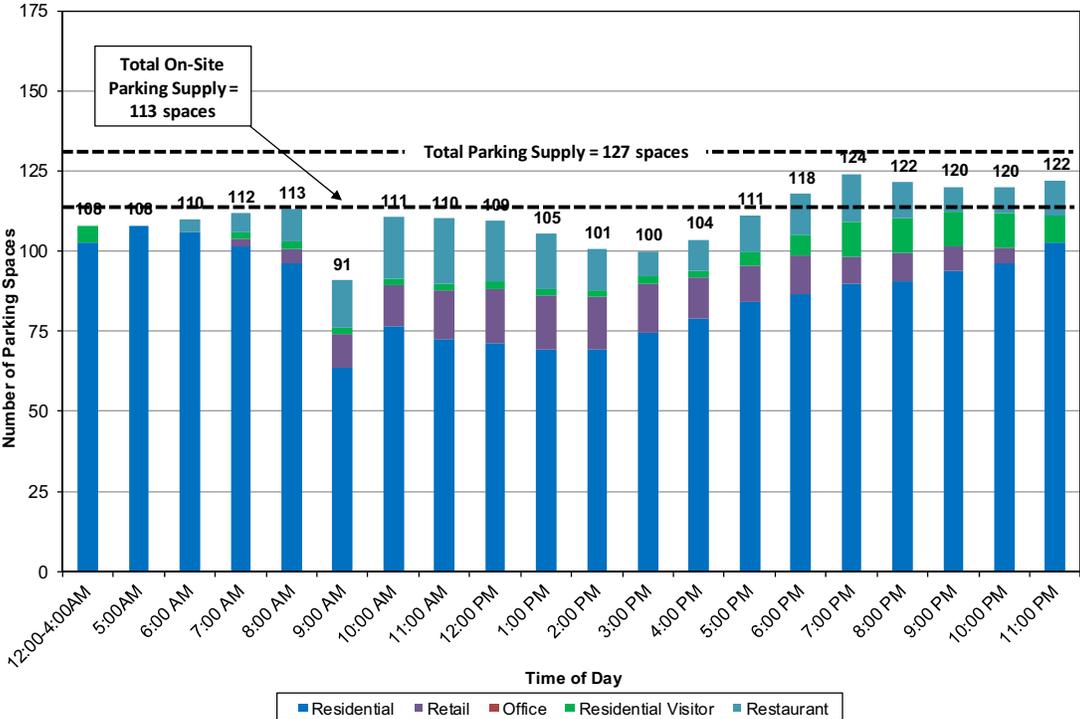
Weekend Shared Parking by Time of Day based on Parking Code Rates

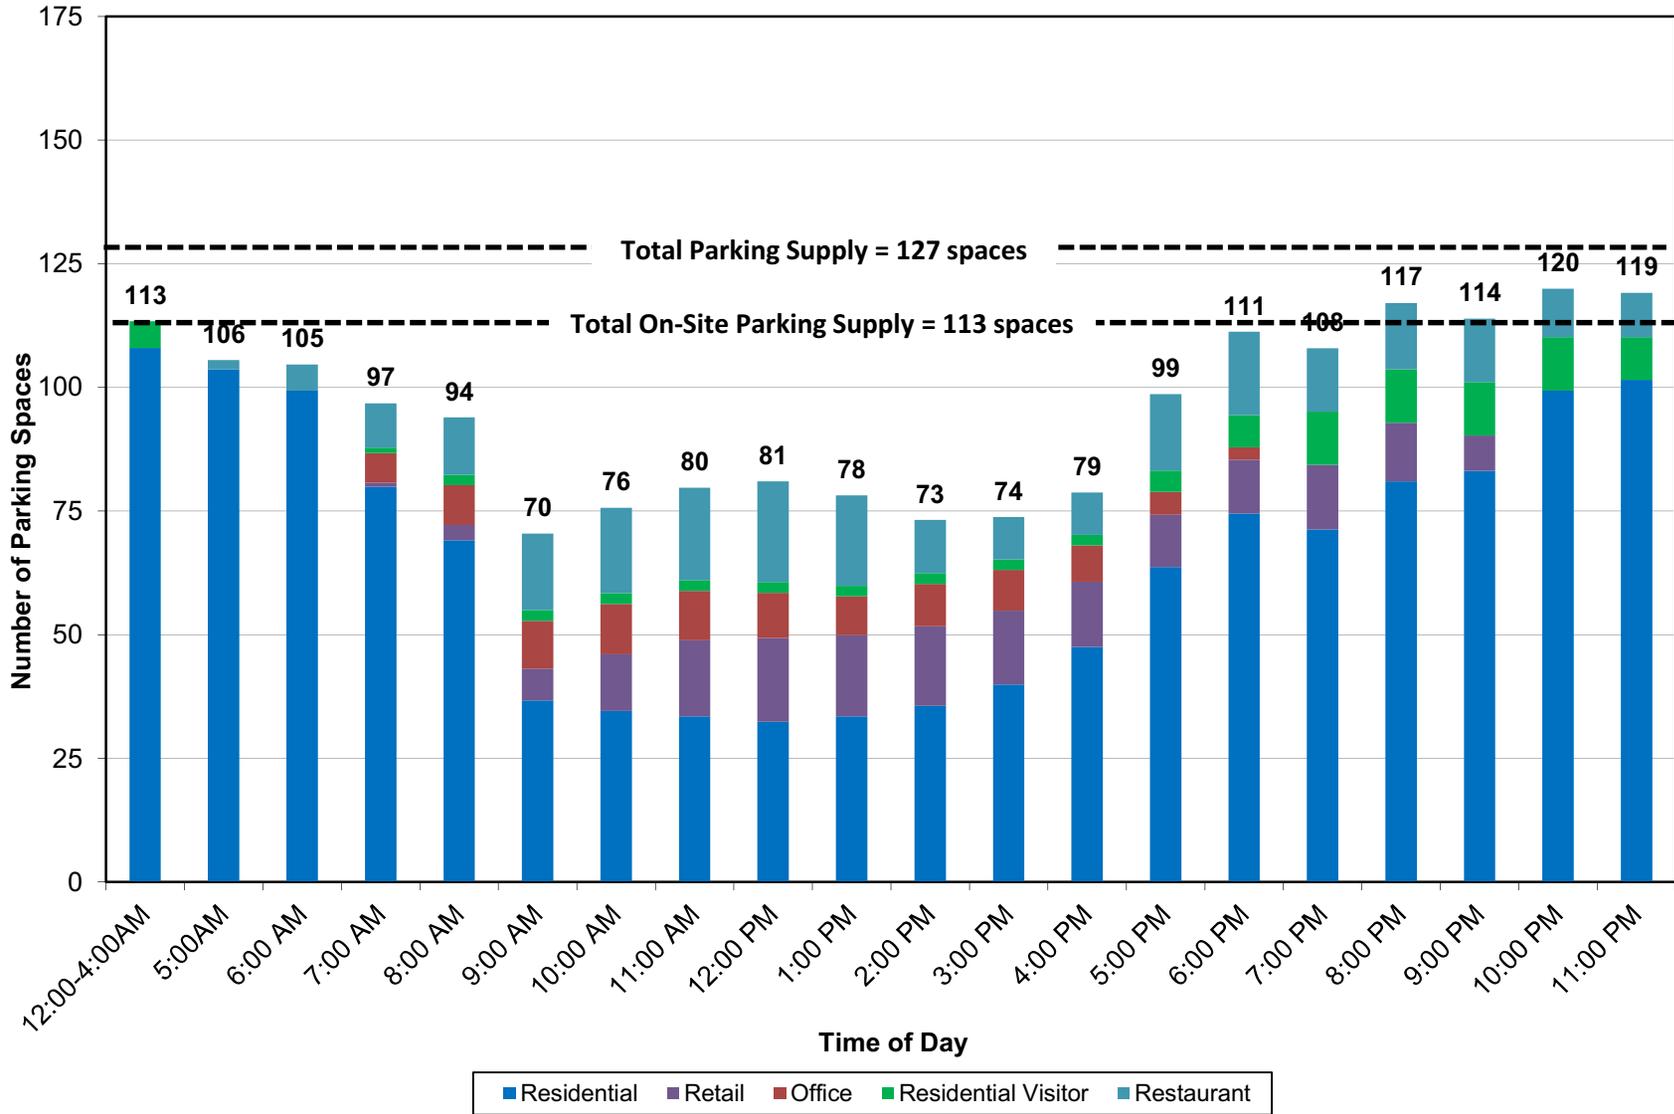
1. Parking rates based on the City of Krikland requirements and a parking ratio of 1.10 spaces per unit for residential.
2. Hourly time of day parking demand percent based on ITE *Parking Generation*, 4th Edition for all uses except the residential visitors where ULI's *Shared Parking*, 2nd Edition was used.

Weekday Shared Parking by Time of Day based on Parking Code Rates

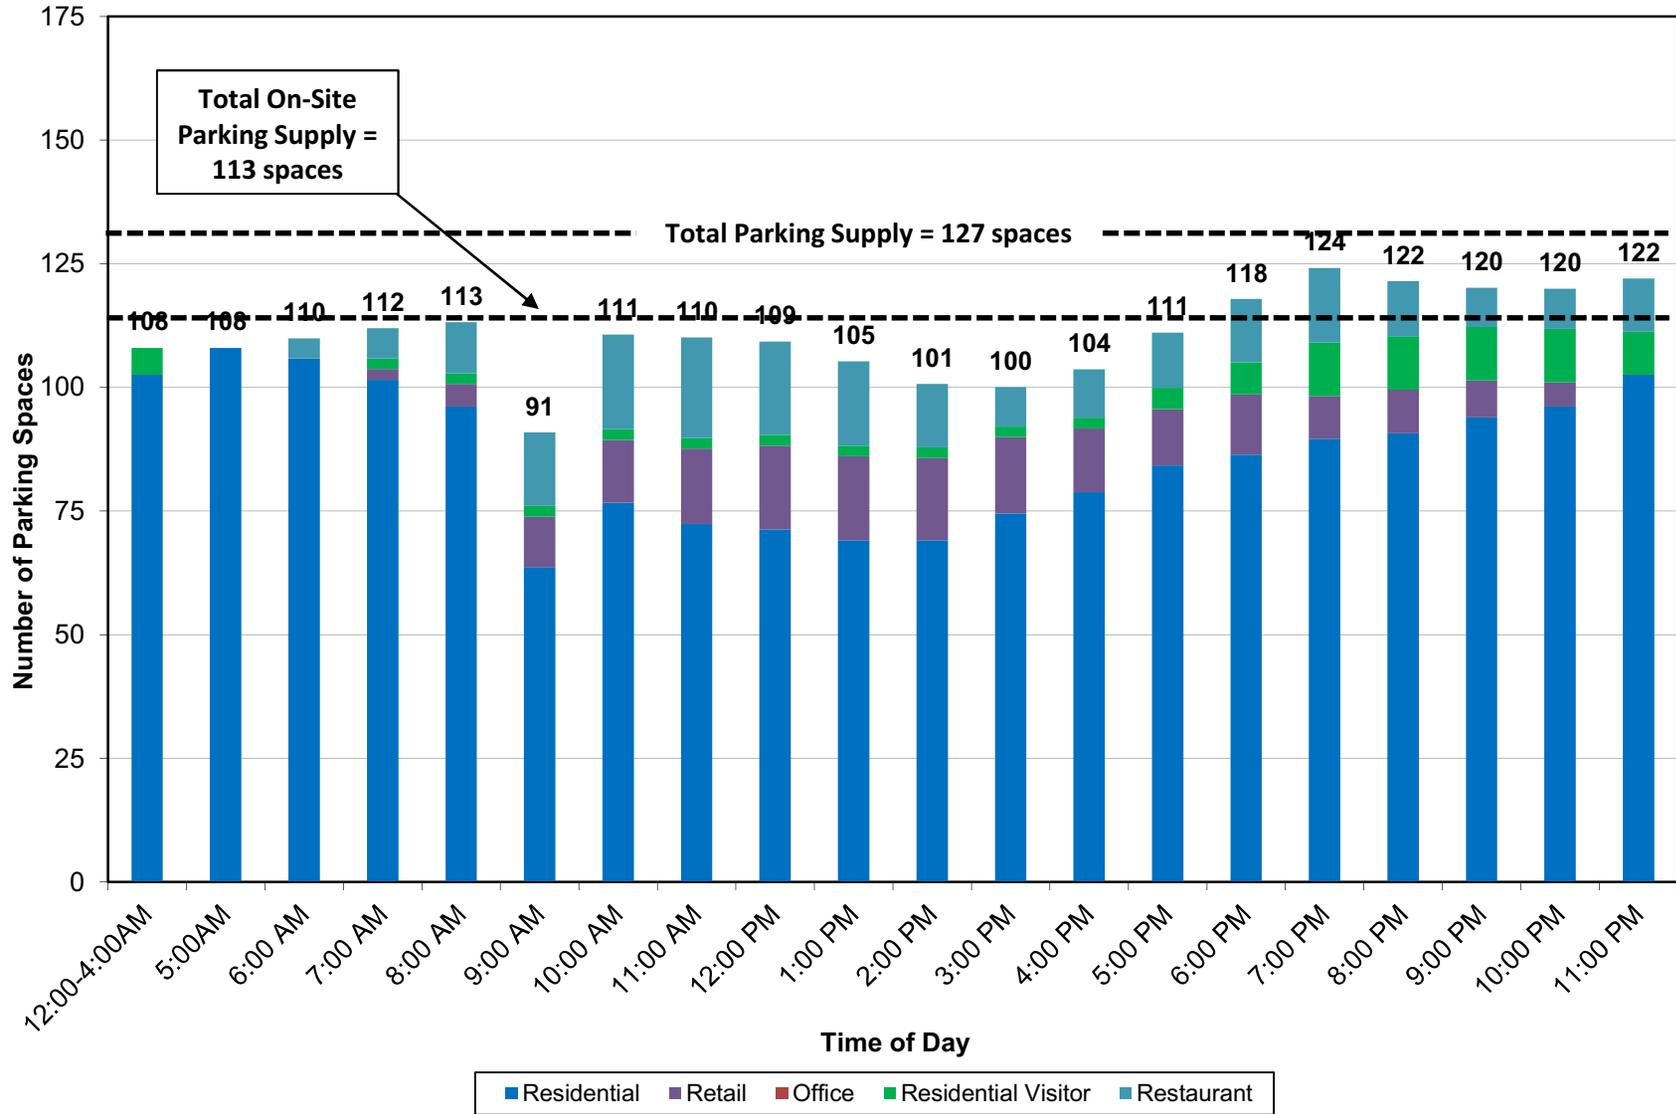
1. Parking rates based on the City of Krikland requirements and a parking ratio of 1.10 spaces per unit for residential.
2. Hourly time of day parking demand percent based on ITE *Parking Generation*, 4th Edition for all uses except the residential visitors where ULI's *Shared Parking*, 2nd Edition was used.

Weekend Shared Parking by Time of Day based on Parking Code Rates

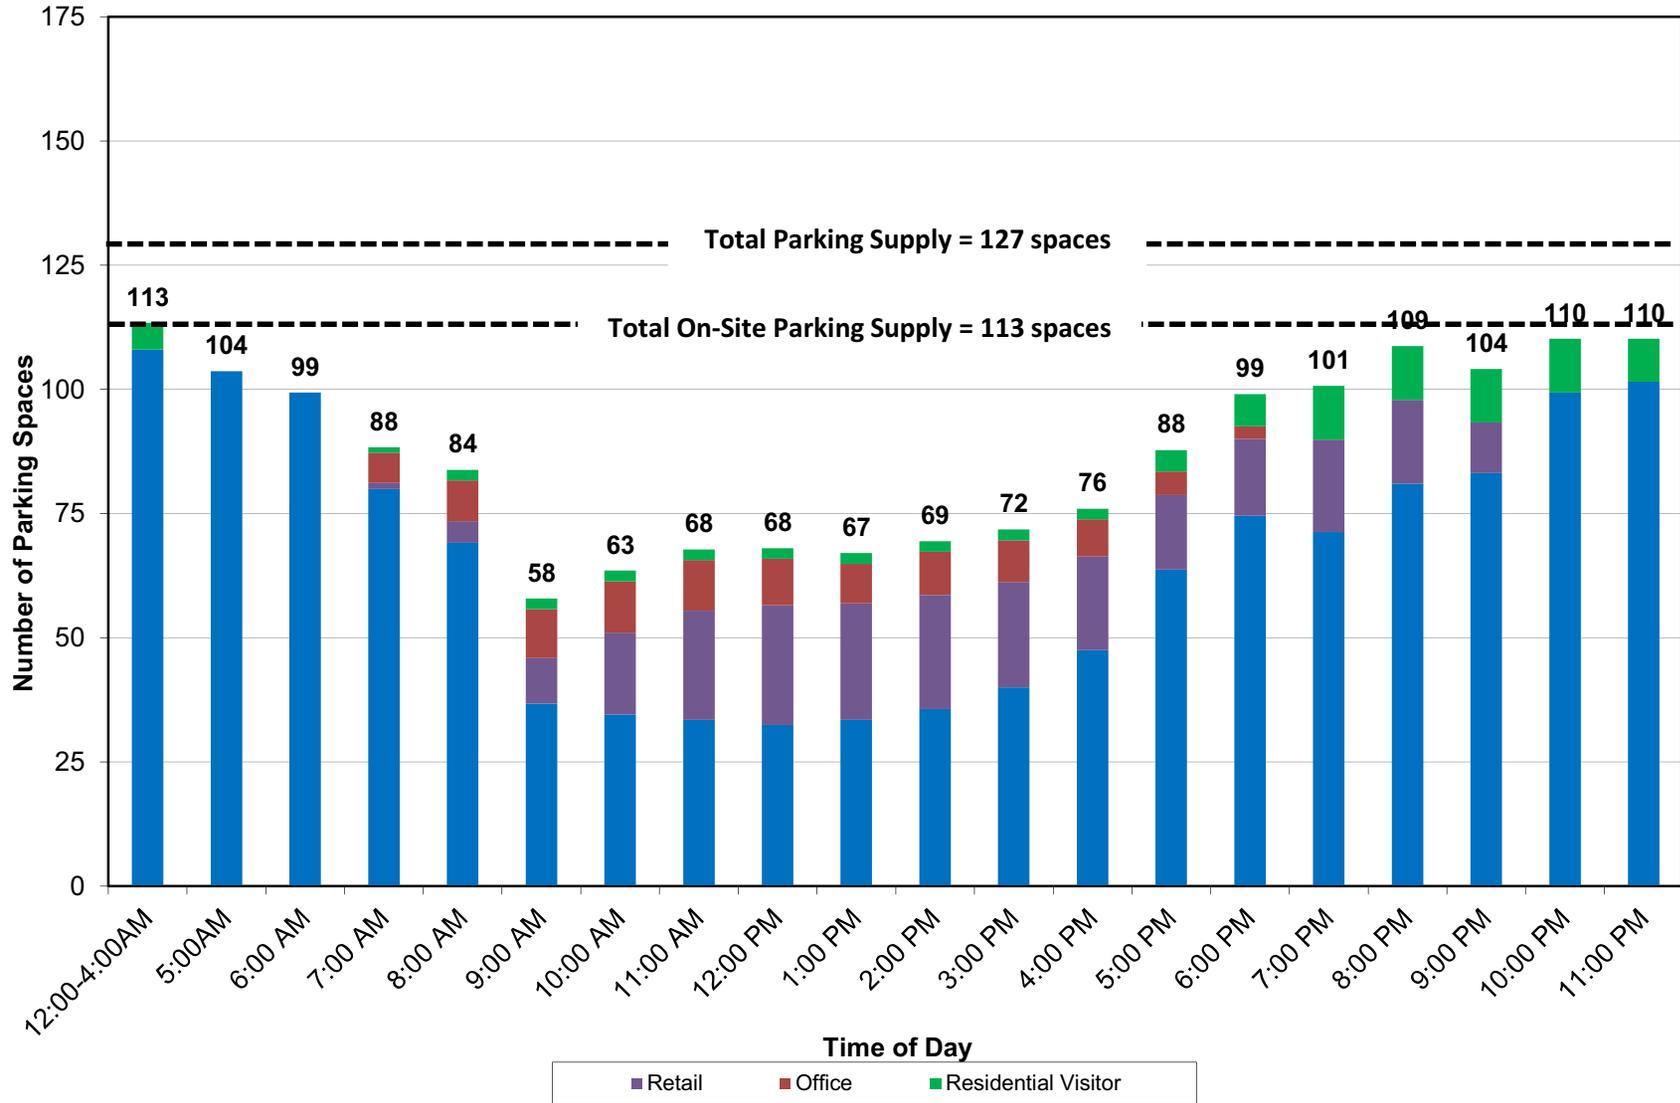
1. Parking rates based on the City of Krikland requirements and a parking ratio of 1.10 spaces per unit for residential.
2. Hourly time of day parking demand percent based on ITE *Parking Generation*, 4th Edition for all uses except the residential visitors where ULI's *Shared Parking*, 2nd Edition was used.

Weekday Shared Parking by Time of Day based on Parking Code Rates Transportation Concurrency Land Use

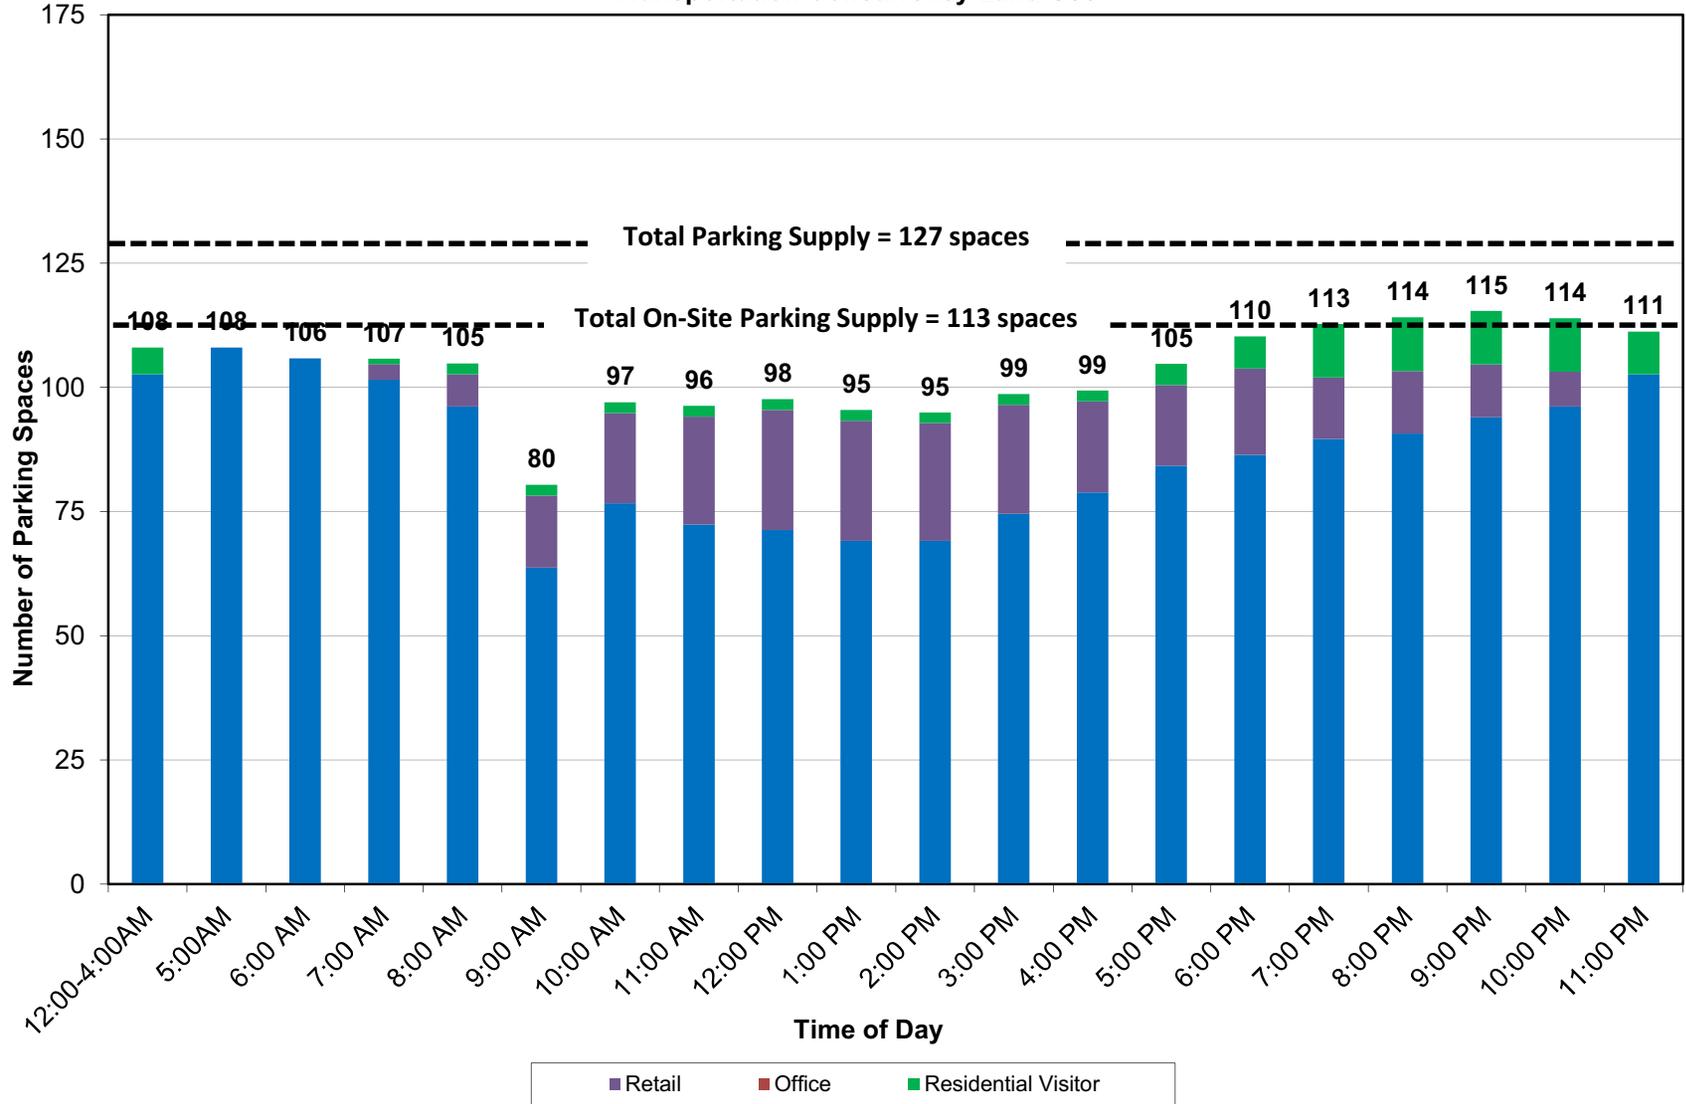
1. Parking rates based on the City of Krikland requirements and a parking ratio of 1.10 spaces per unit for residential.
2. Hourly time of day parking demand percent based on ITE *Parking Generation*, 4th Edition for all uses except the residential visitors where ULI's *Shared Parking*, 2nd Edition was used.

Weekend Shared Parking by Time of Day based on Parking Code Rates Transportation Concurrency Land Use
