**Critical Areas Report:
Wetland Delineation and Habitat Assessment**

Totem Lake Connector
Kirkland, Washington

File No. 0231-090-00

May 25, 2017

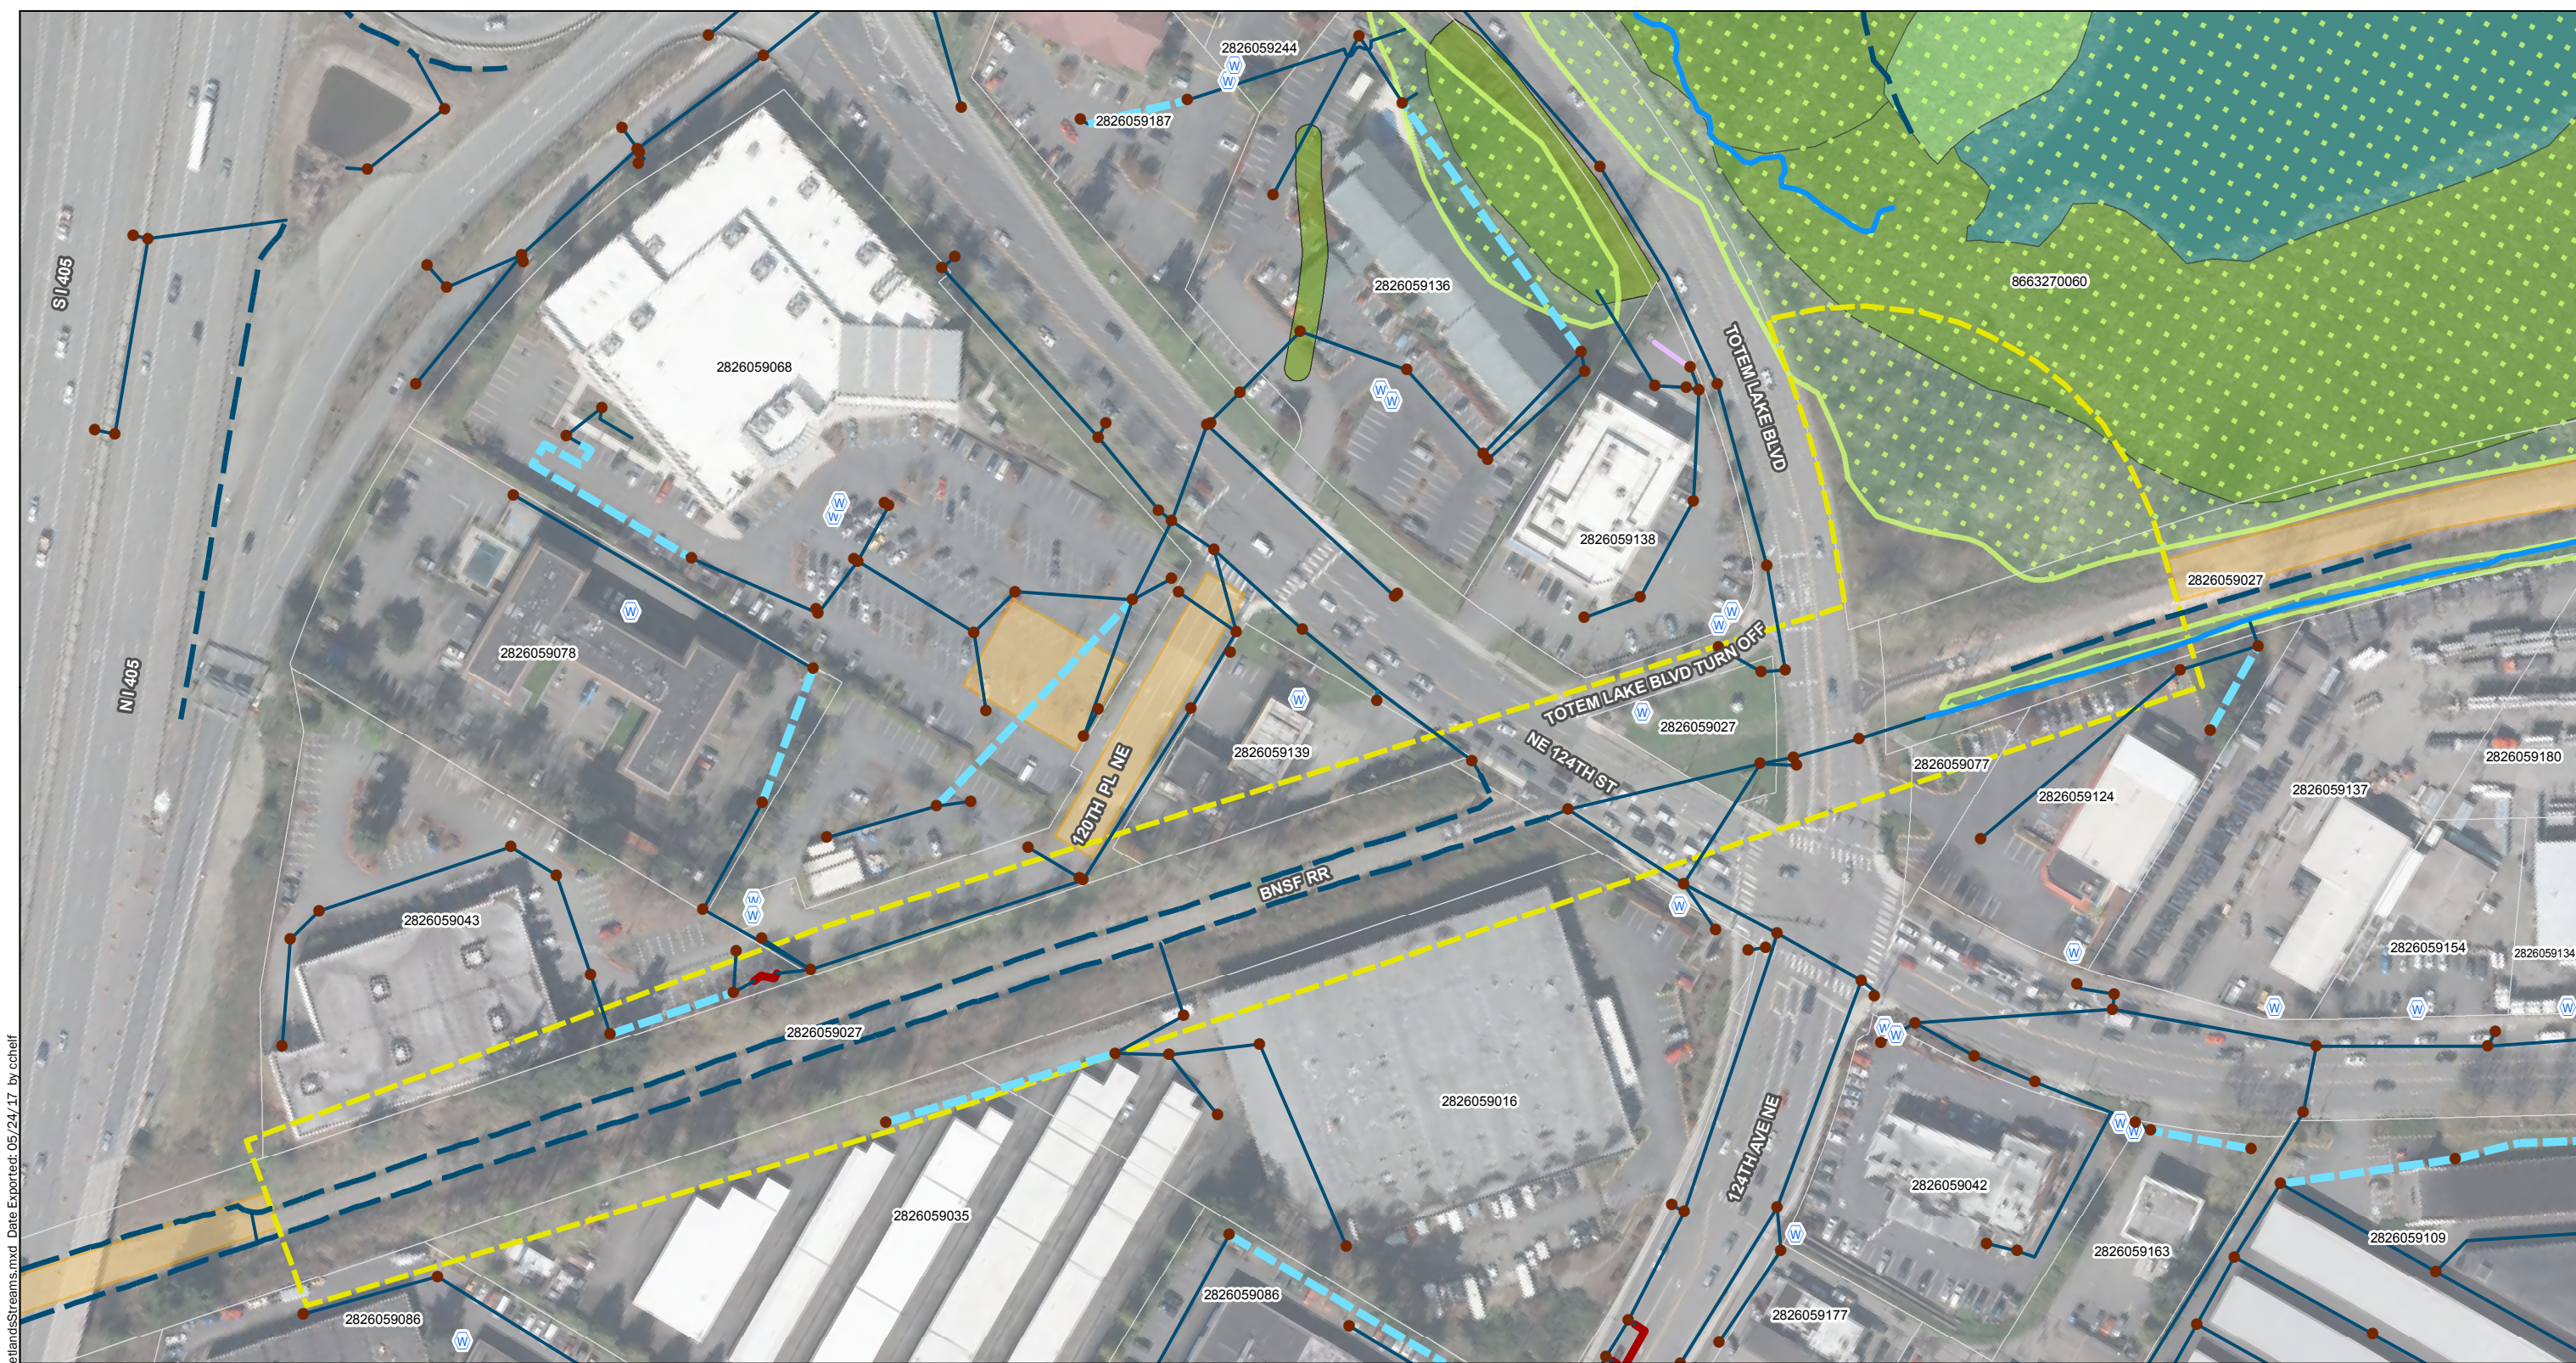
Mapped Wetlands and Drainage Data	
Totem Lake Connector Kirkland, Washington	
	Figure 2

Wetlands and streams mapped by the NWI (USFWS 2016) and City of Kirkland (2016b) are shown on Figure 2. The NWI database depicts several wetlands adjacent to the proposed project: freshwater forested/shrub, emergent, and ponded wetland habitats are shown encompassing the entirety of Totem Lake and partially overlapping the project area. A second wetland forested/shrub wetland is shown on the south side of Totem Lake Boulevard NE, west of the project site. The City of Kirkland database also identifies these same wetland systems in approximately the same locations. City of Kirkland also identifies an open stream/ditch located on the east side of the existing trail, north of the intersection, as well as a linear wetland feature associated with the ditch. Drainage data (City of Kirkland 2016b) indicates that this ditch/wetland system is hydrologically connected to the drainage ditch on the east side of the trail south of the intersection via a pipe under the road intersection, as well as Totem Lake further to the north (and outside the project area) via a pipe under the trail.

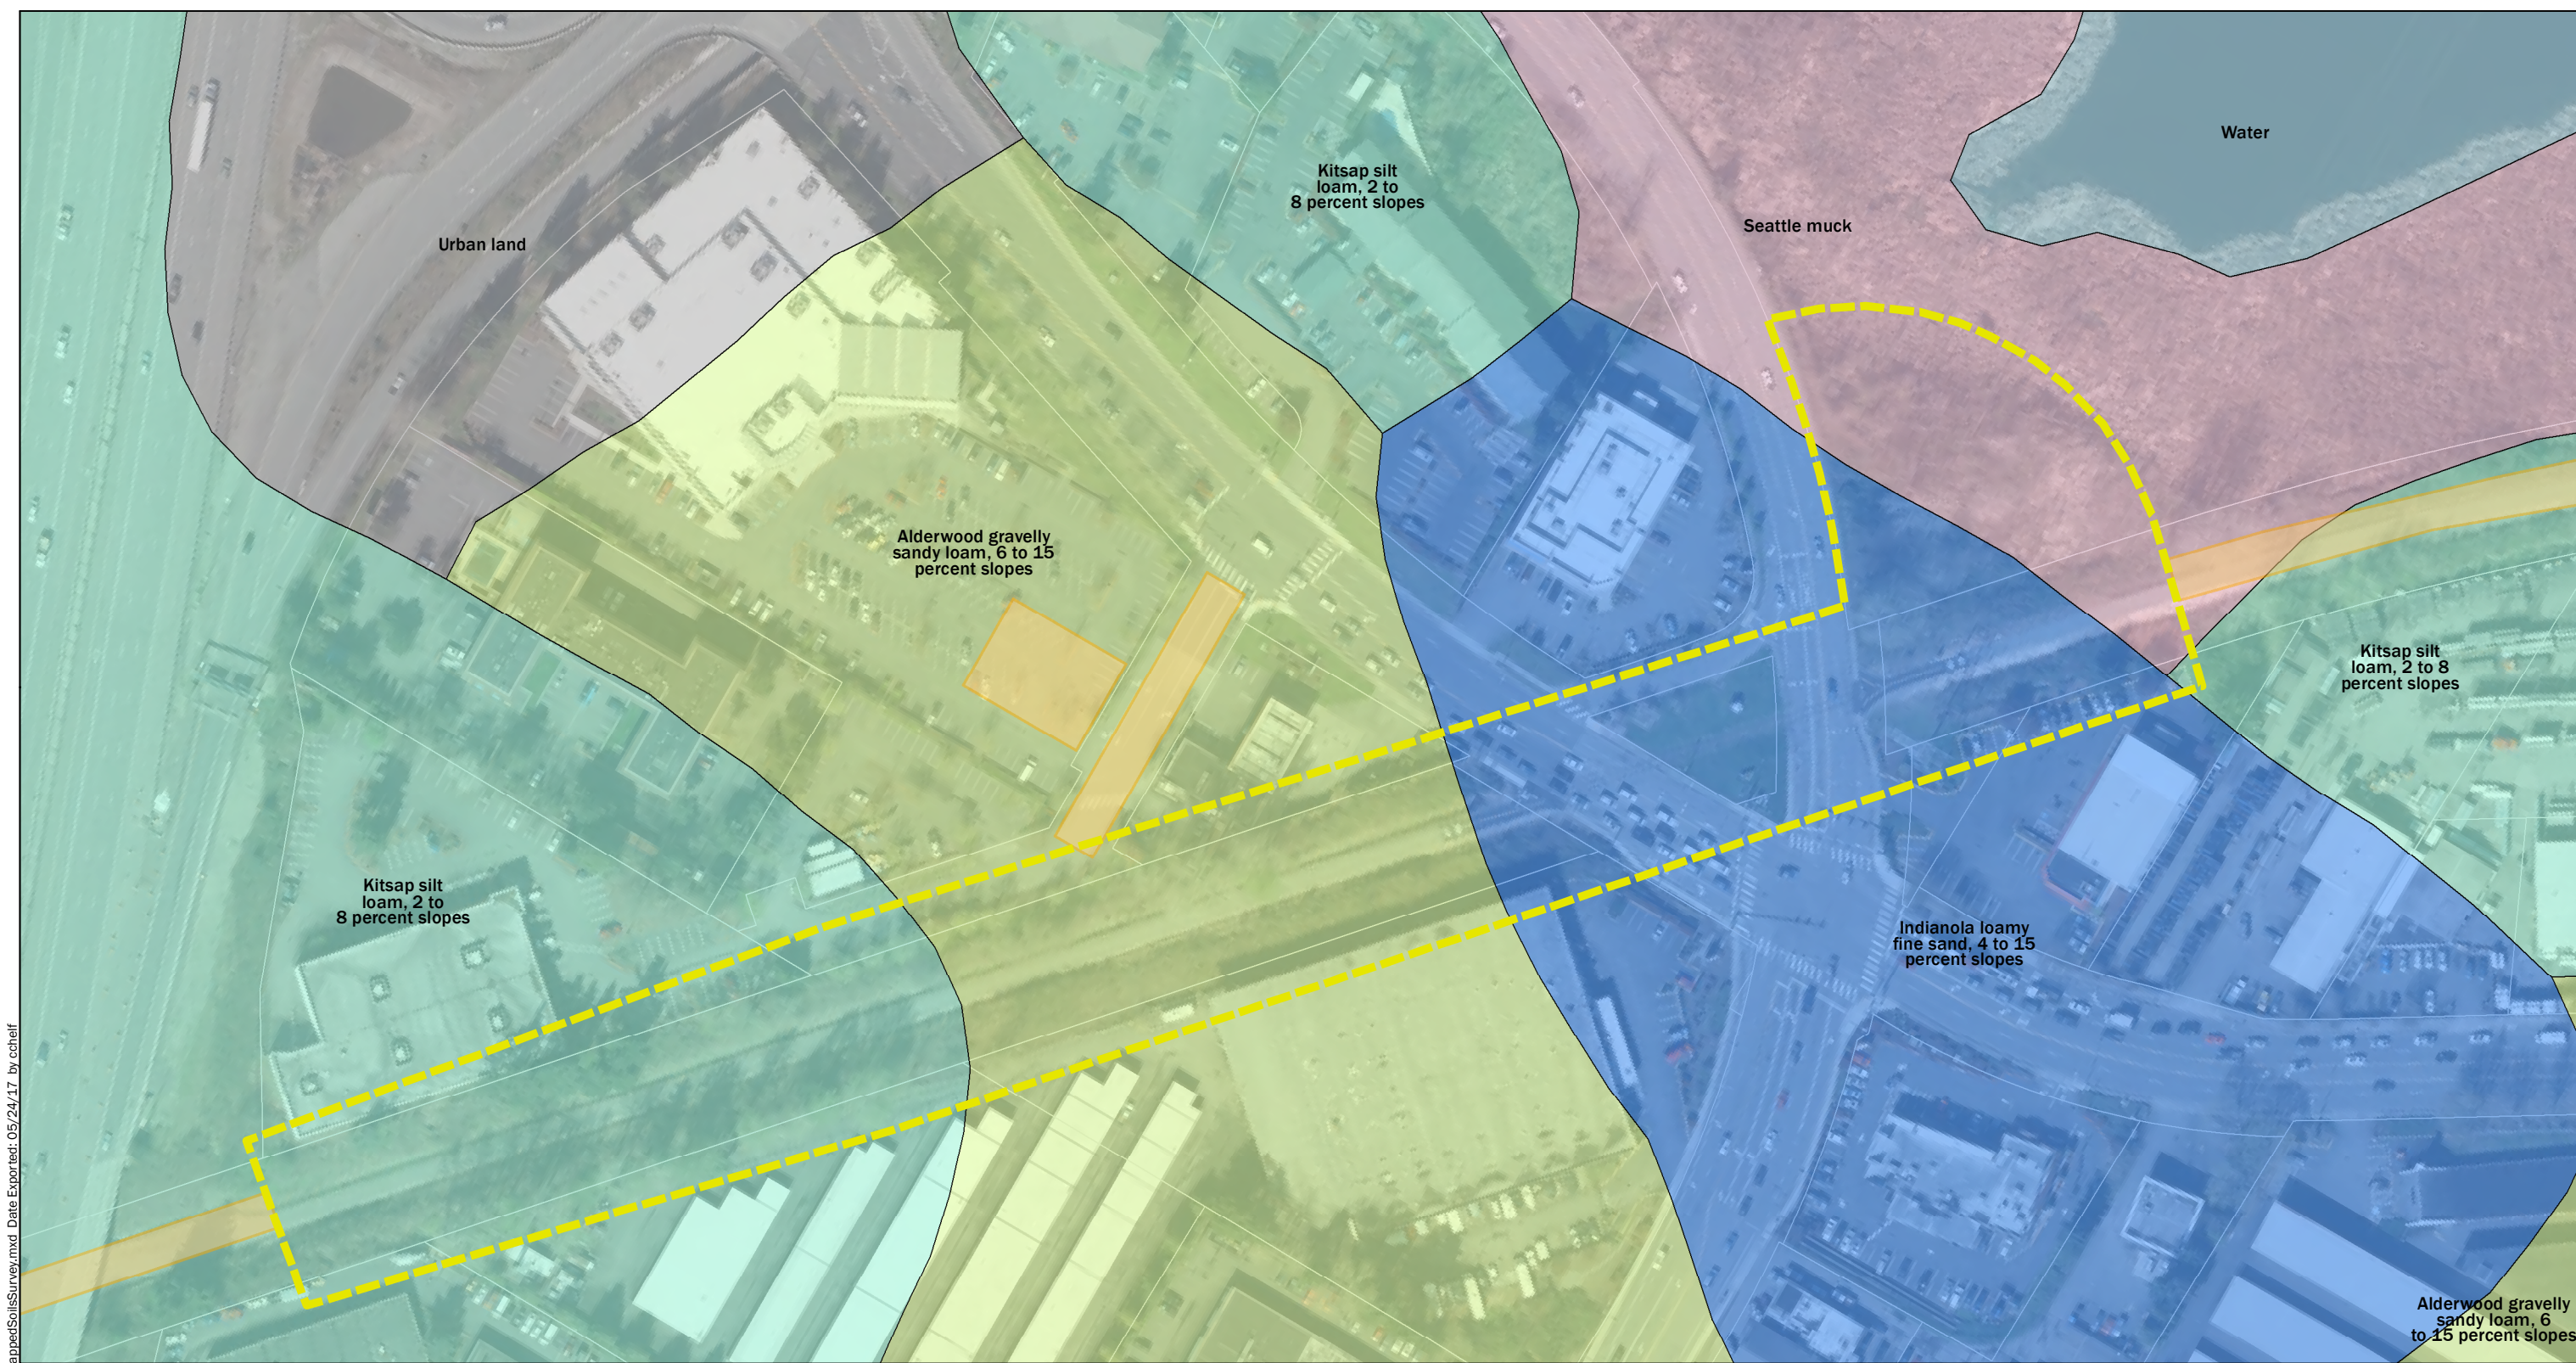
Mapped Soils Survey	
Totem Lake Connector Kirkland, Washington	
	Figure 3

Soil map units identified by the NRCS Web Soil Survey (USDA-NRCS, 2016) are shown on Figure 3. According to these data, four soil types are present in the project area:

The Seattle Muck map unit, which is classified as a poorly drained hydric soil type, corresponds approximately to the Totem Lake wetland complex. Alderwood gravelly sandy loam, Indianola loamy sand

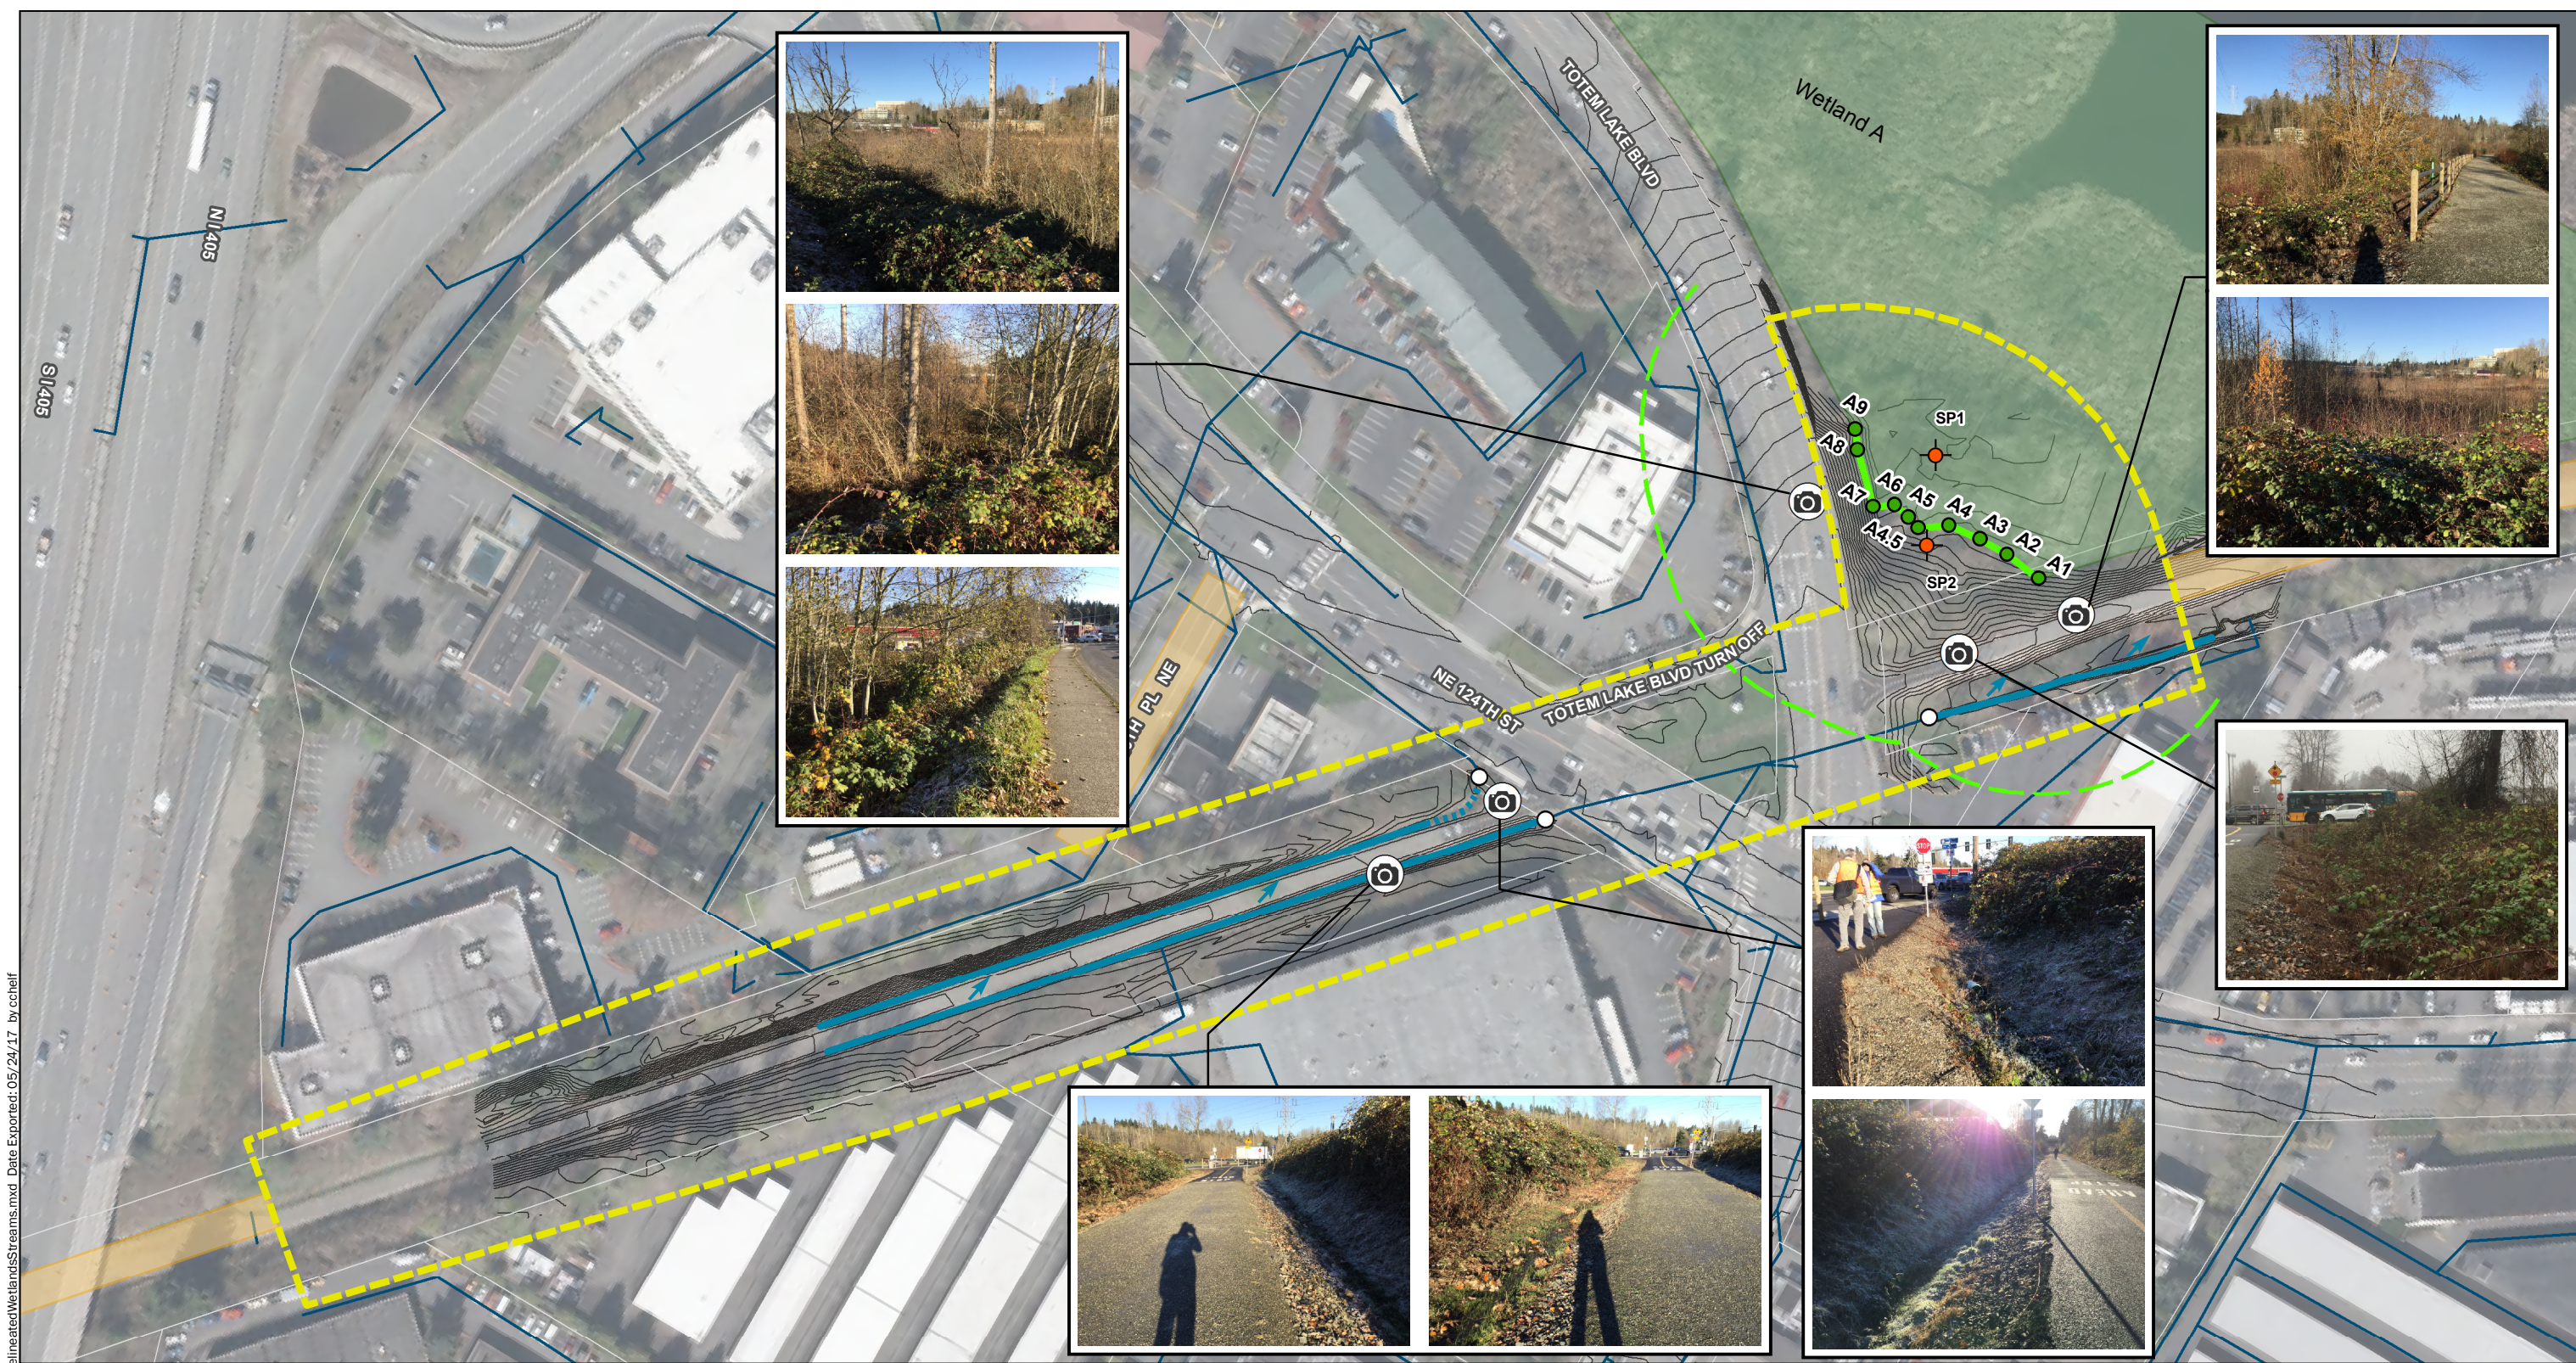
Wetland Delineation Results	
Totem Lake Connector Kirkland, Washington	
	Figure 4

One wetland (Wetland A, also known as Totem Lake) was identified within the project limits during the field investigation, as shown on Figure 4. Other wetlands identified in our data review were outside of the project area and were not delineated. In addition, two ditches occur within the project area and one ditch was confirmed adjacent but outside the project limits. There were no other wildlife habitats documented within or adjacent to the project. Detailed descriptions are included in the subsequent section.

GeoEngineers documented one wetland (Wetland A) within the project area (Figure 4), the boundary of which is generally consistent with prior mapping and studies. The southerly extent of this large wetland overlaps the project boundary and was formally delineated. We established two formal data sample plots to document existing habitat and assist in identifying wetland boundaries (Appendix D) and placed nine wetland boundary flags (A-1 through A-9) for subsequent survey. Other wetlands, including Wetlands B and C, as identified by TWC (2013), were field-verified outside the project limits and were not assessed in detail.

There are no streams within the project area. Ditches were verified on either side of the CKC trail south of NE 124th Street and on the east side of the trail north of Totem Lake Boulevard, as previously mapped (Figure 2). The approximate ditch alignments and representative photographs are shown on Figure 4.

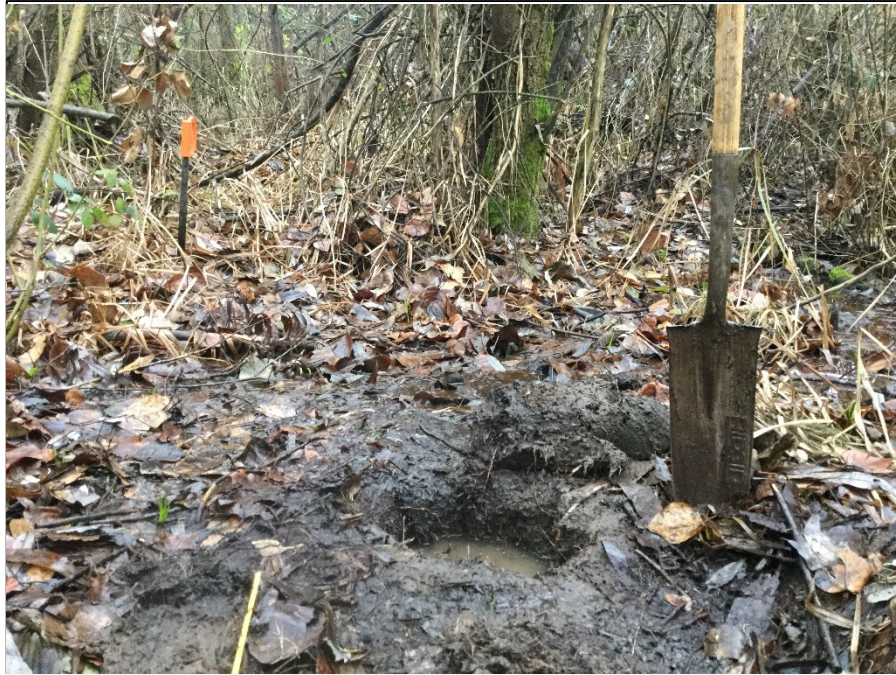
Photograph 1. SP-1 Location. Looking northwest (Photo taken December 19, 2016)

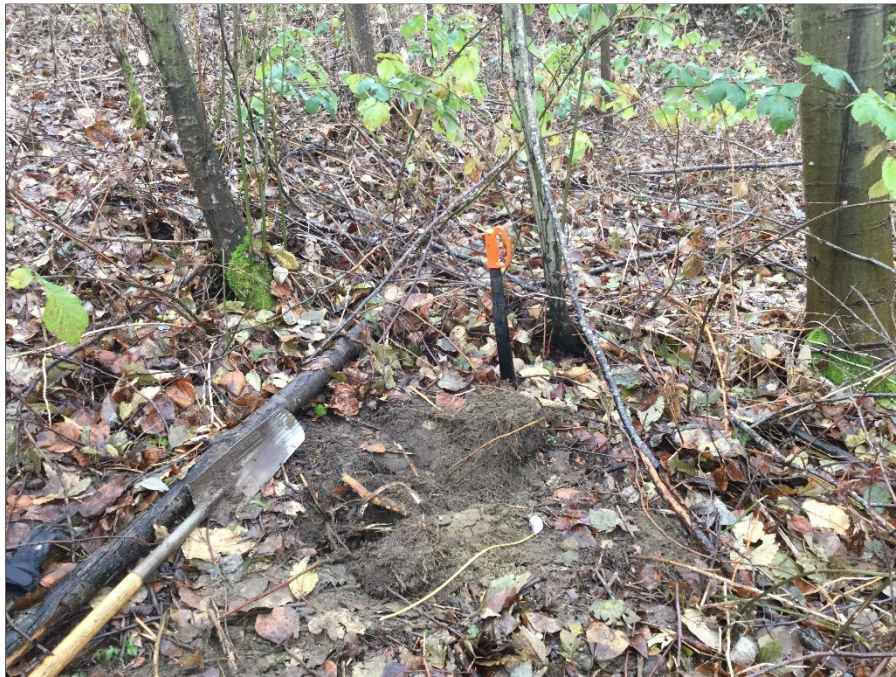
Photograph 2. SP-2 Looking southeast (Photo taken December 19, 2016)

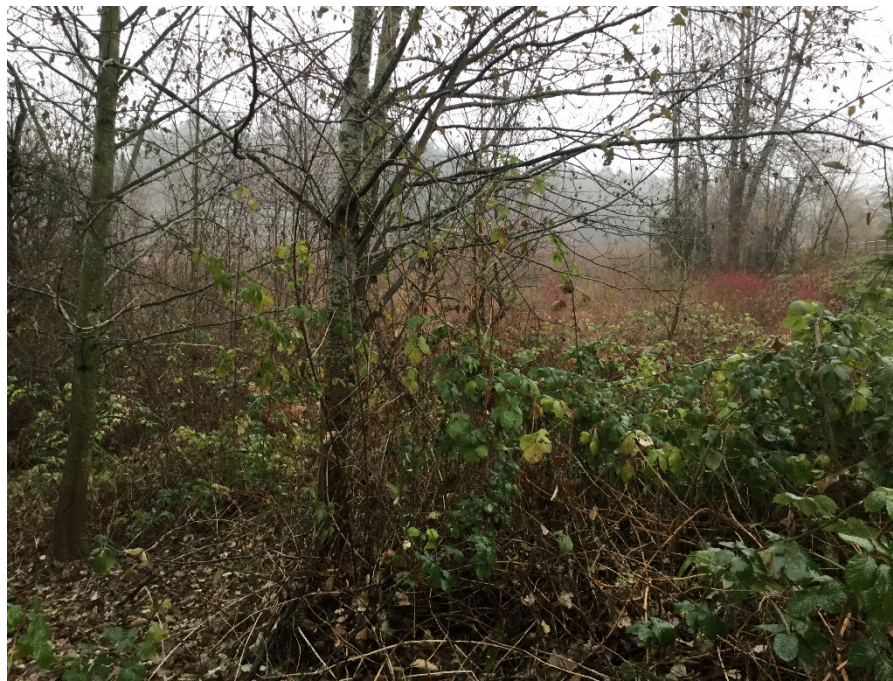
Photograph 3. Riparian wetland associated with Totem Lake. Looking northwest. (Photo taken December 19, 2016)

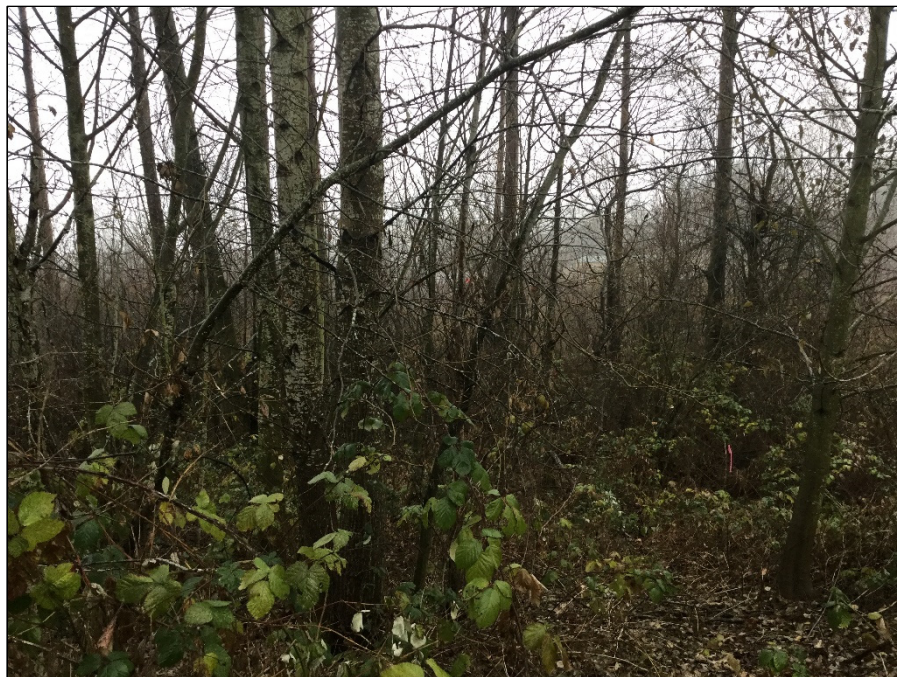
Photograph 4. Riparian wetland associated with Totem Lake. Looking west. (Photo taken December 19, 2016)

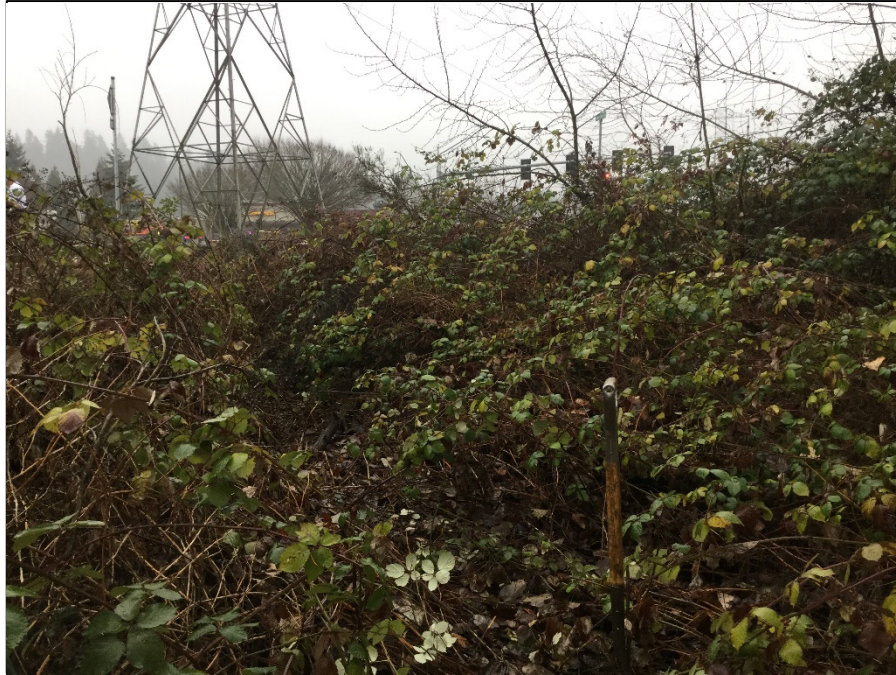
Photograph 5. Typical vegetation in critical area buffer (100 feet) of Totem Lake. Looking south. (Photo taken December 19, 2016)

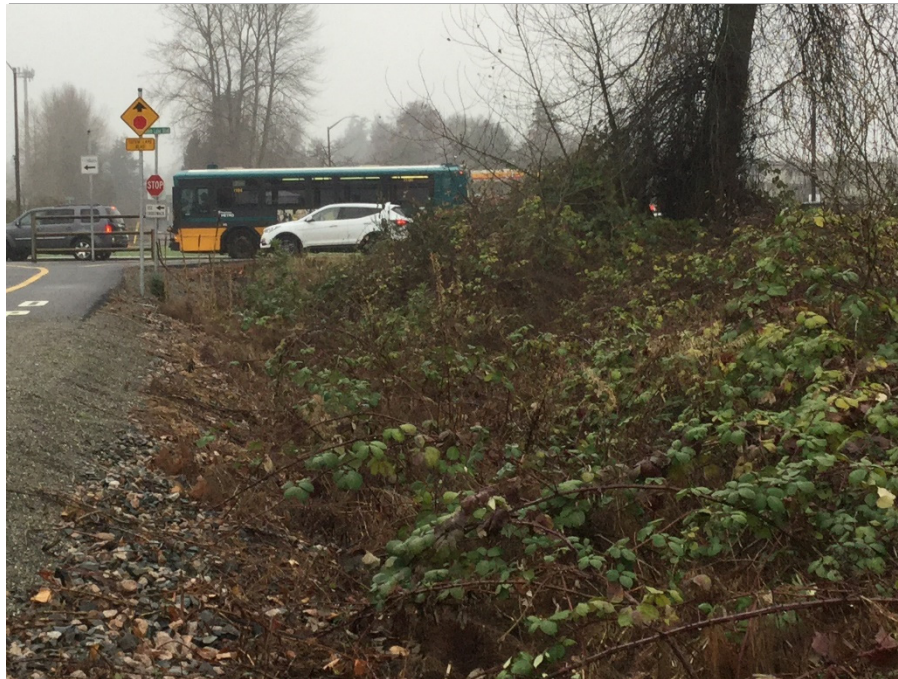
Photograph 6. Typical vegetation in critical area buffer (100 feet) of Tributary W. Looking southwest. (Photo taken December 6, 2016)

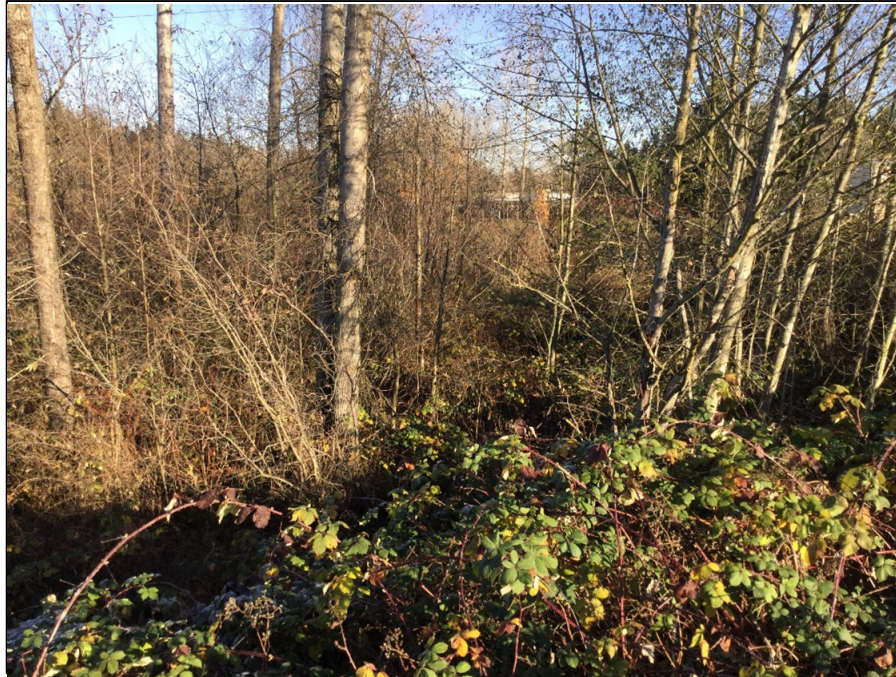
Photo 6. Totem Lake wetland buffer. Looking west from trail. (Photo taken December 19, 2016)

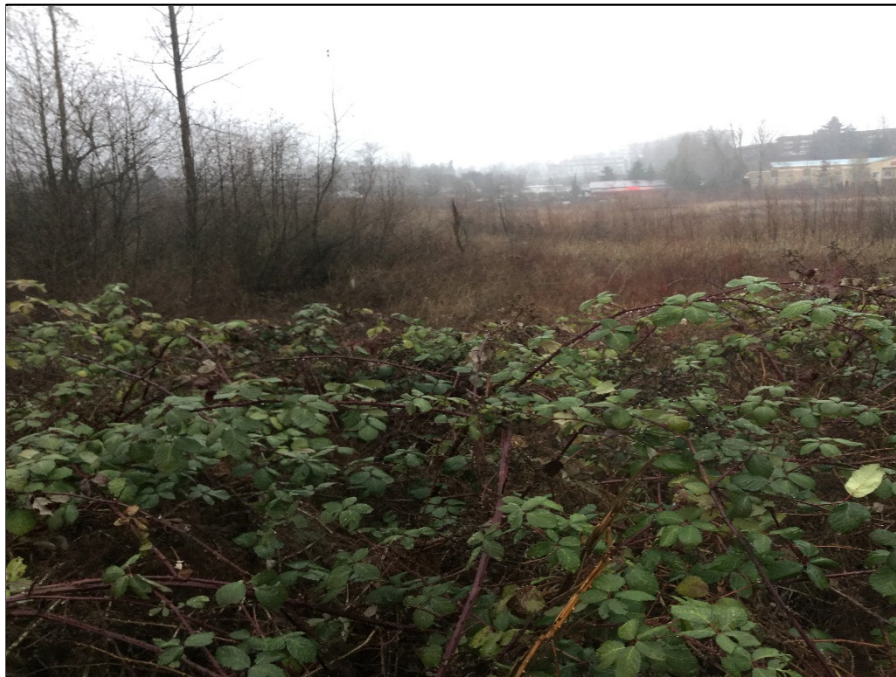
Photograph 8. Totem Lake wetland buffer. Looking west from trail. (Photo taken December 19, 2016)

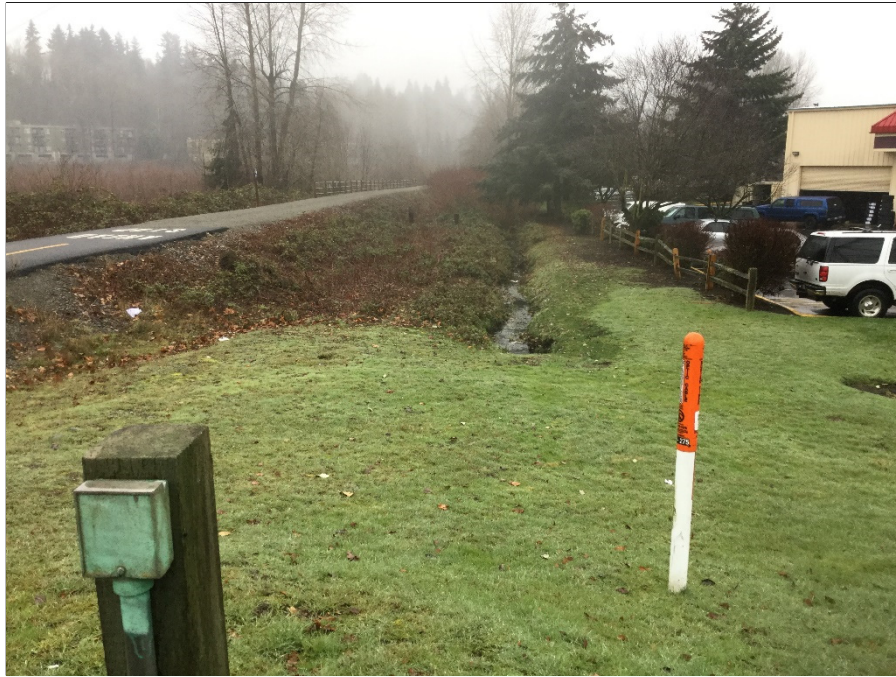
Photograph 9. Open stream/ditch adjacent to project area on north side of NE 124th Street/124th Avenue NE intersection. Looking northwest. (Photo taken December 19, 2016)

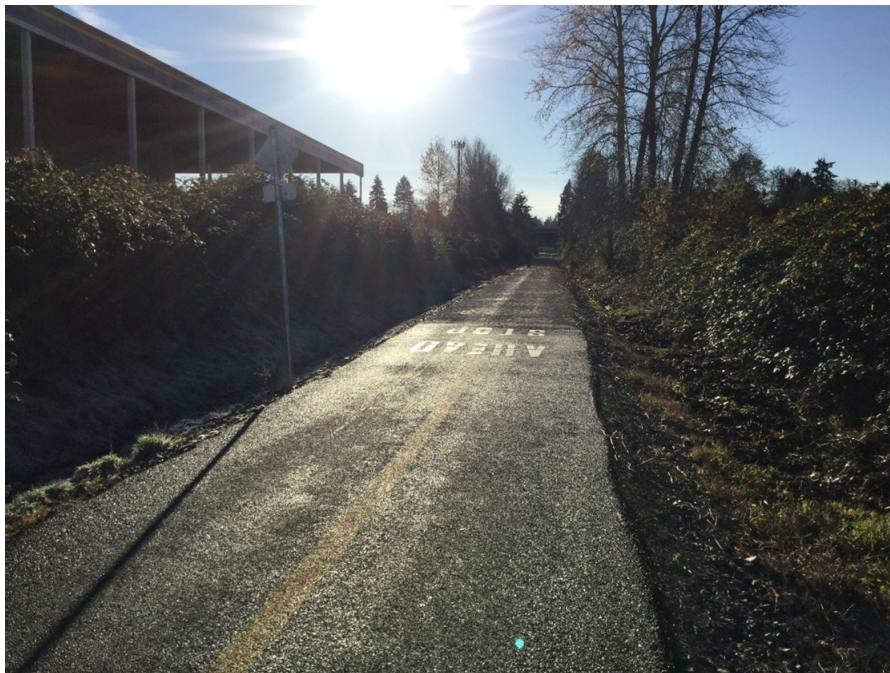
Photograph 10. Southern portion of project site looking down Cross Kirkland Corridor Trail. Ditches adjacent on either side of path. (Photo taken December 19, 2016)

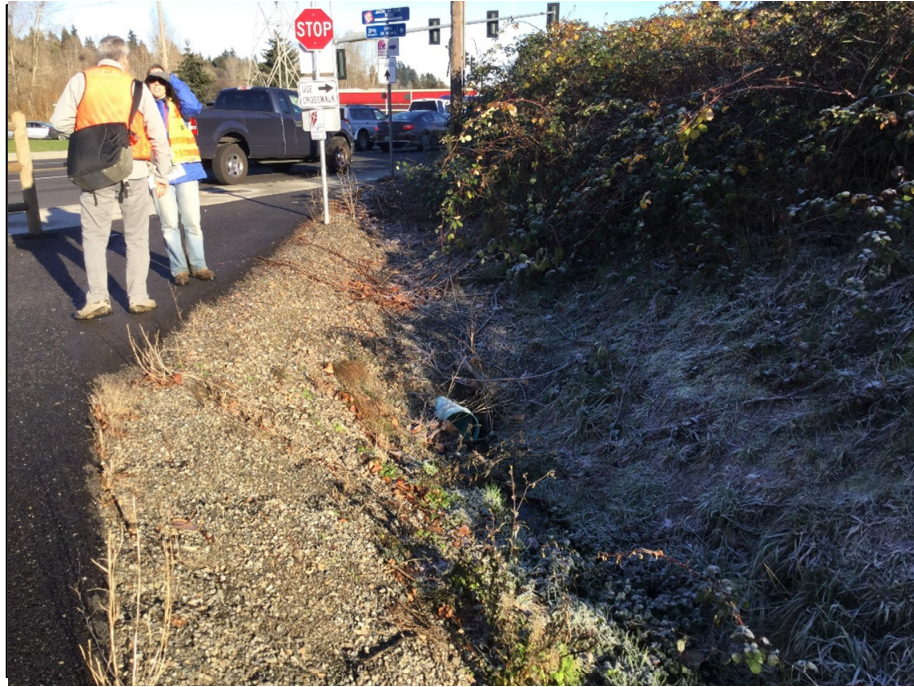
The ditch on the east side of the trail originates outside of the project area to the south but appears to contain only intermittent flow until a point of pipe discharge from the east that occurs within the project area (Figure 2). This ditch is a grass-lined swale approximately 2-3 feet in width at the top of bank and doesn't display a typical Ordinary High Water Mark (OHWM). However, from the point of discharge from the east to NE 124th Street, the flow appears relatively permanent. Flow in the ditch enters a pipe at NE 124th Street which conveys drainage across the intersection to a discharge point on the same side of the trail north of Totem Lake Boulevard. From there, the ditch continues north and enters a wetland system (Wetland C as identified by TWC [2013]) before ultimately entering Totem Lake.

Photograph 9. Adjacent eastern ditch and related piping. Looking north. (Photo taken December 19, 2016)

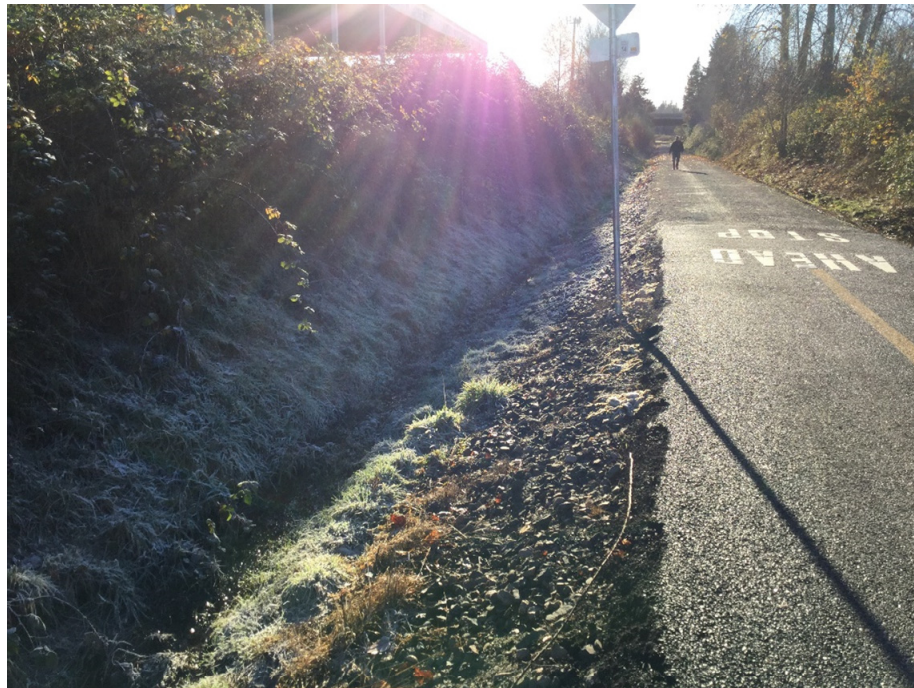
Photograph 10. Adjacent eastern ditch. Looking south. (Photo taken December 19, 2016)

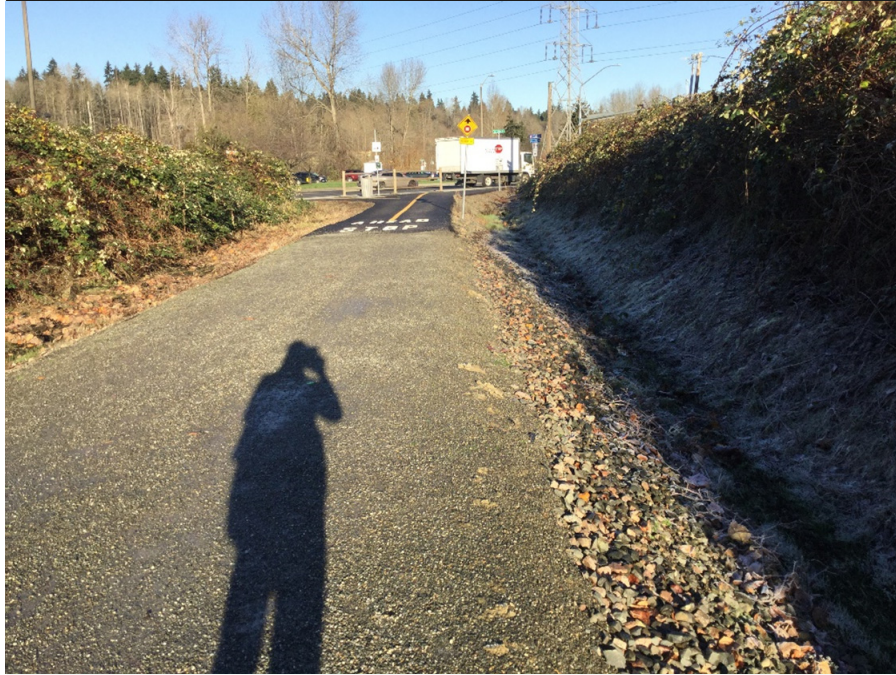
Photograph 11. Adjacent eastern ditch. Looking north. (Photo taken December 19, 2016)

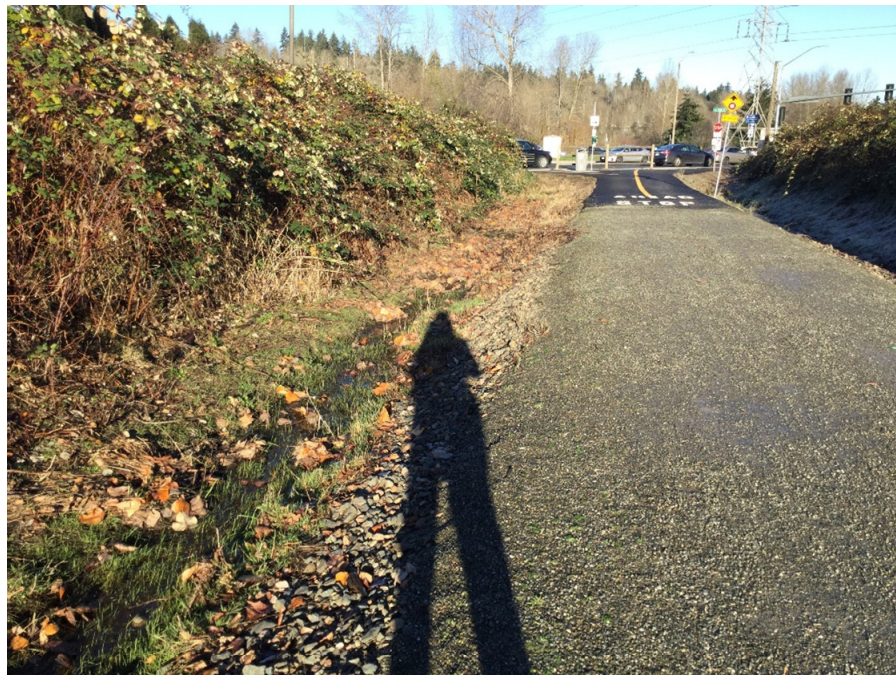
The ditch on the west side of the trail also originates outside of the project area to the south and there are no other point inputs to it within the project area. The ditch continues north and then turns abruptly to the west before reaching NE 124th Street, terminating at a pipe culvert that appears to enter a complex stormwater drainage network before conveying flow into the stormwater pond behind the Comfort Inn, which is shown on Figure 2 and has also been identified as Wetland B by TWC (2013). This ditch consists of a grass-lined swale lacking typical OHWM characteristics. During two site visits in December, both of which occurred within the wet season but during relatively dry weather, flow in this ditch infiltrating before it reached the pipe conveyance at its north end, calling into question the relative permanence of flow connecting this ditch to downstream waterbodies.

Photograph 12. Adjacent western ditch. Looking north. (Photo taken December 6, 2016)
