# COTTON HILL PARK STEWARDSHIP PLAN

May 2014

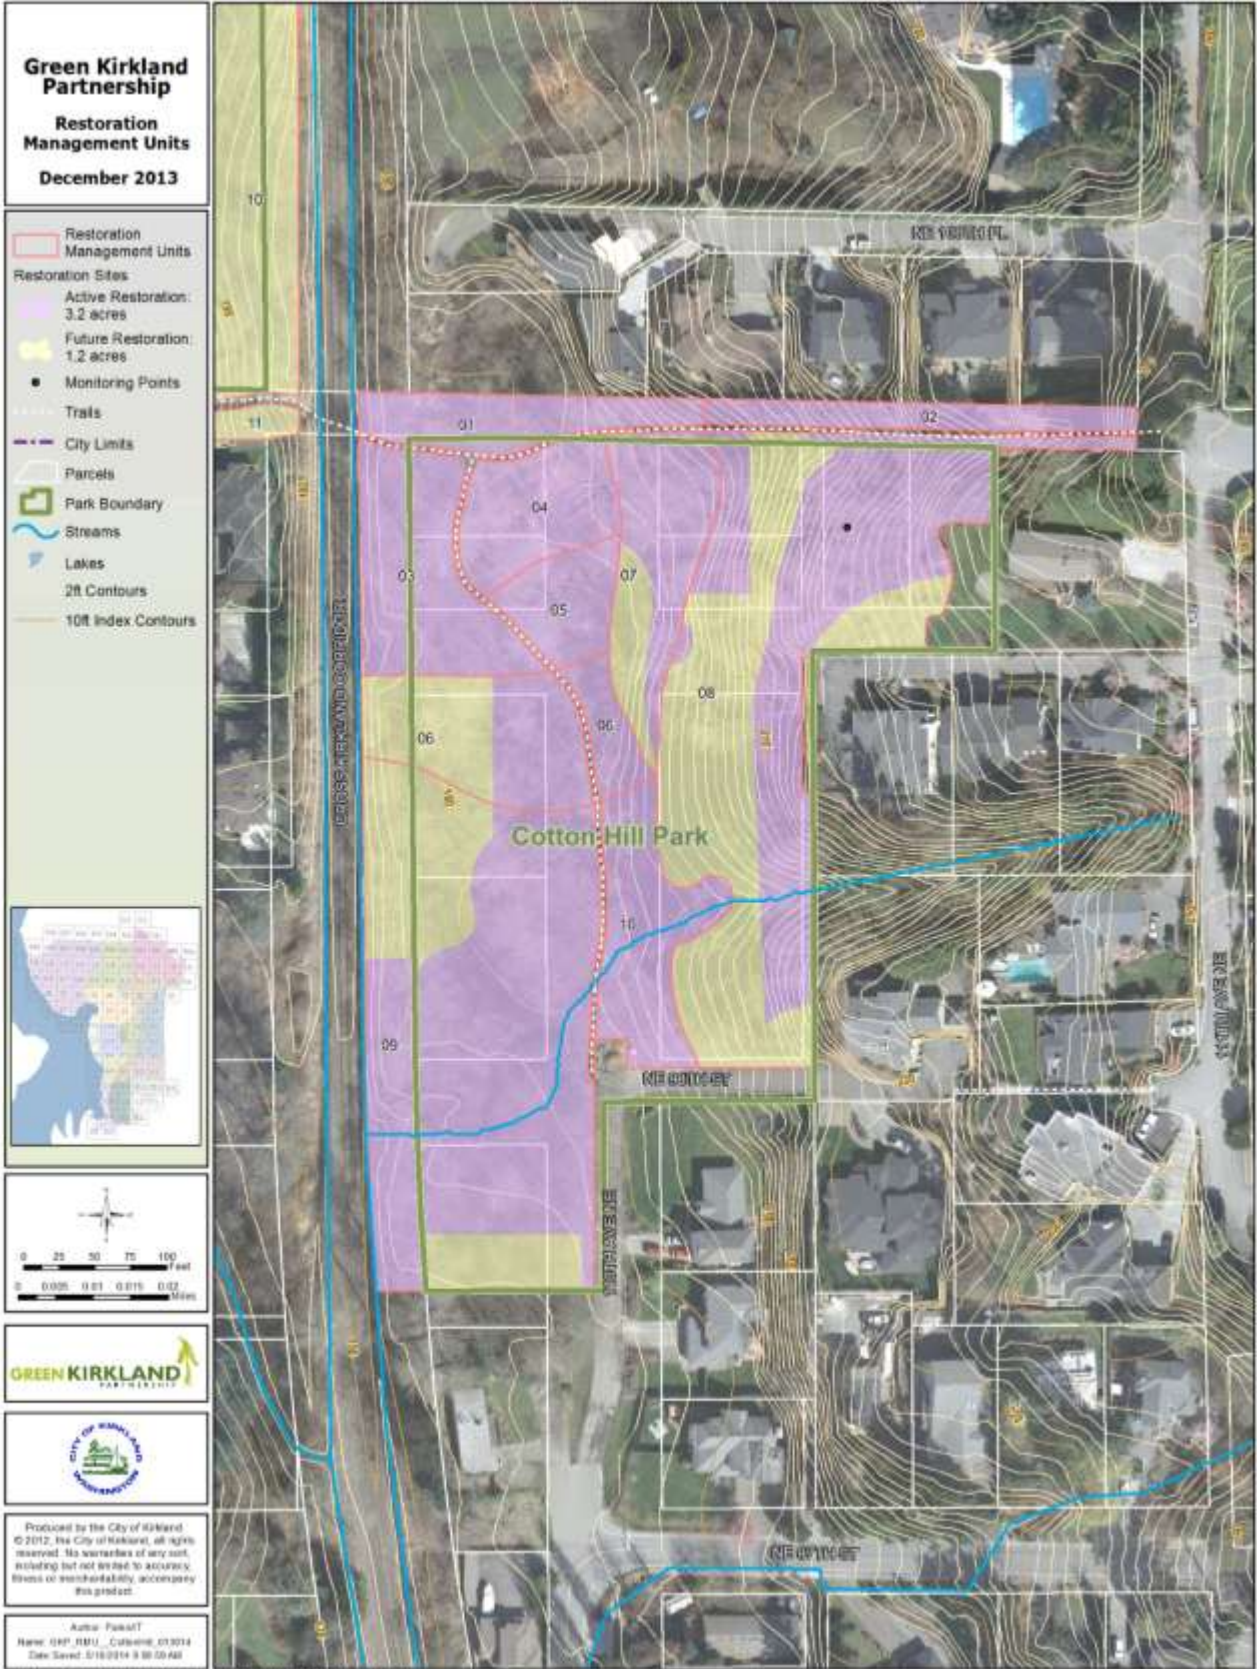
Figure 1. Restoration management units at Cotton Hill Park.

To help organize stewardship efforts and to provide a spatial reference, Cotton Hill Park has been divided into ten restoration management units. These management units were established based on a number of factors including soil characteristics, native vegetation communities, hydrology, disturbance history, and landmark features such as trails.

Hardscape, landscaped and open water areas were excluded, as these areas are not suitable for restoration activities. Figure 1 shows the location, extent, and restoration status of the management units at the park. As of the end of 2013, 3.2 acres of a total of 4.4 acres of parkland and surrounding right-of-way areas had been enrolled in restoration—note that the area targeted for restoration include several right-of-way areas in and around the park that are not included in the official total park acreage.

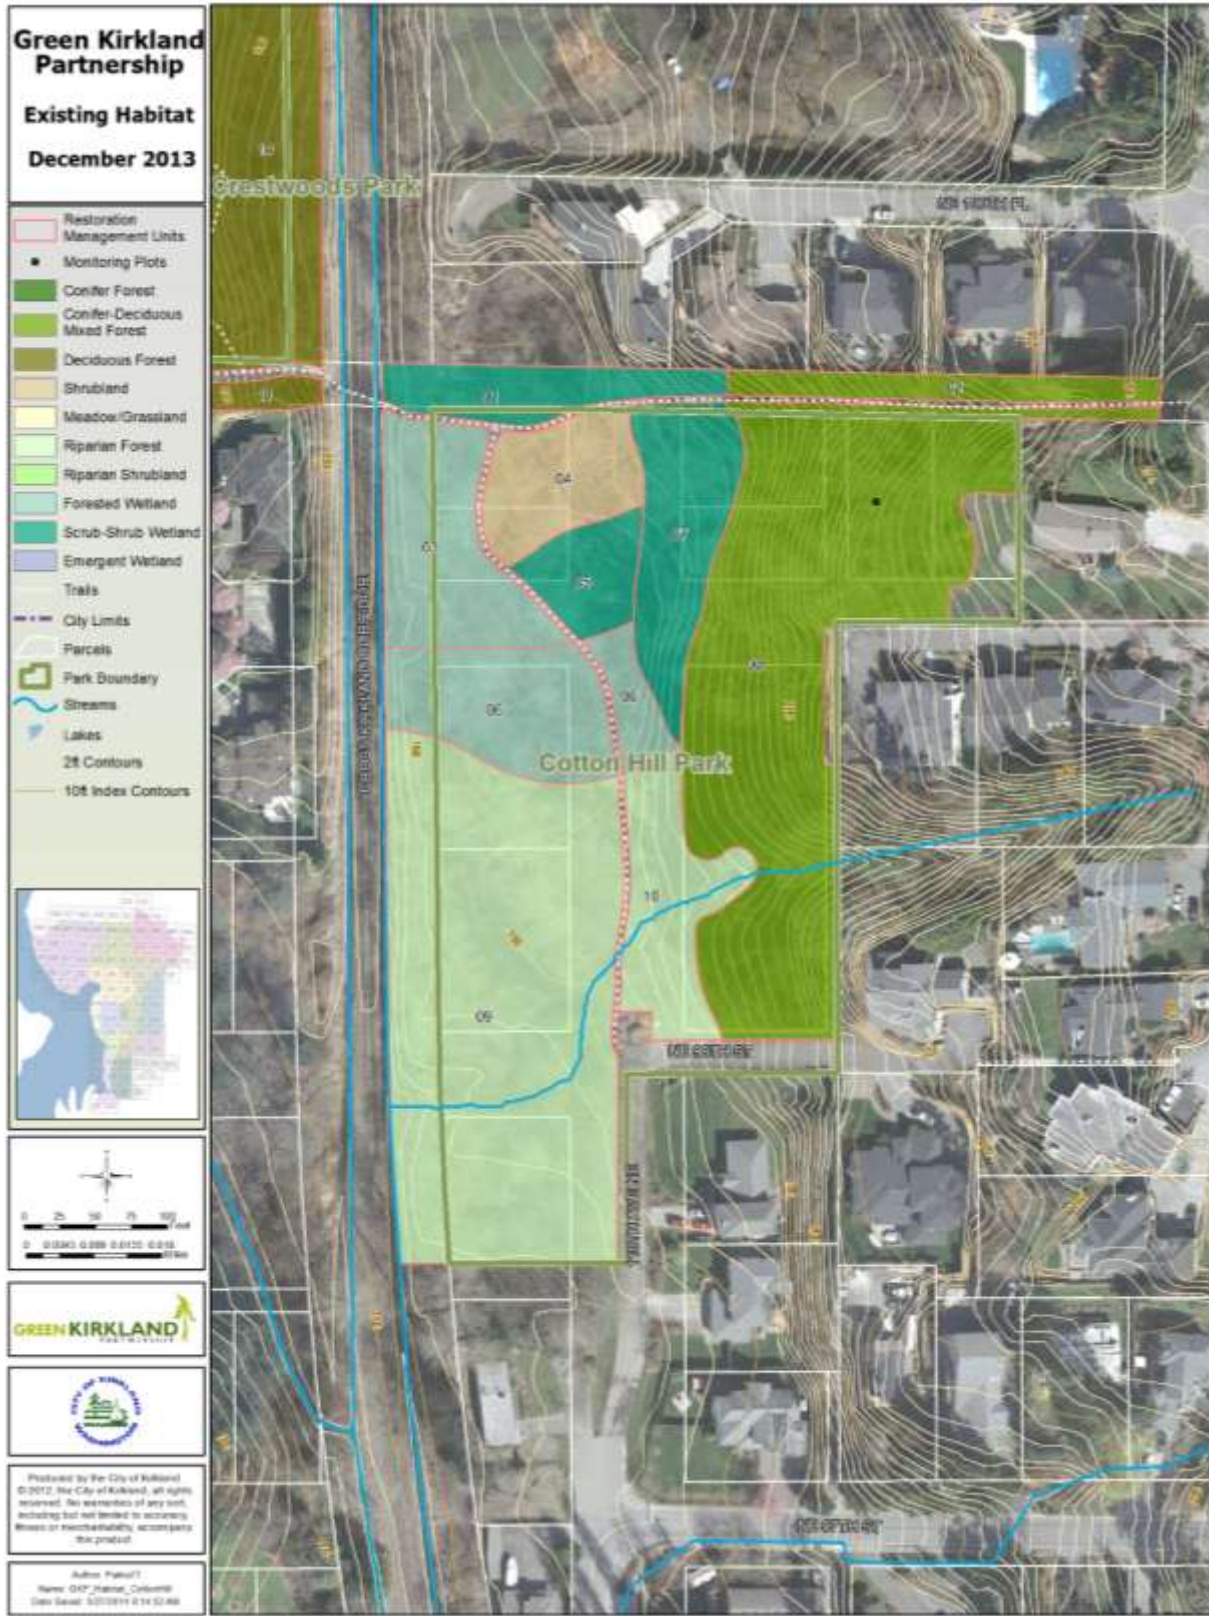
Figure 2. Existing habitat types at Cotton Hill Park

The general site characteristics are summarized in Table 1. The eastern half of the park consists of a relatively steep west-facing slope with mixed conifer-deciduous forest cover. The topography then flattens out, with deciduous forested and scrub-shrub wetland habitats dominating the low-lying western half of the park (Figure 2). Coarse woody debris cover is low in most management units, and there are few snags in the park.

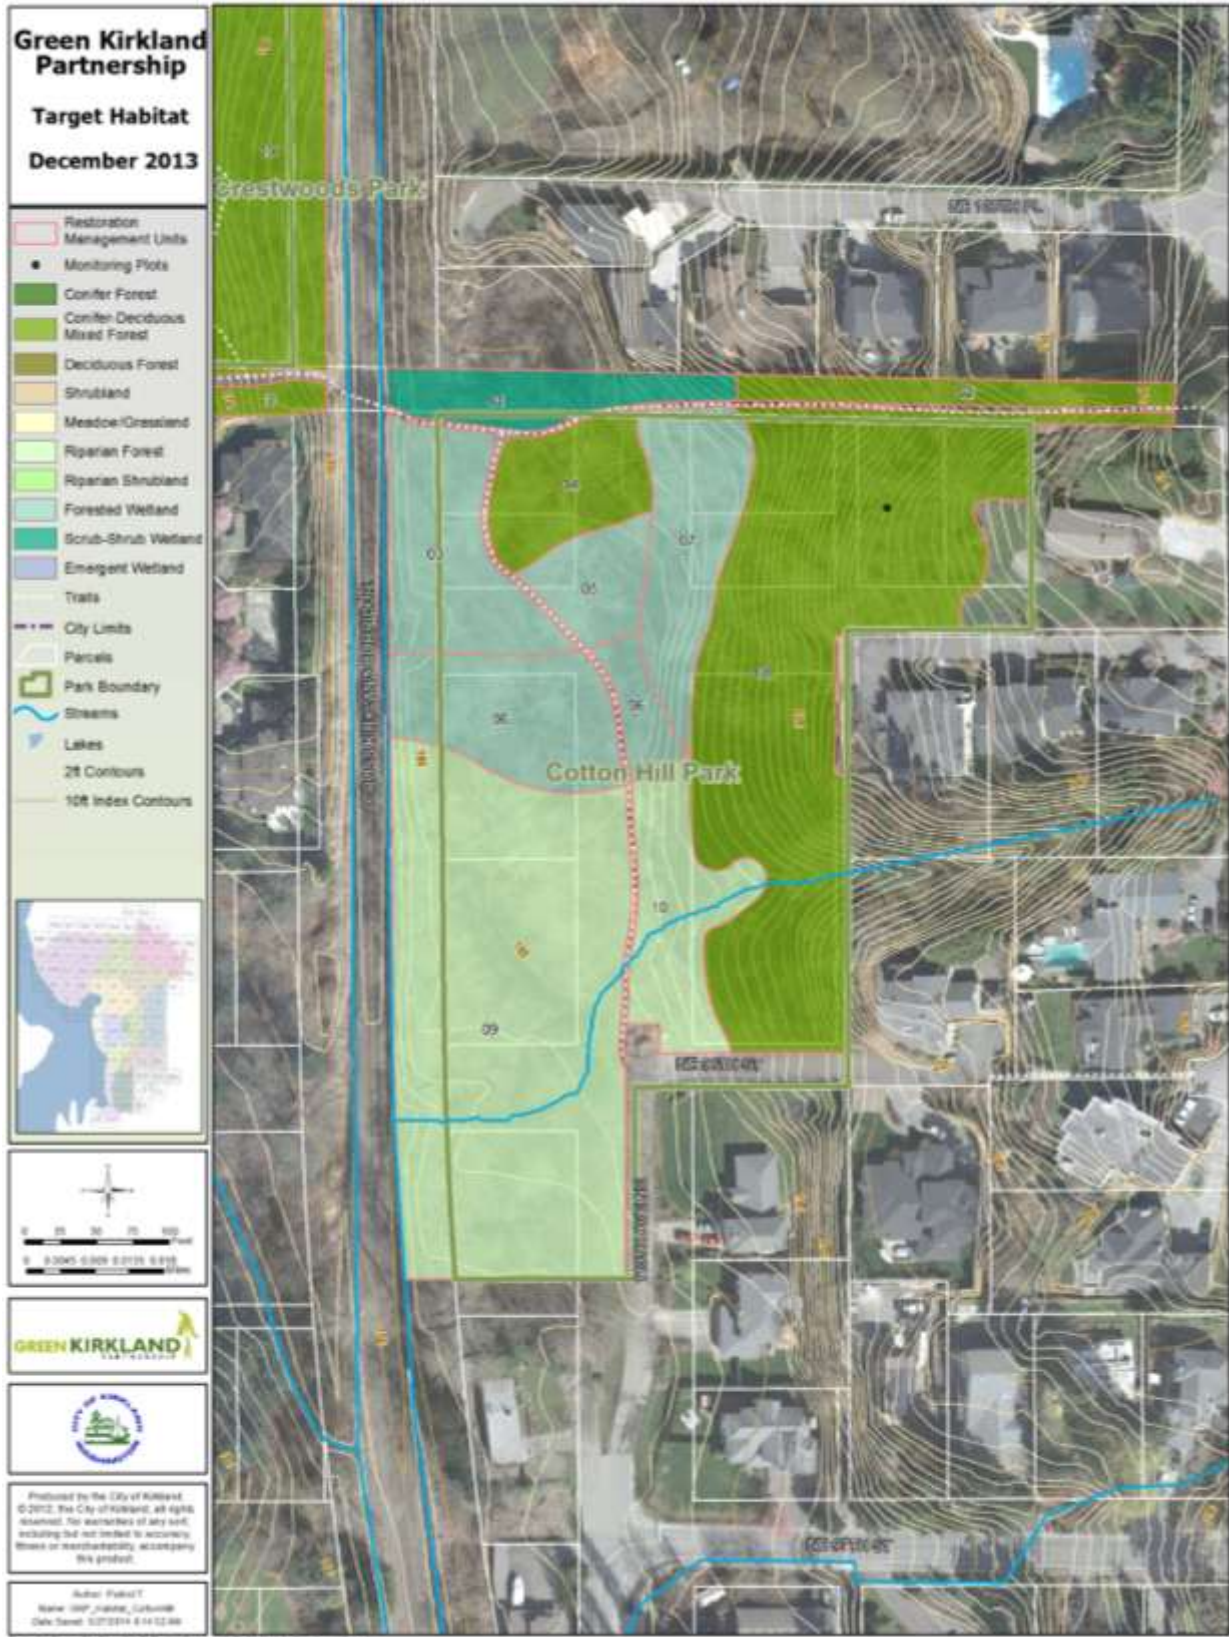
Figure 3. Map of target habitat types at Cotton Hill Park.

The target habitat for this area is conifer-deciduous mixed forest (Figure 3). All of management unit 02 has been enrolled in restoration, and most of 08 should be in restoration by the end of 2014. Work along steep slopes in management unit 08 are being done mostly by professional crews, both for safety reasons, and because of the risk of triggering erosion. Volunteers should also avoid working in the vicinity of the drainage ditch—leave a 10 to 15 foot wide buffer on either side of the ditch. Remaining areas of 08 are accessible to volunteers to do restoration work. Management recommendations include:

The target habitat for management unit 01 is scrub-shrub wetland (Figure 03). All of this unit has been enrolled in restoration. However, cover of non-native invasive plant species is still significant. Recommendations for this area include:

This area appears to be drier than the surrounding management units. The target habitat is conifer-deciduous mixed forest (Figure 3). All of management unit 04 has been enrolled in restoration. Extensive plantings has been installed, but invasive plant species cover remain significant. Recommendations for this areas is limited to continued control of invasive plants,

The target habitat for these areas is forested wetland (Figure 3). Except for part of management unit 07, these areas have been enrolled in restoration. Recommendations for these areas are similar to those for management units 03 and 06, with additional emphasis on planting trees.
