1029 MARKET STREET REDEVELOPMENT
HEIGHT VARIANCE | KIRKLAND, WA 08.19.2016

**RE: HISTORICAL BACKGROUND REGARDING SITE ELEVATIONS
1029 MARKET STREET PROPERTY
KIRKLAND, WASHINGTON
FARALLON PN: 1664-001**

**PHASE I ENVIRONMENTAL SITE ASSESSMENT
and
LIMITED PHASE II ENVIRONMENTAL SITE ASSESSMENT**

**1029 MARKET STREET
KIRKLAND, WASHINGTON 98033**

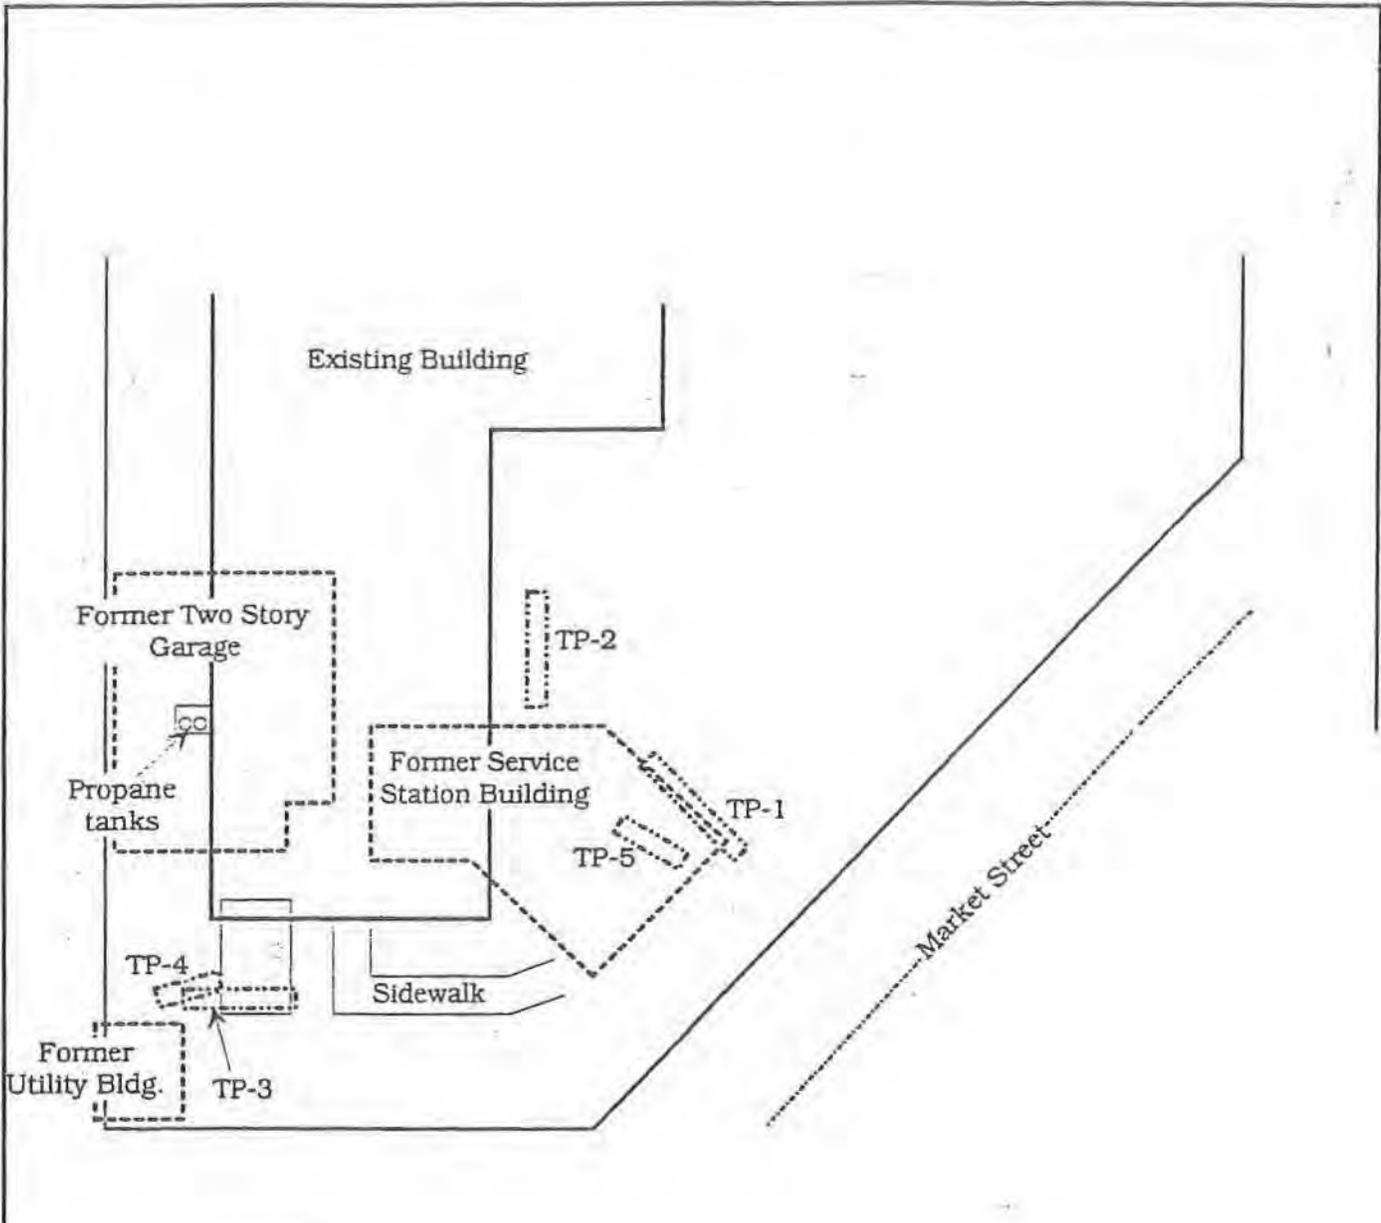
Figure 1 - Site Plan

Test pit TP-1 exhibited strong to moderate petroleum hydrocarbon odors and gray staining from within six inches of the surface to the maximum depth attained, approximately 10 feet below grade. The sample analyzed was selected from approximately 8 feet below grade. Test pit TP-2 was exhibited moderate petroleum odors, as well as other unidentified organic odors. The sample selected for analysis was from 6.5 feet below grade. Test pit TP-3 exhibited staining and petroleum odors from approximately 2 feet below grade. The sample analyzed was collected from 4 feet below grade.

While excavating test pit TP-3, a steel underground storage tank (UST) was discovered. The top of the UST was later exposed, in order to better characterize its dimensions, condition and contents. The UST is approximately 7.5 feet long, and 12 feet long, or of approximately 4,000 gallon capacity. The northernmost 2 feet of the tank are beneath the building. Upon exposing the top of the tank, a wood plug was encountered in a 2-inch port, and a 4-inch port was plugged with a threaded steel plug. The wood plug was removed, and we observed that the UST was completely filled with water. Only a slight sheen was in evidence on the water's surface.

No information on groundwater was obtained, and the lateral and vertical extent of contamination associated with former service station activities has not been assessed. The UST discovered on the site has apparently either leaked or overfilled to the extent that the soils surrounding the UST are impacted with gasoline-range petroleum hydrocarbons.

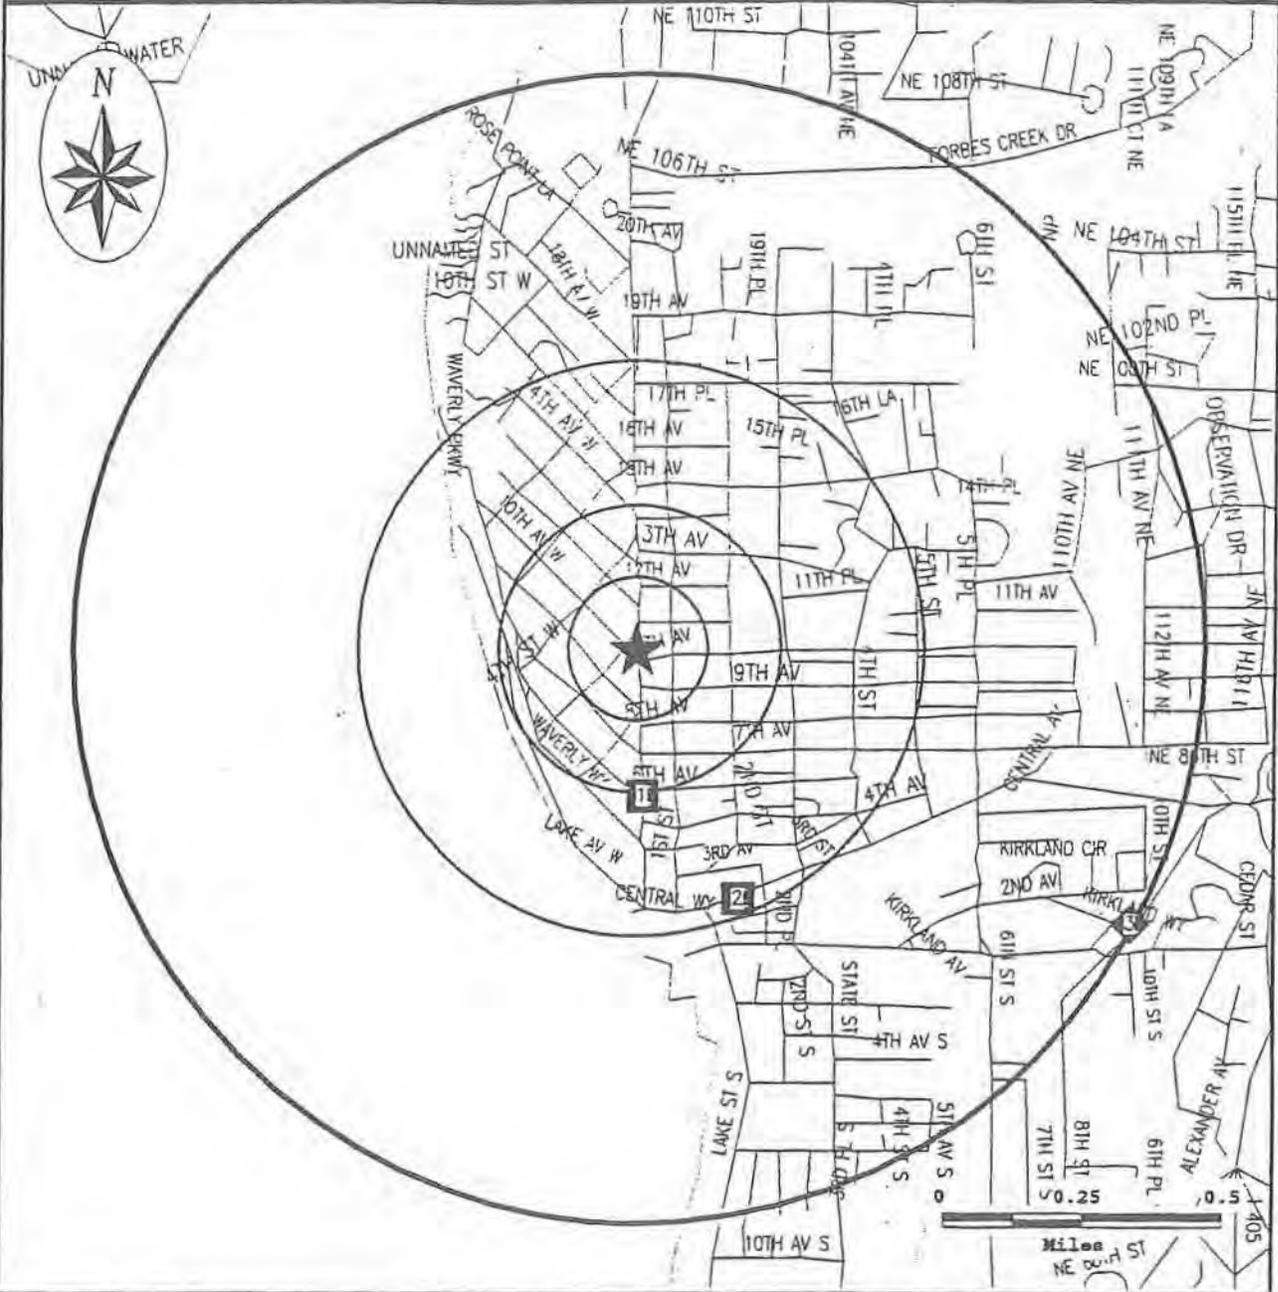
Map of Risks Within One Mile

B) RISK SITES searched to 1/2 mile:				
US EPA	CERCLIS	Sites under Review by US EPA	0	0
STATE	LUST	Sites with Leaking UnderGround Storage Tanks	0	2
STATE	SWLF	Sites permitted as Solid Waste Landfills, Incinerators, or Transfer stations	0	0

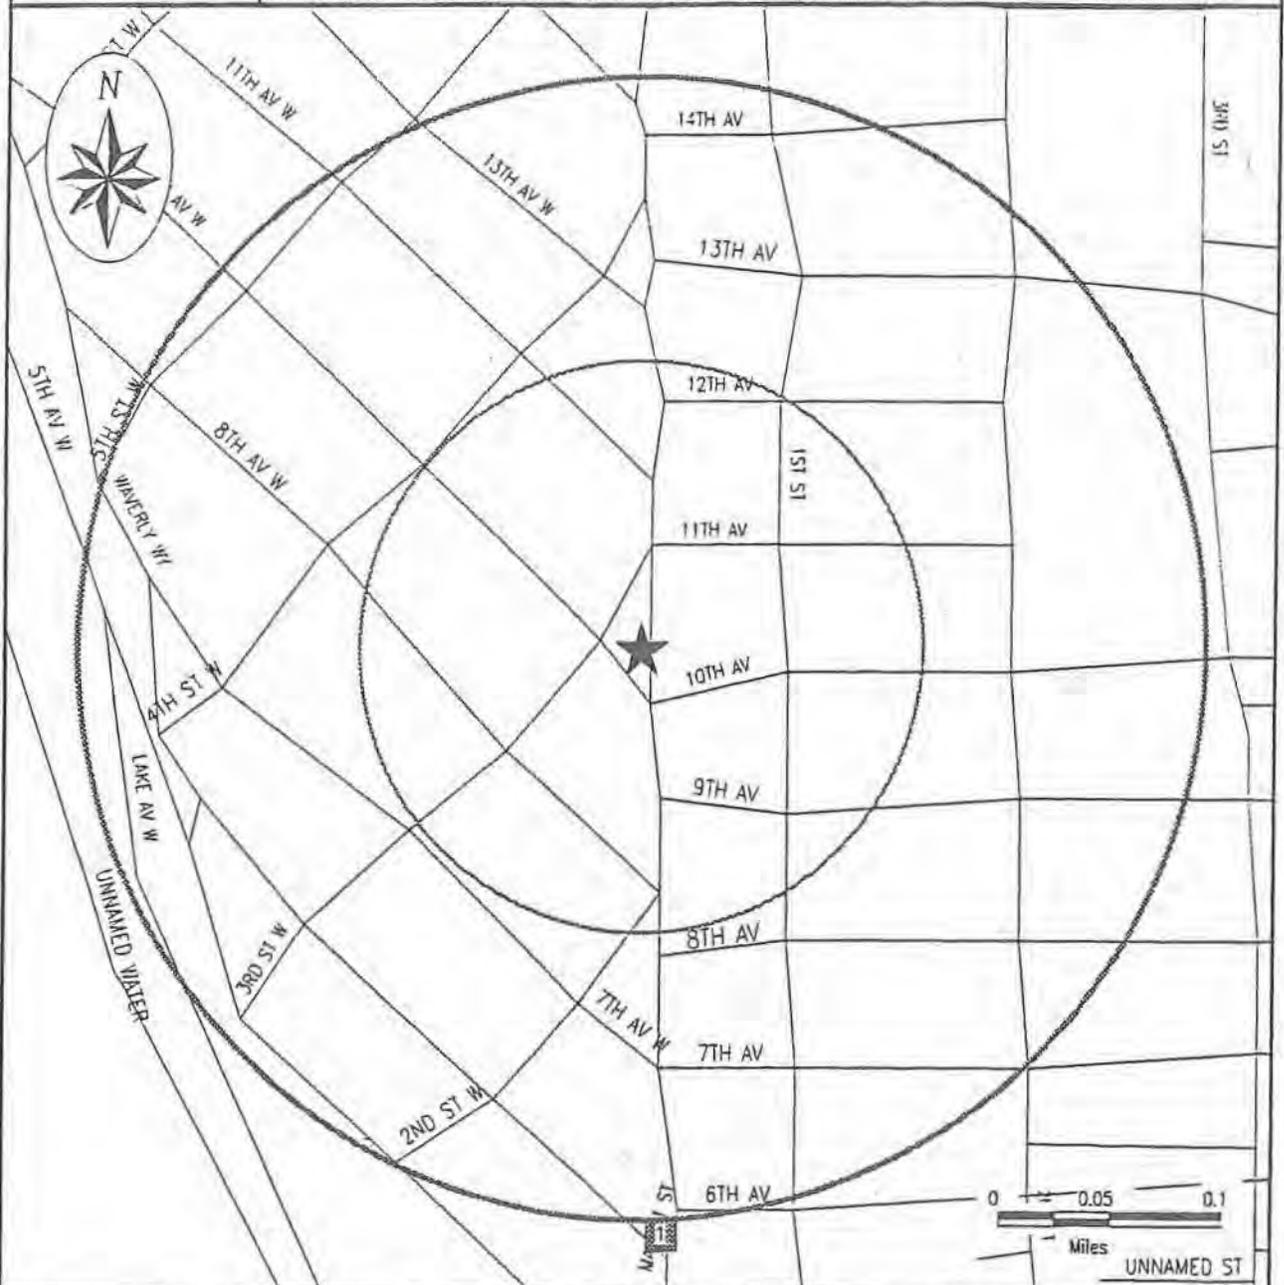
Map of Risks Within Quarter Mile

C) RISK SITES searched to 1/4 mile:				
STATE	UST	Sites with Registered Underground Storage Tanks	0	0
D) RISK SITES searched to 1/8 mile:				
US EPA	ERNS	Sites With Previous Hazardous Materials Spills	0	-
US EPA	RCRIS	Sites that Generate Large Quantities of Haz Waste	0	-
US EPA	RCRIS	Sites that Generate Small Quantities of Haz Waste	0	-
