DETERMINATION OF NON-SIGNIFICANCE (DNS)

Project Name: Bridlestone Estate Subdivision and Rezone

CRITICAL AREAS REPORT AND MITIGATION PLAN

**BRIDLESTONE ESTATES
DETAILED MITIGATION PLAN
EXISTING CONDITIONS**

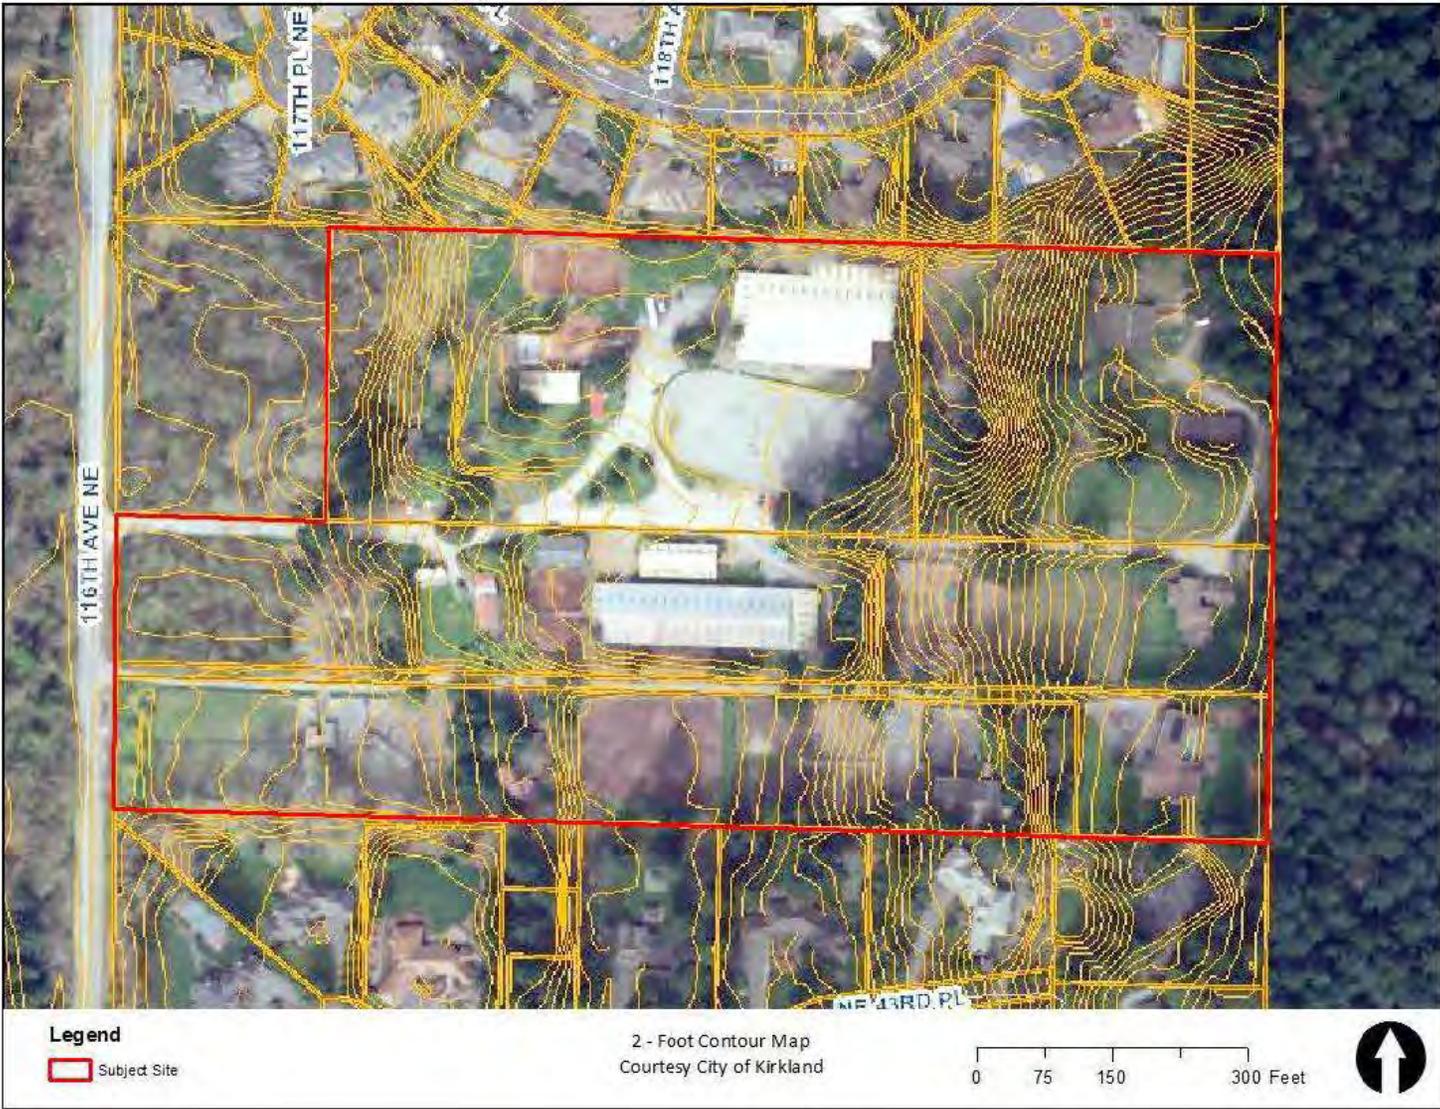
Figure 4: Topographic map of the project site.

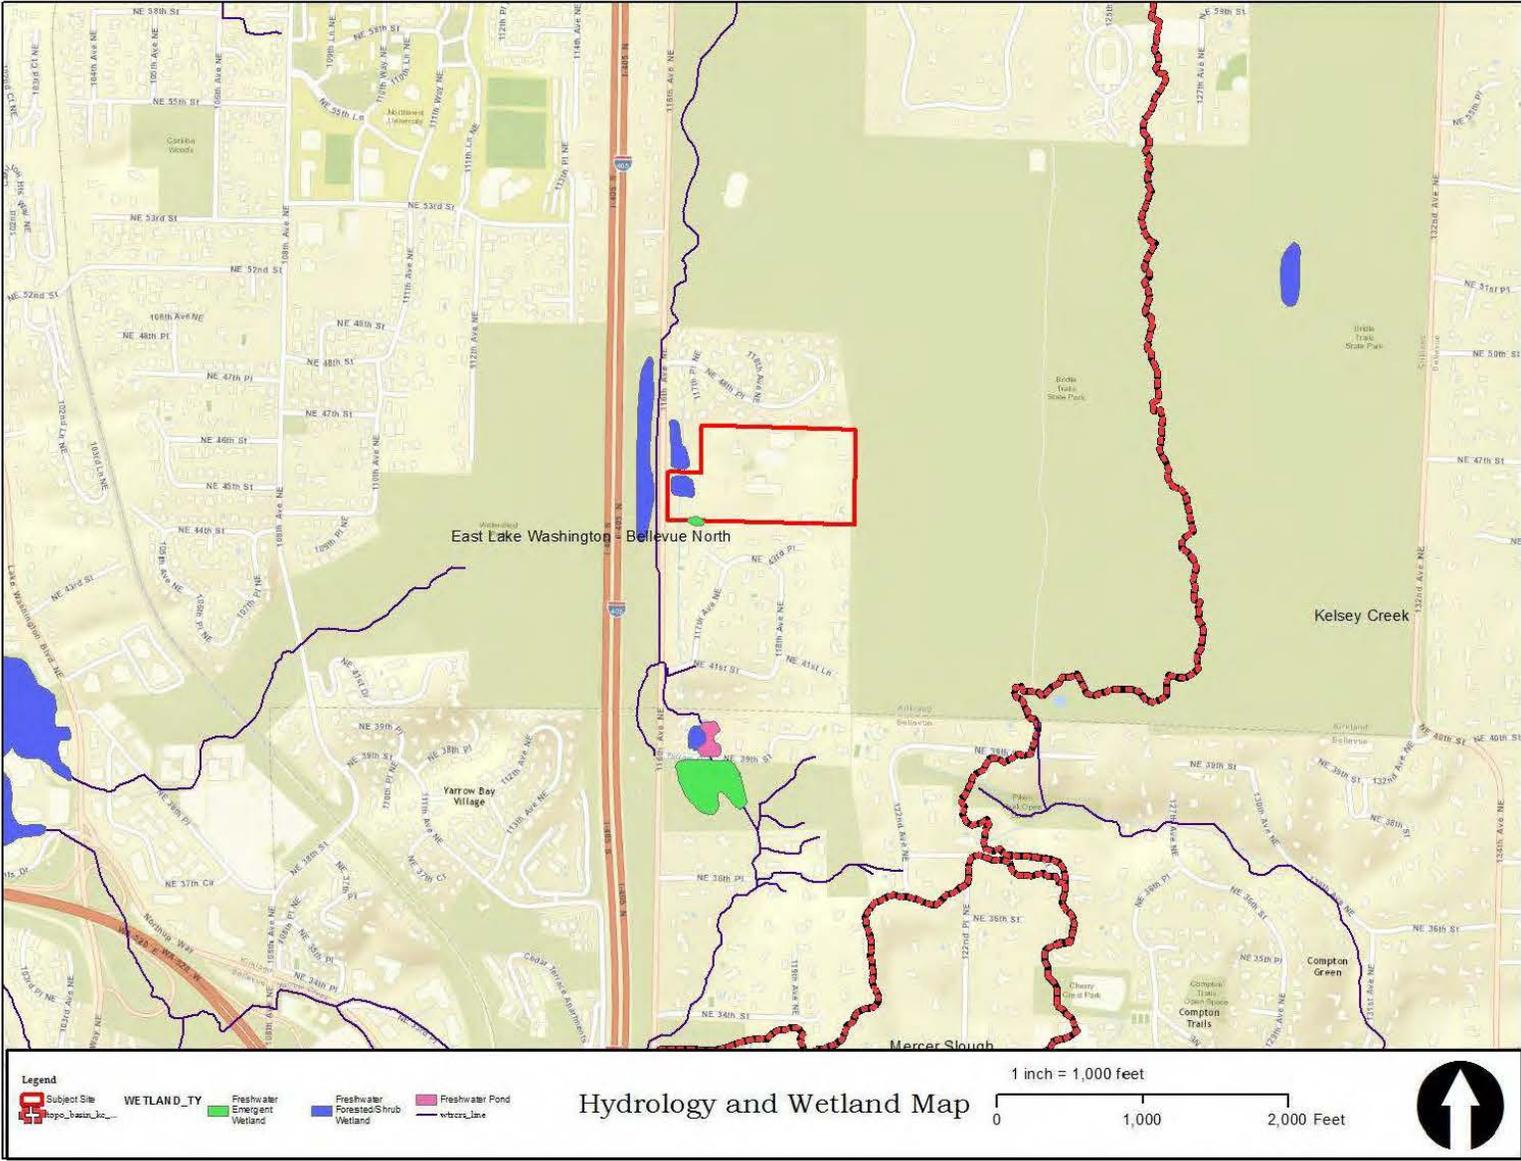
Figure 5: Watercourse and Wetland Map.

Yarrow Creek and associated Wetlands B and C continue off-site to the north and south. Wetland A extends off-site to the north and northeast. The off-site areas have been identified on the critical area map in Appendix A. These areas appear to be largely defined by the existing topography. Additional wetland areas have been observed on the west side of 116th Ave NE adjacent to the subject site. No other wetland or streams have been mapped within 300-feet of the subject site.

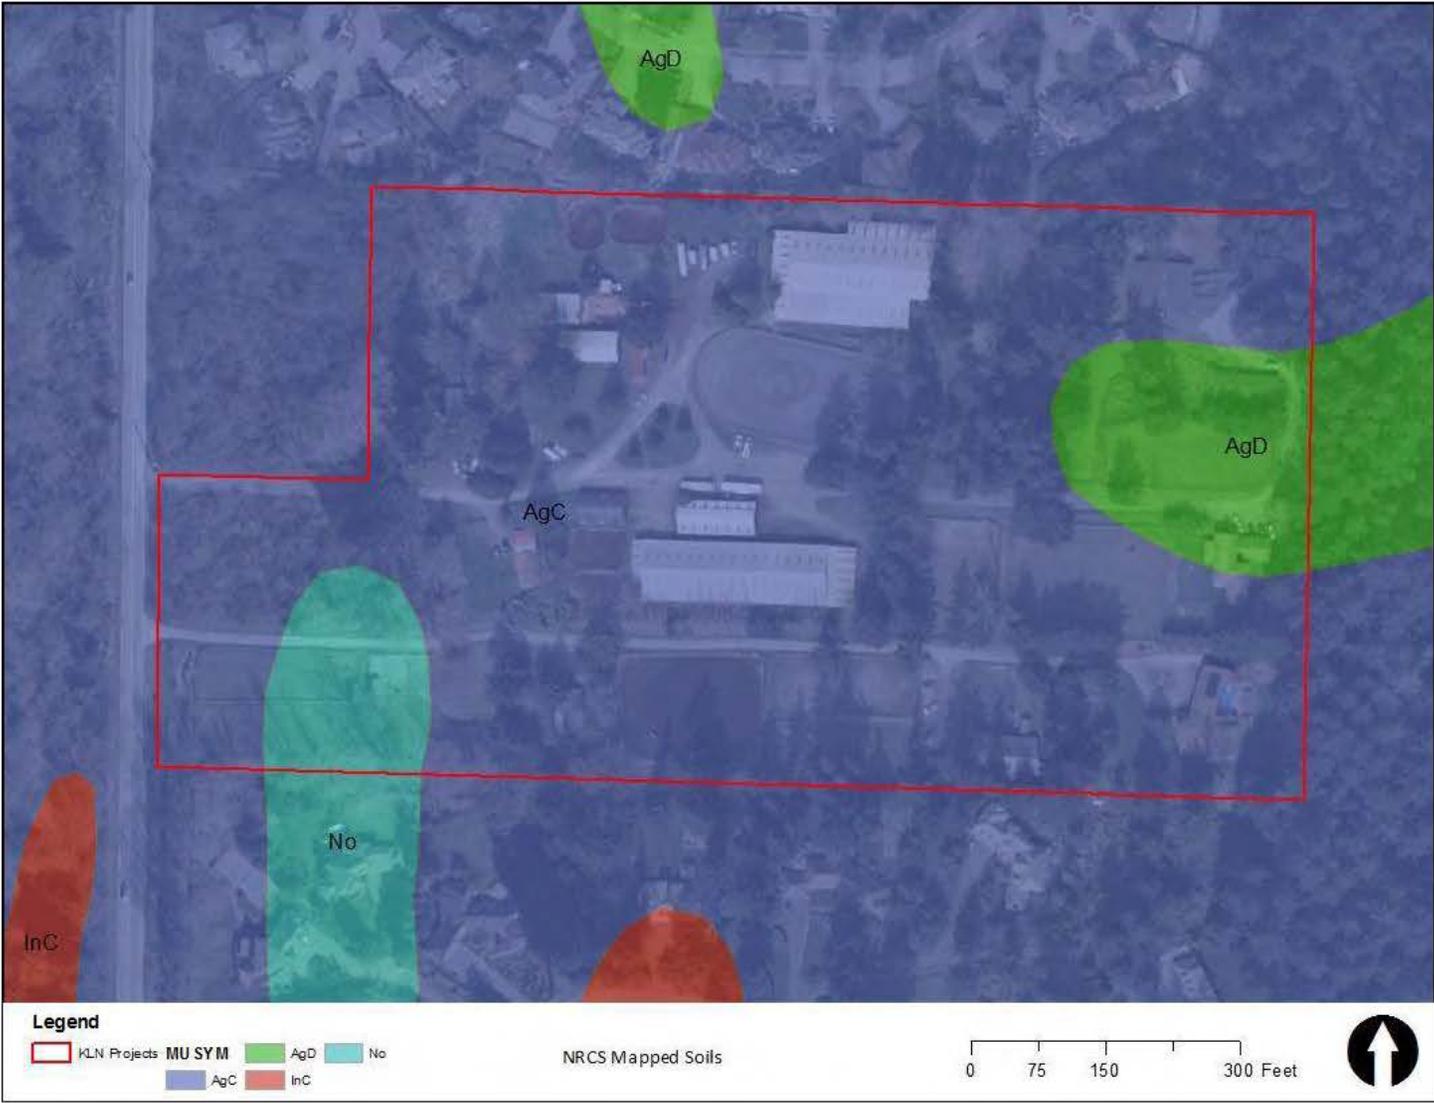
Figure 7: NRCS soil survey of the project area.

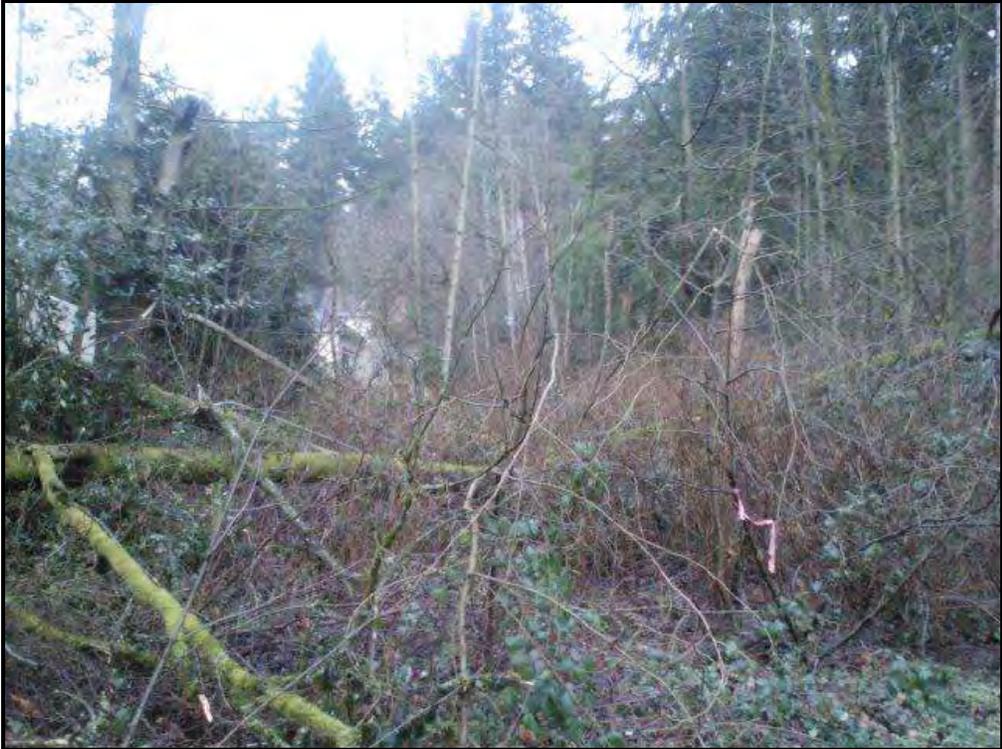
Figure 8: Existing conditions of Wetland A facing north off-site.

Wetland A provides moderate overall functions and values based on the size, location, and condition of the wetland system. Wetland A provides very good habitat and refuge for local wildlife. The wetland corridor connects to the Bridle Trails State Park, which is forested with mature trees and shrubs. The wetland provides low to moderate stormwater control functions, with limited area available for storage and detention. Wetland A provides moderate to high water quality improvement functions based on the opportunity (surface runoff received residential and agricultural sources) and ability to filter and infiltrate water with the existing vegetation and soil characteristics.

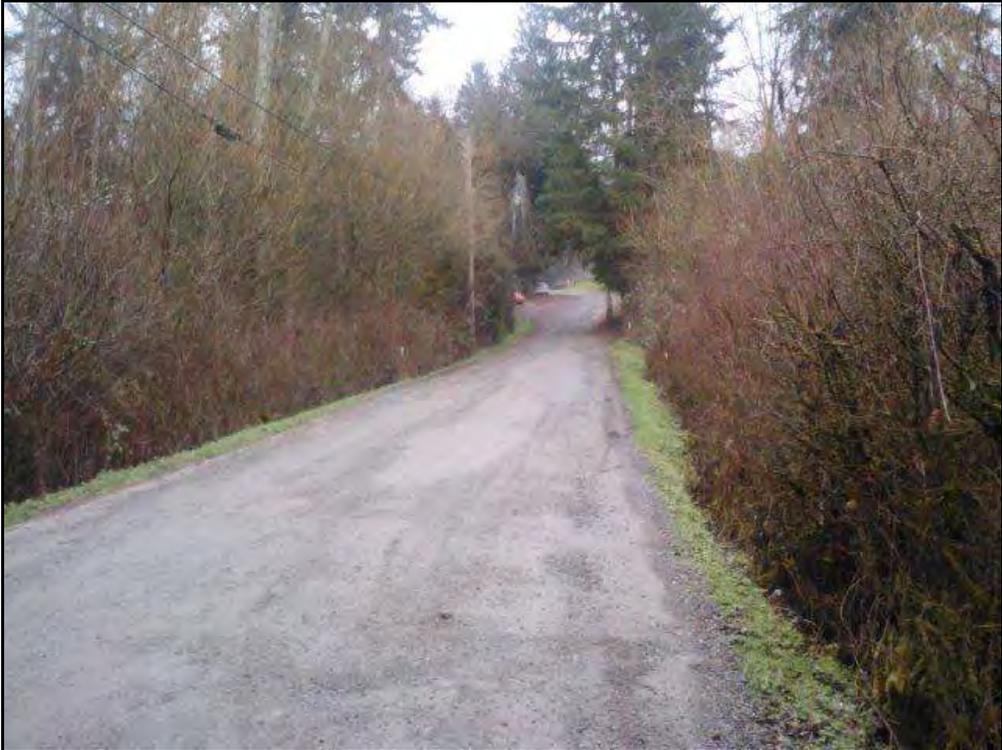
Figure 9: Existing vegetation gravel road bisecting Wetland B – wetland re-establishment area.

The wetland re-establishment area located where the existing northern access driveway will provide a net increase of existing wetland area on-site. The mitigation measures in this area will provide an excellent opportunity to connect a fragmented habitat and remove regular disturbance. The existing gravel road bisects wetland area and limits habitat functions within this area. The road is also a conveyance of impaired surface water runoff that includes turbid water (observed during site investigations) and water that is likely high in nutrients (assumed) due to local sources.

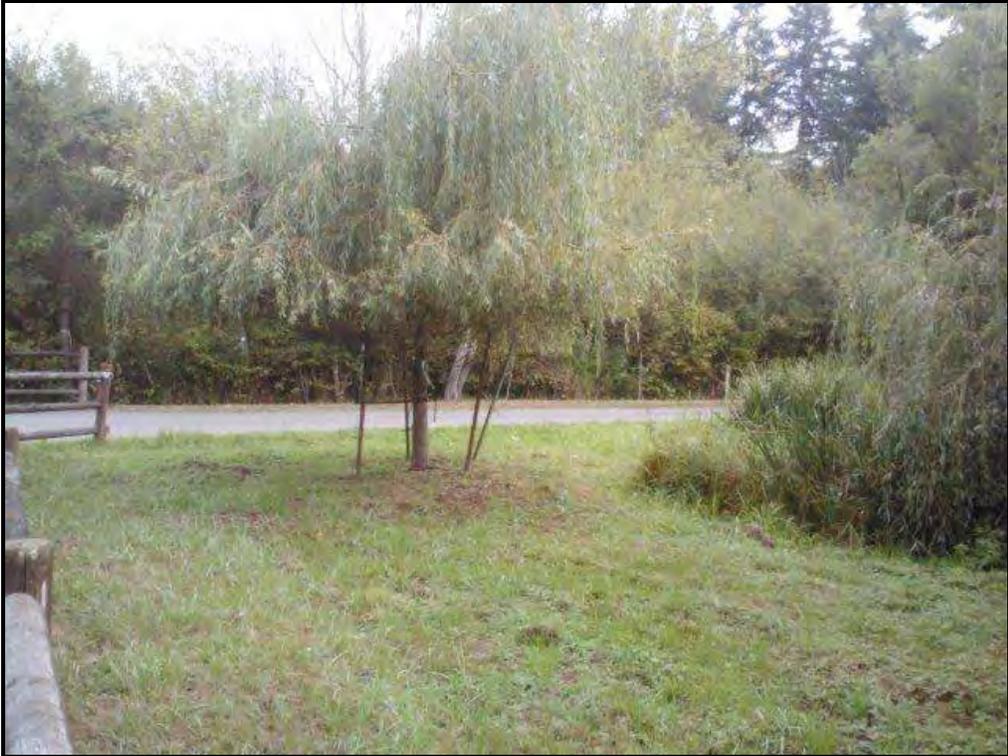
Figure 10: Existing vegetation community Wetland C facing north towards proposed road impact area.

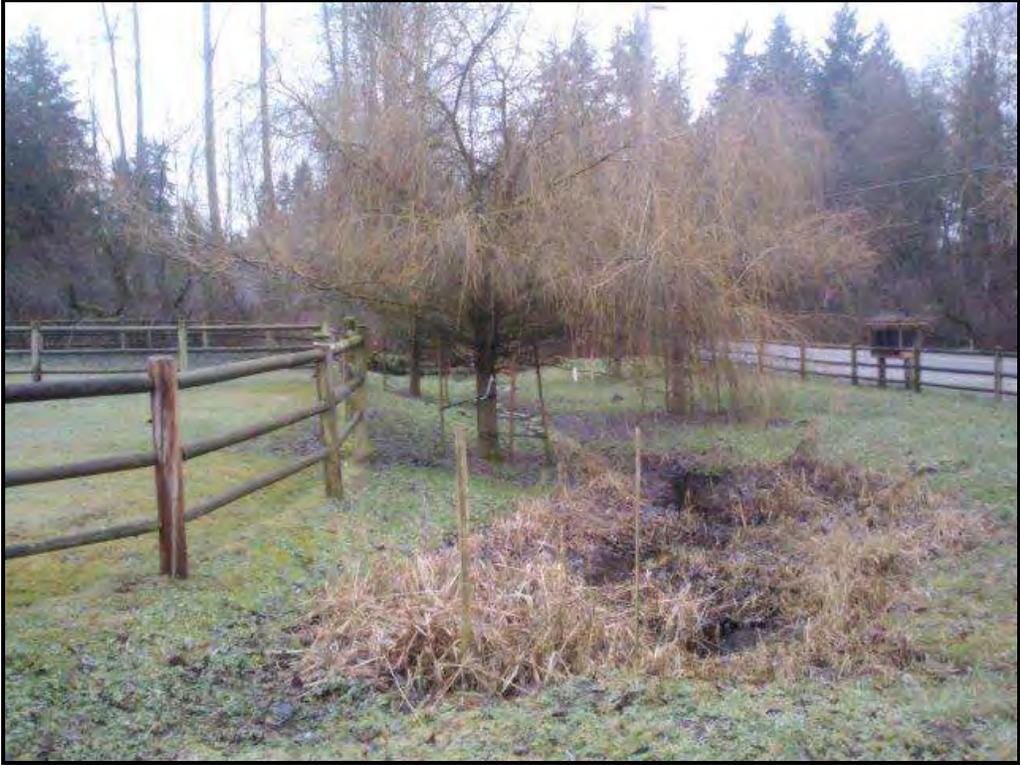
Figure 11: Existing vegetation community Wetland C facing south near proposed road impact area.

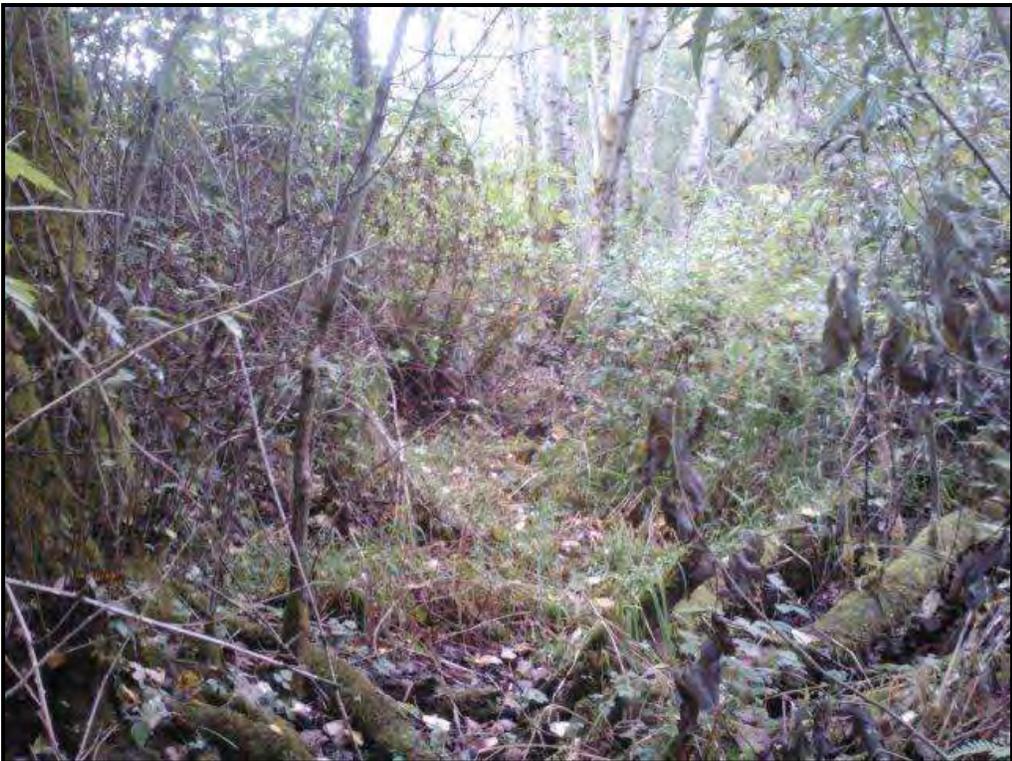
Figure 12: Off-site Wetland C connection.

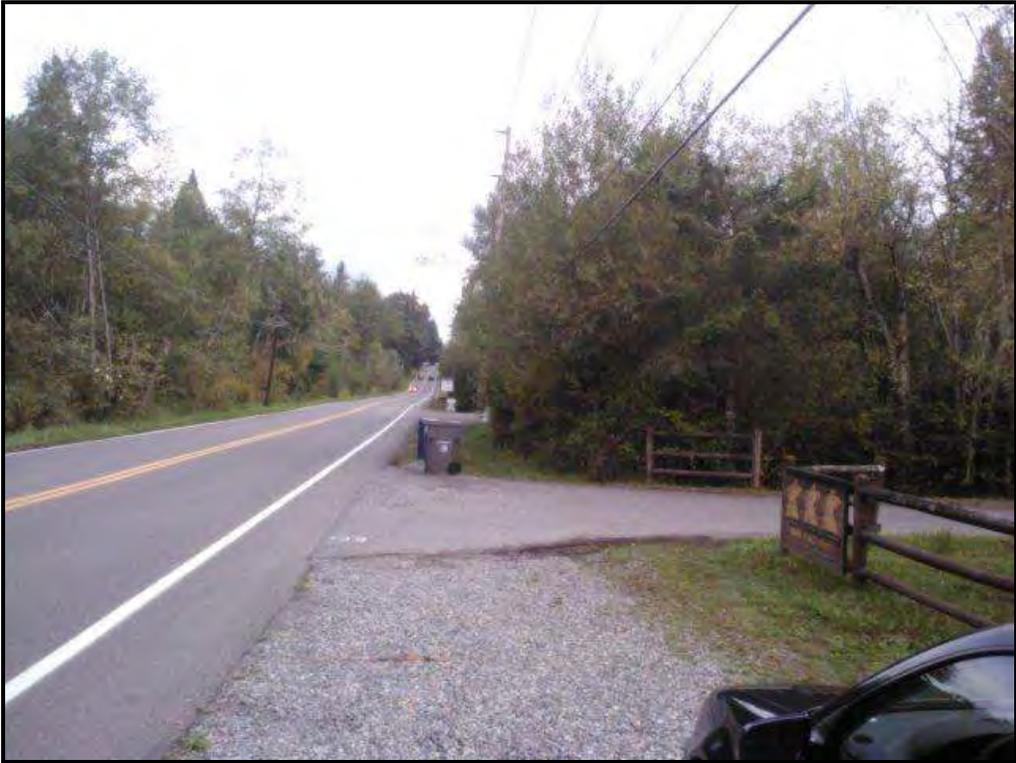
Figure 13: Existing road frontage conditions facing north along 116th Street

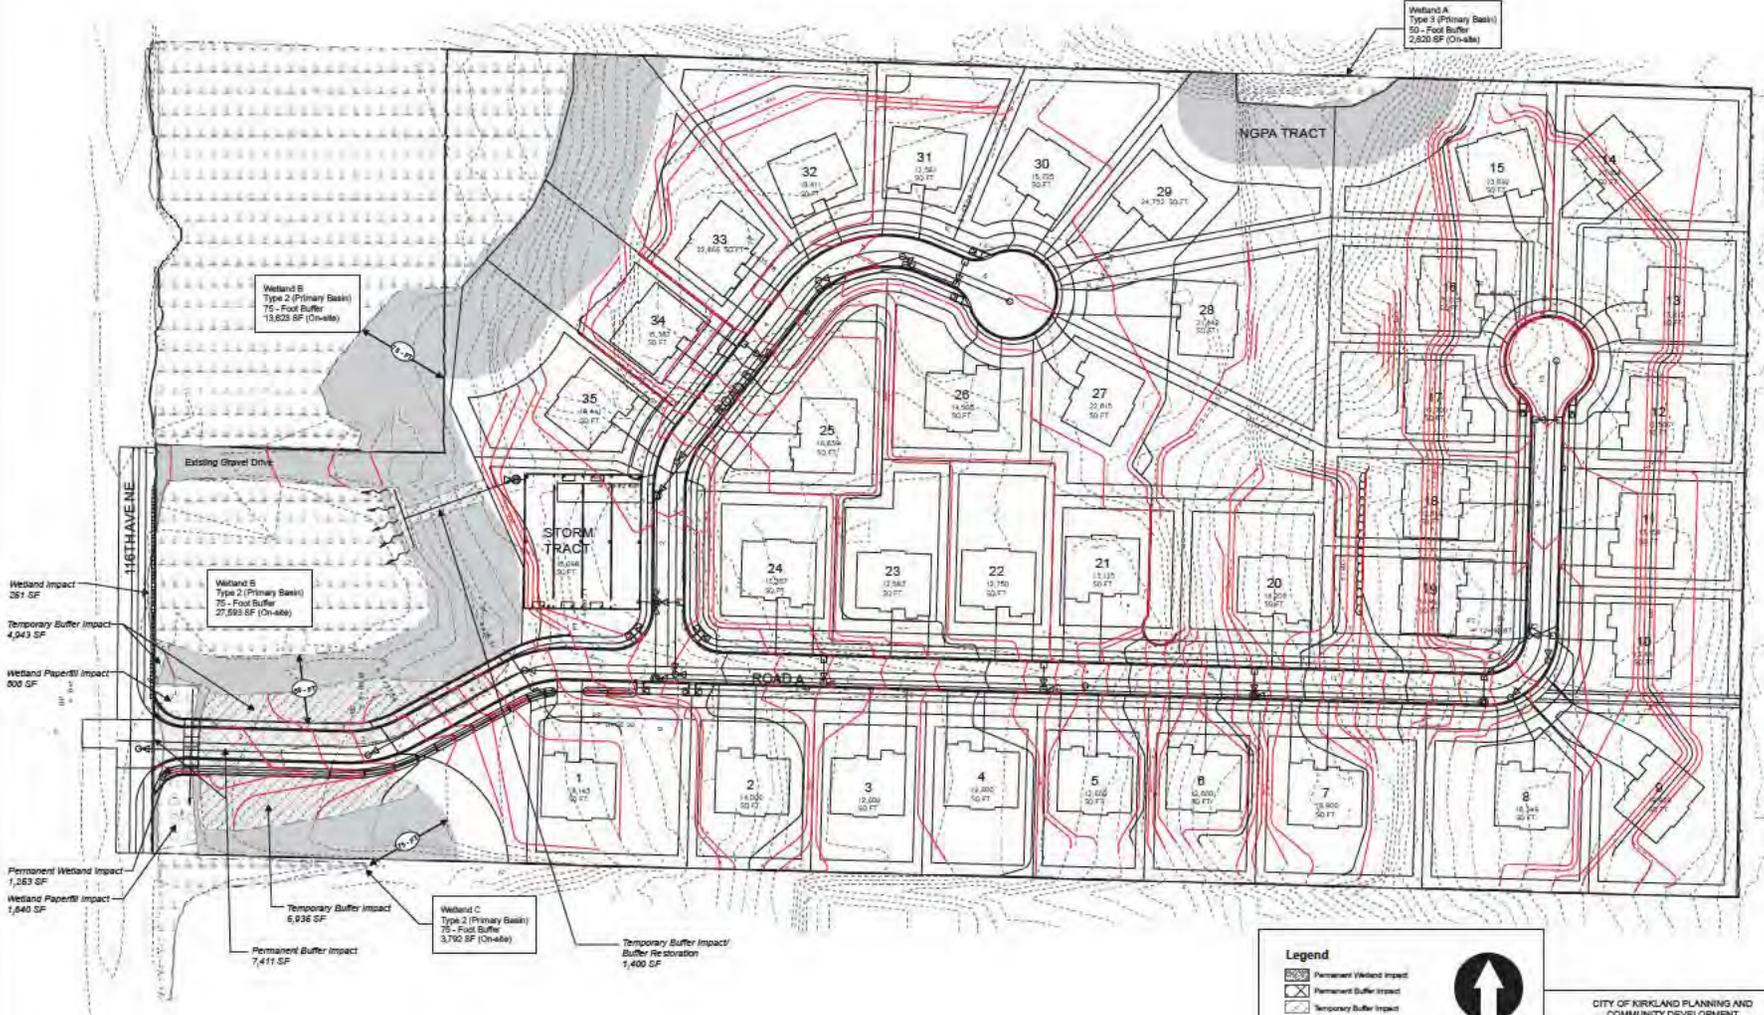
Wetland Impact 251 SF
Temporary Buffer Impact 4,943 SF
Wetland Paperfill Impact 800 SF
Permanent Wetland Impact 1,263 SF
Wetland Paperfill Impact 1,640 SF
Temporary Buffer Impact 6,936 SF
Permanent Buffer Impact 7,411 SF
Wetland C Type 2 (Primary Basin) 75 - Four Buffer 3,792 SF (On-Abn)
Temporary Buffer Impact/ Buffer Restoration 1,400 SF

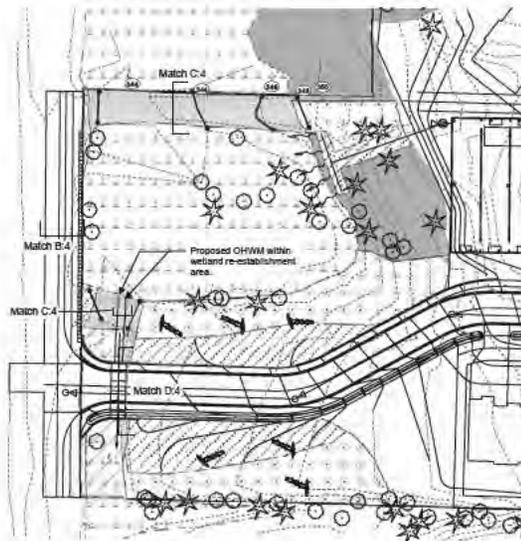
LARGE WOODY DEBRIS PLACEMENT & MITIGATION GRADING

Match A-4
Access Road Cross Section (From Triad Civil Plans Sheet 9 of 14)

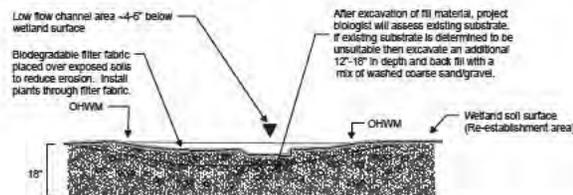
WETLAND RE-ESTABLISHMENT GRADING

Grading for the wetland re-establishment will follow the intent of the proposed grading within this plan. Field changes, where necessary, will occur with the approval of the project biologist.

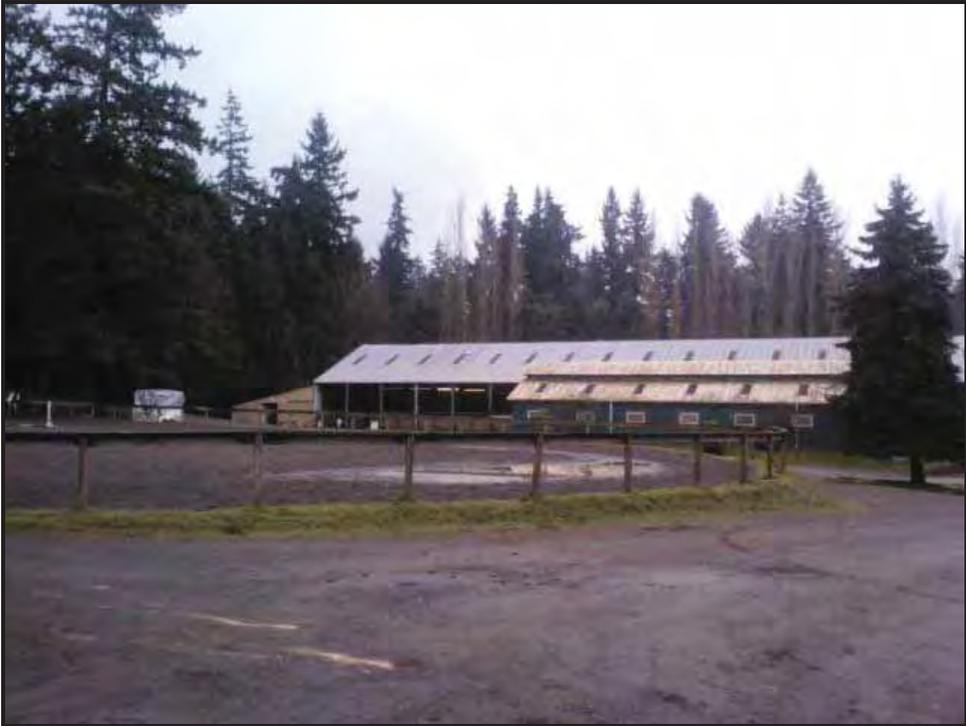
Figure 4: Existing conditions within riding area in the north-central portion of the site.

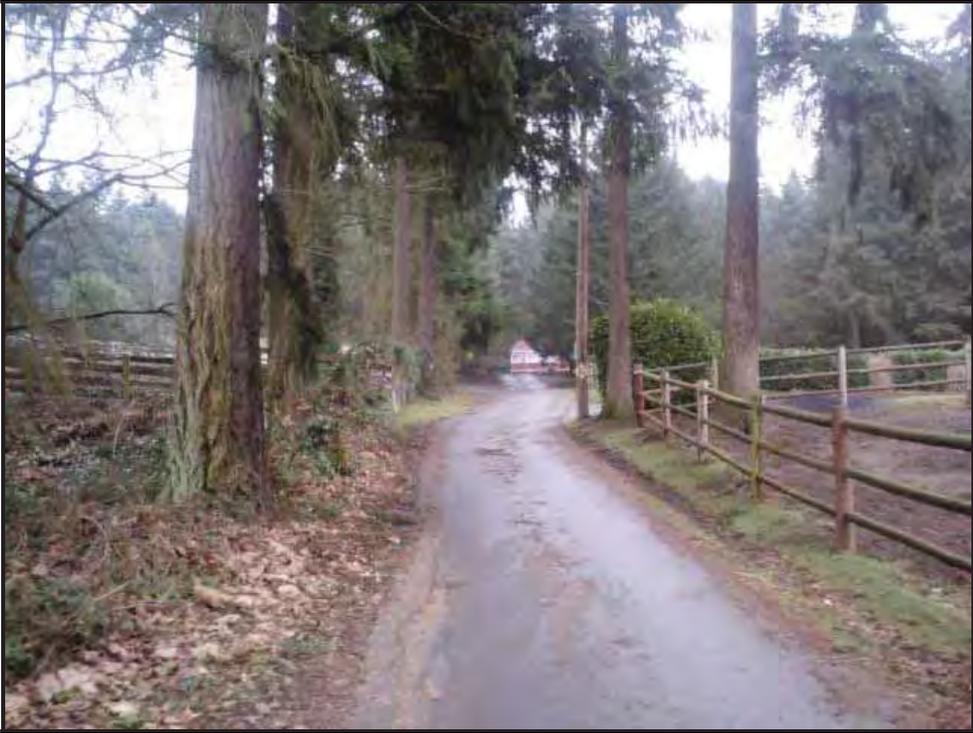
Figure 5: Typical conditions found along both existing access roads.

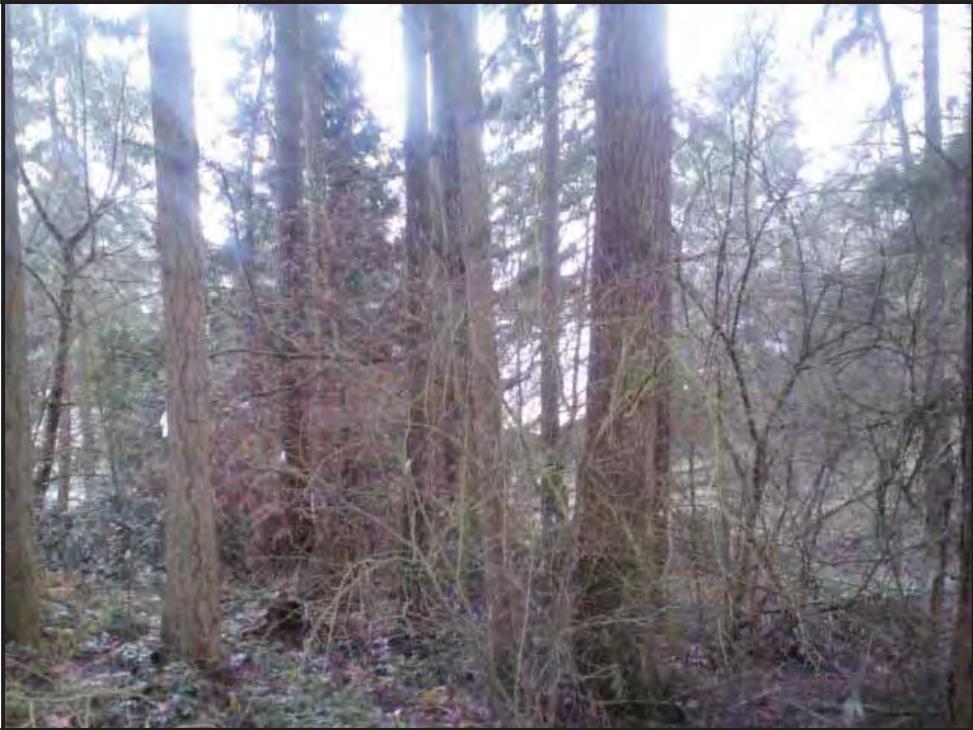
Figure 6: Existing trees within proposed save tree/open space tract.

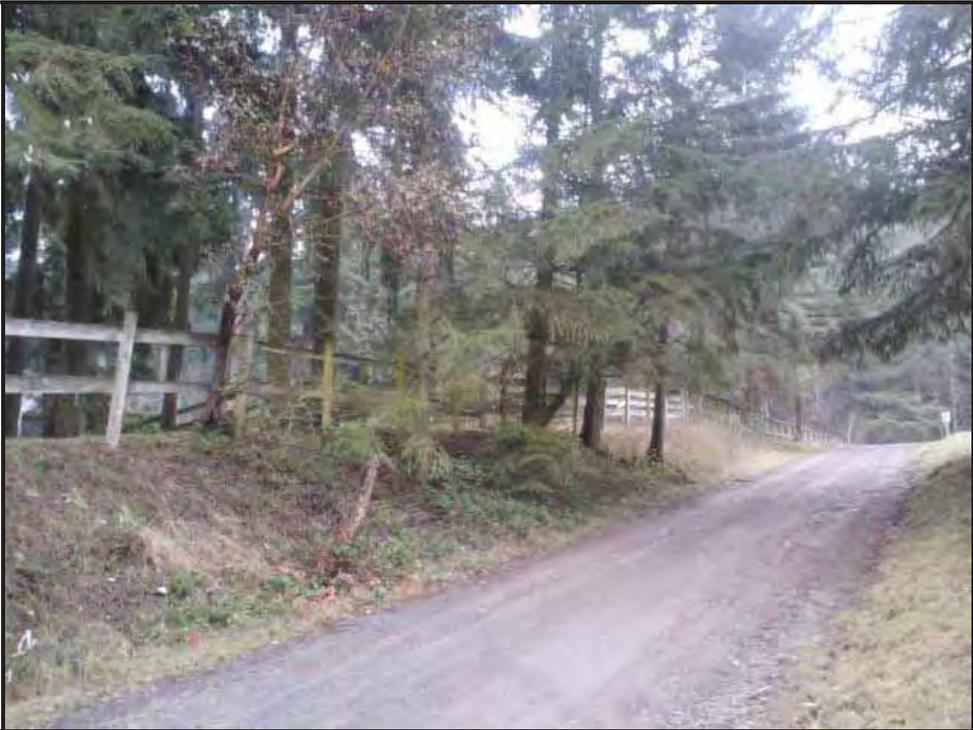
Figure 7: Existing conditions along south side of proposed save tree/open space tract.

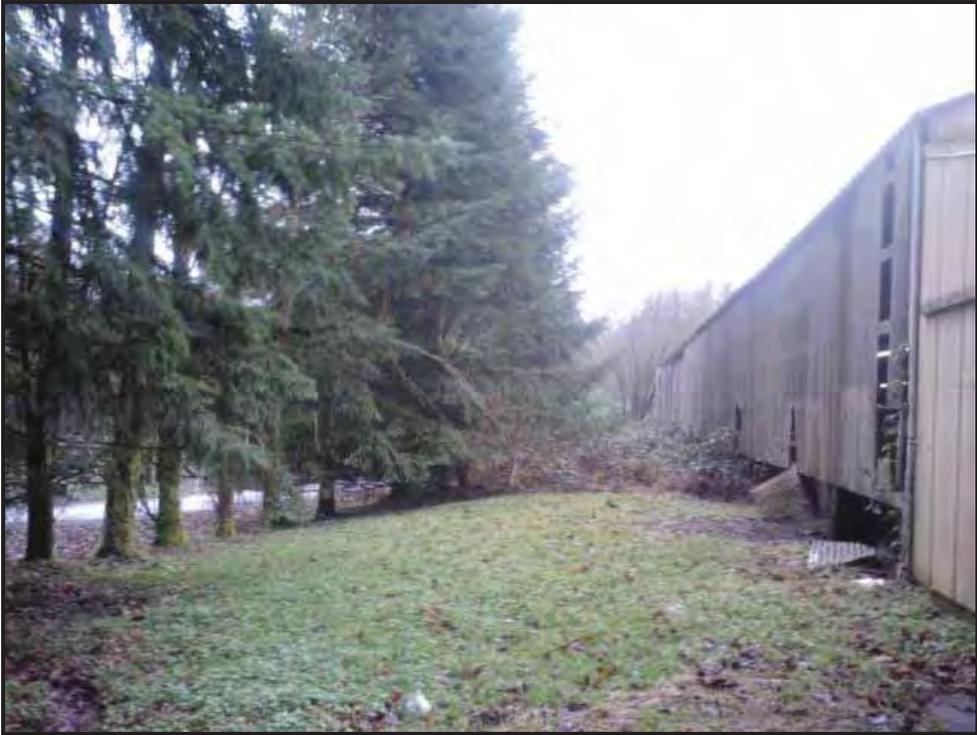
Figure 8: Typical conditions found throughout site. Structures, road, and invasive plants.

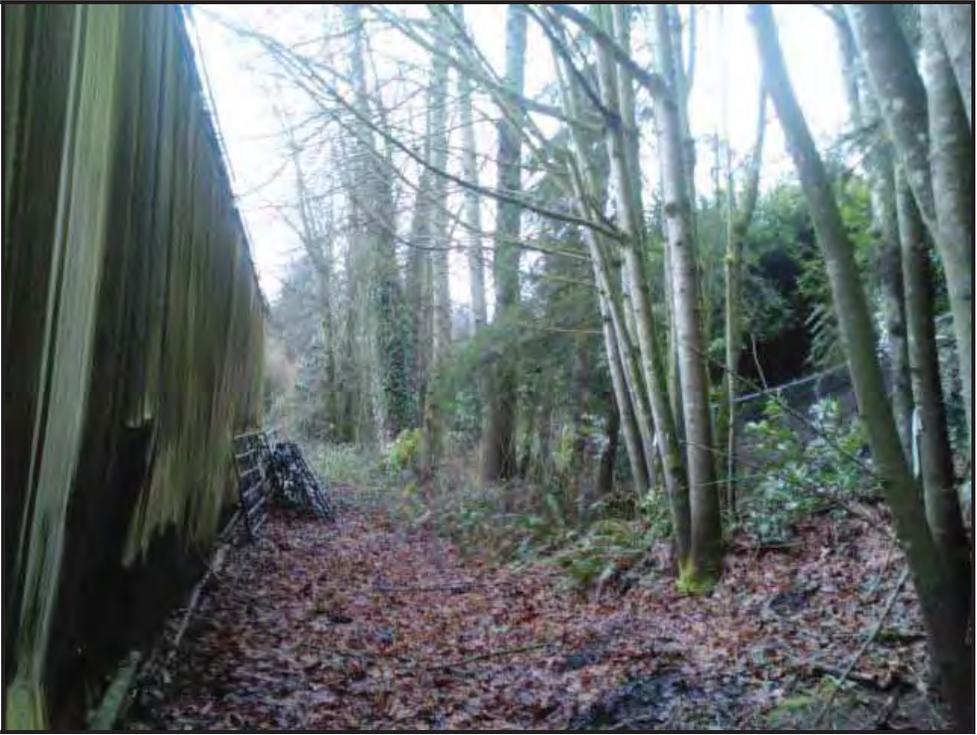
Figure 9: Proposed save trees along north property line.
