ENCLOSURE 1
DIRECTOR'S DECISION

Application for Variance

The purpose of this document is to explain the details associated with the current status of the property located in 10230 111TH AVE NE, Kirkland WA 98033.

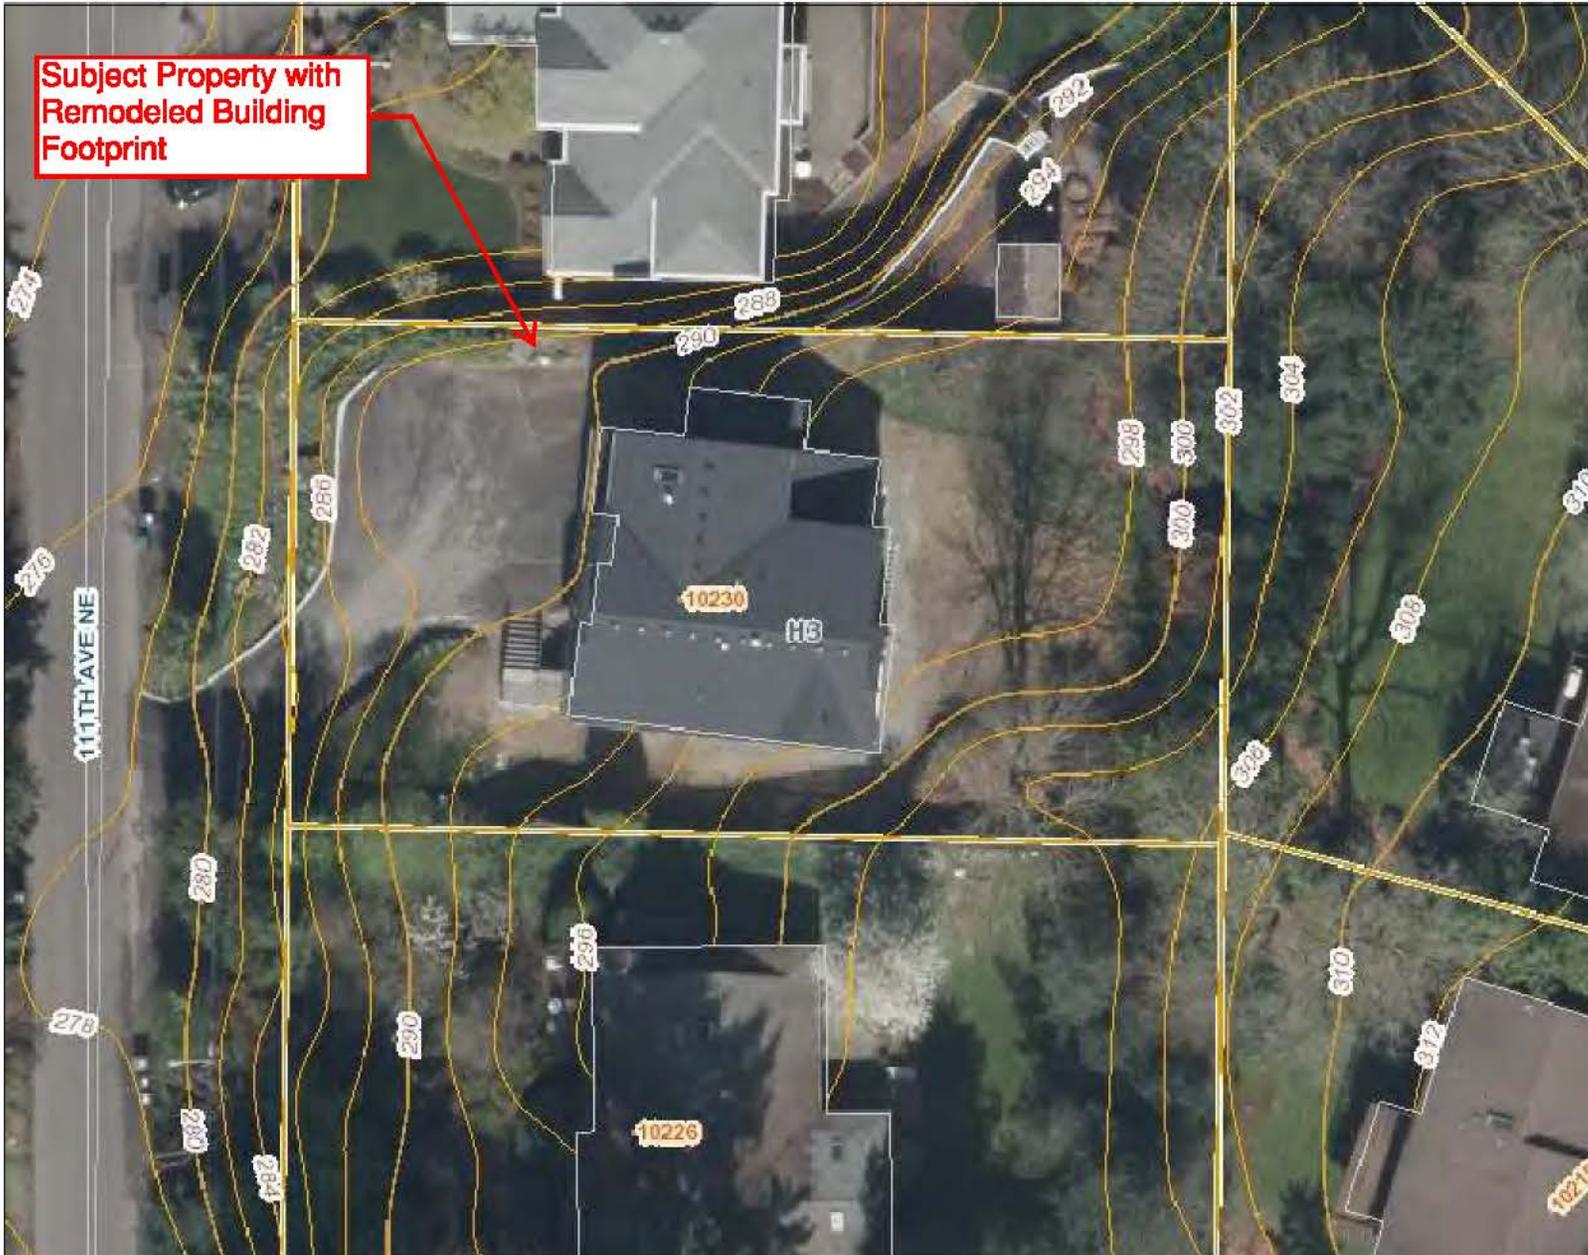
Subject Property with
Remodeled Building
Footprint

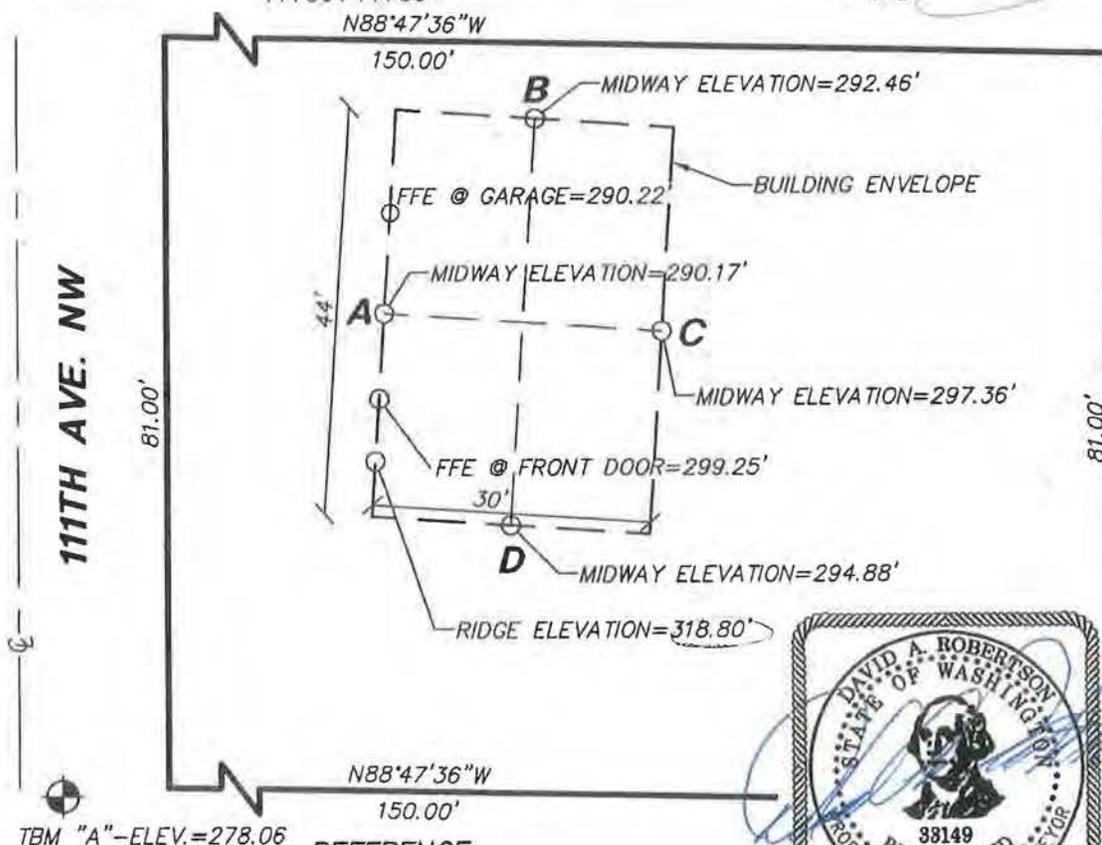
10230-11TH AVE NE, KIRKLAND, WA
AVERAGE BUILDING ELEVATION

AVERAGE BUILDING ELEVATION EQUATION

SCALE: 1" = 20'
$$\frac{(290.2 \times 44) + (292.5 \times 30) + (297.4 \times 44) + (294.9 \times 30)}{44 + 30 + 44 + 30} = \frac{43,476.4}{148} = 293.76 \text{ ABE}$$

The above document is to show that during the planning stage of the CHOI project, the 1st elevation survey was conducted on **EXISTING** foundation. Based on the existing foundation the average building elevation was calculated as 293.76 ft ABE.

1. The property was built with "major remodel" initiative as we wanted to use the existing foundation to save the cost associated with CHOI residence major remodeling project.
2. From the above image, the pink highlighted line shows that elevation of the Ground level on the east side of the property is calculated as 297.36 ft (approximately 4ft higher than the average elevation ABE). This will prove to be key information towards the end of the document.
3. From reviewing below image, you will be able to see the foundation addition towards the east side from the yellow highlighted line.

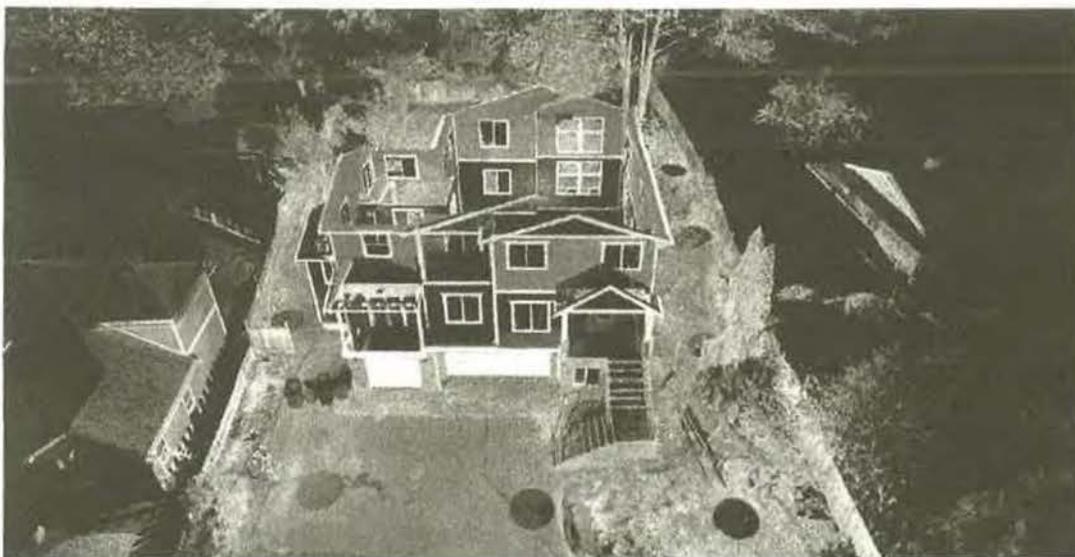
We laser scanned the property for this analysis:

I have had a chance to review the field measurements and assess the data for the survey of the newly constructed house. We found that the roof peak is 323.99 feet City of Kirkland datum based upon their Survey Control point #148. We found this control point to be as described as an "X" in the south rim of Metro sewer manhole, elevation 179.19, which agreed with our GPS elevation.

The biggest issue was determining the original ground elevations for the lot, as most everything in the lot and around it has visibly been graded through the years. The only two areas of original grade appear to be along the south line because some trees were retained and along the east line. Below is a screen shot of the laser scan of the property sitting near the southwest corner looking east and you can see the ground cut.

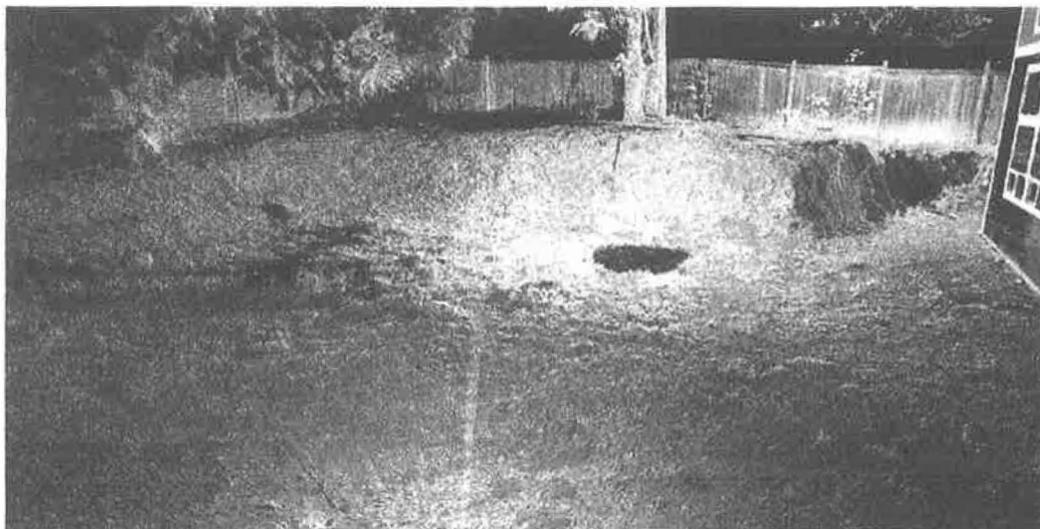
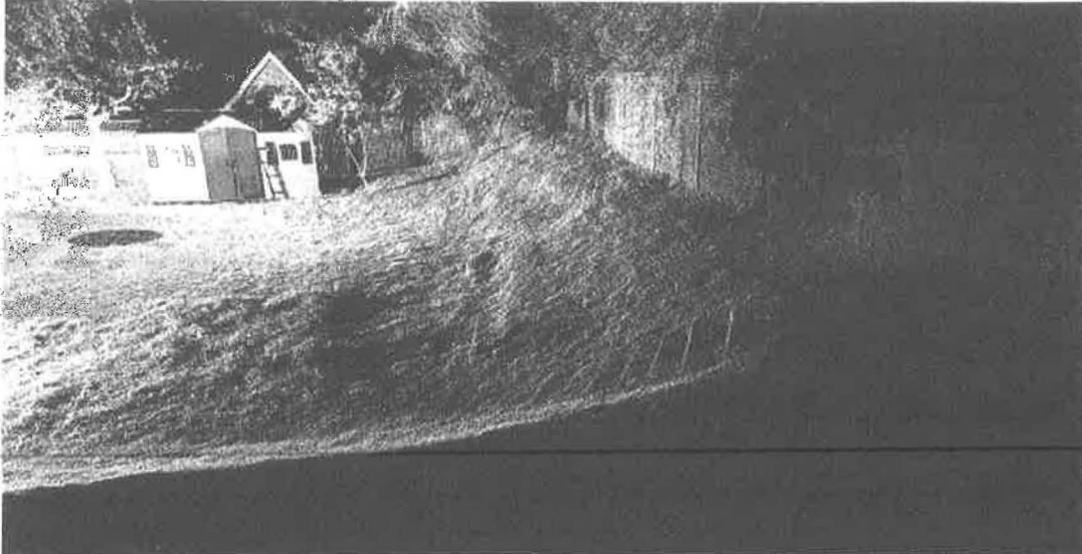
The next two screen shots are from the back yard and you can see the cut around the tree stand as well as the tapering cut on the east line.

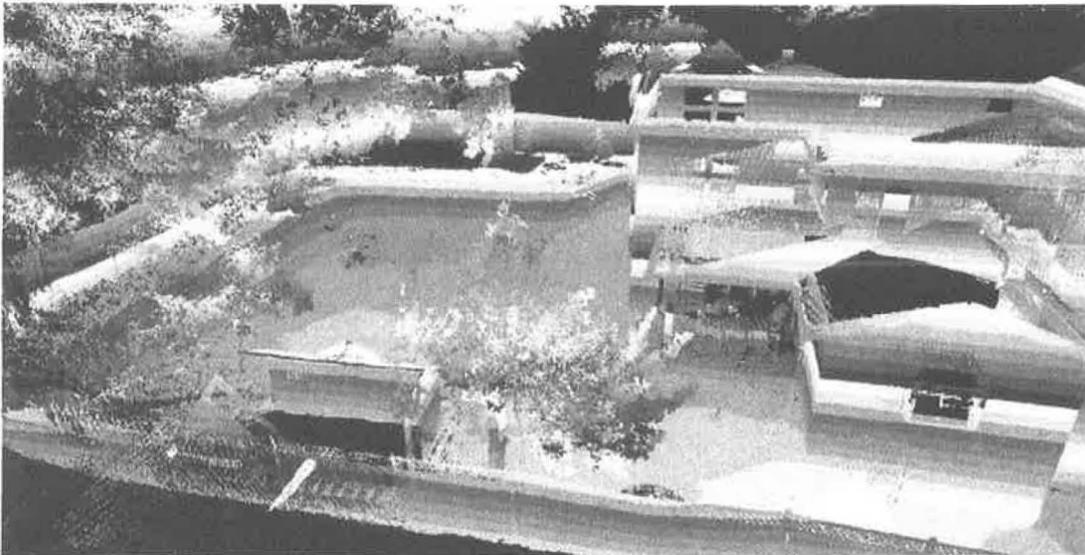
Also looking at the property with some hideous elevation banding yields that the areas we know are original ground to be fairly flat and it really highlights the grading. The screen shot below is with the points set to color in one foot intervals.

As you can see, the top of cut is right at the lower edge of the white band and is fairly consistent. The property does fall off to the north and to the west and it is impossible to tell what the drop to the north should be as no evidence of original ground is left. The drop to the west could be said to be consistent, more or less, with the drop in elevation seen along the south line. The following two shots are from a true orthographic view point from due south, so, the grade of the north line is evident.

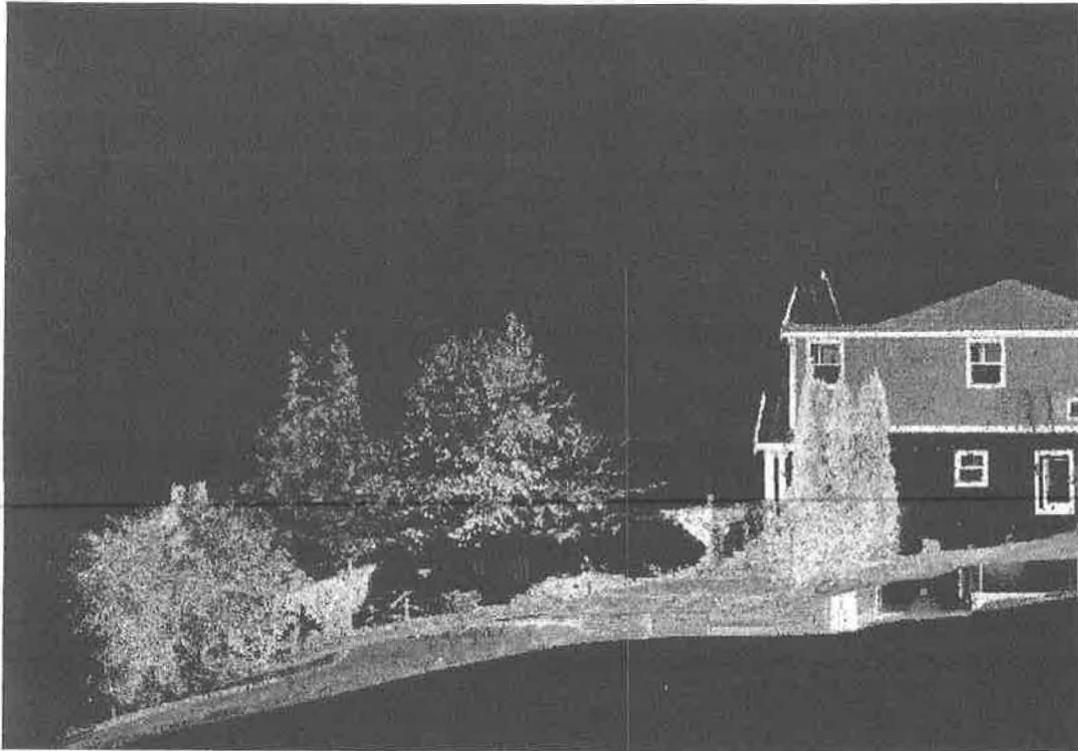
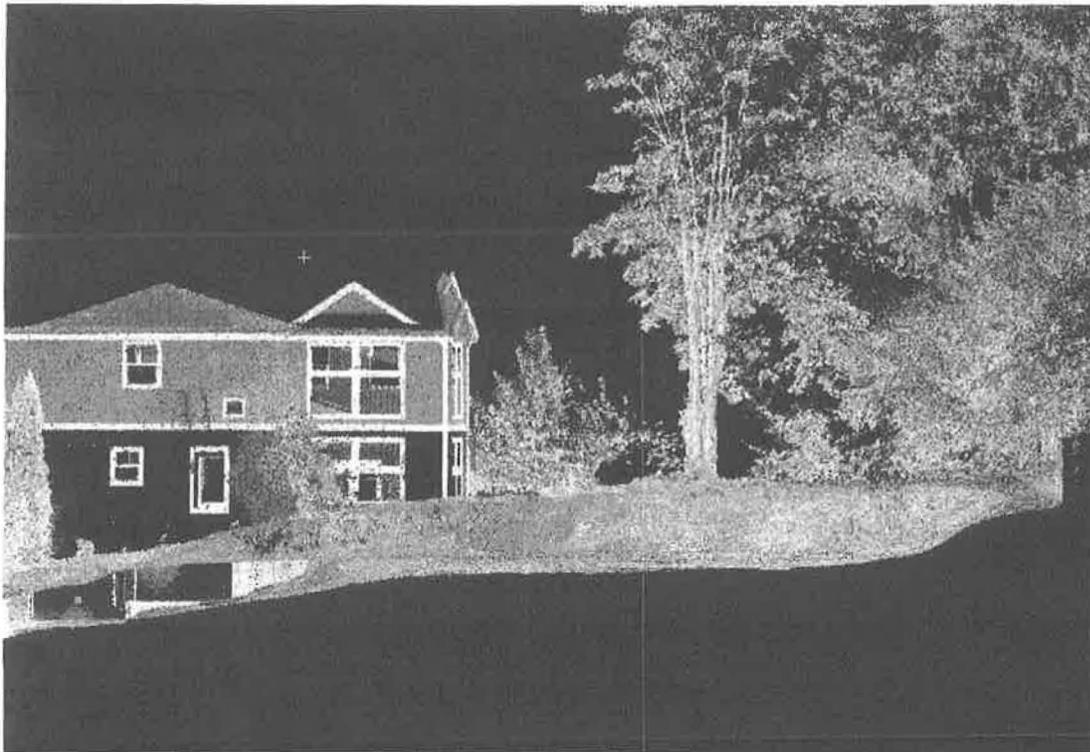
Basically this means that the only two original grade points that I can establish are along the south line. I find that original grade south of the southeast corner is 302.7 feet and south of the southwest corner is 295.3. Based upon a mean elevation from these two points, the mean south line elevation is 299.0 feet. Since all of the ground to the north has been disturbed, this is really the only evidence of the original grade left. The house that has been constructed is from the peak elevation we asbuilt of 323.99 to the average grade on the south side of 299.0 feet is 25.0 feet of separation.

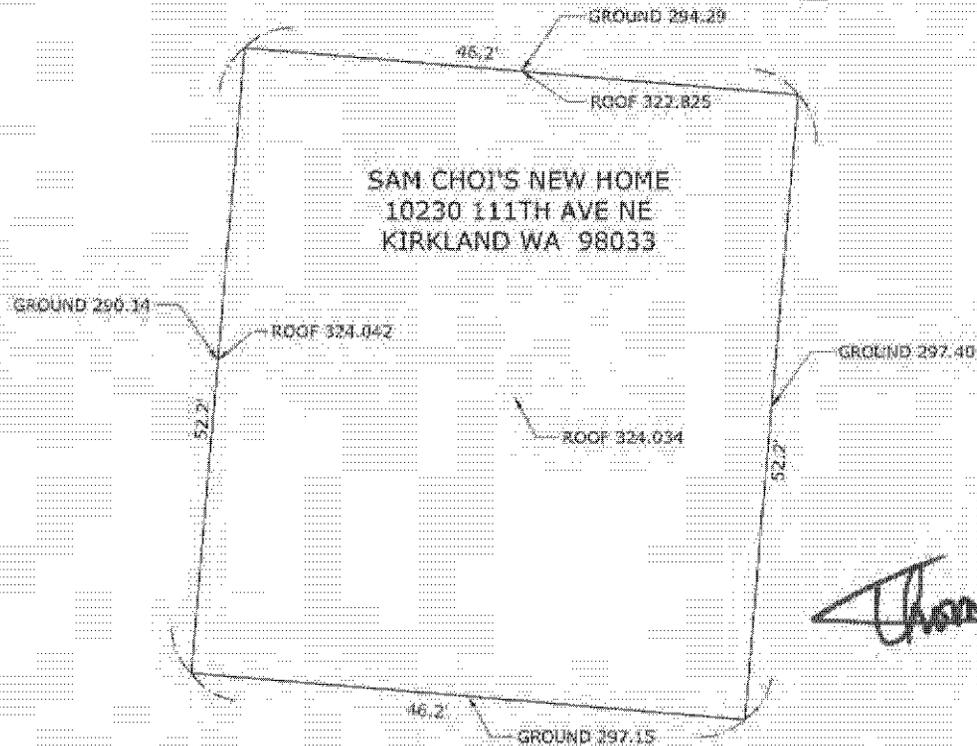
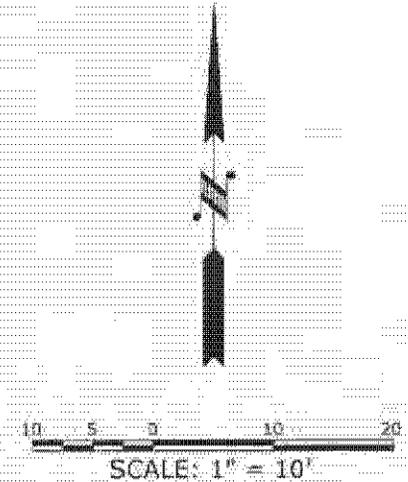
CHOI HEIGHT SURVEY

BASIS OF ELEVATIONS

THE CITY OF KIRKLAND USING THE SAME PROJECT BENCHMARK AS THE APPROVED BUILDING PLANS; PUNCHED "X" IN NORTH RIM OF SANITARY SEWER MANHOLE +/- 20' WEST OF THE SOUTHWEST PROPERTY CORNER. THE ELEVATION IS 278.06.

AVERAGE BUILDING ELEVATION CALCULATION

$$\frac{(52.2 \times 299.14) + (46.2 \times 294.29) + (52.2 \times 297.40) + (46.2 \times 297.15)}{52.2 + 46.2 + 52.2 + 46.2} = 294.69$$

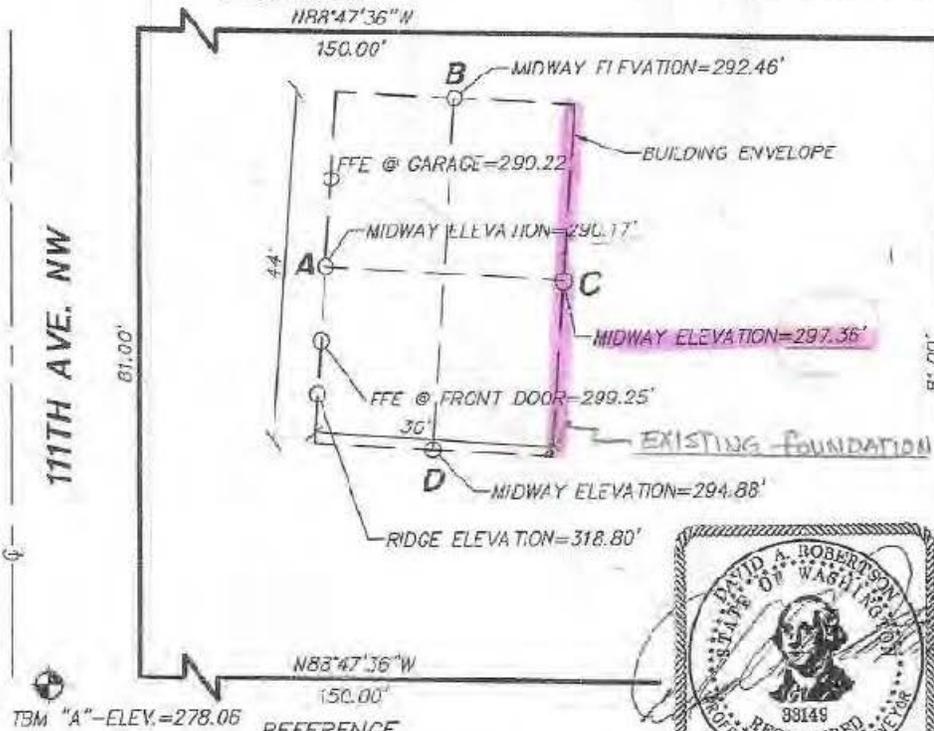
AVERAGE BUILDING ELEVATION EQUATION

$$\frac{(290.2 \times 44) + (292.5 \times 30) + (297.4 \times 44) + (294.9 \times 30)}{44 + 30 + 44 + 30} = \frac{43,476.4}{148} = 293.76 \text{ ABE}$$

The wall segment lengths used should have been based on the proposed footprint, but the labeled dimensions on that document match the original footprint.

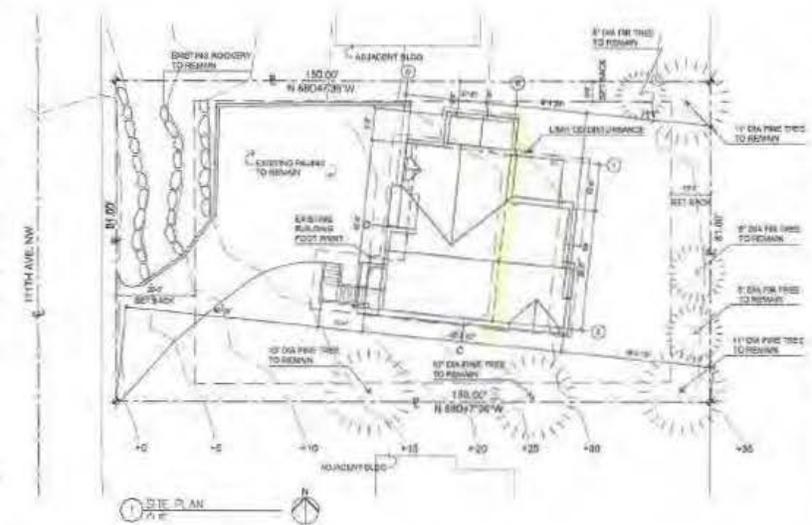
A1

AVERAGE BUILDING ELEVATION CALS

A=24.3' B=24.6' C=22.7' D=18.8'
 P=31.3' Q=32.5' R=23.3'
 (24.3+24.6+22.7+18.8+31.3+32.5+23.3)/7 = 25.18'

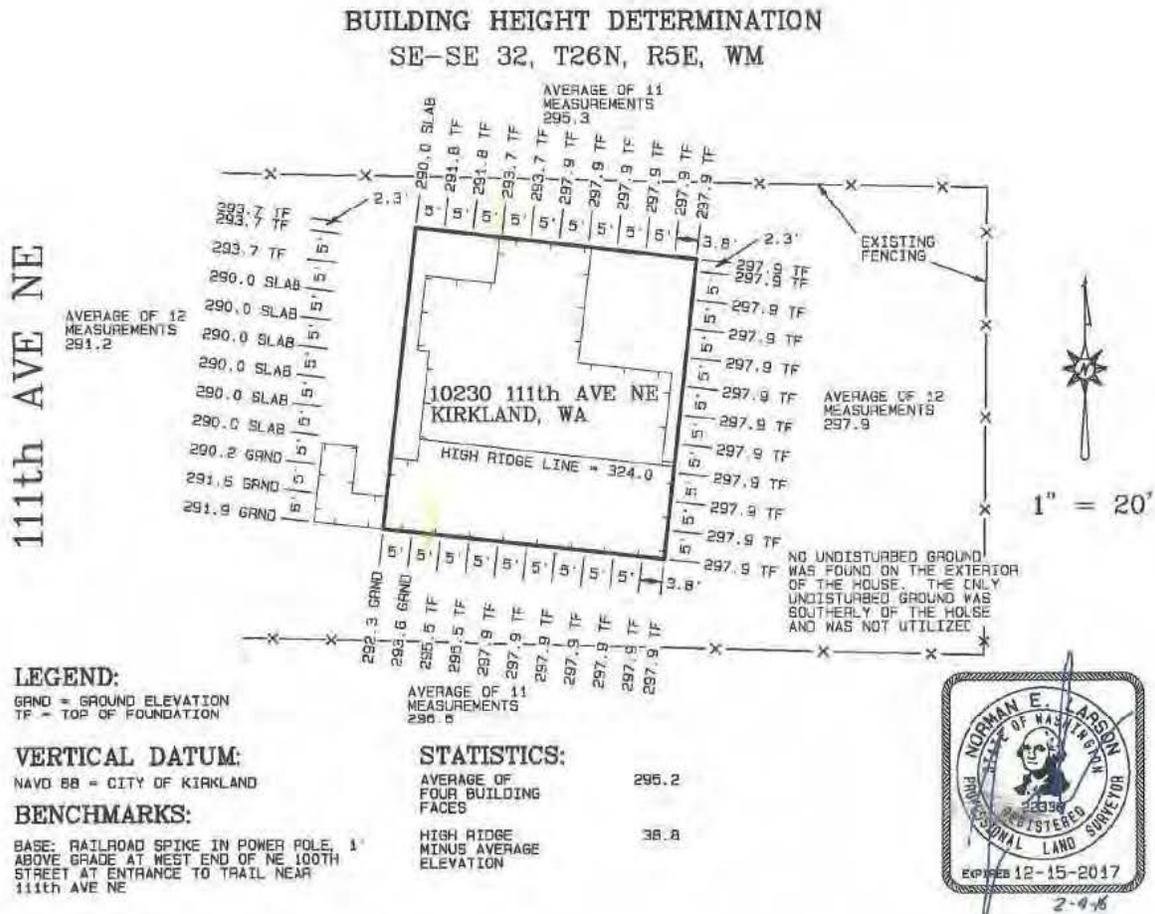
Please refer to below document which was the 2nd Elevation survey we conducted after the property construction was completed.

It shows that the highest ridge line of the property was found to be 324.0 ft.
