**ARBORIST REPORT/TREE PLAN**  
for  
**9252 Slater Avenue NE**  
**Kirkland, WA**

**June 27, 2016**

**FIGURE 2**  
**MR. ISAAH DUMMER**  
**SLATER AVENUE PROPERTY**  
 KIRKLAND, WA  
 WETLAND BUFFER REDUCTION  
 EXISTING CONDITIONS

**FIGURE 3**  
**MR. ISAIAH DUMMER**  
**SLATER AVENUE PROPERTY**  
**KIRKLAND, WA**  
 WETLAND BUFFER REDUCTION  
**PROPOSED SITE PLAN & MITIGATION**

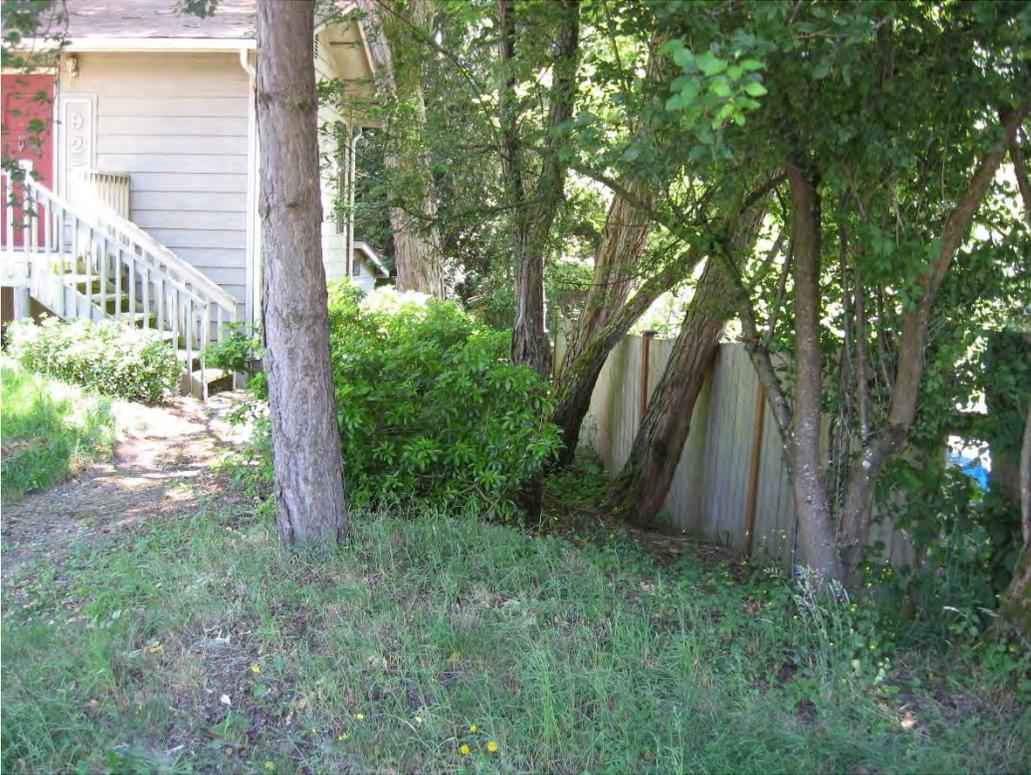
On the south perimeter, there is a large grouping of black locust trees. Some are situated on the subject property and some on the neighboring property. These have developed typical form and structure and are of fairly good vigor. Tree #105 is situated close to the existing home and has a heavy lean over it. All of the subject locust trees are considered to be in fair condition.

South perimeter

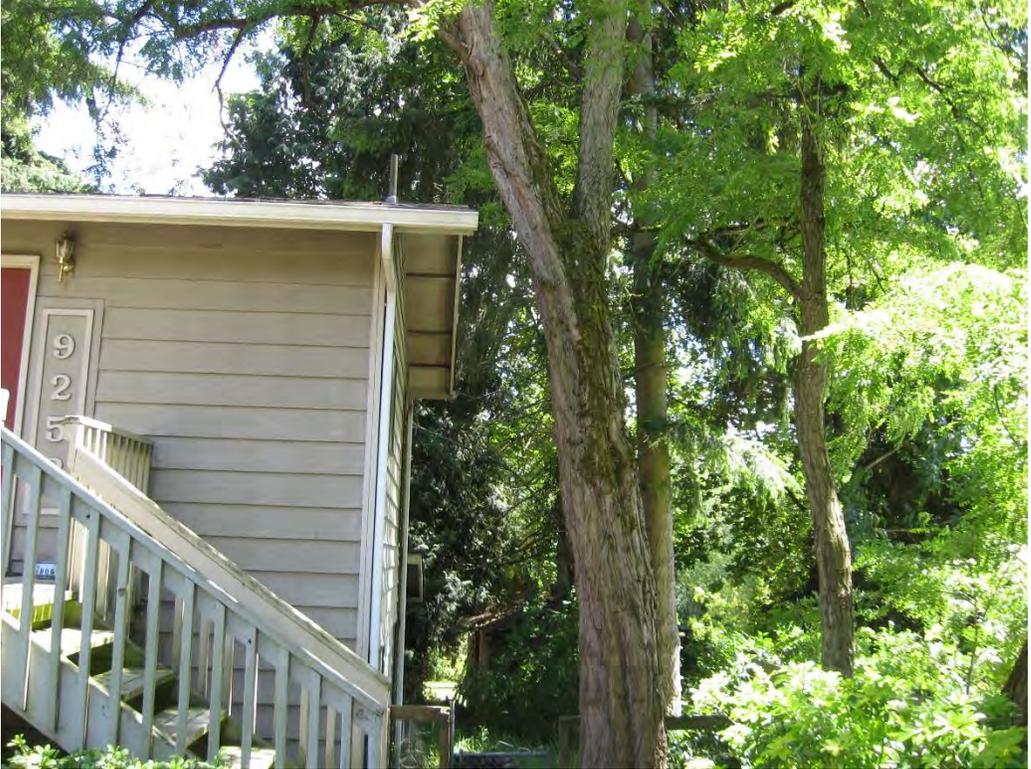
Tree #105, over existing house

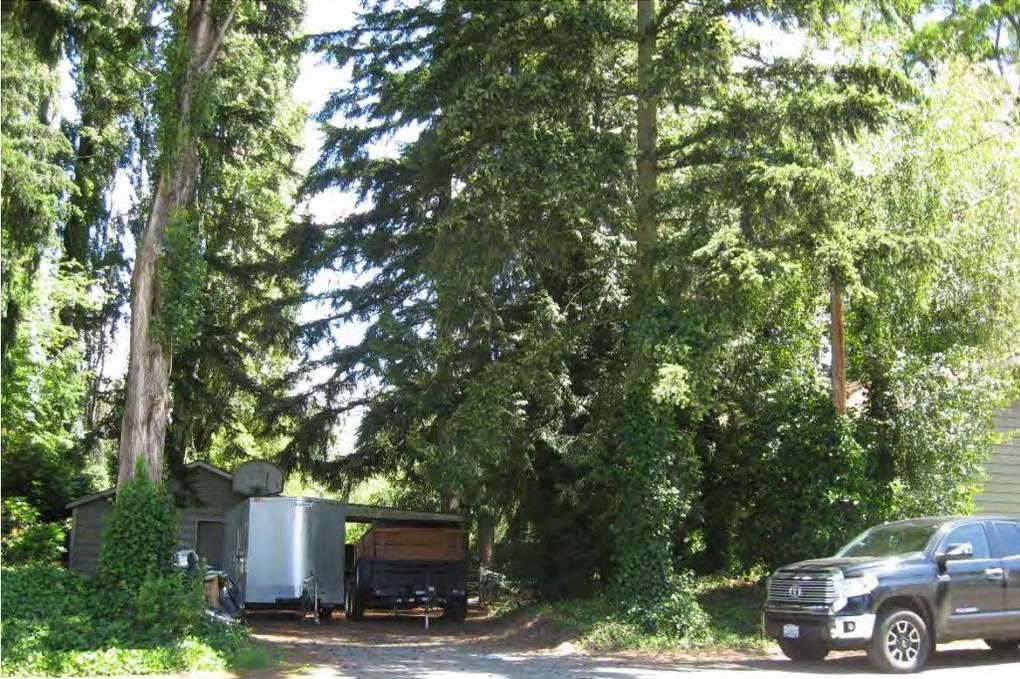
Existing driveway to proposed ADU

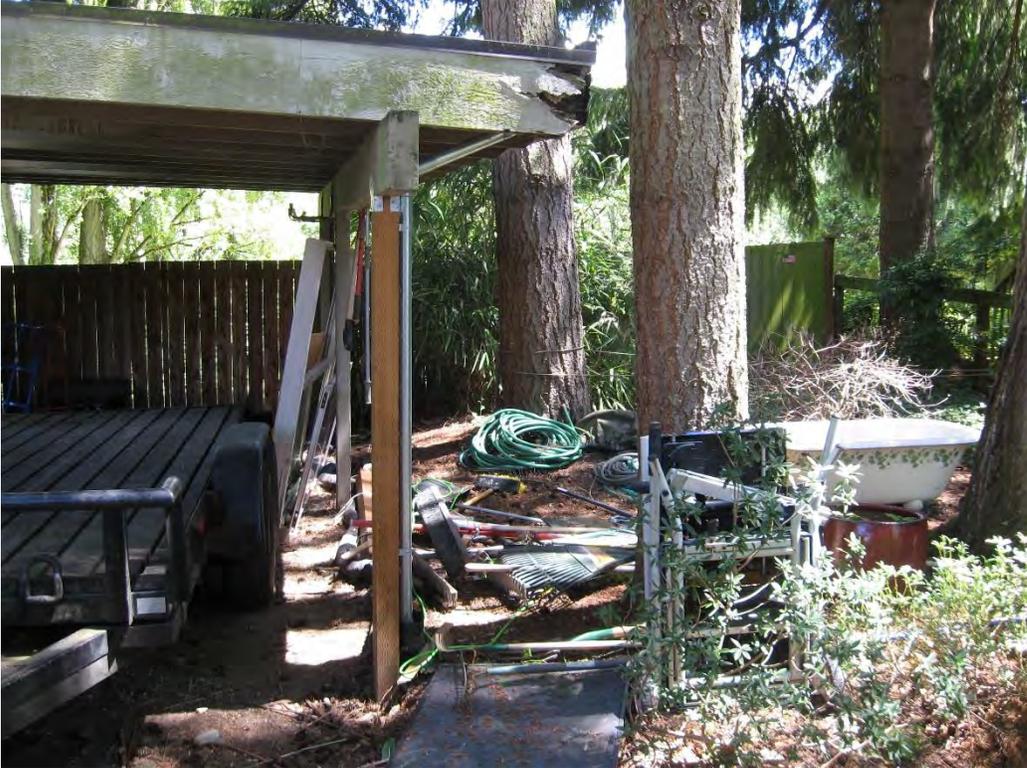
Subject trees #108, #109 and #110 between proposed building footprints

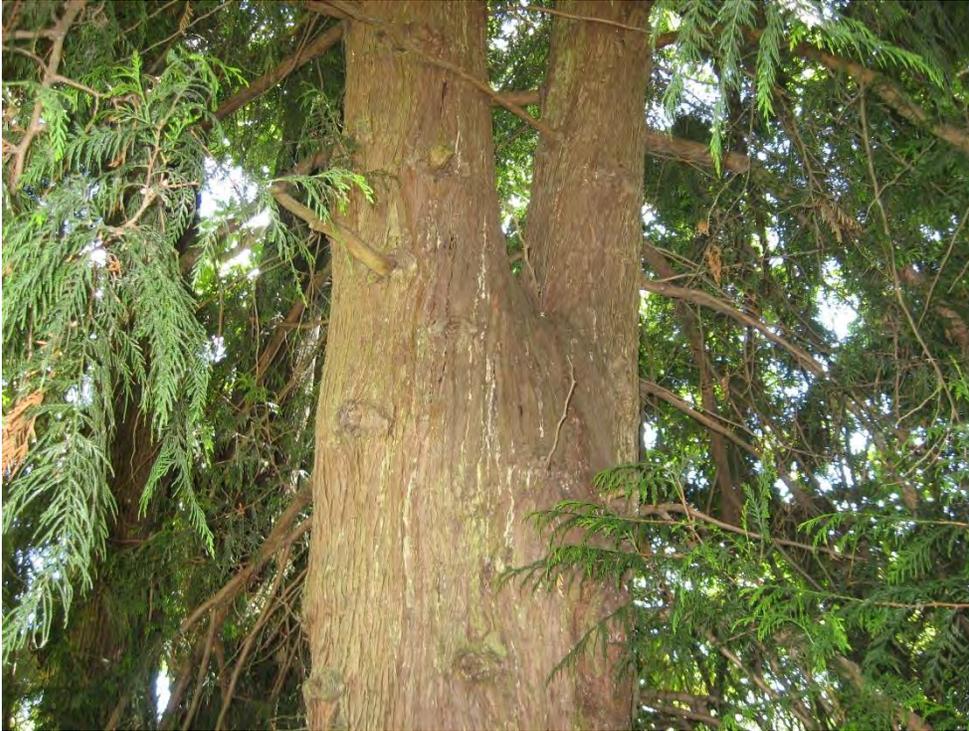
Tree #18 is a semi-mature western red cedar located near the southeast corner of the proposed building footprint. This tree has a major structural defect – forked to with co-dominant (equal diameter) stems. The stems are weakly attached to the main trunk, evidenced by significant included bark and a large seam between the forked stems. Overall condition is considered fair to poor due to the structural defect. It is considered 'non-viable'. A major stem failure is likely within the next few years.

Tree #18, major structural defect, very high probability of failure

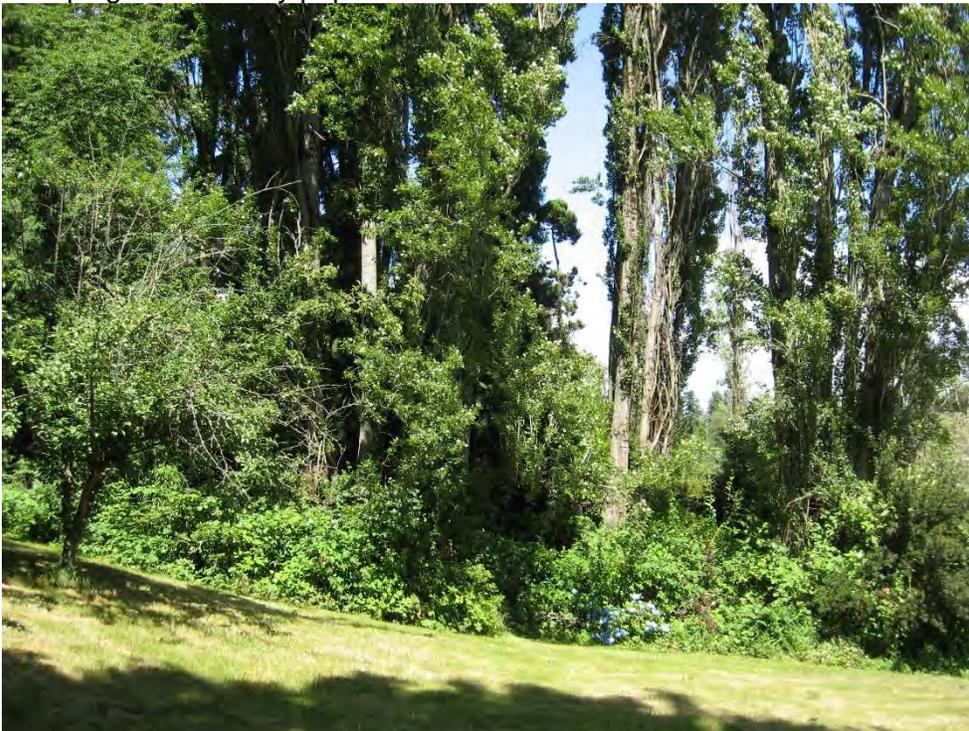
There is a large grouping (Trees #114 > #120) of semi-mature to mature Lombardy poplar trees within the wetland buffer. These appear to be of fairly good vigor. No evidence of top decline was observed. A thorough inspection of the lower trunks was inhibited by a dense infestation of Himalayan blackberry within the grouping. Overall condition of the poplar trees is fair.

Grouping of Lombardy poplar trees in wetland buffer

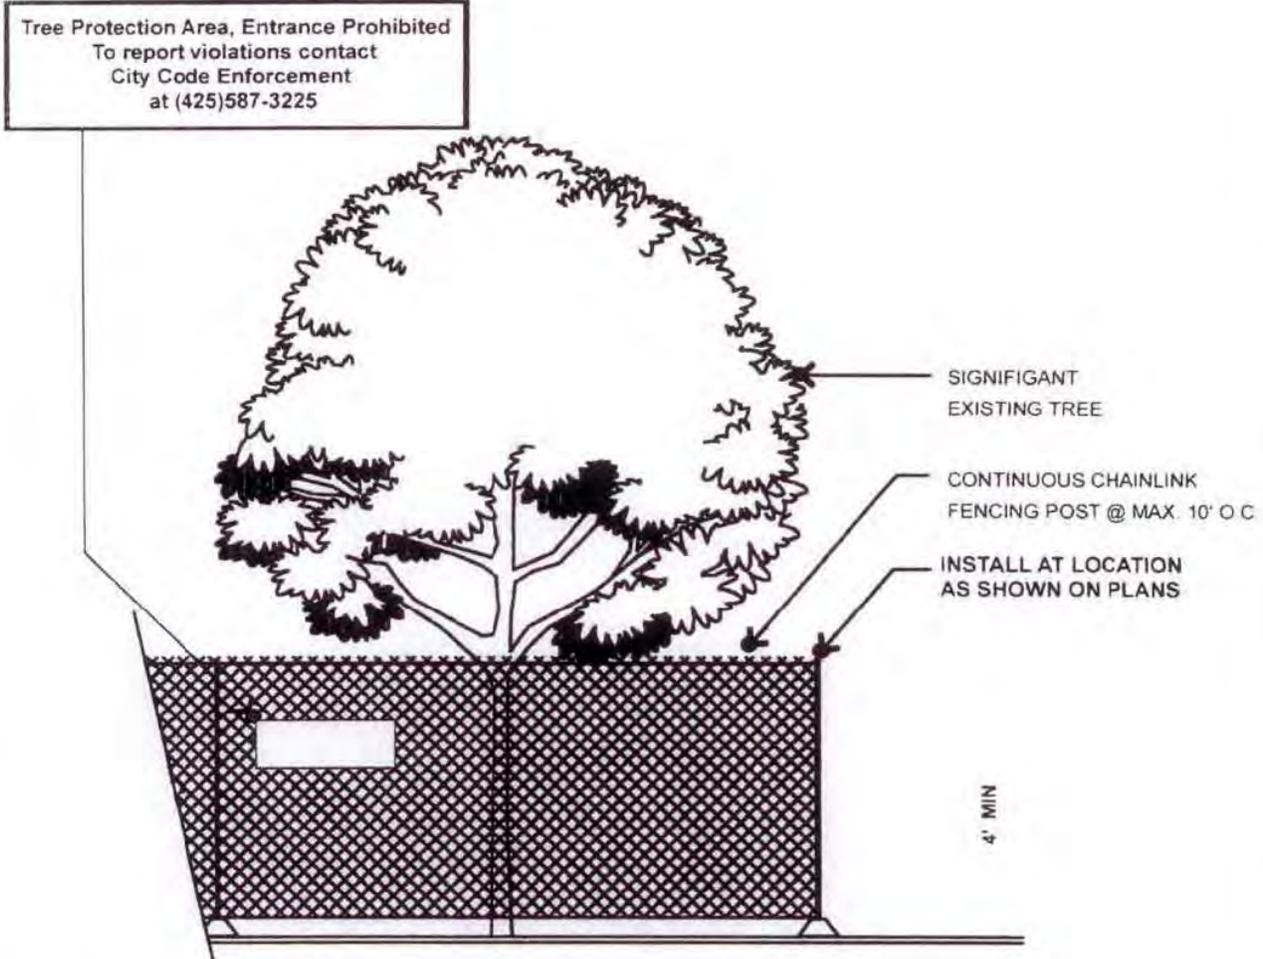
FENCING SIGN DETAIL

1. MINIMUM FOUR (4 ) FOOT HIGH TEMPORARY CHAINLINK FENCE SHALL BE PLACED AT THE CRITICAL ROOT ZONE OR DESIGNATED LIMIT OF DISTURBANCE OF THE TREE TO BE SAVED. FENCE SHALL COMPLETELY ENCIRCLE TREE (S). INSTALL FENCE POSTS USING PIER BLOCK ONLY. AVOID POST OR STAKES INTO MAJOR ROOTS. MODIFICATIONS TO FENCING MATERIAL AND LOCATION MUST BE APPROVED BY PLANNING OFFICIAL.

2. TREATMENT OF ROOTS EXPOSED DURING CONSTRUCTION: FOR ROOTS OVER ONE (1) INCH DIAMETER DAMAGED DURING CONSTRUCTION, MAKE A CLEAN STRAIGHT CUT TO REMOVE DAMAGED PORTION OF ROOT. ALL EXPOSED ROOTS SHALL BE TEMPORARILY COVERED WITH DAMP BURLAP TO PREVENT DRYING, AND COVERED WITH SOIL AS SOON AS POSSIBLE.

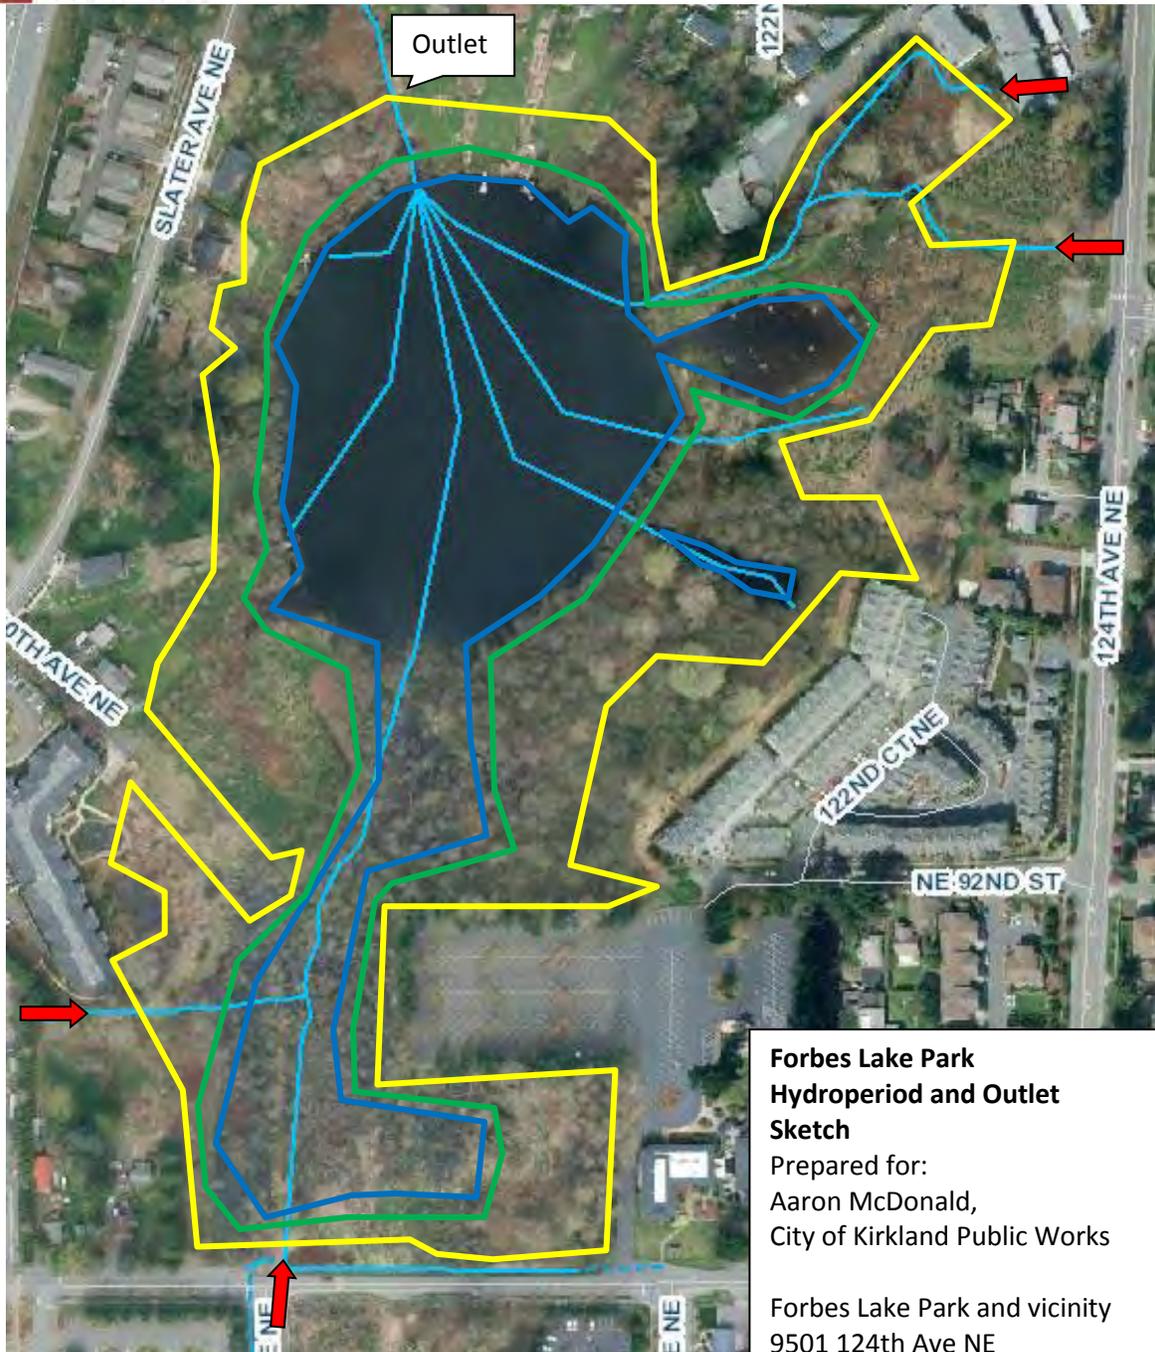
**Forbes Lake Park  
Hydroperiod and Outlet  
Sketch**  
Prepared for:  
Aaron McDonald,  
City of Kirkland Public Works

LEGEND
<b>Light blue:</b> Drainage channel
<b>Dark blue:</b> Permanently flooded
<b>Green:</b> Seasonally inundated
<b>Yellow:</b> Saturated only
<b>Red arrow:</b> Seasonally flowing stream into wetland

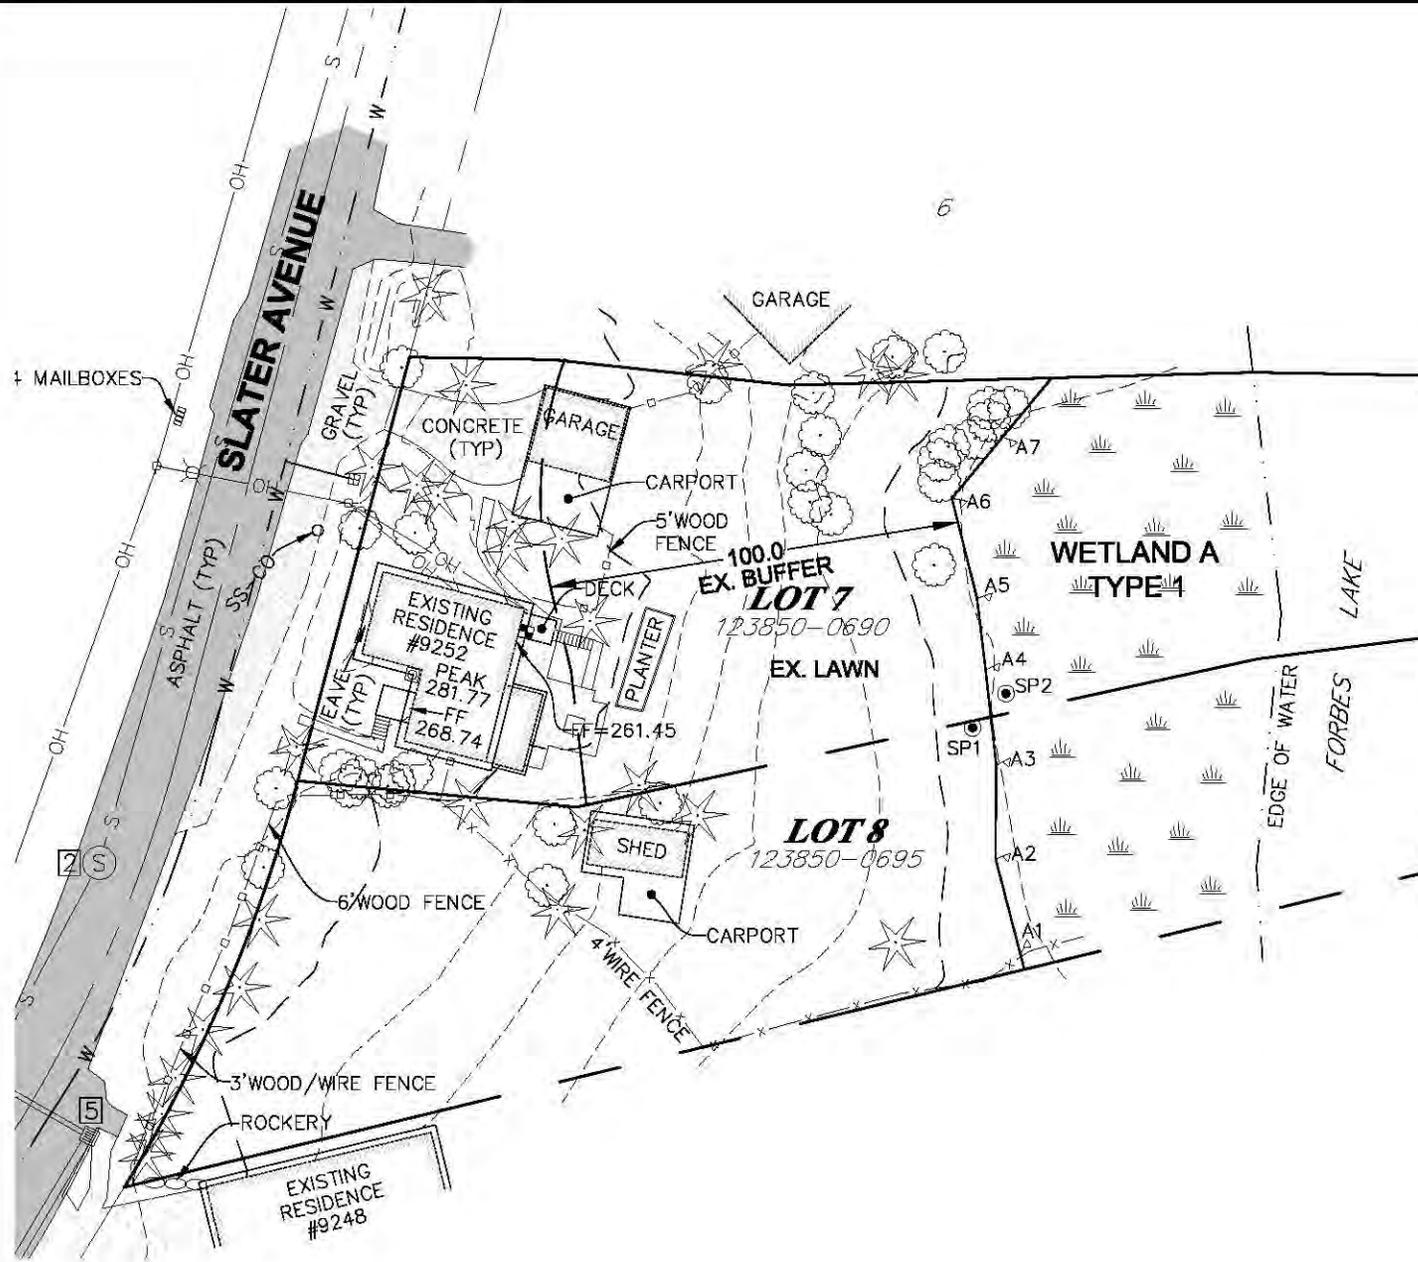
- PROPERTY LINE
- EXISTING WETLAND
- WETLAND FLAG
- SAMPLE PLOT LOCATION
- 100' WETLAND BUFFER
- EXISTING TREES
- EXISTING CONTOURS

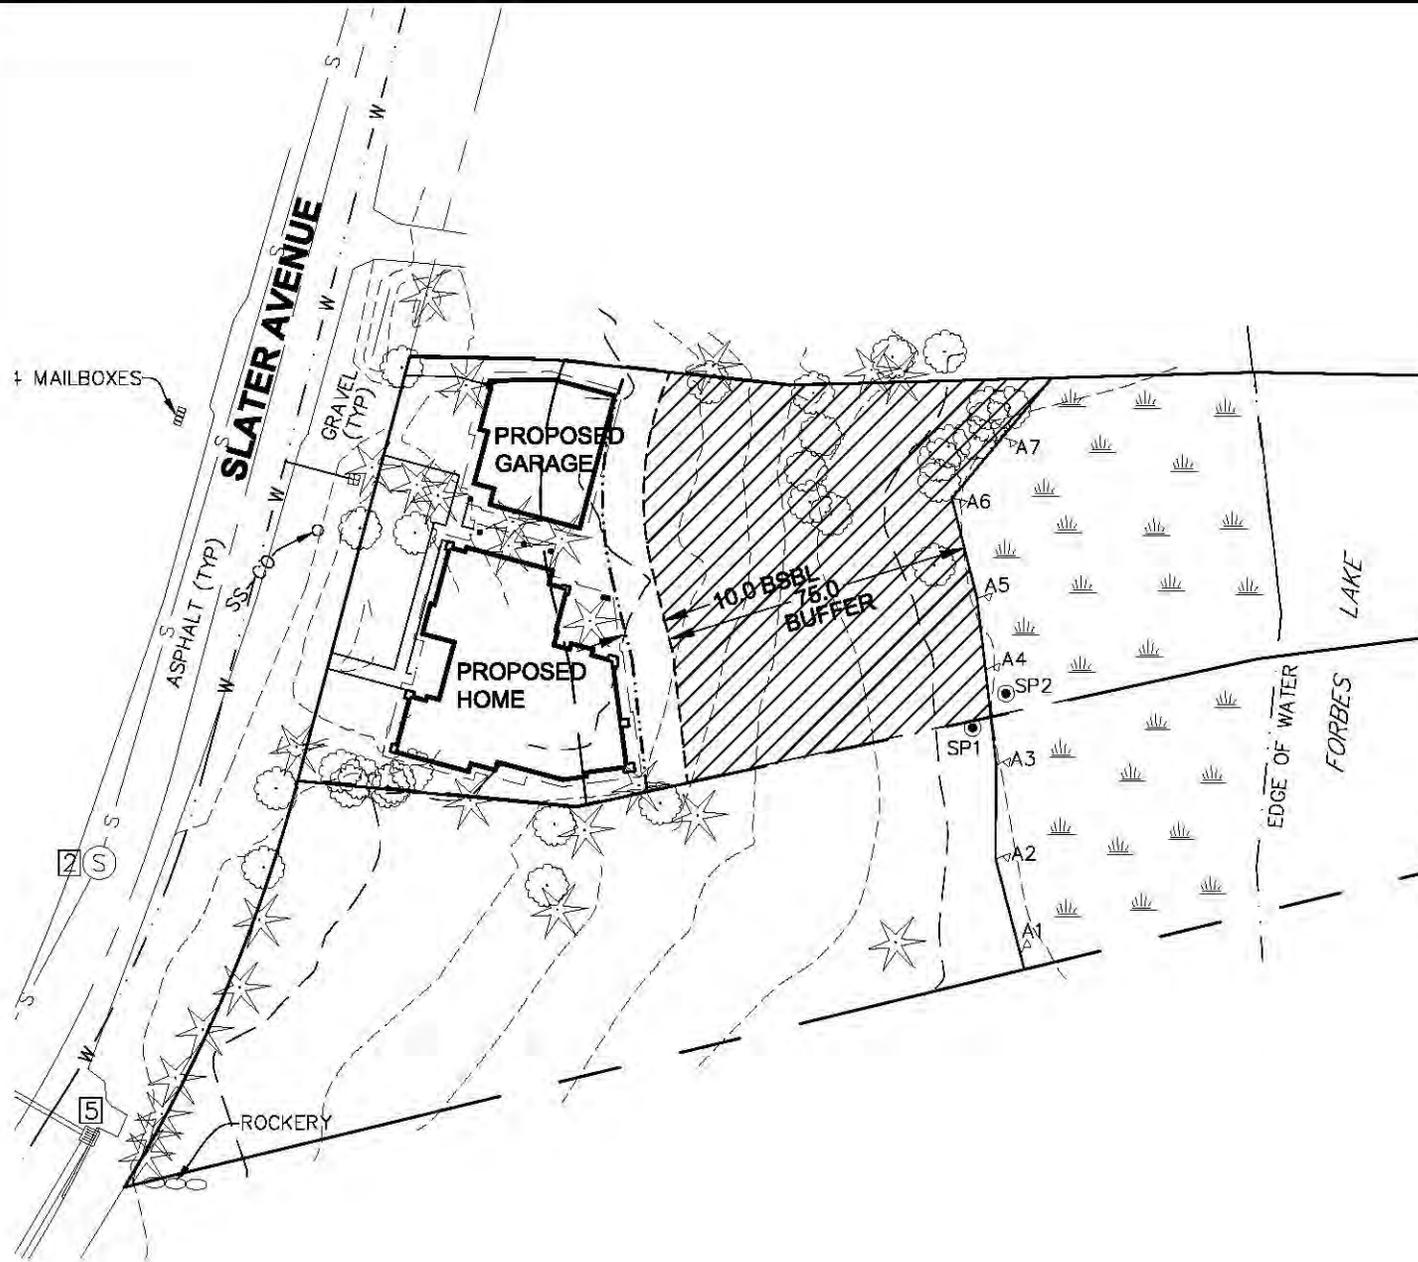
- PROPERTY LINE
- EXISTING WETLAND
- 100' WETLAND BUFFER
- 75' REDUCED BUFFER
- 10' BSBL
- BUFFER ENHANCEMENT  
7,085 SF

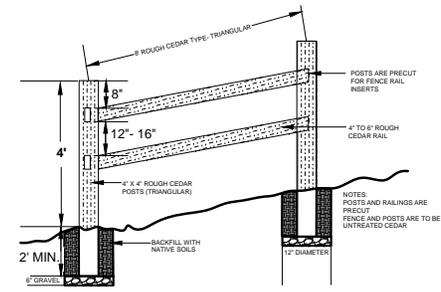
**1 NGPA SPLIT RAIL CEDAR FENCE OR SIMILAR NTS**

1. A permanent split rail, open slatted with at least 18 inches between each slat, wrought iron, chain link, or similar nonsolid fence between three (3) and six (6) feet in height must be installed along the entire edge of the buffer;
2. Solid fencing is not permitted;
3. Except for split rail, a gate is required for pedestrian access to the buffer;

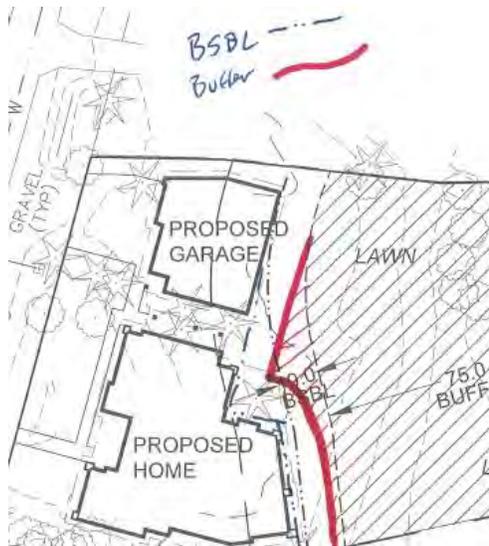
7. The buffer modification criteria in 90.60.2.b.#9 requires there is no practical feasible alternative development proposal that results in less impact to the buffer. Overall the plan meets the criteria except for how the buffer is drawn and where the buffer fence will be. There is about 5 feet between the main house and the building setback line and an additional few hundred square feet occupied by a 24-inch Douglas-fir tree that should be included in the buffer or setback. See figure below.
