ADVISORY REPORT
FINDINGS, CONCLUSIONS, AND RECOMMENDATIONS

File: ZON18-00720 for Kirkland Shelter

3. Request: Construction of a 19,508 square foot shelter for women and families with children. Access will be provided by a 48.5-foot access and utility easement across parcel 123310-0170 (Salt House Church, 11920 NE 80th Street). Parking for the shelter will be shared with the Salt House Church, and available on-street parking along 120th Ave NE (see Attachment 2).

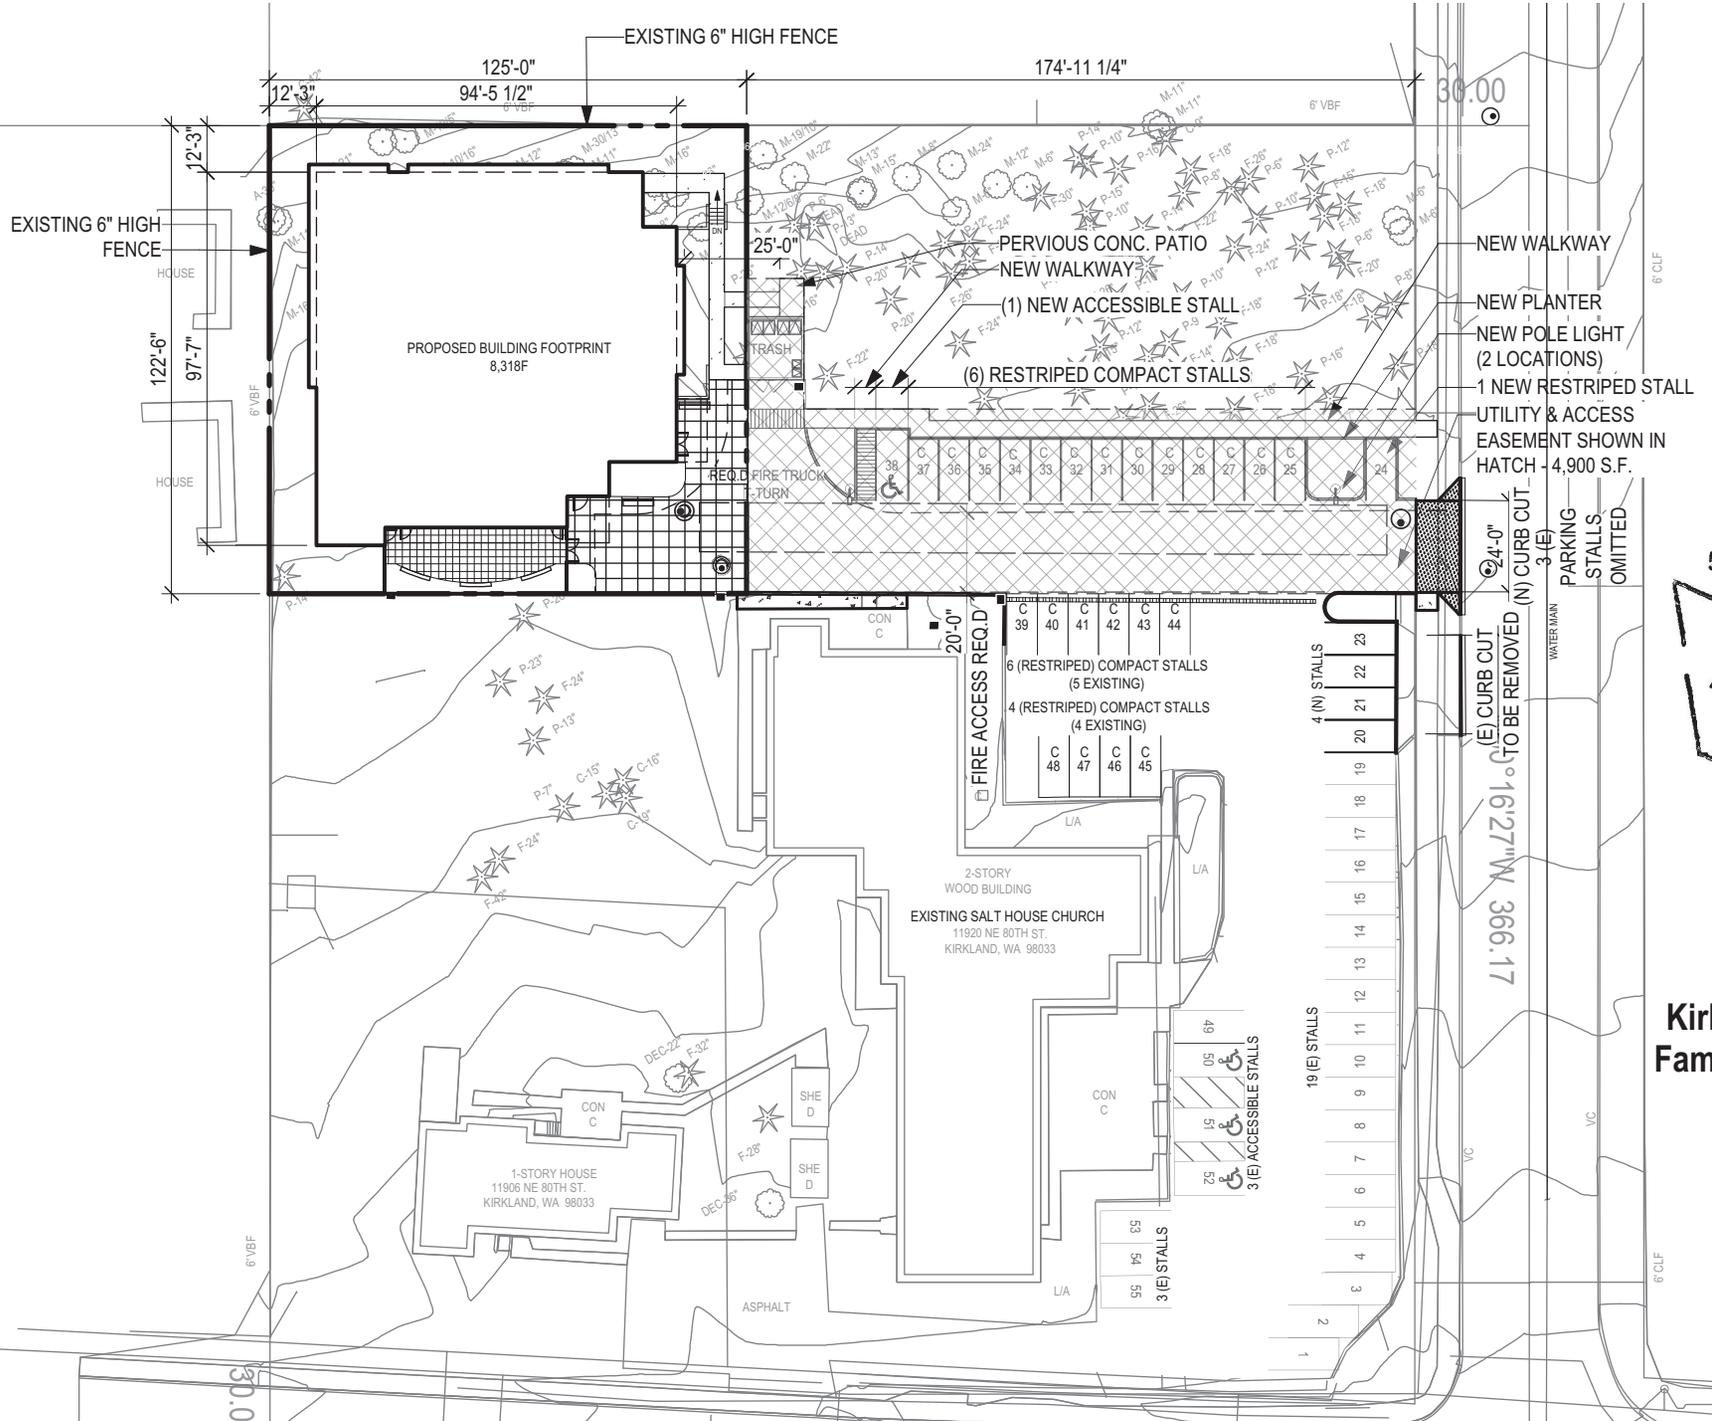
1
A1.1

SITE PLAN

Scale: 1" = 50 ft

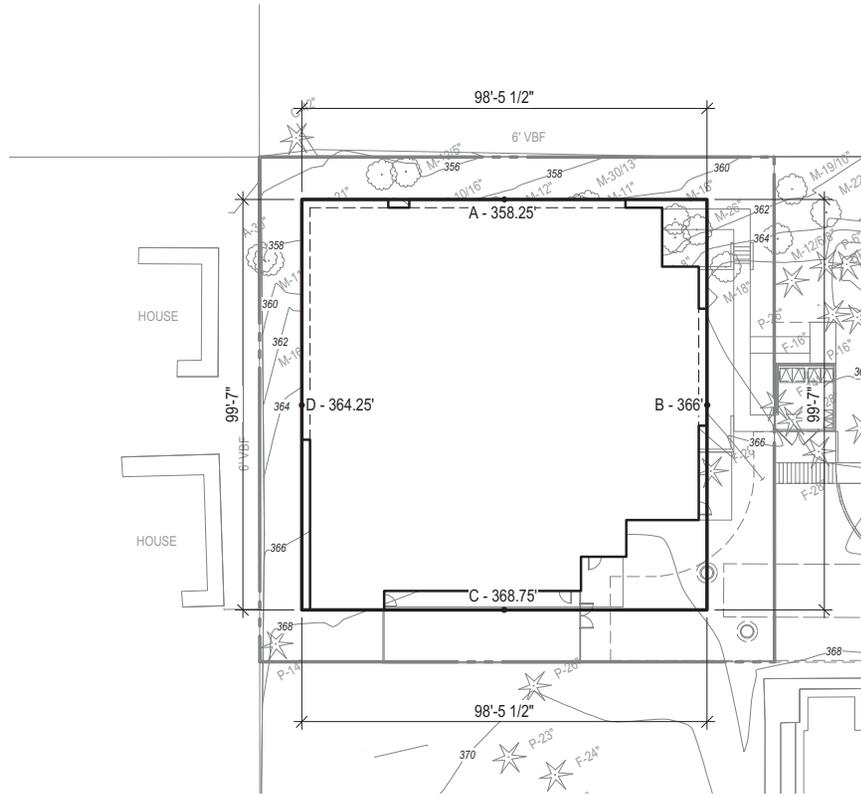
METHOD 1:
PER KZC CHAPTER 180

A= 358.25	x	a= 98.458	=	35272.5785
B= 366	x	b=99.583	=	36447.378
C= 368.75	x	c=98.458	=	36306.3875
D= 364.25	x	d=99.583	=	36273.10775
		396.08 /	144299.45	= 364.317

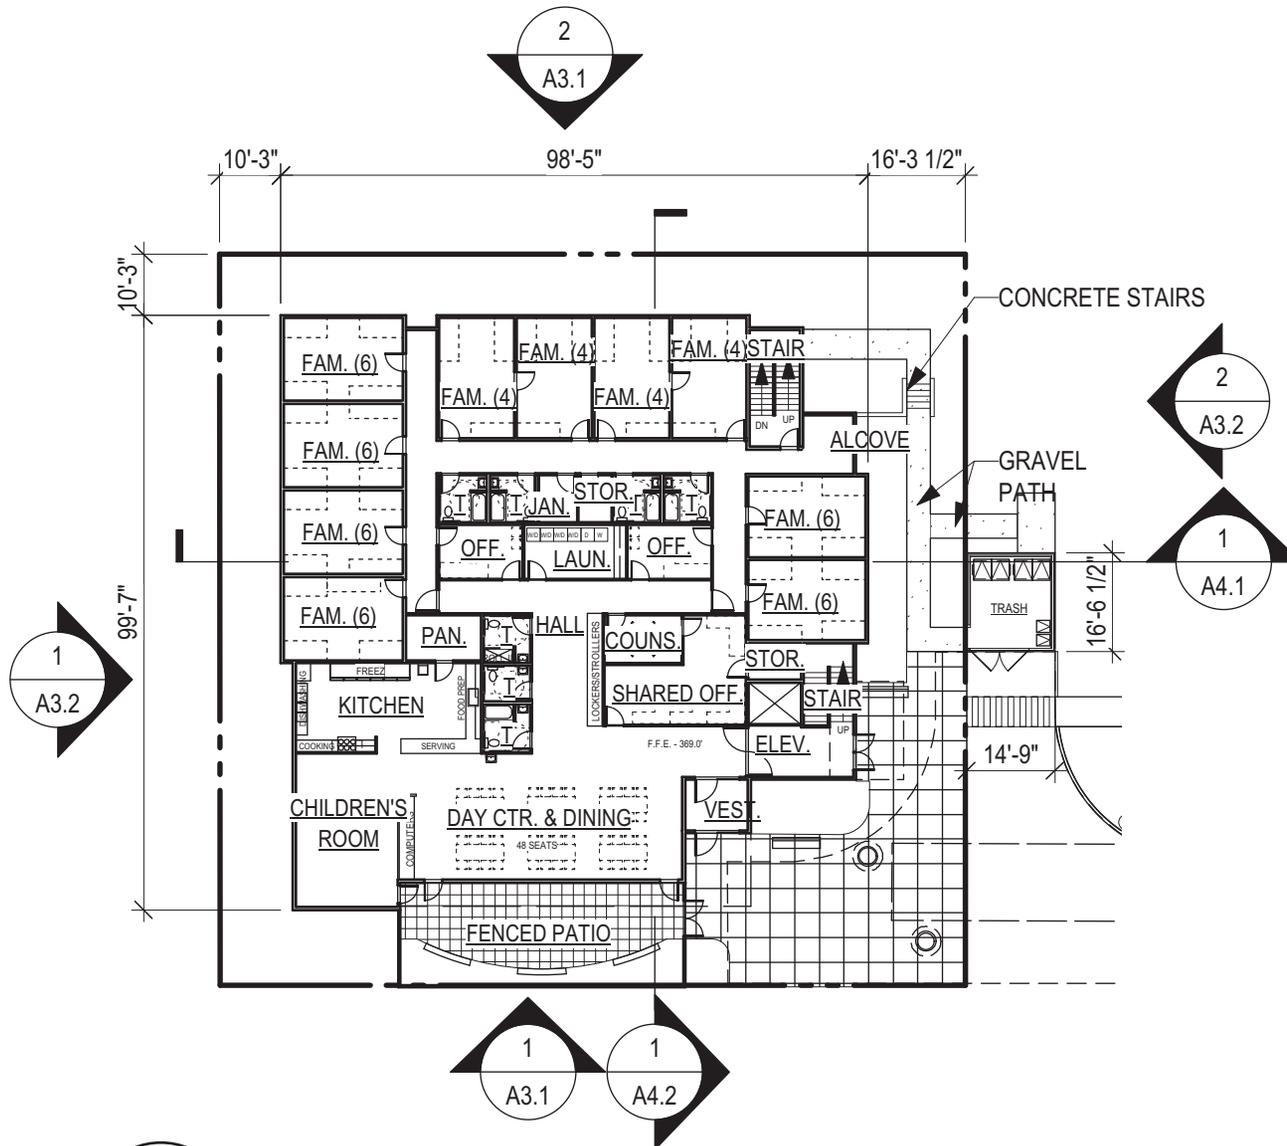
First Floor Plan

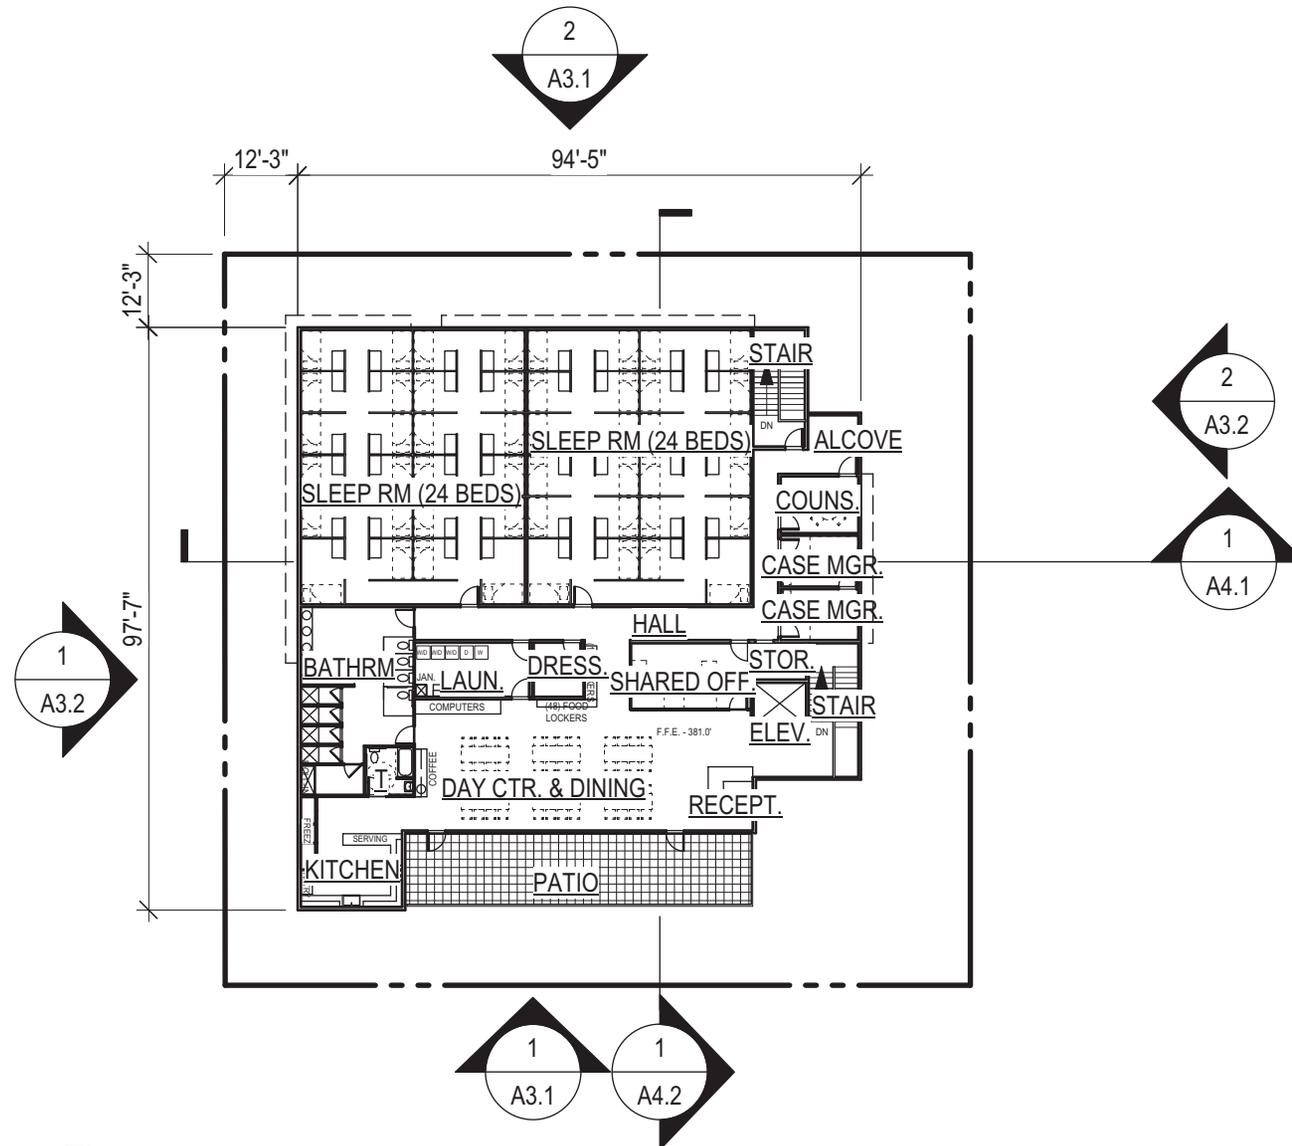
Second Floor Plan

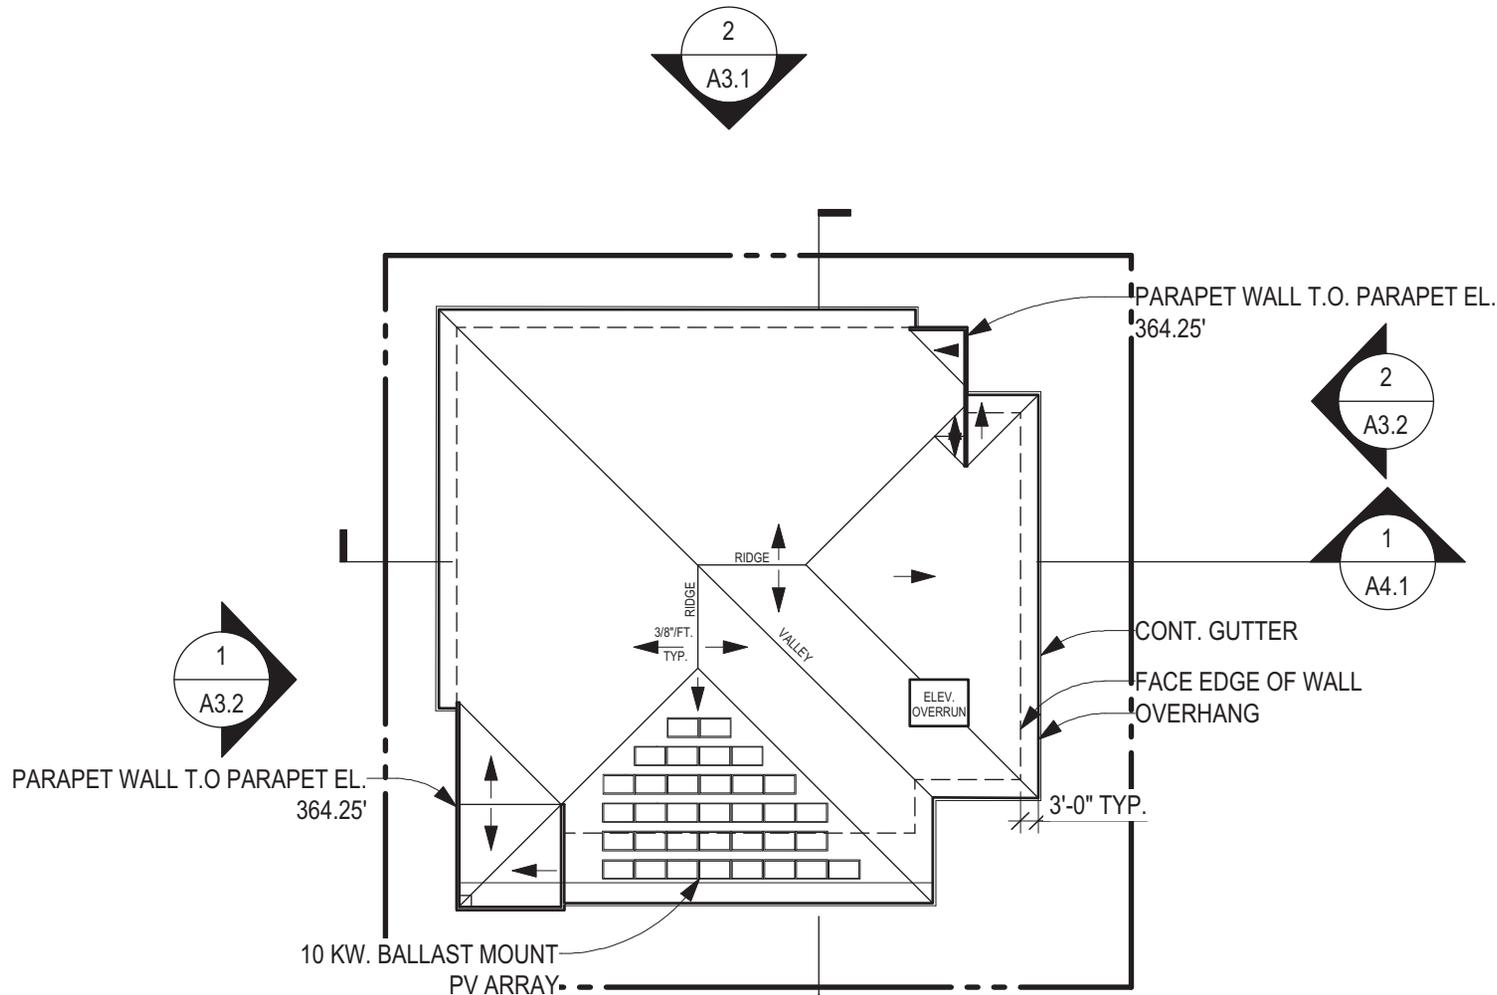
1
A2.3

Roof Plan

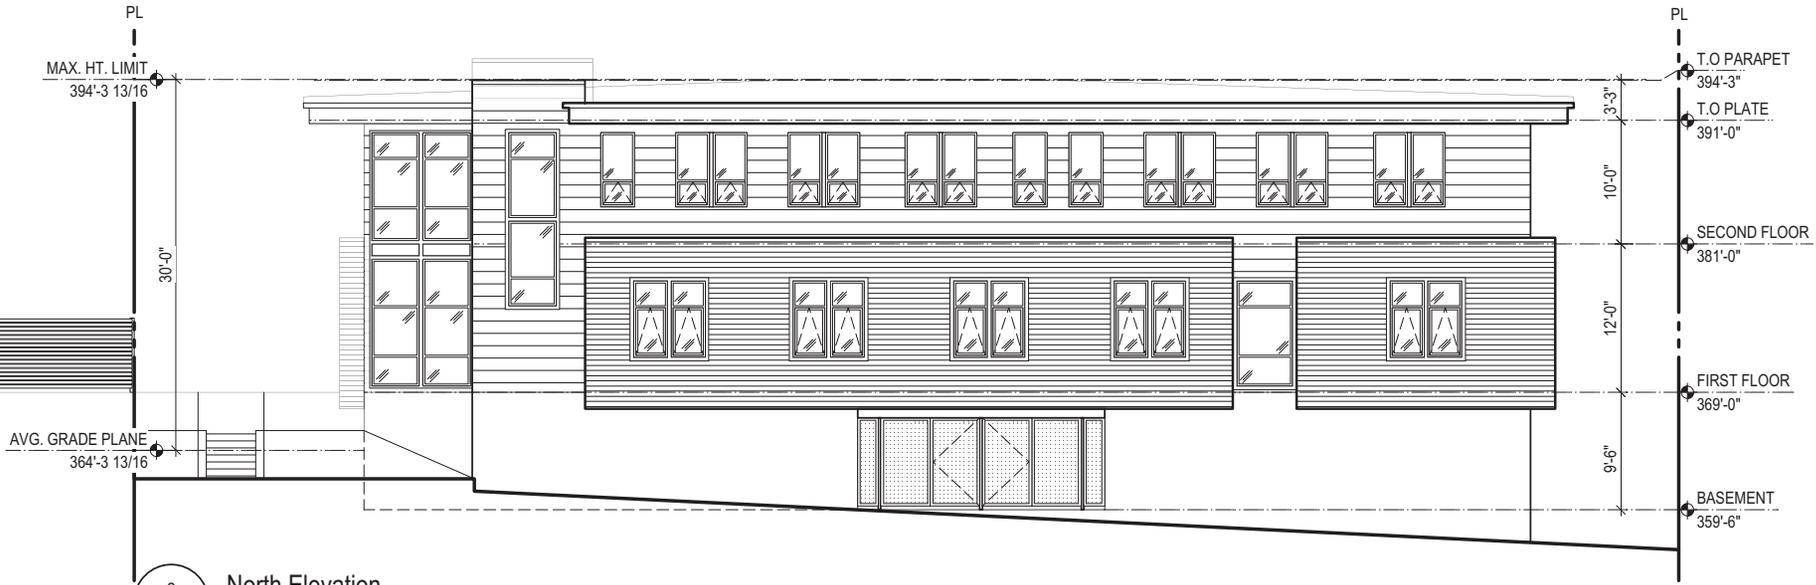
2 North Elevation
A3.1 Scale: 1/8" = 1'-0"

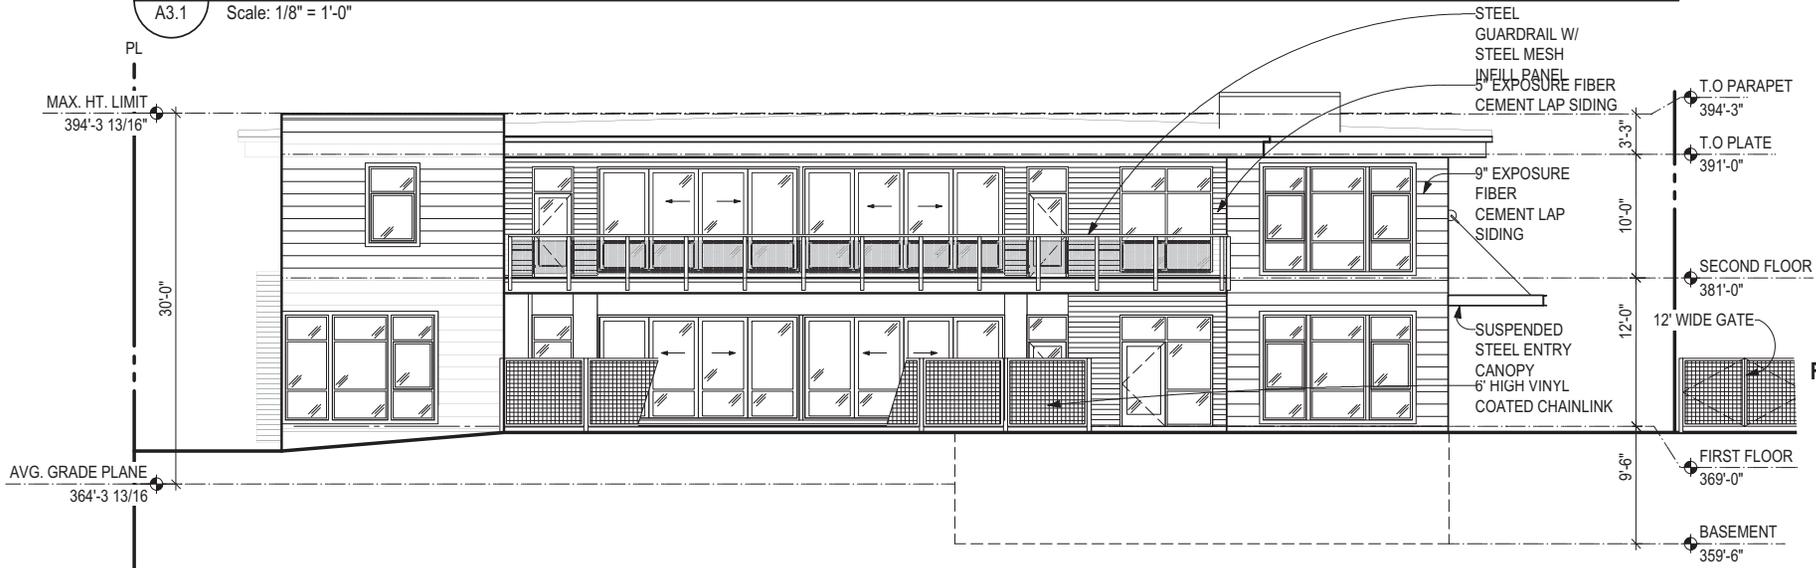
1 South Elevation
A3.1 Scale: 1/8" = 1'-0"

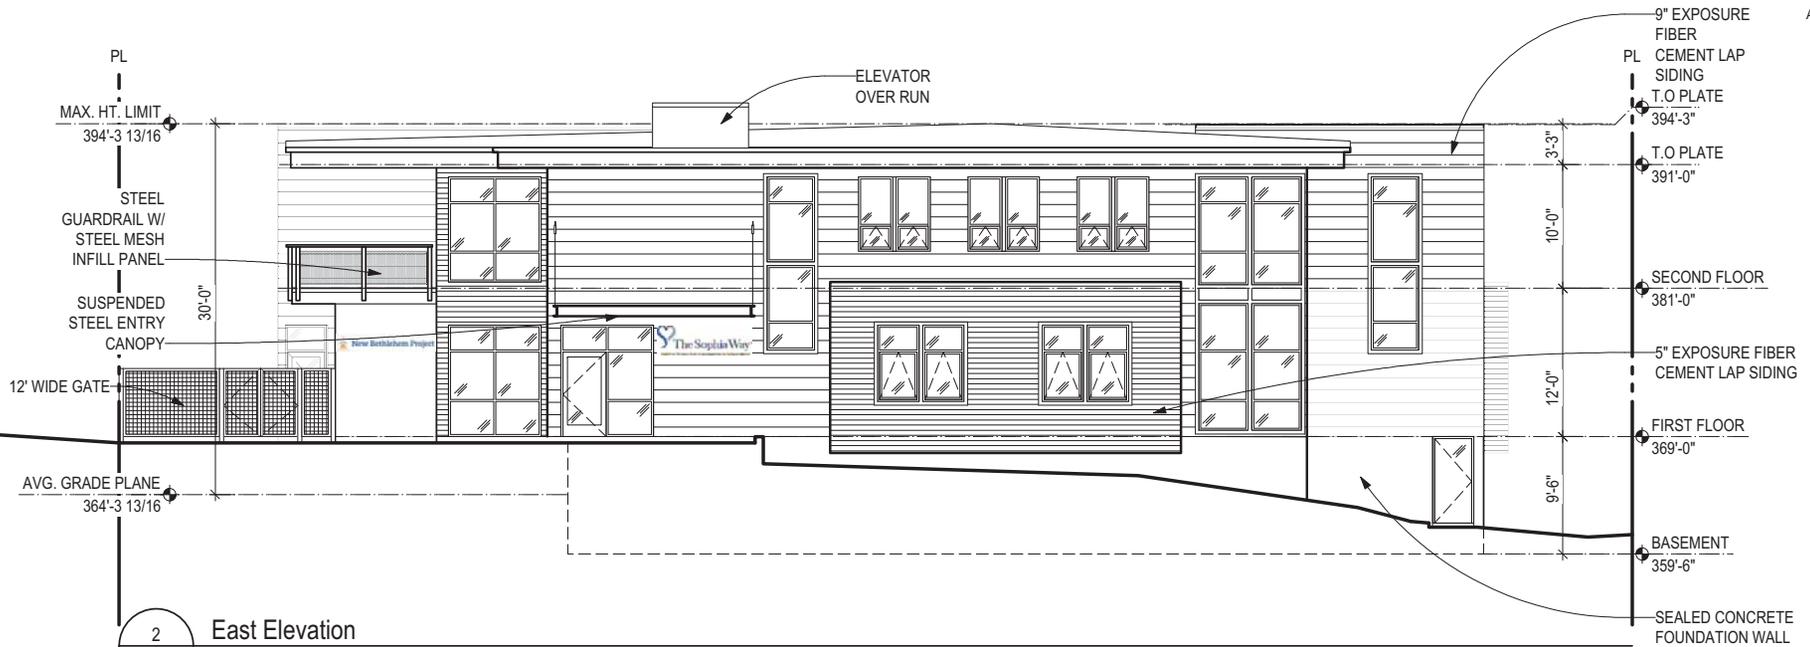
2 East Elevation
A3.2 Scale: 1/8" = 1'-0"

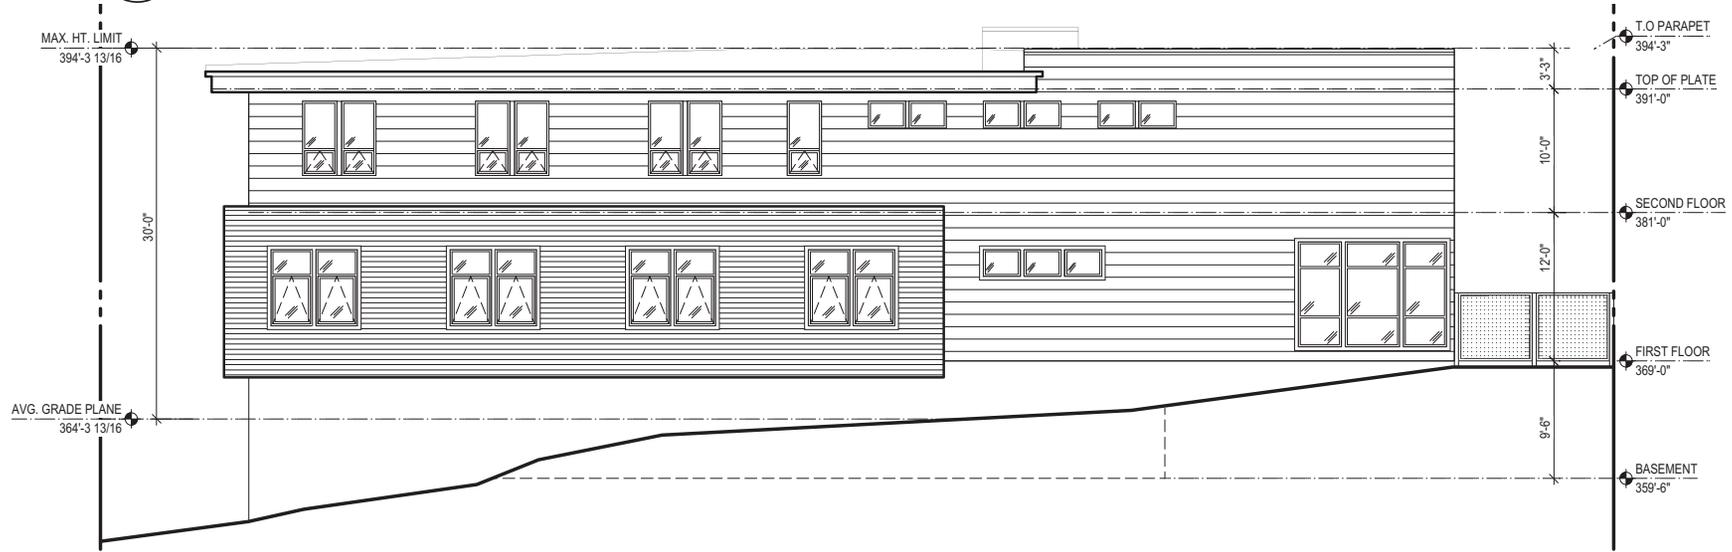
1 West Elevation
A3.2 Scale: 1/8" = 1'-0"

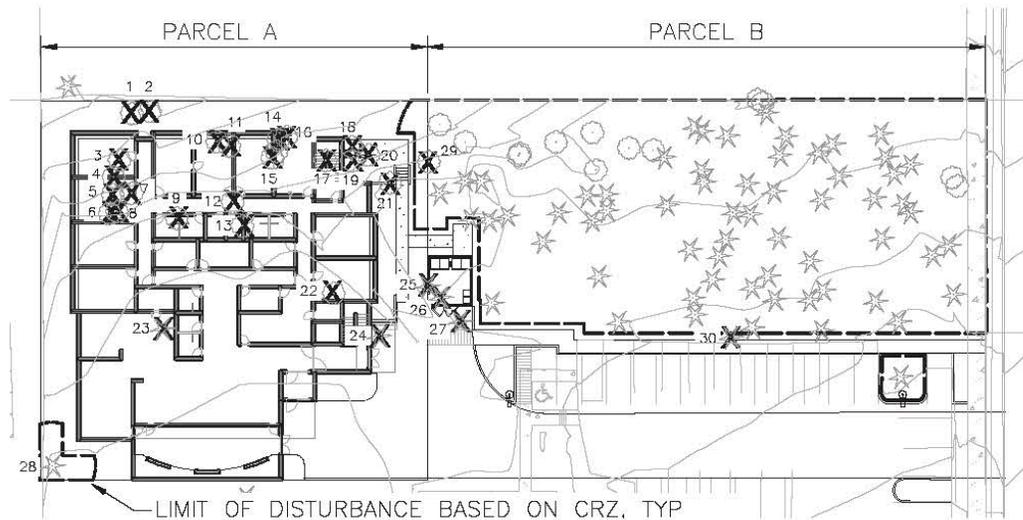
1. REFER TO SHEET L2.0 FOR PROPOSED TREES TO BE PLANTED
2. REFER TO ARBORIST REPORT FOR FULL DESCRIPTION OF EXISTING TREES

1 TREE RETENTION PLAN
SCALE: 1"=40'

- (f) Retain and protect trees with high retention and moderate retention value (if feasible)
 - (2) The applicant has submitted a Tree Plan, prepared by a certified arborist (see Attachment 12). The extent of the arborist's analysis was confined to the property upon which the shelter will be located and the portion of the Salt House property adjacent to the access and parking improvements, not the entire Salt House Church site. Specific information regarding the viability of each tree and recommendations for retention during construction, can be found in Attachment 3, Development Standards.

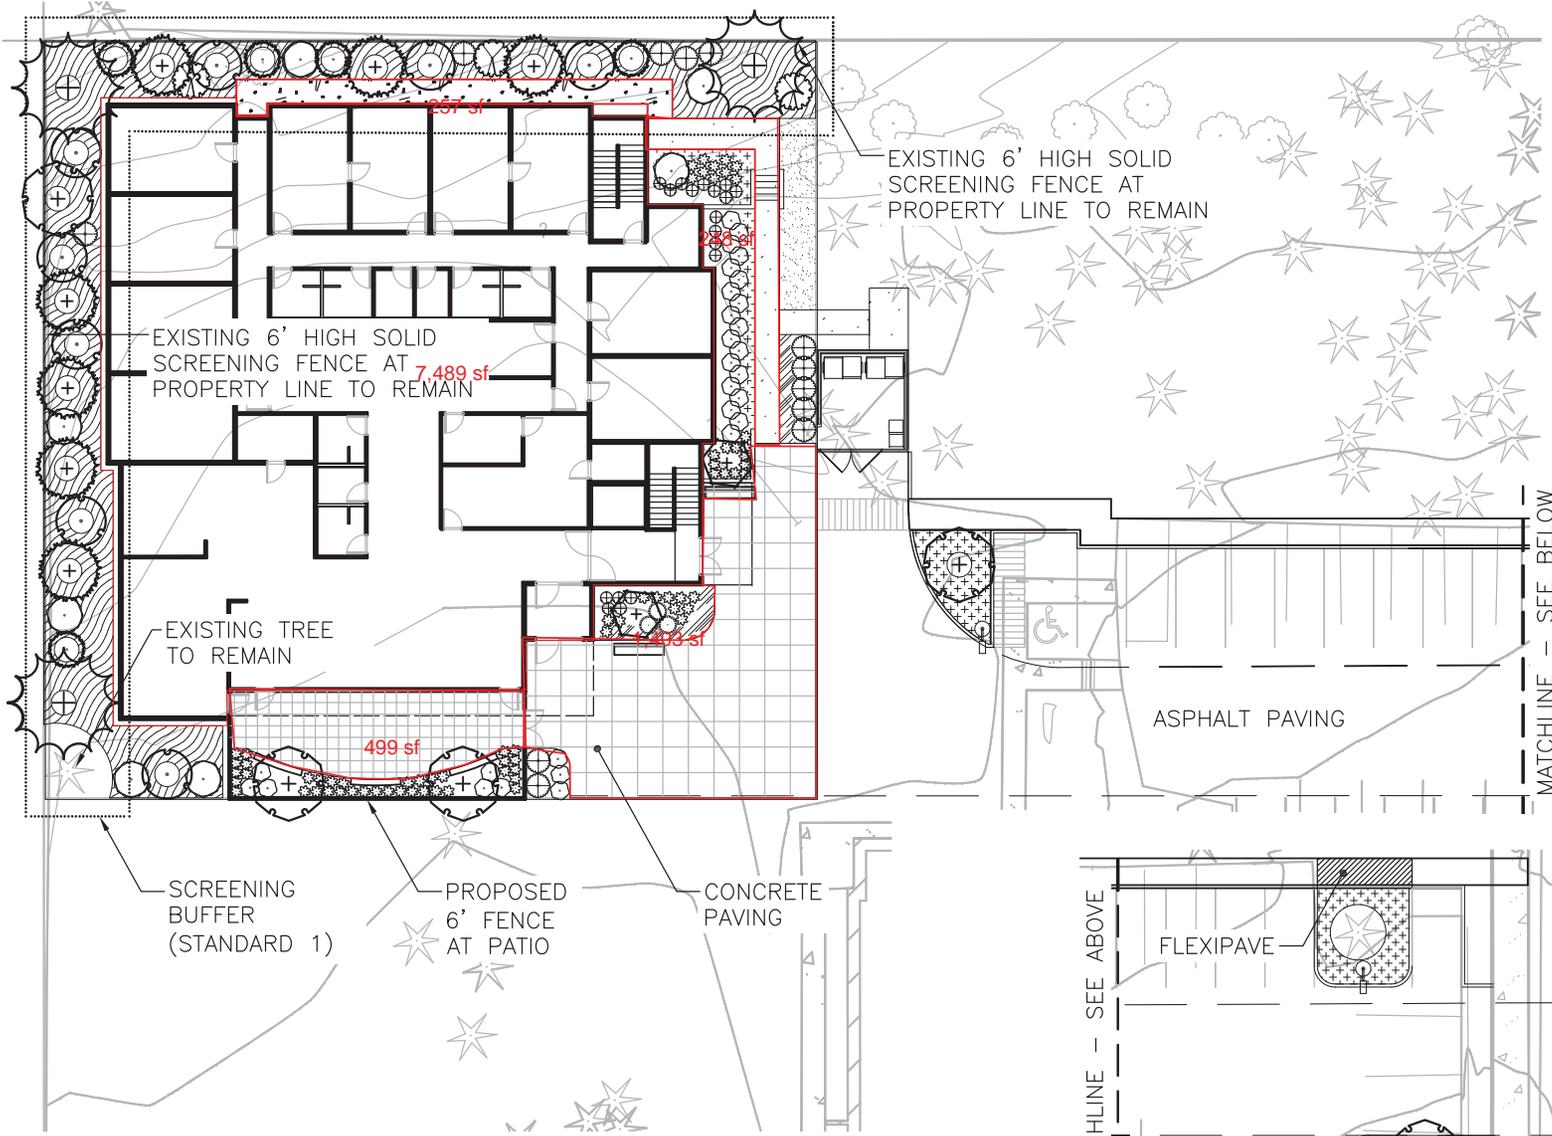
1 LANDSCAPE PLAN
SCALE: 1"=20'

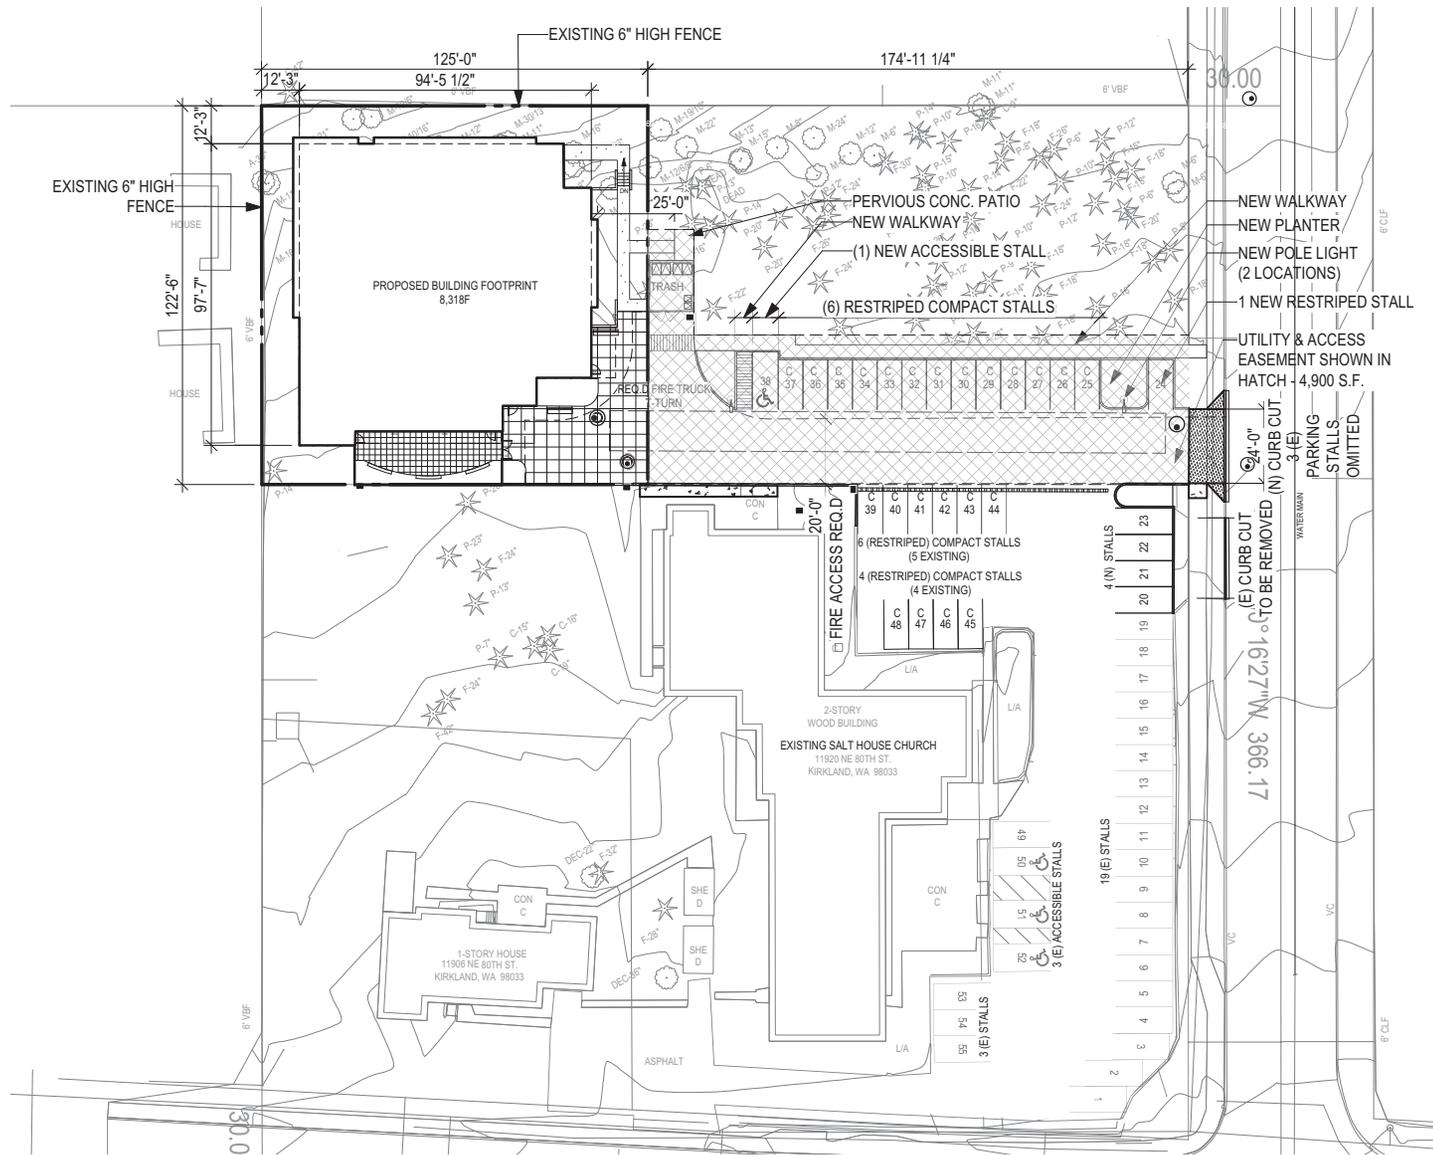
1
A1.1

SITE PLAN
Scale: 1" = 40'-0"

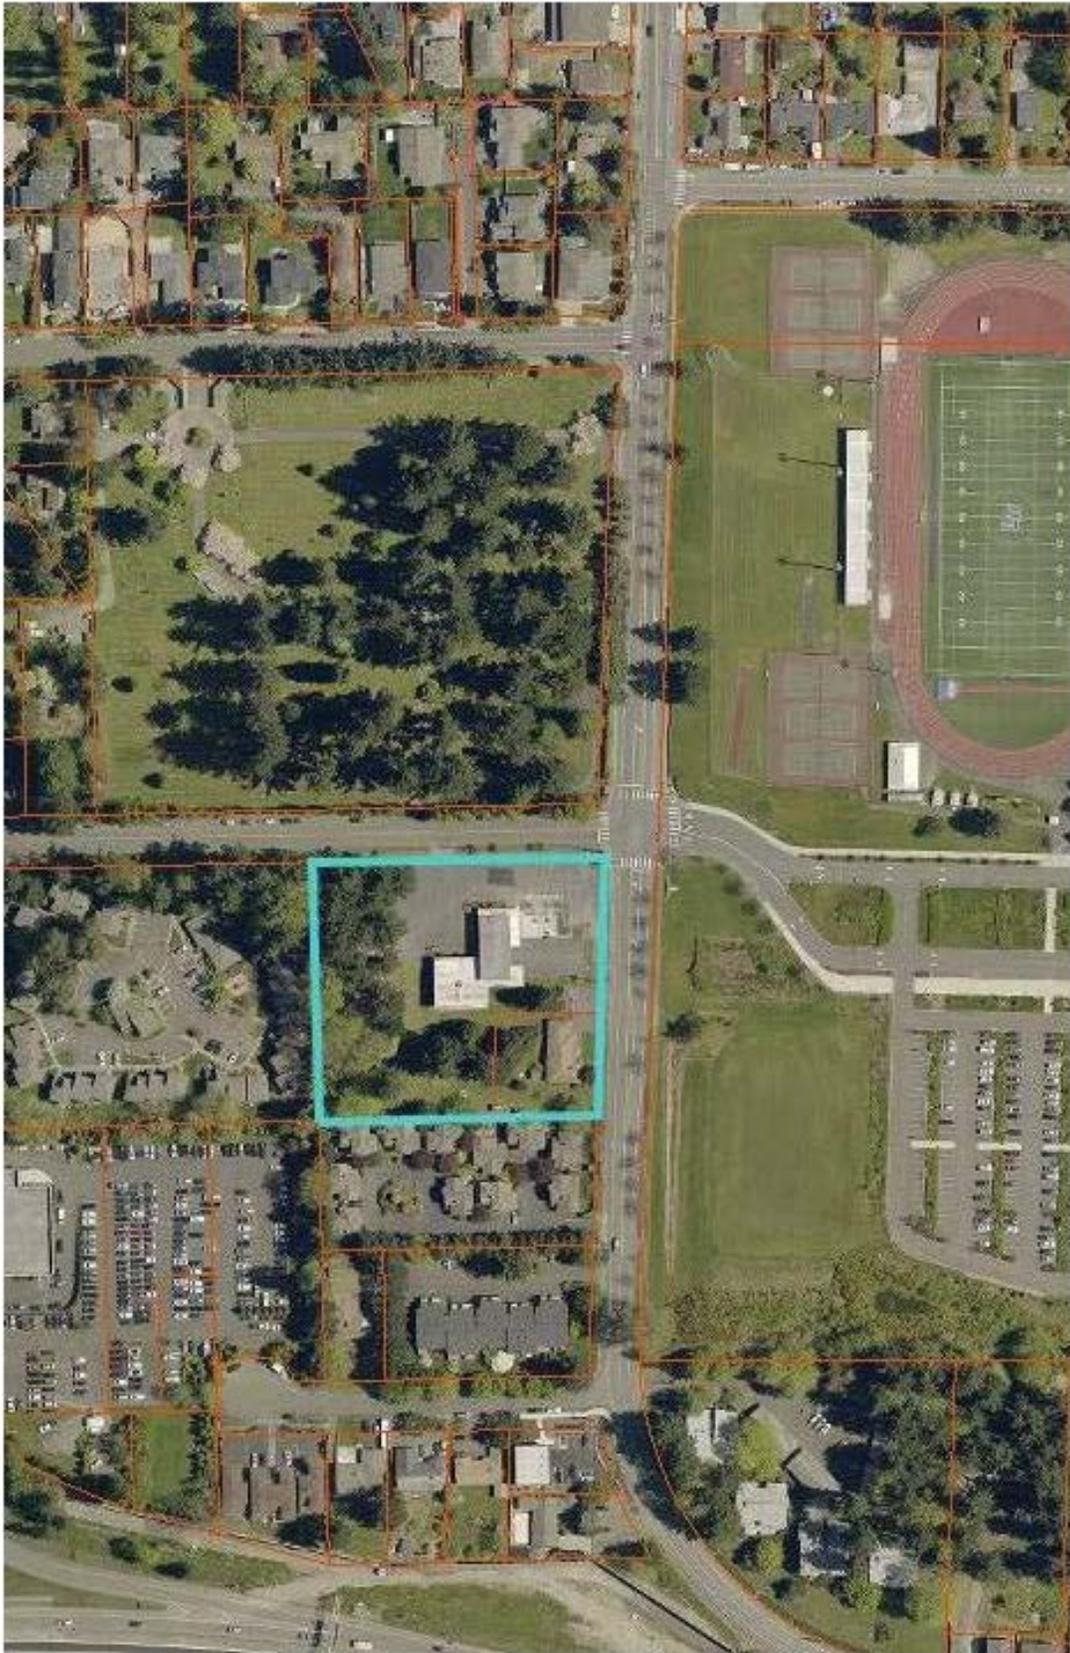
Parking Observations

Sophia's Place					
Thursday 12/8/2016					
Time	# Stalls	# Parked	% Parked	Guests	Rate (spaces / guest)
11:00 AM	27	8	29.6%	29	0.28
12:00 PM	27	10	37.0%	34	0.29
1:00 PM	27	9	33.3%	27	0.33
Friday 12/9/2016					
Time	# Stalls	# Parked	% Parked	Guests	Rate (spaces / guest)
11:00 AM	27	12	44.4%	33	0.36
12:00 PM	27	14	51.9%	38	0.37
1:00 PM	27	11	40.7%	34	0.32
Average Weekday Peak Parking Demand: 0.33 spaces / guest

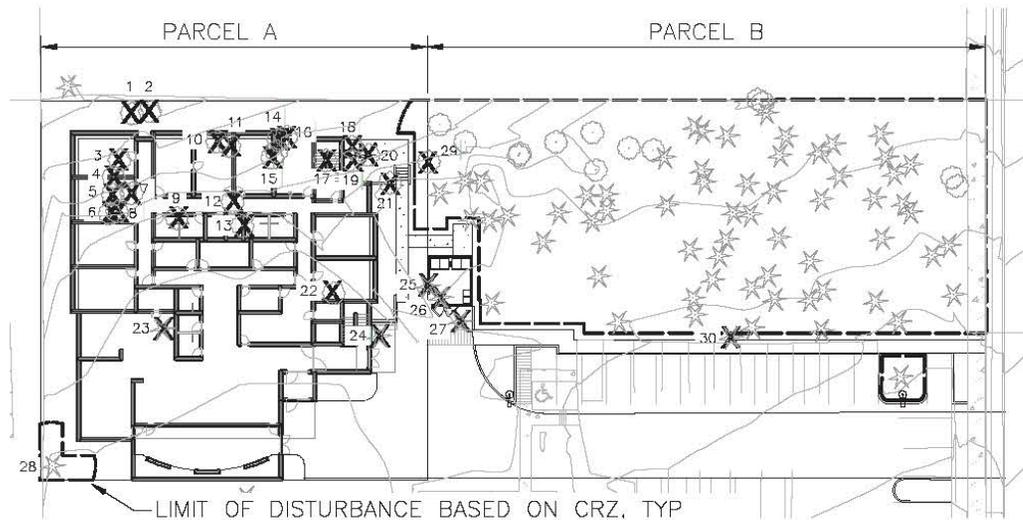
1. REFER TO SHEET L2.0 FOR PROPOSED TREES TO BE PLANTED
2. REFER TO ARBORIST REPORT FOR FULL DESCRIPTION OF EXISTING TREES

1 TREE RETENTION PLAN
SCALE: 1"=40'

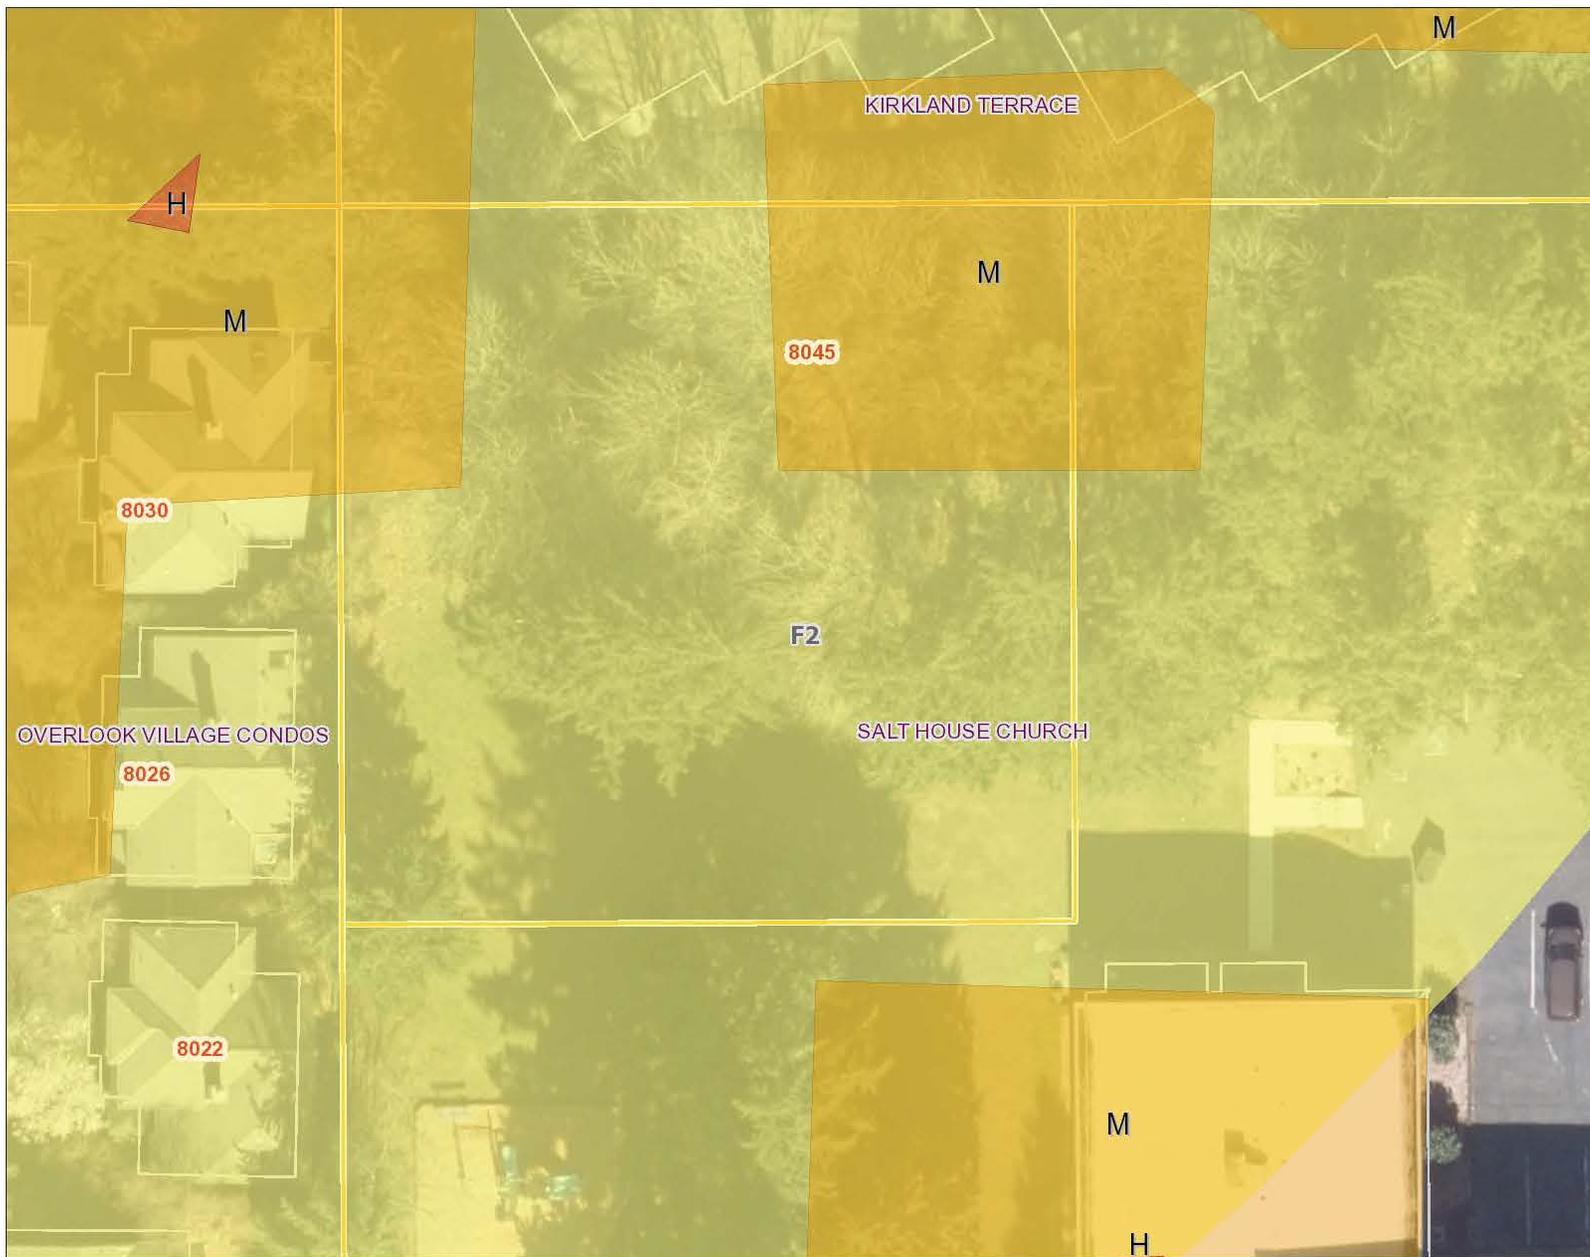
City of Kirkland GIS

- (2) The City's Geological Hazardous Areas Map situates the subject property in an area of moderate landslide susceptibility and medium or mixed liquefaction (seismic potential) (see Attachment 13).

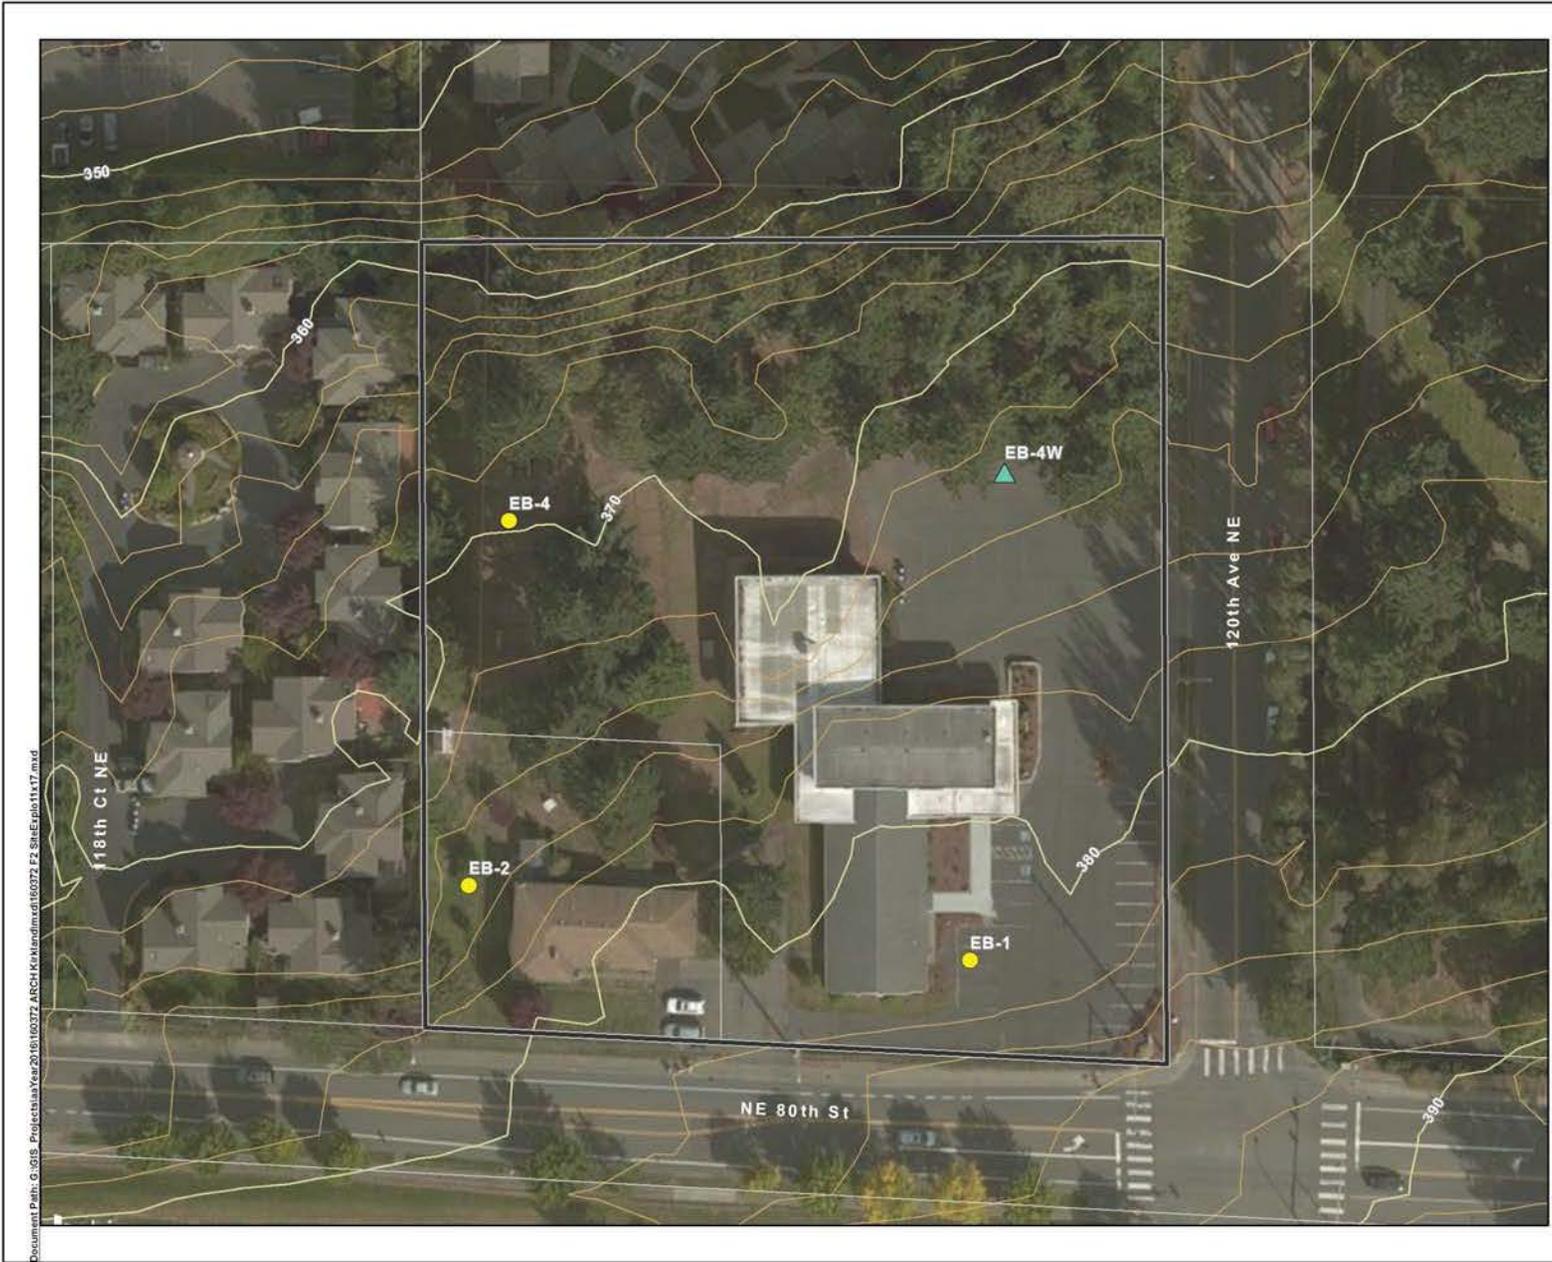
PROJ. NO.	DATE	FIGURE
EE160372A	10/16	2

- LEGEND:**
- EXPLORATION BORING
 - ▲ EXPLORATION BORING / MONITORING WELL
 - SITE
 - PARCEL
 - ~ CONTOUR 2 FT
 - ~ CONTOUR 10 FT
