ADVISORY REPORT
FINDINGS, CONCLUSIONS, AND RECOMMENDATIONS

File: ZON18-00720 for Kirkland Shelter

3. Request: Construction of a 19,508 square foot shelter for women and families with children. Access will be provided by a 48.5-foot access and utility easement across parcel 123310-0170 (Salt House Church, 11920 NE 80th Street). Parking for the shelter will be shared with the Salt House Church, and available on-street parking along 120th Ave NE (see Attachment 2).

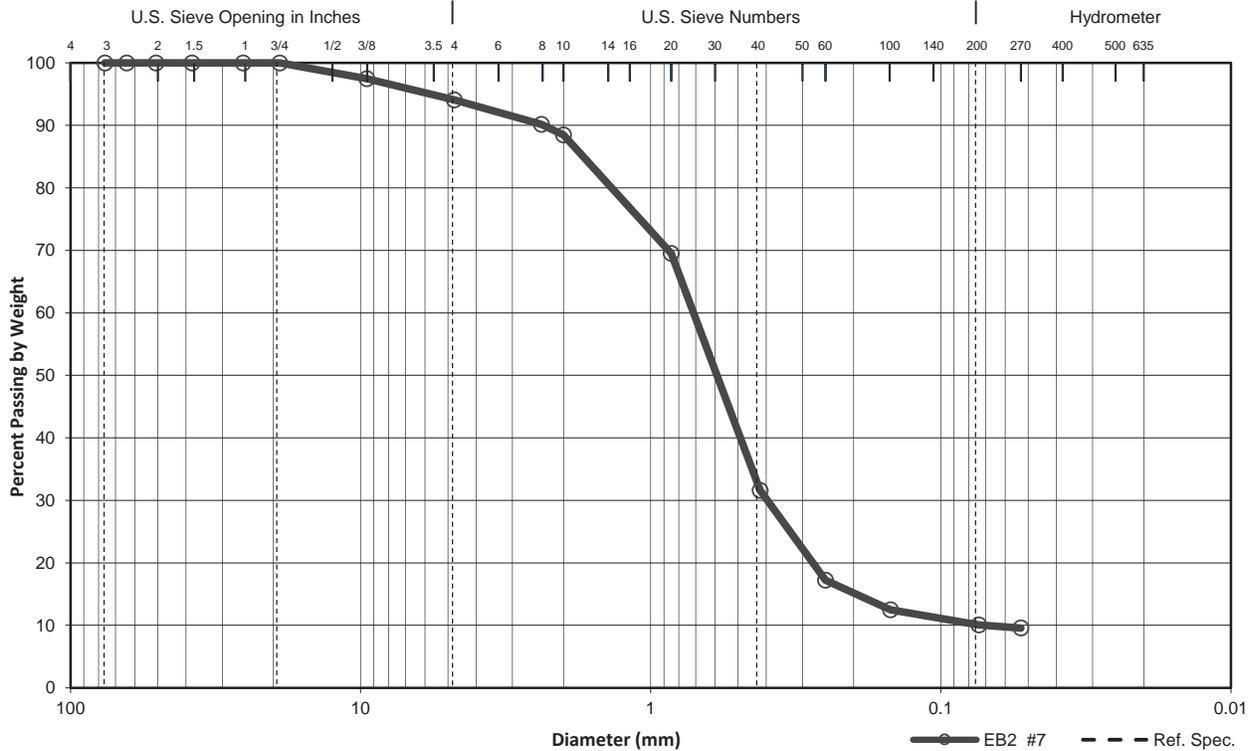
GRAIN SIZE ANALYSIS - MECHANICAL ASTM D422

Project Name ARCH Kirkland	Project Number EE160372A	Date Sampled 9/22/2016	Date Tested 10/7/2016	Tested By MS
Sample Source Onsite	Sample No. EB2 #7	Depth (ft) 25	Soil Description SAND, some silt, some gravel (SP-SM)	
Total Sample Dry Wt. (g) 580.1	Moisture Content (%) 7	D ₁₀ (mm) 0.071	Reference Specification

Sieve No.	Diam. (mm)	Cum. Wt. Ret. (g)	% Ret. by Wt.	% Passing by Wt.	% Specs. Pass. by Wt.	
					Min	Max
3	76.1		0.0	100.0		
2.5	64		0.0	100.0		
2	50.8		0.0	100.0		
1.5	38.1		0.0	100.0		
1	25.4		0.0	100.0		
3/4	19		0.0	100.0		
3/8	9.51	14.7	2.5	97.5		
#4	4.76	34.2	5.9	94.1		
#8	2.38	57.2	9.9	90.1		
#10	2	66.8	11.5	88.5		
#20	0.85	177.0	30.5	69.5		
#40	0.42	396.8	68.4	31.6		
#60	0.25	480.1	82.8	17.2		
#100	0.149	507.5	87.5	12.5		
#200	0.074	521.7	89.9	10.1		
#270	0.053	524.6	90.4	9.6

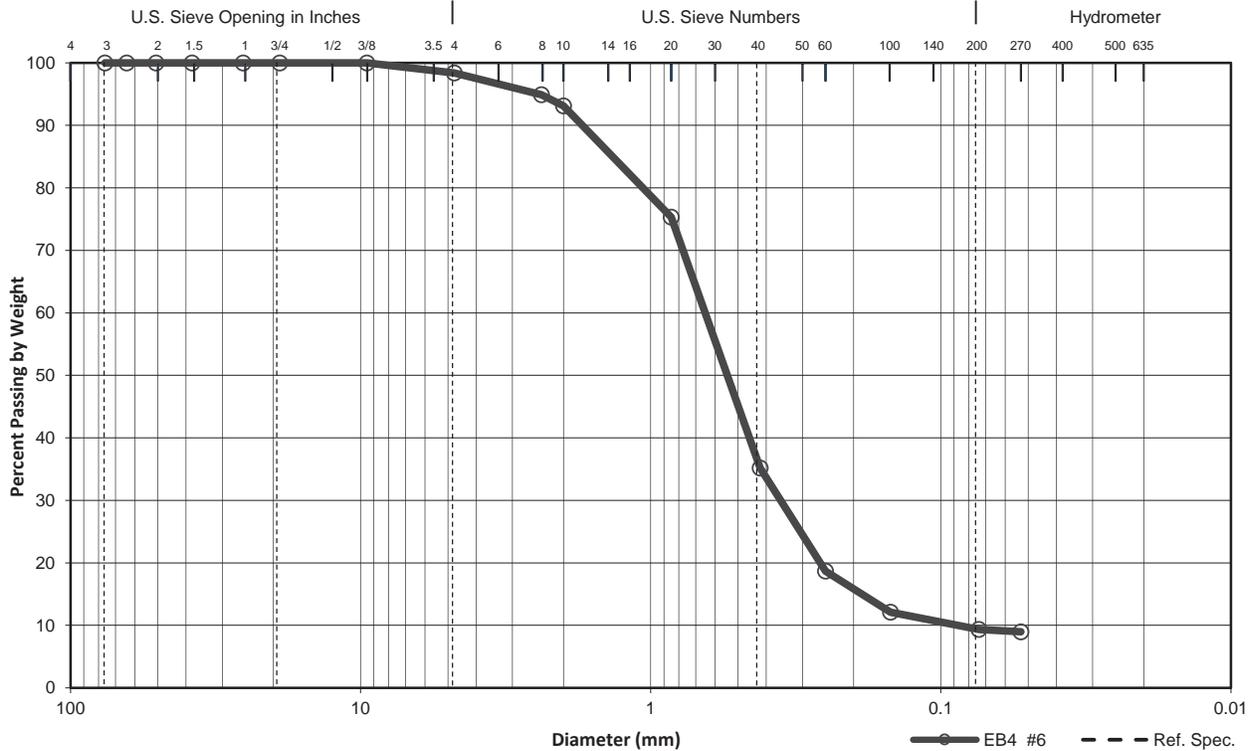
GRAIN SIZE ANALYSIS - MECHANICAL ASTM D422

Project Name ARCH Kirkland	Project Number EE160372A	Date Sampled 9/22/2016	Date Tested 10/7/2016	Tested By MS
Sample Source Onsite	Sample No. EB4 #6	Depth (ft) 20	Soil Description SAND, some silt, trace gravel (SW-SM)	
Total Sample Dry Wt. (g) 559.7	Moisture Content (%) 8	D ₁₀ (mm) 0.086	Reference Specification

Sieve No.	Diam. (mm)	Cum. Wt. Ret. (g)	% Ret. by Wt.	% Passing by Wt.	% Specs. Pass. by Wt.	
					Min	Max
3	76.1		0.0	100.0		
2.5	64		0.0	100.0		
2	50.8		0.0	100.0		
1.5	38.1		0.0	100.0		
1	25.4		0.0	100.0		
3/4	19		0.0	100.0		
3/8	9.51		0.0	100.0		
#4	4.76	9.0	1.6	98.4		
#8	2.38	28.5	5.1	94.9		
#10	2	38.6	6.9	93.1		
#20	0.85	138.1	24.7	75.3		
#40	0.42	362.7	64.8	35.2		
#60	0.25	455.2	81.3	18.7		
#100	0.149	491.8	87.9	12.1		
#200	0.074	507.2	90.6	9.4		
#270	0.053	509.4	91.0	9.0
