REFERENCE: Arborist Report

SITE ADDRESS: Forbes Creek, TPN 3890100050 & 3890100055.

DATE: November 20, 2017

PREPARED BY: Favero Greenforest, ISA Certified Arborist # PN -0143A
 ISA Tree Risk Assessment Qualified
 ASCA Registered Consulting Arborist® #379

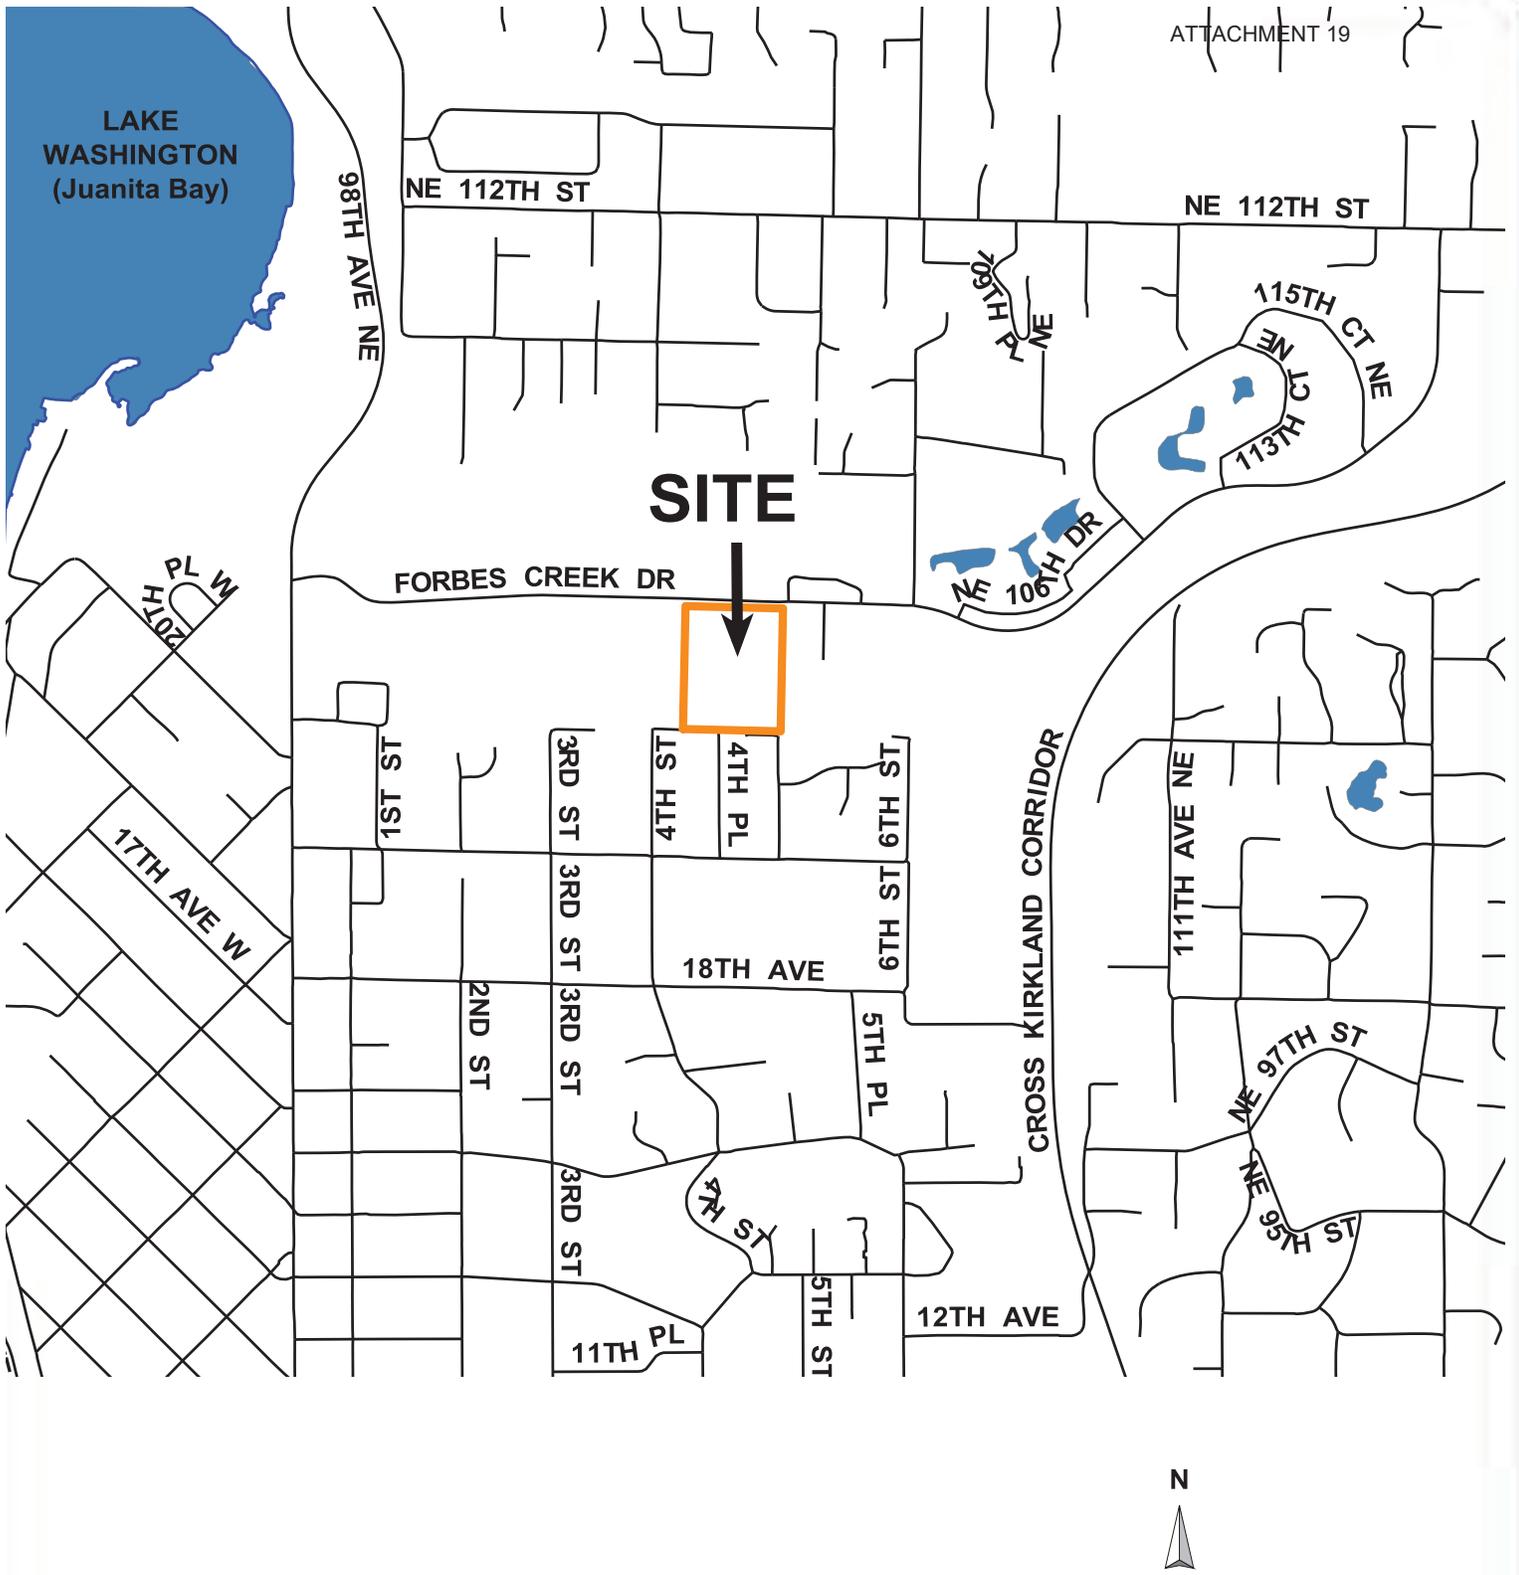
VICINITY MAP
ORCAS MOON PROJECT
KIRKLAND, WASHINGTON

Reference: GIS parcel, road, and water body data from City of Kirkland, 2015.

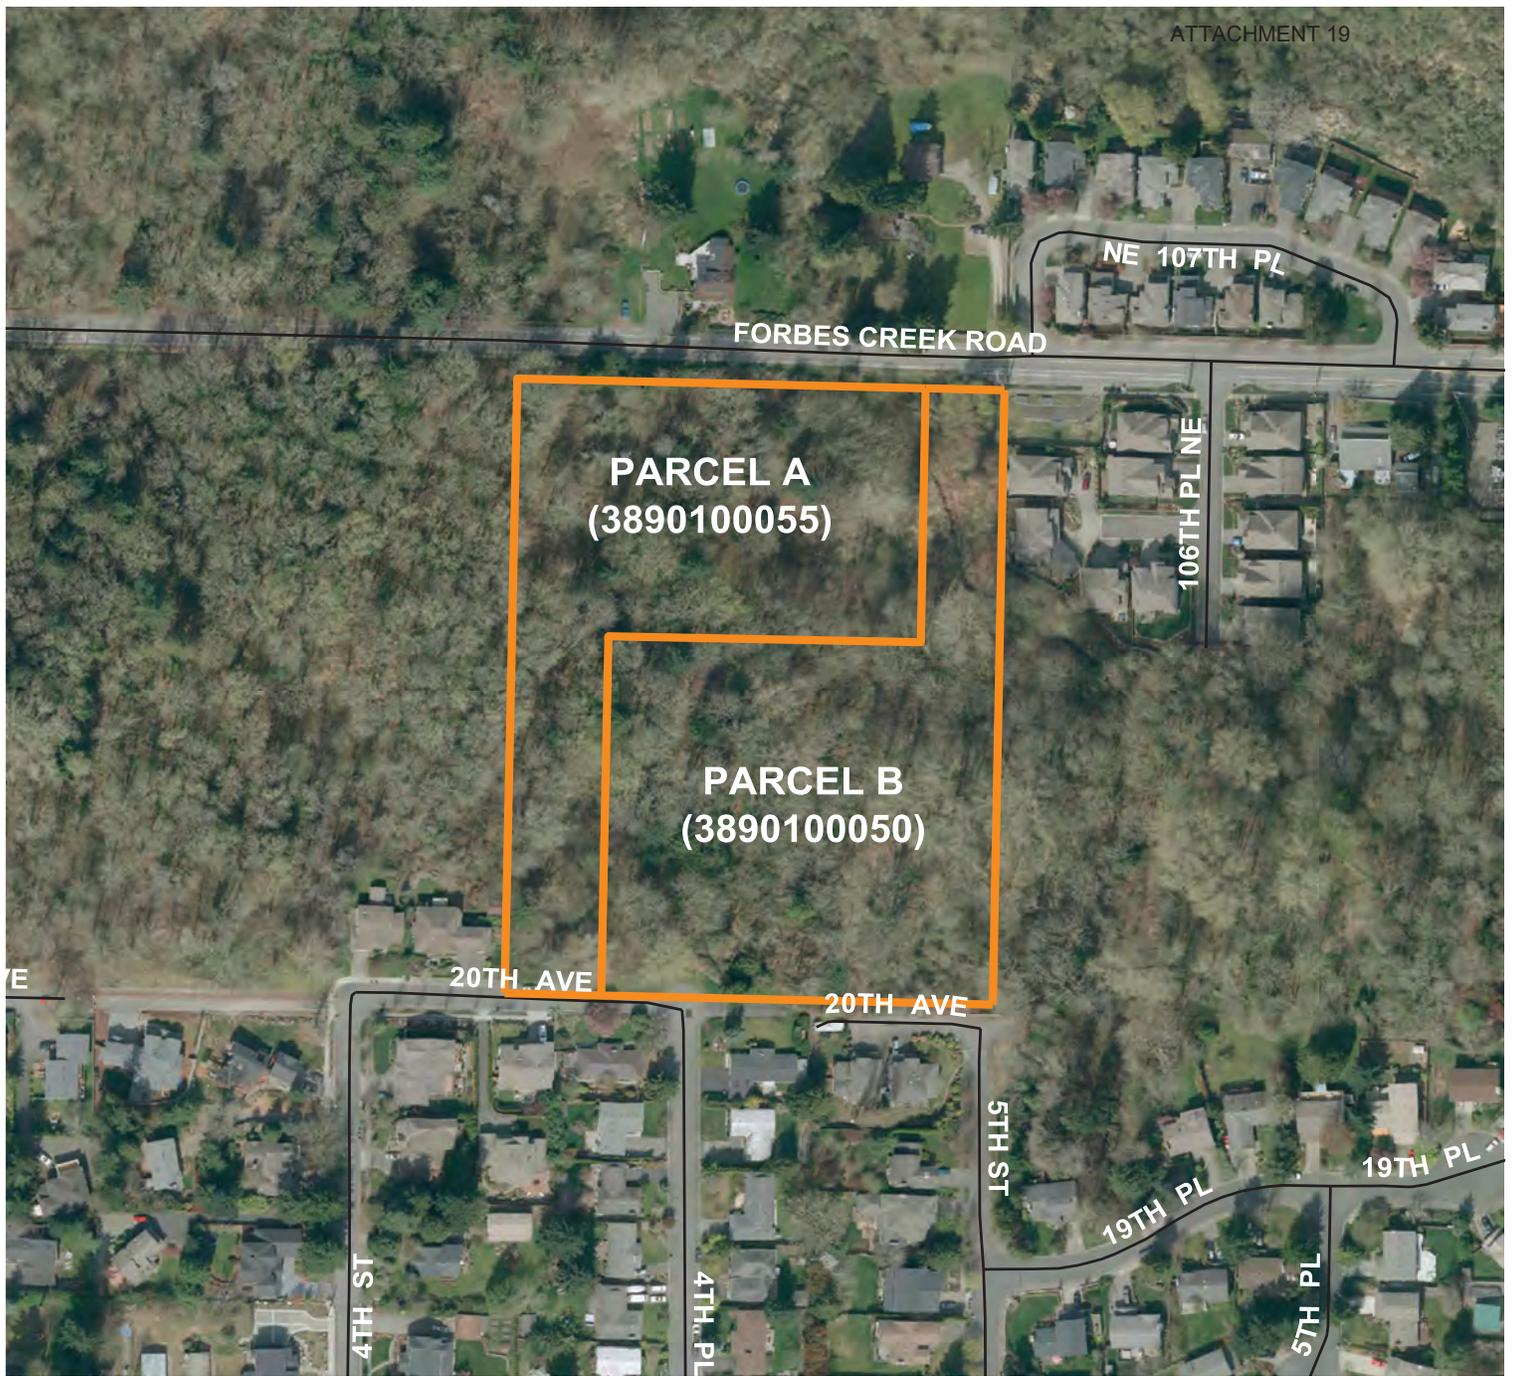
SITE MAP
 ORCAS MOON PROJECT
 KIRKLAND, WASHINGTON

Reference: GIS parcel and road data from City of Kirkland, 2015.
 Aerial image 2012 from Earth Explorer, downloaded 2016).

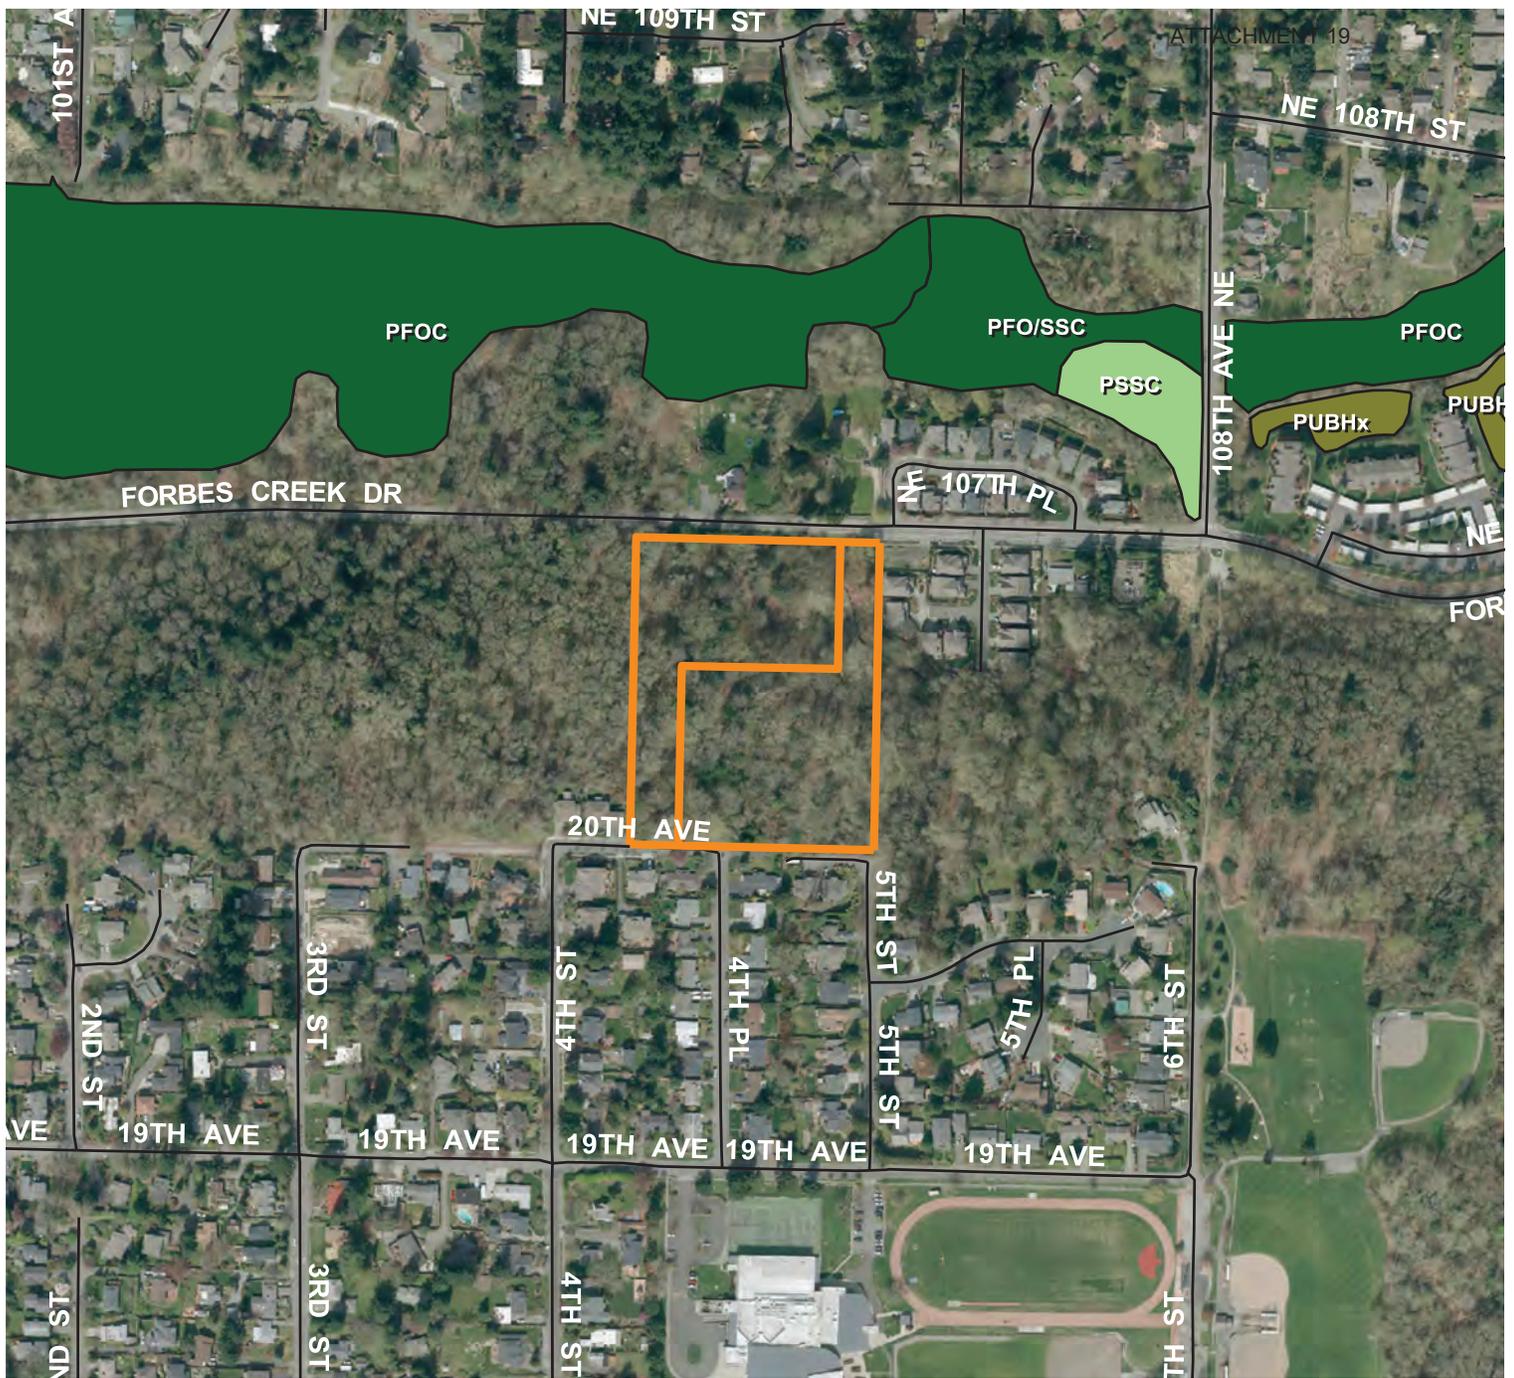
FIGURE 3

Reference: GIS parcel and road data from City of Kirkland, 2015.
 National Wetlands Inventory GIS data from USFWS, 2012. Aerial
 image 2012 from Earth Explorer, downloaded 2016.

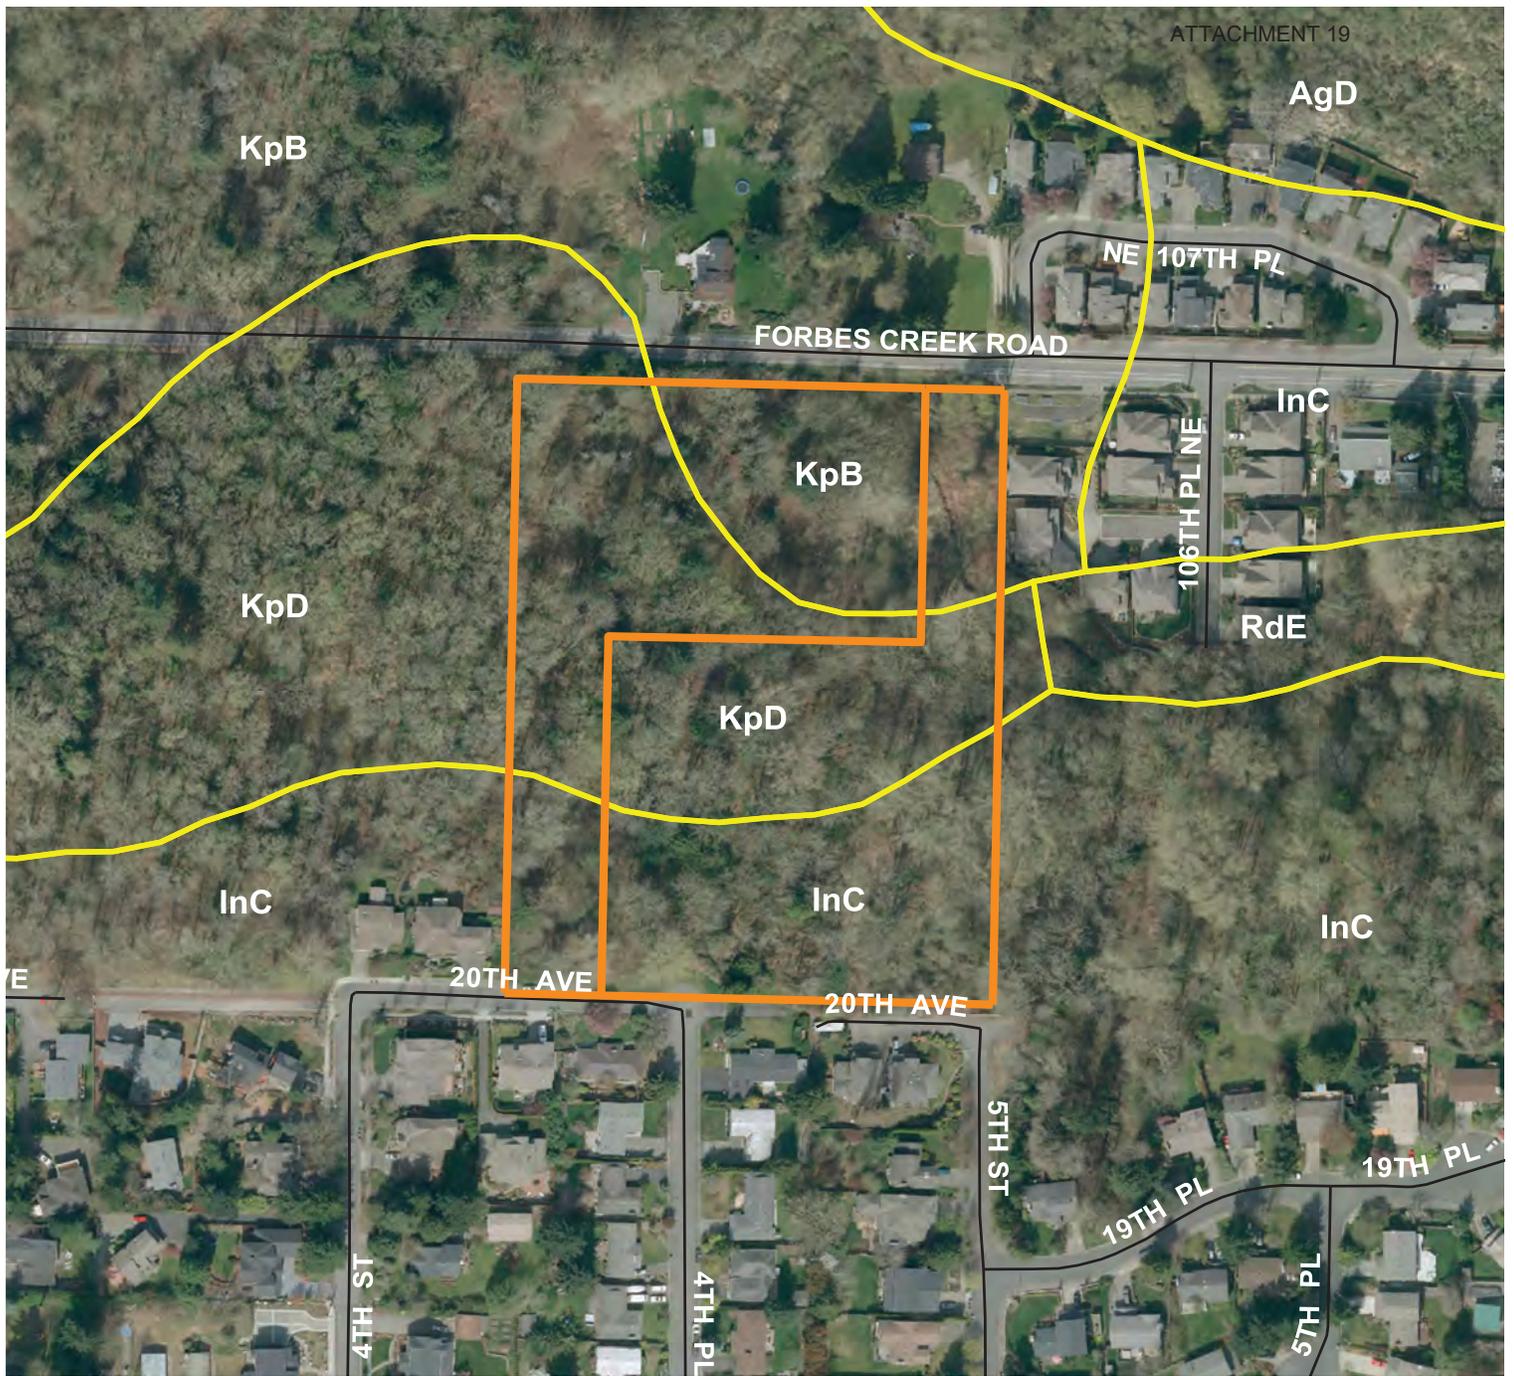
SOIL KEY

- AgD - Alderwood gravelly sandy loam, 15 to 30 percent slope
- InC - Indianola lomay sand, 5 to 15 percent slope
- KpB - Kitsap silt loam, 2 to 8 percent slope
- KpD - Kitsap silt loam, 15 to 30 percent slope

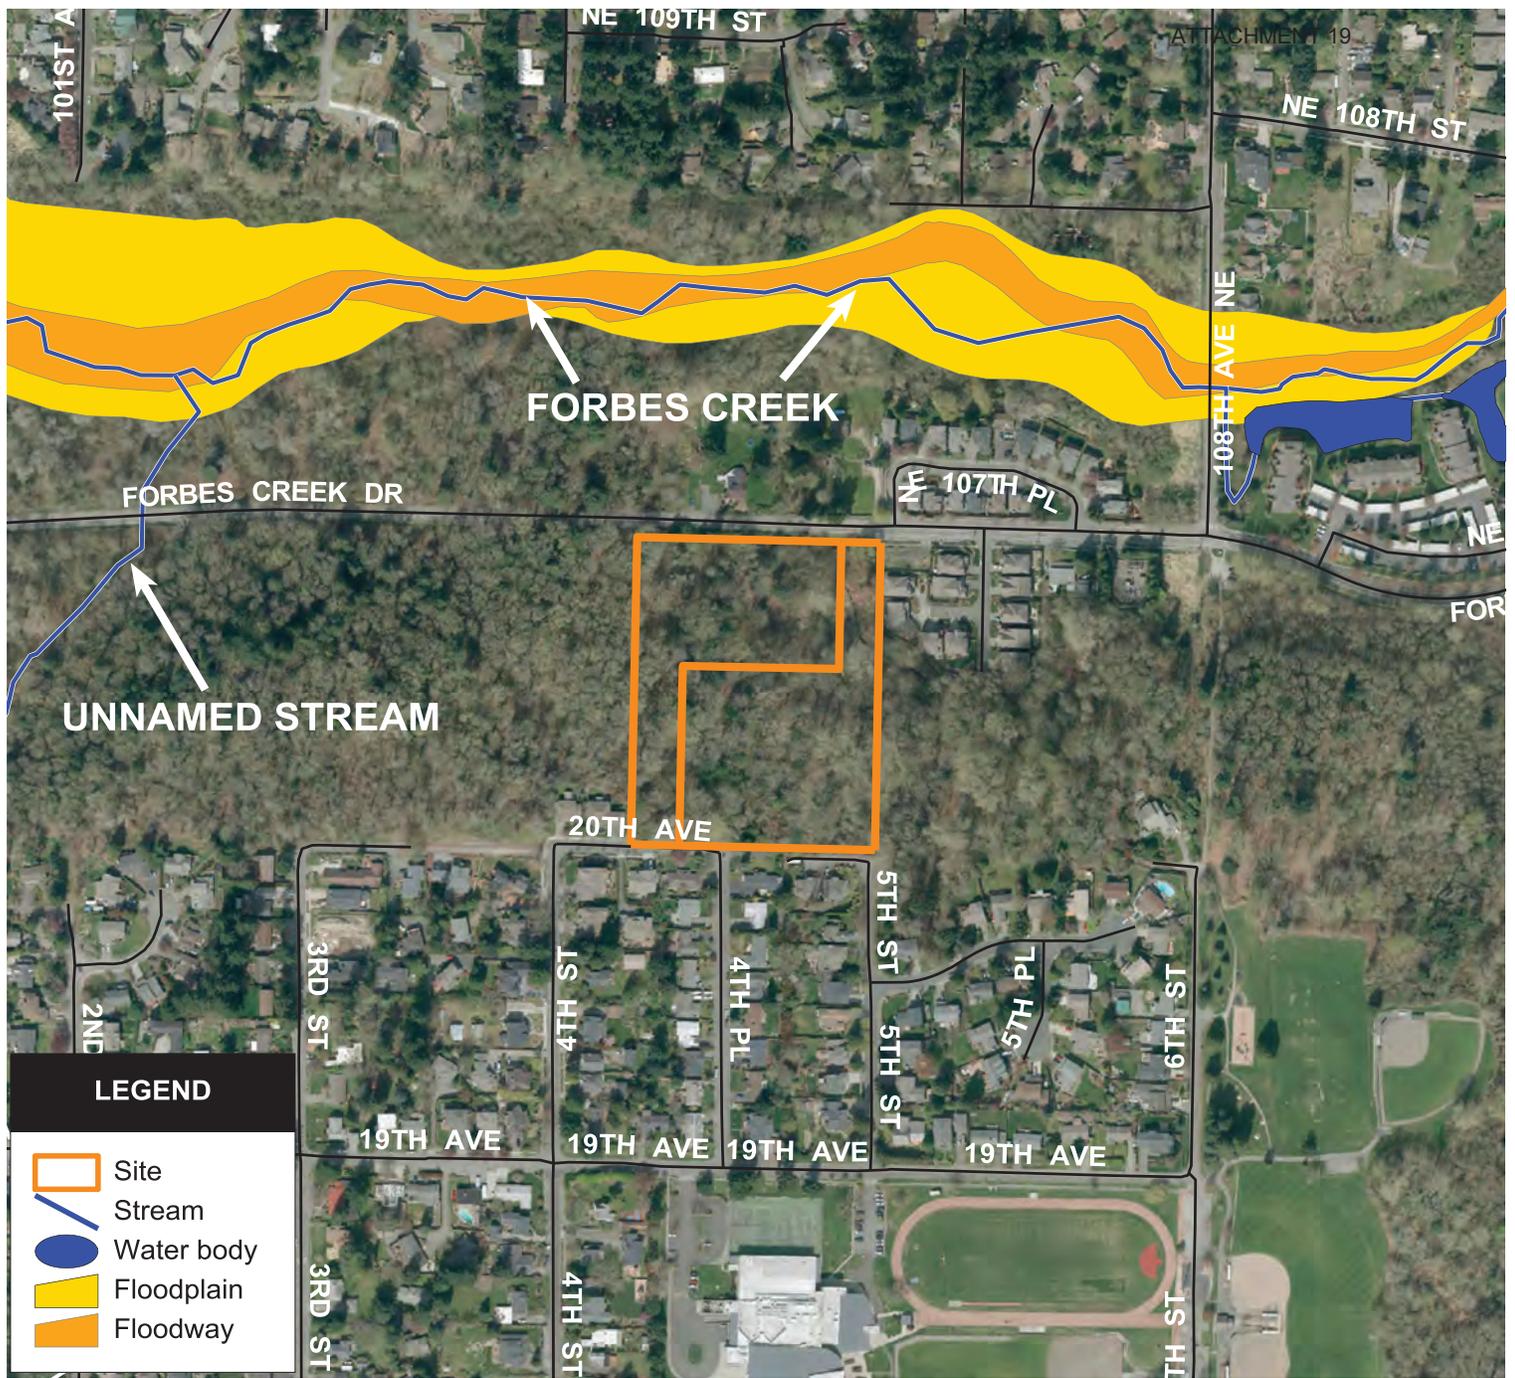
KING COUNTY CRITICAL AREAS GIS DATA
 ORCAS MOON PROJECT
 KIRKLAND, WASHINGTON

Reference: GIS parcel and road data from City of Kirkland, 2015.
 Stream, water body, floodway, and floodplain data from King County GIS, 2015. Aerial image 2012 from Earth Explorer, downloaded 2016.

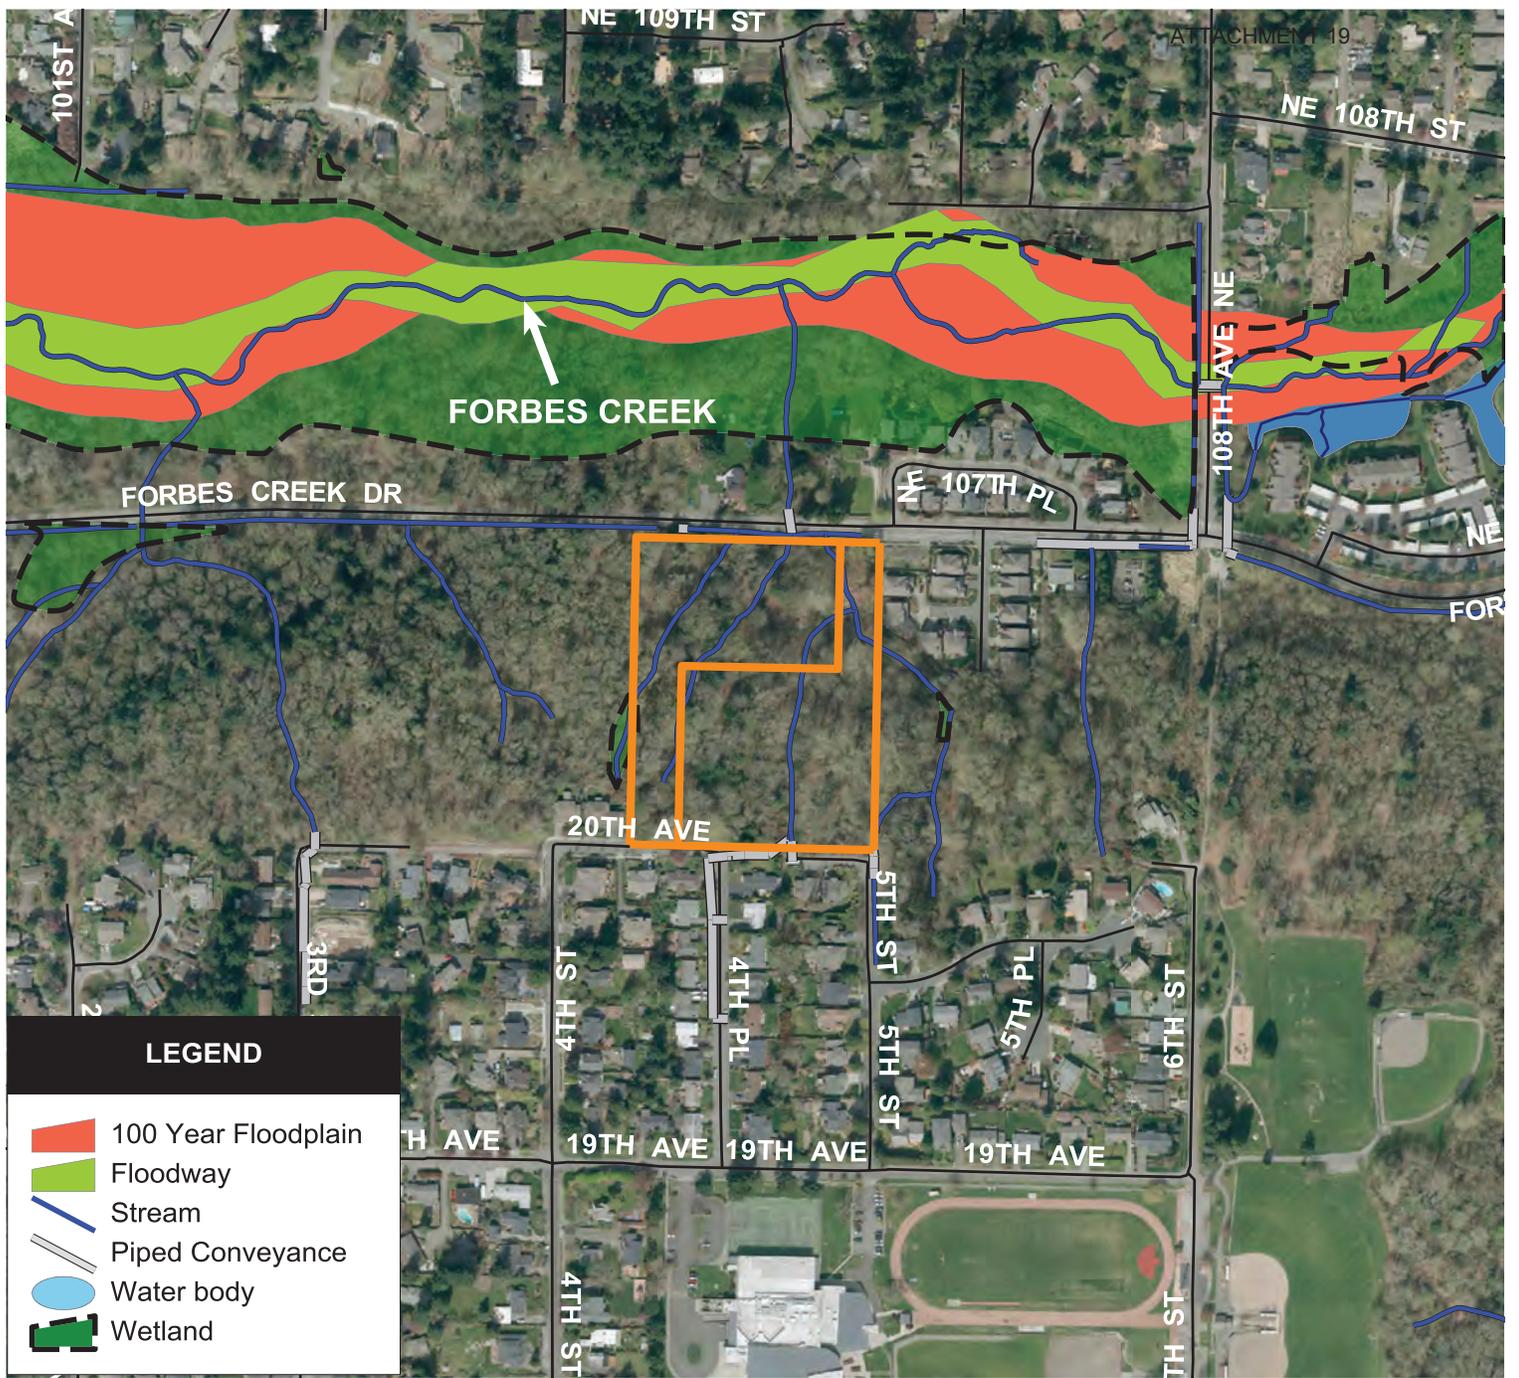
FIGURE 6

Reference: GIS parcel, road, stream, wetland, water body, floodplain, and floodway data from City of Kirkland, 2015.
Aerial image 2012 from Earth Explorer, 2016.

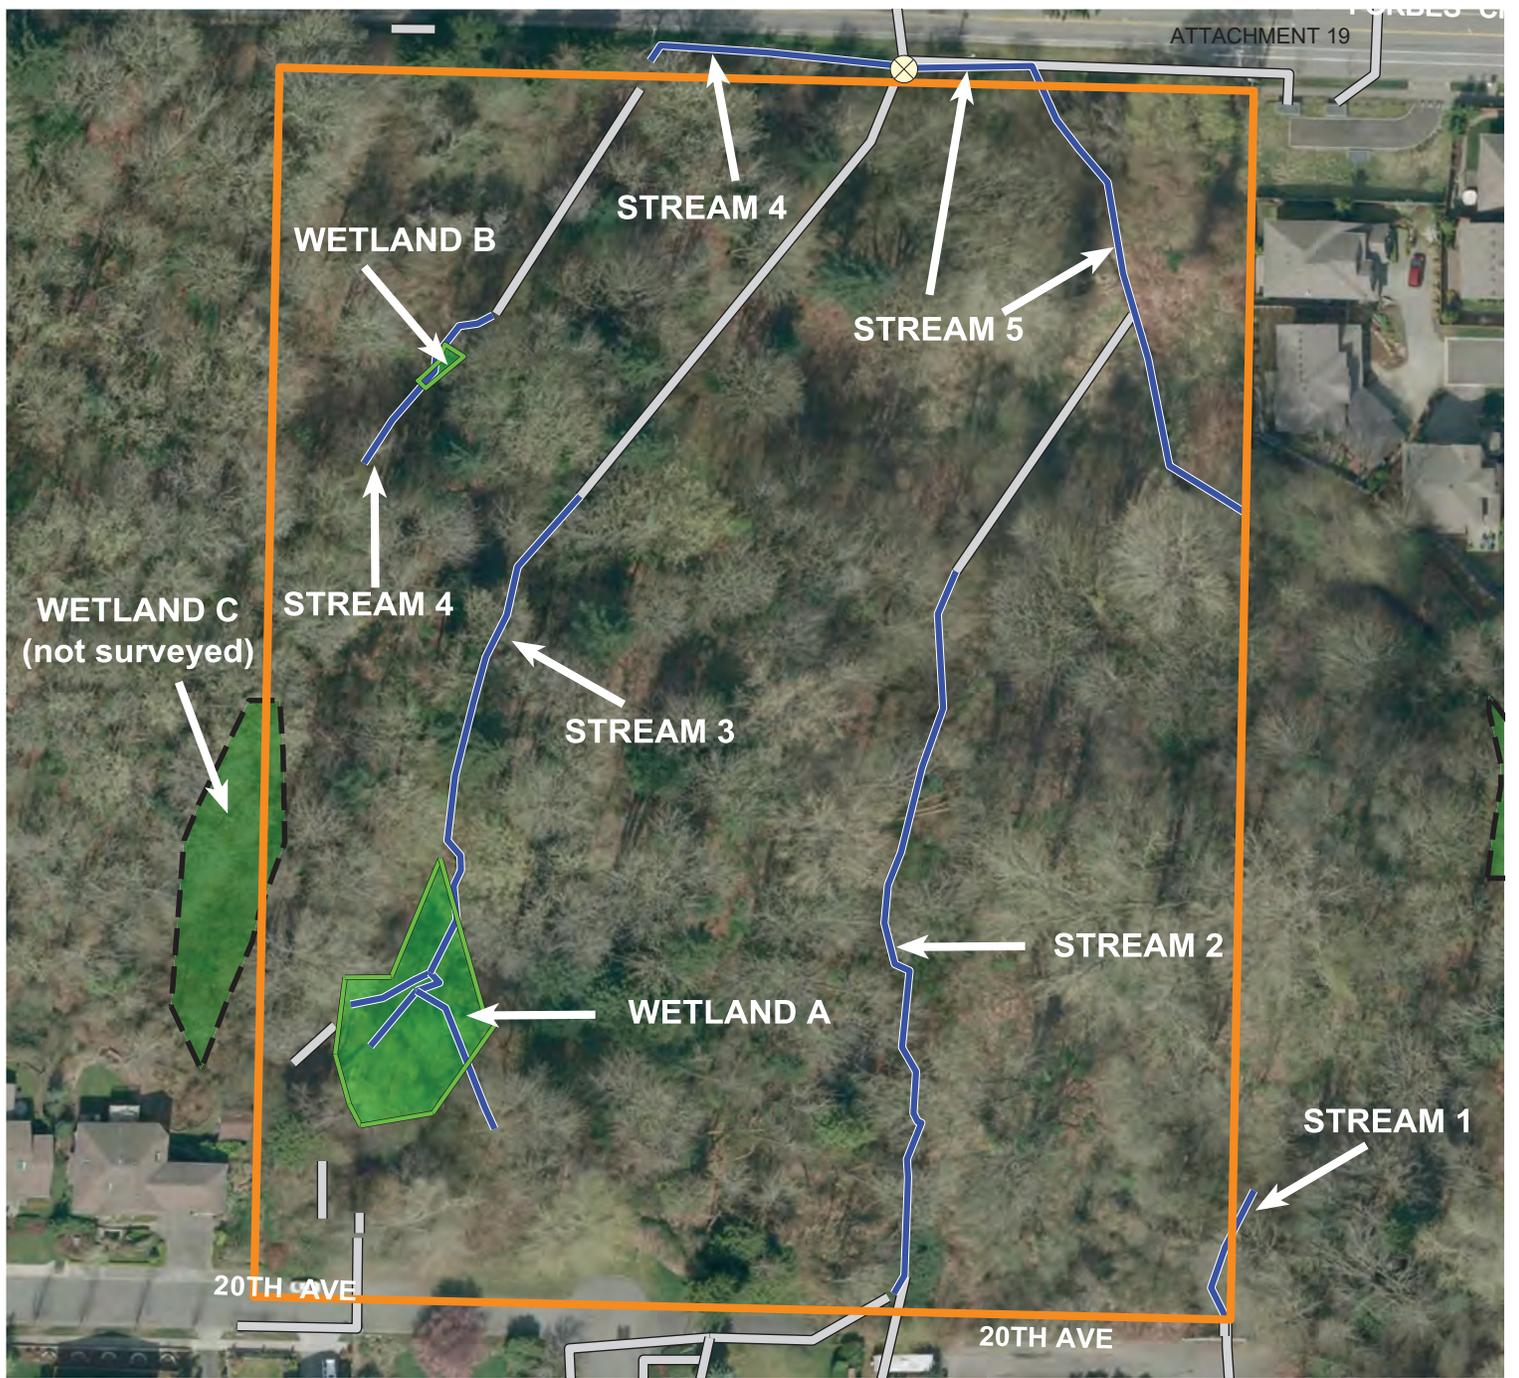
WETLAND AND STREAM MAP
 ORCAS MOON PROJECT
 KIRKLAND, WASHINGTON

Reference: GIS parcel and wetland data from City of Kirkland, 2015.
 Surveyed stream and wetland data provided by Blueline Group, 2016.
 Aerial image 2012 from Earth Explorer, downloaded 2016.

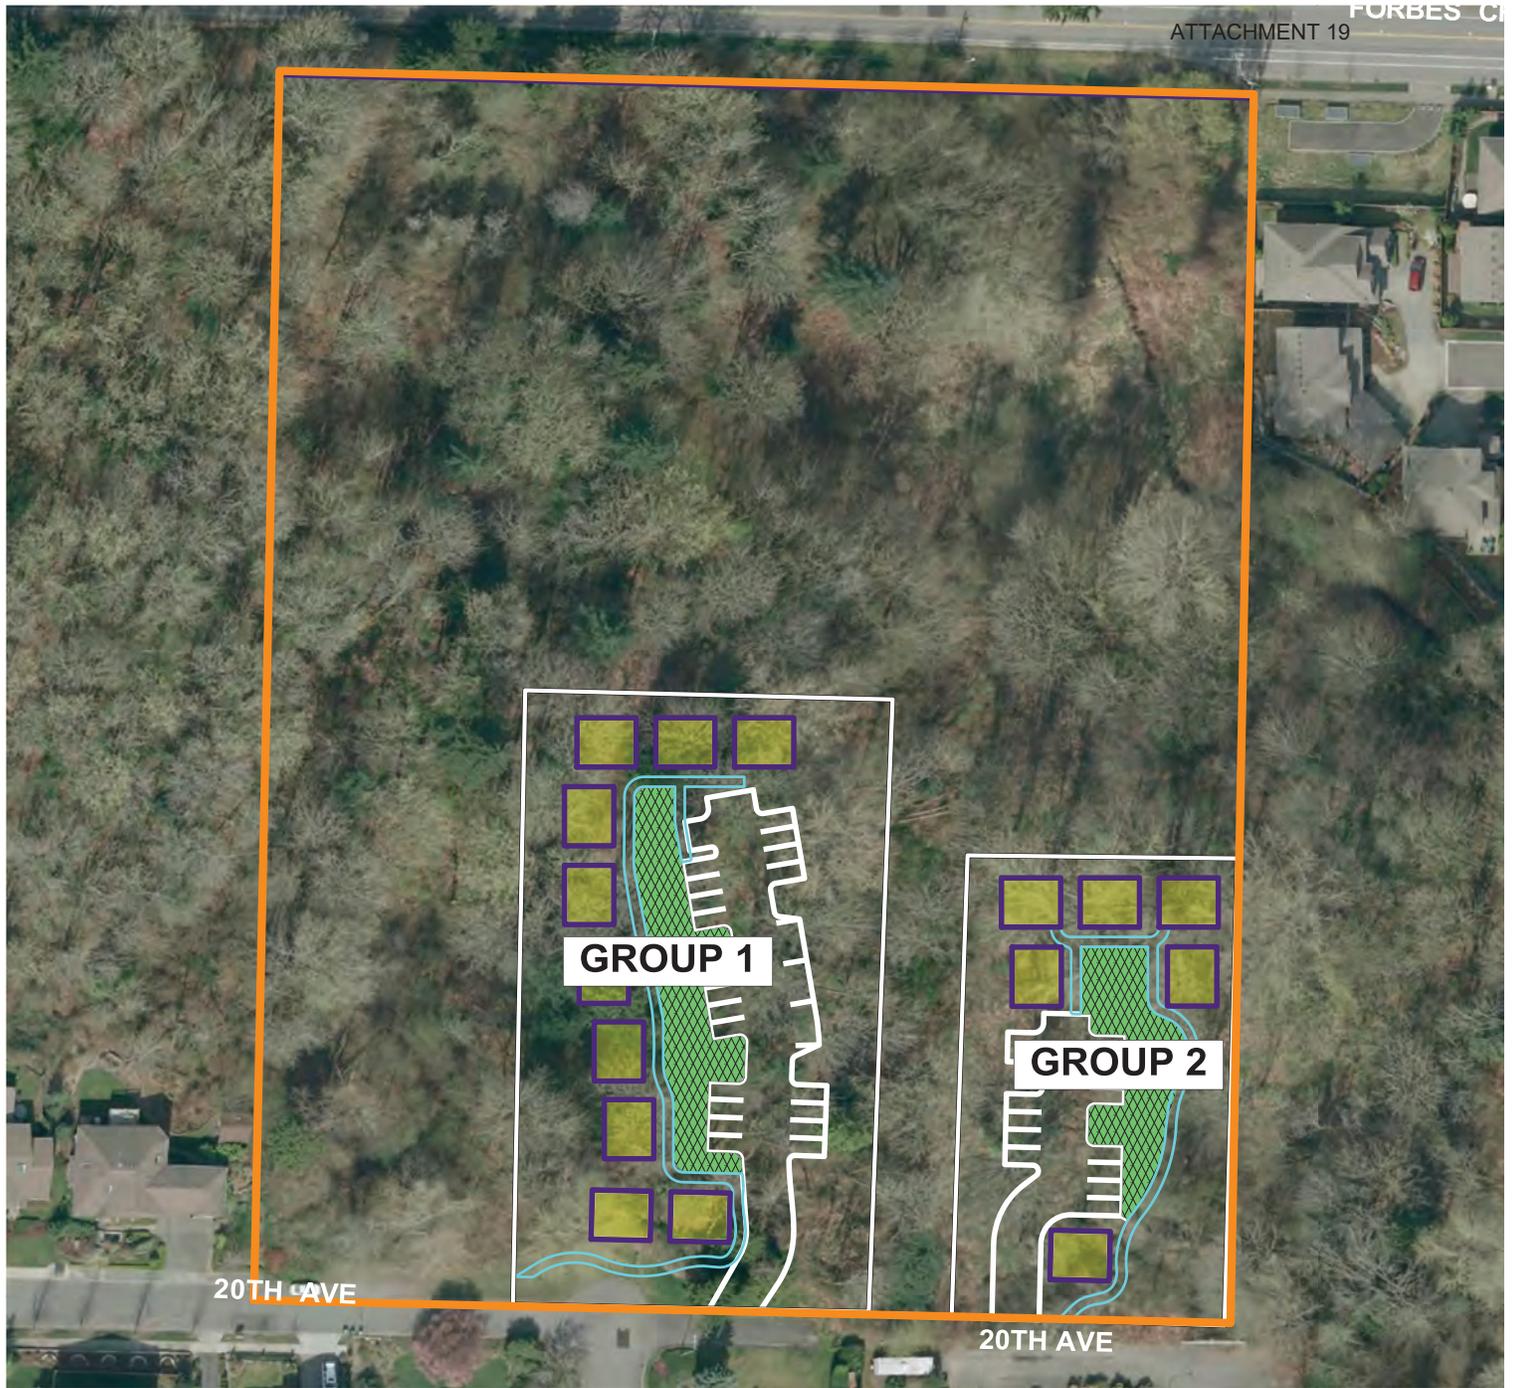
COTTAGE UNIT LAYOUT MAP
ORCAS MOON PROJECT
KIRKLAND, WASHINGTON

Reference: GIS parcel, road ... data from City of Kirkland, 2015.

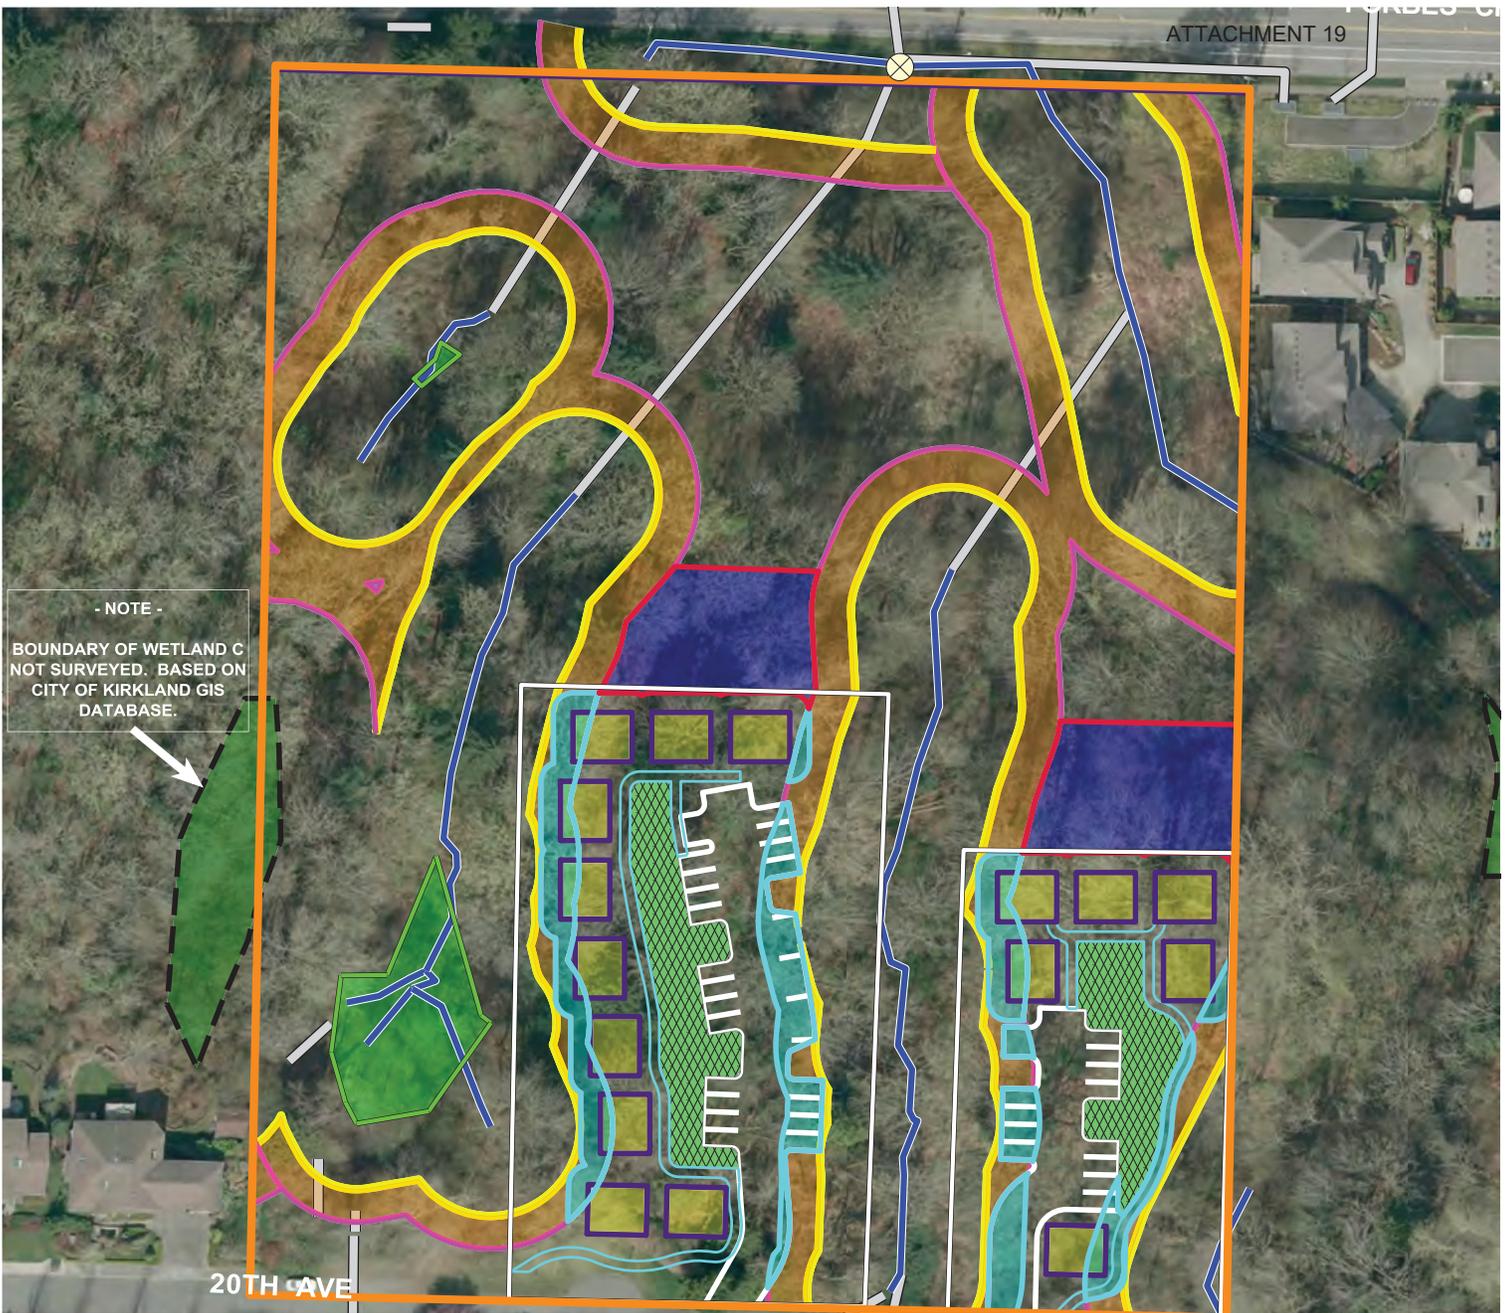
- NOTE -
BOUNDARY OF WETLAND C NOT SURVEYED. BASED ON CITY OF KIRKLAND GIS DATABASE.

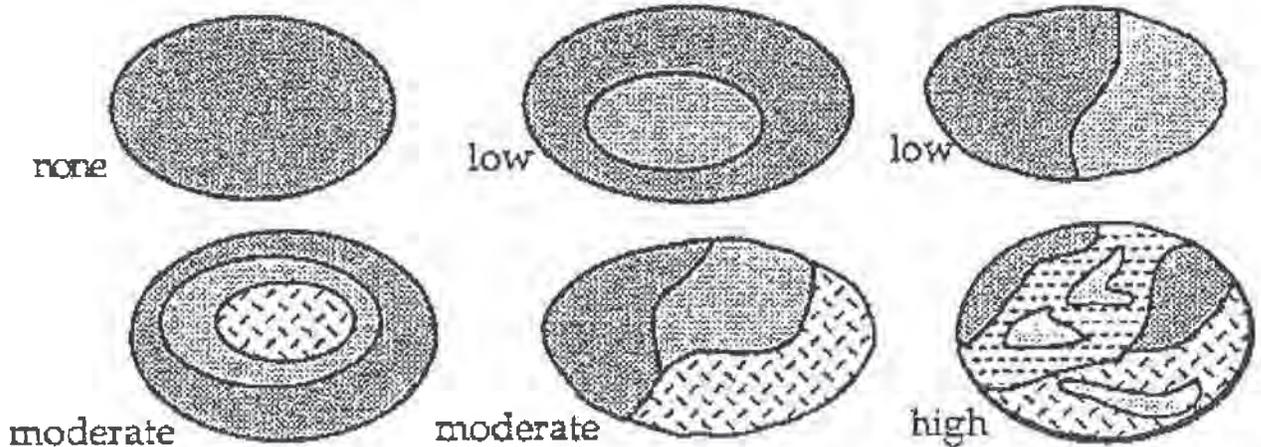
Decide from the diagrams below whether interspection between wetland classes is high, moderate, low or none

3	=	High
2	=	Moderate
1	=	Low
0	=	None

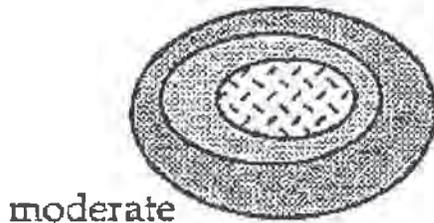
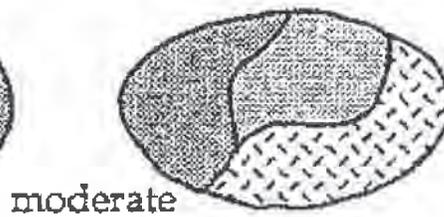
Decide from the diagrams below whether interspection between wetland classes is high, moderate, low or none

3	=	High
2	=	Moderate
1	=	Low
0	=	None

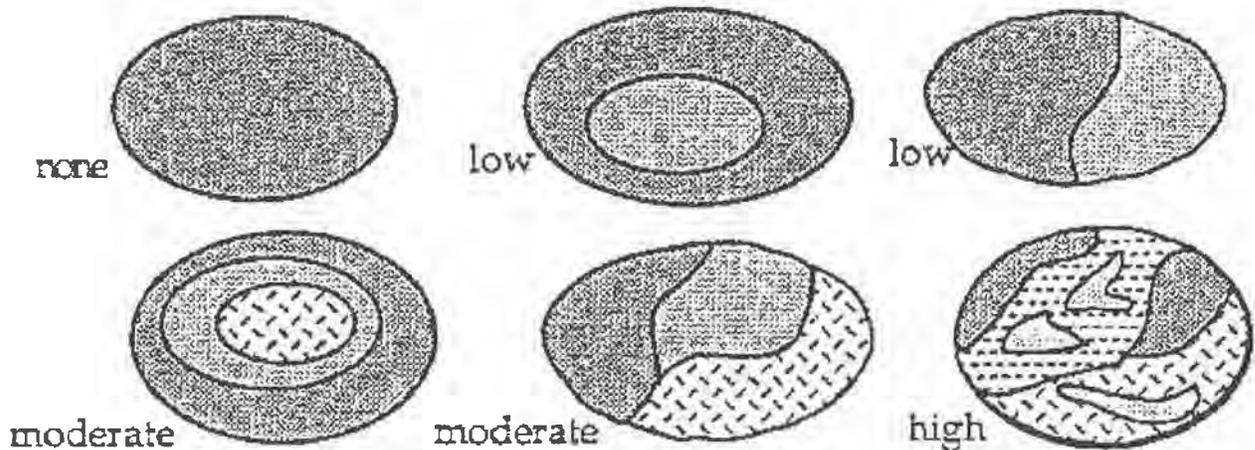
Decide from the diagrams below whether interspection between wetland classes is high, moderate, low or none

3	=	High
2	=	Moderate
1	=	Low
0	=	None
