**ADVISORY REPORT  
 FINDINGS, CONCLUSIONS, AND RECOMMENDATIONS**

**File:** SIMONDS ROAD SUBDIVISION, FILE SUB16-03082

**SIMONDS ROAD PLAT  
SUB16-03082**

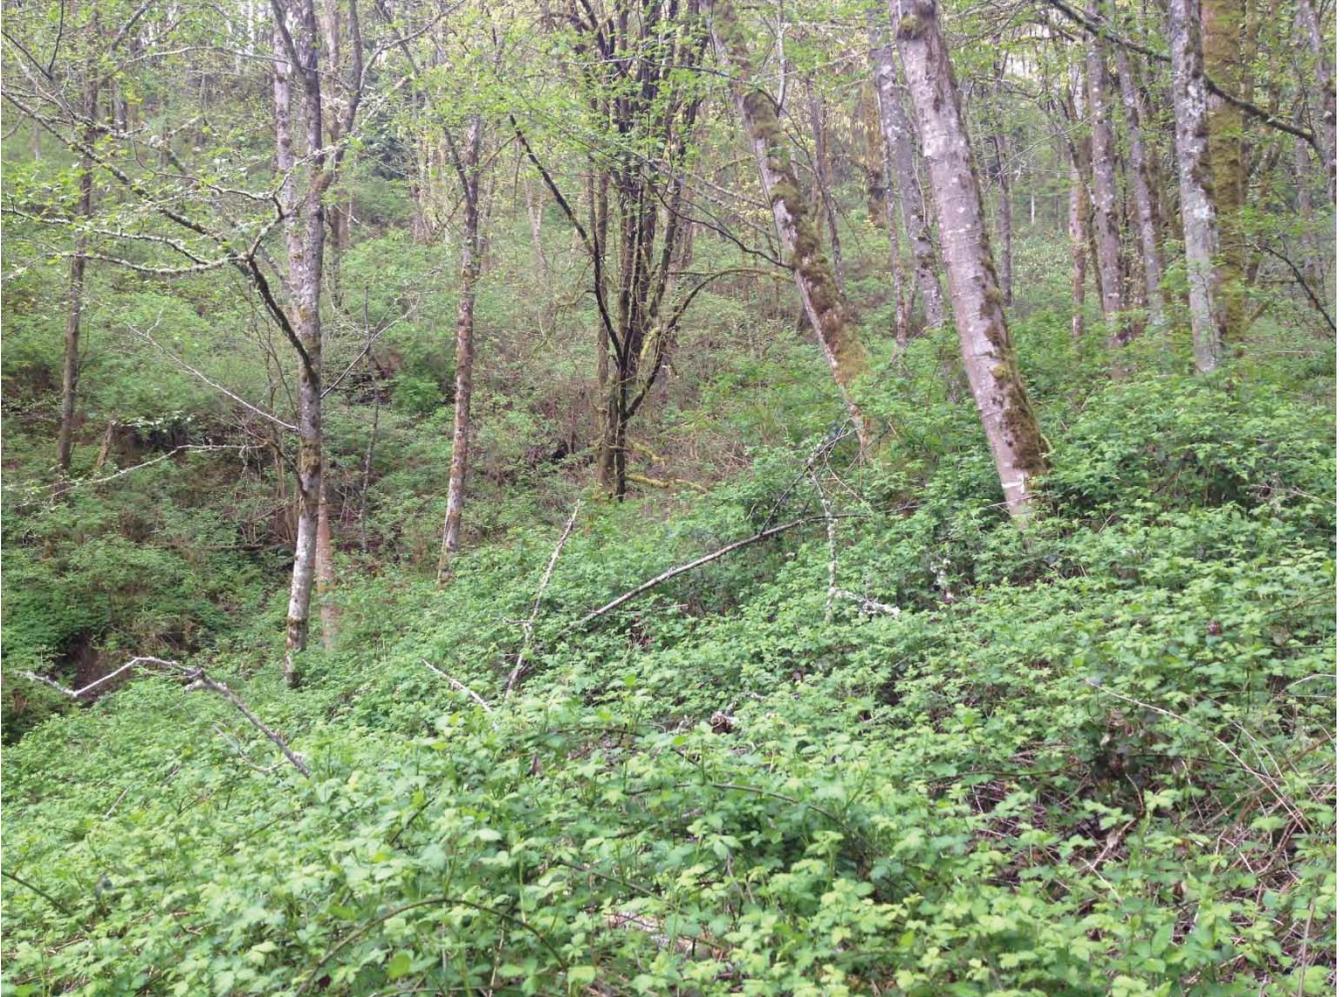
*Image 1: stream buffer looking west near tree #1784, note extent of blackberry understory*

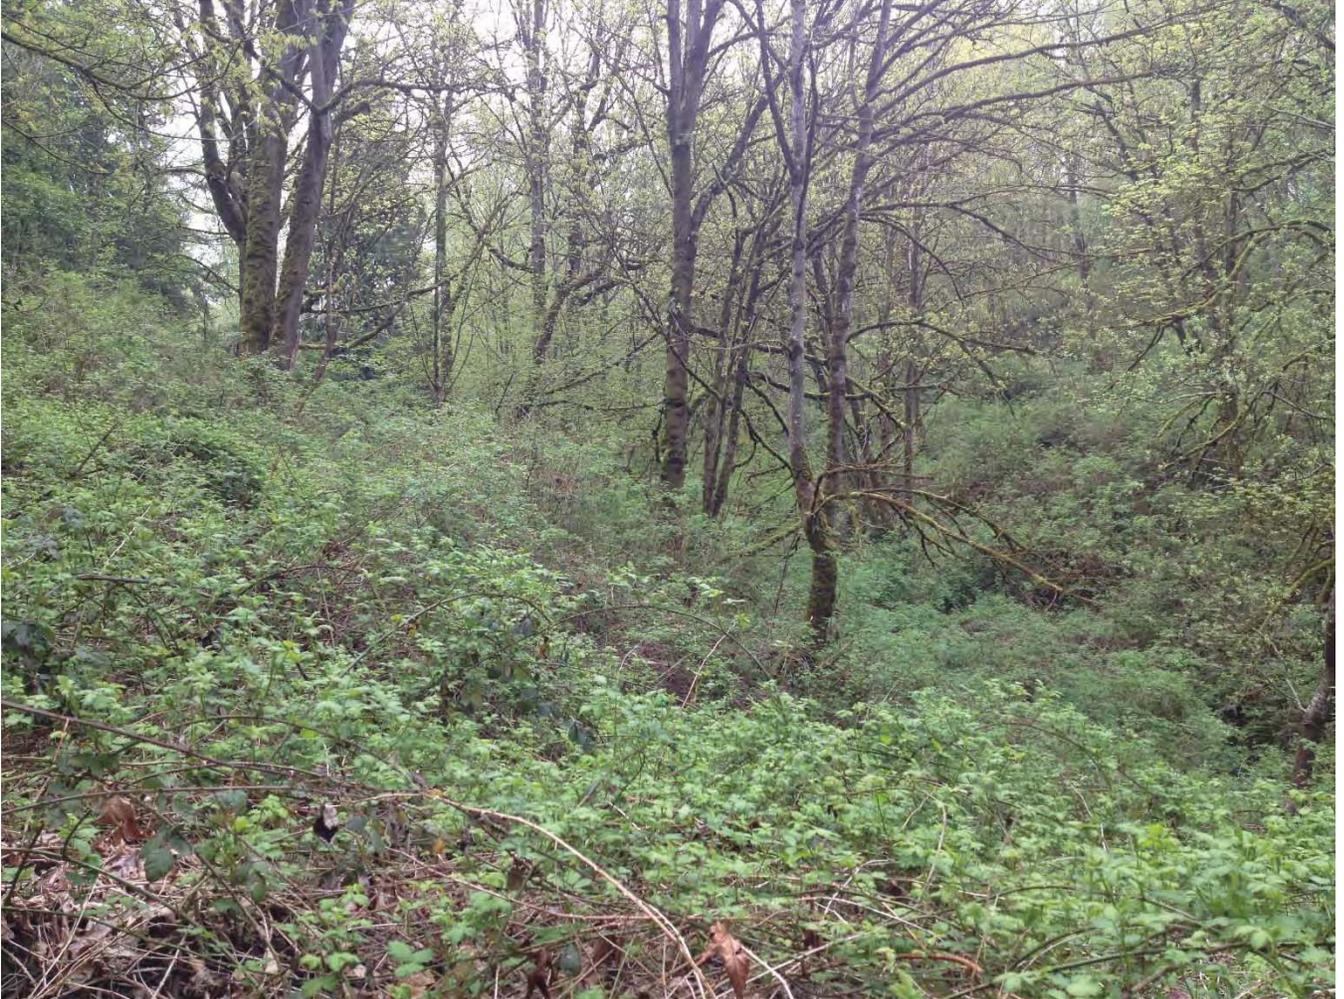
*Image 2: stream buffer looking east near tree #1784, again note extent of blackberry understory*

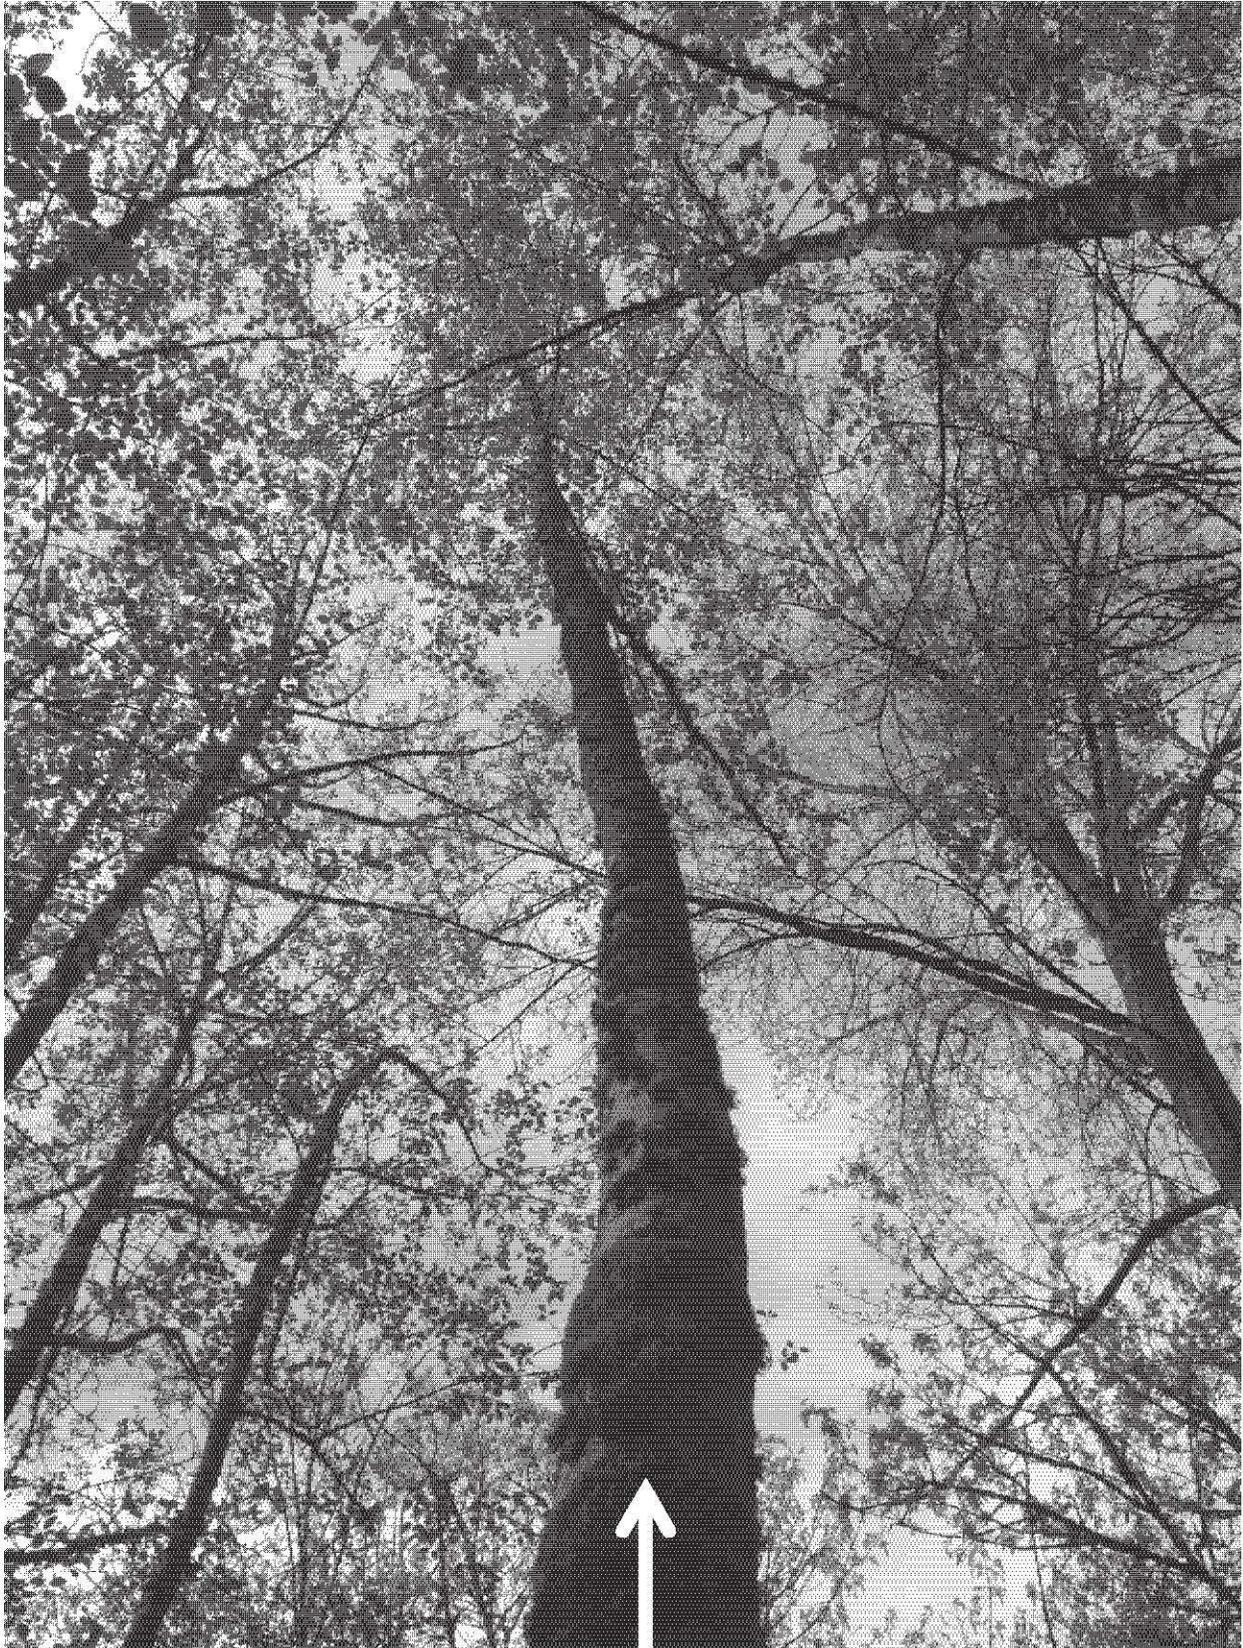
*Image 3: tree #1775, typical low canopy ration of forest grown tree which would be unstable if some or part of the grove is removed because it has not developed a root zone to withstand new wind forces if nearby trees are removed*

During my site visit I did confirm that the majority of trees on-site are in early senescence and have developed as a low co-dominant canopy. This condition is not conducive to very many trees being retained because of health, condition and windfirmness concerns.
