Shannon & Wilson, Inc.  
400 N. 34th St., Suite 100  
Seattle, Washington 98103

FINAL WETLAND/STREAM DELINEATION REPORT and MITIGATION PLAN

# JUANITA BEACH PARK PHASE II IMPROVEMENTS PROJECT

KIRKLAND, WASHINGTON

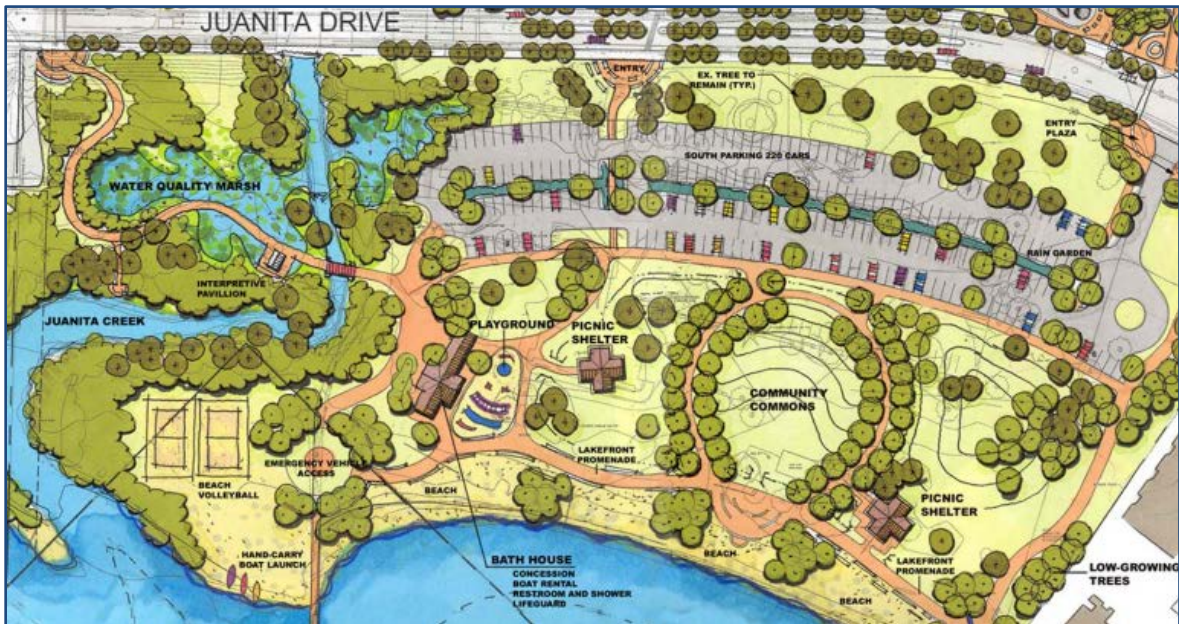
Exhibit 1. Excerpt from Juanita Beach Park Master Plan (J.A. Brennan Associates PLLC, 2006).

The City has been implementing the Juanita Beach Park Master Plan (J.A. Brennan, 2006) in phases (Exhibit 1). In 2006, the City issued a Determination of Non-Significance based on a programmatic State Environmental Policy Act (SEPA) checklist for the Master Plan. At the time, the presence of wetlands in the park, other than those associated with Juanita Creek, was not confirmed so the programmatic SEPA did not identify any project-related wetland impacts.

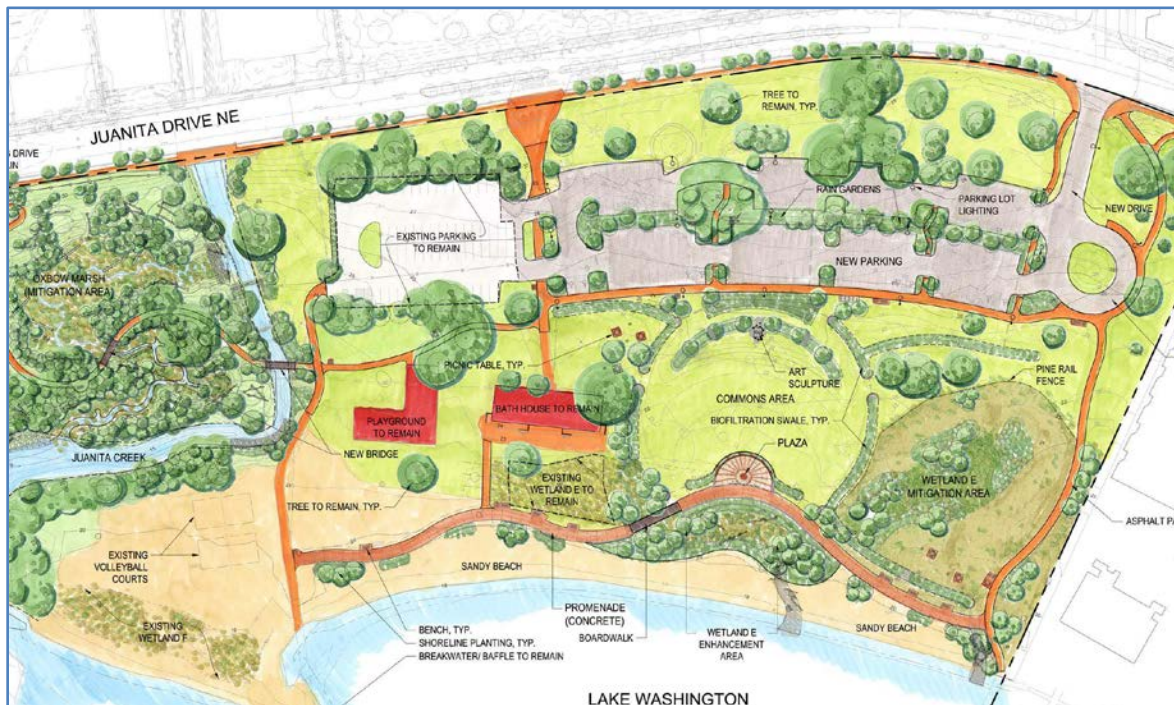
Exhibit 2. Phase I Improvements at Juanita Beach Park (J.A. Brennan Associates PLLC, 2010).

During development of the Phase I plans, an additional wetland was confirmed on the Lake Washington shoreline. The Phase I SEPA analysis documented the stream and wetland impacts and associated mitigation, and the City issued a Determination of Non-Significance in 2009. The remaining project permits were obtained for Phase I in 2009 and 2010, and construction was completed in 2011. The final permitted condition is shown in Exhibit 2.

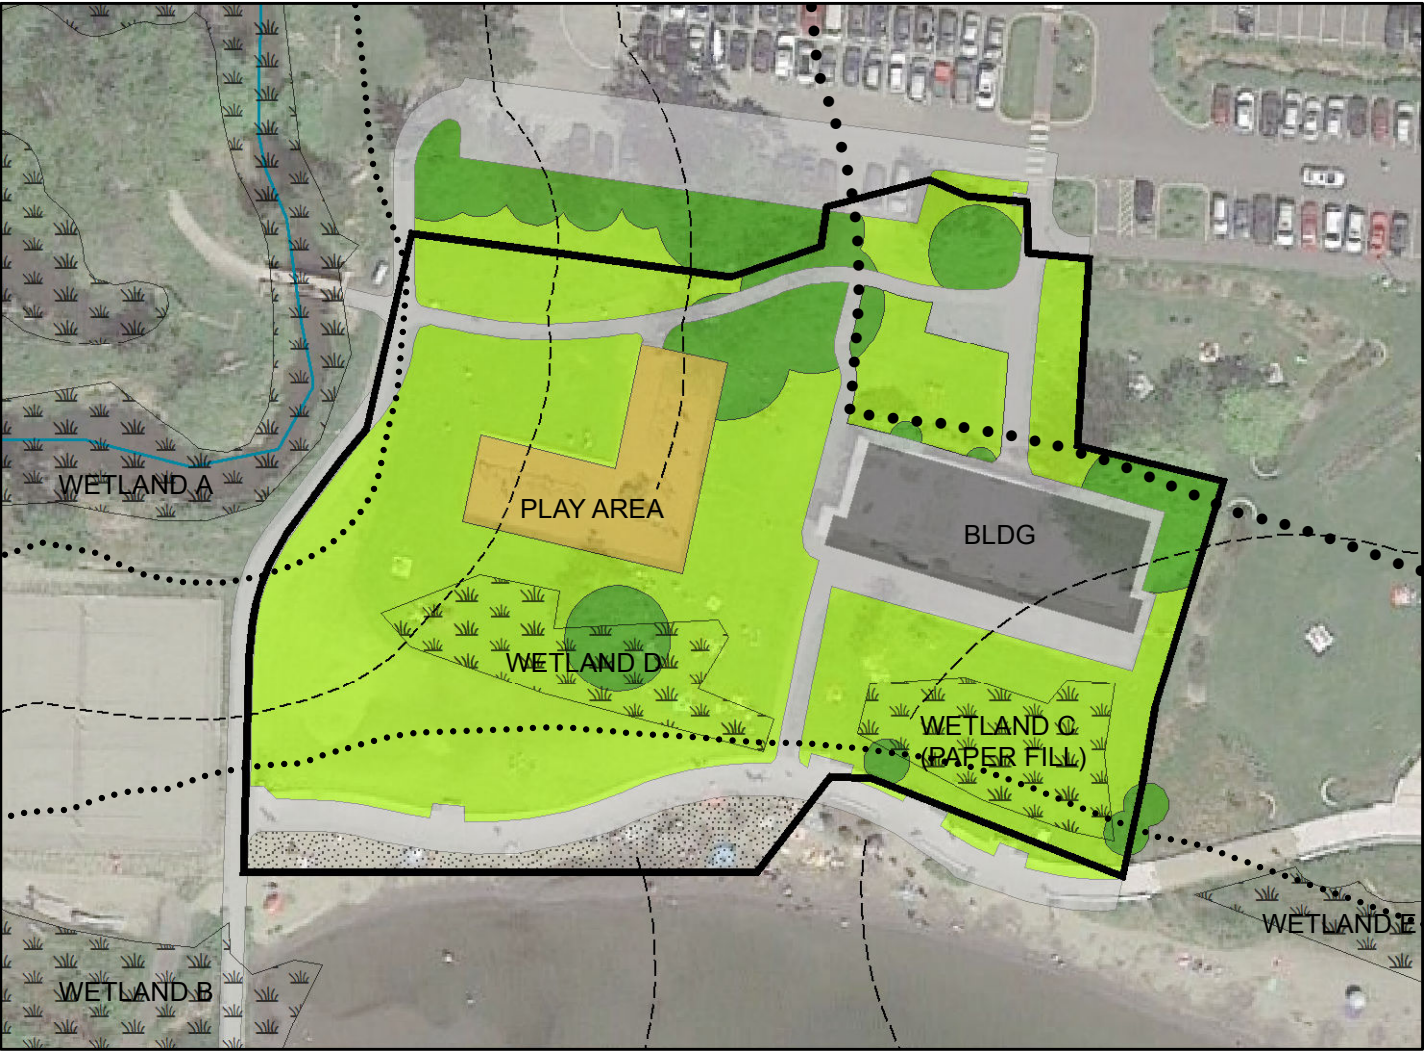
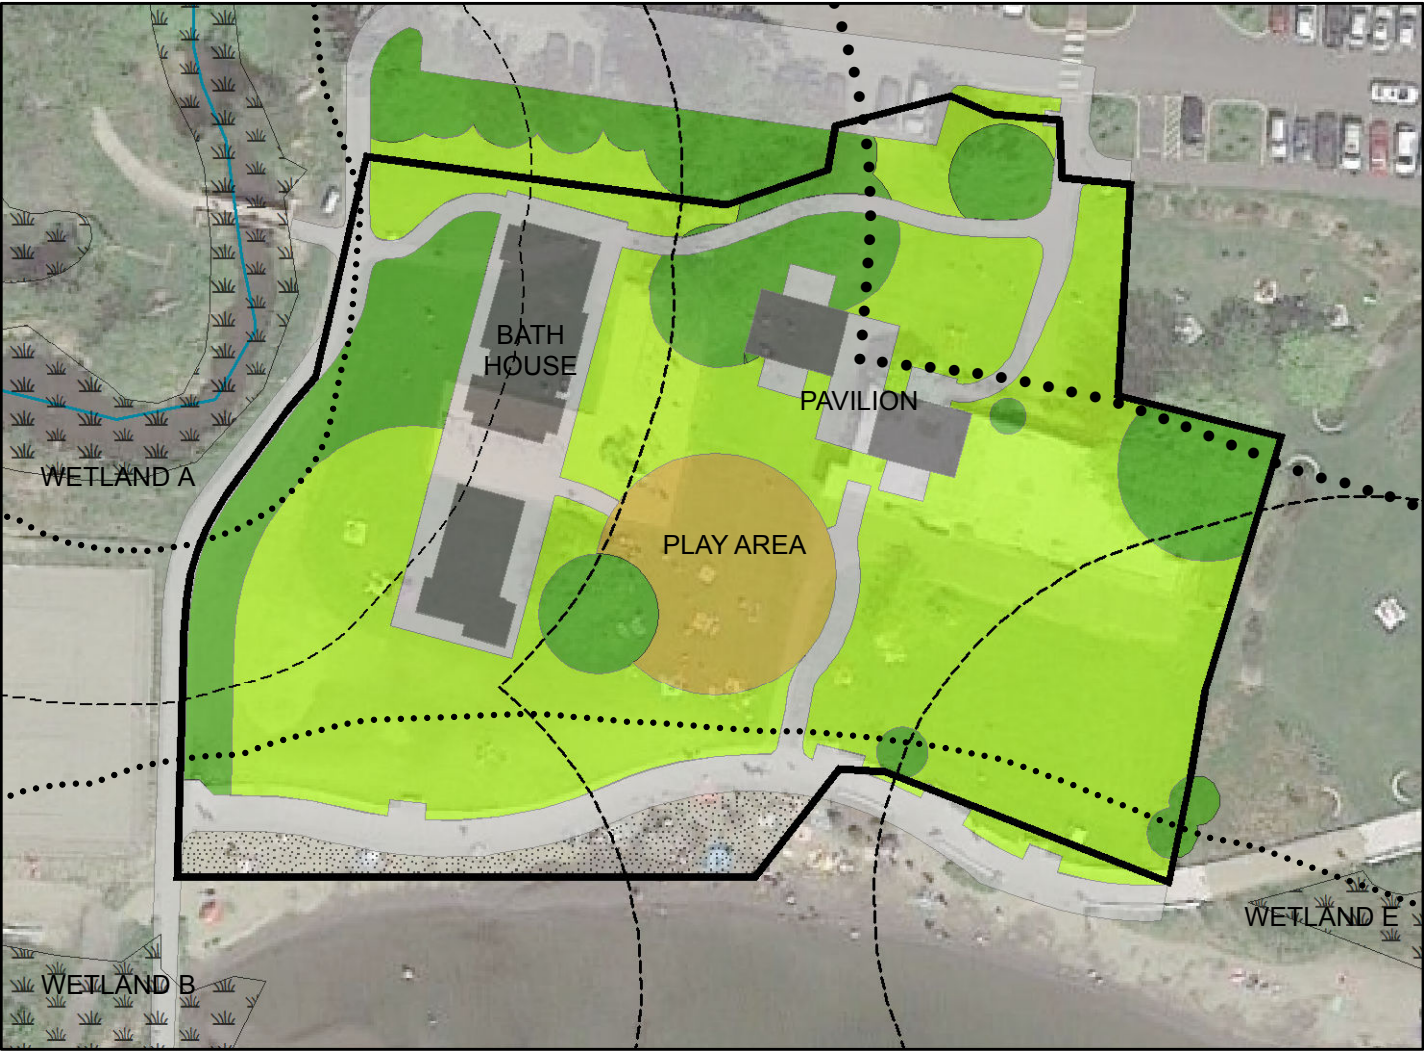
| SHANNON & WILSON, INC.<br>GEOTECHNICAL AND ENVIRONMENTAL CONSULTANTS | FIG. 6 |

EXISTING CONDITIONS

PROPOSED CONDITIONS

| <b>SITE PLAN<br/>BEFORE AND AFTER</b> | |

The selected alternative avoids impacts to the greatest extent possible (see Table 3 and Figure 6), within the confines of the site conditions and project requirements. While the selected

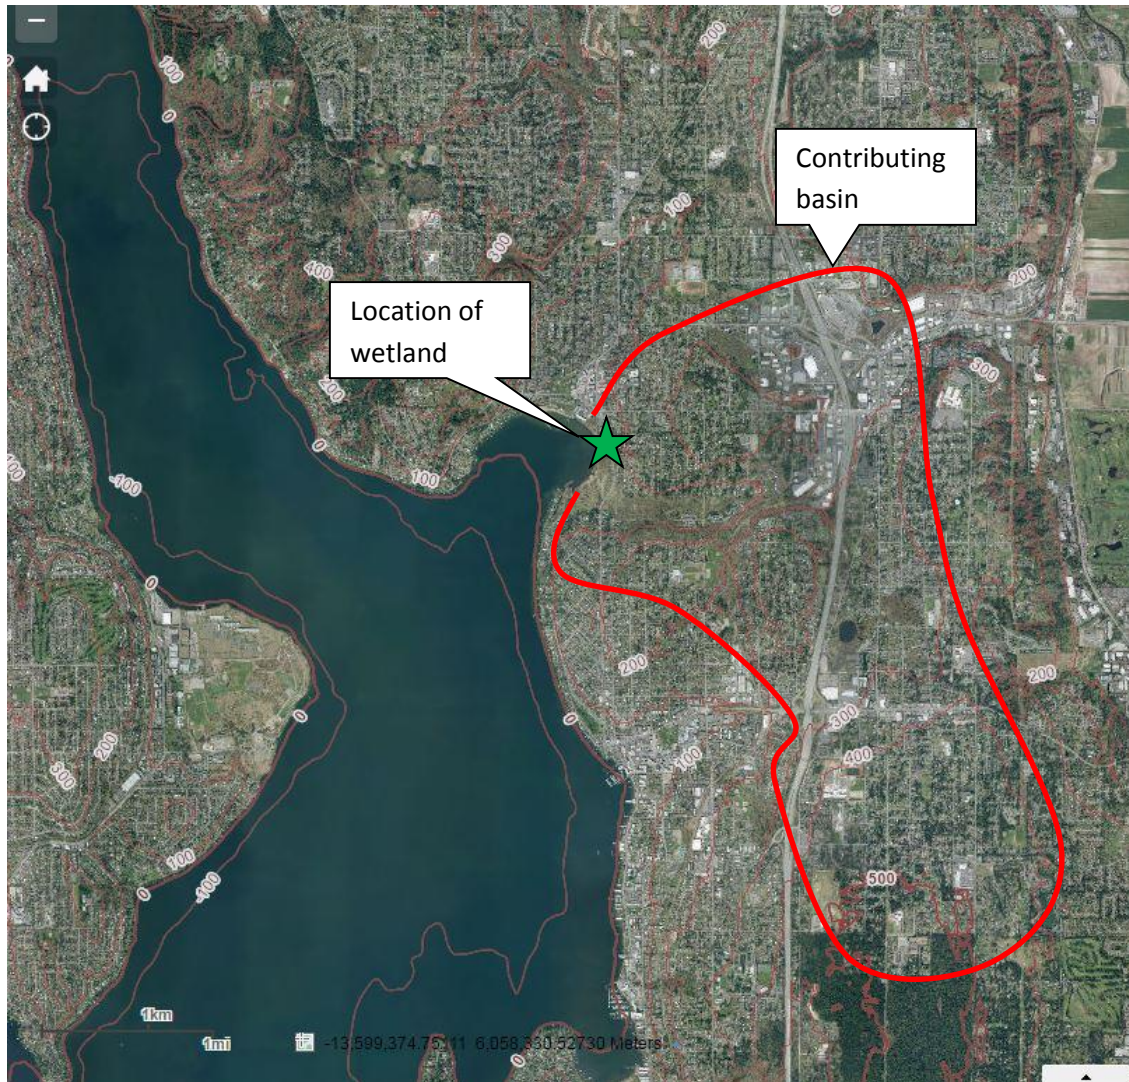
Figure 3. Contributing basin – D4.3, D5.3
