7.2.13 12804 109th Ave. NE, Kirkland

Figure 1. Sammamish–Juanita 115 kV Transmission Line Project location map.

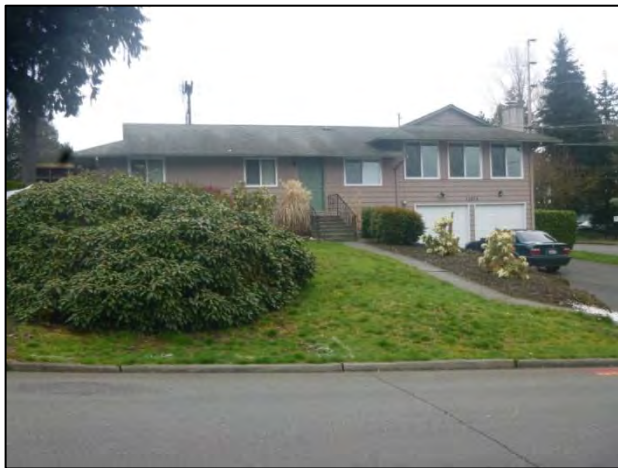
Built in 1963, the single-family dwelling fronting west at 12804 109th Ave. NE is a two-story, Modern Tri-Level Split Ranch house (Figures 7-47 and 7-48). The 1,420-sq-ft rectangular building is built into a hillside on the north end, sits on a poured-concrete foundation, is clad in lap siding, and is topped by a two-level, gable-on-hip roof with asphalt-composition cladding. Cement stairs access a central doorway in the facade, and fenestration includes two vinyl sliders north of the door and four large vinyl sliders, three of which are side by side over the two-bay garage with replacement doors. The house has moderate eaves. A secondary elevation is visible on the south and includes a chimney on the west end and a door on the east end. No associated structures are visible on the parcel from the ROW.

Figure 7-47. 12804 109th Ave. NE, view east.

Figure 7-48. 12804 109th Ave. NE, view northeast.

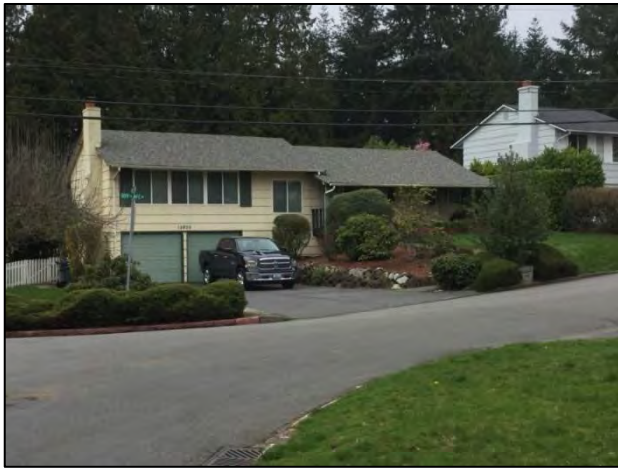
Built in 1964, the single-family dwelling fronting east at 12805 109th Ave. NE is a two-story, Modern Tri-Level Split Ranch house (Figures 7-49 and 7-50). The 1,420-sq-ft rectangular building is built into a hillside on the north end, sits on a poured-concrete foundation, is clad in cedar shake, and is topped by a two-level, low-pitch, side-gabled roof with asphalt-composition cladding. The facade features a central doorway beneath a roof overhang supported by four simple wood posts. Fenestration includes two vinyl sliders north of the door and four large vinyl sliders to the south, three of which are side by side over the two-bay garage with replacement doors. The house has moderate eaves. A secondary elevation is visible on the south and includes a chimney on the east end and a door with corrugated-metal overhang on the west end. No associated structures are visible on the parcel from the ROW.

Figure 7-49. 12805 109th Ave. NE, view northwest.

Figure 7-50. 12805 109th Ave. NE, view north.

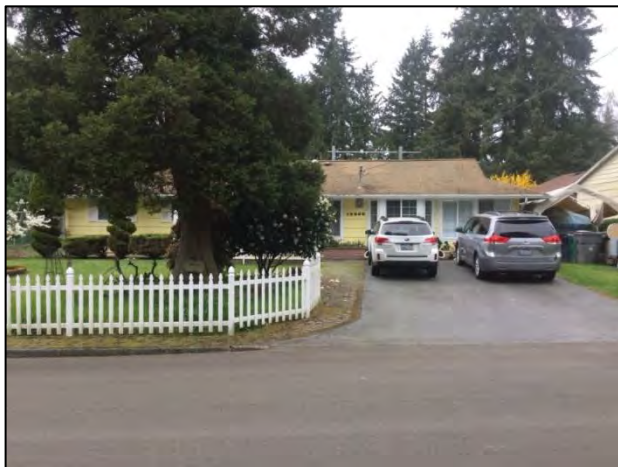
Built in 1962, the single-family dwelling fronting east at 13035 110th Ave. NE is a one-story Modern Ranch house (Figures 7-51–7-53). The 1,740-sq-ft building has an addition off the northwest corner of the originally rectangular building. The building sits on a poured-concrete foundation, is clad in cedar-shake siding, and is topped by a gable-on-hip roof with asphalt-composition cladding. The facade features a doorway somewhat obscured behind lattice fencing along the front walkway. Fenestration includes gridded vinyl windows on the north end of the building (likely an infilled garage) and vinyl sliders to the south. The house has moderately overhanging eaves. Unadorned secondary elevations are visible on the north and south ends. No associated structures are visible on the parcel from the ROW.

Figure 7-51. 13035 110th Ave. NE, view west.

Figure 7-52. 13035 110th Ave. NE, view southwest.

Figure 7-53. 13035 110th Ave. NE, view northwest.

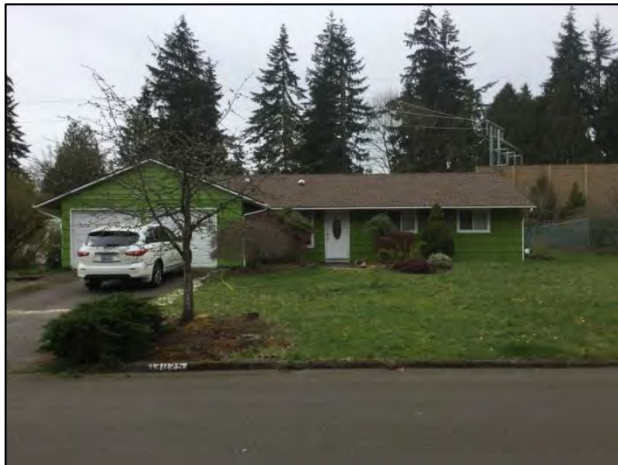
Built in 1962, the single-family dwelling fronting east at 13025 110th Ave. NE is a one-story Modern Ranch house (Figures 7-54 and 7-55). The L-shaped building is 1,962 sq ft with a projecting two-bay garage with vinyl roll-up doors on the south end. The building sits on a poured-concrete foundation, is clad in cedar-shake siding, and is topped by a cross-gabled roof with asphalt-composition cladding. The facade features a central door with an oval window, vinyl sliders north of the door, and side-by-side vinyl-sash windows between the door and the projecting garage. The house has minimal eaves. Secondary elevations are visible on the north and south and appears to include fenestration on the south side behind mature foliage. No associated structures are visible on the parcel from the ROW.

Figure 7-54. 13025 110th Ave. NE, view west.

Figure 7-55. 13025 110th Ave. NE, view northwest.

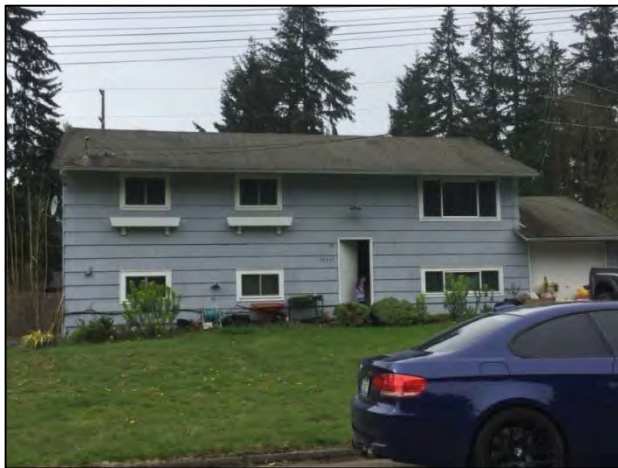
Built in 1962, the single-family dwelling fronting east at 13015 110th Ave. NE is a two-story Modern Bi-Level Ranch (“raised Ranch”) house (Figures 7-56 and 7-57). The rectangular building is 2,020 sq ft with a one-story attached garage on the north end. The building sits on a poured-concrete foundation, is clad in cedar-shake siding, and is topped by a side-gabled roof with asphalt-composition cladding. The facade features an unadorned doorway. Fenestration is identical on the first and second floors and includes vinyl sliders. The house has moderately overhanging eaves. Secondary elevations are visible on the north and south and include fenestration on the south. No associated structures are visible on the parcel from the ROW.

Figure 7-56. 13015 110th Ave. NE, view west.

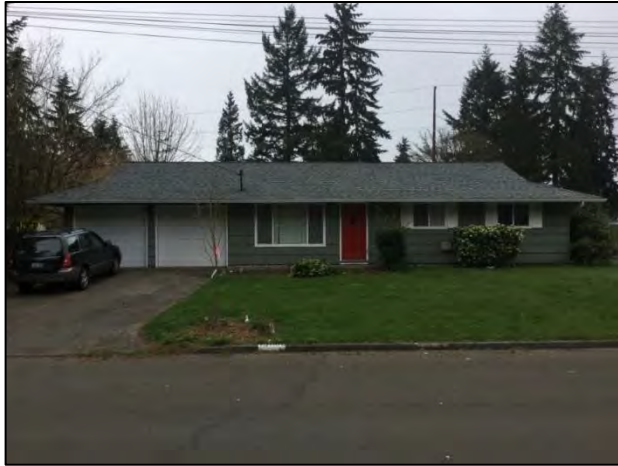
Built in 1962, the single-family dwelling fronting east at 13005 110th Ave. NE is a one-story Modern Ranch building (Figures 7-58 and 7-59). The L-shaped building is 1,430 sq ft with an addition projecting west on the north end of the west elevation (behind the attached garage). The building sits on a poured-concrete foundation, is clad in cedar-shake siding, and is topped by a gable-on-hip roof with asphalt-composition cladding. The facade features a central doorway, two vinyl sliders north of the door, a three-light vinyl window south of the door, and an attached two-bay garage at the south end. The house has moderately overhanging eaves. Mature foliage obscures the secondary elevations on the north and south ends. No associated structures are visible on the parcel from the ROW.

Figure 7-58. 13005 110th Ave. NE, view west.

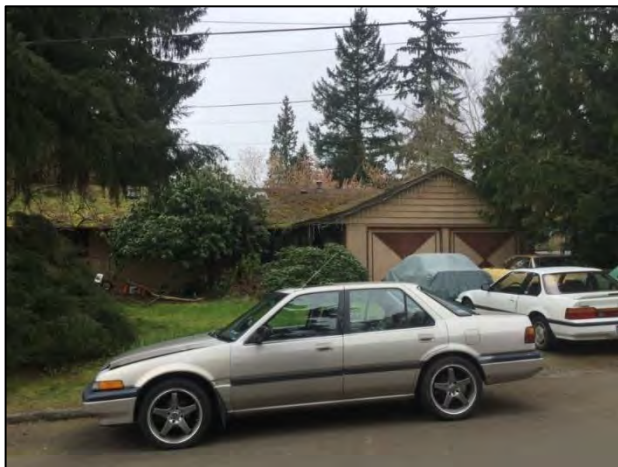
Built in 1962, the single-family dwelling fronting east at 12855 110th Ave. NE is a one-story Modern Ranch house (Figures 7-60 and 7-61). The L-shaped building is 1,040 sq ft with a double garage projecting east on the north side of the primary facade. The building sits on a poured-concrete foundation, is clad in vertical board with drop siding in the gable over the garage, and is topped by a cross-gabled roof. The facade features a covered walkway formed by an extension from the garage gable. Fenestration is minimally visible behind mature foliage but includes shutters on the windows. The house has moderately overhanging eaves on the primary massing and minimal eaves on the front gable. An unadorned secondary elevation is visible on the south side. No associated structures are visible on the parcel from the ROW.

Figure 7-60. 12855 110th Ave. NE, view west.

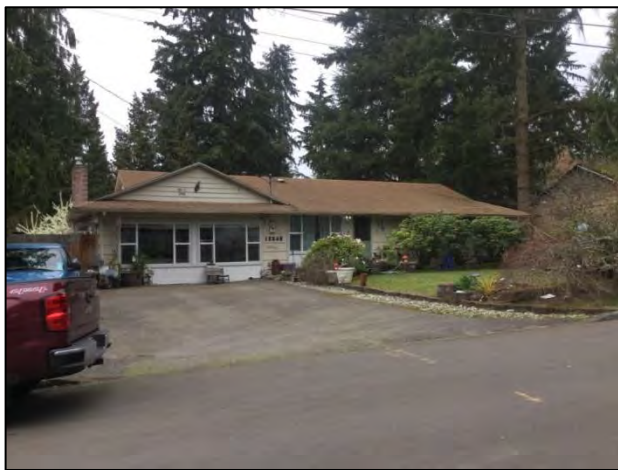
Built in 1962, the single-family dwelling fronting east at 12845 110th Ave. NE is a one-story Modern Ranch house (Figures 7-62 and 7-63). The L-shaped building is 1,520 sq ft with a projecting gable on the south end. The building sits on a poured-concrete foundation, is clad in cedar shake with drop siding in the gable, and is topped by a cross-gable-on-hip roof with asphalt-composition cladding. The facade features a doorway slightly north of center, vinyl windows on either side of the doorway, and additional matching windows replacing garage doors in the former two-bay garage (since converted to living space). The house has moderate overhanging eaves broken by a chimney on the south elevation. A fenestrated secondary elevation is visible on the south end. No associated structures are visible on the parcel from the ROW.

Figure 7-62. 12845 110th Ave. NE, view northwest.

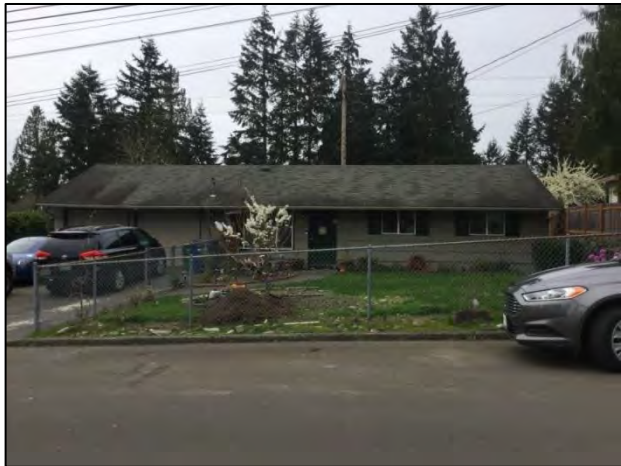
Built in 1962, the single-family dwelling fronting east at 12835 110th Ave. NE is a one-story Modern Ranch house (Figures 7-64 and 7-65). The rectangular building sits on a poured-concrete foundation, is clad in cedar shake, and is topped by a side-gabled roof with asphalt-composition cladding. The facade features a central doorway, two vinyl sliders north of the door, a three-light vinyl window to the south of the door, and a two-bay garage with roll-up doors. The house has moderate overhanging eaves. An unadorned secondary elevation is visible on the south end. No associated structures are visible on the parcel from the ROW.

Figure 7-64. 12835 110th Ave. NE, view west.

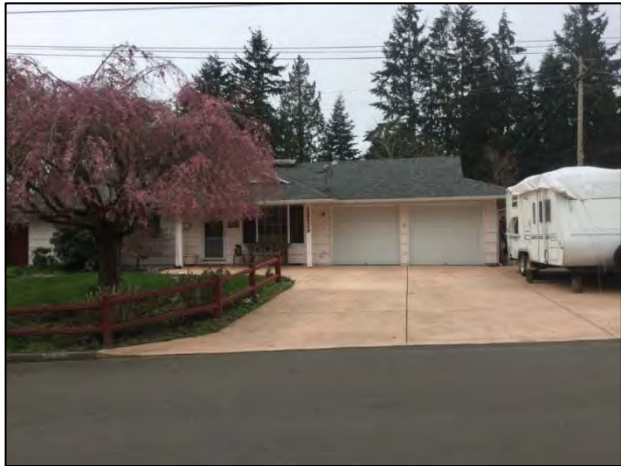
Built in 1963, the single-family dwelling fronting east at 12829 110th Ave. NE is a one-story Modern Ranch house (Figures 7-66 and 7-67). The rectangular building is 910 sq ft with a two-bay garage on the north end. The building sits on a poured-concrete foundation, is clad in cedar-shake siding, and is topped by a gable-on-hip roof with asphalt-composition cladding. The facade features a hipped-roof overhang supported by two support beams, and the entry door is flanked to the north by a gridded vinyl three-light window north and to the south by a gridded vinyl slider. The house has skylights and moderate overhanging eaves. Minimally visible on the south end is a secondary, gabled elevation. No associated structures are visible on the parcel from the ROW.

Figure 7-66. 12829 110th Ave. NE, view west.

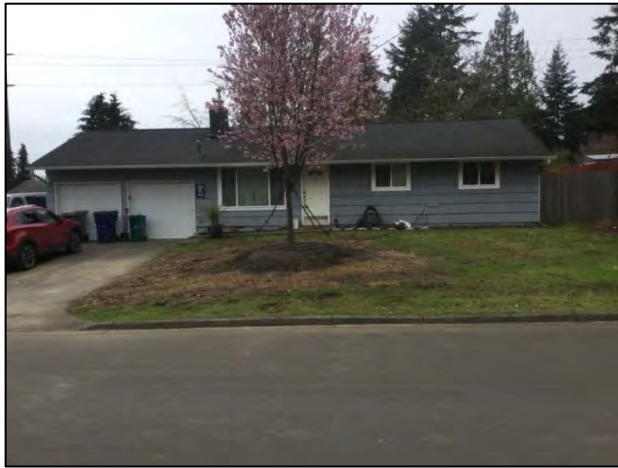
Built in 1963, the single-family dwelling fronting east at 12821 110th Ave. NE is a one-story Modern Ranch house (Figures 7-68 and 7-69). The rectangular building is 910 sq ft, sits on a poured-concrete foundation, is clad in cedar shake, and is topped by a side-gabled roof with asphalt-composition cladding. The facade features a central doorway, two vinyl sliders north of the door, a three-light vinyl window to the south of the door, and a two-bay garage with roll-up doors to the south of that. The house has moderate overhanging eaves. An unadorned secondary elevation is visible on the north. No associated structures are visible on the parcel from the ROW.

Figure 7-68. 12821 110th Ave. NE, view west.

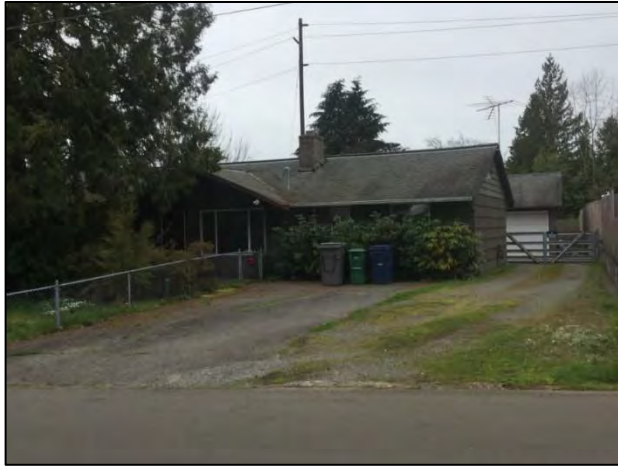
Built in 1963, the single-family dwelling fronting east at 12811 110th Ave. NE is a one-story Modern Ranch house (Figures 7-70 and 7-71). Irregular in plan, the building is 1,420 sq ft, sits on a poured-concrete foundation, is clad in cedar shake, and is topped by a cross-gabled roof with asphalt-composition cladding. The facade features a doorway beneath a central, low-pitched gabled entry portico, and a vinyl slider and three-light windows to the south of the door. The north end of the facade is likely an infilled garage with no fenestration. The house has a central chimney and minimal eaves, aside from the porch. An unadorned secondary elevation is visible on the north. Associated resources visible from the ROW include two outbuildings—a two-bay, side-gabled garage on the northwest corner of the parcel, and a front-gabled shed on the southwest corner.

Figure 7-70. 12811 110th Ave. NE, view west.

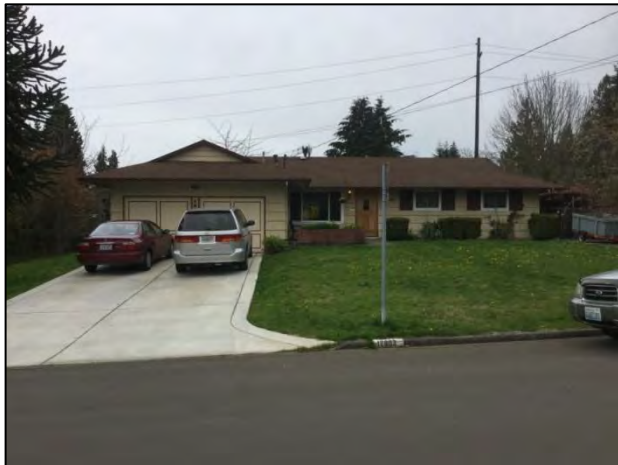
Built in 1963, the single-family dwelling fronting east at 12803 110th Ave. NE is a one-story, Modern Ranch house (Figures 7-72 and 7-73). The L-shaped building is 1,190 sq ft with a projecting garage on the south end. The building sits on a poured-concrete foundation, is clad in cedar shake, and is topped by a cross-gabled roof with asphalt-composition cladding. The facade features a central, simple doorway, two vinyl sliders north of the doorway, a three-light vinyl window to the south of the door, and a two-bay garage on the south end that appears to retain its original doors. The house has moderate eaves and a chimney on the south end of the west elevation. A secondary elevation is visible on the south and includes a door and narrow vinyl slider. No accessory buildings are visible from the ROW.

Figure 7-72. 12803 110th Ave. NE, view west.

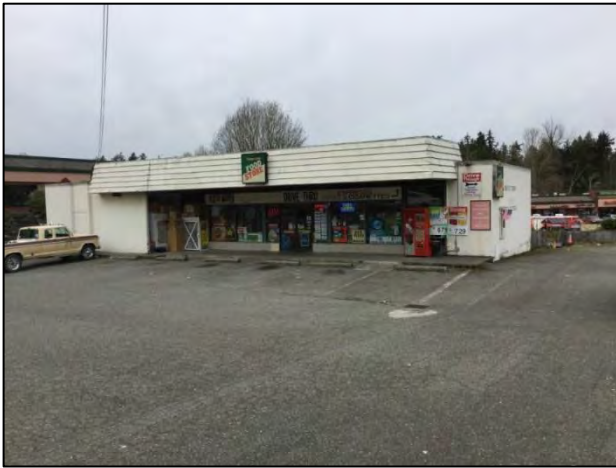
Built in 1969, the one-story commercial building fronts south at 11438 NE 124th St. (Figures 7-74–7-76). The rectangular building is 2,584 sq ft, sits on a concrete-block foundation, and is constructed of concrete masonry units (CMU). A flat roof with a parapet clad in wood shingles on the primary facade gives the appearance of a mansard-style roof. The facade features a recessed bank of commercial glass windows with double glass doors near the center. Secondary elevations are visible on all sides: the north is unadorned, the west includes a doorway, and the east includes a small aluminum slider window.

Figure 7-74. 11438 NE 124th St., view northwest.

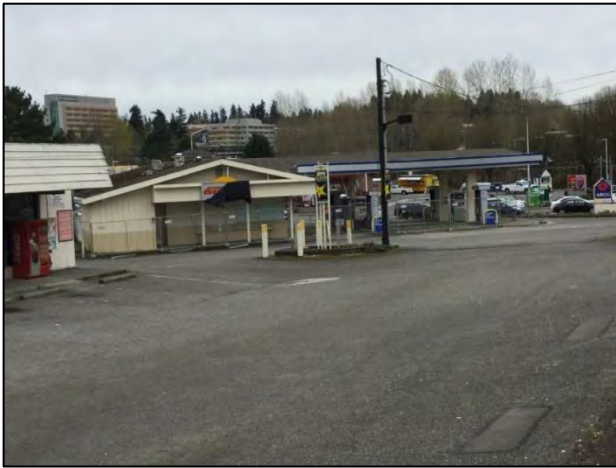
Built in 1968, the now-vacant one-story gas station/convenience store fronts southeast at 11450 NE 124th St. (at the intersection of NE 124th St. and 116th Ave. NE) (Figures 7-77–7-79). The rectangular building is 1,568 sq ft with a large, attached canopy addition extending southeast. The building sits on a poured-concrete foundation, is clad in board and batten, with brick on the southeast and part of the southwest elevations. It is topped by a side-gabled roof over the primary massing, and a flat roof on the canopy. The facade features central double doors bordered by a ribbon of windows that wraps around the southwest elevation. The building features a small pyramidal-roofed ornament at the ridge line, wide barge boards on a roof overhang wrapping around all but the rear face of the building, and modest eaves. The overhang is cantilevered on the primary facade and supported by three narrow beams on the southwest. The southwest elevation includes a recessed doorway.

Figure 7-77. 11450 NE 124th St., view northeast.

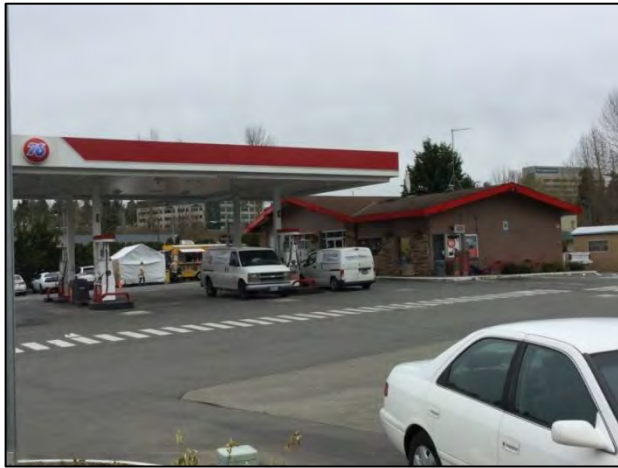
Built in 1970, the gas station/convenience store that fronts west at 12412 NE 116th Ave. NE is a one-story commercial building with a large, freestanding canopy addition (Figures 7-80–7-82). The rectangular building is 1,798 sq ft, sits on a poured-concrete foundation, and is clad in brick and horizontal boards. It has a low-pitched, cross-gabled roof. The facade features windows and double doors separated by evenly spaced brick-clad pilasters. The building features moderate eaves with barge boards and visible support beams extending beyond the barge boards. A secondary elevation is visible on the south and includes a doorway. The canopy has a flat roof with wide barge boards and is supported by four beams.

Figure 7-80. 12412 NE 116th Ave. NE, view northeast.

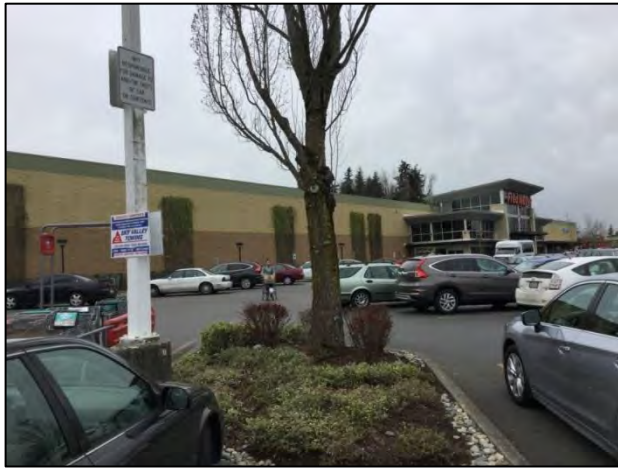
Built in 1980, the one-story commercial building fronts east at 12221 120th Ave. NE (Figures 7-83–7-85). Irregular in plan, the building is 164,277 sq ft with two large east-facing projecting entry bays at the north and south ends of the facade. The building sits on a concrete foundation and is clad in concrete and stucco. The primary massing has a flat roof with parapet, while the projecting bays have shed roofs. The facade features the two-level projecting bays with glass and aluminum walls. Flat canopies cover multiple doorways. Aside from the entry windows, fenestration is limited to fixed-pane aluminum windows near the northeast corner of the building where there is also a doorway. A colonnade runs along the north end of the primary (east) elevation.

Figure 7-83. 12221 120th Ave. NE, view northwest.

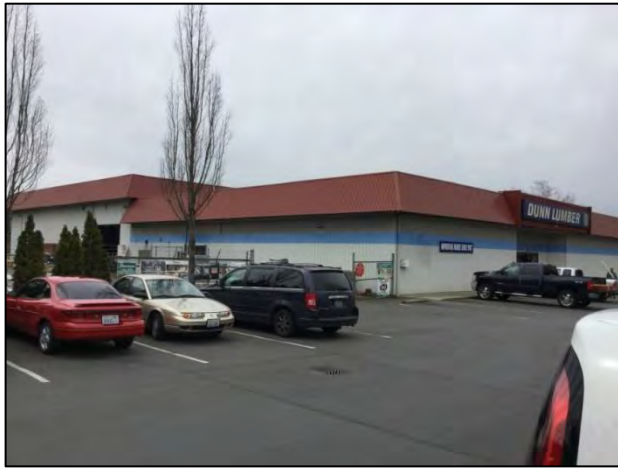
Built in 1978, the one-story commercial building fronts east at 11835 120th Ave. NE (Figures 7-86–7-88). The rectangular building is 19,680 sq ft with a large canopy off the north elevation. The building sits on a poured-concrete foundation, is clad in vertical board siding, and is topped by a standing-seam-metal mansard roof. The facade features a recessed entryway with a four-panel, glass door, where the facade walls angle back, and no visible fenestration. The roofline is uneven to accommodate the height of the taller western portion of the building. Secondary elevations are visible on the north and south and include the canopy on the north and large garage bay on the south.

Figure 7-86. 11835 120th Ave. NE, view northwest.

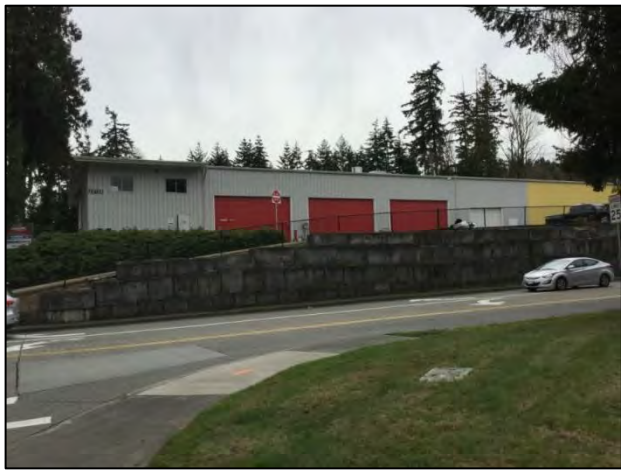
Built in 1977, the one-story commercial garage at 11731 120th Ave. NE fronts south on a driveway extending west from 120th Ave. (Figures 7-89–7-91). The rectangular 18,558-sq-ft building features multiple garage bays with roll-up metal doors on both the north and south elevations. The building sits on a poured-concrete foundation, is clad in corrugated metal, and is topped by a flat roof with minimal eaves, aside from the primary entry, where the facade features a deep overhanging canopy above an office addition to the garage. The office includes two double doorways on the south elevation with two three-light aluminum windows above.

Figure 7-89. 11731 120th Ave. NE, view south.

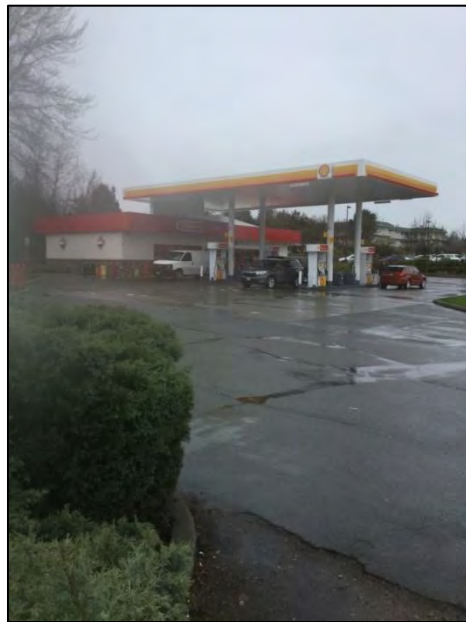
Built in 1971, the significantly remodeled one-story gas station at 12221 NE 124th St. fronts north on NE 124th St (Figures 7-92 and 7-93). The rectangular 2,142-sq-ft building has a large attached canopy perpendicular to the primary massing. The building sits on a poured-concrete foundation, is clad in cement with brick-veneer skirting, and is topped by a flat roof. The facade features two spans of metal and glass windows. The set on the east frames a two-door entry. The building has a wide, projecting barge board. Secondary elevations are visible on the east and west and include diamond-shaped ornamentation behind two light fixtures on both elevations.

Figure 7-92. 12221 124th St. NE, view southwest.

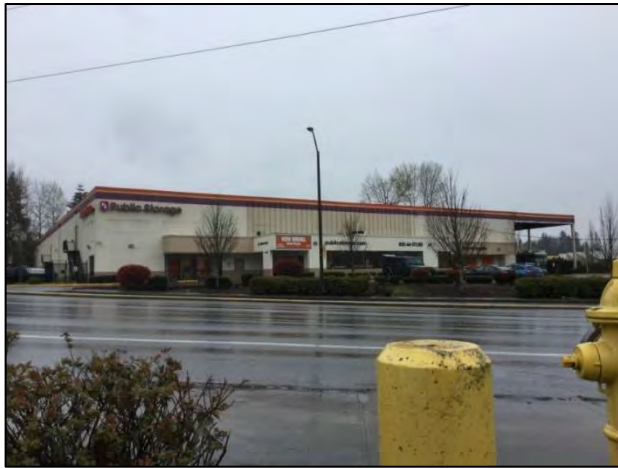
Built in 1967, the mostly two-story commercial warehouse fronting northeast at 12249 NE 124th St. is a Modern storage building at the intersection of NE 124th St. and Totem Lake Blvd. NE (Figures 7-94–7-97). The rectangular 53,250-sq-ft building has a one-story office extending from the center of the primary facade. The building sits on a concrete foundation, is clad in poured cement, and is topped by a flat roof with parapet. At the primary entry, the office building has a covered entry with metal-frame doorways leading to the office and another set into the main warehouse. Above the office, there are 35 vertical, ornamental, cement bars centered on the facade. Fenestration includes three large metal-frame windows on the northeast face of the office and an additional window wrapping around the northwest elevation. Secondary elevations are visible on the northwest and southeast. The northwest elevation is marked by a full-height canopy spanning the length of the face, supported by narrow beams. The southeast elevation includes multiple doorways; there is an entry on the far north end, and six additional single doorways, three on the ground floor and three accessed via metal external stairways hugging the building.

Figure 7-94. 12249 124th Ave. NE, view southwest.

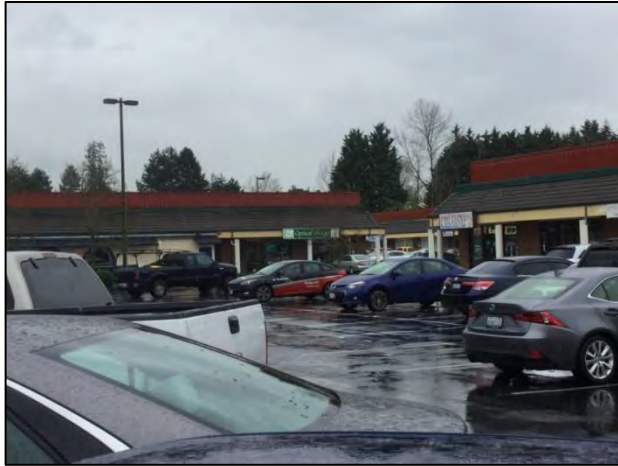
Built in 1980, the commercial strip mall located at 11961 124th Ave. NE comprises nine, one-story buildings that front generally east on 124th Ave. NE (Figures 7-98–7-101). The mall complex reflects elements of Modern and Spanish Revival style. Eight of the buildings are rectangular, and one, on the northeast corner of the parcel, is L-shaped in plan. All are surrounded by paved parking lots. The buildings have poured-concrete foundations. They are clad in concrete, brick, stucco, and glass. The five buildings on the east side of the parcel have parapets clad in standing-seam metal and overhangs clad in clay Mission-style tile. Round concrete pillars support the overhangs. The building on the southeast portion of the parcel extends outward to incorporate the pillars into the building's massing. Between them are semicircular windows. Fenestration in all buildings includes metal-frame window walls and doorways.

Figure 7-98. 11961 124th Ave. NE, view southwest.

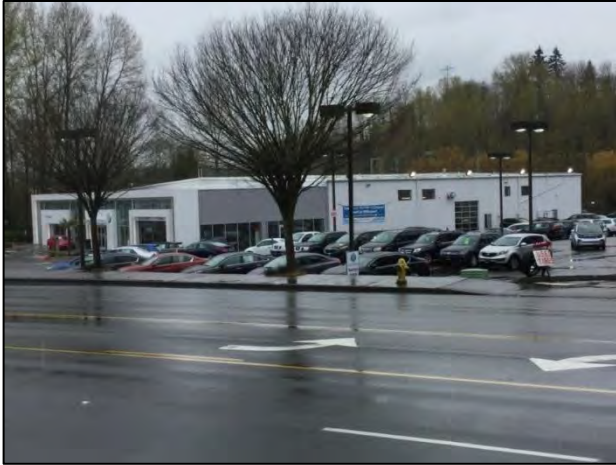
Built in 1976, this auto showroom complex located at 12626 NE 124th St. is a one-story commercial building with a showroom in front (south) and a functionally related workspace in the back (north) (Figures 7-105–7-108). Irregular in plan, the 28,537-sq-ft commercial building sits on a concrete foundation, is clad in concrete in the front massing and metal on the rear massing, and is topped by a flat roof in front and low-pitched, front gable in the rear. The facade features a window wall with three sets of metal-framed double doors with protruding framing. Secondary elevations are visible

on the east and north. The east elevation is marked by side-by-side metal-frame windows on the south end, a central garage bay or window panel with glass and metal windows, a door, and four windows near the roofline. The north elevation features a service entry and multiple open bays.

Figure 7-105. Auto showroom (*left*) and office space/garage (*right*) at 12626 NE 124th St., view northwest.

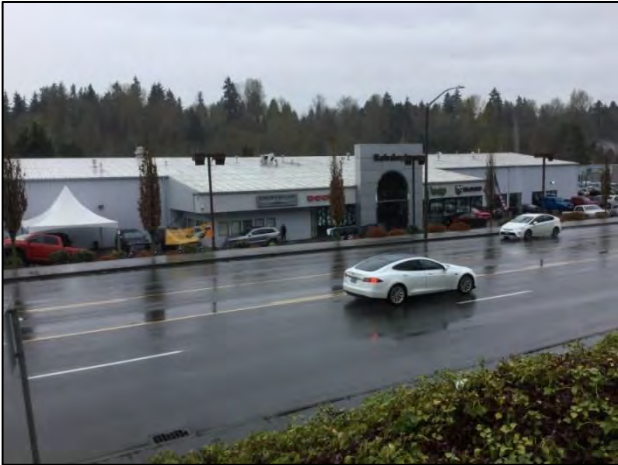
massing with a south-projecting portion on the primary (south) facade. The building sits on a concrete foundation, is clad in metal, and is topped by a shed roof with metal cladding. The facade features a large panel that projects above the roofline and has a round fanlight above double entry doors. Fenestration includes numerous metal windows on the south facade: a series of side-by-side windows on the west end of the projecting entry, stacked windows north of the doorway, and additional windows on the east end of the building. A series of evenly spaced metal windows are located near the roofline on the north elevation. The east elevation features a large canopy extending east.

Figure 7-109. 12828 NE 124th St., view northeast.

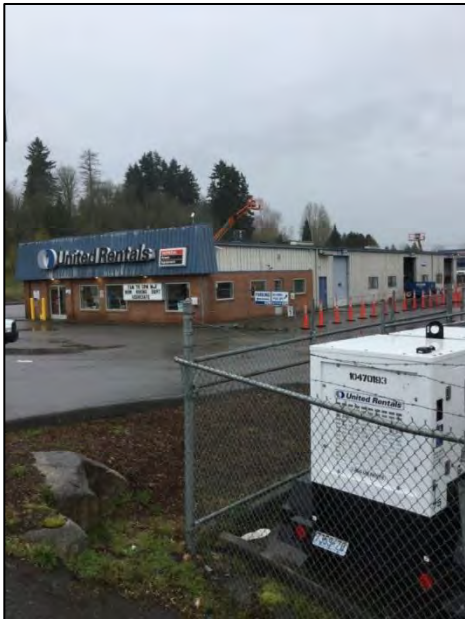
Built in 1980, the commercial building complex located at 12502 Slater Ave. NE includes a one-story Modern building that fronts west on Slater Ave. NE and two functionally related garages to its south (Figures 7-116–7-118). The main, 8,456-sq-ft building is rectangular in plan with two associated garages; sits on a poured-concrete foundation; is clad in vertical boards with bricks on the west end; and is topped by a low-pitched gable roof with minimal eaves on the north, east, and south faces and a wood-clad mansard-style parapet on its facade. The brick-clad facade features a metal, two-door entry on the north end and three large, fixed-pane vinyl windows. The south elevation includes two service doors and three garage bays with roll-up metal doors and additional windows. The garage on the south border of the parcel is a long, rectangular building. It has six garage bays on the north elevation: the four to the west have no doors and the two to the east have roll-up doors. The other garage, located between the primary building and the garage to the south, is a low-pitched front-gabled building with a roll-up door.

Figure 7-116. 12502 Slater Ave. NE, view northeast.

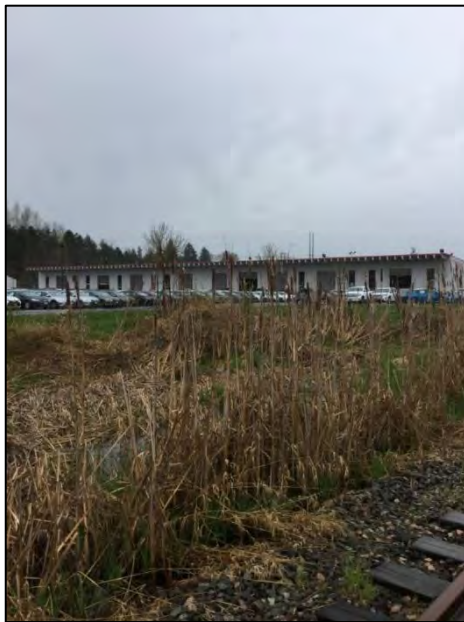
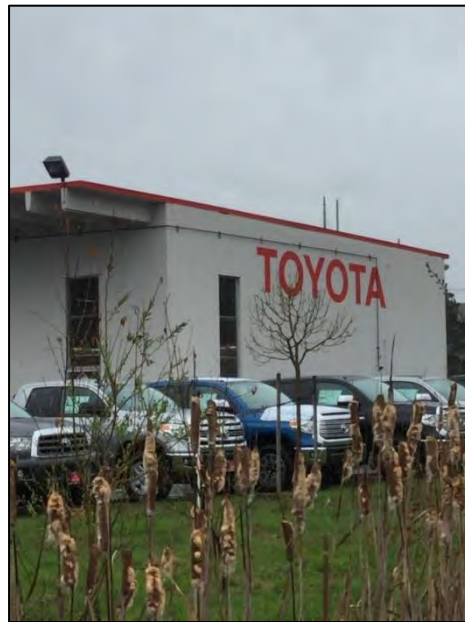
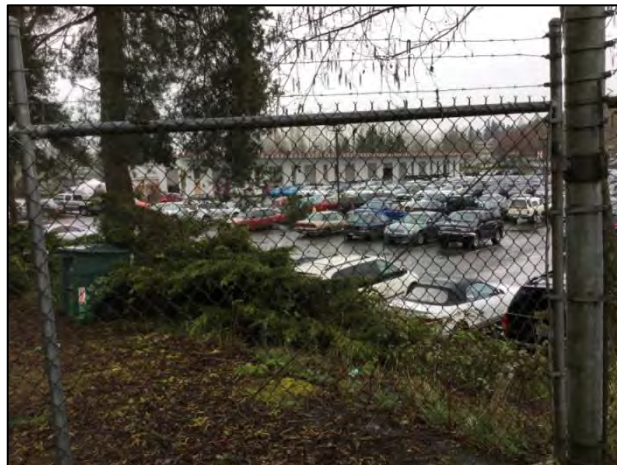
Tax records indicate that 13225 NE 126th Pl. in Kirkland comprises a five-building complex (Figures 7-119–7-121). Only one building is visible from the ROW, a one-story warehouse built in 1974. The rectangular, 25,872-sq-ft building appears to be constructed of poured concrete and is topped by a shed roof. The west elevation appears to be the primary facade of the building and features nine garage bays, some of which are separated by narrow, vertical windows the same height as the bays, giving the facade a geometric appearance. At the roofline, exposed rafters extend over the west elevation. Secondary elevations are visible on the north, where there is a covered central entryway and single garage bay on the west end, and on the south, where there is a single tall, narrow window on the west end in the same style as those spaced on the west elevation.

Figure 7-119. 13225 NE 126th Pl., view northeast.

Figure 7-120. 13225 NE 126th Pl., view northeast.

Figure 7-121.
13225 NE
126th Pl., view
southeast.

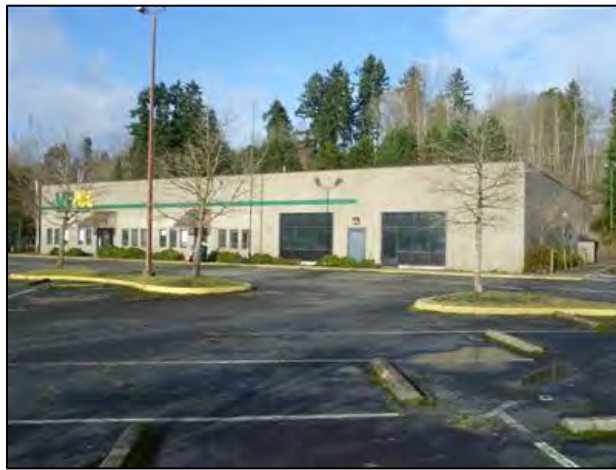
Built in 1973, the commercial building fronting southeast at 12545 135th Ave. NE is a one-story Modern building (Figure 7-122). Because HRA could not see the building from the ROW, our description is based on information from the King County Department of Assessments. The rectangular masonry building is 12,444 sq ft and topped by a flat roof. The facade features two gridded glass walls with a doorway between them on the east half of the face. The west end of the elevation is marked by two additional doorways with shed-roof overhangs spaced between many small windows.

Figure 7-122. 12545 135th Ave. NE, view north. Image courtesy of King County Department of Assessments.

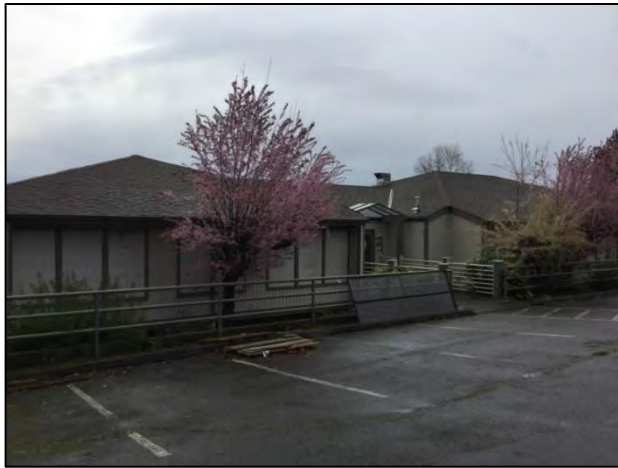
Built in 1981, the commercial building fronting east at 12525 Willows Rd. NE, is a two-story Modern Contemporary building built into a hillside (Figures 7-123–7-125). Generally rectangular, the building is 15,963 sq ft, sits on a poured-concrete foundation, is clad in vertical board, and is topped by a hip roof. The building features entries on the east and west elevations. The west elevation is one story and features two setback entryways with gabled glass overhangs. Fenestration includes grouped side-by-side, wood-framed windows. The east elevation is two stories, with the top floor projecting out, creating a covered walkway supported by round columns below. Fenestration on this face includes metal windows framing a set of double doors on the south end of the elevation and grouped, side-by-side windows on the top floor, creating a ribbon-effect with a central pairing of six windows. Entry is through three additional doorways, two of which are topped by square windows, in the south half of the elevation, and multiple garage bays on the north end. Secondary elevations are visible on the north and south and include ribboned, wood-frame windows on the top floor. No associated structures are visible on the parcel from the ROW.

Figure 7-123. 12525 Willows Rd. NE, view southeast.

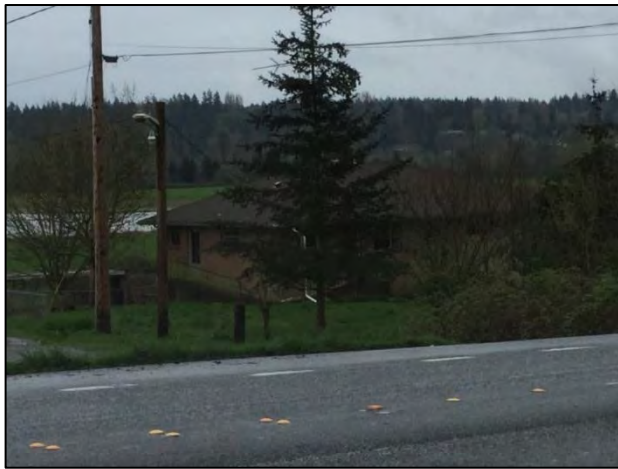
Built in 1954, the house is a one-story, rectangular, 2,390-sq-ft Modern house. The building sits on a poured-concrete foundation, is clad in brick and lap siding, is topped by a hip roof, and has a large addition on the south end. On the west elevation, the east end of the face is clad in brick and the west end is clad in lap siding. Cement ramps with metal railings access doorways on the north and west elevations. Sash and slider vinyl windows are present on all visible elevations.

Figure 7-126. House at 12210 Willows Rd. NE, view southeast.

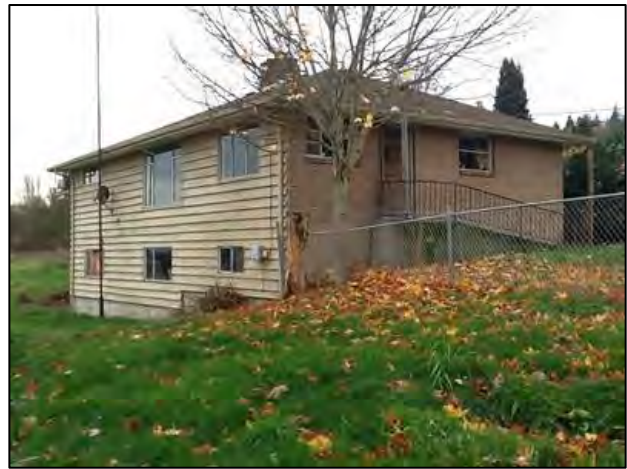
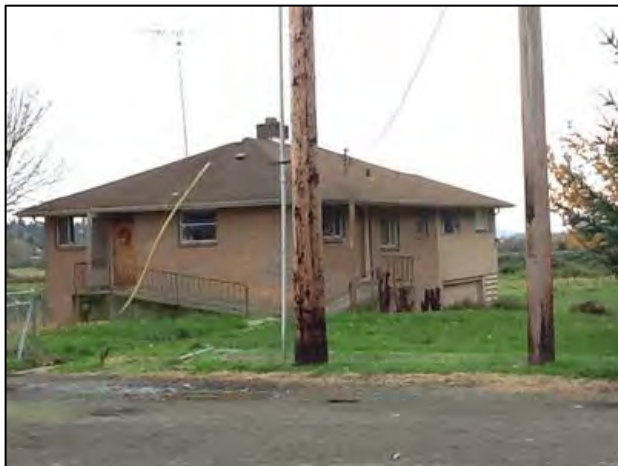
Figure 7-127. House at 12210 Willows Rd. NE, view southwest. Image courtesy of the King County Department of Assessments.

Figure 7-128. House at 12210 Willows Rd. NE, view southeast. Image courtesy of the King County Department of Assessments.

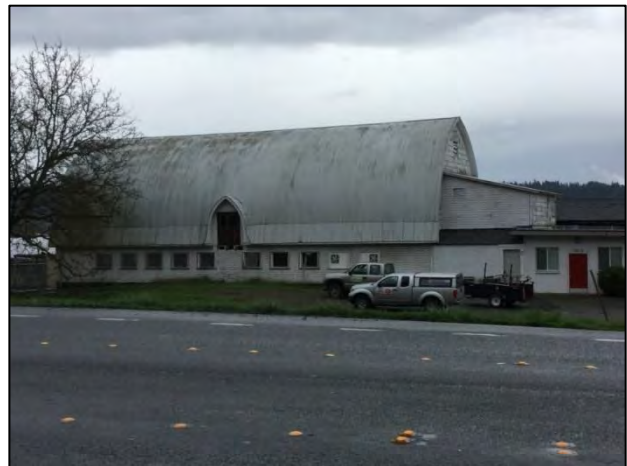
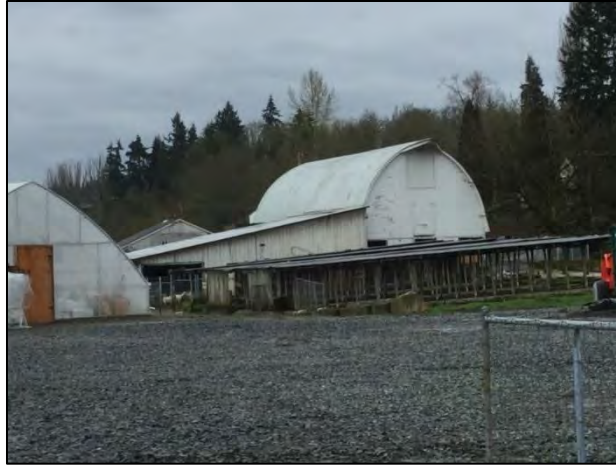
The barn consists of a central barn, with a lean-to on the northeast and a wing on the south. It sits on a poured-concrete foundation, is clad in horizontal board and cedar shake, and is topped by a gothic roof clad in corrugated metal. The west elevation is marked by ten window openings; on the south end, two of these openings have been filled. In the center of the elevation, there is a through-the-cornice, gothic-roof dormer with a covered opening, likely a hayloft door. The north elevation includes hayloft doors and a hay hood. There is a one-story addition on the south end of the barn, connected to the barn with a shed-roof wing. Off the northeast corner of the barn is a large shed-roof, lean-to extension.

Figure 7-129. Barn at 12210 Willows Rd. NE, view east.

Figure 7-130. Barn at 12210 Willows Rd. NE, view southwest.

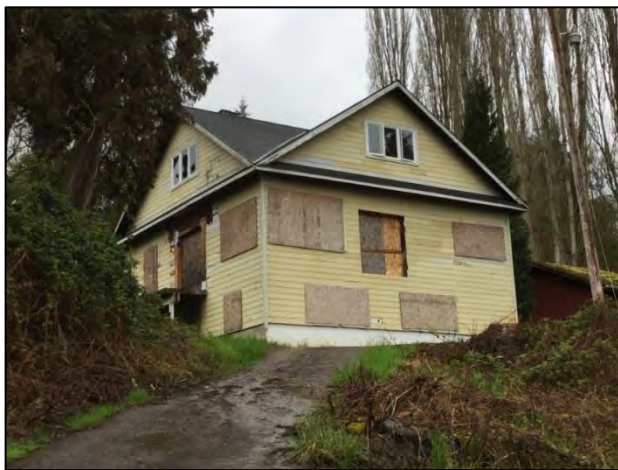
Built in 1922, the single-family dwelling fronting east at 12195 Willows Rd. NE, is a two-and-one-half-story vernacular house (Figures 7-131 and 7-132). Accessed via a steep, semicircular driveway, the foursquare building sits on a concrete foundation, is clad in clapboard siding, and is topped by a cross-gabled roof. At the time of survey in 2017, plywood covered all windows on the first and second floor. On the third floor were three-light vinyl windows on the north, east, and south elevations. According to PSE, as of 2019, this resource has been remodeled and is functioning as a business.

Figure 7-131. 12195 Willows Rd. NE, house, view northwest.

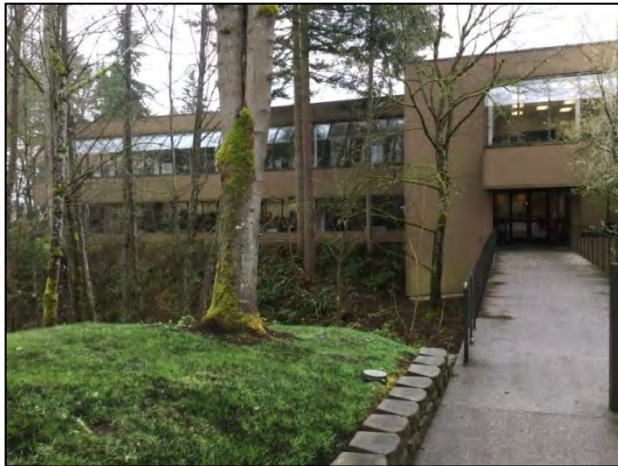
Built in 1974, the Physio-Control Corporation Headquarters Building, located on a company campus at 11811 Willows Rd. NE, is a two-story Modern Contemporary building (Figures 7-133–7-136). Irregular in plan, the building is approximately 92,741 sq ft, sits on poured-concrete foundation, is clad in vertical boards, and is topped by a flat roof. The north facade has four segments that step back (toward the south) from the west end to the east end. Central in the facade is the primary entry, which is accessed via an elevated walkway leading to glass, metal-framed double doors with sidelights. The entryway is beneath a slight overhang created by a bank of oriel garden-style windows above spanning the upper floor of the facade. Fenestration on the first floor is made of a ribbon of metal-framed windows, spanning the facade like the oriel garden-style windows above. The west elevation has clean lines and is unadorned. There is a recessed entry on the north end and a recessed four-bay loading dock on the south end. The south elevation features ribbon windows on the first and second floor. The building has a central atrium. Associated resources include two small storage buildings.

Figure 7-133. 11811 Willows Rd. NE, view west.

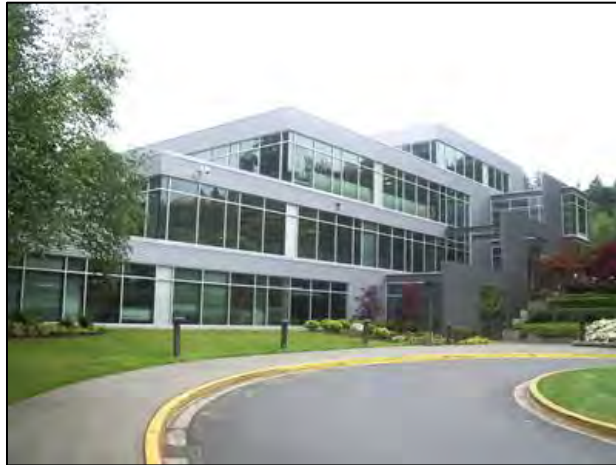
Built in 1981, this large office building at 10525 Willow Rd. NE is a four-story Modern commercial building (Figure 7-137). Because HRA could not see the building from the ROW, our description is based on information from the King County Department of Assessments. The rectangular building is 95,441 sq ft and is built into a hillside with four levels stepping toward the west end. The building sits on a poured-concrete foundation, is clad in glass and concrete, and is topped by a flat roof. Metal-framed windows comprise the majority of the building's exterior.

Figure 7-137. 10525 Willows Rd. NE. Image courtesy of the King County Department of Assessments.

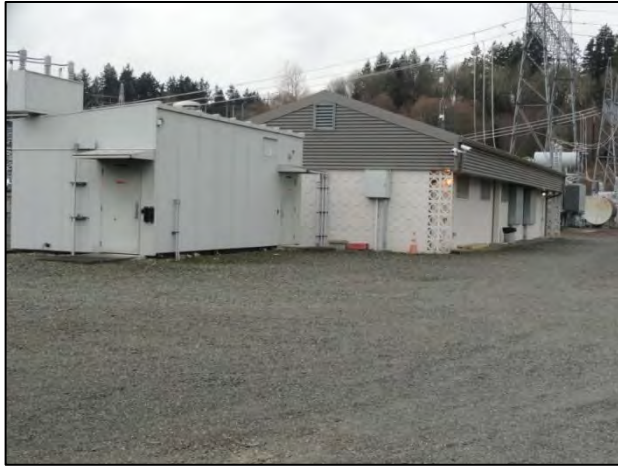
The Sammamish Substation, constructed to serve the Redmond to Renton system in 1967, includes a control house and 230-kV and 115-kV equipment (transformers, circuit breakers, protection equipment, etc.). The control house is a rectangular building of concrete block with a side-gabled roof (Figure 7-138). The building includes decorative concrete block on the east and west elevations. The building is topped by a gabled metal roof with an overhanging eave on the north elevation. A single door is located on the north elevation along with screened windows directly under the eave. The building is minimally ornamented, but the use of decorative concrete block is evidence of an effort to make the substation aesthetically pleasing in an era when proliferating transmission lines led to an industry-wide effort to beautify these systems.

Figure 7-138. The Sammamish Substation in Redmond, view west.

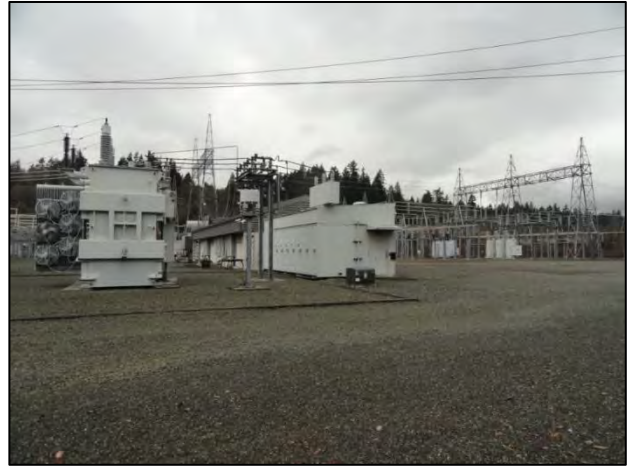
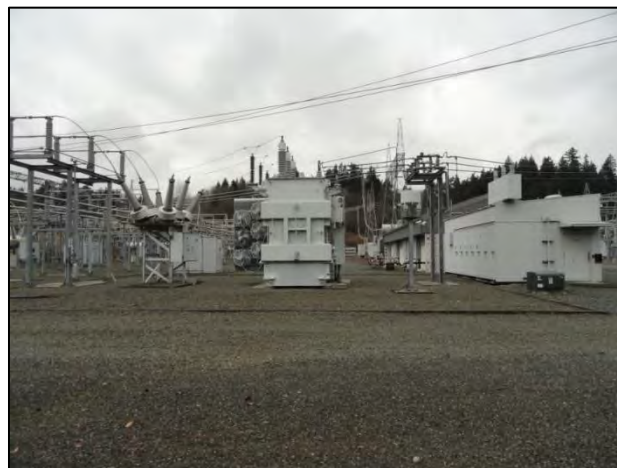
During field survey, access to the substation was restricted. From the public ROW, other structures visible on site included a rectangular metal-sided building, conducting bus work (conductors of rigid metal tubing) with their supporting metal grids, oil switches or circuit breakers, steel towers, conductors, and one transformer (Figures 7-139 and 7-140). A second transformer was minimally visible. All buildings and structures are Modern and Utilitarian in style.

Figure 7-139. Transformer, control house, and bus work at the Sammamish Substation, view northwest

Figure 7-140. Transformer, control house, and bus work at the Sammamish Substation, view west.

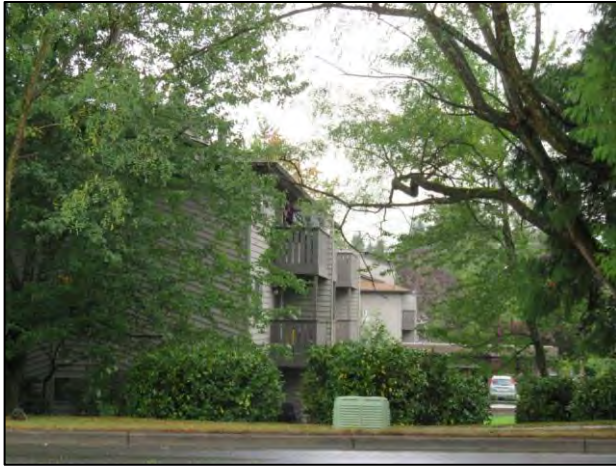
The Emerson Apartment complex at 11010 NE 124th Pl. was constructed in 1983 and is a complex of 23 two- and three-story apartment buildings on 16.81 acres with a central leasing office and pool at the center of the complex (Figures 7-141 and 7-142). Buildings are rectangular, side-gabled, and sit on poured concrete foundations. Constructed in phases, the complex includes buildings clad in various materials. Newer buildings are clad in cement boards, and older buildings are clad in diagonal wood boards. Apartments visible from the public ROW include aluminum-framed windows on all floors and wood balconies above ground-floor recessed porches on secondary elevations. Exterior stairs provide access to upper-floor apartments. The buildings are topped by side-gabled, asphalt shingle roofs. The central leasing office, constructed during a later period of construction, includes a projecting entry with battered columns in a modified Craftsman style.

Figure 7-141. Emerson Apartment complex at 11010 NE 124th Pl., view north.

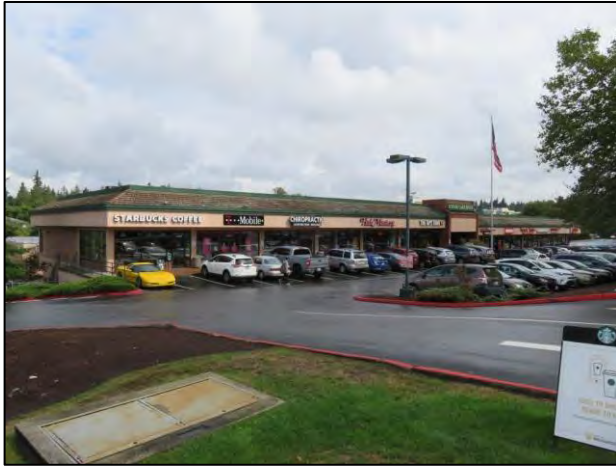
The single-story commercial block at 11410 NE 124th St. in Kirkland was constructed in 1984. It sits atop a daylight basement and is constructed as two wide, commercial wings separated by a covered stair leading from the basement level parking area in the rear (north) to the upper level street frontage facing south (Figure 7-143). The building is utilitarian in design with elements of the International style evident in its boxy form. The building sits on a poured concrete foundation and is constructed of concrete clad in stucco. Its various storefronts are made up of glass paneled pedestrian doors paired with large, metal-framed windows above a skirt of brick veneer. Storefronts are separated by stuccoed columns. Above the storefronts is a projecting, stuccoed eave with room for signage. The eave is topped by a flat roof with hipped eaves covered in semi-circular clay tiles. Between the two wings is a central roof projection that includes signage reading “Totem Lake West.” The central projection shelters a breezeway between the two wings with a zigzag concrete stair to the lower level (Figures 7-144 and 7-145). The building’s rear elevation includes basement level retail. Retail spaces with large storefront windows face a concrete walkway that shelters under the projecting second story. On this elevation (north), the second story is covered in stuccoed concrete panels with pairs of large, fixed windows.

Figure 7-143. Totem Lake West at 11410 NE 124th St., view northeast.
