7.2.13 12804 109th Ave. NE, Kirkland

Figure 1. Sammamish–Juanita 115 kV Transmission Line Project location map.

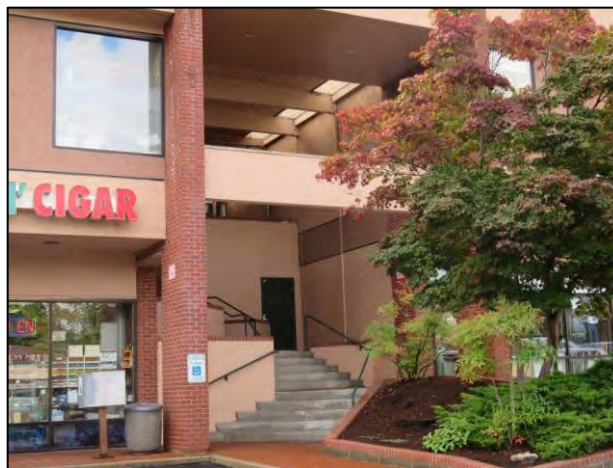
The single-story commercial block at 11410 NE 124th St. in Kirkland was constructed in 1984. It sits atop a daylight basement and is constructed as two wide, commercial wings separated by a covered stair leading from the basement level parking area in the rear (north) to the upper level street frontage facing south (Figure 7-143). The building is utilitarian in design with elements of the International style evident in its boxy form. The building sits on a poured concrete foundation and is constructed of concrete clad in stucco. Its various storefronts are made up of glass paneled pedestrian doors paired with large, metal-framed windows above a skirt of brick veneer. Storefronts are separated by stuccoed columns. Above the storefronts is a projecting, stuccoed eave with room for signage. The eave is topped by a flat roof with hipped eaves covered in semi-circular clay tiles. Between the two wings is a central roof projection that includes signage reading “Totem Lake West.” The central projection shelters a breezeway between the two wings with a zigzag concrete stair to the lower level (Figures 7-144 and 7-145). The building’s rear elevation includes basement level retail. Retail spaces with large storefront windows face a concrete walkway that shelters under the projecting second story. On this elevation (north), the second story is covered in stuccoed concrete panels with pairs of large, fixed windows.

Figure 7-145. The breezeway, Totem Lake West at 11410 NE 124th St., view south.

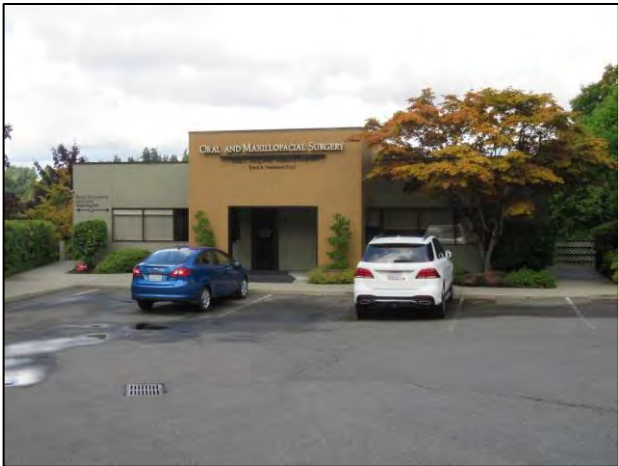
Constructed in 1983, the office block at 12330 120th Ave. NE is a single-story professional building atop a daylight basement. The building faces a parking lot. The building is a modest example of the International style, featuring the typical blocky, flat-roofed form. The building sits on a poured concrete foundation, is constructed of concrete clad in stucco, and is topped by a flat roof with parapet. The building features a central, projecting entry with square arch. The projection shelters a pedestrian door. The entry is flanked east and west by bands of aluminum-framed windows. A second pedestrian entry is accessed from the building's west elevation and a stair from the basement level. Wide bands of windows face east, and signage for the building is located on the north and south elevations (Figures 7-146 and 7-147).

Figure 7-146. 12330 120th Ave. NE, view north.

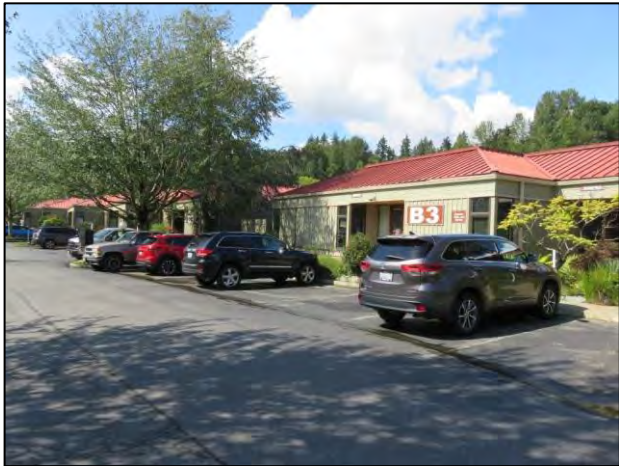
The single-story business block located at 12509 130th Ln. NE in Kirkland was constructed in 1983 and is Modern in design, featuring office suites with generous windows and entries with access to the outdoors. The building is part of a complex of office blocks connected by parking lots and throughways. The building is wide, rectangular, and faces south. It includes suites with stepped-back entries on its facade. Recessed entries face small brick plazas or concrete steps. The building sits on a poured concrete foundation, is clad in board and batten siding, and includes wide ribbons of metal-framed windows topped by awning window-transoms at the entries. The building is topped by a flat roof with hipped, standing seam metal eaves on the facade (Figures 7-148 and 7-149).

Figure 7-148. 12509 130th Ln. NE, view northwest.

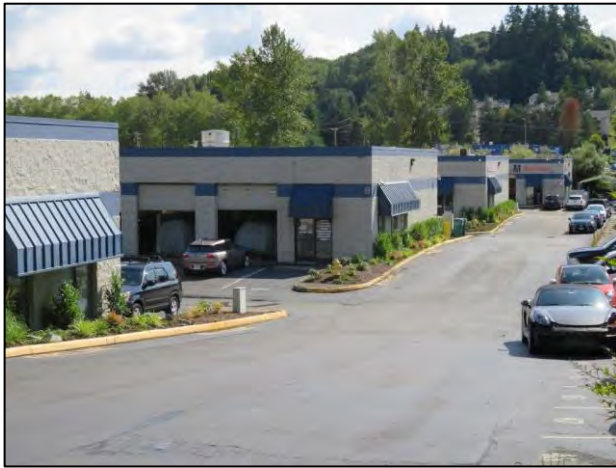
The building complex at 13209 NE 126th Pl. in Kirkland was constructed in 1984 and includes four nearly identical warehouse buildings used for automotive services (Figures 7-150 and 7-151). The buildings are utilitarian in design, featuring rectangular warehouse spaces designed for flexibility. Each building is constructed of concrete block, with decorative parging and decorative bands of concrete block on all elevations. The buildings sit on poured concrete foundations and include multiple garage bays with overhead garage doors and metal pedestrian doors. Pedestrian doors and office windows (primarily on the west elevations) are topped by metal awnings. The buildings are topped by flat roofs with modest parapets.

Figure 7-150. 13209 NE 126th Pl., view south.

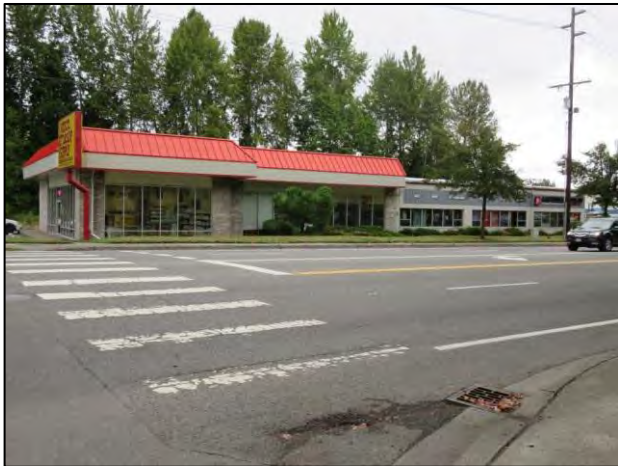
The single-story, irregularly shaped retail block at 13400 NE 124th St. is a prefabricated steel building constructed in 1984 (Figures 7-152 and 7-153). The building sits on a poured concrete foundation and faces south. Stylistically, the building is utilitarian but designed in two distinct sections. The east half is clad in prefabricated steel panels with steel-framed fixed and casement windows on the south- and east-facing elevations. It is used as an automotive warehouse. To the west, the building has been ornamented by brick veneer-clad columns, wide ribbons of floor-to-ceiling windows on a south-facing projection, and a decorative, painted, standing seam metal, hipped eave attached to the moderately gabled roof. The west section of the building is designed for offices and retail services.

Figure 7-152. 13400 NE 124th St., view northeast.

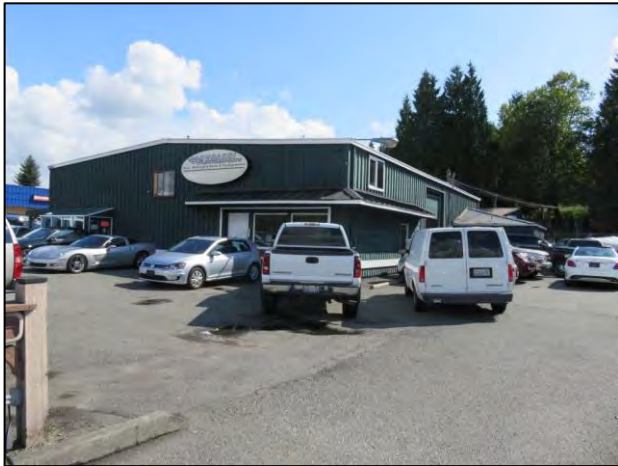
The rectangular, single-story warehouse building at 13131 NE 124th St. was constructed in 1974. It has a shallow, front-facing gable and a pedestrian entry on the north elevation. The building sits on a poured-concrete foundation, is utilitarian in design, and constructed of prefabricated steel. Its facade features a projecting awning over the decorative steel pedestrian door, vinyl-framed windows located at the entry, and a projecting bay window. The building features projections at the southwest corner and southeast corner. It is topped by a metal roof (Figures 7-154 and 7-155). At the rear of the parcel is a simple, rectangular, front-gabled garage clad in metal with a corrugated metal roof.

Figure 7-154. 13131 NE 124th St., view southeast.

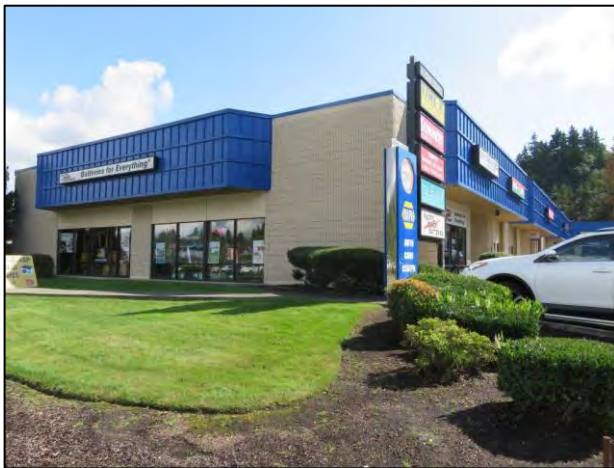
The single-story, rectangular retail block at 13205 NE 124th St., was constructed in 1983. It is utilitarian in style, featuring some elements of Modern or International style, visible in its blocky form, its large windows and modest ornament (Figures 7-156 and 7-157). The building sits on a poured concrete foundation, is of masonry construction, and is clad in a veneer of coursed soldier bricks on the its north and west facing elevations. The building features multiple suites, accessible from the west-facing elevation. Pedestrian entries are recessed and include pedestrian doors paired with metal-framed windows. Some include garage bays. Large, blocky, metal eaves project from the building on the north and west elevations. The north-facing facade includes two ribbons of tall, metal-framed display windows.

Figure 7-156. 13205 NE 124th St., view south.

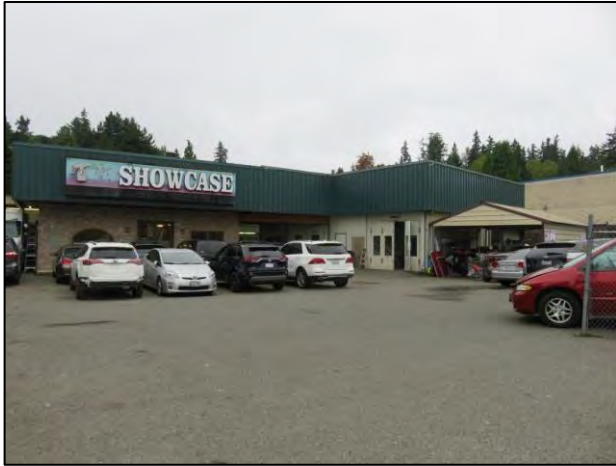
The single-story, irregularly shaped building hosting an auto detailing business at 13325 NE 124th St. was constructed in 1973 (Figure 7-158). The building includes an L-shaped mass with utilitarian character, but it has been greatly enlarged to the rear, which is minimally visible from the public ROW. The building's primary mass sits on a poured concrete foundation, is partially clad in brick veneer, and is topped by a flat roof with metal-clad eave. The building's facade features a pedestrian entry flanked to the west by an arched window and to the east by a square window. To the west of this mass is a covered parking bay with overhead garage door. To the west of the bay is a projecting wing with accordion doors. Prefabricated storage bays have been added to the building's east and north elevations. Also on the parcel is a two-story, steel-framed storage structure for vehicles (Figure 7-159).

Figure 7-158. 13325 NE 124th St., view southwest.

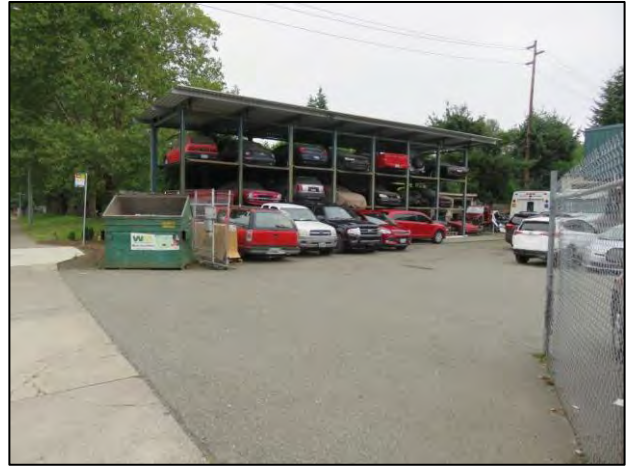
Figure 7-159. Vehicle storage at 13325 NE 124th St., view southeast.

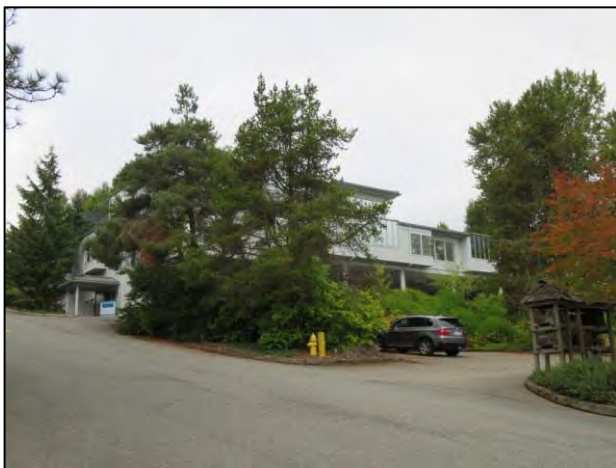
The irregular, L-shaped, two-story office block at 12515 Willows Rd. NE was constructed in 1984 (Figures 7-160 and 7-161). The building sits on a poured concrete foundation, includes a daylight basement, and is built into a hill sloping up to the west. The building's massing is International in style, featuring a wide, single story projecting east. It is supported by posts and projects over covered parking at the basement level. Above the main floor is a stepped back second story. The building is clad in diagonal wood boards with ribbons of fixed aluminum, corner-wrapping windows. Designed to take advantage of views east, south, and west, the building includes projecting bays with windows facing three directions. Solarium windows wrap the edge of the roofline. The building's roof is hipped with eaves covered in half-round, clay tiles. The building hosts Halvorson Construction Group. Its facade faces west and is not visible from the public ROW.

Figure 7-160. 12515 Willows Rd. NE, view west.

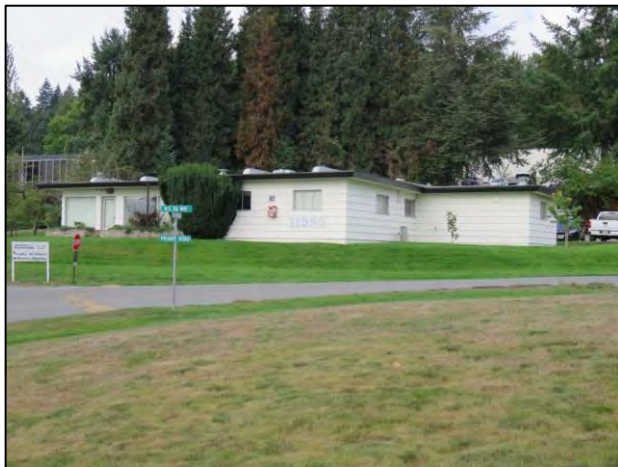
The single-story office block at 11595 139th Pl. NE, which has the massing and low, horizontal emphasis of a former Modern-era Ranch style residence, was constructed at an unknown date and is not detailed in the King County Department of Assessments' online records. A review of aerials shows that while a small building was located on this site as early as 1952, the building did not achieve its present footprint until approximately 1964 (NETR 2019). The building is irregular in plan, sits on a poured concrete foundation and is clad in shingles (Figures 7-162 and 7-163). It faces east toward Willow Rd. On primary and secondary elevations, the building features three-part, sliding, aluminum-framed windows. The building's facade includes an off-center entry flanked by two large picture windows. An attached garage is located to the south. The building's facade also includes brick planter boxes. The building is topped by a flat roof with deep eaves. It appears to function as the main offices and visitor center for the Primex Aerospace Co.

Figure 7-162. 11595 139th Pl. NE, view southwest.

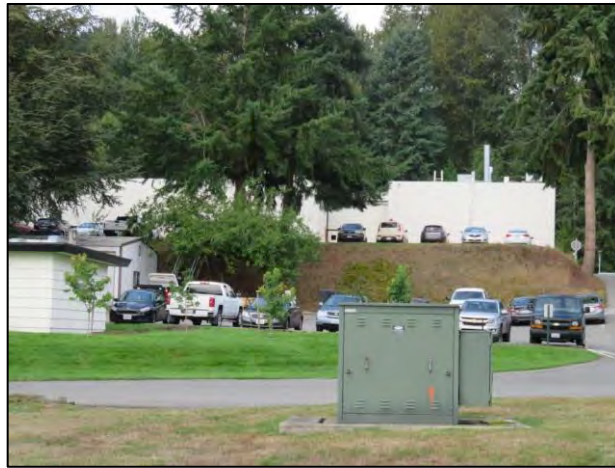
The large concrete warehouse located at 11550 139th Pl. NE was constructed at an unknown date. Its date of construction is not detailed in the King County Department of Assessments' online records. However, a review of aerial photographs suggests that the manufacturing warehouse was constructed between 1964 and 1968 (NETR 2019). The building is part of the secure Primex Aerojet facility and is only minimally visible from the public ROW (Figure 7-164). It appears to be a large, square or rectangular, one- or two-story block with no fenestration on the east elevation. The building is utilitarian in style and features no architectural ornament on visible elevations.

Figure 7-164. 11550 139th Pl. NE, view west.

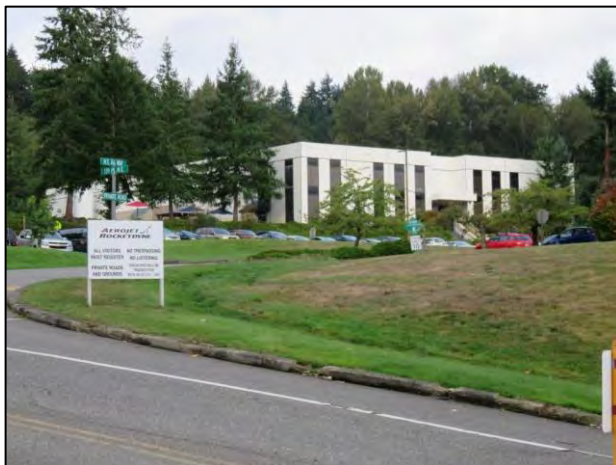
The two-story office block located at 11650 139th Pl. NE in Redmond was constructed in 1981, according to the King County Assessor. The building is generally rectangular, sits on a poured-concrete foundation, and is of masonry construction (Figures 7-165 and 7-166). The building's facade faces east toward Willows Rd. NE. The building's facade includes a central entry set into a full-height, concave recession. The central entry shelters under a projecting eave and is accessed by an external concrete stair. Flanking the entry are full floor-to-ceiling windows with dark glass, giving the facade a striped appearance. The building is topped by a flat roof with parapet. As with 11595 and 11550 139th Pl. NE, the building is located on the secure Primex Aerospace Co. campus and is minimally visible from the public ROW.

Figure 7-165. 11650 139th Pl. NE, view northwest.

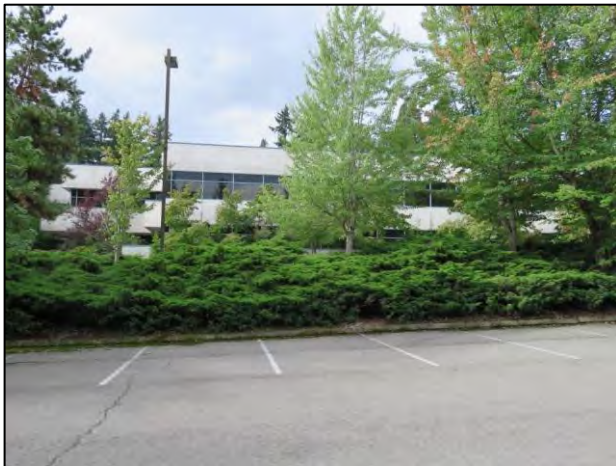
The two-story office block at 10301 Willows Rd. NE was constructed in 1984 in the International style, featuring the irregular massing, flat surfaces, repetitive geometric forms, and mass-produced materials typical of the style (Figures 7-167 and 7-168). The irregularly shaped building sits on a poured concrete foundation, is built into the southwestern slope of a hill, and includes a daylight basement visible on the south elevation. The building is clad in precast (tilt-up) concrete panels and is topped by a flat roof on most elevations, although an eave projects over balconies on the south elevation. The building was constructed to take advantage of views south, east, and west. On the south elevation, concrete framed balconies provide wide exterior walkways with stepped projections covered by deep eaves. All elevations include continuous ribbons of fixed metal-framed windows on both the first and second floors. The building is part of a larger industrial complex and is associated with the more elaborately designed building on the parcel to the south. Wide lawns, concrete walkways, and irregularly shaped parking areas connect the two buildings. The building at 10301 Willows Rd. NE is surrounded by foundational plantings that have matured and screened much of the lower floor.

Figure 7-167. 10301 Willows Rd. NE, view west.

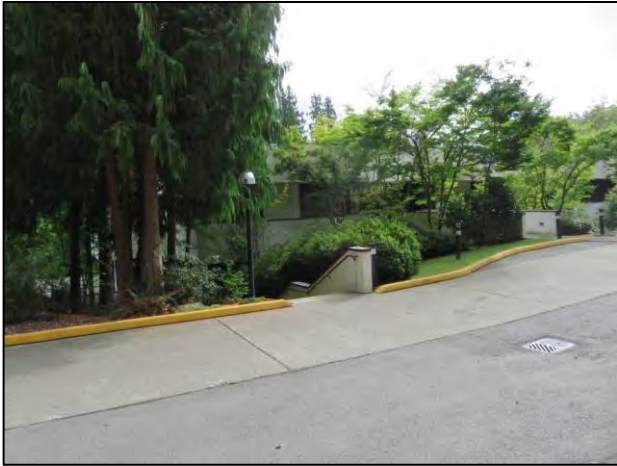
The three-story office block at 10201 Willows Rd. NE was constructed in 1984. As with the building to the north (10301 Willows Rd. NE), the building at 10201 Willows Rd. NE was constructed in an irregular plan on a concrete foundation and clad in precast (tilt-up) concrete panels, with extensive ribbons of gridded, metal-framed windows on all elevations (Figures 7-169 and 7-170). The building includes wide, concrete balconies with projecting plazas along all three floors (Figures 7-171–7-173). The building is topped with a flat roof with deep eaves sheltering lower balconies. The facade faces west toward a parking area. Access from the parking area to the tiered entrance is by way of concrete paths and stairs through parklike settings. The building's primary entry is off-center on the top floor and consists of paired metal doors with glazed, semi-circular cutouts and semi-circular handles. These elaborate doors are used on secondary elevations at lower levels as well.

The building is part of a larger industrial complex and is associated with 10301 Willows Rd. NE to the north. Wide lawns, concrete walkways, and irregularly shaped parking areas connect the two buildings. The building at 10201 Willows Rd. NE is surrounded by a park-like setting with foundational plantings that have matured and screened much of the lower floor, a pond, and walkways and trails through surrounding natural areas.

Figure 7-169. 10201 Willows Rd. NE, view southeast.

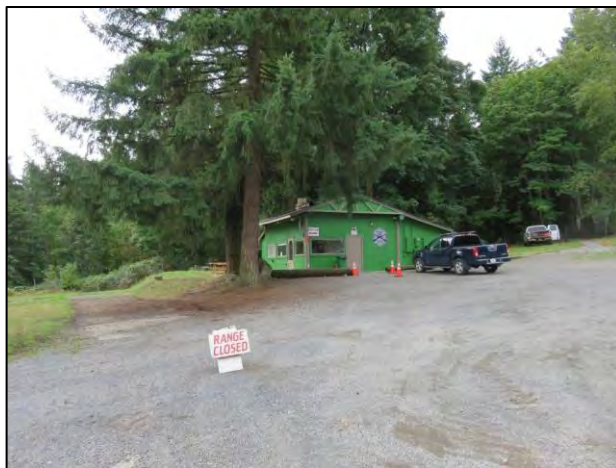
The 11.03-acre parcel addressed as 13633 NE 97th St. is known as the Interlake Sporting Association and is a gun range with a single clubhouse, or skeet house, visible from the public ROW. It was constructed in 1953 (Figures 7-174 and 7-175). The site is secured by chain link fencing. The single-story, post-and-beam building sits on a poured-concrete foundation and is clad in plywood panels. Wood-framed picture windows and a pedestrian door with arched window are located on the building's east elevation. The building is topped by a front-gabled roof with eaves. The building's northeast corner appears to have been squared. It is framed in post and beam and is topped by a gable with applied boards in the overhanging eave. The elevation includes a solid pedestrian door and a wide, wood-framed, fixed window.

Figure 7-174. 13633 NE 97th St., shooting range and clubhouse or skeet building, view south.

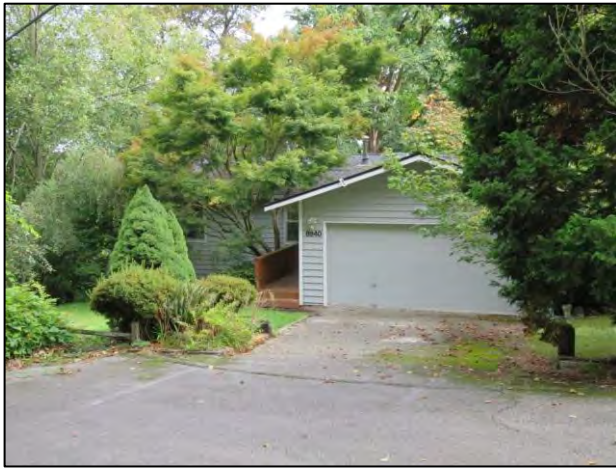
The single-family residential building at 8940 142nd Ave. NE was constructed in 1982 (Figures 7-176 and 7-177). It sits on a poured-concrete foundation and includes a daylight basement. The building is L-shaped in plan with a projecting garage and is a modest example of a late-era Ranch style plan, with a wide elevation, side-gabled roof with deep eaves, and attached garage. The building is clad in horizontal wood boards, and its facade includes a central entry beside the garage, accessed by a walkway with rail, and one-over-one, vinyl-framed windows. The building is located in a park-like setting that drops off to the northeast. Aerials suggest that the building includes a wood balcony to the northeast.

Figure 7-176. 8940 142nd Ave. NE, view northeast.

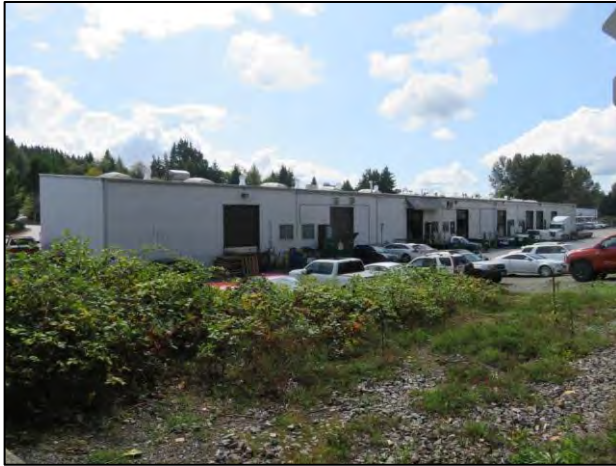
The single-story warehouse building located at 12706 NE 124th St. was constructed in 1972 (Figures 7-178 and 7-179). It is utilitarian in design and roughly rectangular, with stepped elevations on the east and west ends. The buildings are associated with Lanco Industries, located on a separate parcel to the south. The warehouse building sits on a poured concrete foundation, is clad in prefabricated metal panels, and topped by metal shed roof with shallow gable. The building includes multiple garage bays with overhead doors and some vinyl-framed windows.

Figure 7-178. 12706 NE 124th St., view southwest.
