2022 KIRKLAND WATERSHED REPORT CARDS

Kirkland Public Works
Storm & Surface Water Division
kirklandwa.gov/stormwater

2022 Watershed Report Card

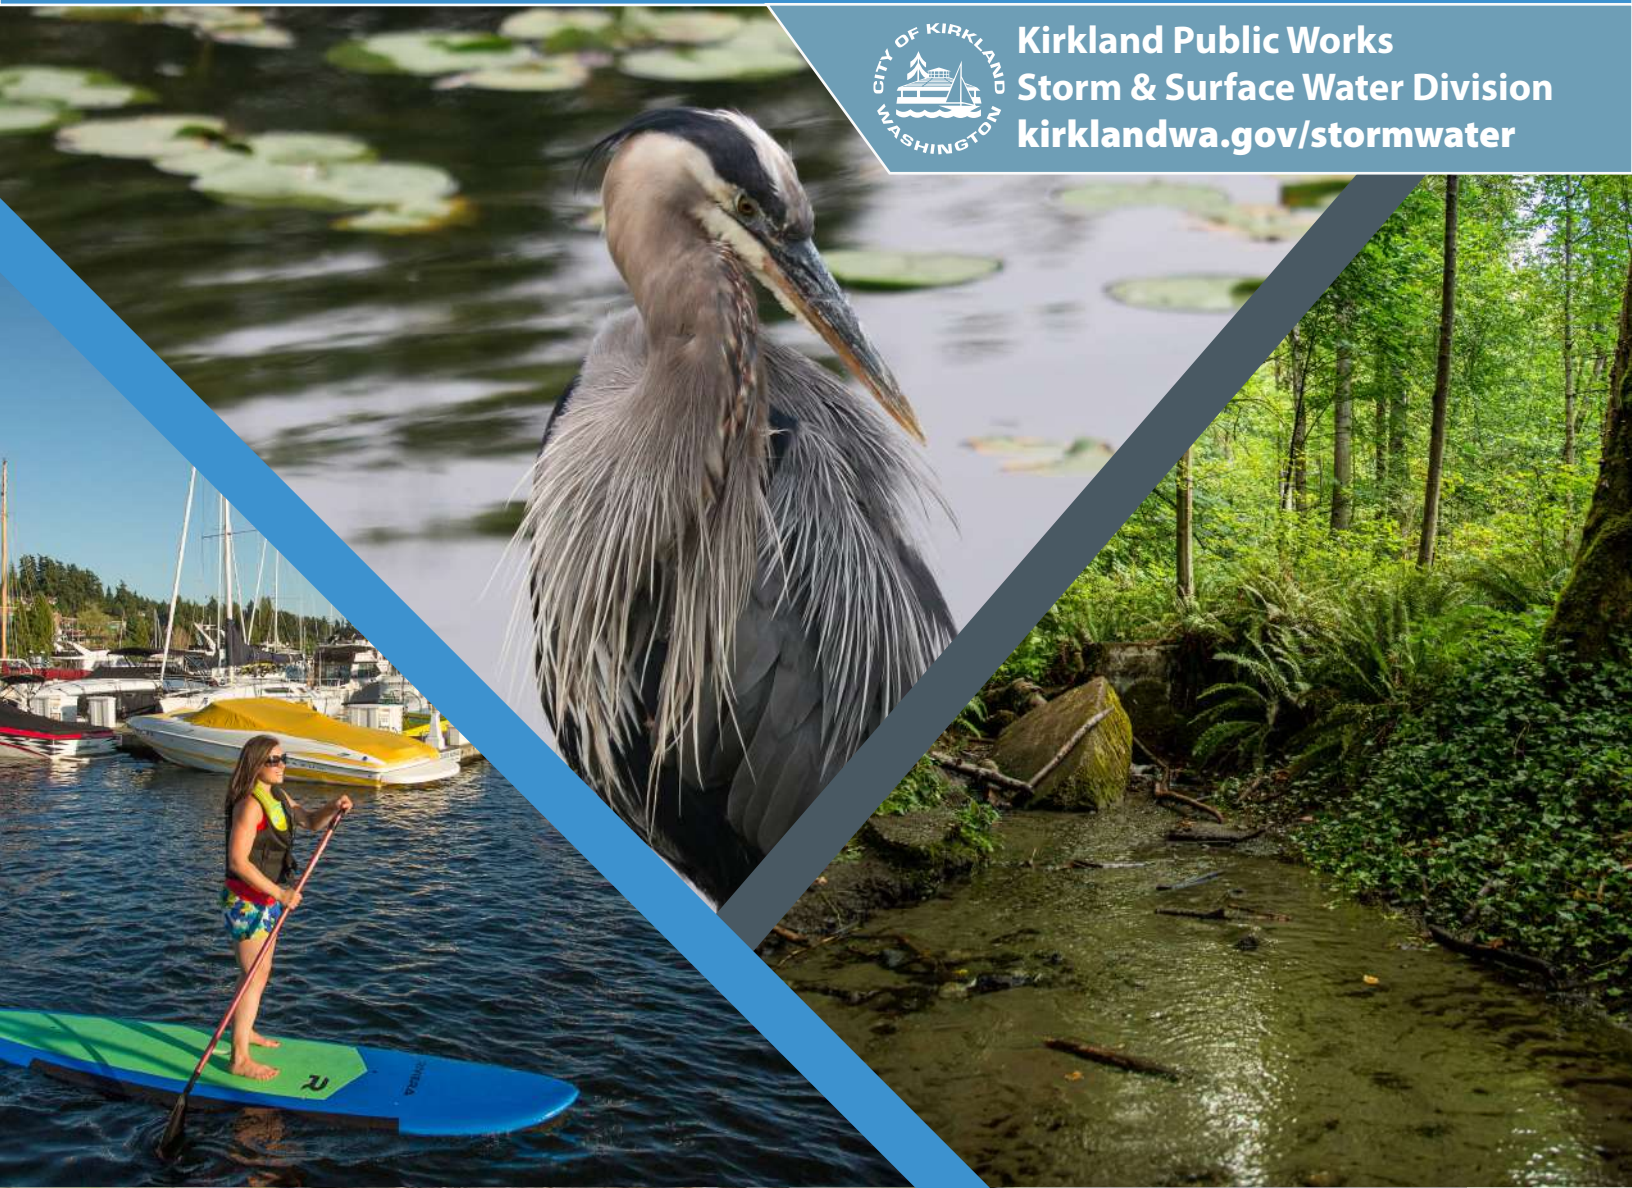
2021 Water Quality Scores

A **watershed** is the area of land that drains water to a specific creek or waterbody. The thick black lines on the map of Kirkland outlines the various watersheds in the city. Watersheds are also referred to as "basins" in these report cards.

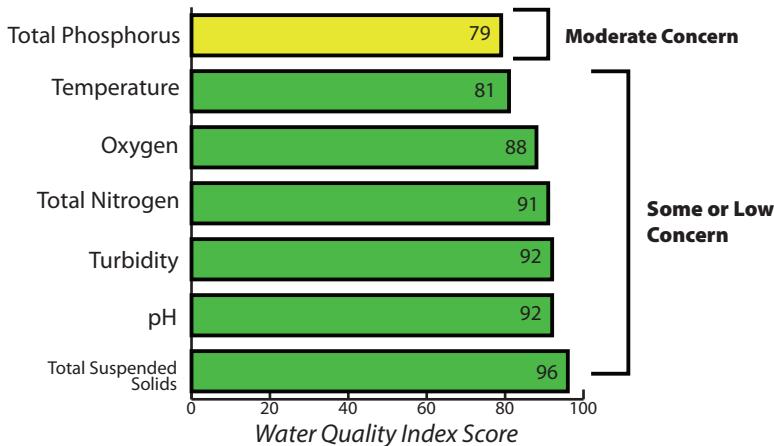
2021 Water Quality

Water quality in Carillon Creek was in the **Some or Low Concern** category in 2021. High levels of phosphorus combined with high water temperatures are the primary reasons this basin did not score higher.

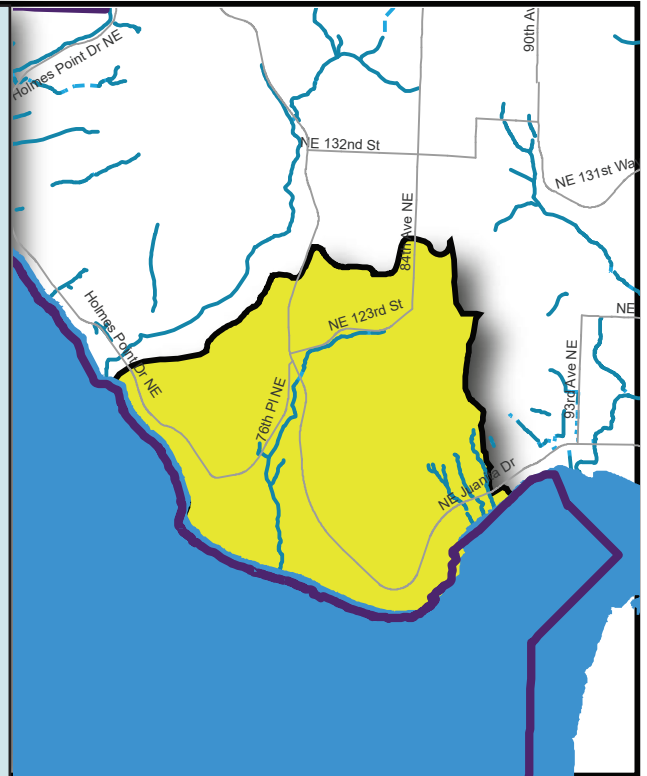
Champagne Creek is a mid-sized basin in northern Kirkland that drains to Lake Washington. Water quality and creek health are affected by land upstream, shown in yellow on the map.

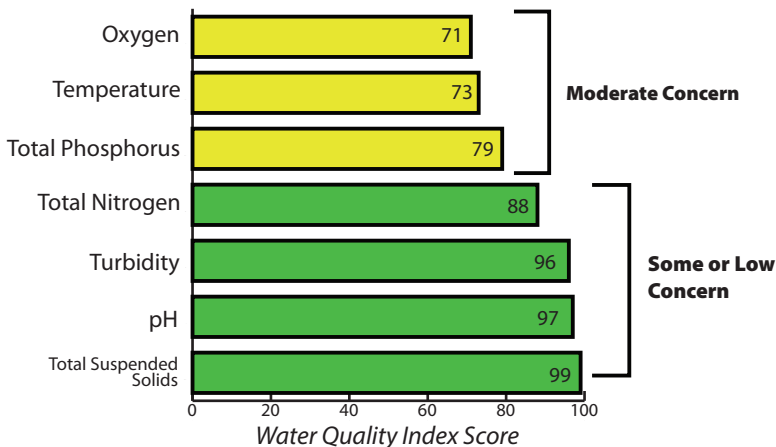
2021 Water Quality

Water quality in Champagne Creek was in the **Moderate Concern** category in 2021. Low levels of oxygen combined with high water temperatures and high phosphorus levels are the primary contributors to a lower score.

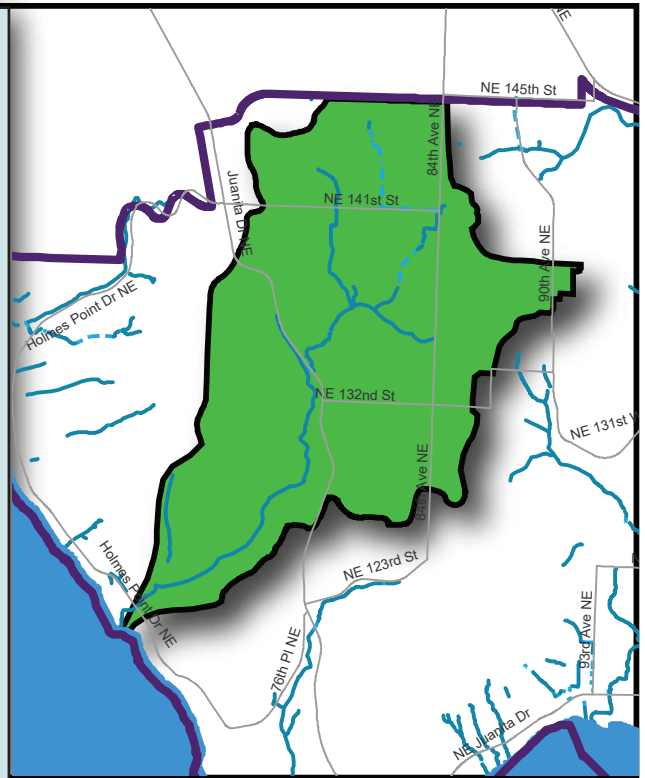
Denny Creek is in northern Kirkland and drains to Lake Washington. Water quality and the health of the creek is affected by land upstream, shown in green on the map.

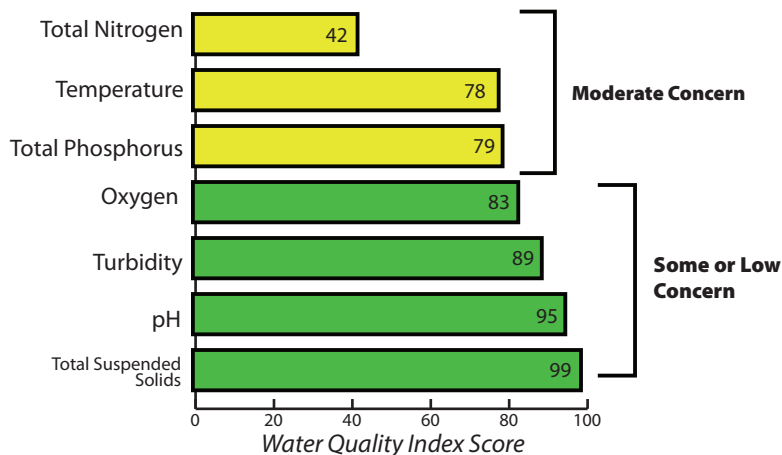
2021 Water Quality

Water quality in Denny Creek was in the **Some or Low Concern** category in 2021. High levels of nitrogen and phosphorus combined with high water temperatures are the primary reasons why Denny Creek did not score higher.

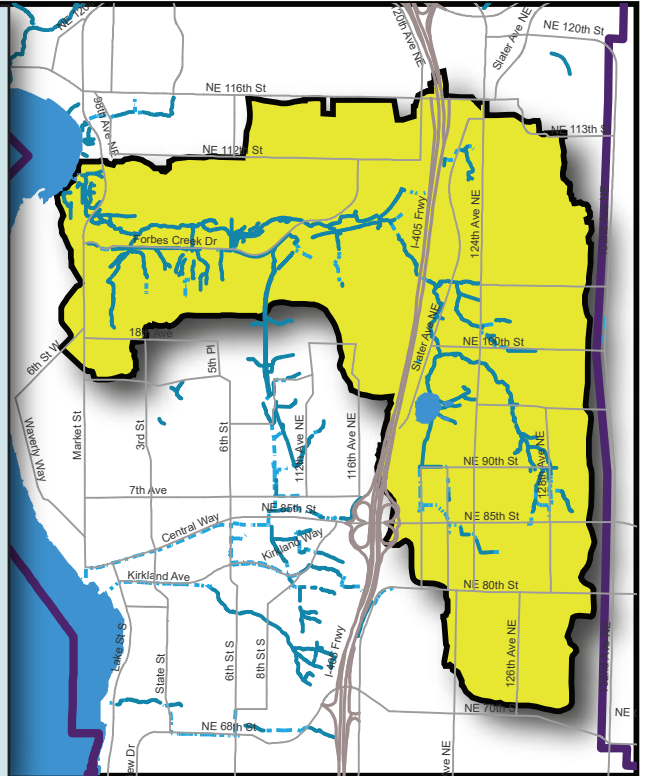
Forbes Creek begins east of I-405 at Forbes Lake and eventually flows into Lake Washington. Water quality and the health of the creek is affected by land upstream, shown in yellow on the map.

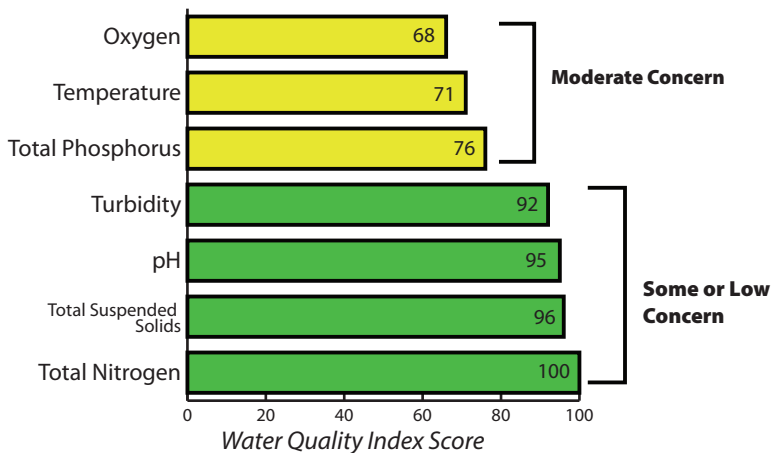
2021 Water Quality

Water quality in Forbes Creek was in the **Moderate Concern** category in 2021. Low levels of oxygen combined with high water temperatures and high levels of phosphorus are the primary contributors to a lower score.

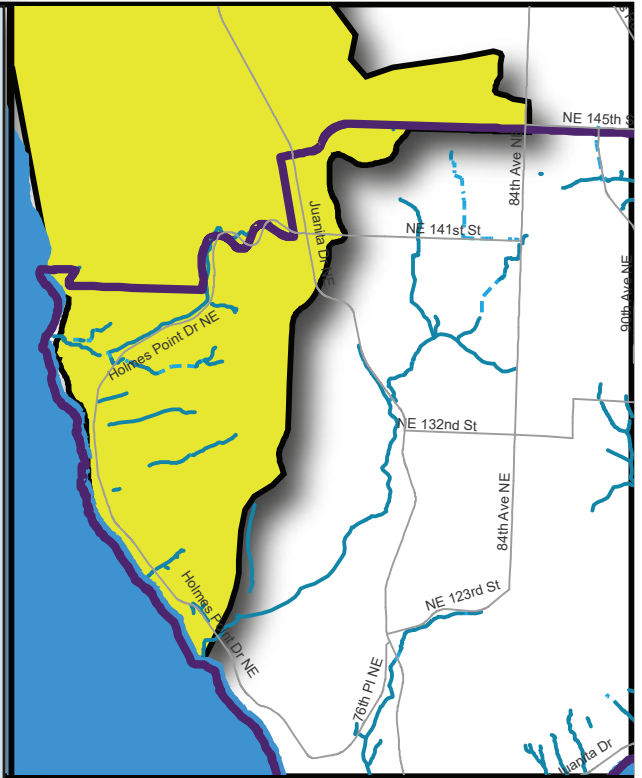
Holmes Point Creek and other stream channels in this basin drain to Lake Washington. Water quality and the health of these stream channels is affected by the land upstream, shown in yellow on the map.

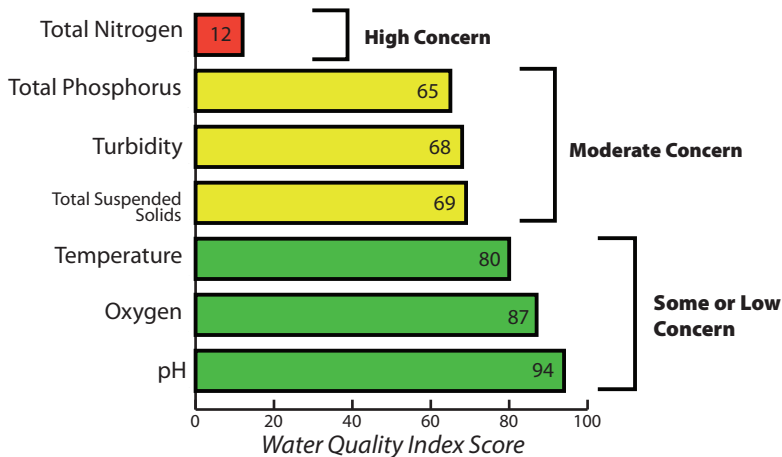
2021 Water Quality

Water quality in Holmes Point was in the **Moderate Concern** category in 2021. High levels of nitrogen and phosphorus combined with very cloudy water with high amounts of suspended solids are the primary contributors to the low score in Holmes Point.

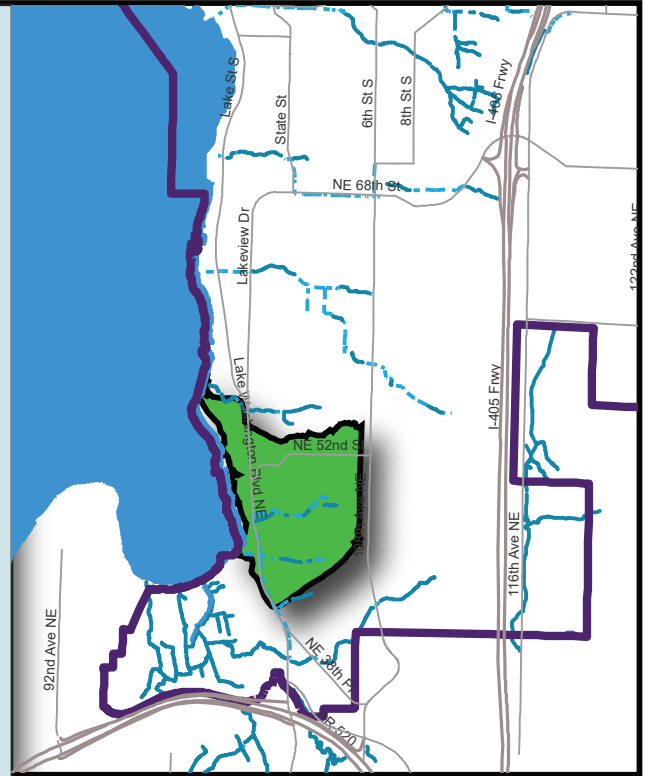
Houghton Slope B has many stream channels in the basin that drain to Lake Washington. Water quality and the health of these stream channels is affected by the land upstream, shown in green on the map.

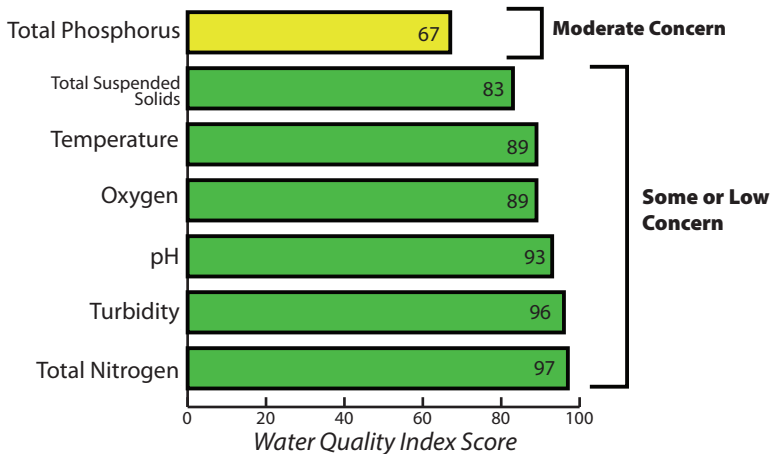
2021 Water Quality

Water quality in Houghton Slope B was in the **Some or Low Concern** category in 2021. A high level of phosphorus is the primary reason that Houghton Slope B did not score higher.

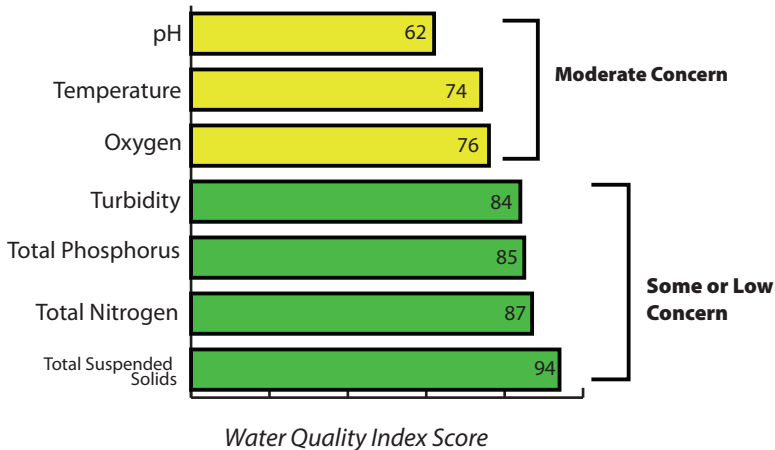
2021 Water Quality

Water quality in Juanita Creek was in the **Moderate Concern** category in 2021. Water quality samples were collected from five different sites throughout the basin.

Overall, low levels of oxygen combined with high temperatures were common contributors to low scores. In addition, high levels of nitrogen and phosphorus in the Billy Creek tributary and generally low water quality scores in the Totem Lake tributary were worth note. The Kingsgate Tributary had the highest water quality scores in the Juanita Basin.

**Based on Juanita Creek sampling site*

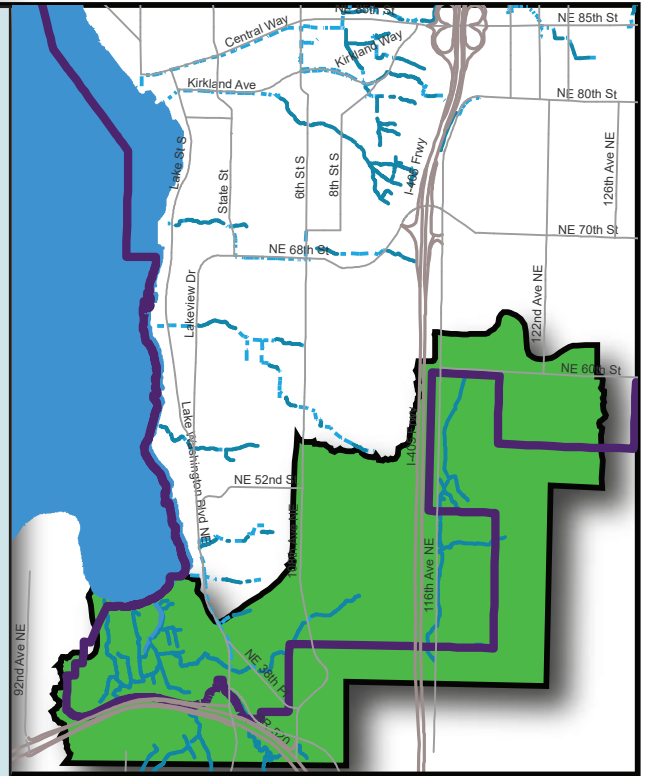
Cochran Springs Creek and **Yarrow Creek** are in this basin and drain to Yarrow Bay in Lake Washington. Water quality and the health of these stream channels is affected by land upstream, shown in green on the map.

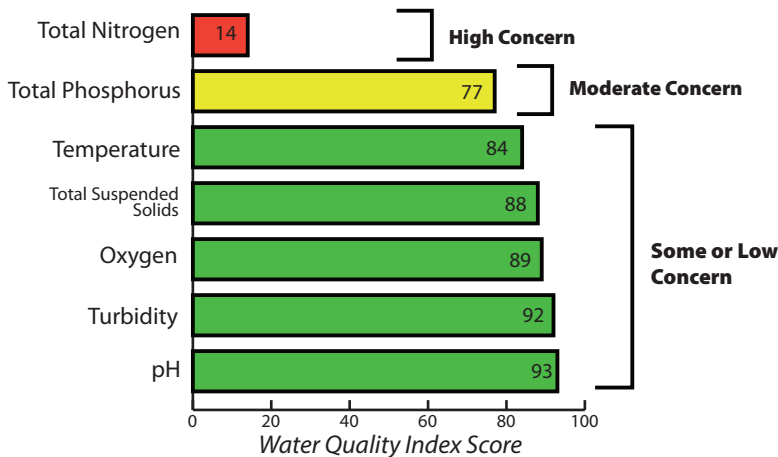
2021 Water Quality

Water quality in Yarrow Creek was in the **Some or Low Concern** category in 2021. High levels of nitrogen and phosphorus are the primary reasons why Yarrow Creek did not score higher.
