WETLAND/STREAM DELINEATION REPORT AND MITIGATION PLAN JUANITA BEACH BATHHOUSE REPLACEMENT AND SHELTER JUANITA BEACH PARK PHASE II IMPROVEMENTS KIRKLAND, WASHINGTON

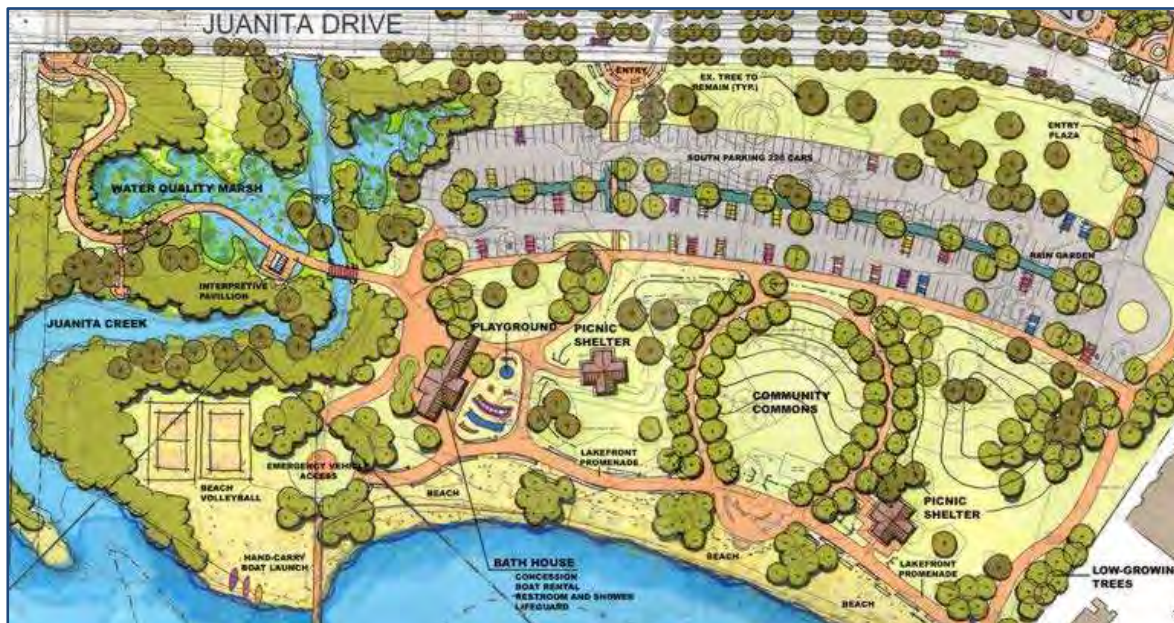
Exhibit 1. Excerpt from Juanita Beach Park Master Plan (J.A. Brennan Associates PLLC, 2006).

The City has been implementing the Juanita Beach Park Master Plan (J.A. Brennan, 2006) in phases (Exhibit 1). In 2006, the City issued a Determination of Non-Significance based on a programmatic State Environmental Policy Act (SEPA) checklist for the Master Plan. At the time, the presence of wetlands in the park, other than those associated with Juanita Creek, was not confirmed so the programmatic SEPA did not identify any project-related wetland impacts.

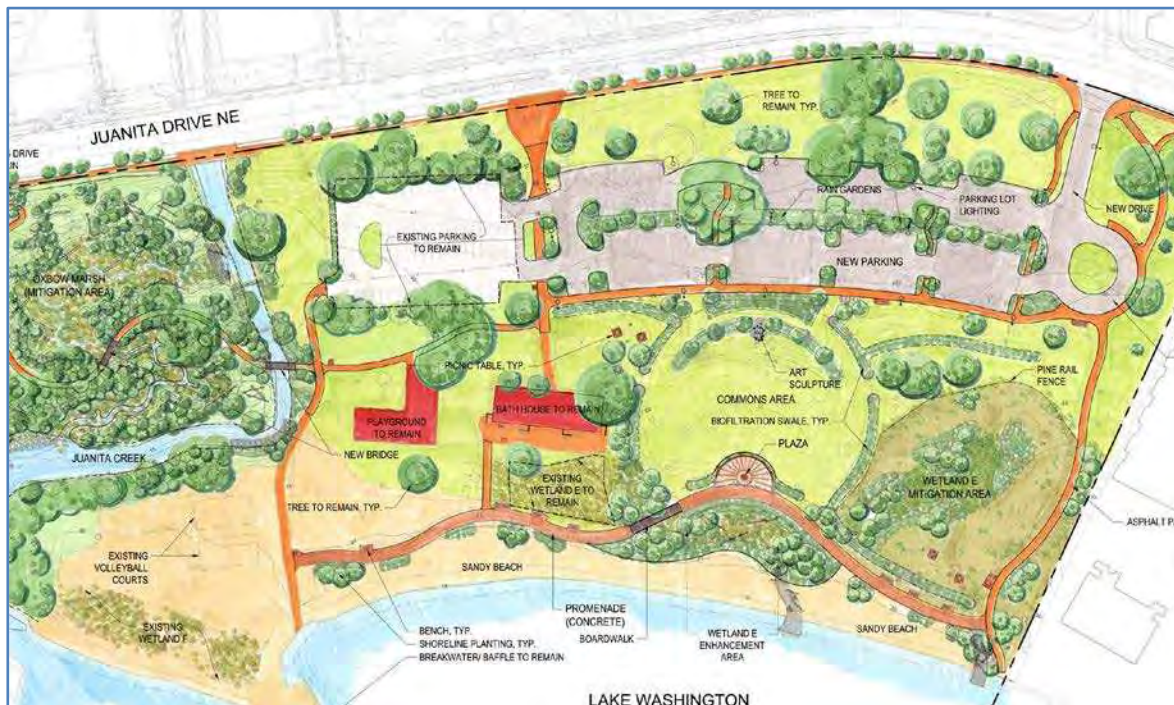
Exhibit 2. Phase I Improvements at Juanita Beach Park (J.A. Brennan Associates PLLC, 2010).

During development of the Phase I plans, an additional wetland was confirmed on the Lake Washington shoreline. The Phase I SEPA analysis documented the stream and wetland impacts and associated mitigation, and the City issued a Determination of Non-Significance in 2009. The remaining project permits were obtained for Phase I in 2009 and 2010, and construction was completed in 2011. The final permitted condition is shown in Exhibit 2.
