Juanita Beach Park Property  
Kirkland, Washington

#### WETLAND MITIGATION PLAN SHEET

## WETLAND BUFFER MITIGATION PLAN SHEET

**JUANITA PARK SIDEWALK CAPITAL IMPROVEMENT PROJECT  
WETLAND AND LAKESHORE DELINEATION REPORT  
(THE WATERSHED COMPANY, 2016)**

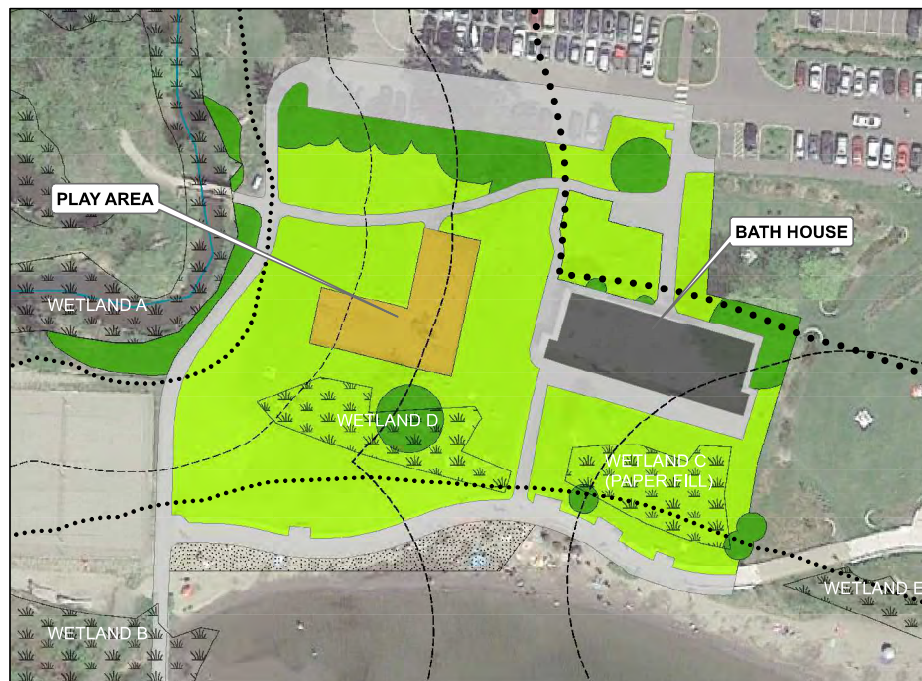
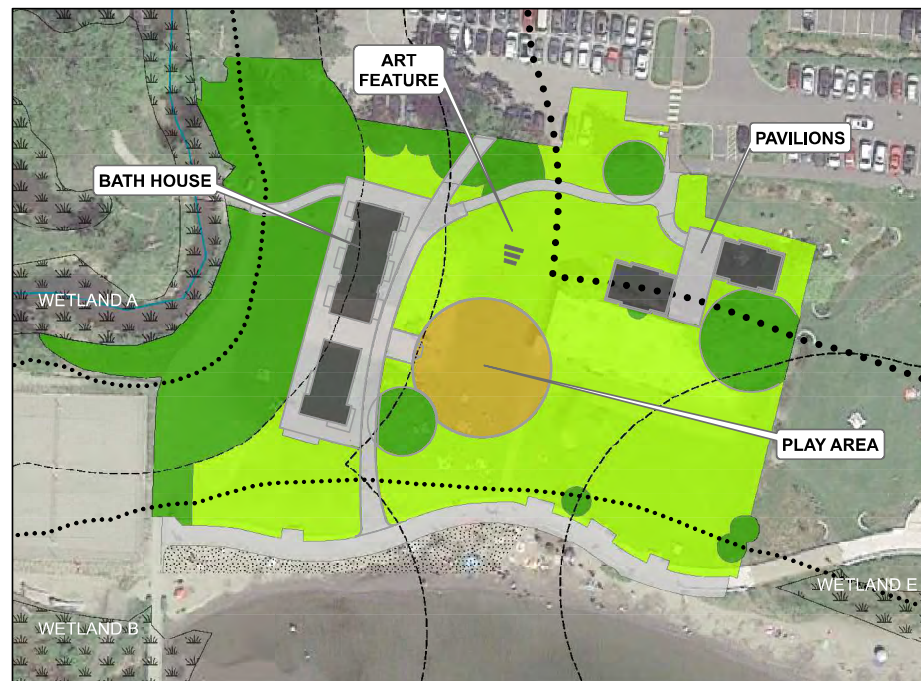
FIG. 6

EXISTING CONDITIONS

PROPOSED CONDITIONS

**SITE PLAN  
BEFORE AND AFTER**

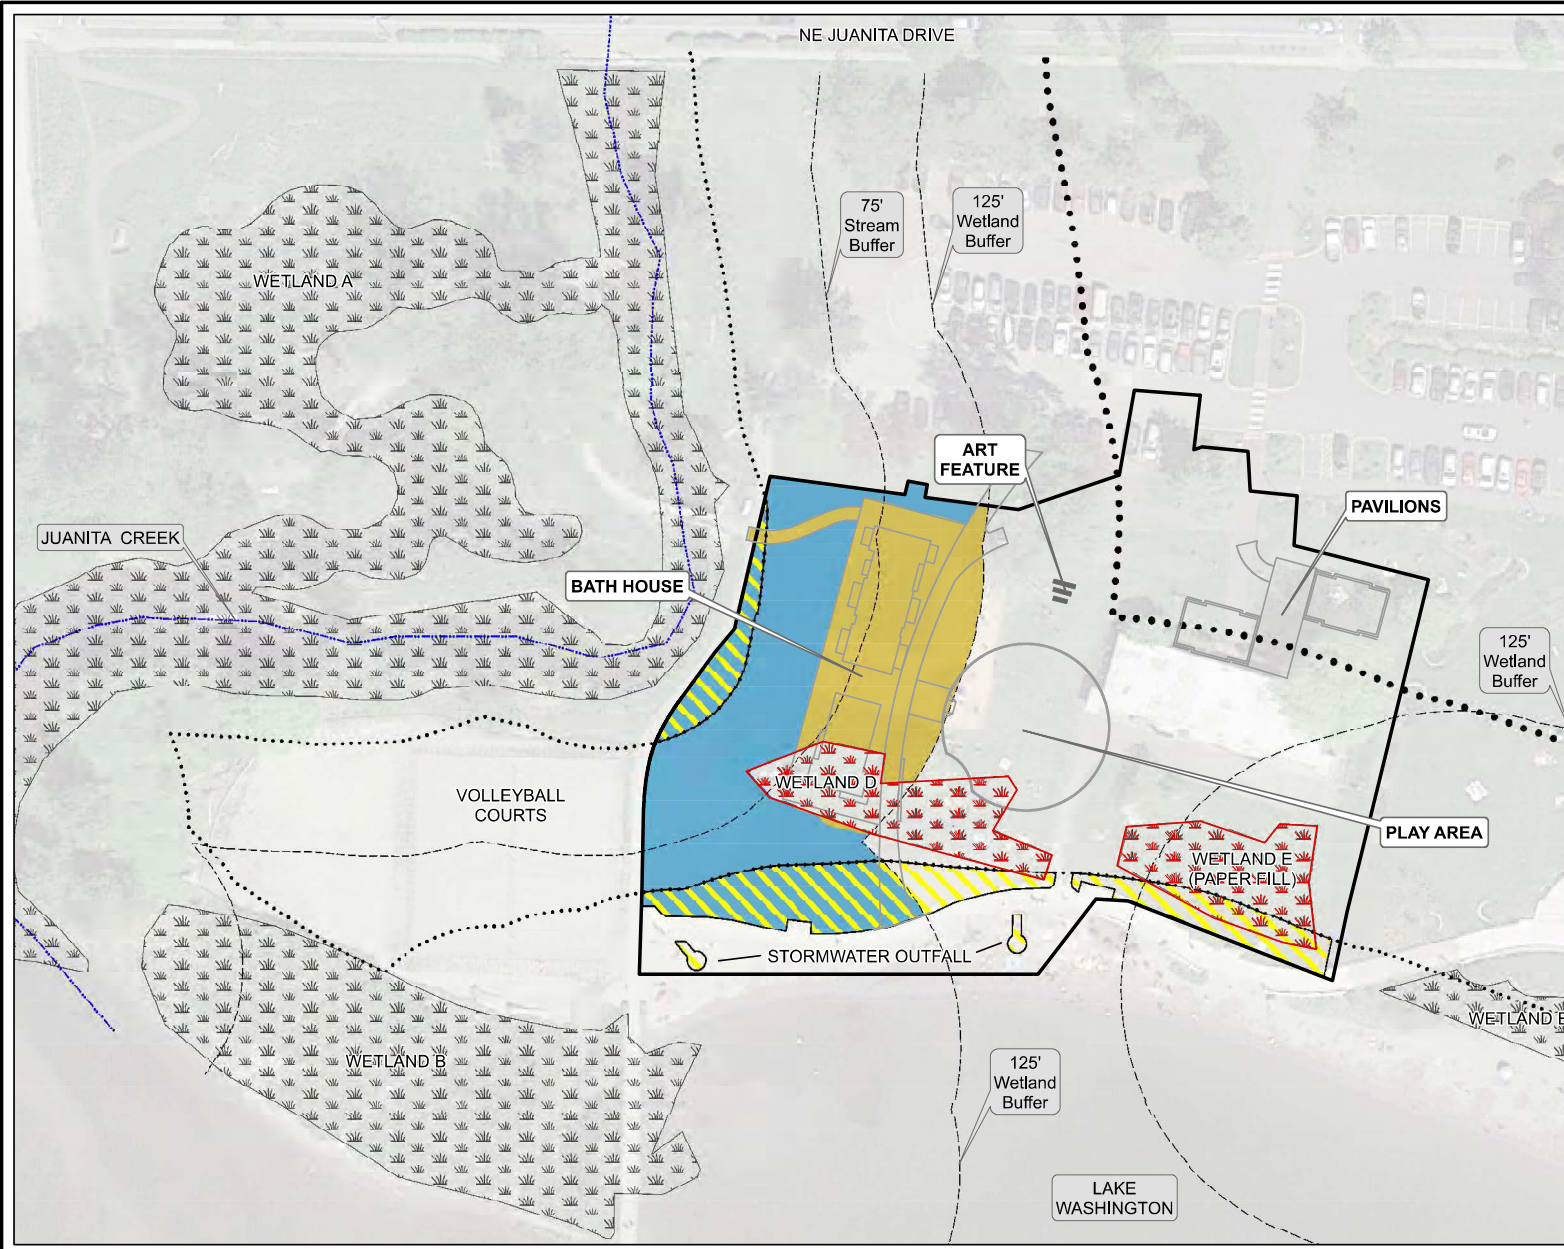
FIG. 7

Wetland Fill 8,180 sf
-

Permanent Buffer Loss 8,421 sf
-

Temporary Buffer Impact 14,904 sf
-

Shoreline Setback  
Temporary Impacts 7,612 sf
-

## WETLAND AND BUFFER IMPACTS

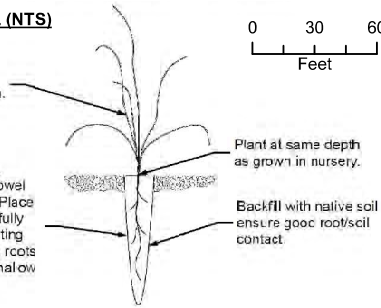
#### PLUG DETAIL (NTS)

Avoid breaking or burying top growth.

Dig hole w/ dibble, small shovel, or trowel to full root depth. Place plant so roots are fully extended into planting hole. Do not force roots into too small or shallow a planting hole.

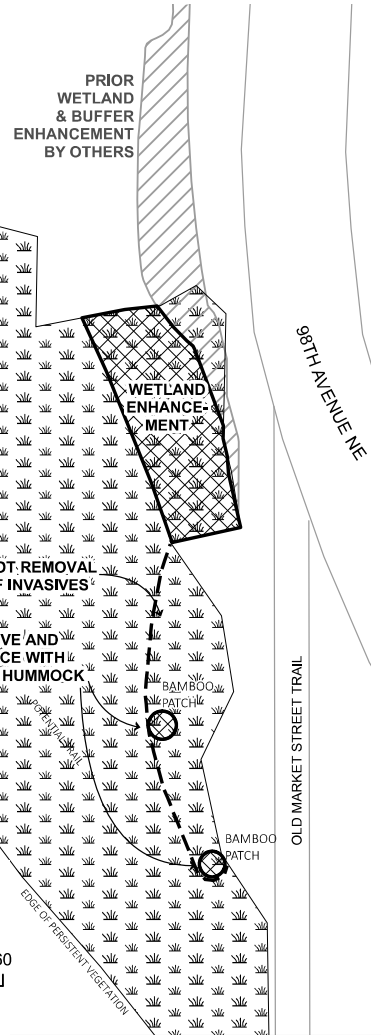
FIG. 8

- Wetland Enhancement (4,866 sf)
- Existing Wetland
- Prior Wetland & Buffer Enhancement by Others
