**Re: Orcas Moon Property  
Stream & Wetland Delineation & Buffer Modification 2<sup>nd</sup> Review**  
The Watershed Company Ref. No.: 160622.6

This letter presents the findings of an environmental review of the applicant's response to my previous review letter for the Orcas Moon property, dated September 2, 2016. The Orcas Moon LLC property is located between 20<sup>th</sup> Avenue and Forbes Creek Drive (Parcel numbers 389010-0050 and -0055). The following documents were reviewed for this study:

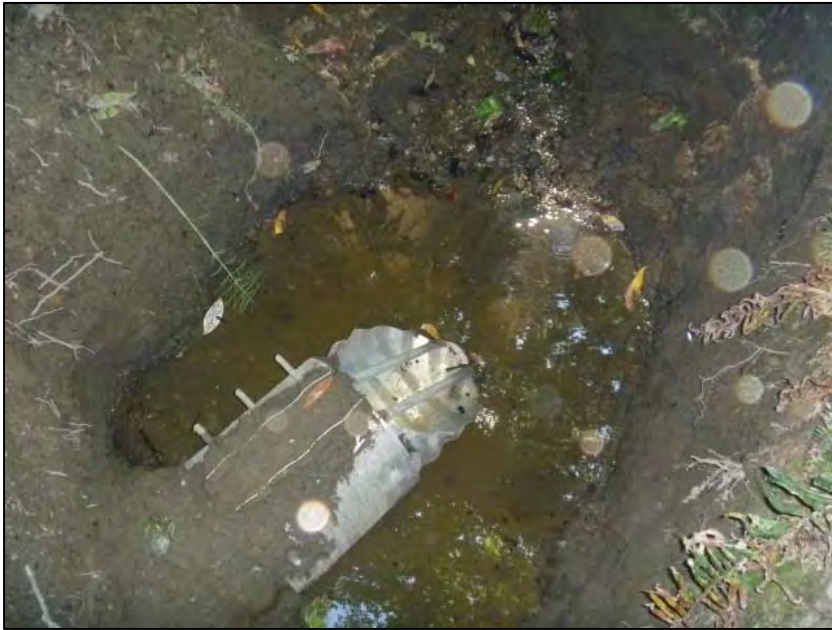
Photo 1. One of the installed trash racks (Photograph taken 7/6/17)

As I shared with you following my July 6<sup>th</sup> site visit, recently installed trash racks were observed on the culverts in streams 2, 3 and 4. Additionally, hay bales and straw wattles were placed in the stream channels above the modified culverts (see Photos 1 and 2 below). Per the email documentation you forwarded to me, the property owner has reviewed these improvements with Elizabeth Torrey of the Washington Department of

Regarding Stream 2, it should be noted that a culvert maintenance plan is proposed in lieu of other alternatives, such as daylighting. The applicant proposes to retain existing culverts and reinstalling trash racks on culverts for Streams 2, 3 and 4. As Fish and Wildlife Biologist Elizabeth Torrey at WDFW noted in her July 19, 2017 email for this project:

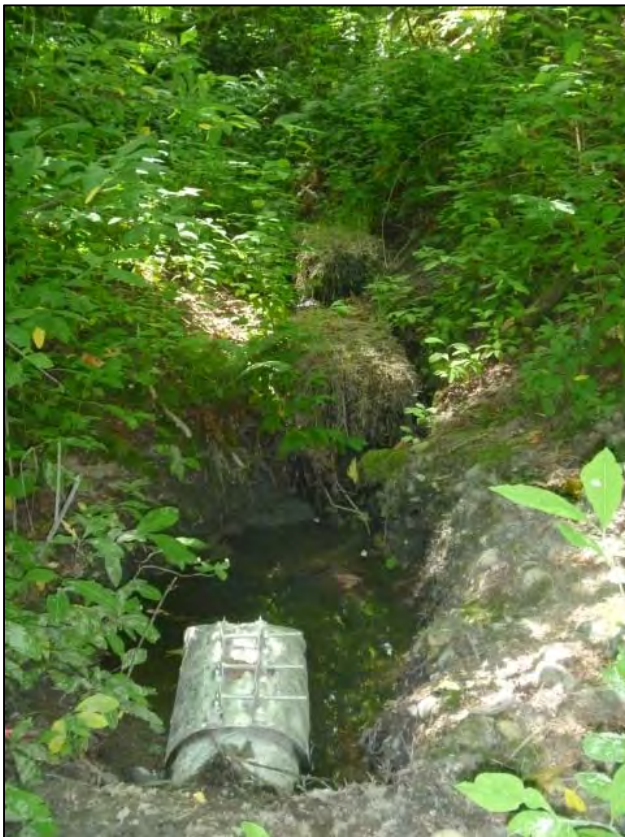
Photo 2. Trash rack with straw bales in upstream channel. (Photograph taken 7/6/17)

The applicant's engineer provided an analysis of drainage capacity for the existing culverts (CAR, Appendix C) and states they are adequate for a 100-year storm event. However, it is unclear if this analysis was for unobstructed pipes or if bedload and debris passage was included. Observed sediment deposition, and in the case of Stream 2 downstream erosion, indicates these culverts are not presently functioning well. From a biological perspective, the streams, most notably Stream 2, would benefit from daylighting and in-channel enhancement to better manage flows and sediment transport. Not only would the interaction between the forest and the stream improve but removal would eliminate the risk the pipes plug and the streams cut new channels.

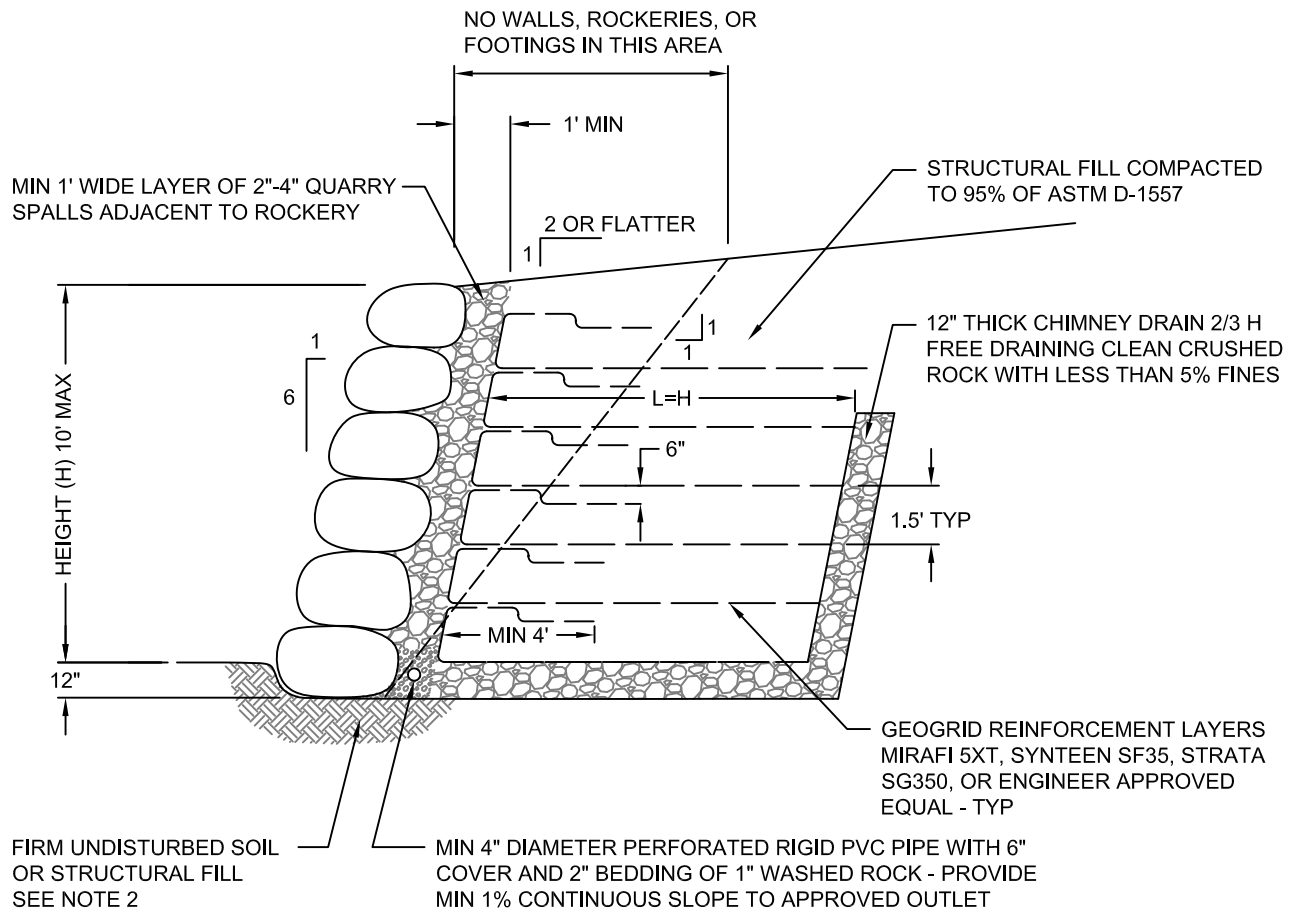
1. ROCKERIES HIGHER THAN 5' SHALL BE CONSTRUCTED OF ROCKS OF GRADUATED SIZES FROM 5-MAN TO 2-MAN, FROM BOTTOM TO TOP. ROCKERIES OF 5' OR LOWER SHALL BE CONSTRUCTED OF 3-MAN TO 2-MAN, FROM BOTTOM TO TOP.
