*Subsurface Exploration, Geologic Hazard, and  
Geotechnical Engineering Report*

**LONDO FORBES CREEK**

Kirkland, Washington

Project No. 160384E001

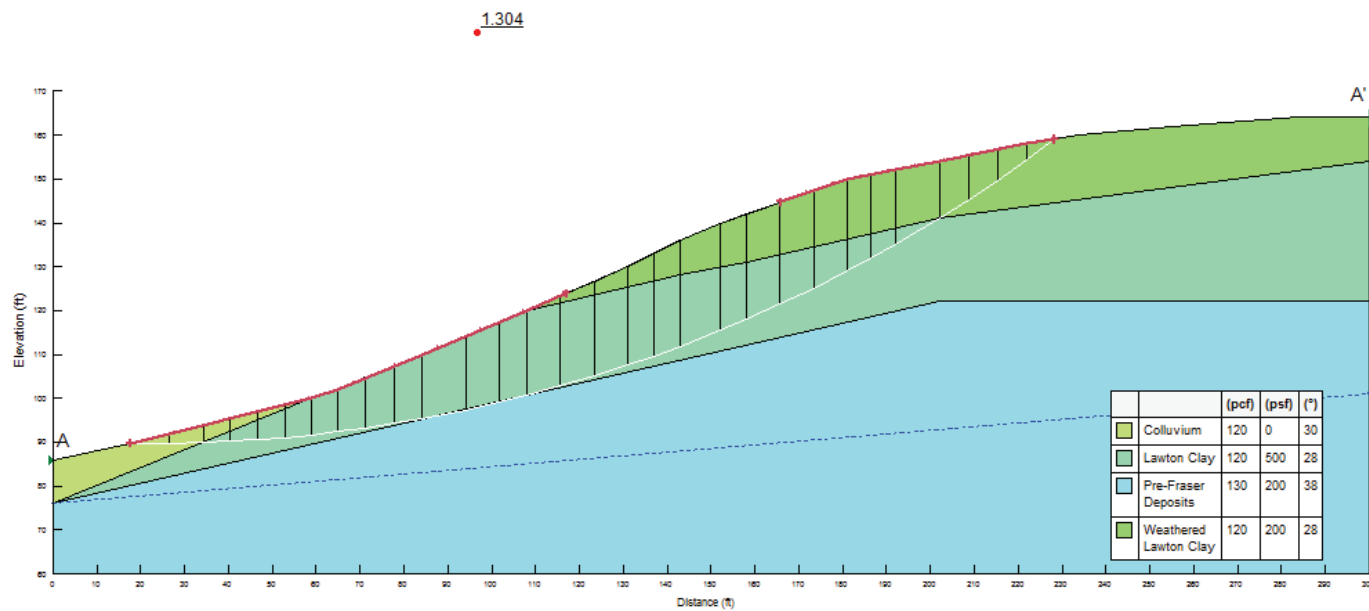
PROJ NO. 160384E001 DATE: 10/18 FIGURE: 3

- Attachments:
- Figure 1: Vicinity Map
  - Figure 2: Site and Exploration Plan
  - Figure 3: Slope Stability - Existing - Cross-Section A-A' (seismic)
  - Figure 4: Slope Stability - Existing - Cross-Section A-A' (static)
